Bridge 00411 Inspection Report

Route:64 Section:02 Log:17.54

IDENTIFICATION	
(1) State Names	5 - Arkansas
(8) Structure Number	00411
(5) Inventory Route	1
(2) Highway Agency District	04 - District 04
(3) County Code	33 - Crawford County

INSPECTIONS *			
(90) Inspection Date			11/03/2025
(91) Frequency			24
(92) Critical Feature Inspection	Done	Freq. (Mon)	Date
A: Fracture Critical Detail	No		
B: Underwater Inspection	No		
C: Other Special Inspection	No		
<p>* The inspection date and frequency information in this box contains the current NBI date and frequency information. Please refer to the report header for the date this inspection was conducted.</p>

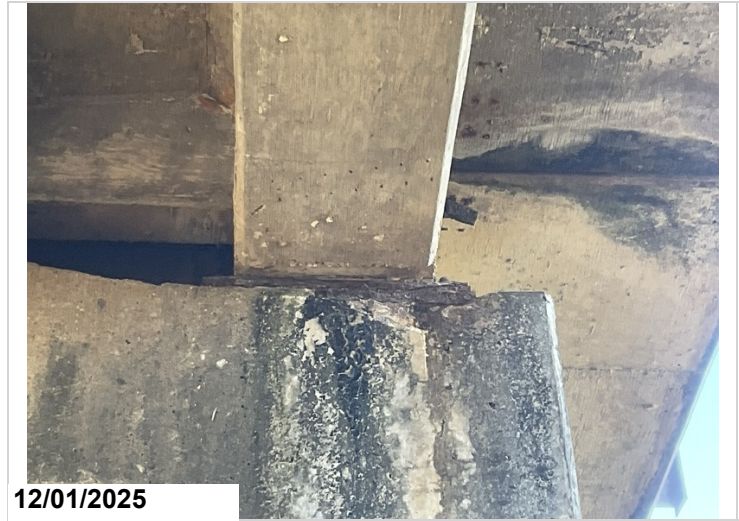
Bents # 2 Ahead Side, Bearing # 1: Bearing has corrosion with flaking rust/ section loss. Cap has shallow spalling with minor loss of bearing area to the masonry plate of bearing. Corrosion 1EA CS3.

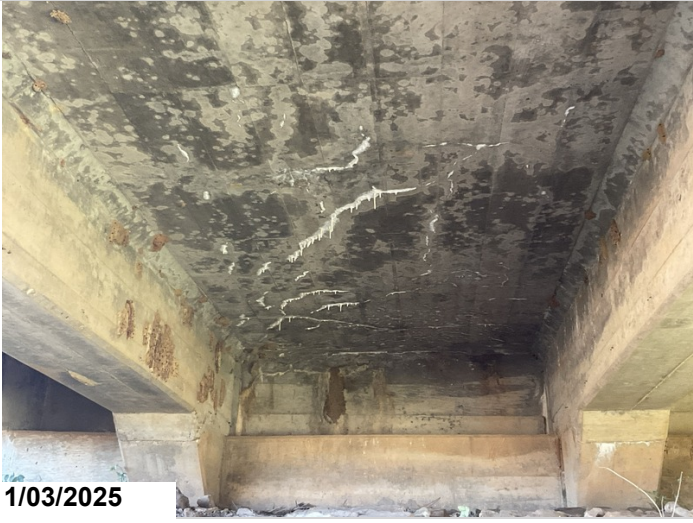
Span # 9 Undersurface, Bays # 2, Near Abutment # 2: Area of mapcracking with efflorescence. Cracking 48SF CS3.

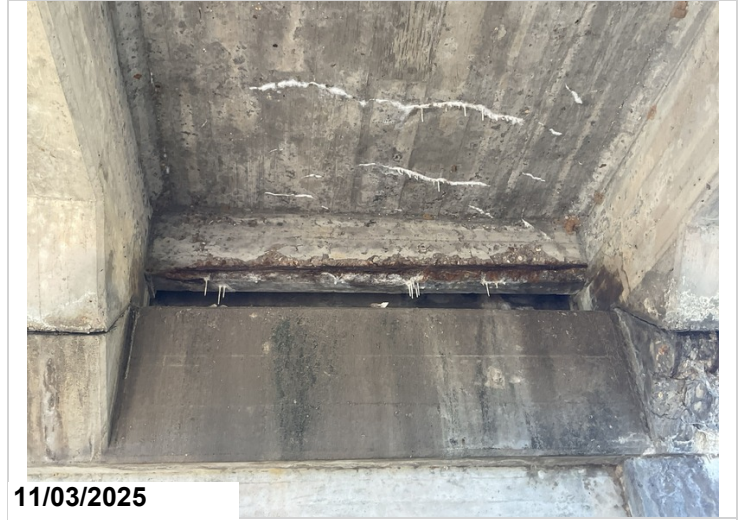
Span # 8, Over Bent # 8, Bay # 2: Spalling with exposed reinforcing steel. Exposed steel 7SF CS3.

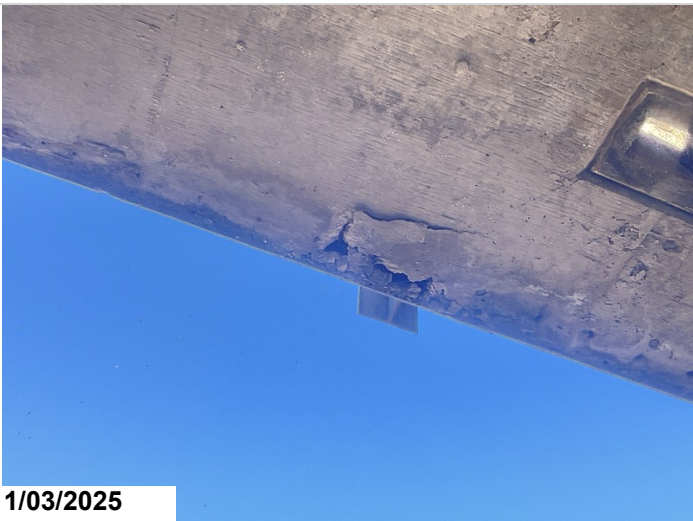
Span # 8, Left Deck Overhang: Spall/ delaminated area with exposed reinforcing steel. Exposed steel 1SF CS3.

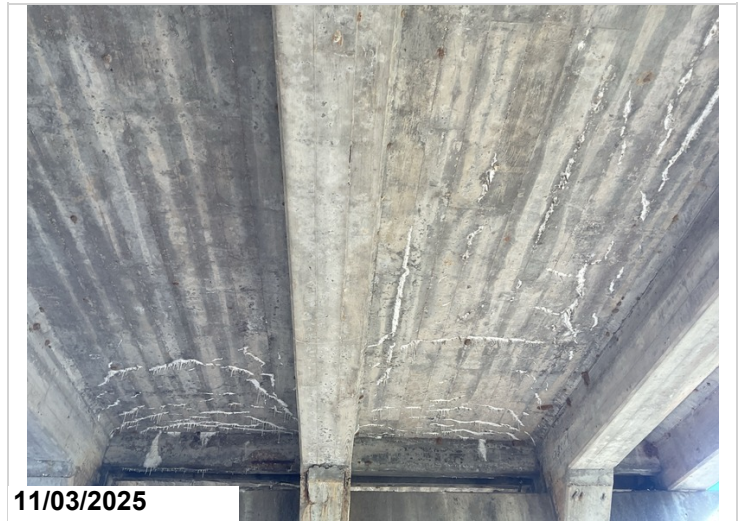
Span # 7, Bays # 2 and 3: Cracking with efflorescence.

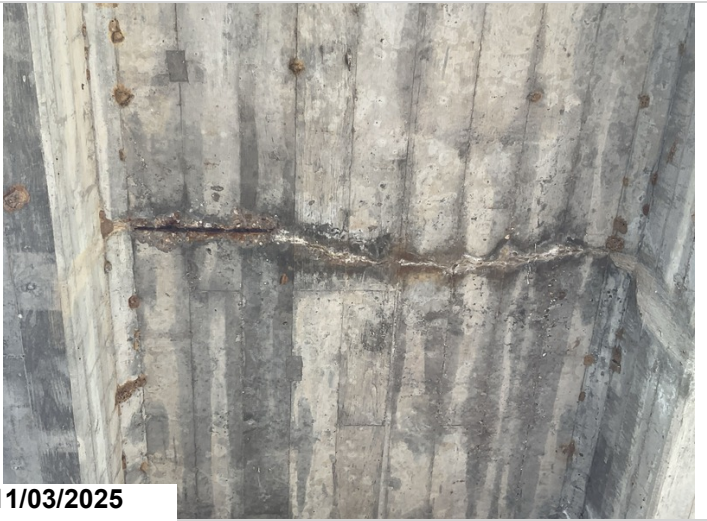
Span # 7, Bay # 2: Transverse cracking with efflorescence and spalling with exposed reinforcing steel. Efflorescence 5SF CS2, Exposed steel 2SF CS3.

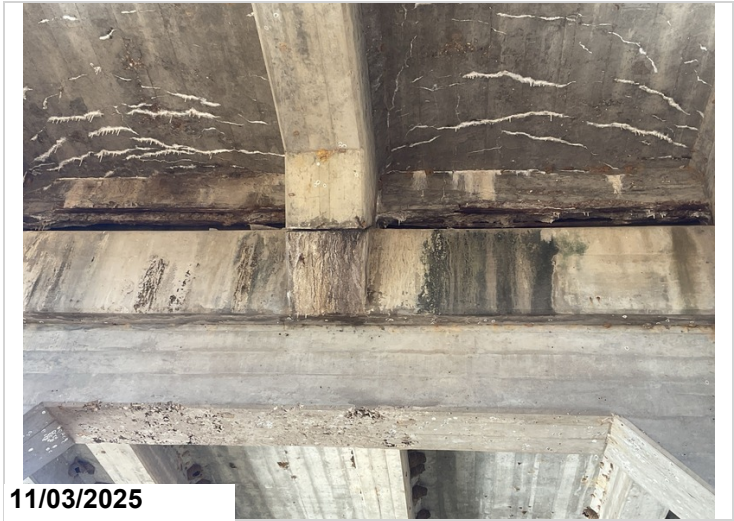
Span # 4, Over Bent # 4: Spalling with exposed reinforcing steel in expansion dam. Exposed steel 10SF CS3.

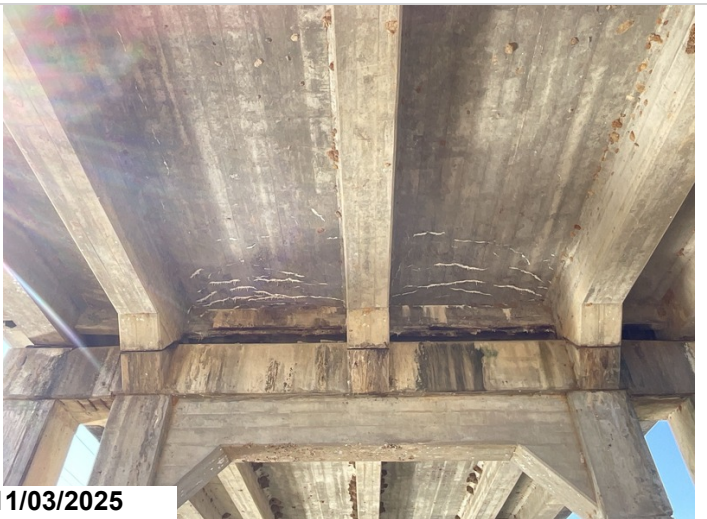
Span # 4, Bays # 2 and 3, At Bent # 4: Mapcracking with efflorescence. Cracking 48SF CS3.

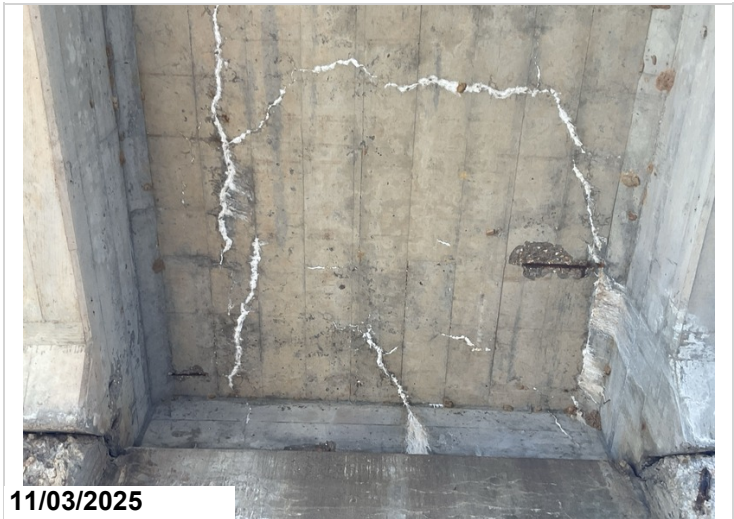
Span # 2, Bay # 2, At Bent # 2: Spalls with exposed reinforcing steel and cracking with efflorescence. Exposed steel 2LF CS3.

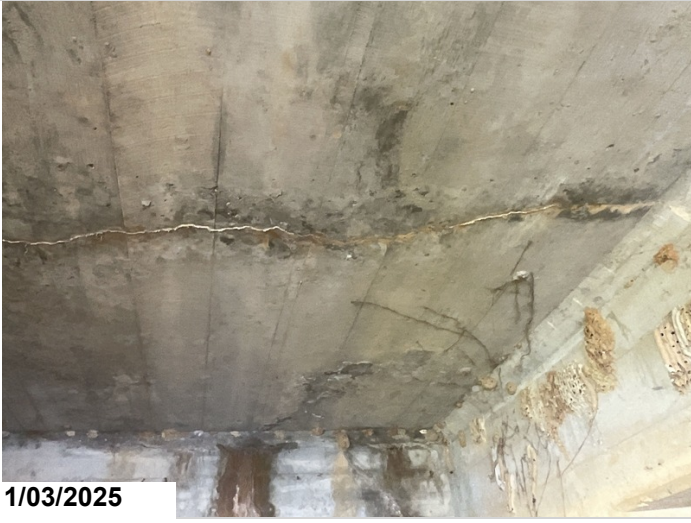
Span # 1 Undersurface, Bay # 1, 4' From Abutment # 1:
Transverse crack with light efflorescence/ staining. 7SF CS3.

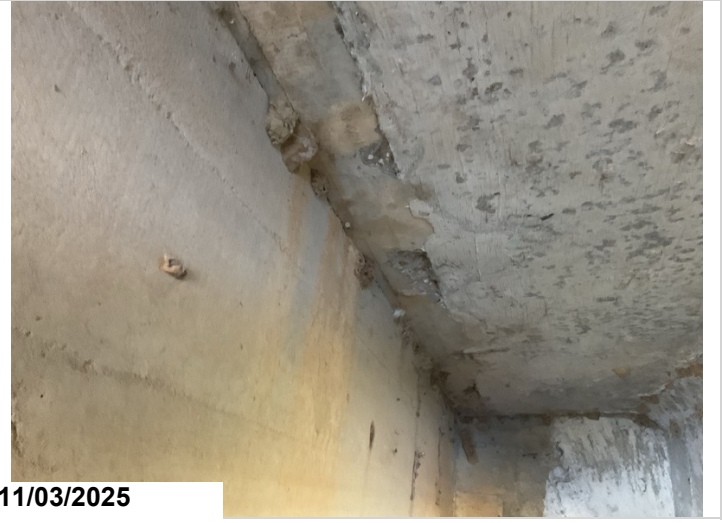
Span # 1, Bay # 1: Shallow spalling along Girder # 2 where
the structure was widened. Spall/delam 10SF CS2.

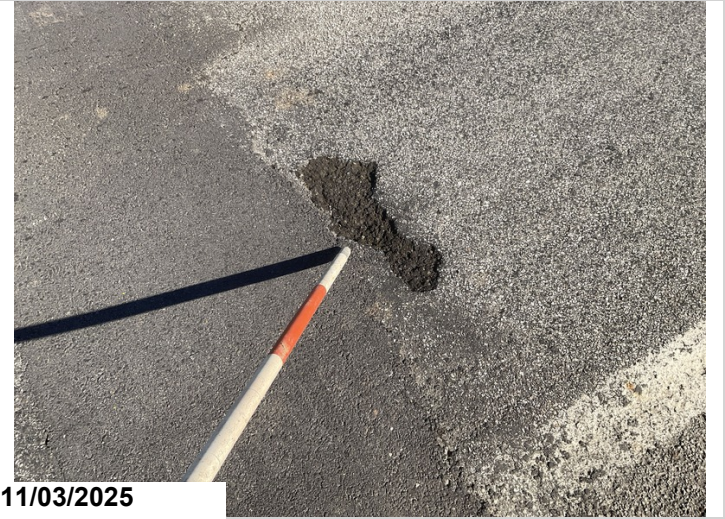
Span # 4, Right Lane, At Bent # 4: Pothole. Spall/ delam 2SF CS3.

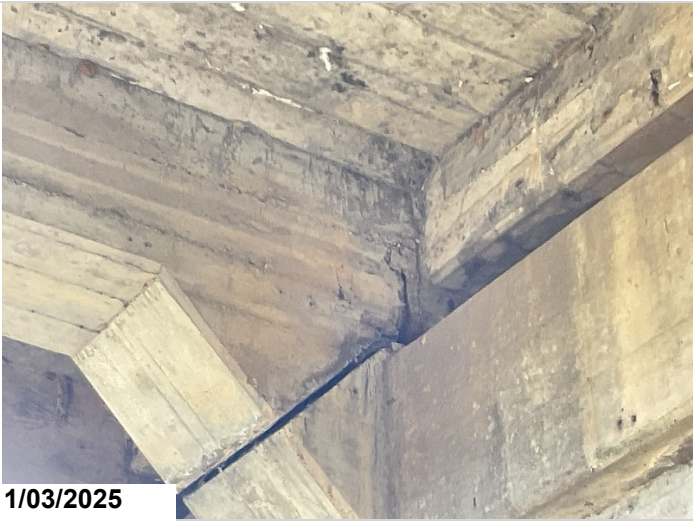
Span # 6, Bent # 6, Girder # 4: Shallow 5" high spall with exposed reinforcing steel. Exposed steel 1LF CS3.

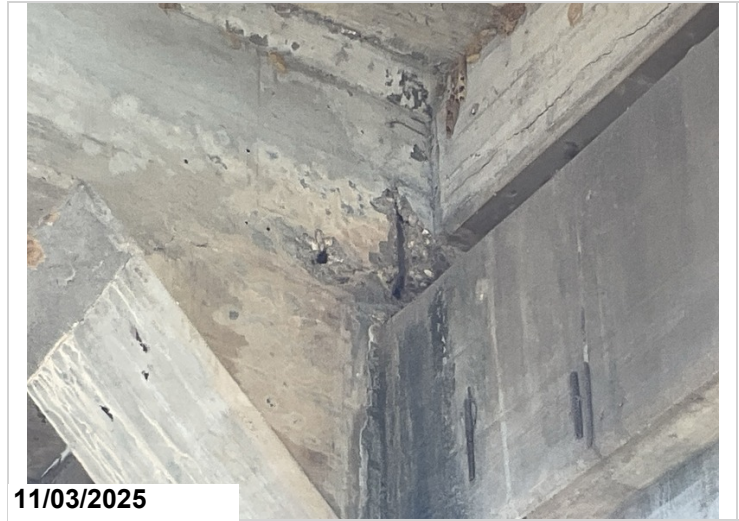
Span # 5, Bent # 6, Girder # 3: Shallow spalls with exposed reinforcing steel. Exposed steel 1LF CS3.

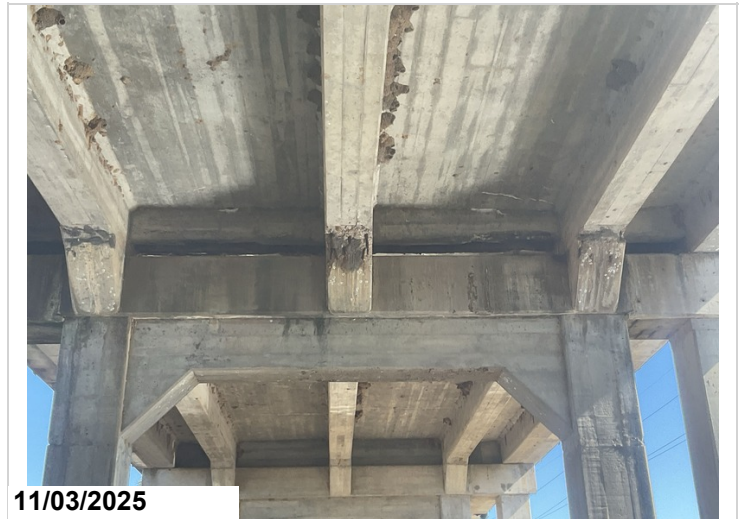
Span # 3, At Bent # 4: Spalling in ends of girders at haunch interface. Exposed steel 4LF CS3.

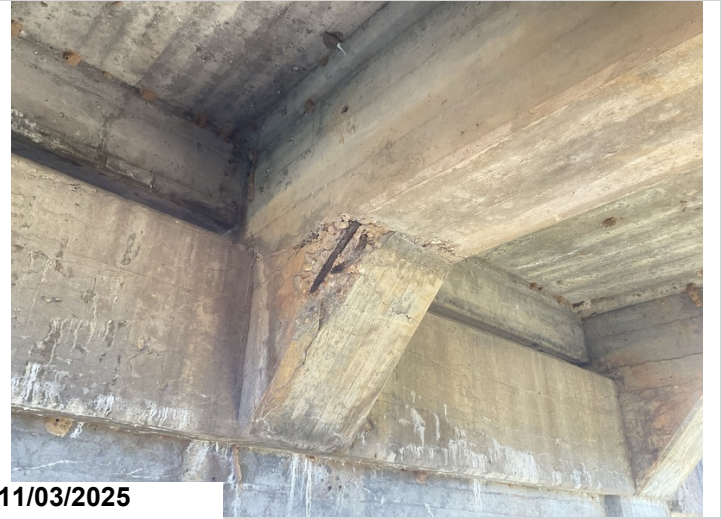
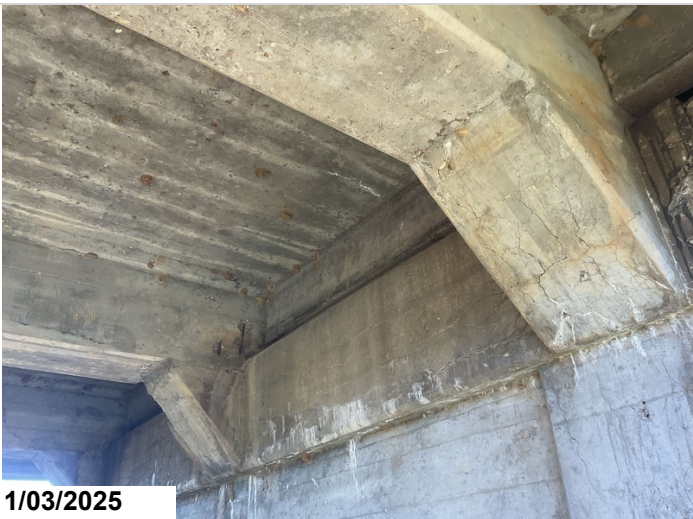
Span # 1, Girders # 3 and 4, At Bent # 2: Mapcracking in haunch, girder # 3 has spalls with exposed steel. Cracking 1LF CS3, Exposed steel 1LF CS3.

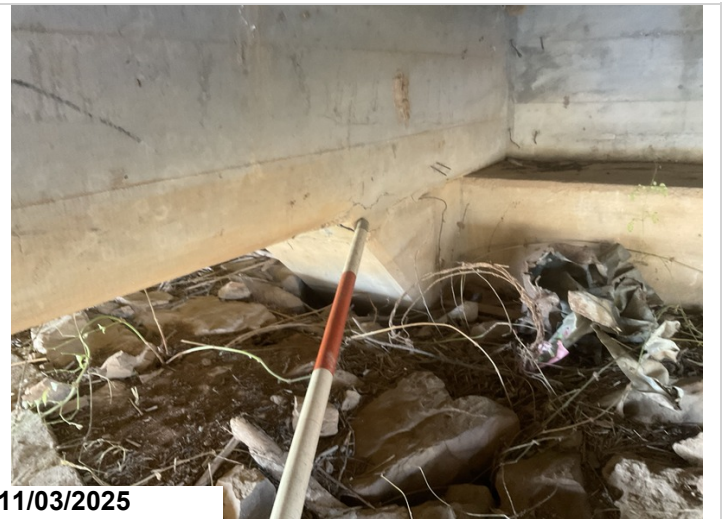
Span # 1, Girder # 3, Abutment # 1: Delaminated area. Spall/delam 1LF CS2.

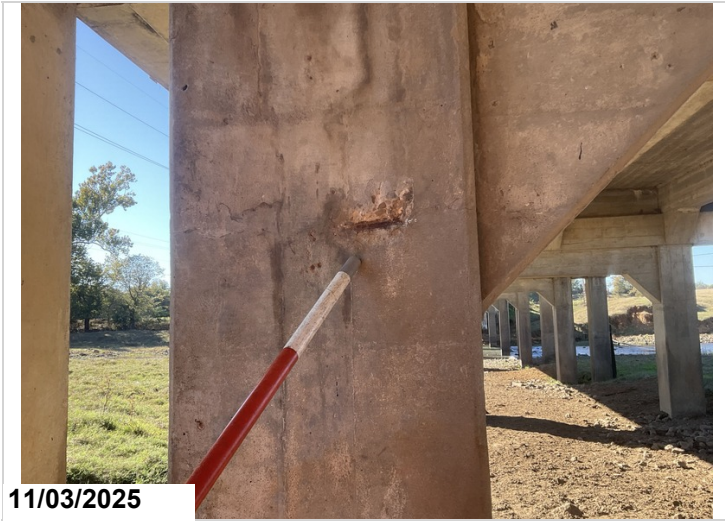
Bent # 8, Column # 3, Ahead Side: Spall with exposed reinforcing steel.

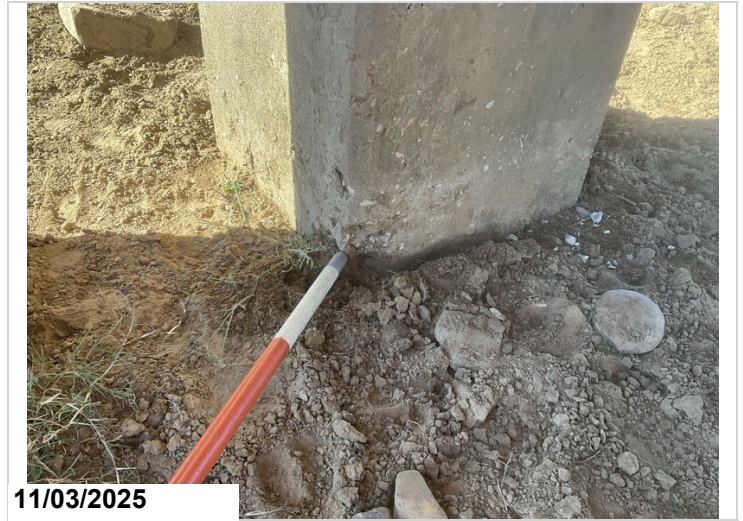
Bent # 8, Column # 3, Ahead Side: Spall at base with no exposed reinforcing steel.

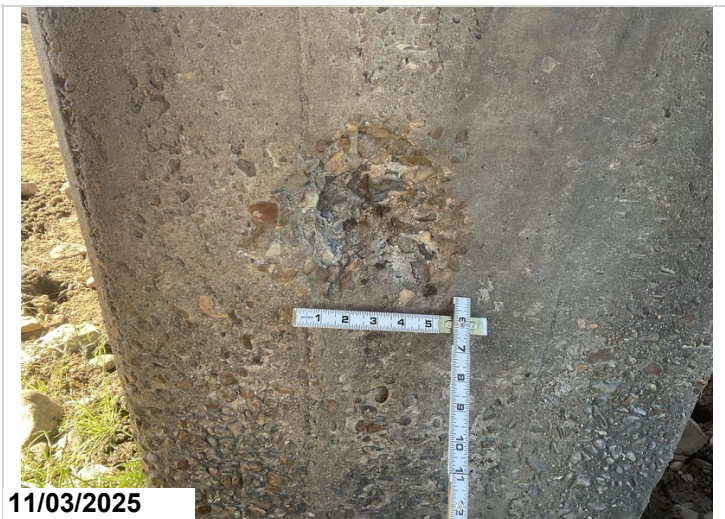
Bent # 6, Column # 2, Ahead Side: 6" spall with no exposed reinforcing steel. Spall/ delam 1EA CS3.

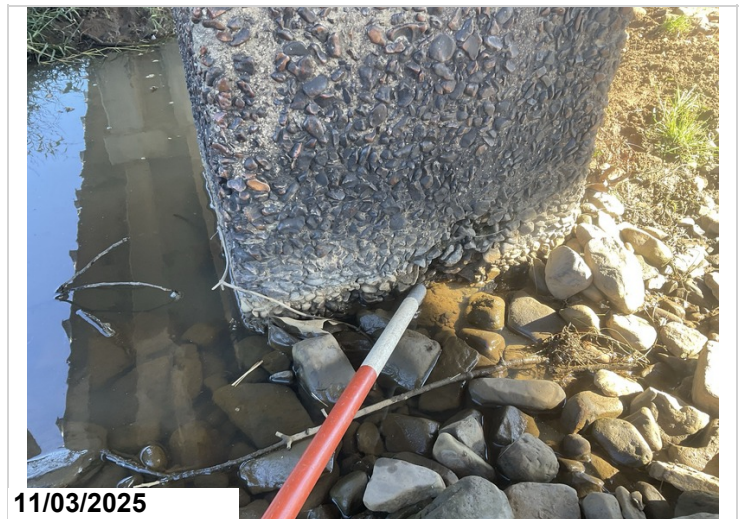
Bent # 5, Column # 2: Concrete deterioration/ heavy abrasion. Abrasion 1EA CS3.

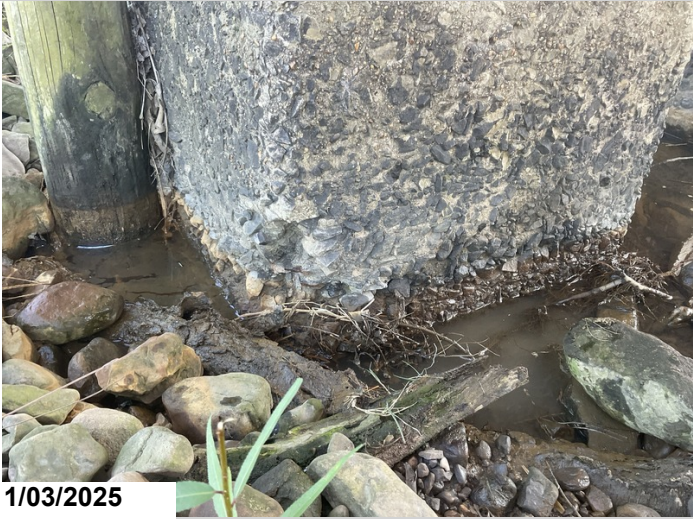
Bent # 5, Column # 1: Concrete deterioration with exposed steel. Exposed steel has complete section loss. Exposed steel 1EA CS3

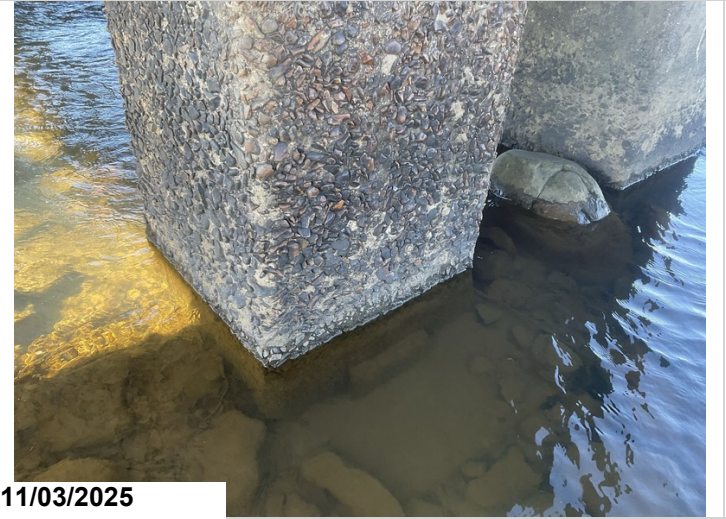
Bent # 4, Column # 2: Medium/ heavy abrasion. Abrasion 1EA CS3.

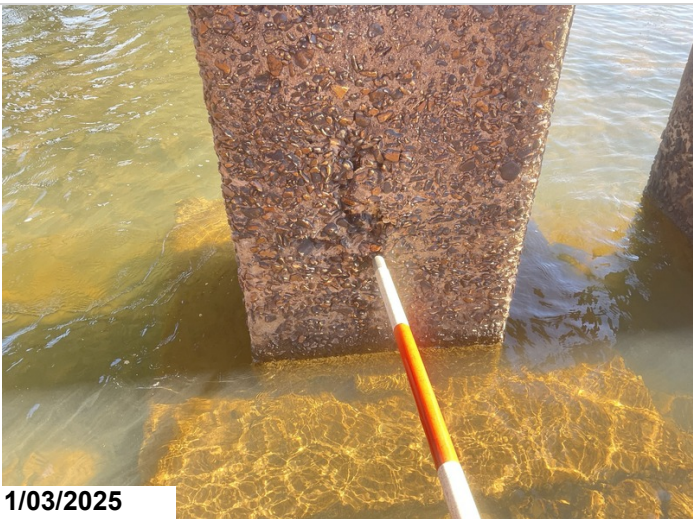
Bent # 3, Column # 3: Light abrasion with area of concrete deterioration. Spall/ delam 1EA CS3.

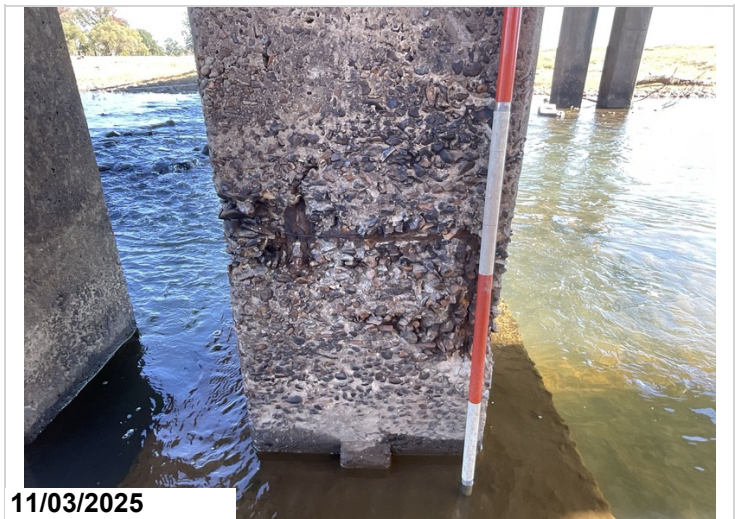
Bent # 3, Column # 2, Back Side: Full width x 15" high area of concrete deterioration with exposed reinforcing steel and up to 2" of concrete section loss. Exposed steel has section loss. Exposed steel 1EA CS3

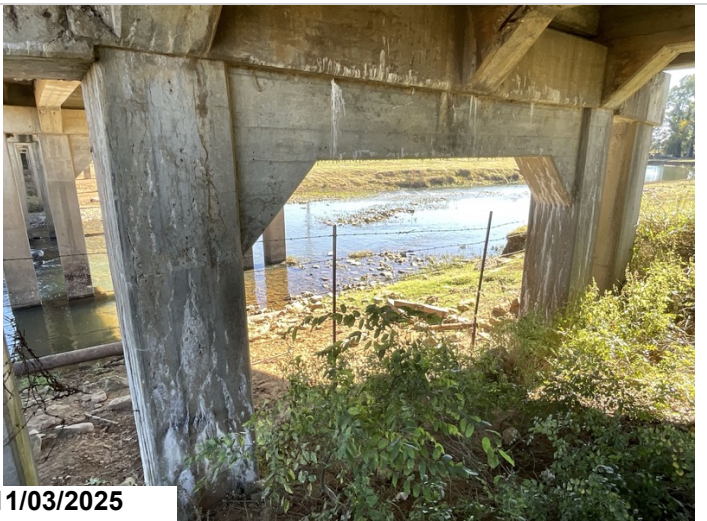
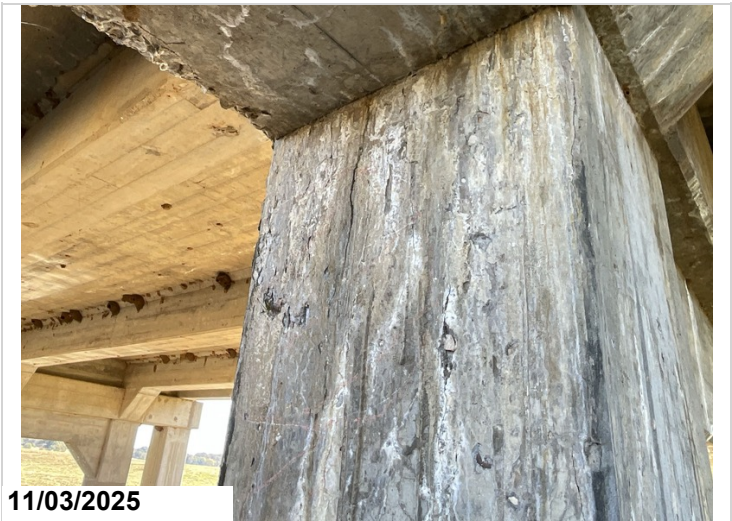
Bent # 2, Columns # 2 & 3: Map cracking and delaminated areas with efflorescence. Bent # 2, column # 2 has numerous vertical cracks with efflorescence with a 30" delaminated area in the exterior face near cap juncture. Cracking 2EA CS3.

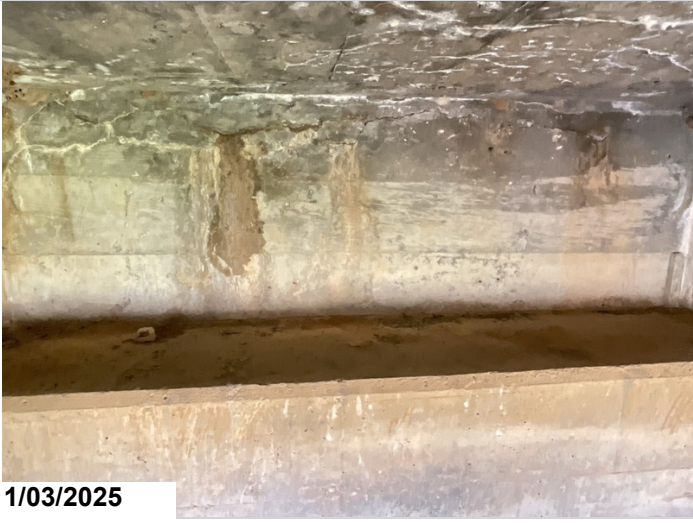
Abutment # 2 Back wall, Bay # 2: Moderate width horizontal cracking with efflorescence near deck juncture. Efflorescence 3LF CS2, Cracking 2LF CS2, 2LF CS3.

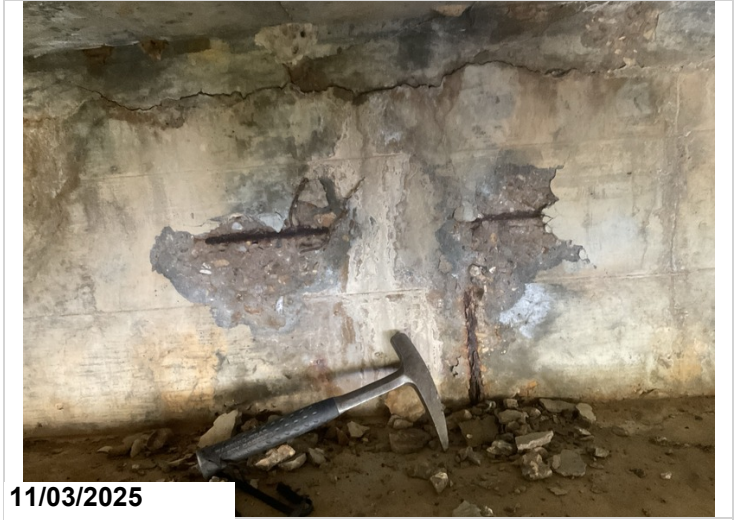
Span # 1, At Abutment # 1: Girder haunches have horizontal cracking with delaminated areas.

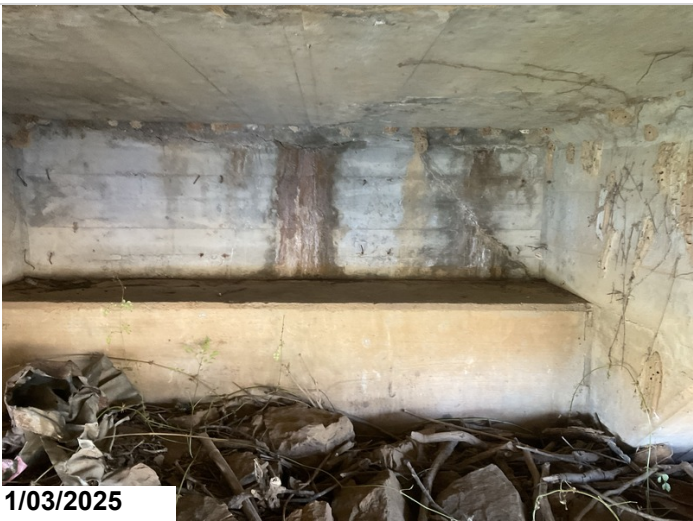
Abutment # 1 Backwall, Bay # 2: Vertical and diagonal cracking with efflorescence and rust staining. Efflorescence/staining 3LF CS3.

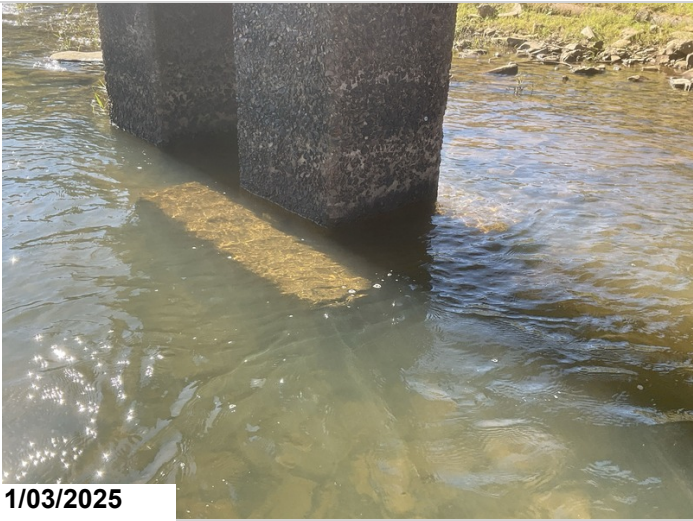
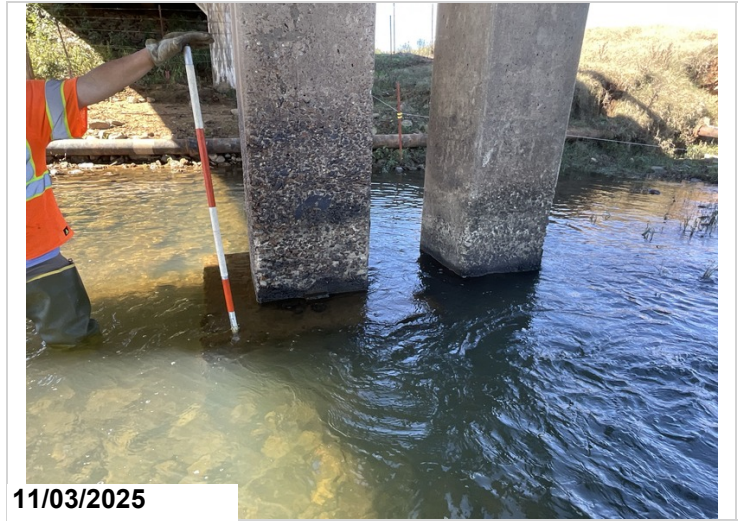
Visual observation during relatively low and clear water conditions indicate that bent # 3 footings are exposed at all 4 columns. Columns # 2 and 3 have up to approximately 24" of the vertical face of footing exposed. Column # 3 footing pictured.

Visual observation during relatively low and clear water conditions indicate that bent # 3 footings are exposed at all 4 columns. Columns # 2 and 3 have up to approximately 24" of the vertical face of footing exposed.

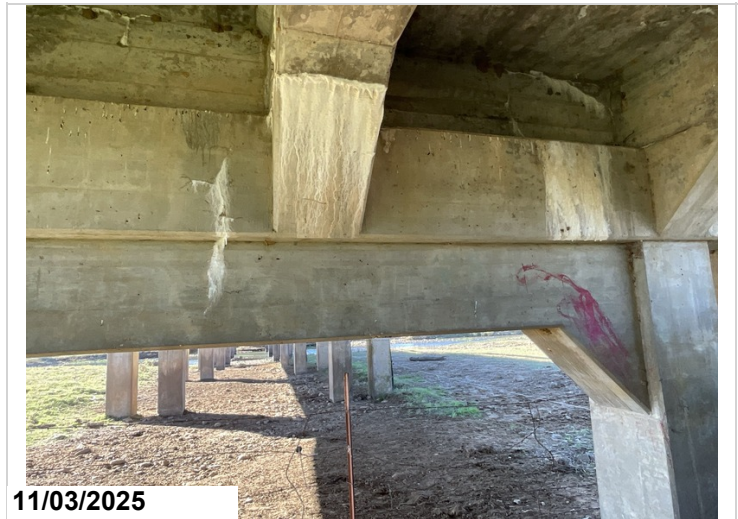
Bent # 2, Cap, Ahead Side: Vertical cracks with efflorescence. Efflorescence 2LF CS2.

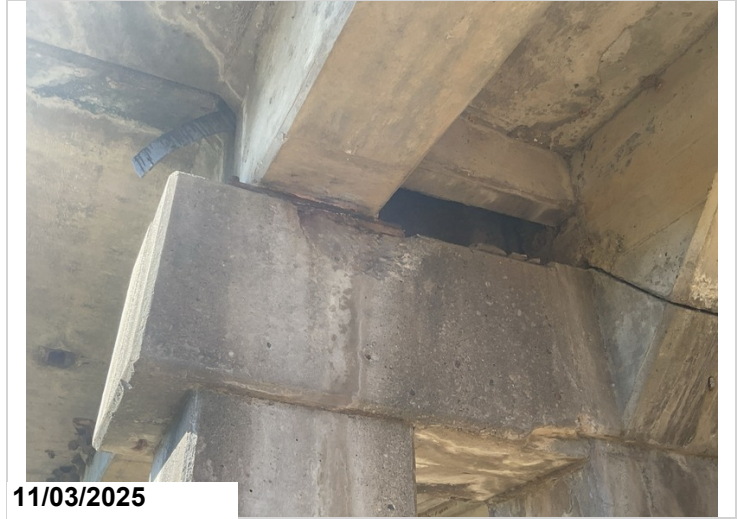
Bent # 8 Cap, Over Column # 4: Shallow spall with no exposed rebar under the bearing masonry plate over column # 4. Spall/delam 1LF CS3.

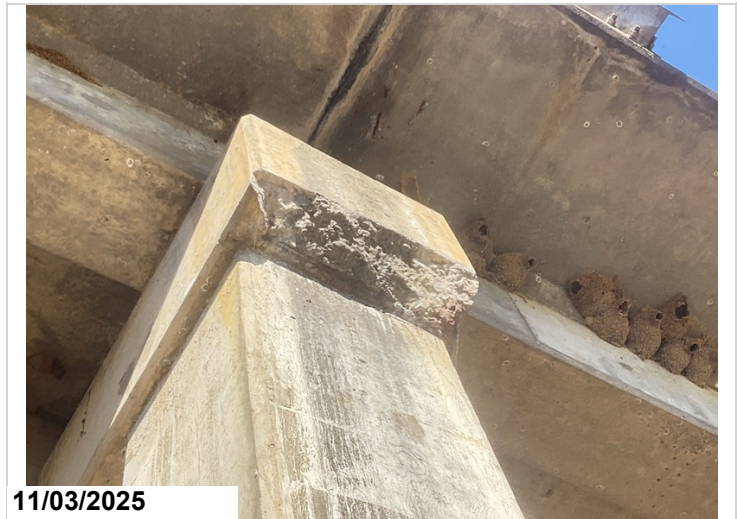
Bent # 5, Cap, Right End: Spalling with exposed reinforcing steel.

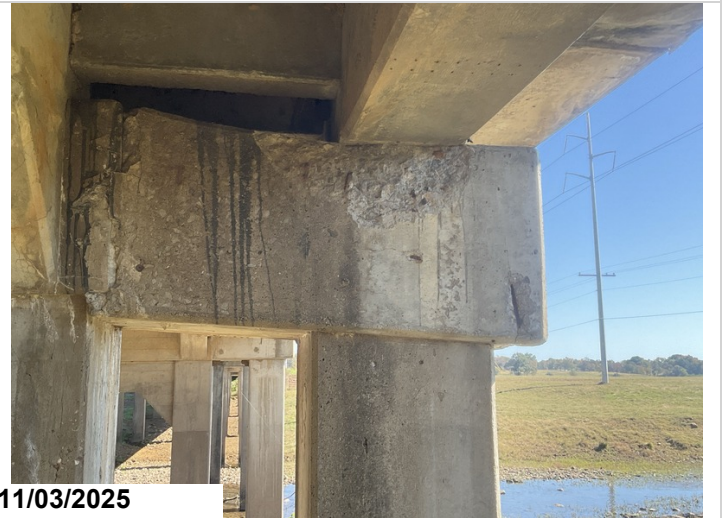
Bent # 2 Cap, Right Back Side: Spall/ delaminated areas and exposed steel. Spall/delam 1LF CS2, 2LF CS3, Exposed steel 1LF CS3.

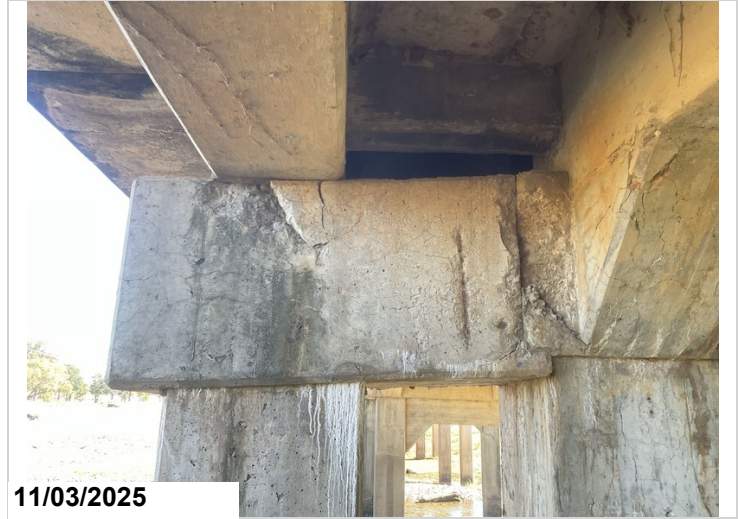
Bent # 2 Cap, Left Back Side: Spall/ delaminated areas and exposed steel. Spall/delam 1LF CS2, 2LF CS3, Exposed steel 1LF CS3.

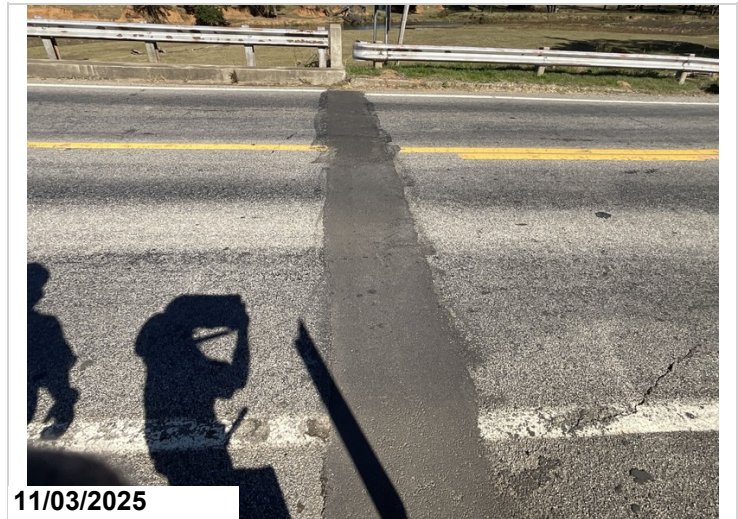
Abutment # 2, Expansion Joint: Asphalt patch.

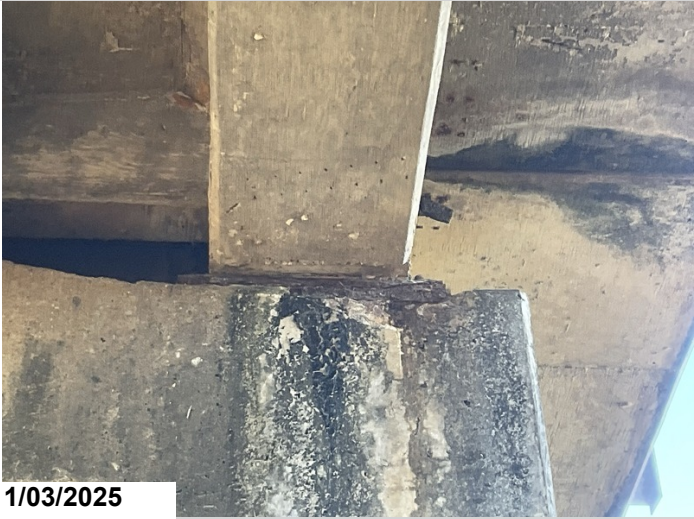
Bents # 2 Ahead Side, Bearing # 1: Bearing has corrosion with flaking rust/ section loss. Cap has shallow spalling with minor loss of bearing area to the masonry plate of bearing. Corrosion 1EA CS3.

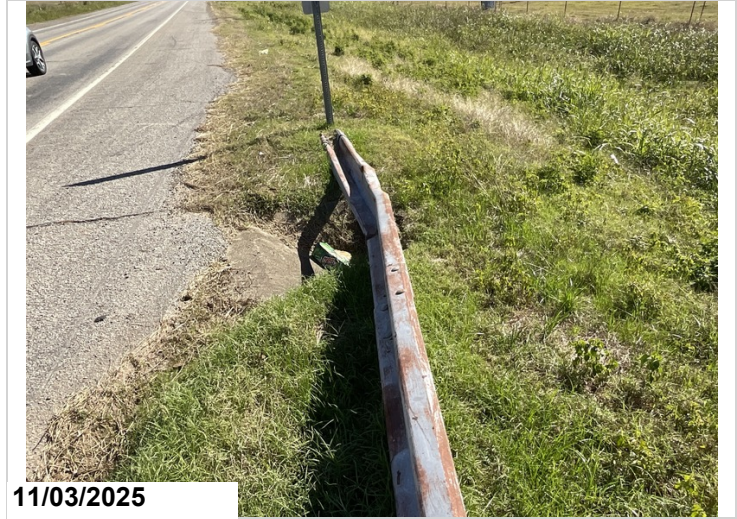
Abutment # 2 right approach railing has collision damage to the turn-down section of railing.

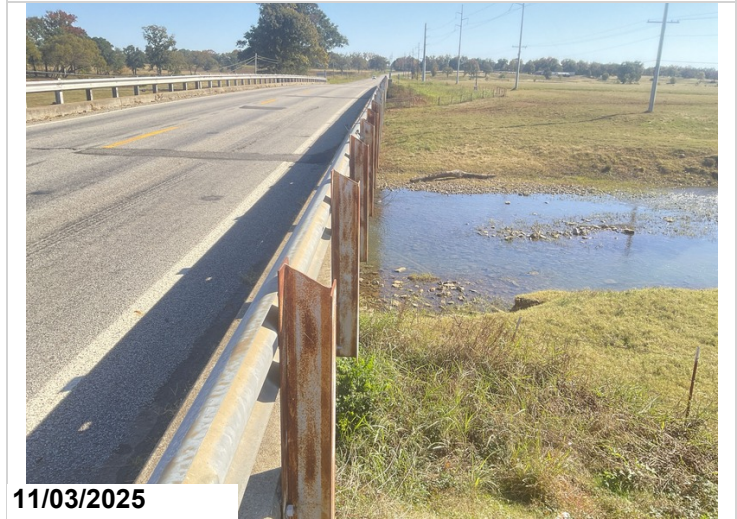
Paint system on the bridge railing post is failing in locations.

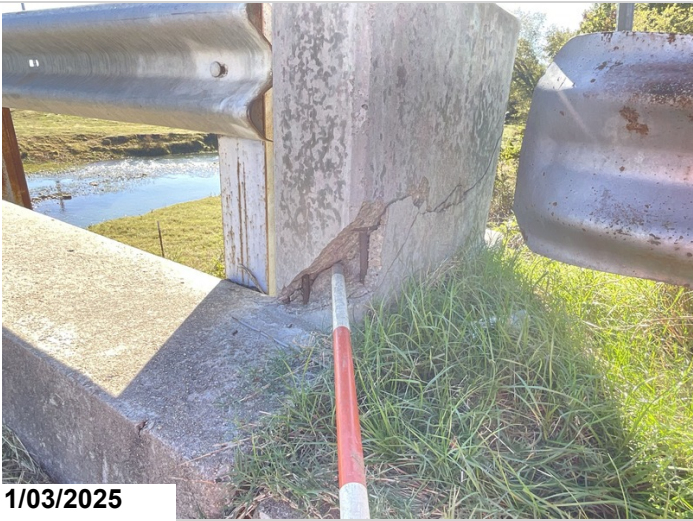
Abutment # 1, Right End Post: Fractured at the base with spalling that exposes reinforcing steel. Damage 1LF CS4.

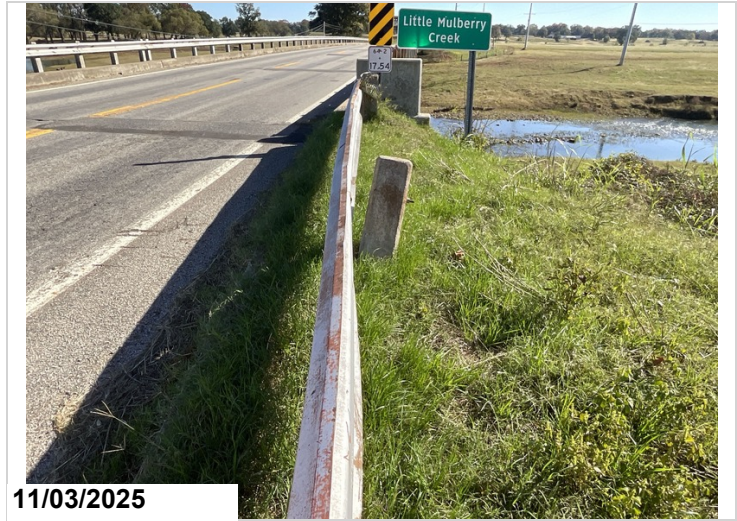
Abutment # 1 right approach railing has a failed bolted connection that attaches the railing to a post.

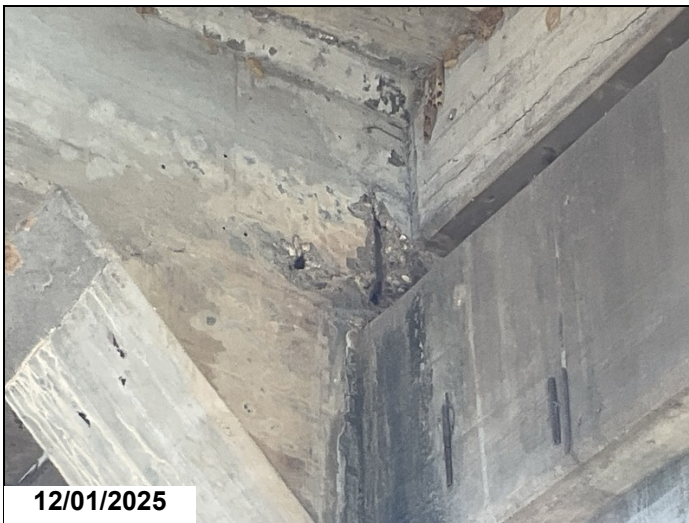
Span # 5, Bent # 6, Girder # 3: Shallow spalls with exposed reinforcing steel.

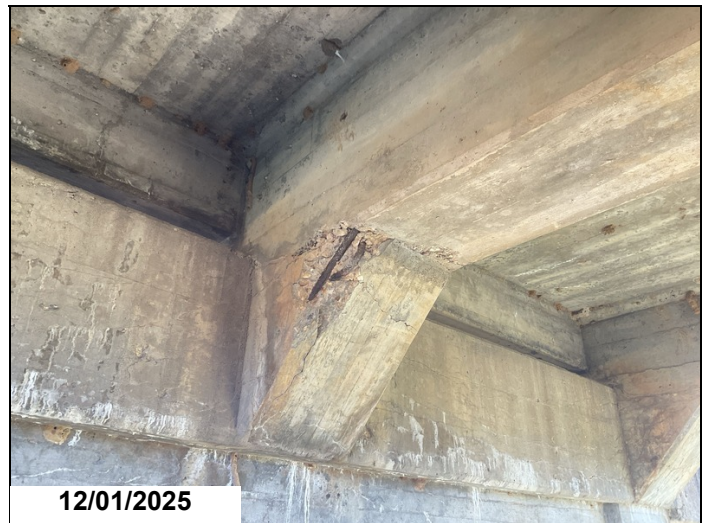
Span # 1, Girders # 3 and 4, At Bent # 2: Map cracking in haunch, girder # 3 has spalls with exposed steel.

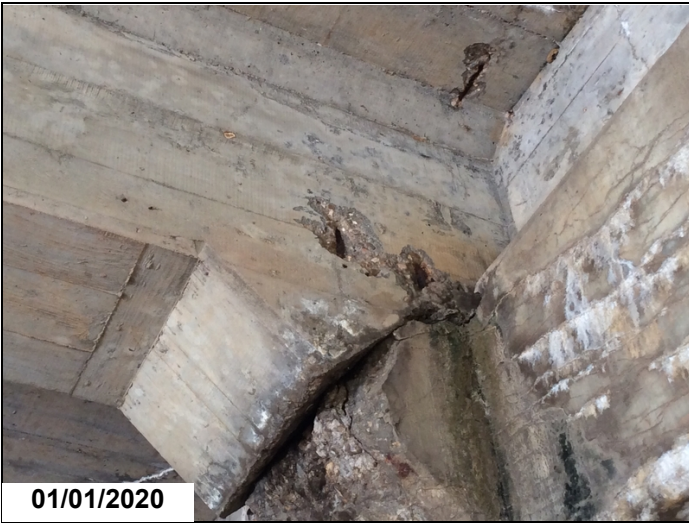
Shallow spalls with exposed hoops at the ends of girders are typical with exposed reinforcing steel that has active corrosion with initial section loss.

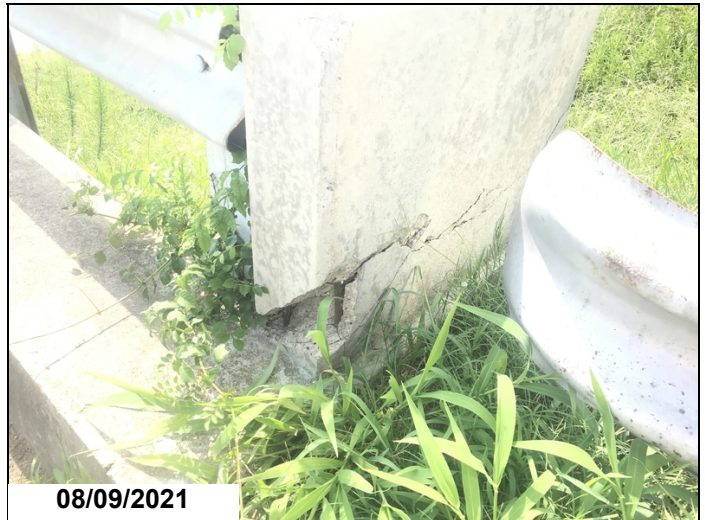
Abutment # 1 right end post is fractured at the base with spalling that exposes reinforcing steel.

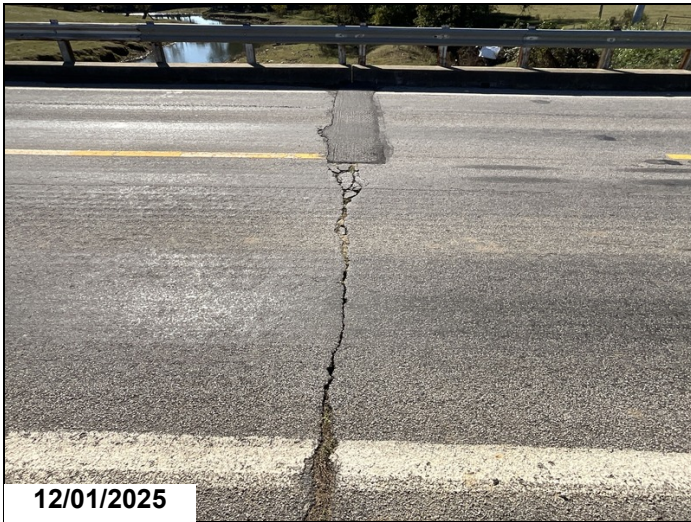
Bent # 2 Expansion Joint: Asphalt breaking apart.

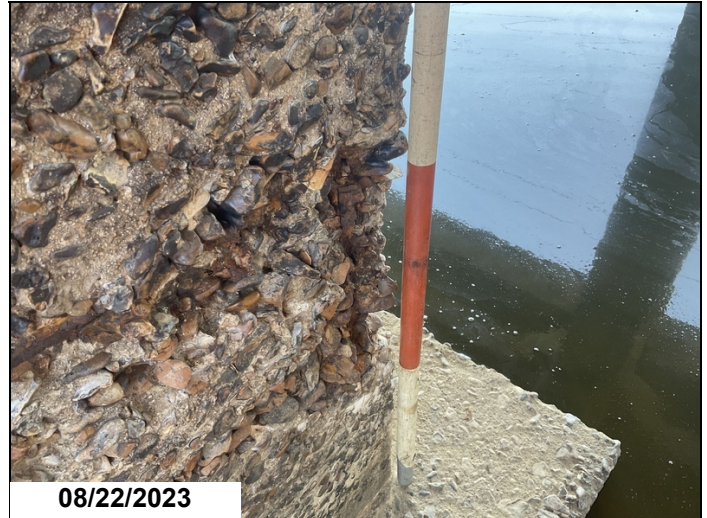
Bent # 3, column # 2 has a full width x 12" high area of concrete deterioration with exposed reinforcing steel and up to 2" of concrete section loss.

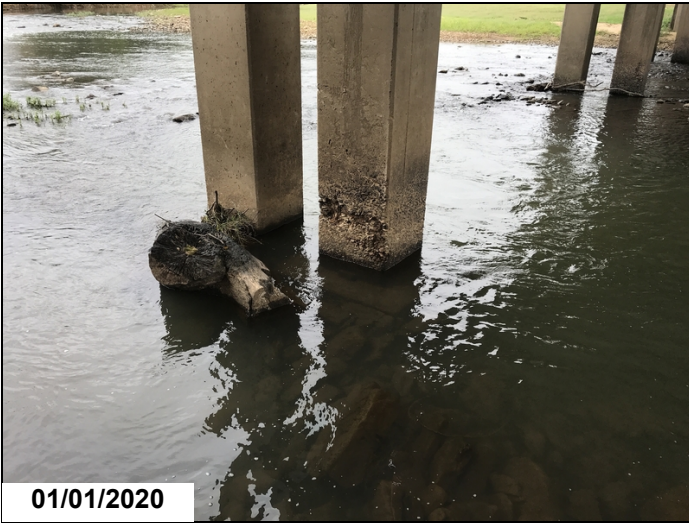
Bent # 3, column # 2 has concrete deterioration with exposed reinforcing steel.

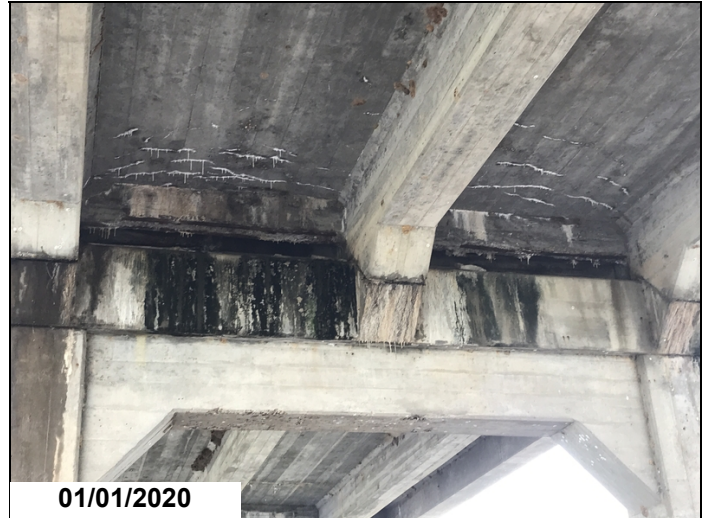
Bent # 4 spalling with exposed reinforcing steel in the expansion dam.

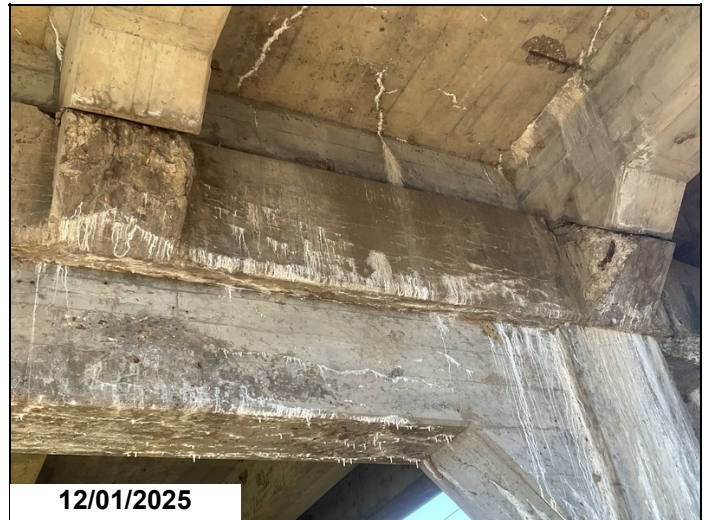
Bent # 2, Cap, Ahead Side: Haunches under Girders # 2 and 3: Map cracking with spalling and exposed steel.

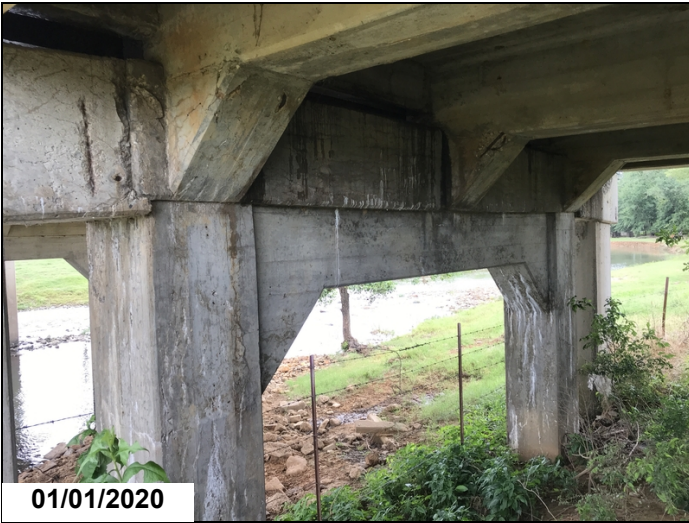
Bent # 2 cap has significant map cracking with efflorescence and water leaking out of the cracks in the cap. The top of cap in bays # 1 and 4 (widened portion of cap) has soft deteriorated concrete.

Top of bent # 2 cap has an 1/8" wide longitudinal crack near the center of cap between girders # 2 and 3 and 3 & 4 (original portion of cap) with delaminated areas along the crack.

The backface of cap has large spalled areas under girders # 1 and # 5 with several delaminated areas.

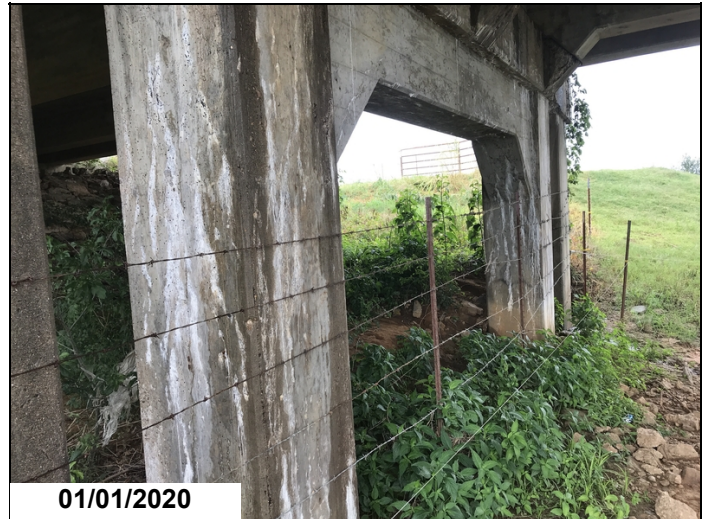
Bent # 2, columns # 2 & 3 have cracking with efflorescence.

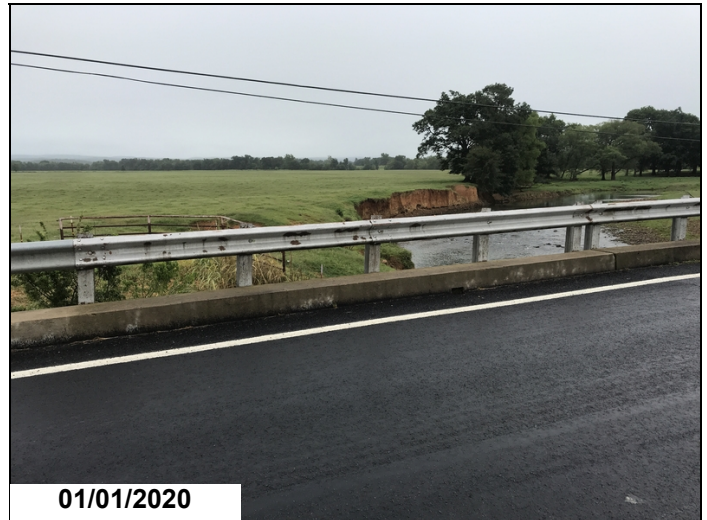
Bridge railing protective coating failing.

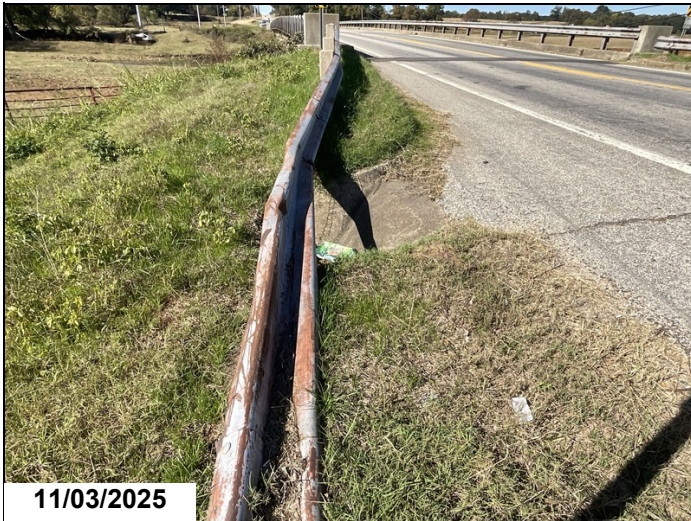
Abutment # 2 right approach railing has collision damage to the turndown section of railing.
