Bridge 00411 Inspection Report

Route:64 Section:02 Log:17.54

IDENTIFICATION	
(1) State Names	5 - Arkansas
(8) Structure Number	00411
(5) Inventory Route	1
(2) Highway Agency District	04 - District 04
(3) County Code	33 - Crawford County

INSPECTIONS *			
(90) Inspection Date			11/03/2025
(91) Frequency			24
(92) Critical Feature Inspection	Done	Freq. (Mon)	Date
A: Fracture Critical Detail	No		
B: Underwater Inspection	No		
C: Other Special Inspection	No		
<p>* The inspection date and frequency information in this box contains the current NBI date and frequency information. Please refer to the report header for the date this inspection was conducted.</p>

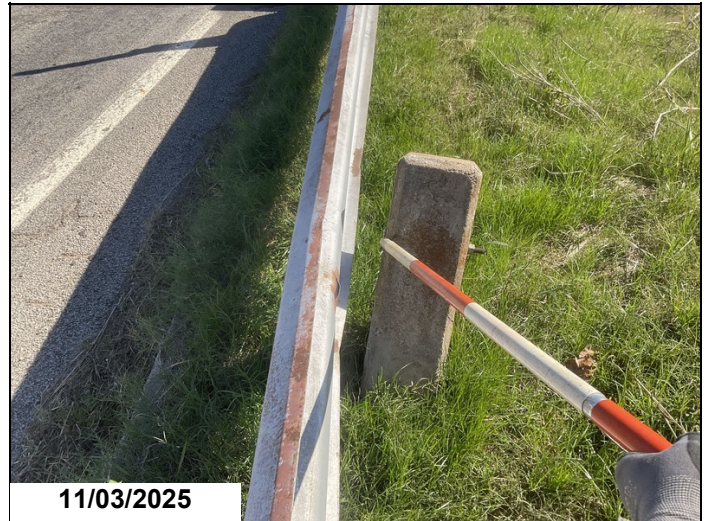
Abutment # 1 right approach railing has a failed bolted connection that attaches the railing to a post.

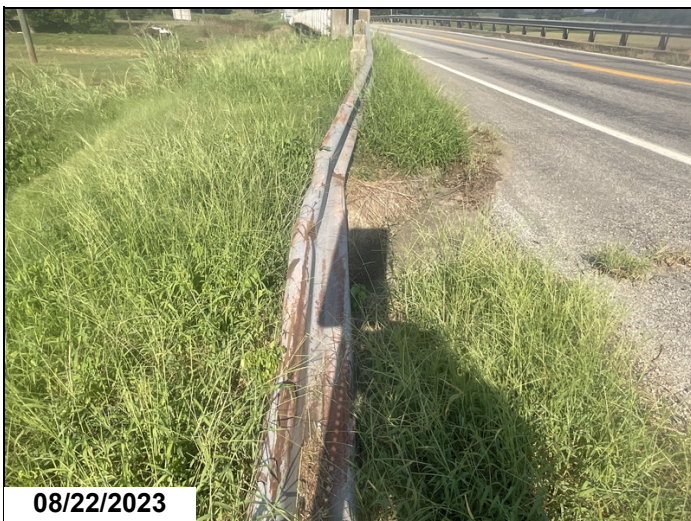
Abutment # 2 right approach railing has collision damage to the turndown section of railing

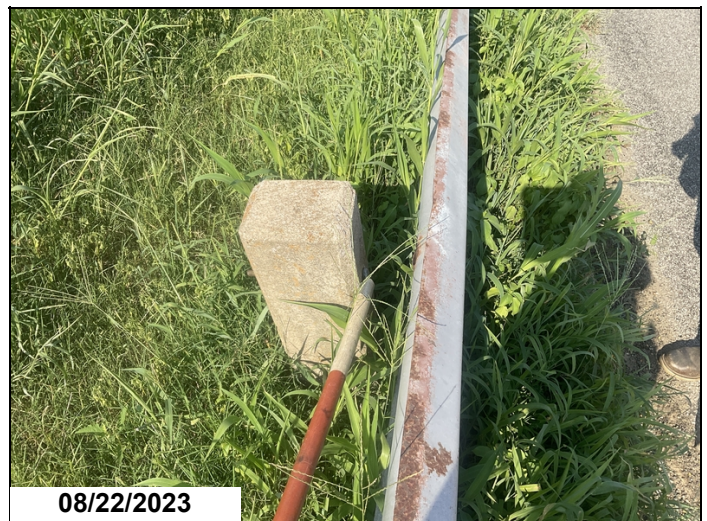
Abutment # 1 right approach railing has a failed bolted connection that attaches the railing to a post.
