Bridge 00412 Inspection Report

Route:64 Section:02 Log:19.65

(4) Place Code	48200
(6) Features Intersected	Millers Branch
(7) Facility Carried	US Highway 64
(9) Location	11.5 E JCT US 71
(11) Mile Point	19.65 mi
(12) Base Highway Network	No

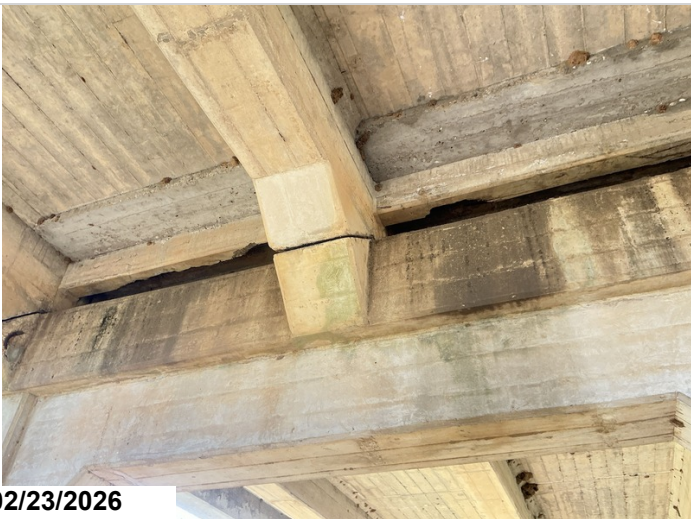
Bent # 8: spalling in the end diaphragm of bay # 2 & 3.

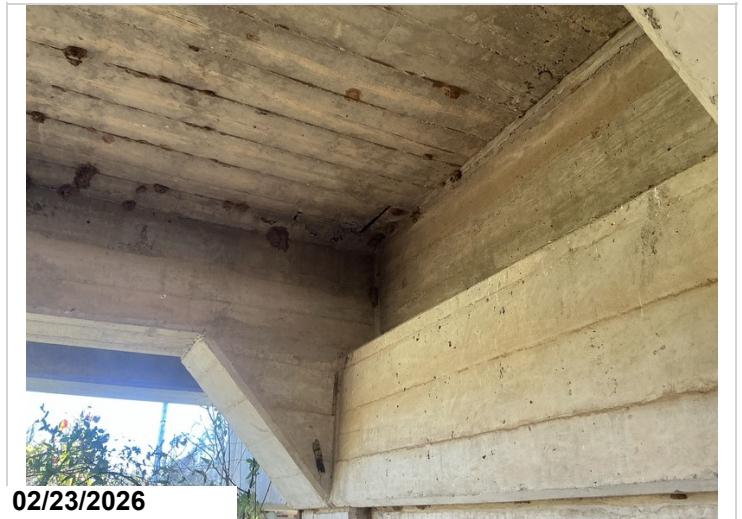
Span # 11 undersurface in Bay # 3 has shallow 10" long spall adjacent to bent # 11 with exposed reinforcing steel.

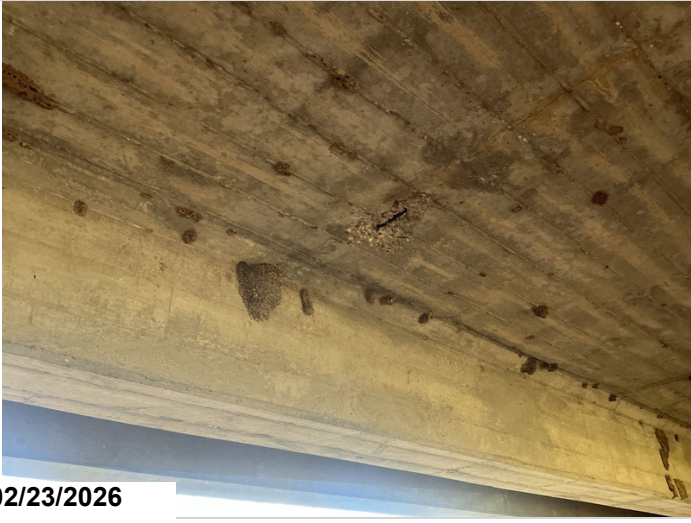
Span # 11 undersurface in bay # 2 located approximately 8' from bent # 11 has a 12" x 8" spall with exposed reinforcing steel. Exposed reinforcing steel has corrosion with flaking rust with an estimated 1/8" section loss.

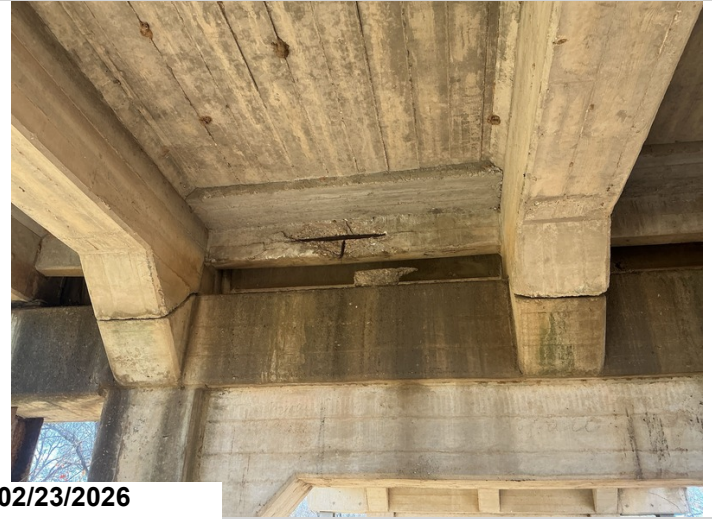
Span # 10, bay # 3: spalling with exposed reinforcing steel in the end diaphragm.

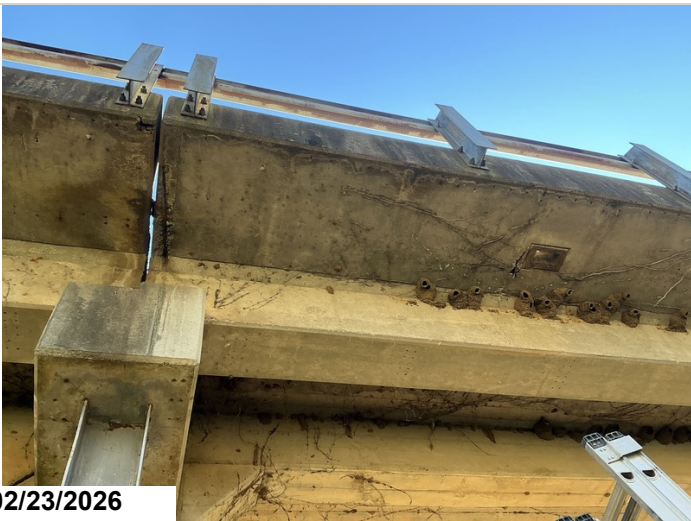
Span # 5, left: the undersurface has spalling with exposed reinforcing steel.

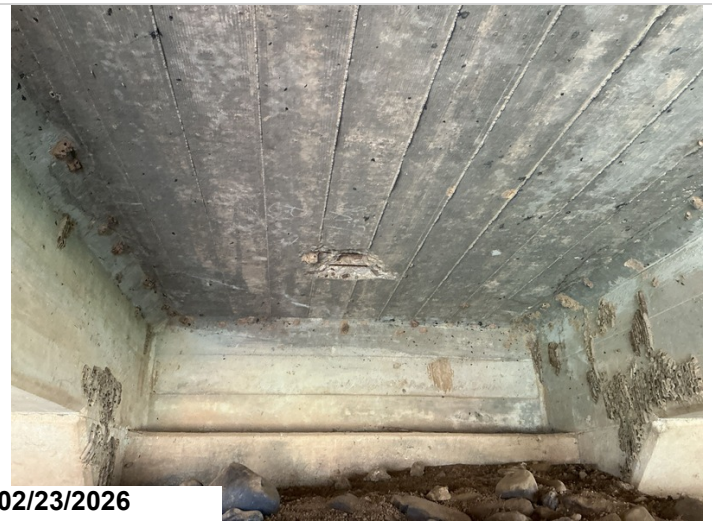
Span # 1 undersurface in bay # 3 adjacent to abutment # 1 has a 12" diameter spall approximately 1-1/2" deep with exposed reinforcing steel. Exposed reinforcing steel has no apparent section loss. 1SF CS3 rebar

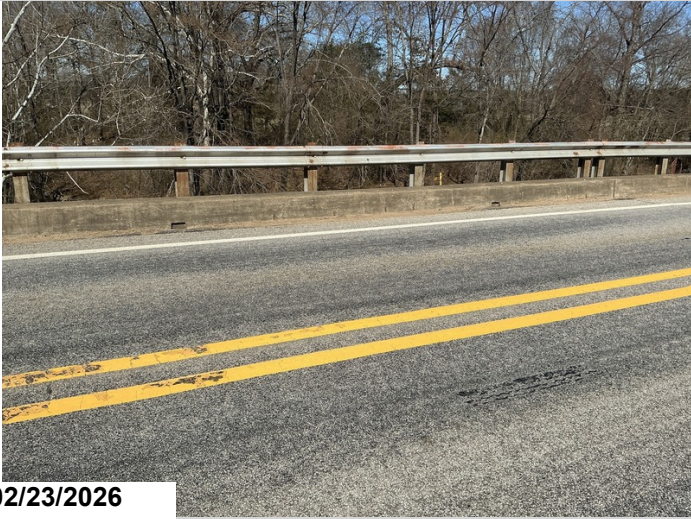
Span # 5: spalling with exposed reinforcing steel. 8SF CS3 rebar

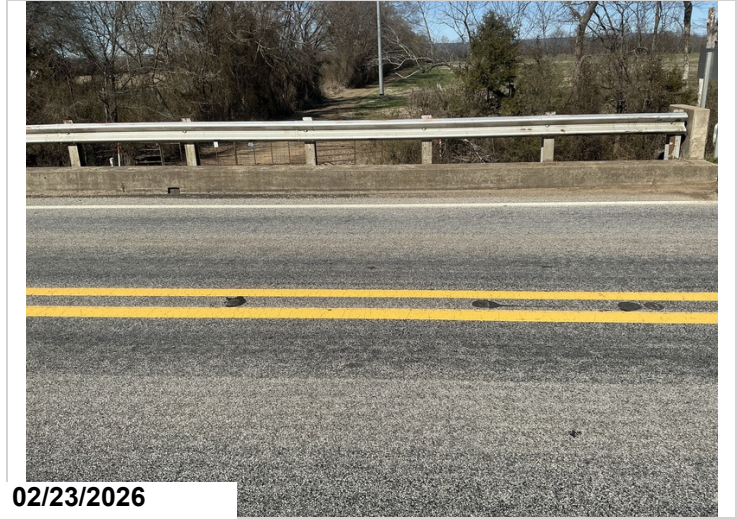
Span # 11: spalling with exposed reinforcing steel. 4SF CS3 rebar

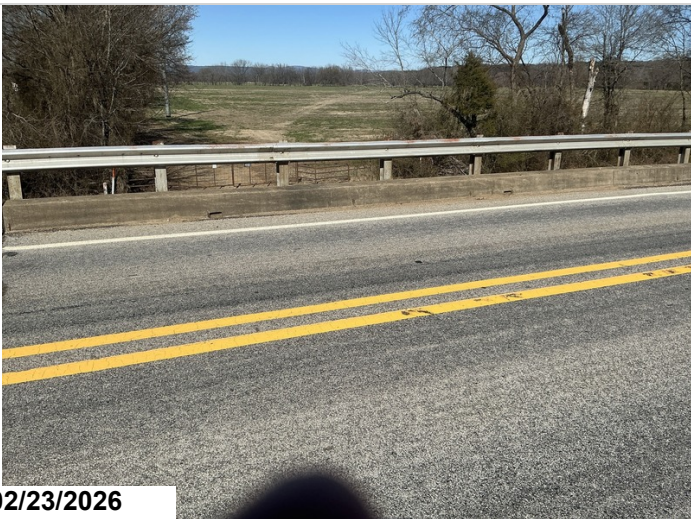
Span # 10, left: spalling with exposed reinforcing steel. 8SF CS3 rebar

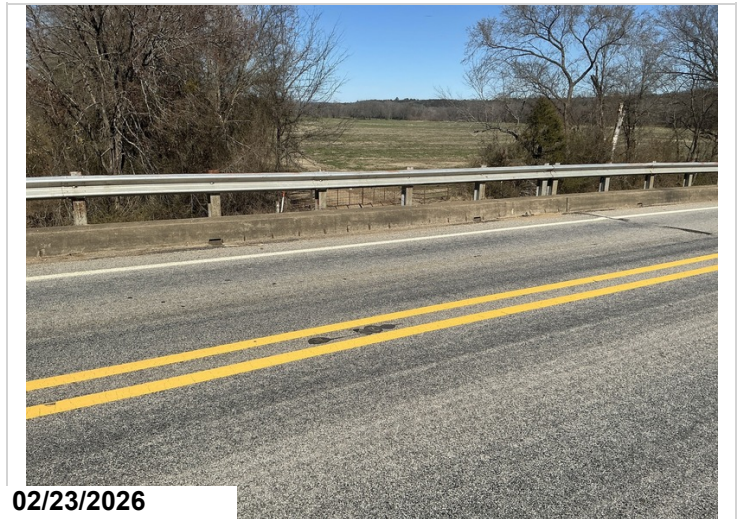
Span # 9, left: spalling with exposed reinforcing steel. 16SF CS3 rebar

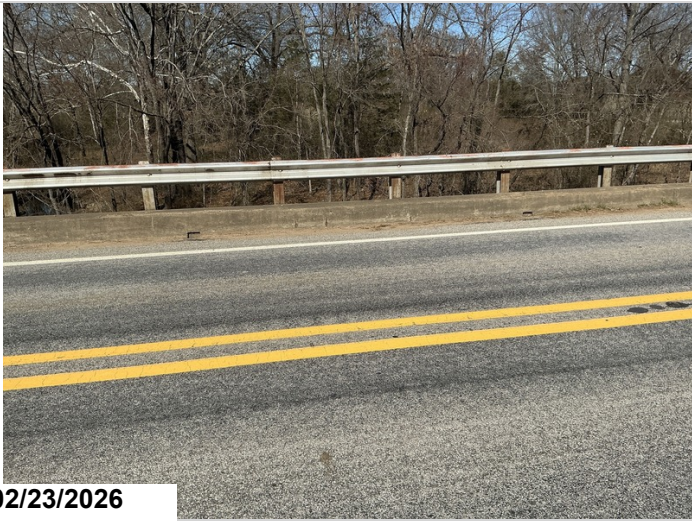
Span # 6, left: spalling with exposed reinforcing steel. 3SF CS3 rebar

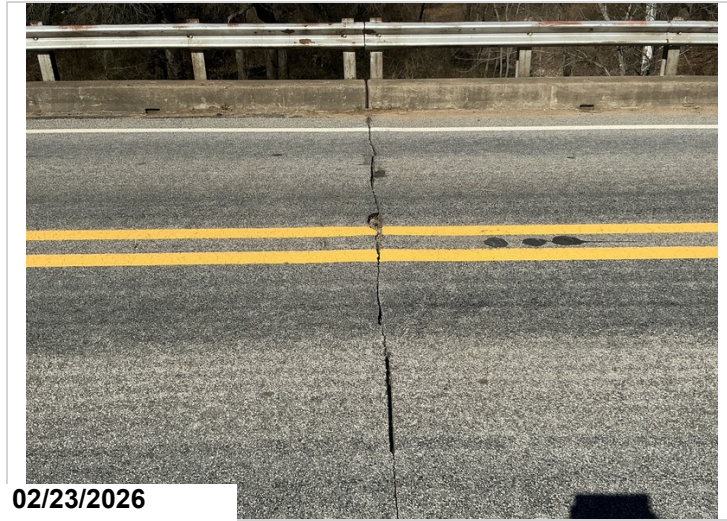
Bent # 4: 12" pothole over the bent in the westbound lane. 1SF CS3 spall

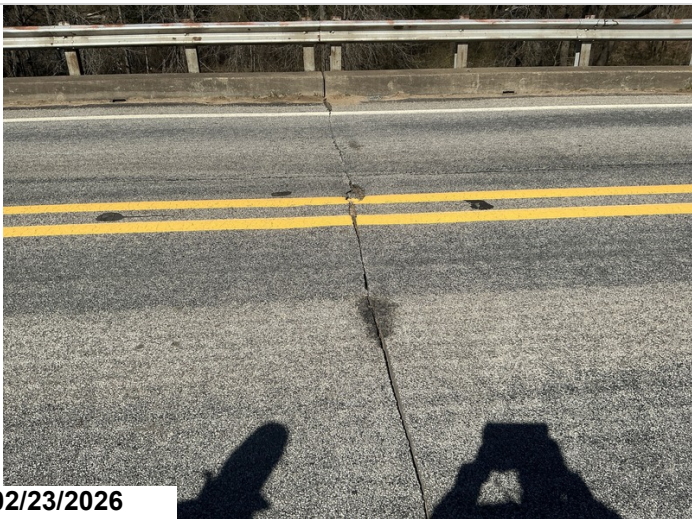
Bent # 2: 12" pothole over the bent in the westbound lane. 1SF CS3 spall

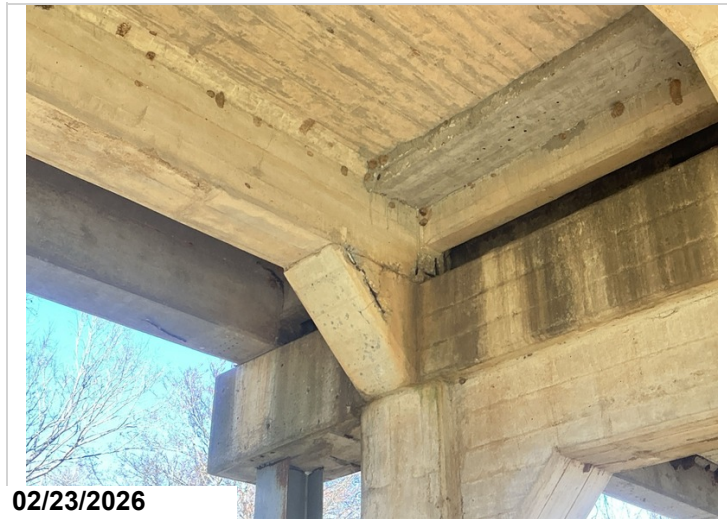
Span # 7, girder # 2 spalling with exposed reinforcing steel over bent # 8.

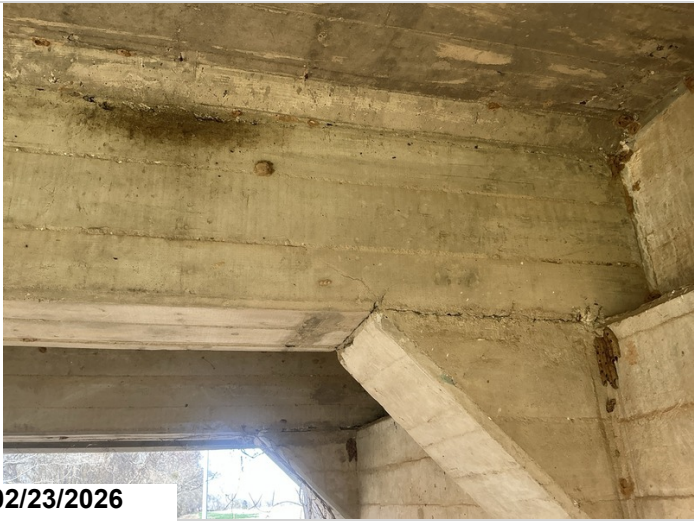
Span # 10, girder # 3 at bent # 11 has a diagonal hairline shear type crack.

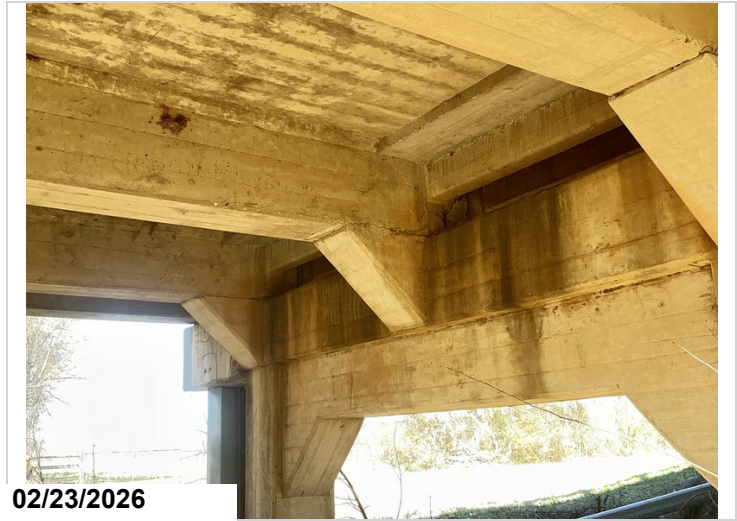
Span # 9, girder # 3: 14" long spalling with exposed reinforcing steel over bent # 10.

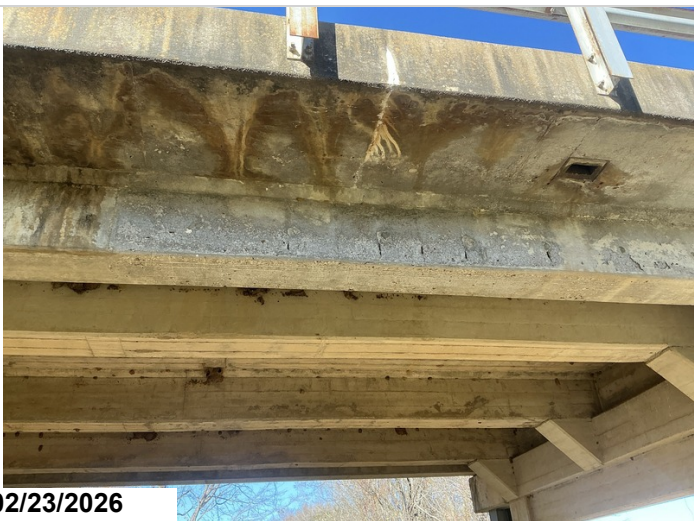
Span # 8, girder # 5 has scaling with several small shallow spalls with exposed reinforcing steel in the exterior face of girder.

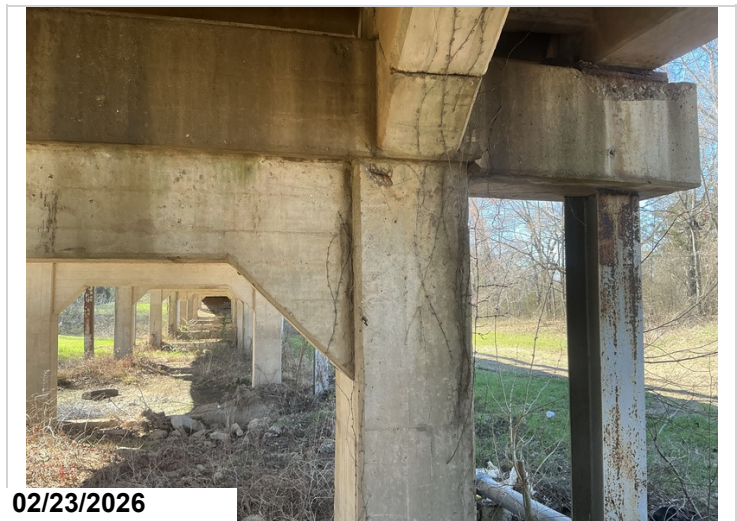
Bent # 10, column # 2 aheadface at the cap juncture has a shallow 4" spall with exposed reinforcing steel.

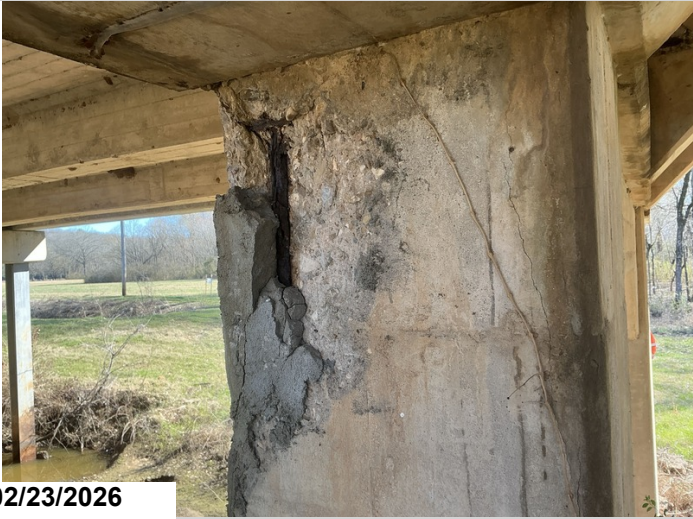
Bent # 8, column # 2 exterior face at the cap juncture has a 20" high x 12" wide spall with exposed reinforcing steel. Past repair to the spalled area has failed.

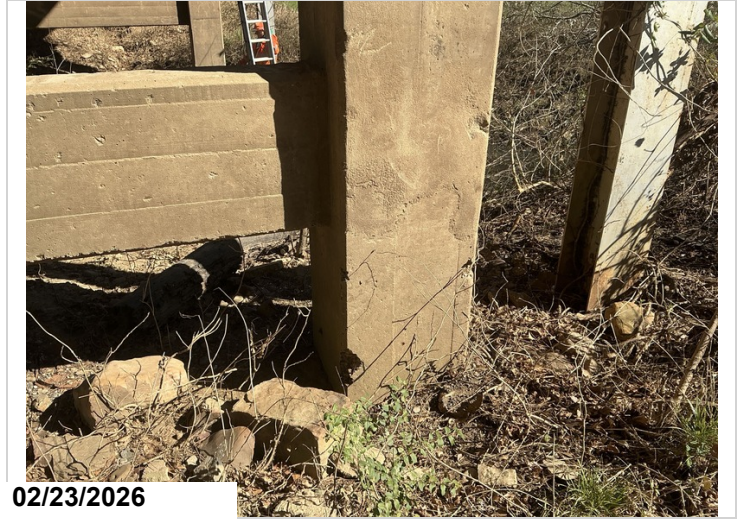
Bent # 4, column # 2: there is honeycombing/ concrete deterioration at the base of column.

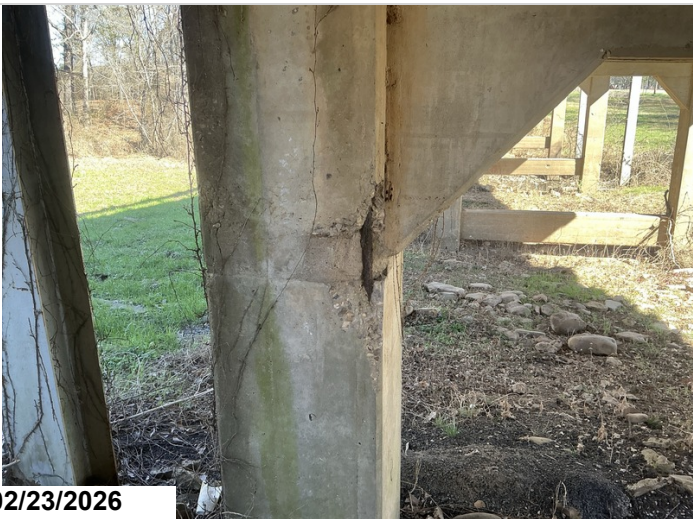
Bent # 2, column # 2 backface has a 24" high spall with exposed primary reinforcing steel. Exposed reinforcing steel has an estimated 1/16" section loss.

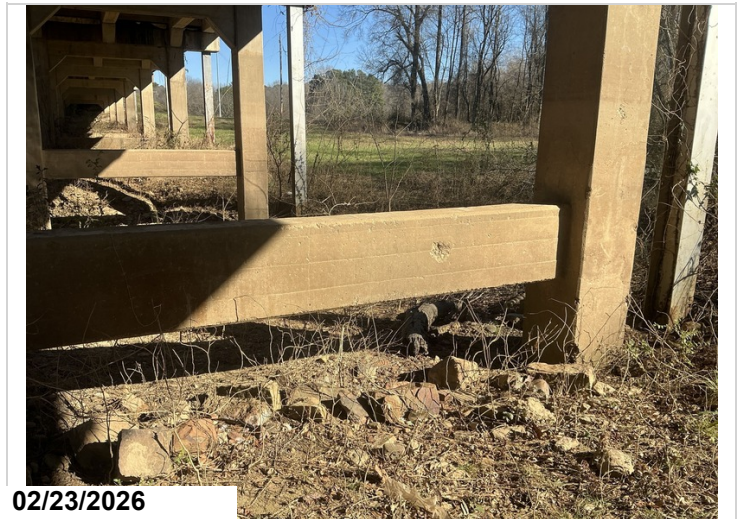
Bent # 4 strut backface has a 6" shallow spall with no exposed reinforcing steel

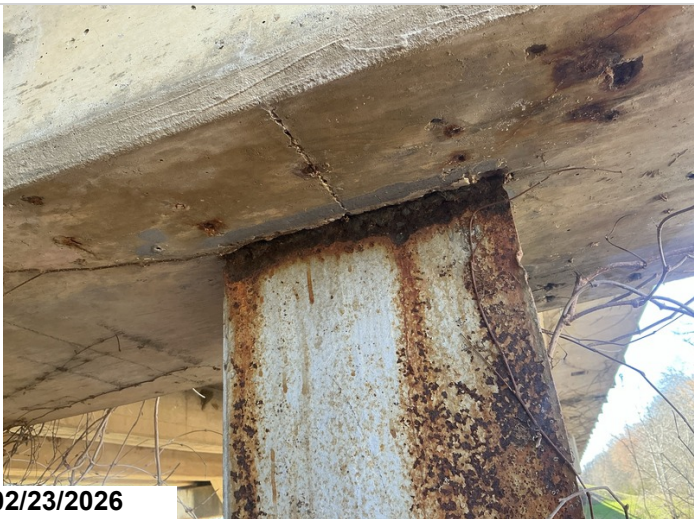
Bent # 11 left pile ahead flange has active corrosion with up to knife edge section loss at the cap juncture.

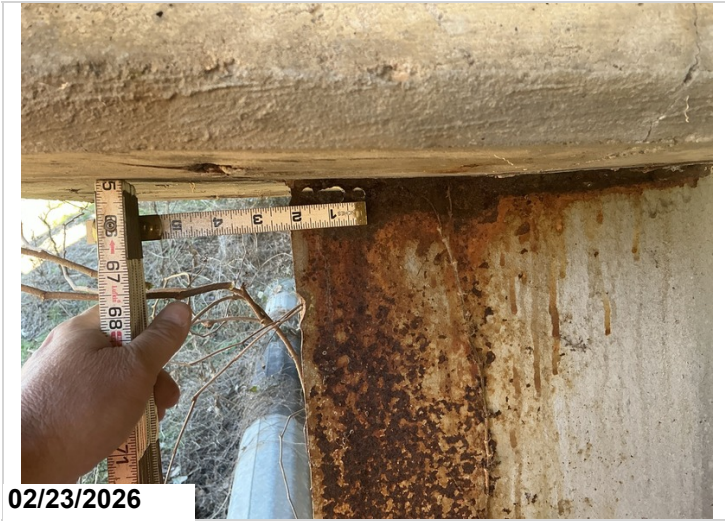
Bent # 11, left: The back flange has a 2" x 1/2" hole rusted through at the cap juncture.

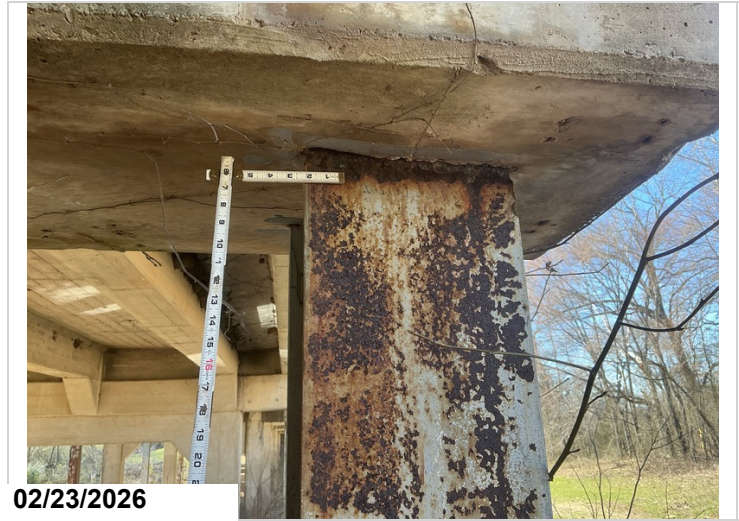
Bent # 10 left pile has active corrosion with knife edge section to the ahead flange with a 1/2" hole and a 1" hole rusted through the flange at the cap juncture.

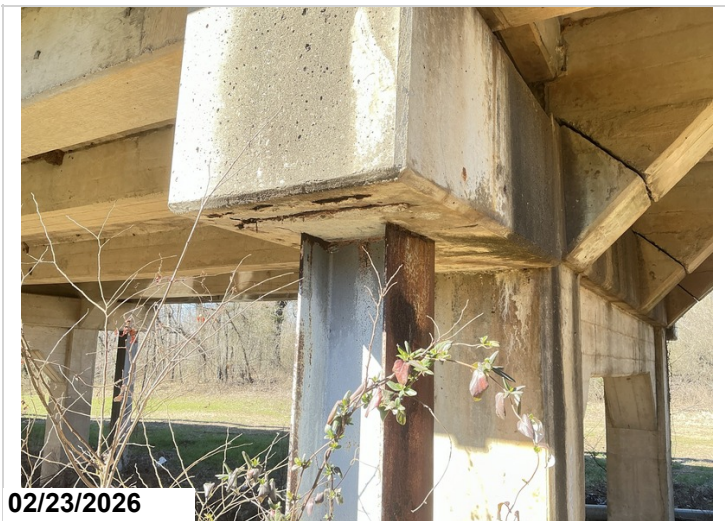
Bent # 10 right pile has a rust coating on the majority of the steel pile with up to 1/4" section loss at the cap juncture.

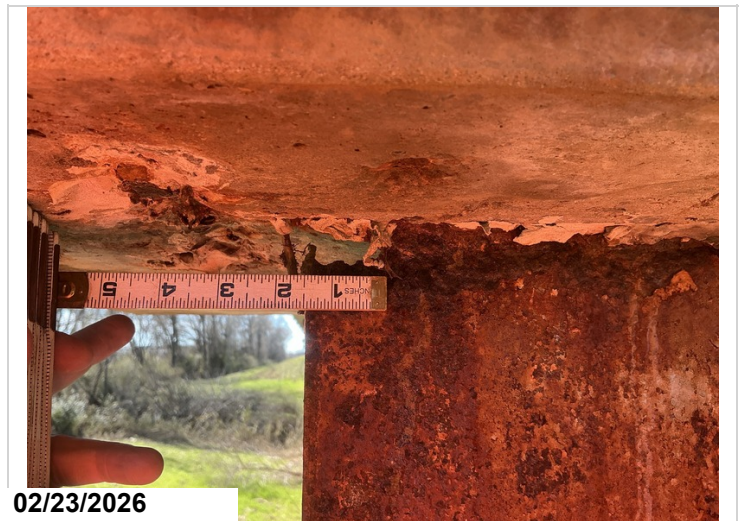
Bent # 8 right pile has active corrosion with a 1-1/2" long x 5/8" high hole rusted through the flange at the cap juncture. The left pile has 1/4" section loss at the cap juncture on the ahead face.

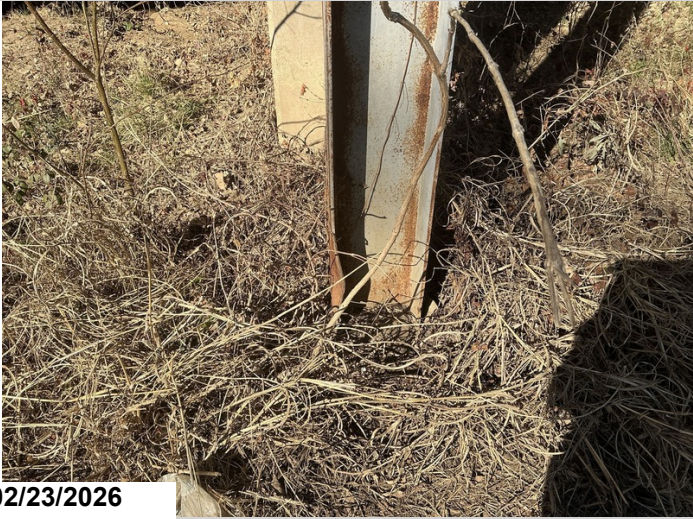
Bent # 7 right pile back flange has 1-1/8" out of plane bending to base of pile in an area approximately 16" high at the base of the pile.

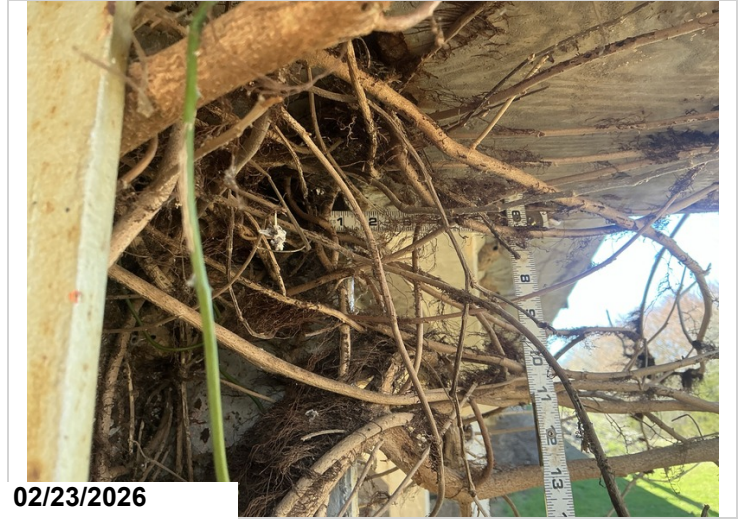
Bent # 4 left pile back flange at cap juncture has a 1" long x 1/2" wide hole rusted through the flange. The ahead flange has section loss that has reduced the thickness to 3/16".

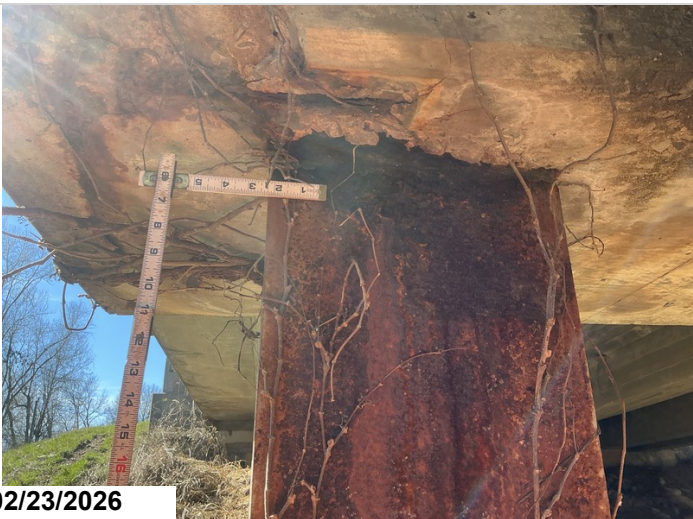
Bent # 2 right pile has active corrosion up to knife edge section loss at the cap juncture with an area of complete section loss to ahead flange that is 2-1/4" long x 1/2" wide.

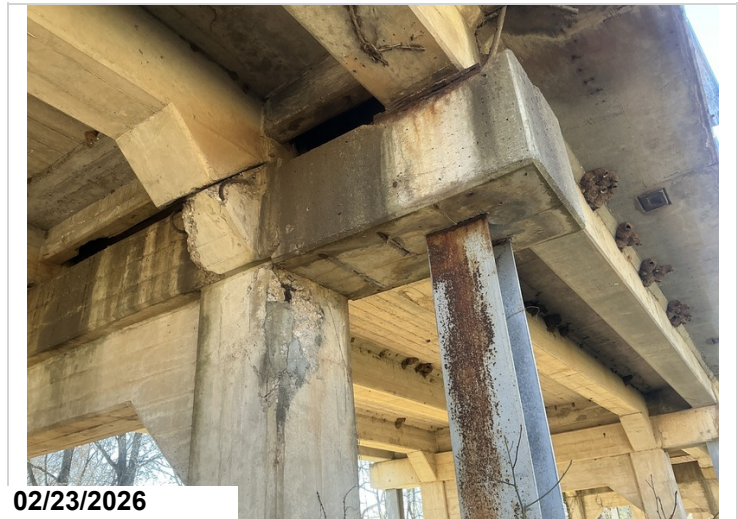
Bent # 8: the cap ahead face has a spall under girder # 1 that extends to the edge of the masonry plate. No loss of bearing area at this inspection. The cap haunch under girders # 2 & 4 have spalling that has been grouted in the past. Repairs have failed and are no longer in place exposing the reinforcing steel with up to initial section loss. The cap undersurface on both sides has several narrow width long shallow spalls with exposed reinforcing steel.

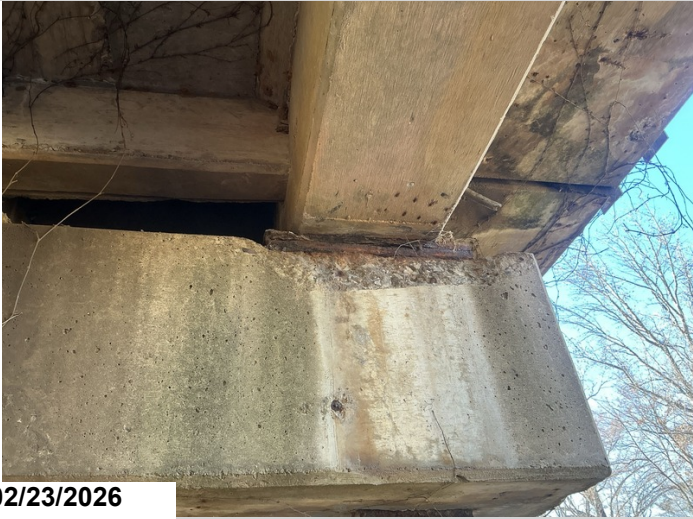
Bent # 10: the cap ahead face has a 24" long x 8" high spall in the bearing area of girder # 1 that reaches the edge of the masonry plate. No loss of bearing area at this inspection.

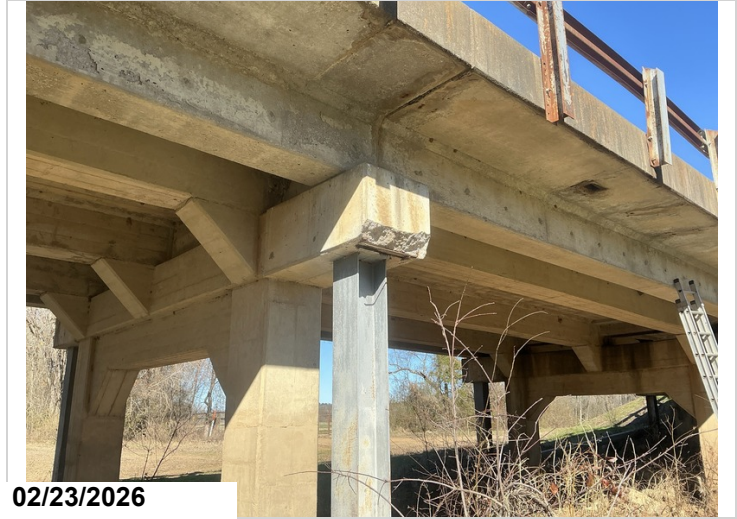
Bent # 9: the cap on right end has spalled on the bottom edge exposing the reinforcing steel. The exposed reinforcing steel has lost bond with the concrete.

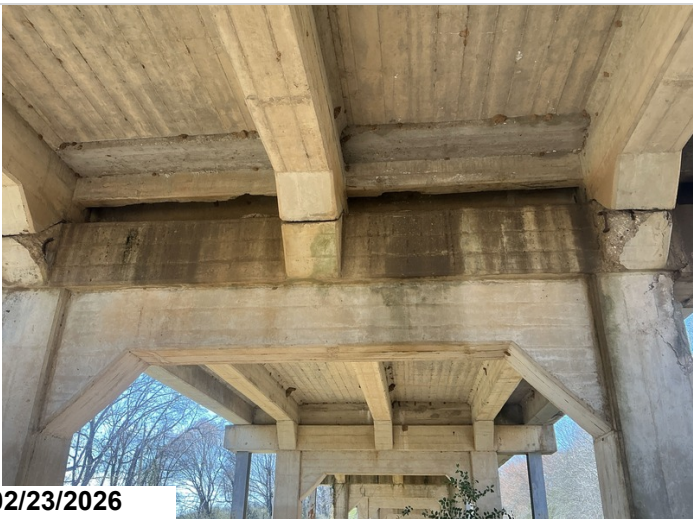
Bent # 8: the cap ahead face has a spall under girder # 1 that extends to the edge of the masonry plate. No loss of bearing area at this inspection. The cap haunch under girders # 2 & 4 have spalling that has been grouted in the past. Repairs have failed and are no longer in place exposing the reinforcing steel with up to initial section loss. The cap undersurface on both sides has several narrow width long shallow spalls with exposed reinforcing steel.

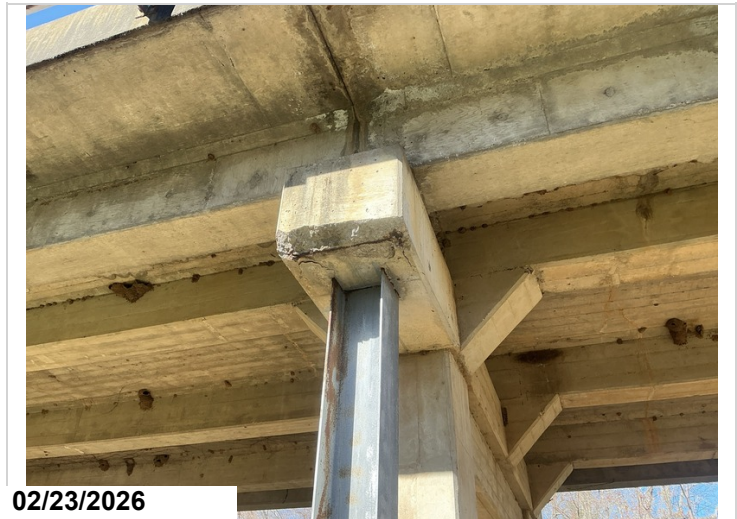
Bent # 7: the cap undersurface on right end has spalling with exposed secondary reinforcing steel. The reinforcing steel has lost bond with the concrete.

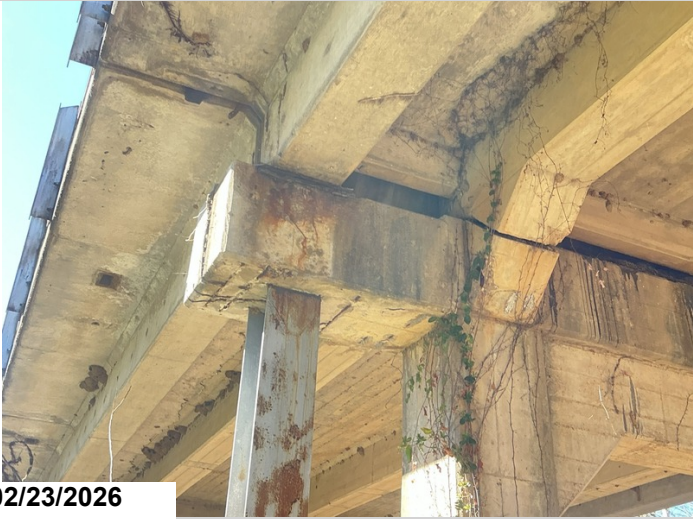
Bent # 6: the cap ahead face has a 10" high x 16" long spall in the bearing area of girder # 5 that extends approximately 1" under the masonry plate in an area approximately 5" long causing minor loss of bearing area. The cap undersurface on right end has several narrow width shallow spalls with exposed reinforcing steel.

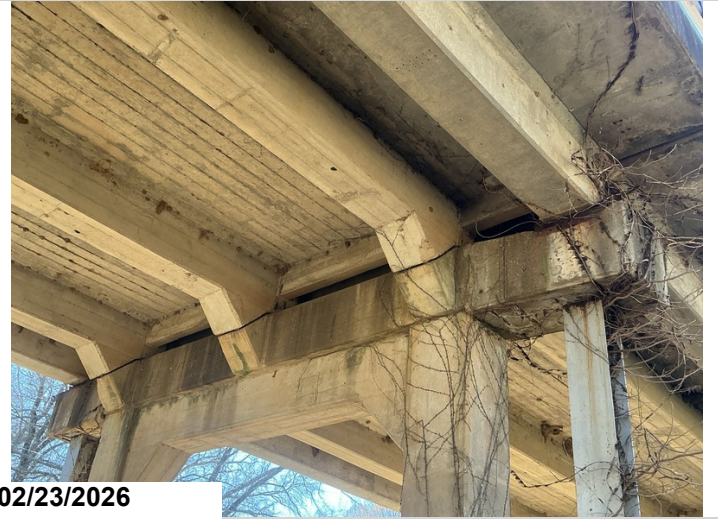
Bent # 4: the cap ahead face has a spall in the cap haunch under girder # 4, and a spall under girder # 1 that reaches the edge of the bearing masonry plate. The left and right overhang has spalling with exposed reinforcing steel. No loss of bearing area at this inspection.

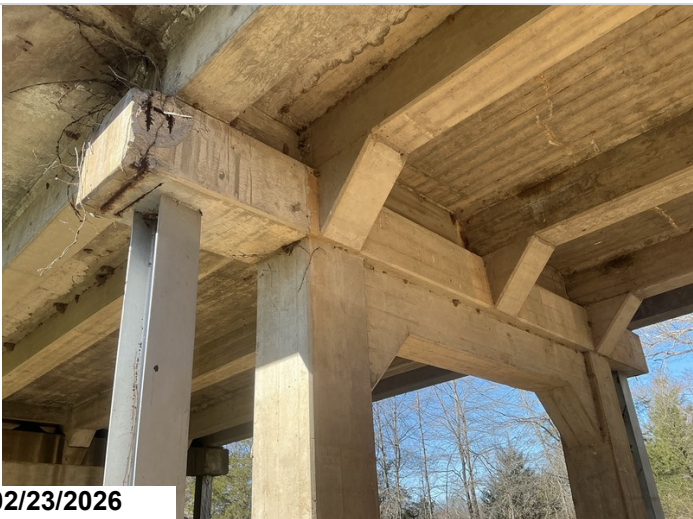
Bent # 3: the cap undersurface on left and right ends have shallow 18" long spalls with exposed reinforcing steel. The ahead face of cap on right side under girder # 5 has a 16" spall with exposed reinforcing steel. Exposed reinforcing steel has corrosion with initial section loss.

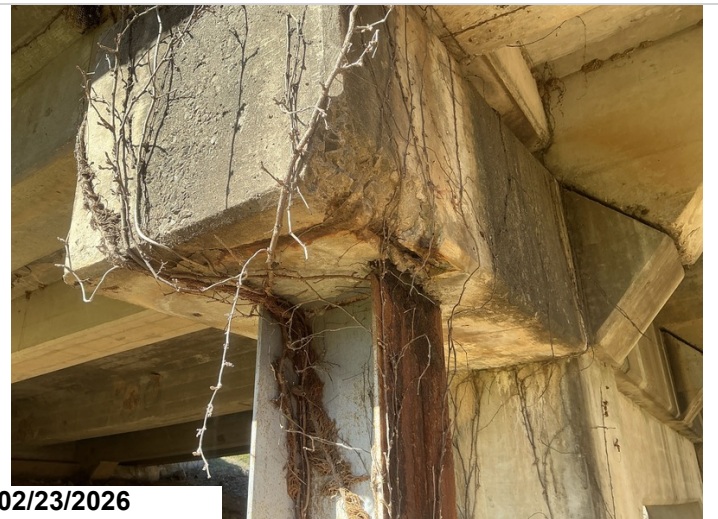
Bent # 2, right: The right end of cap has a moderate size area of spalling with exposed reinforcing steel.

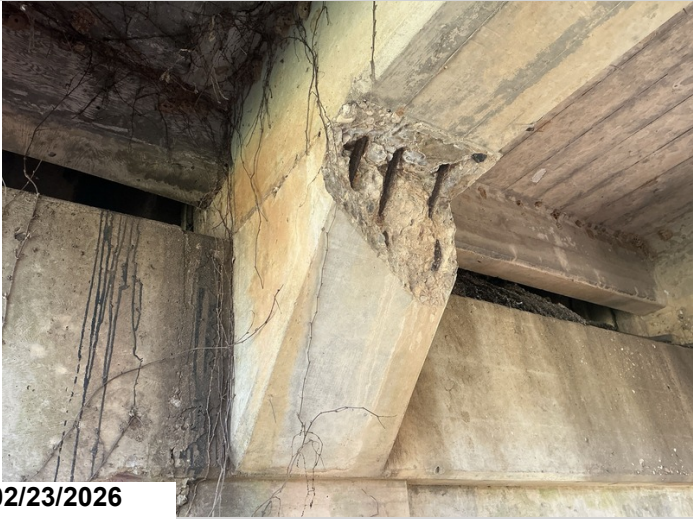
Bent # 2: the back face has a 14" spall with exposed reinforcing steel in haunch under girder # 2.

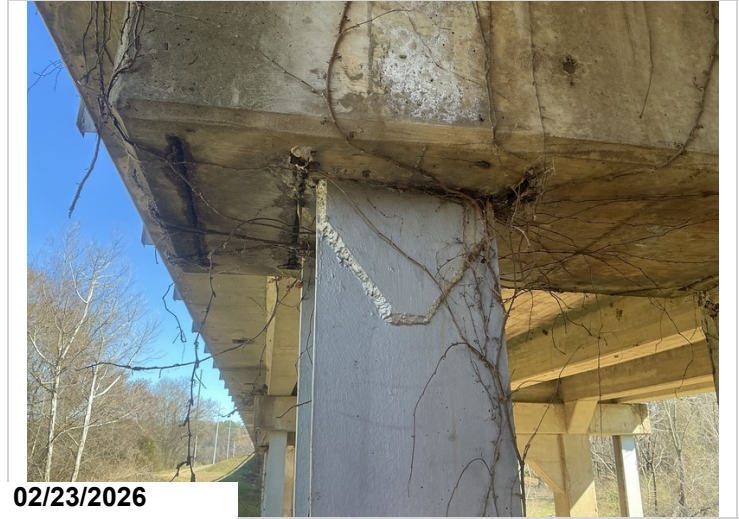
Bent # 2, left: The undersurface of cap on left end has two 18" long shallow spalls with exposed reinforcing steel.

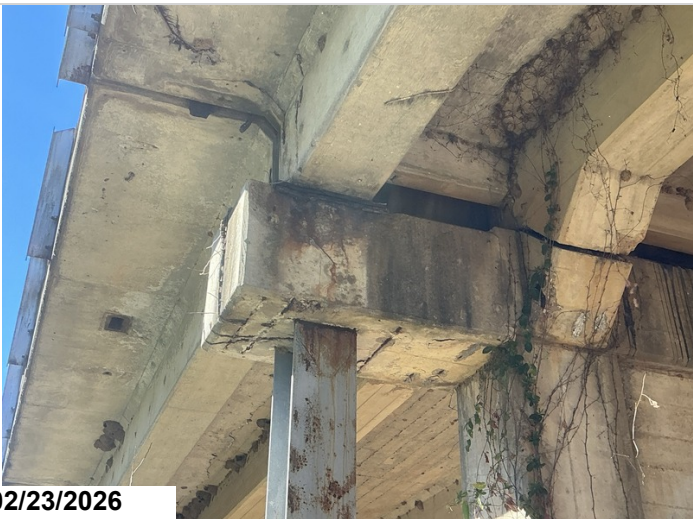
Span # 6, bearing # 5, bent # 6: bearing has heavy corrosion with layers of flaking rust/ section loss. The bearing has approximately 1" bearing area loss in a 5" long area due to spall in bent cap.

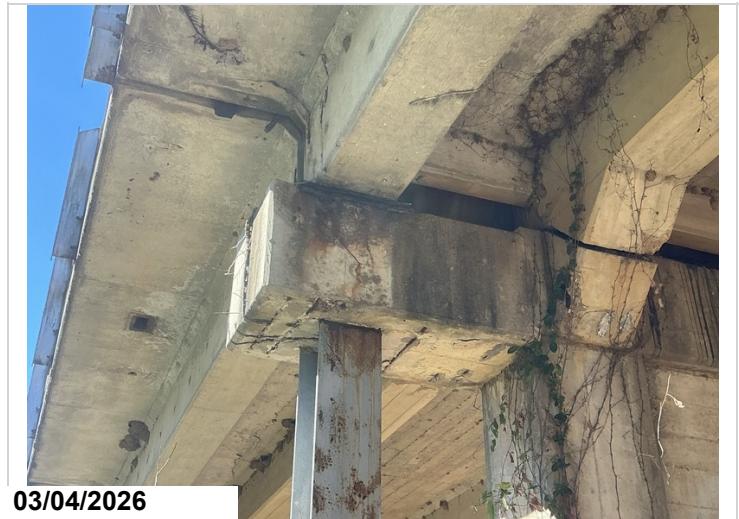
Span # 6, bearing # 5, bent # 6: bearing has heavy corrosion with layers of flaking rust/ section loss. The bearing has approximately 1" bearing area loss in a 5" long area due to spall in bent cap.

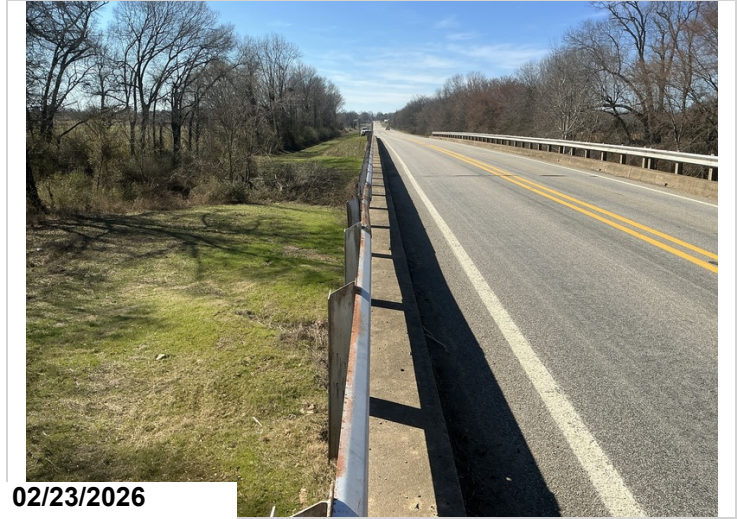
Span # 9, right: the bridge railing has minor collision damage in an area approximately 12' long that has caused out of plane bending to the railing and bent one post out of plumb.

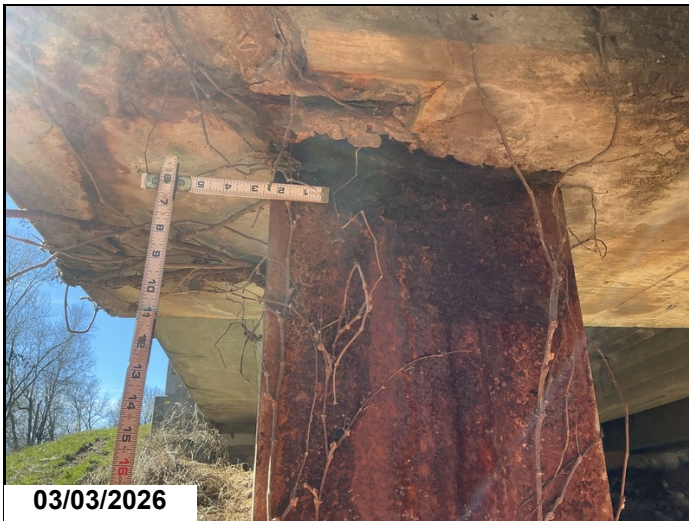
Steel columns have active corrosion, layers of rust and section loss at base of piles and at the cap juncture. Numerous areas of old section loss scars that have been painted over by maintenance forces in the past. Section loss ranges from initial up to 2" holes rusted through the flanges at the cap juncture. Bent # 11 left pile is the most notable area of corrosion with knife edge section loss to the flanges and a 2" x 1/2" hole rusted through at the cap juncture. Base of pile at ground elevation has heavy corrosion with thick layers of flaking rust to web and flanges in an area approximately 12" high. Flanges have knife edge section loss along the edges. The ahead flange in the affected area is reduced to 5/16" thickness and has a 1/4" hole rusted through.

Bent # 2 right pile has active corrosion up to knife edge section loss at the cap juncture with an area of complete section loss to ahead flange that is 2-1/4" long x 1/2" wide.

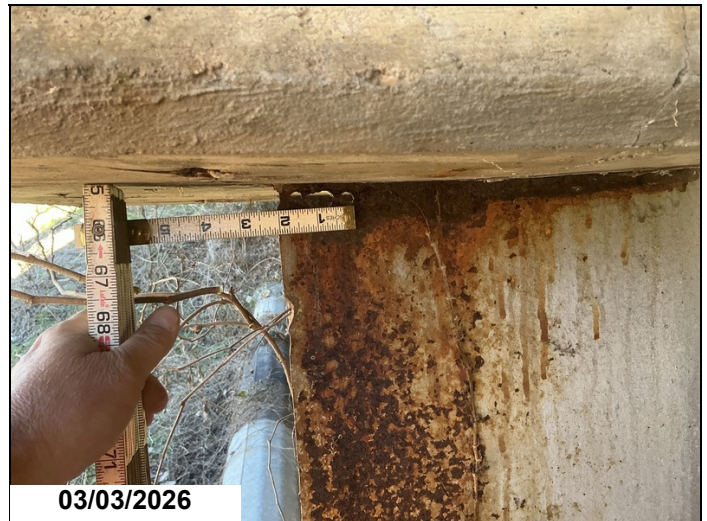
Bent # 11, left: The back flange has a 2" x 1/2" hole rusted through at the cap juncture.

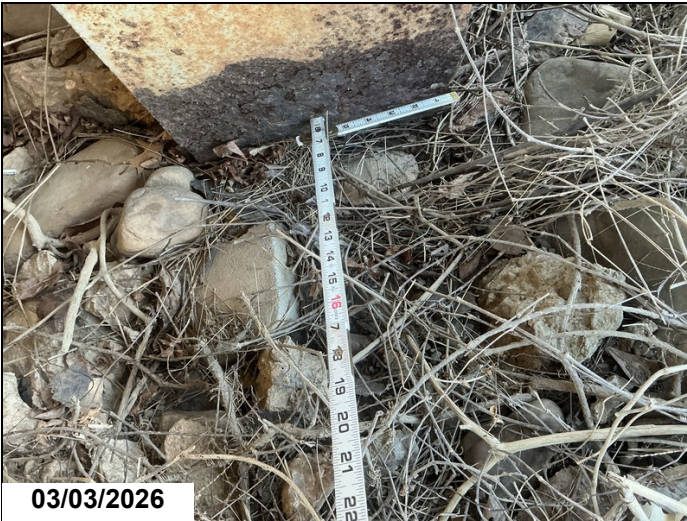
Bent # 11, left : Base of pile at ground level has heavy corrosion with thick layers of flaking rust to web and flanges in an area approximately 12" high. Flanges have knife edge section loss along Bent # 11, left : Base of pile at ground level has heavy corrosion with thick layers of flaking rust to web and flanges in an area approximately 12" high. Flanges have knife edge section loss along the edges. The ahead flange in the affected area is reduced to 5/16" thickness and has a 1/2" hole rusted through.

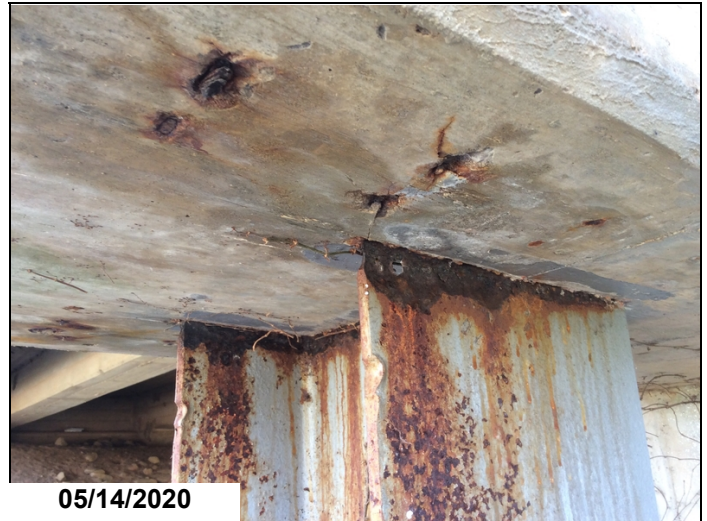
Bent # 11, left pile has active corrosion up to knife edge with some holes rusted through the top of the column at the cap juncture.

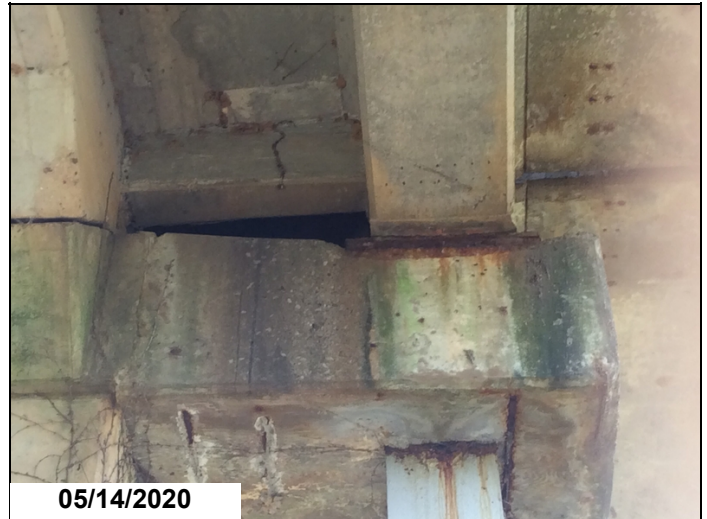
Exterior expansion bearings have active corrosion with layers of rust. The bearing anchor bolts are corroded into and are missing in several locations. The remaining anchor bolts have heavy corrosion/ section loss.

Span # 4, bearing # 1 at bent # 4-Corrosion.

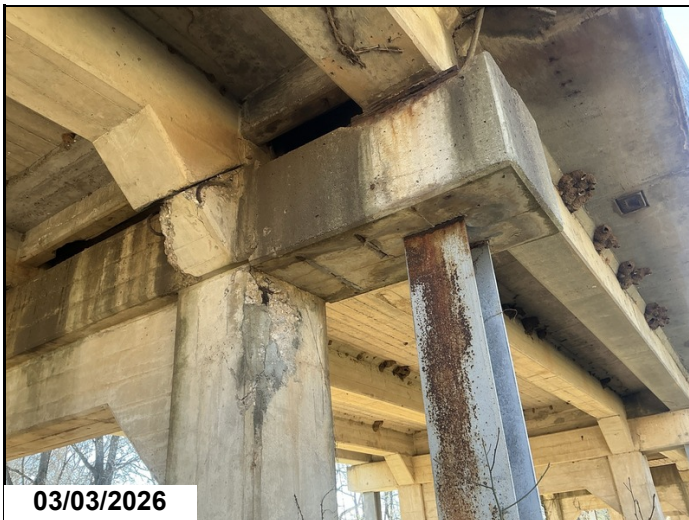
The majority of the concrete caps have areas of spalling with exposed reinforcing steel in random locations. Several caps have spalling with exposed reinforcing steel in the undersurface where the structure was widened in the past. Areas of spalling appear to be from insufficient concrete cover from the construction process. The caps have spalling in the bearing areas that extends to the edge of the masonry plates in some locations. The area of spalling in the aheadface of bent # 6 cap under girder # 5 extends approximately 1" under the masonry plate in an area approximately 5" long causing minor loss of bearing area. The cap haunches under the girders in some locations have areas of spalling with exposed reinforcing steel.

Bent # 8 cap aheadface has a spall under girder # 1 that extends to the edge of the masonry plate. No loss of bearing area at this inspection. The cap haunch under girders # 2 & 4 have spalling that has been grouted in the past. Repairs have failed and are no longer in place exposing the reinforcing steel with up to initial section loss. The cap undersurface on both sides has several narrow width long shallow spalls with exposed reinforcing steel.

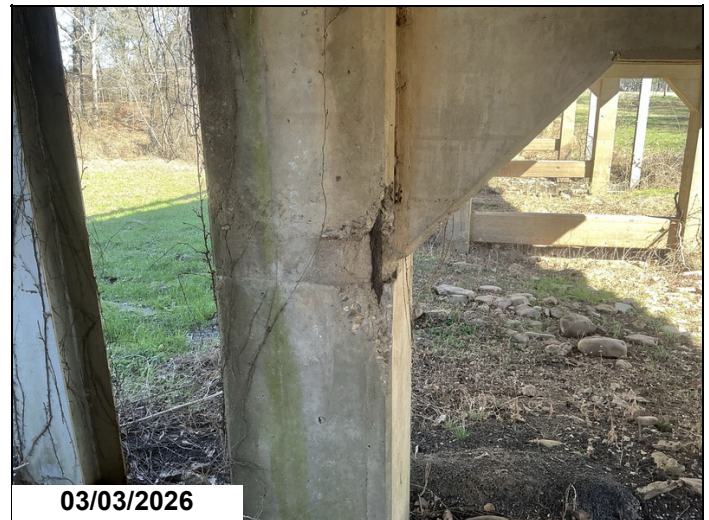
Bent # 2, column # 2 backface has a 24" high spall with exposed primary reinforcing steel. Exposed reinforcing steel has an estimated 1/16" section loss.

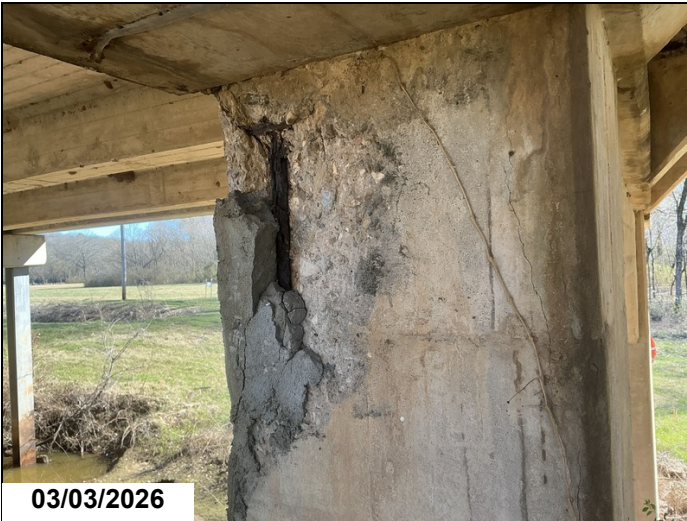
Bent # 8, column # 2 exterior face at the cap juncture has a 20" high x 12" wide spall with exposed reinforcing steel. Past repair to the spalled area has failed.

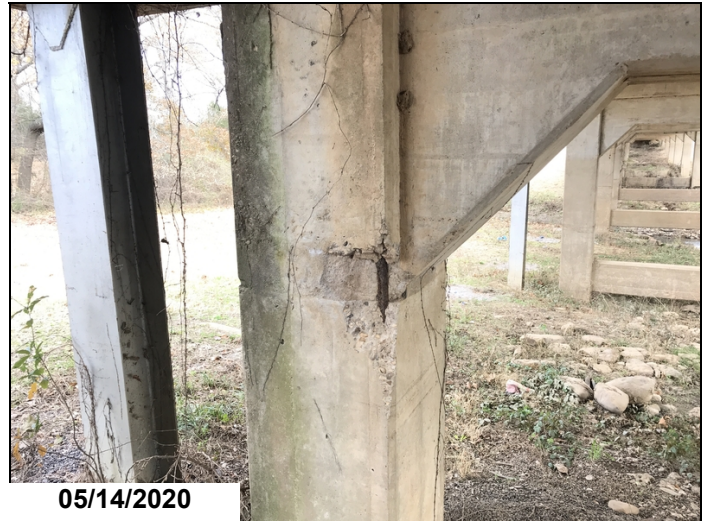
Bent # 2, column # 2 backface- Spalling with exposed reinforcing steel.

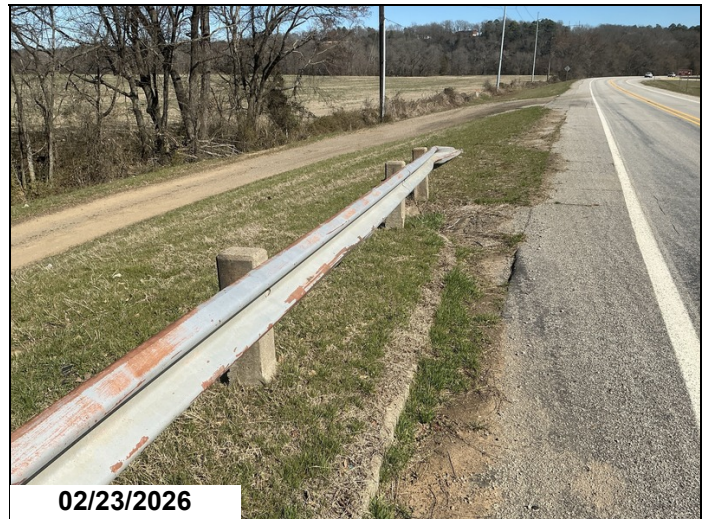
Abutment # 2 left approach railing (Northwest) has minor collision damage to the turndown portion of railing.

Abutment # 2 left approach railing has minor collision damage to the turndown portion of the railing
