Bridge 00412 Inspection Report

Route:64 Section:02 Log:19.65

(4) Place Code	48200
(6) Features Intersected	Millers Branch
(7) Facility Carried	US Highway 64
(9) Location	11.5 E JCT US 71
(11) Mile Point	19.65 mi
(12) Base Highway Network	No

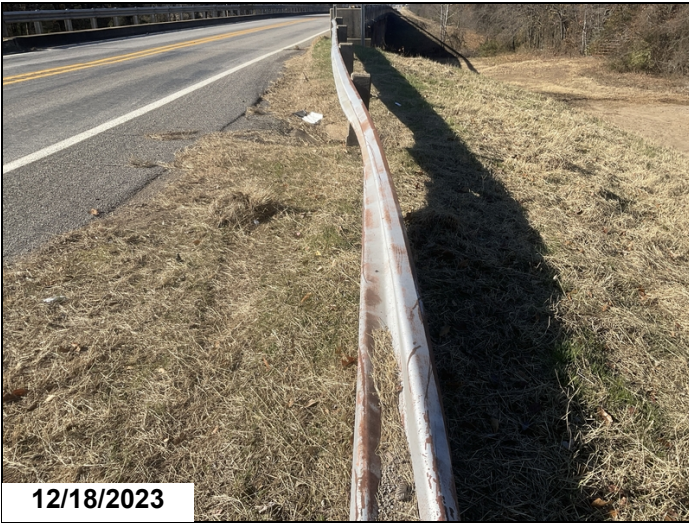
Abutment # 2 left approach railing has minor collision damage to the turndown portion of the railing

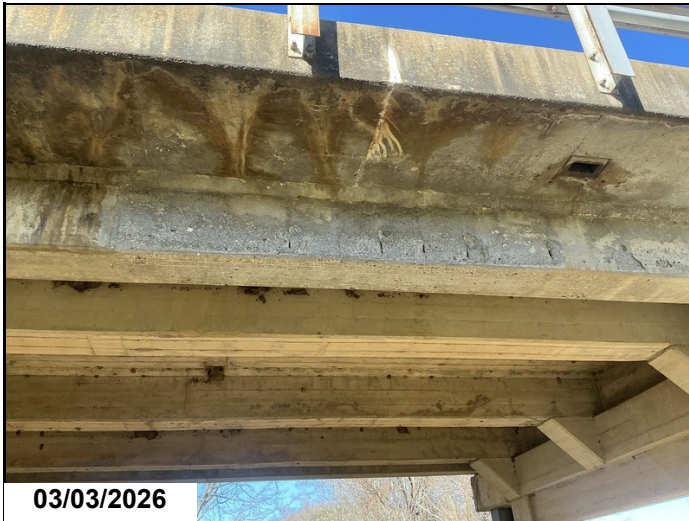
Concrete deck girders have several areas of spalling with exposed reinforcing steel. The ends of the girders over the intermediate bents are fractured/ spalled in some locations.

Span # 8, girder # 5 has scaling with several small shallow spalls with exposed reinforcing steel in the exterior face of girder.

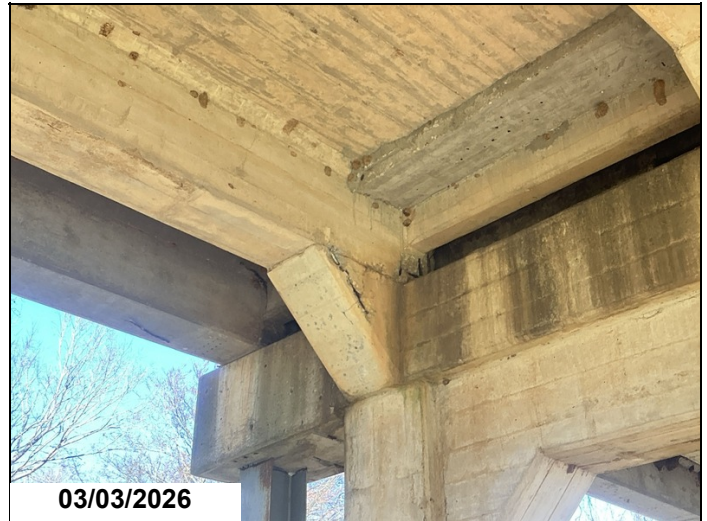
Span # 7, girder # 2 spalling with exposed reinforcing steel over bent # 8.

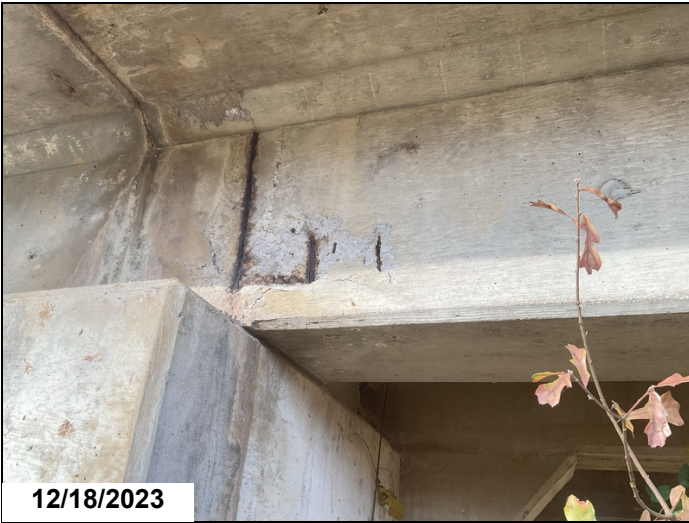
Span # 11, girder # 5 at bent 11 has an 8" shallow spall with exposed reinforcing steel with horizontal cracking under the spall.

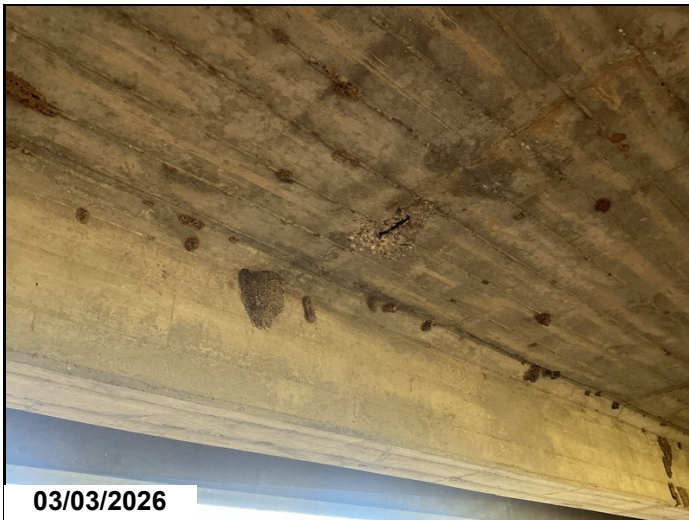
Span # 11 undersurface in bay # 2 located approximately 8' from bent # 11 has a 12" x 8" spall with exposed reinforcing steel. Exposed reinforcing steel has corrosion with flaking rust with an estimated 1/8" section loss.

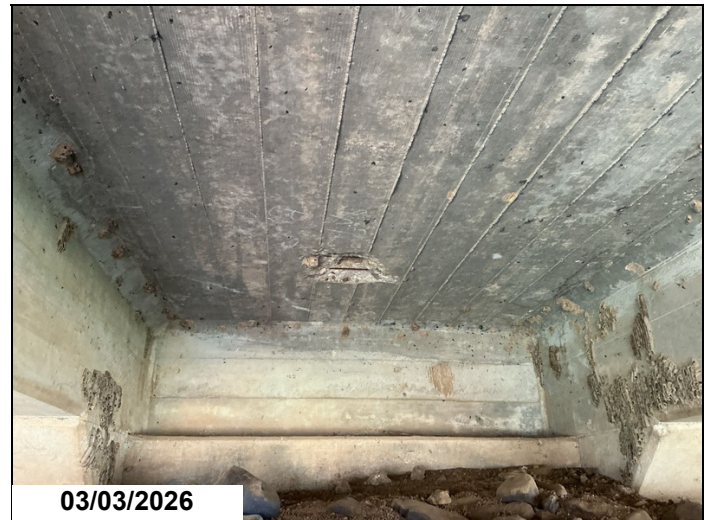
Span # 1 undersurface in bay # 3 adjacent to abutment # 1 has a 12" diameter spall approximately 1-1/2" deep with exposed reinforcing steel. Exposed reinforcing steel has no apparent section loss.

Span # 1 undersurface in bay # 3 adjacent to abutment # 1 has a 12" diameter spall approximately 1-1/2" deep with exposed reinforcing steel. Exposed reinforcing steel has no apparent section loss. 1SF CS3 rebar

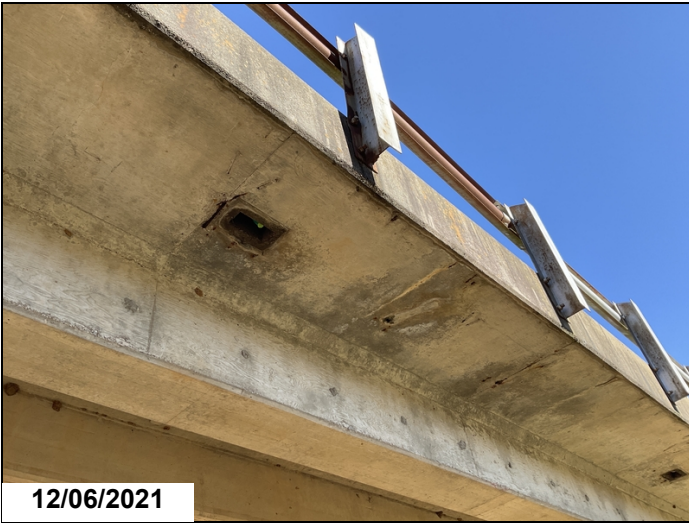
The undersurface of the deck has areas of spalling with exposed reinforcing steel in the overhangs adjacent to the deck drains and in a few other random locations.

Spalls with exposed reinforcing steel in undersurface of deck overhang adjacent to deck drain.

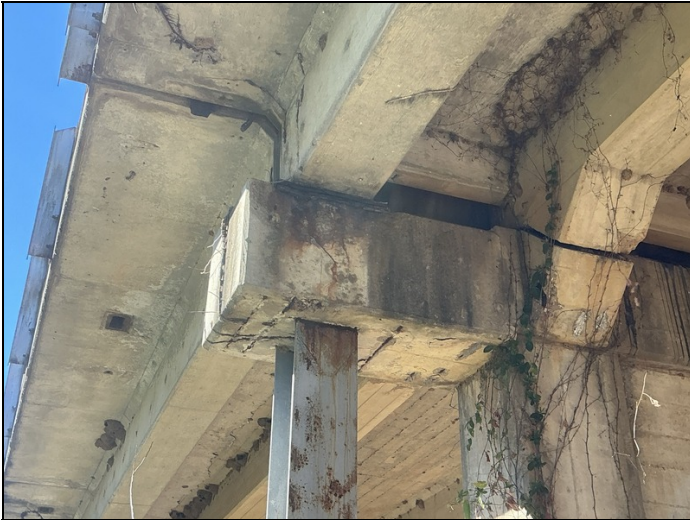
The bearings over the intermediate bents have corrosion with flaking rust.

Span # 6, bearing # 5, bent # 6: bearing has heavy corrosion with layers of flaking rust/ section loss. The bearing has approximately 1" bearing area loss in a 5" long area due to spall in bent cap.

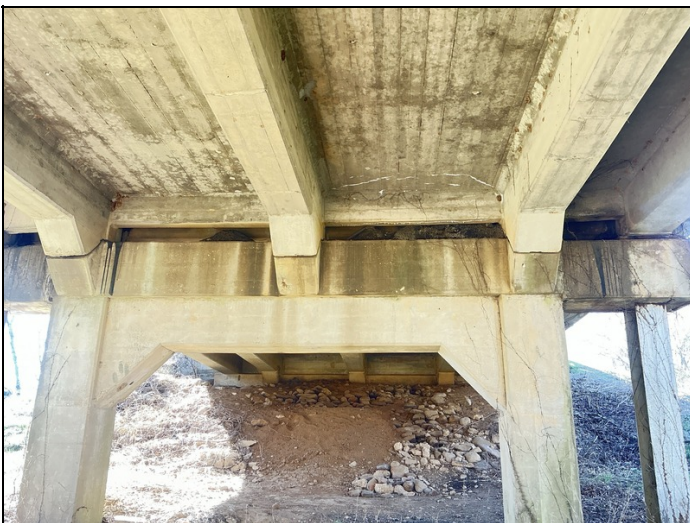
Bearing areas have dirt and debris that has accumulated against the steel bearing devices and ends of concrete girders.

Bent # 2 asphalt on the bent cap.
