Bridge 00413 Inspection Report

IDENTIFICATION	
(1) State Names	5 - Arkansas
(8) Structure Number	00413
(5) Inventory Route	1
(2) Highway Agency District	04 - District 04
(3) County Code	33 - Crawford County

(4) Place Code	0
(6) Features Intersected	Big Mulberry River
(7) Facility Carried	US Highway 64
(9) Location	1 MI E JCT 215 IN MULBERRY
(11) Mile Point	19.9 mi

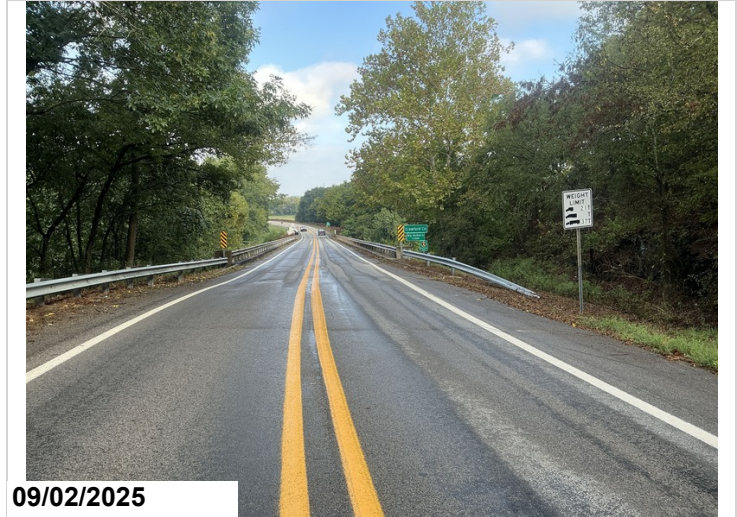
East approach load posting sign.

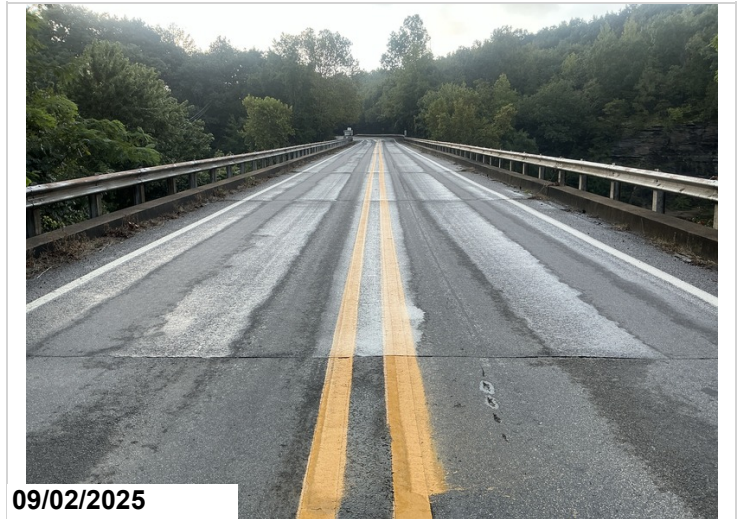
Driving Surface: typical.

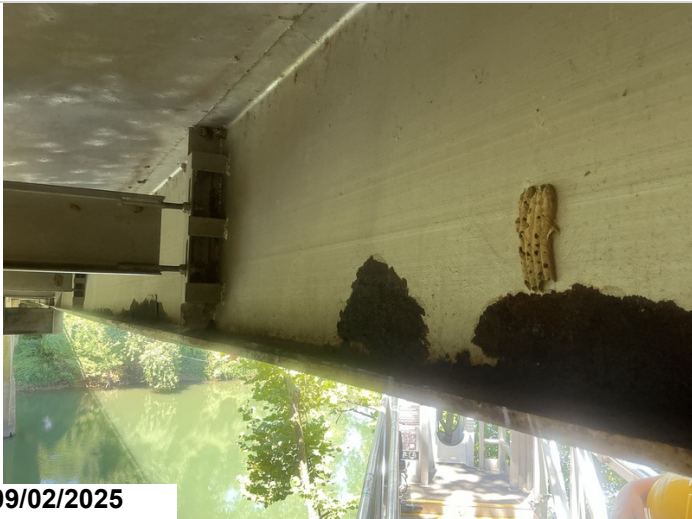
Steel girders have areas of active corrosion with flaking rust. The bottom and top flanges at the ends of girders have the most significant areas of corrosion and section loss.

There are no visible cracks apparent in the NSTM steel girders during this inspection.

Span 5, Girder 1 has areas of active corrosion, flaking rust and section loss on the interior web and bottom flange located in several areas between diaphragm 2 and bent 6.

Sec loss ranges from 0.07" up to 0.28"

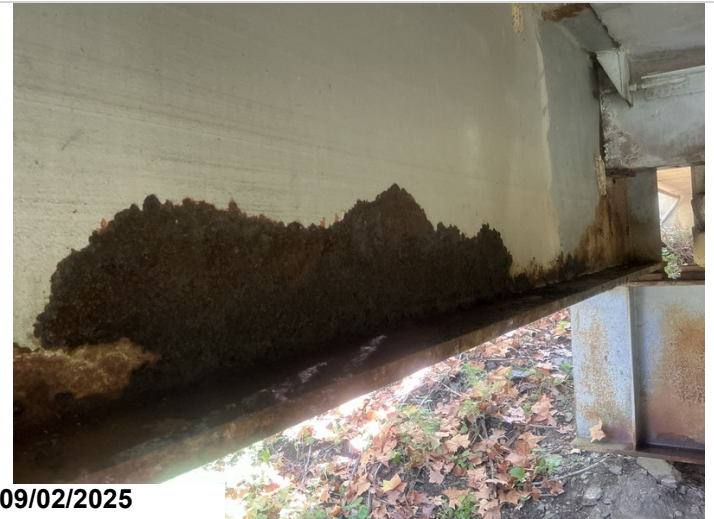
Steel girders have areas of active corrosion with flaking rust. The bottom and top flanges at the ends of girders have the most significant areas of corrosion and section loss.

There are no visible cracks apparent in the NSTM steel girders during this inspection.

Span 5, Girder 1 has areas of active corrosion, flaking rust and section loss on the interior web and bottom flange located in several areas between diaphragm 2 and bent 6.

Sec loss ranges from 0.07" up to 0.28"

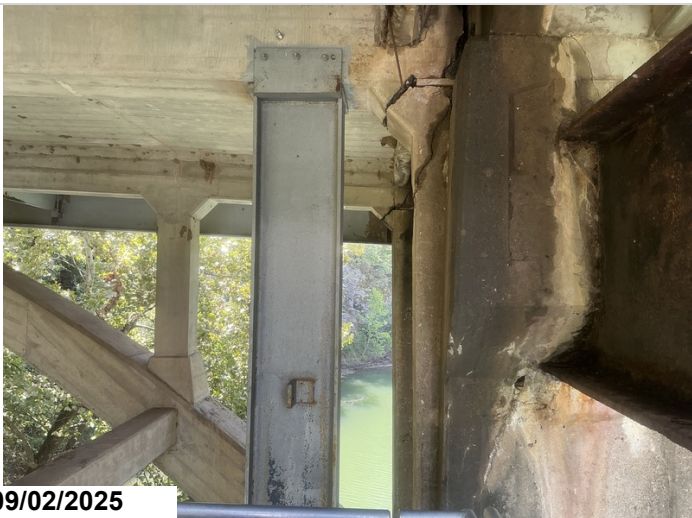
Repair in place.

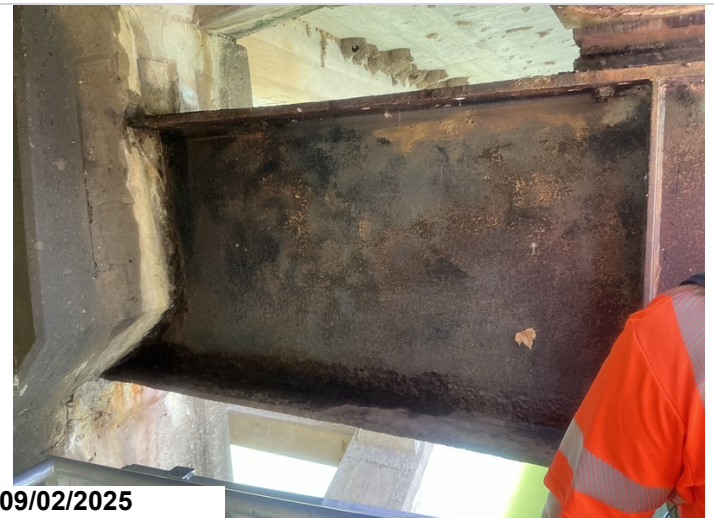
Steel Cap, Bent # 5, Span # 5: the web has active corrosion with up to 5/16" section loss to the steel cap at the juncture where the w-beam passes through the (original) reinforced concrete cap.

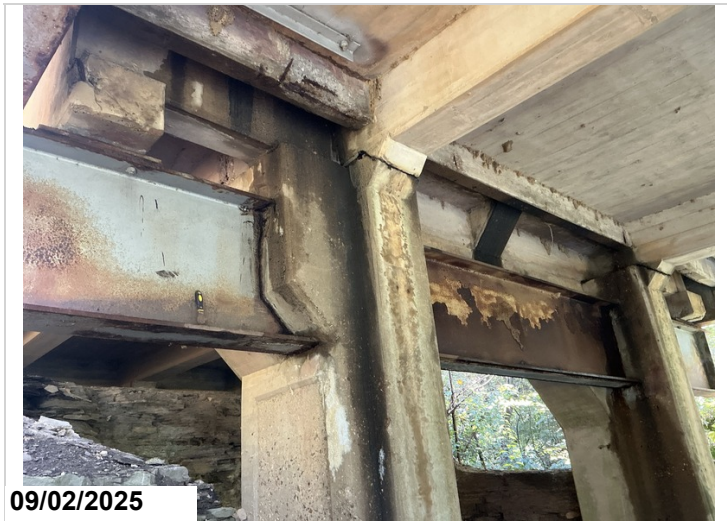
Bent # 6: typical

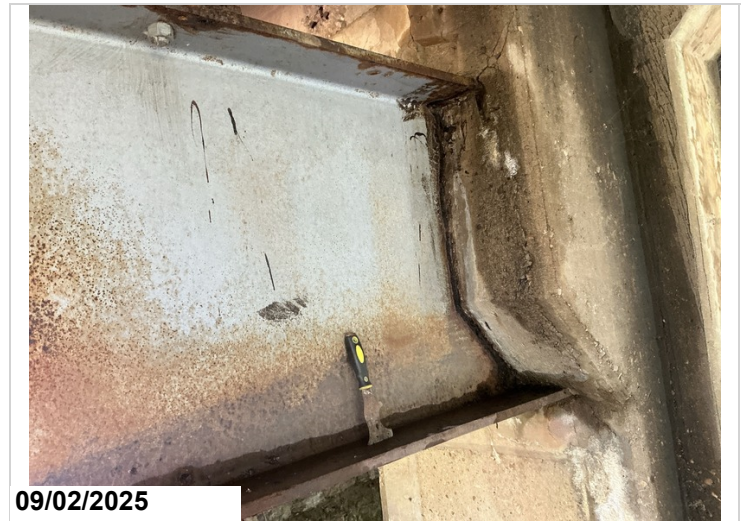
Bent # 6 Steel Cap, Left Side:
The Span # 5 side of web has 1/8" section loss to the steel cap at the juncture where the w-beam passes through the (original) reinforced concrete cap.

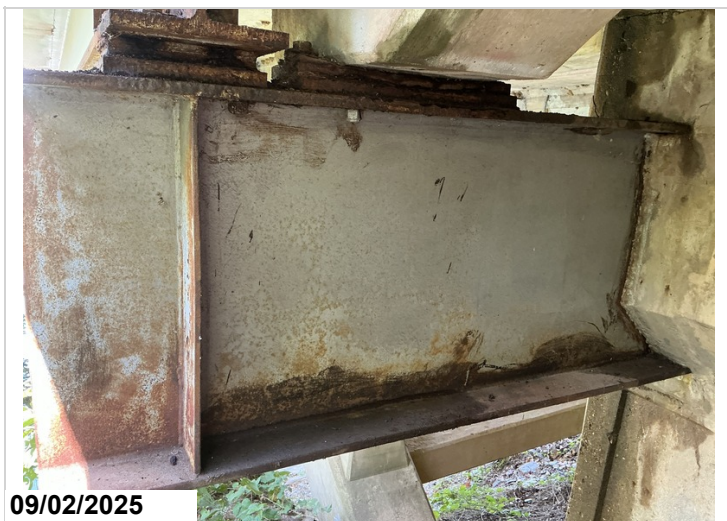
Span # 6 Steel Cap, Right Side:
The Span # 5 side of web has 1/16" section loss to the steel cap at the juncture where the w-beam passes through the (original) reinforced concrete cap.

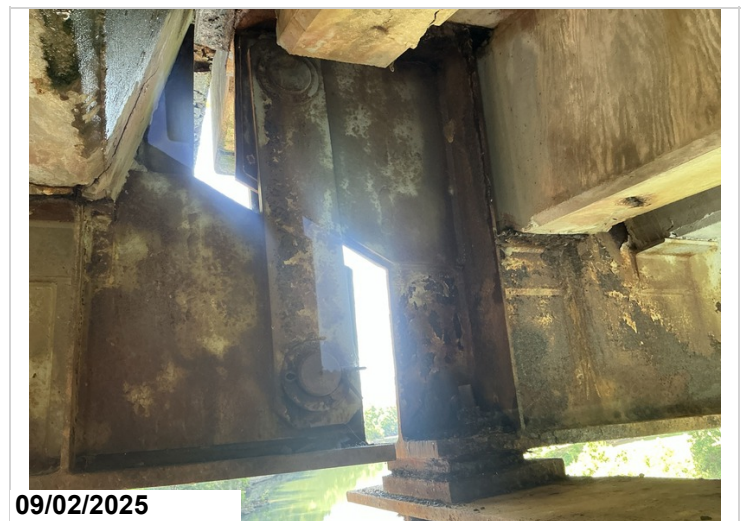
Pin hanger Assembly, Bent # 5, girder # 4: typical.

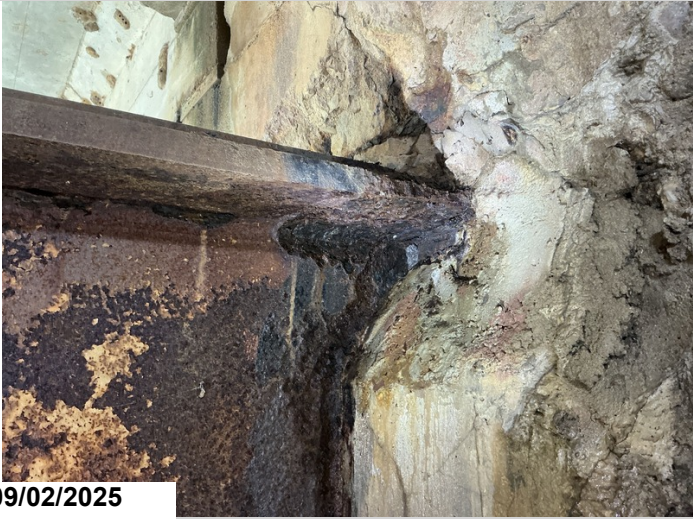
Bent # 5 Steel Cap, Center section between the columns:
The steel cap section between the concrete columns has active corrosion, flaking rust and section loss up to 1/4" on the web adjacent to the top flanges at the column juncture. The top flange has up to 1/2" section loss along the edge of the flange.

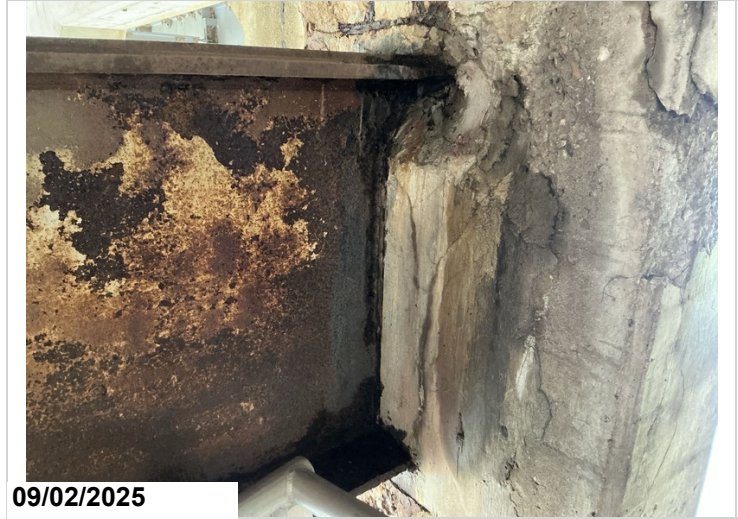
Bent # 5 Steel Cap, Center section between the columns:
The steel cap section between the concrete columns has active corrosion, flaking rust and section loss up to 1/4" on the web adjacent to the top flanges at the column juncture.

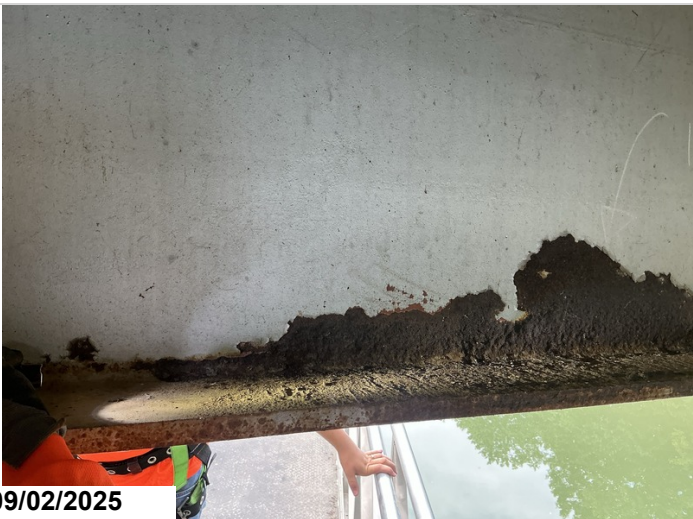
Span 4, Girder 4 has a 2' area at the base of web and on the bottom flange that has active corrosion with 5/16" section loss to the interior side of girder at the web connection located approximately 6' from Bent 5.

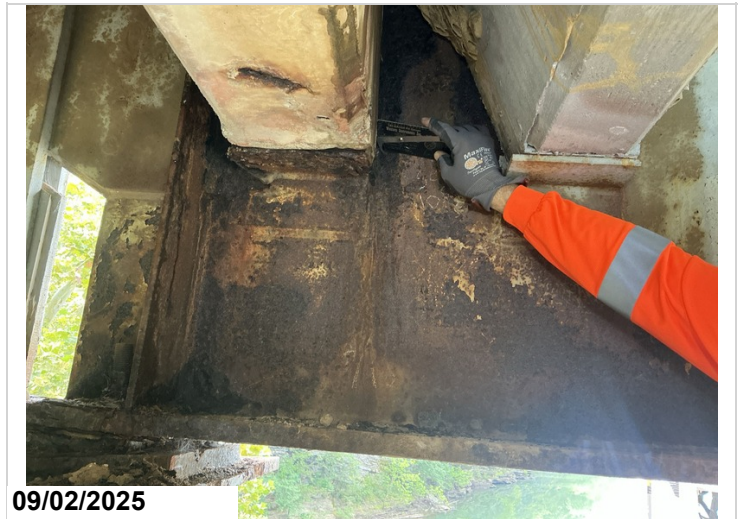
Bent # 5, Span # 4, Girder 4: girder has approximately 3/8" section loss to the web located 20" from the end of girder at Bent 5 adjacent to the expansion dam.

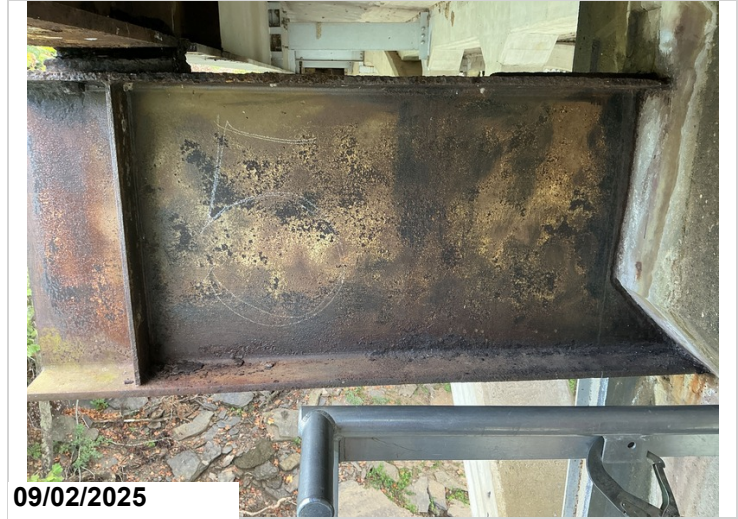
Bent # 5 Steel Cap, Left Side:

The Span # 4 side of web has active corrosion with up to 3/16" section loss to the steel cap at the juncture where the w-beam passes through the (original) reinforced concrete cap.

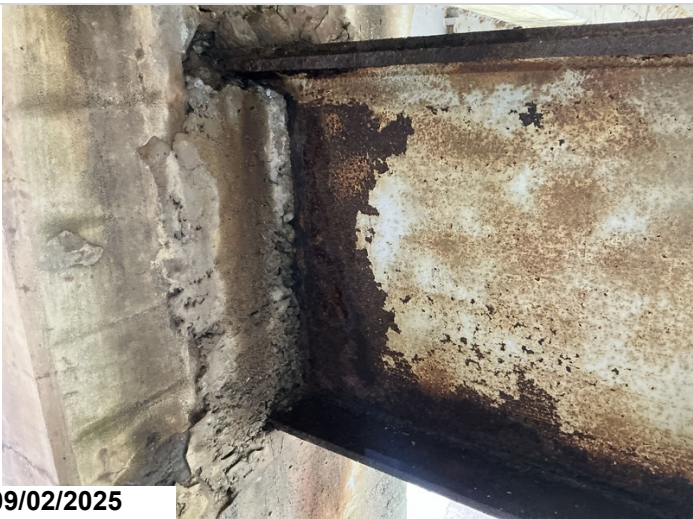
Bent # 4 Steel Cap, Center section column # 2

The steel cap section between the concrete columns has active corrosion, flaking rust and section loss up to 1/4" on the web and top and bottom flanges at the column juncture.

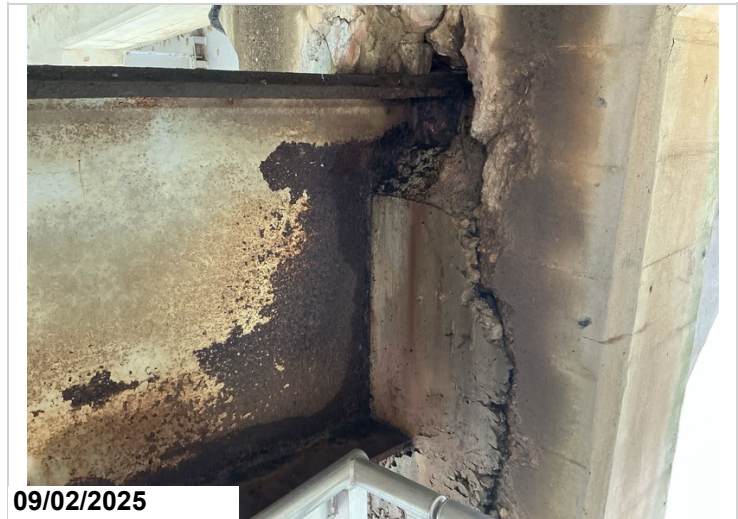
Bent # 4 Steel Cap, Center section, column # 1:

The steel cap section between the concrete columns has active corrosion, flaking rust and section loss up to 1/4" on the web and top and bottom flanges at the column juncture.

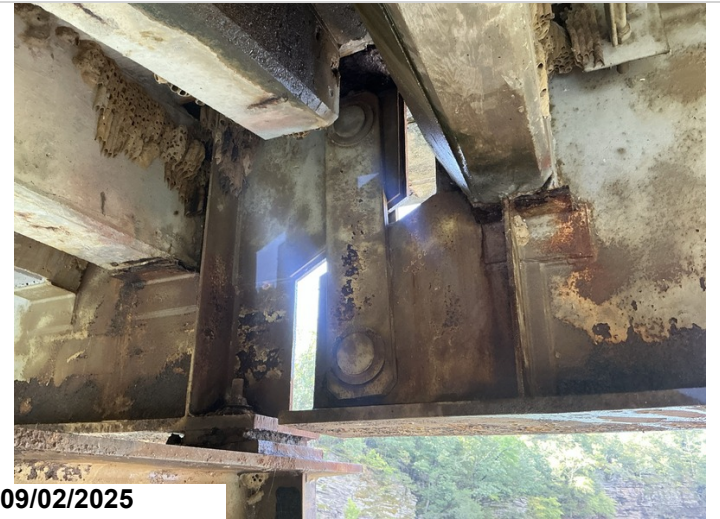
Pin Hanger assembly, Bent # 4, girder # 4: typical.

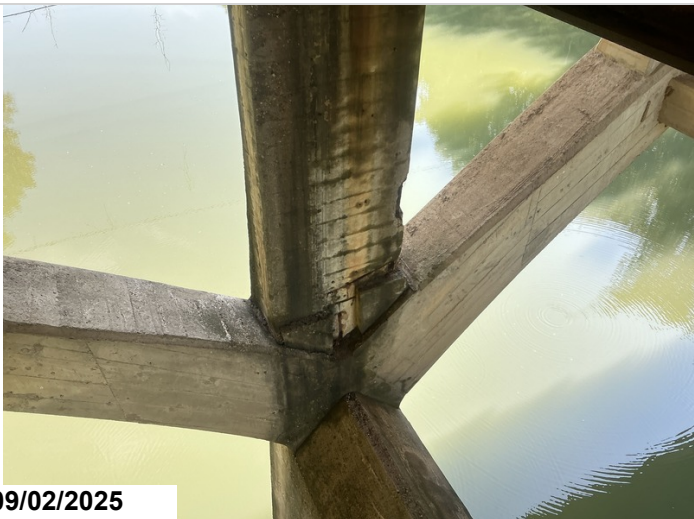
Bent # 4, column # 1: spalling with exposed reinforcing steel.

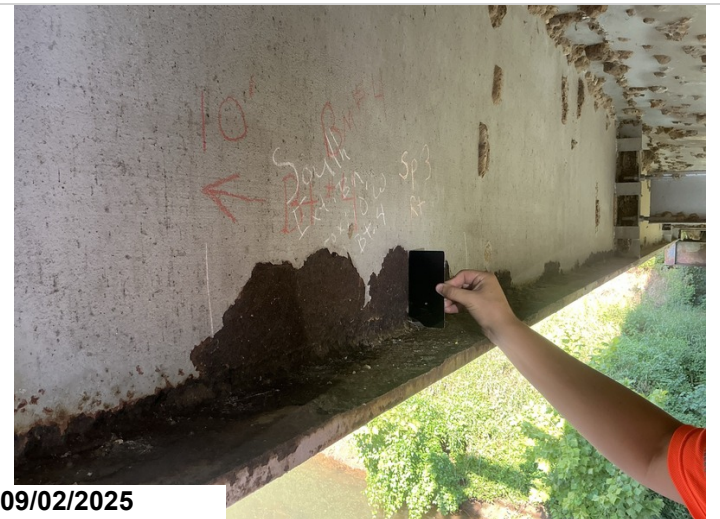
Span 3, Girder 4 has a 2' area at the base of web and on the bottom flange that has active corrosion with 3/16" section loss to the interior side of beam at the web juncture located approximately 10' from Bent 4.

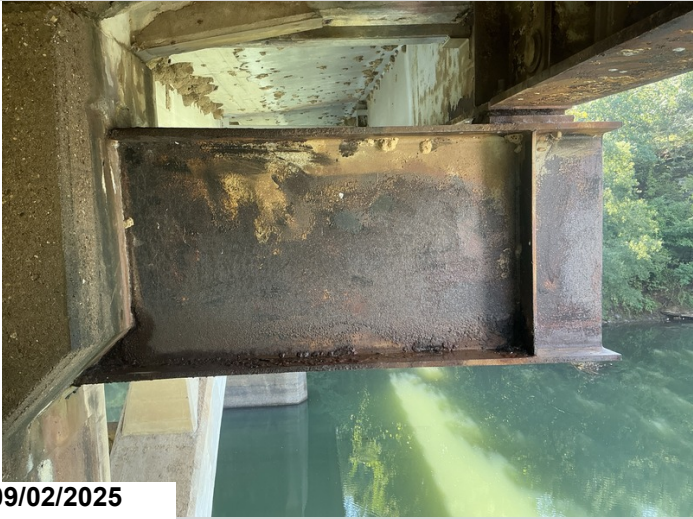
Bent # 4 Steel Cap, Right Side:
The Span # 3 side of cap has 3/16" section loss to the steel cap at the juncture where the w-beam passes through the (original) reinforced concrete cap.

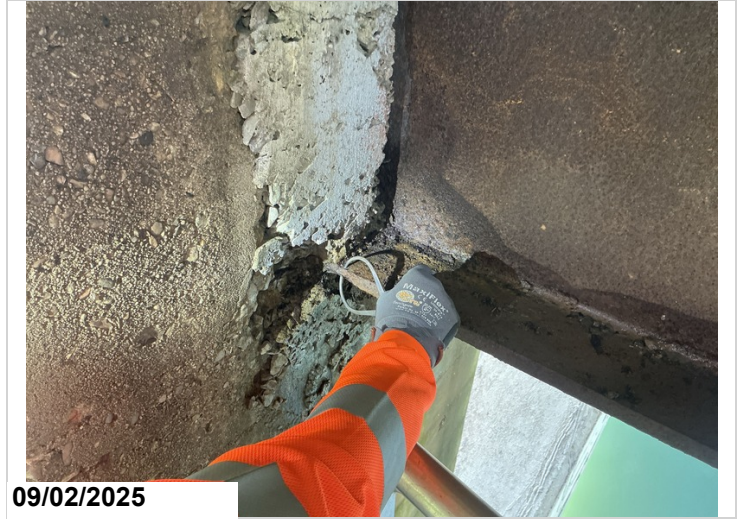
Bent # 4 Steel Cap, Center section between the columns
Bent # 4 Steel Cap, Center section between the columns:

The steel cap section between the concrete columns has active corrosion, flaking rust and section loss up to 1/8" on the web and top and bottom flanges at the column juncture. The top flange of the steel cap has active corrosion with up to 5/16" section loss at the juncture where the w-beam passes through the (original) reinforced concrete cap. The bottom flange has flaking rust on the undersurface.

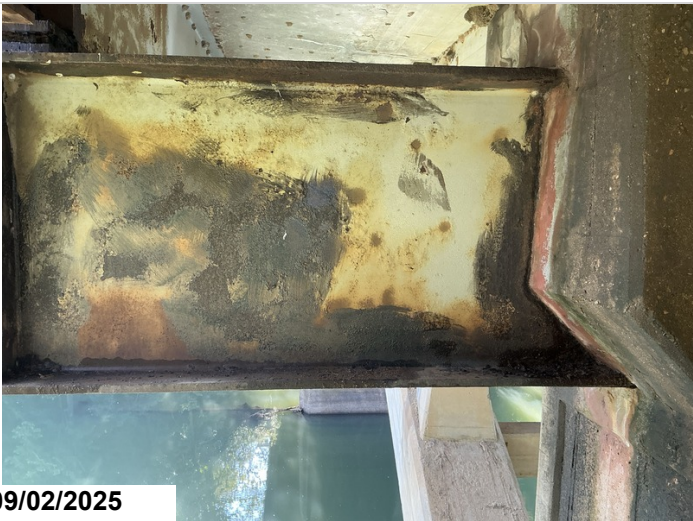
Bent # 4 Steel Cap, Left side:
The Span # 3 side of web has 1/8" section loss to the steel cap at the juncture where the w-beam passes through the (original) reinforced concrete cap. The top flange of the steel cap has active corrosion with up to 5/16" section loss at the juncture where the w-beam passes through the (original) reinforced concrete cap.
The bottom flange has flaking rust on the undersurface.

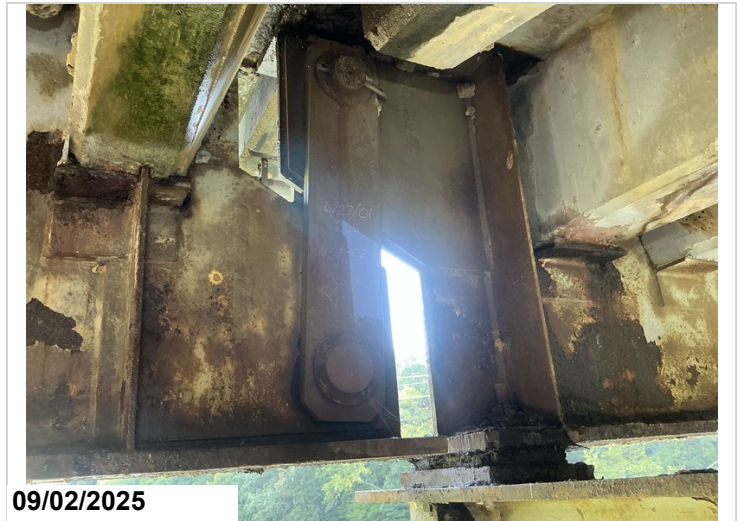
Pin hanger assembly, bent # 4, girder # 1: typical.

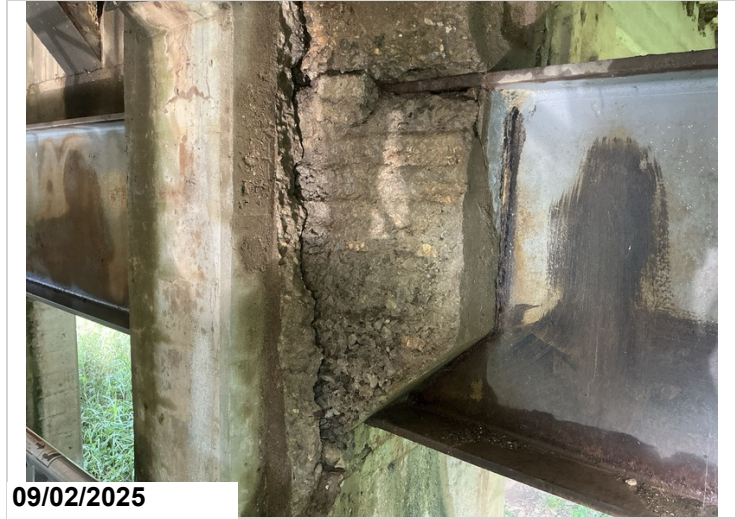
Bent # 3 ahead face. The top of the left column of bent # 3 has vertical and diagonal cracking approximately 3/8" wide with a delaminated area under the bearing for left concrete girder. (This deficiency appears to be similar to the area repaired in the past by installing a vertical support at bent # 5, column # 1 as noted above.)

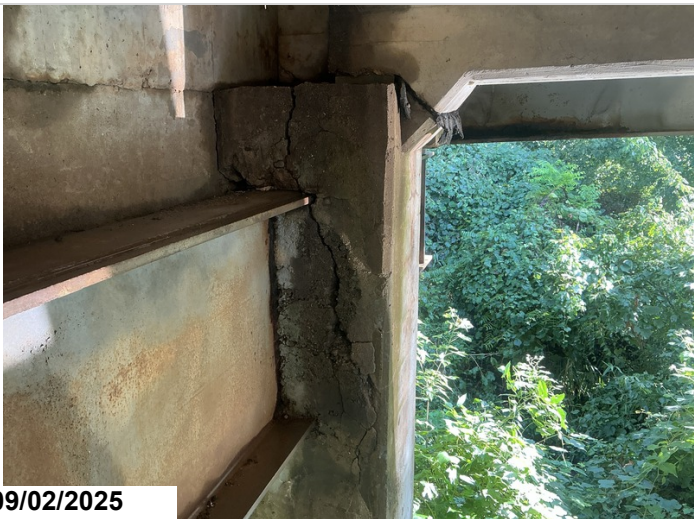
Bent # 3 ahead face. The top of the left column of bent # 3 has vertical and diagonal cracking approximately 3/8" wide with a delaminated area under the bearing for left concrete girder. (This deficiency appears to be similar to the area repaired in the past by installing a vertical support at bent # 5, column # 1 as noted above.)

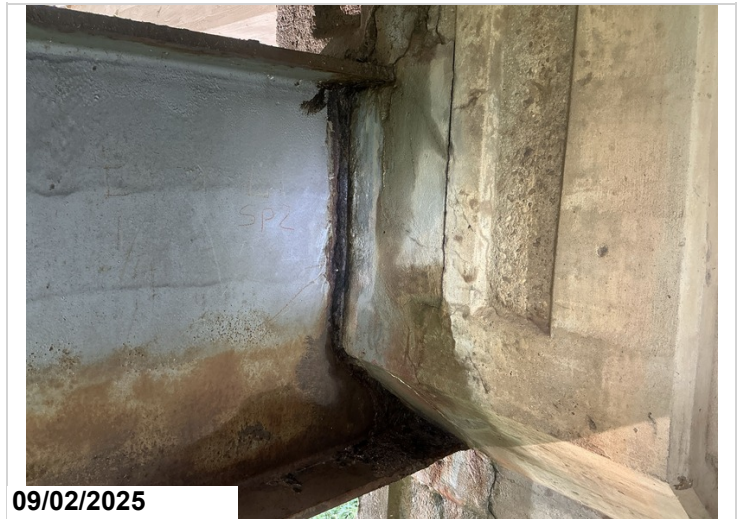
Bent # 3 Steel Cap, Left side:
The Span # 2 side of web has 5/16" section loss to the steel cap at the juncture where the w-beam passes through the (original) reinforced concrete cap.

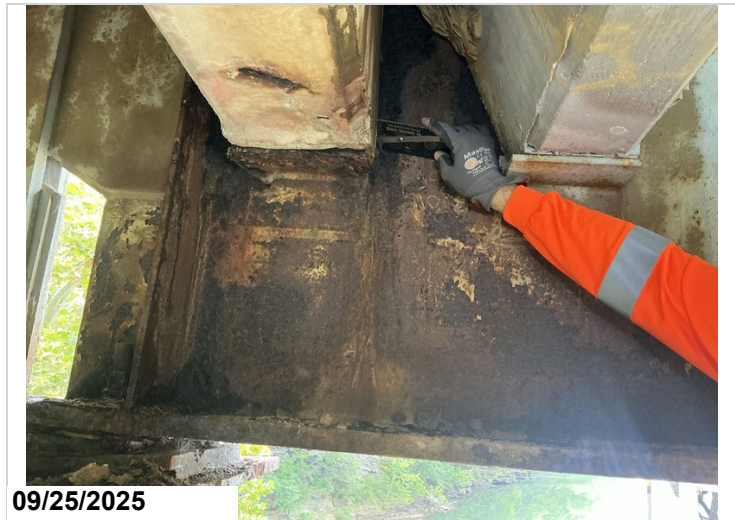
The girder ends and bearings have active corrosion and pack rust.

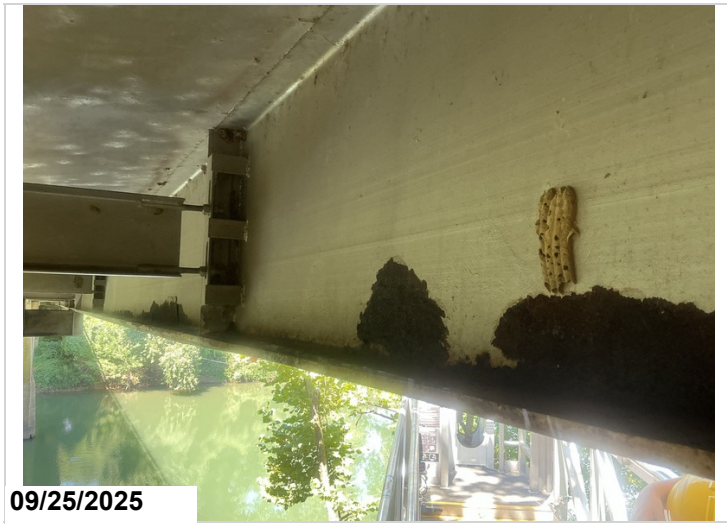
The girders have a failing paint system.

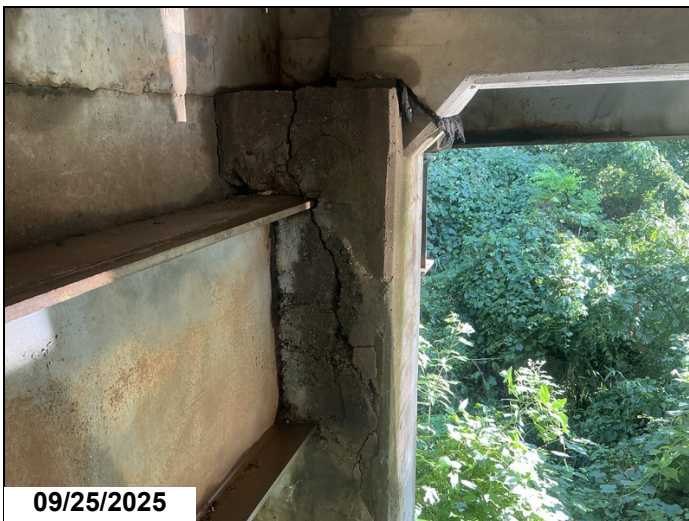
07/18/2024 - EJW - The crack width has increased since the last inspection, priority modified to reflect changes since the last inspection.

Bent # 3 ahead face. The top of the left column of bent # 3 has vertical and diagonal cracking approximately 3/8" wide with a delaminated area under the bearing for left concrete girder. (This deficiency appears to be similar to the area repaired in the past by installing a vertical support at bent # 5, column # 1 as noted above.)

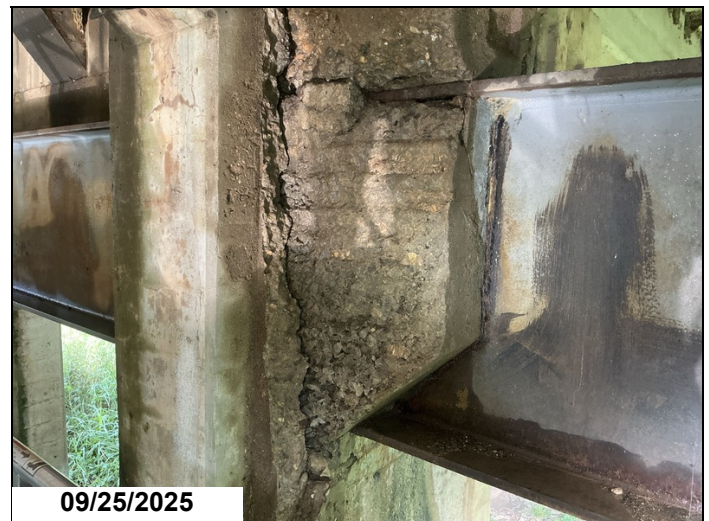
Bent # 3 ahead face. The top of the left column of bent # 3 has vertical and diagonal cracking approximately 3/8" wide with a delaminated area under the bearing for left concrete girder. (This deficiency appears to be similar to the area repaired in the past by installing a vertical support at bent # 5, column # 1 as noted above.)

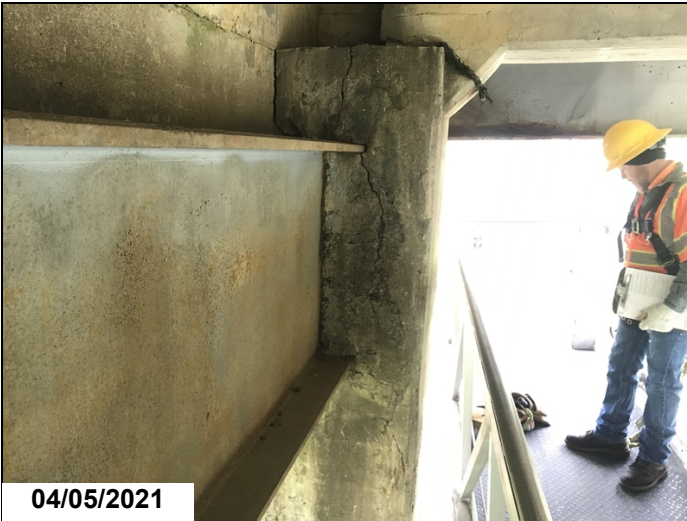
Bent # 3 ahead face of left column has vertical and diagonal cracking approximately 3/8" wide with a delaminated area under the bearing of the left concrete girder. (This deficiency appears to be similar to the area repaired in the past at bent # 5 left column by placing a steel vertical support under concrete arch girder.

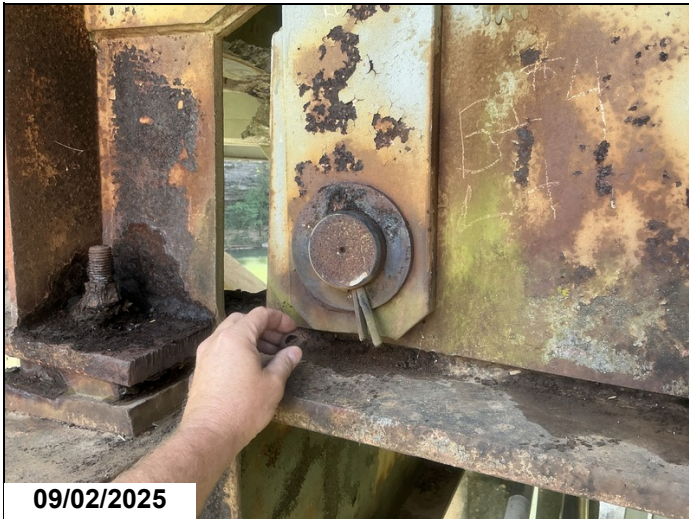
Bent # 4, span # 3, left: pin hanger assembly with fractured cotter pin.

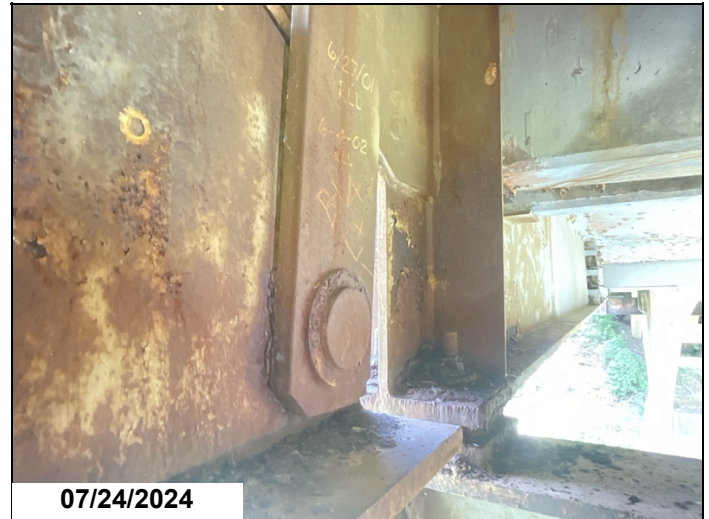
Bent # 4, span # 3, left: pin hanger assembly with active corrosion behind the pin hanger.

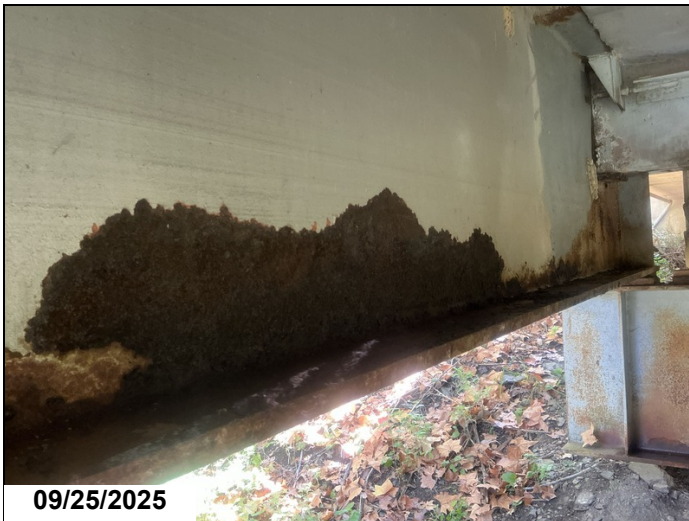
Steel girders have areas of active corrosion with flaking rust.

The bottom and top flanges at the ends of girders have the most significant areas of corrosion and section loss. There are no visible cracks apparent in the NSTM steel girders during this inspection.

Span 5, Girder 1 has areas of active corrosion, flaking rust and section loss on the interior web and bottom flange located in several areas between diaphragm 2 and bent 6. Sec loss ranges from 0.07" up to 0.28"

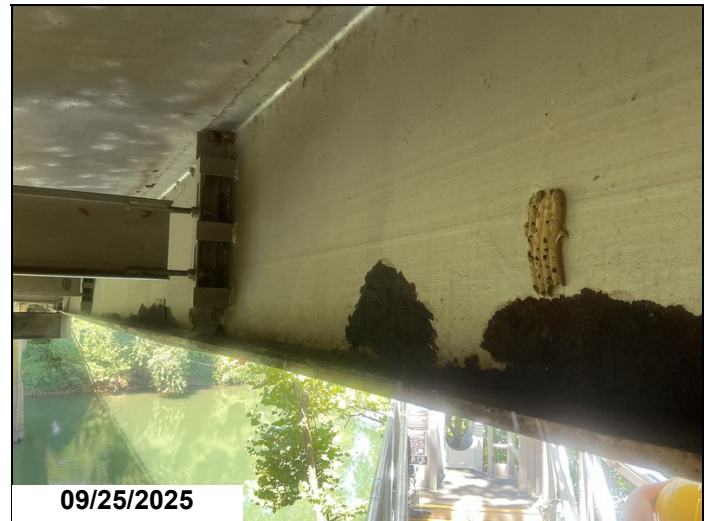
Steel girders have areas of active corrosion with flaking rust.

The bottom and top flanges at the ends of girders have the most significant areas of corrosion and section loss. There are no visible cracks apparent in the NSTM steel girders during this inspection.

Span 5, Girder 1 has areas of active corrosion, flaking rust and section loss on the interior web and bottom flange located in several areas between diaphragm 2 and bent 6. Sec loss ranges from 0.07" up to 0.28"

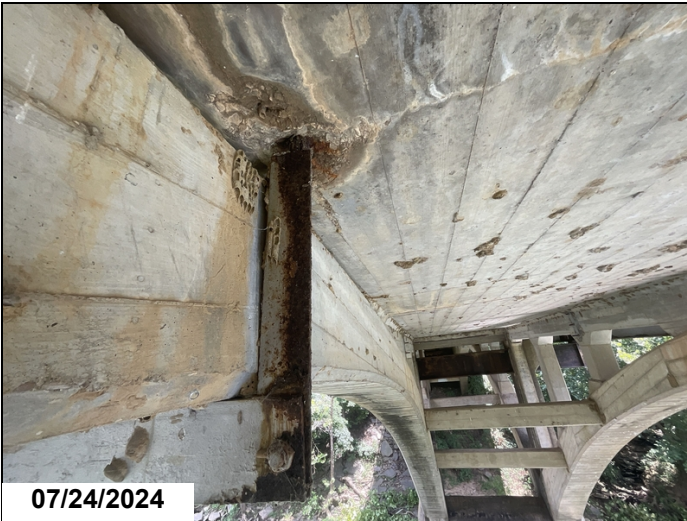
Span # 4, girder # 2, mid span: active corrosion with section loss to the anchor bolt that secures the diaphragm to the deck adjacent to the arch rib.

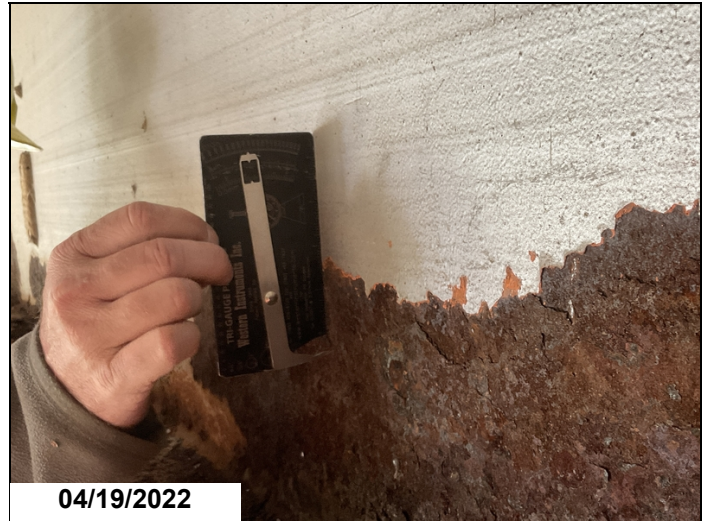
Span # 5, beam # 1 near bent # 6-Section loss to web.

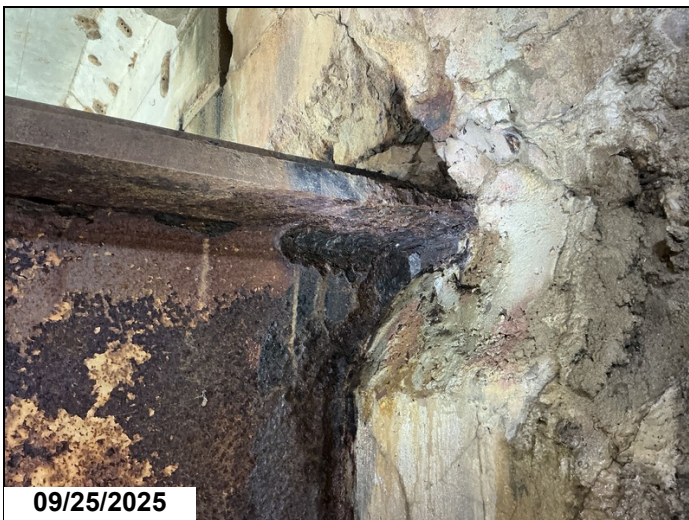
Bent # 5 Steel Cap, Center section between the columns:
The steel cap section between the concrete columns has active corrosion, flaking rust and section loss up to 1/4" on the web adjacent to the top flanges at the column juncture. The top flange has up to 1/2" section loss along the edge of the flange.

HBM Crew cleaned and painted corrosion areas at Bent 5 with calcium sulfonate CSL 8/4/2020

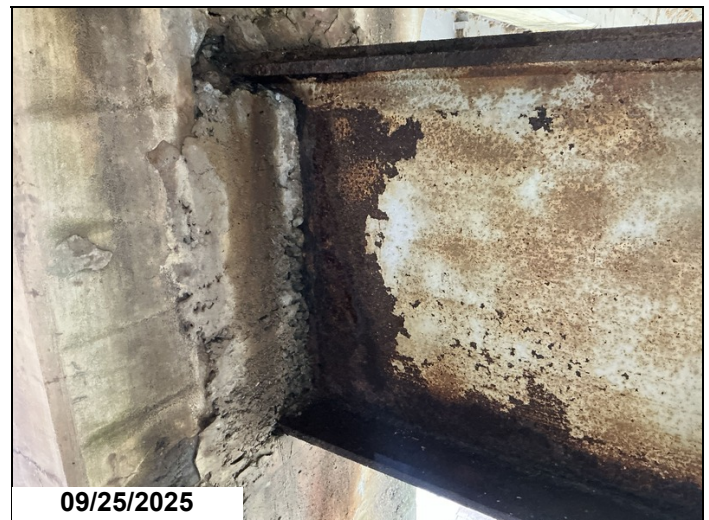
Bent # 4 Steel Cap, Center section column # 2
The steel cap section between the concrete columns has active corrosion, flaking rust and section loss up to 1/4" on the web and top and bottom flanges at the column juncture.

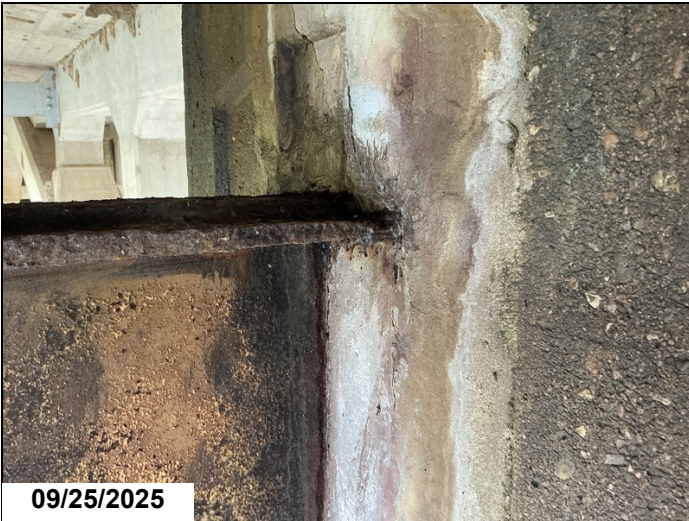
Bent # 5, Span # 4 , left: the top flange has been reduced to 5/16" thickness.

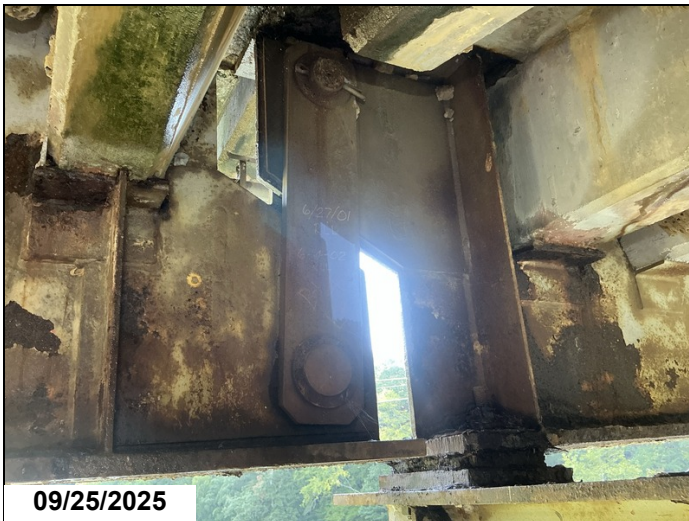
Pin hanger assembly, bent # 4, girder # 1: typical.

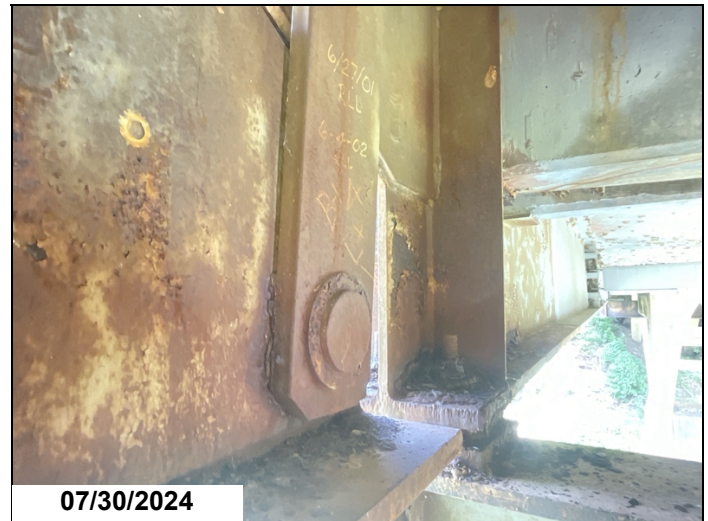
Bent # 4, span # 3, left: pin hanger assembly with active corrosion behind the pin hanger.

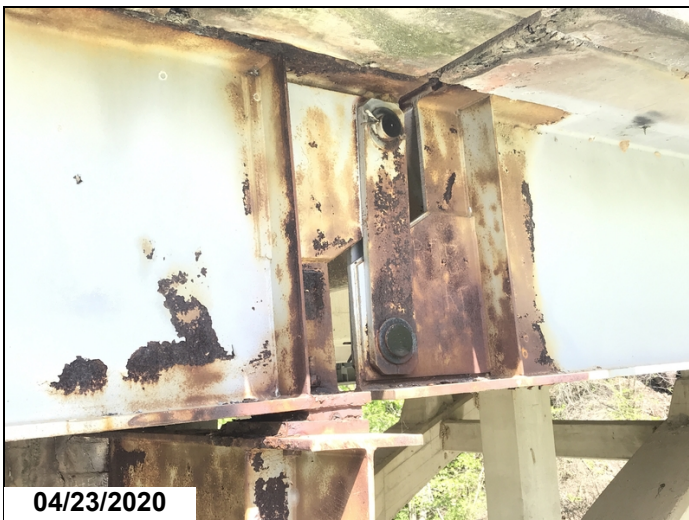
General view of pin assembly # 2 over bent # 5. Right.

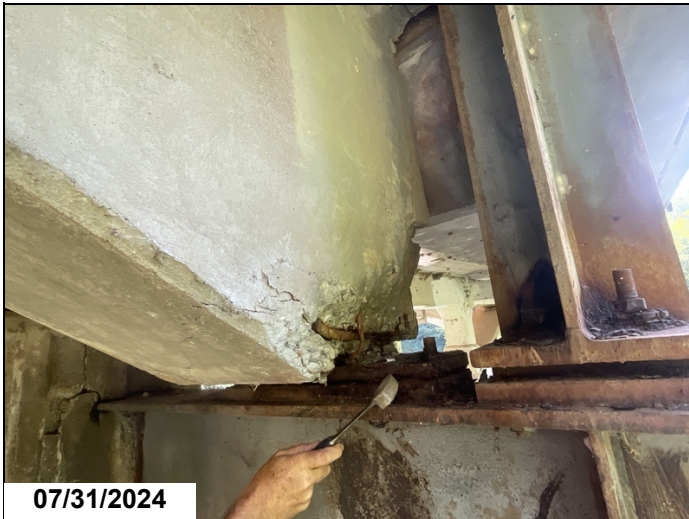
Span # 2, bent # 3, girder # 5: concrete spalling with exposed reinforcing steel, exposed reinforcing steel has up to 75% section loss.

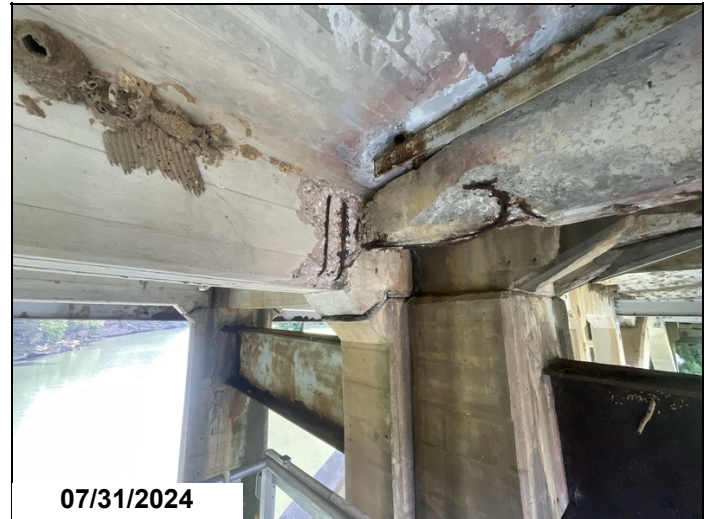
Bent # 4, span # 4, girder # 2, left: spalling with exposed reinforcing steel.

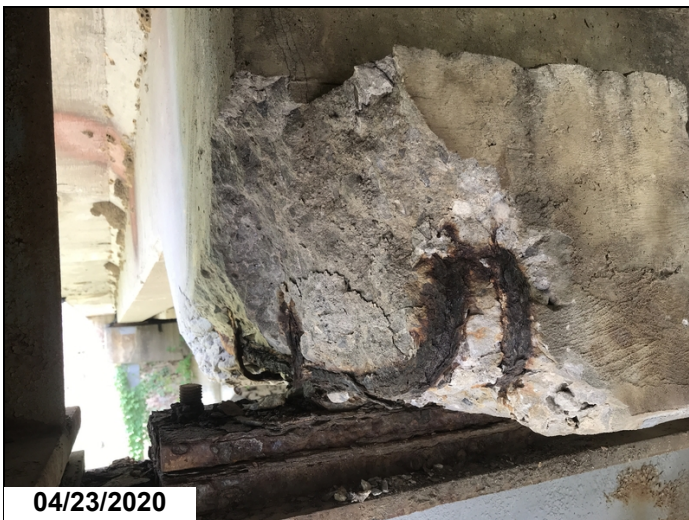
Span # 2, girder # 1-Spalling with exposed reinforcing steel.

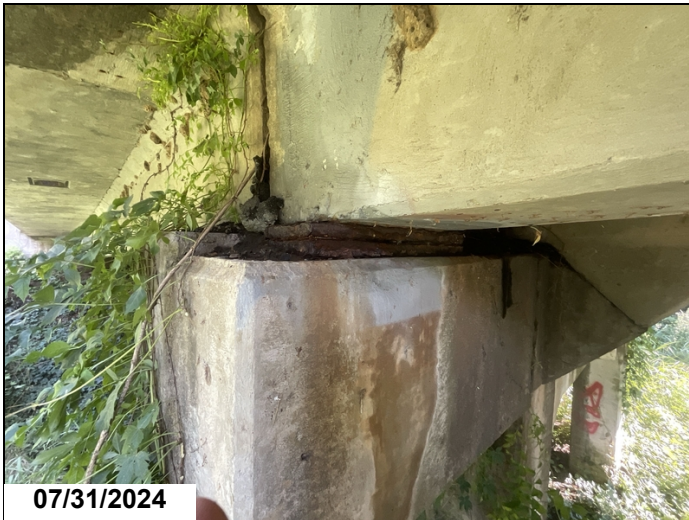
05/23/2023 - RSM - Priority code changed from "D" to "C" due to continued deterioration with heavy corrosion / section loss.

Bent # 2, girder # 5: bearing has active corrosion and pack rust.

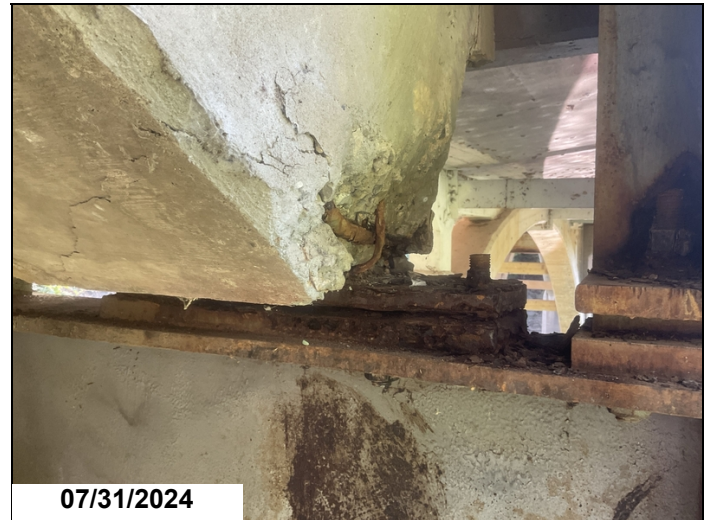
Span # 2, Bent # 3, girder # 5: bearing has active corrosion and pack rust.

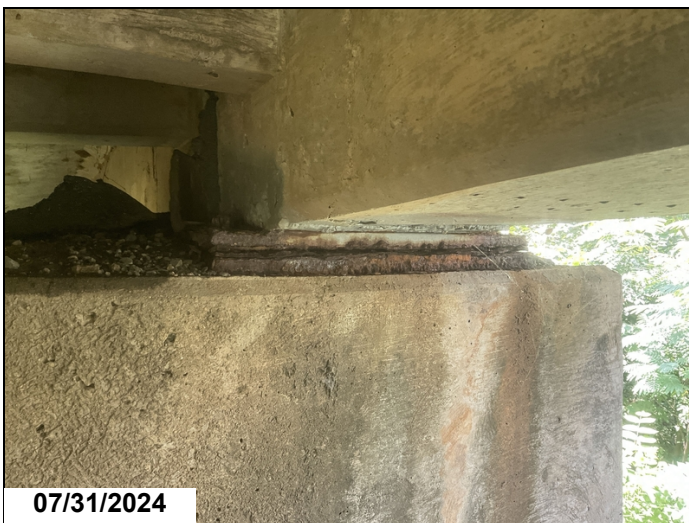
Span # 2, bent # 2, girder # 2: active corrosion with pack rust.

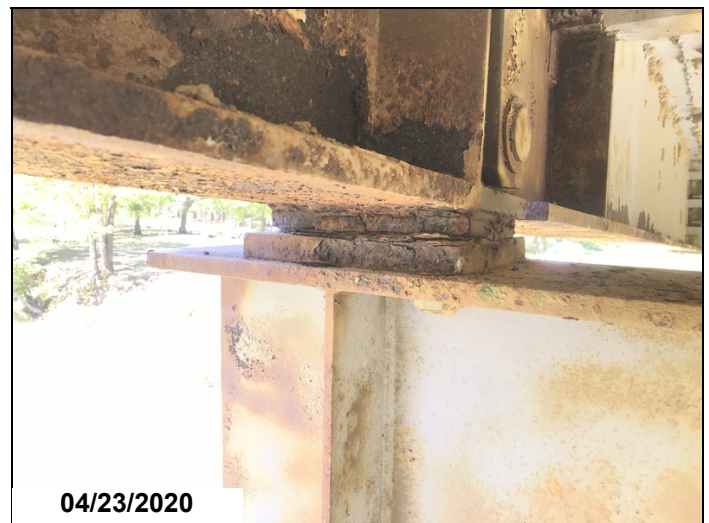
Bearing at bent # 4. Right side of structure.

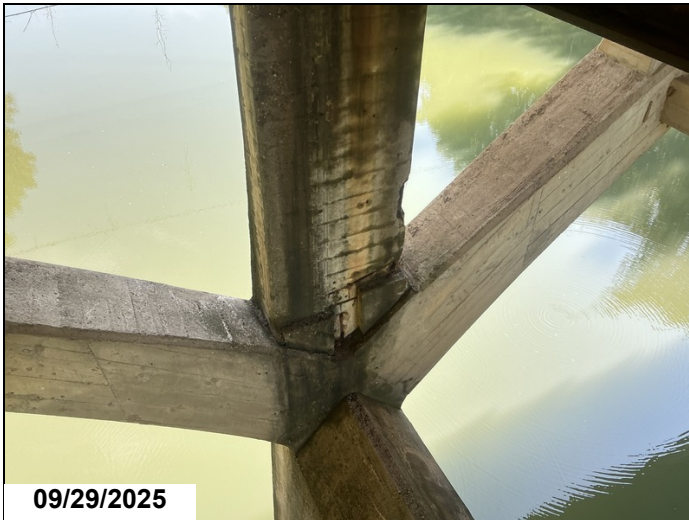
Bent # 4, column # 1: spalling with exposed reinforcing steel.

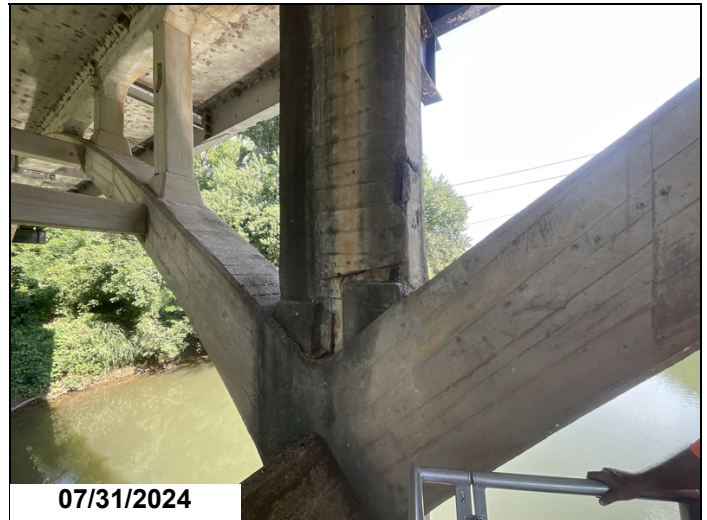
Bent # 4, column # 1, right: concrete deterioration with exposed reinforcing steel at the arch rib junction.

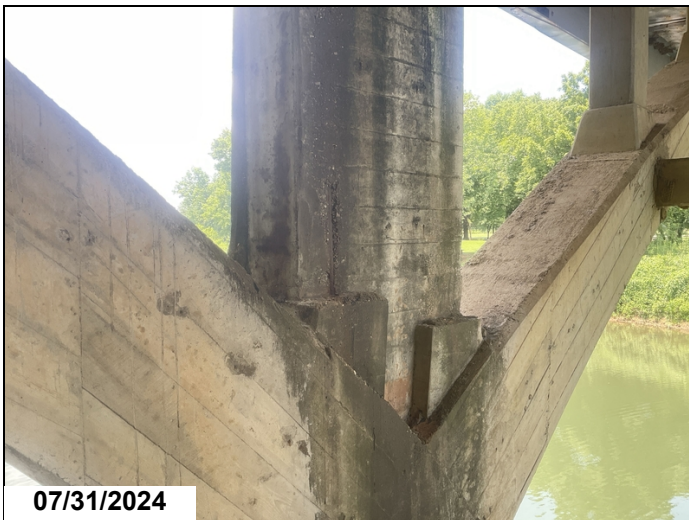
Bent # 5, column # 2, left spalling with exposed reinforcing steel.
