Bridge 00413 Inspection Report

IDENTIFICATION	
(1) State Names	5 - Arkansas
(8) Structure Number	00413
(5) Inventory Route	1
(2) Highway Agency District	04 - District 04
(3) County Code	33 - Crawford County

(4) Place Code	0
(6) Features Intersected	Big Mulberry River
(7) Facility Carried	US Highway 64
(9) Location	1 MI E JCT 215 IN MULBERRY
(11) Mile Point	19.9 mi

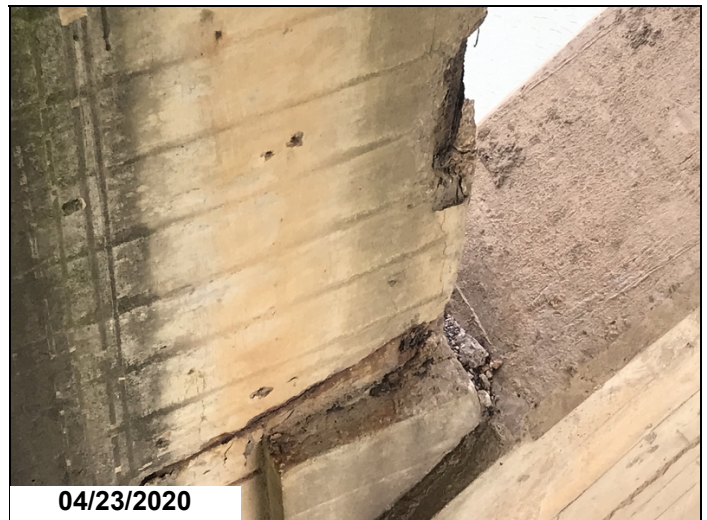
Span # 3 -Spalling with exposed reinforcing steel in arch rib # 1 column at bent # 4.

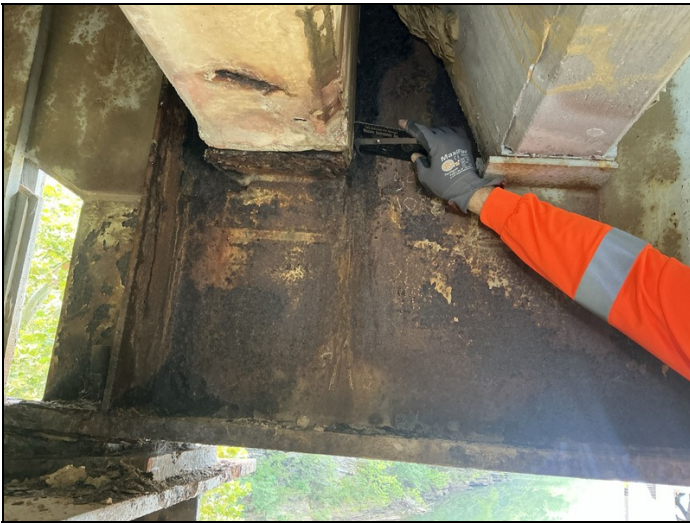
The girder ends and bearings have active corrosion and pack rust.

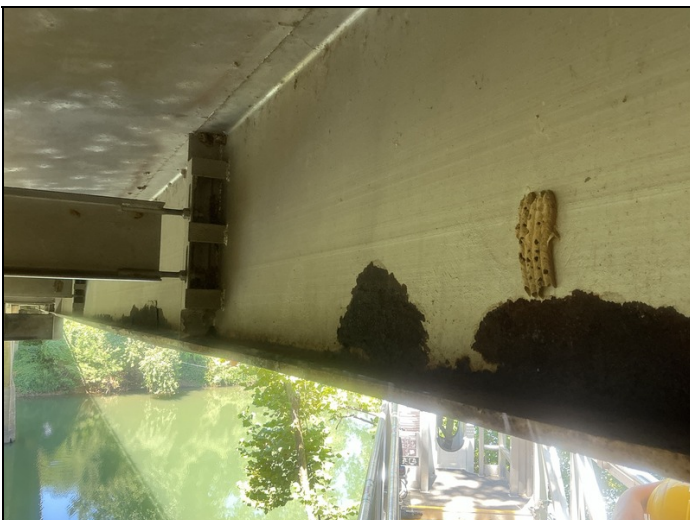
The girders have a failing paint system.

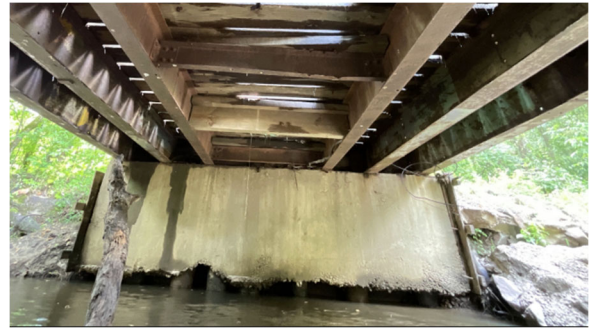
Figure 1 Undermining of the abutment exposing piles.
