## Bridge 02282 Inspection Report

Asset #02282(Routine, Underwater type 2)

US Highway 64 over Heard Branch

Team Lead: Eric West Inspection Date: 08/13/2025

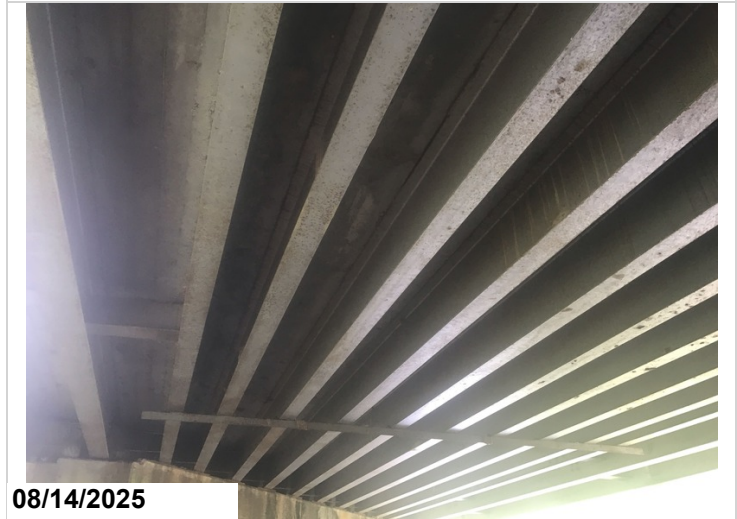
Undersurface: typical.

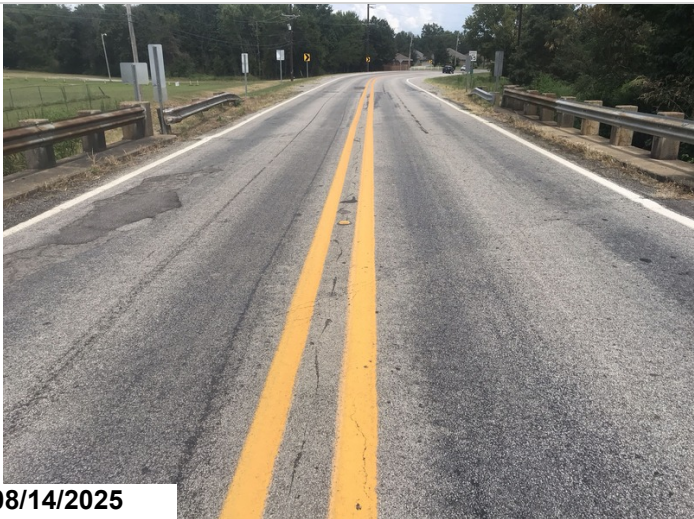
Driving Surface: typical.

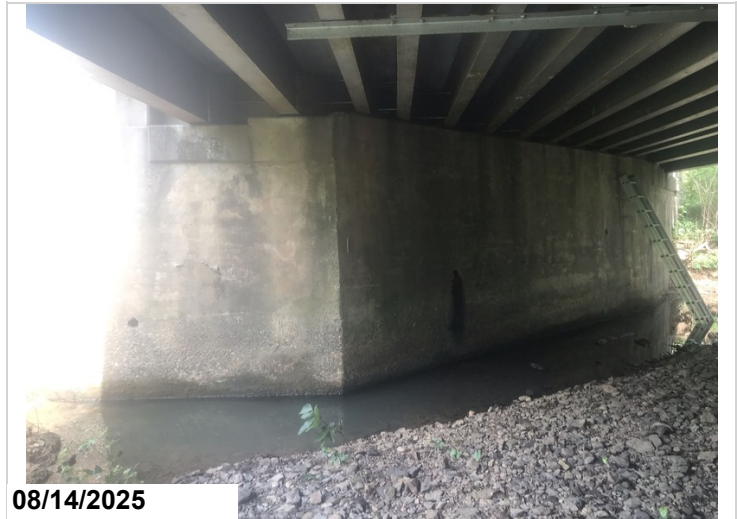
Abutment # 2: typical.

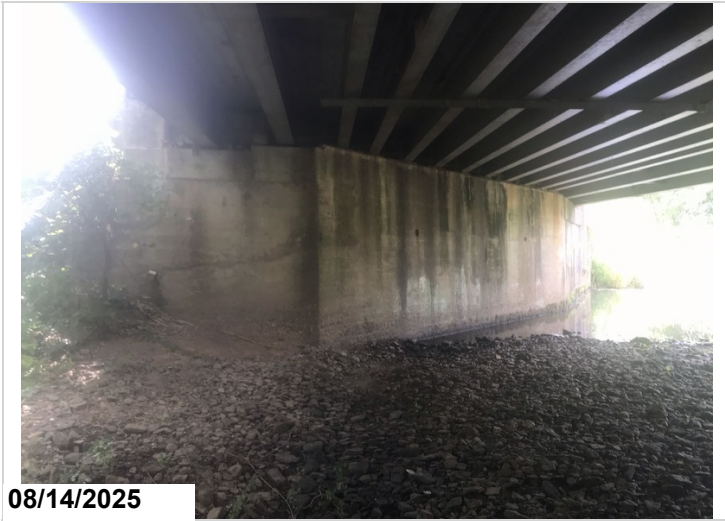
Abutment # 1: typical.

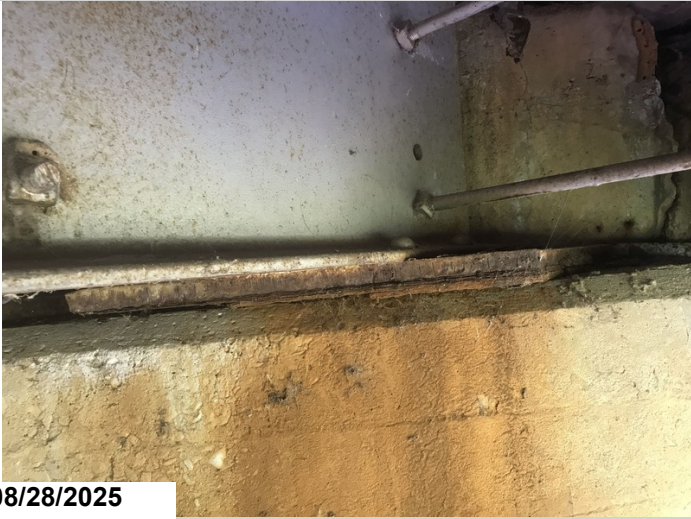
The girder ends and bearings have areas with active corrosion and layers of flaking rust.

The bearings have areas with active corrosion and layers of flaking rust.

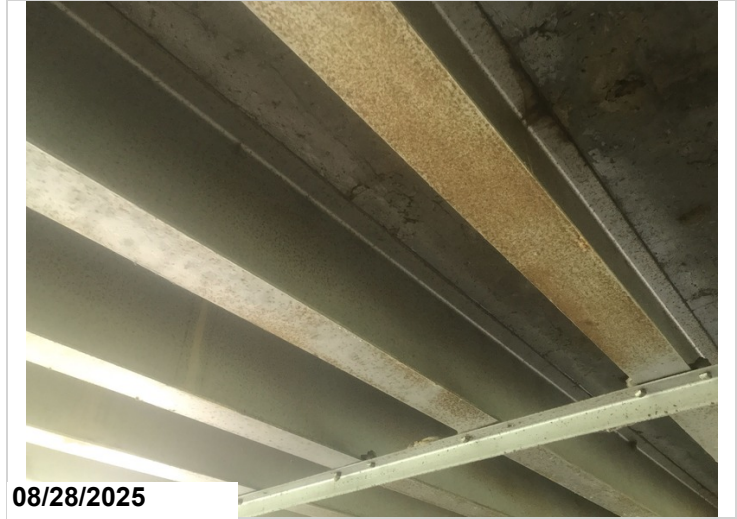
The girders have a failing paint system with freckled rust visible throughout.

Failing paint system.

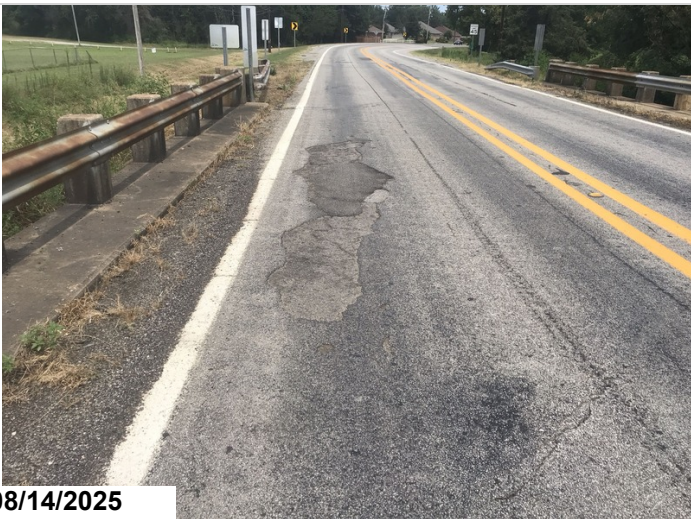
Left lane: Chip and seal wearing surface in left lane is missing in an area approximately 12' long x 2-1/2' wide.

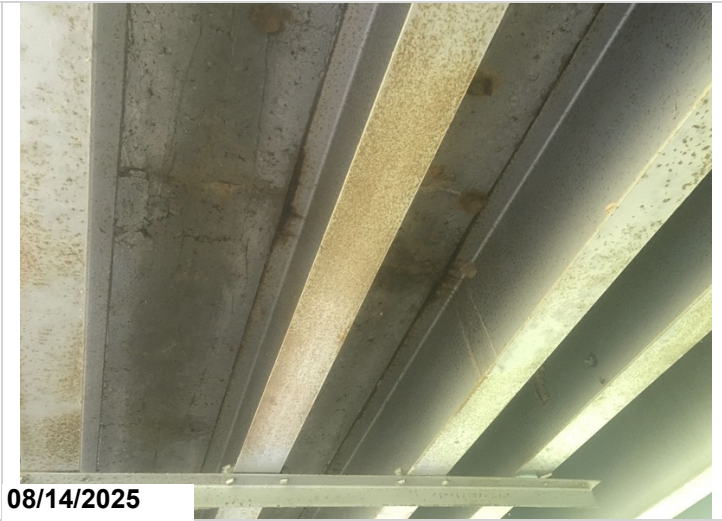
Steel Girder: top flange corrosion at full depth cracks.

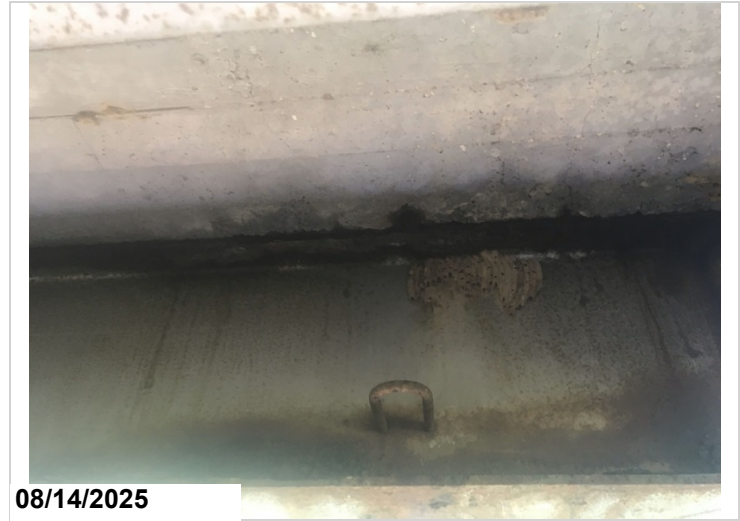
Girder # 14: The top flange of beam # 14 has an area of active corrosion with flaking rust on the exterior side near abutment # 2. Top flange appears to have approximately 1/8" section loss.

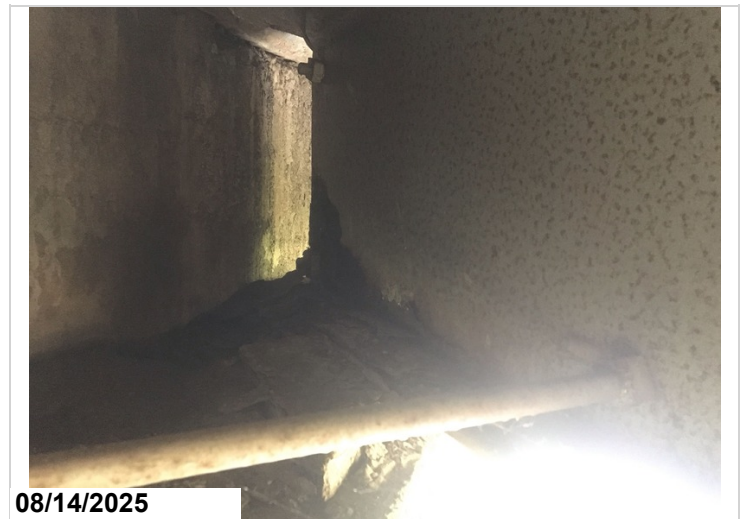
Abutment # 1, girder # 8: active corrosion, pack rust and approximately 1/8" section loss.

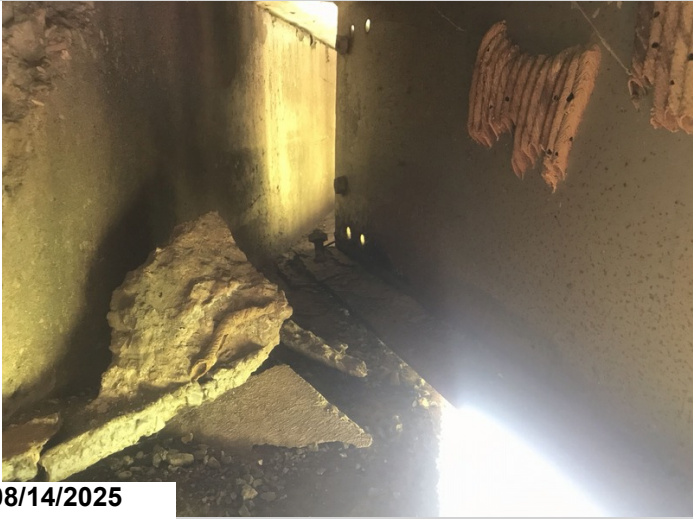
Abutment # 1, girder #2: girders have 16" of flaking rust base of web and 1/16" section loss to bottom flange in a 4" long area.

-Beams # 2 and 4 at abutment # 1 have 16" of flaking rust base of web and 1/16" section loss to bottom flange in a 4" long area. Beam # 4 over abutment # 2 has a 24" long area of corrosion with flaking rust / initial section loss along base of web.

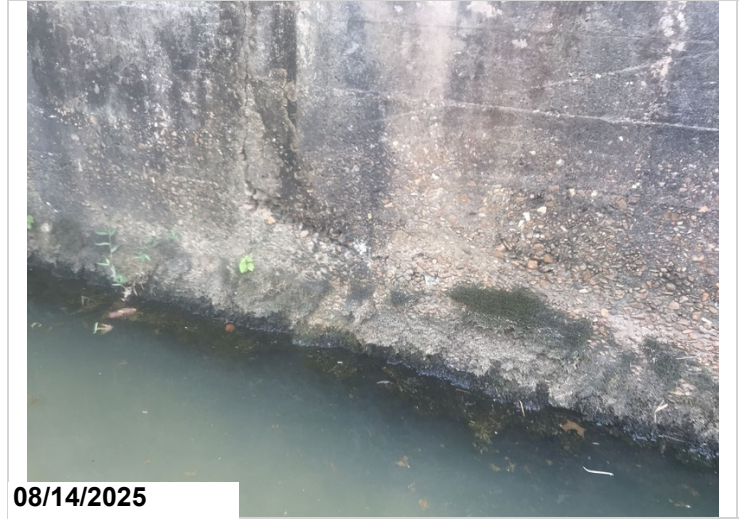
Abutment # 1, left: the left side near base of stem wall has a 16" area of shallow concrete deterioration with no exposed reinforcing steel.

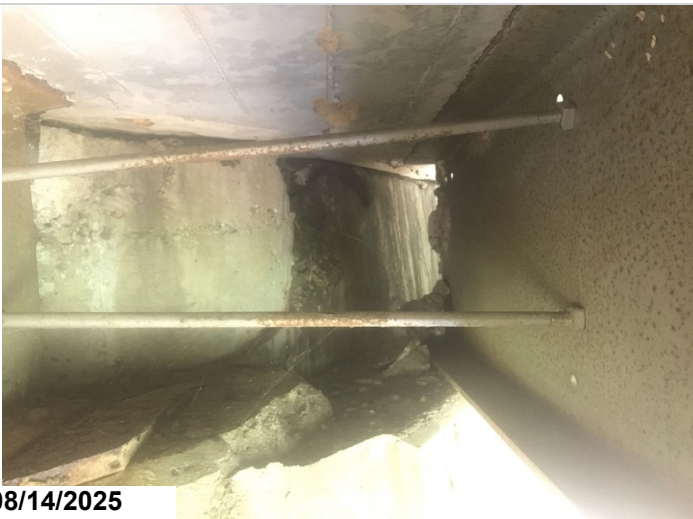
Abutment # 2, right: the backwall has a 12" x 16" spall with exposed reinforcing steel where the backwall transitions back at the wing wall juncture.

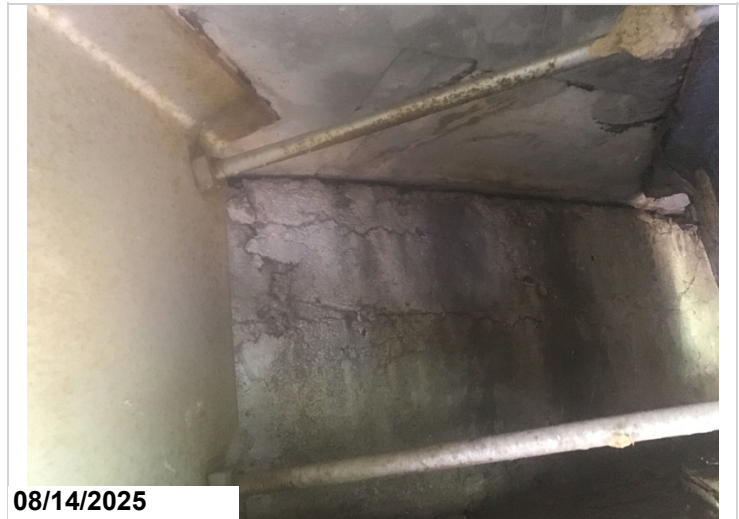
Abutment # 2: has a horizontal crack / delaminated area in the backwall behind girder # 10.

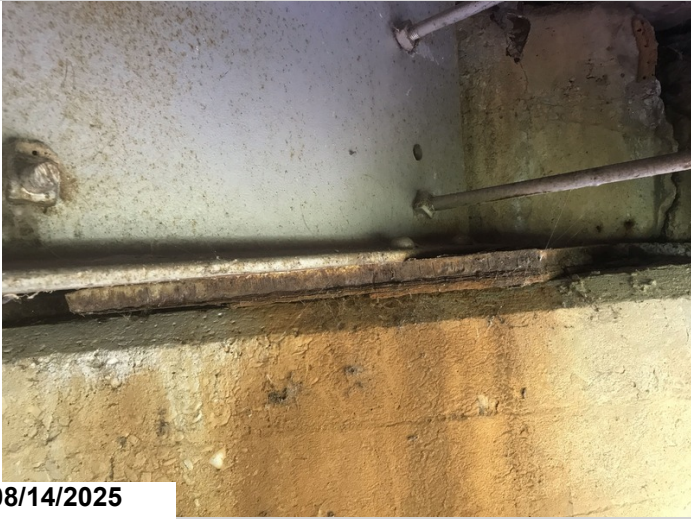
Moveable Bearings: The bearings have areas with active corrosion and layers of flaking rust.

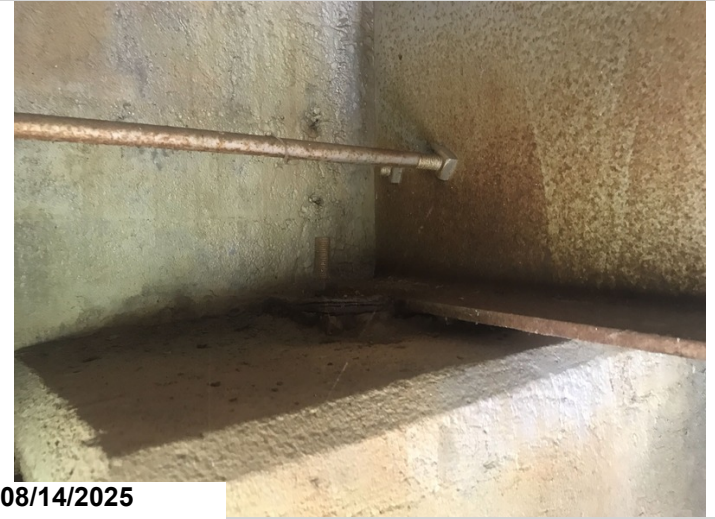
Abutment # 2, bearing # 2: active corrosion, pack rust and section loss.

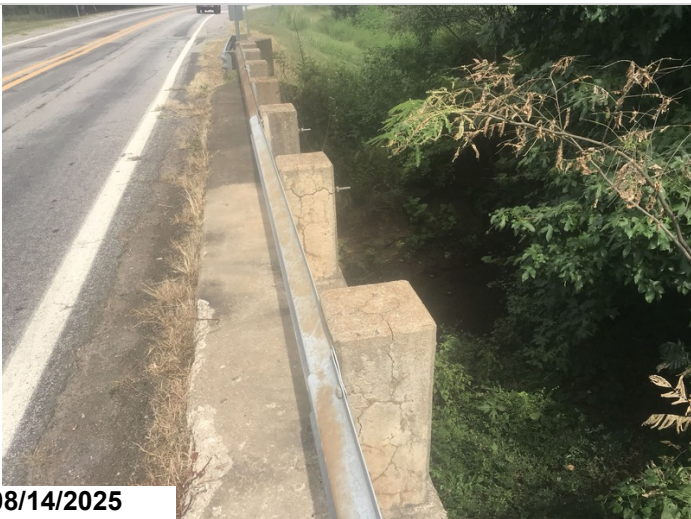
Right, posts # 3 & 4: map cracking.

The bridge railing and approach guard rails have areas with light rust coating. Concrete bridge rail posts on the right side of the structure have heavy map cracking.

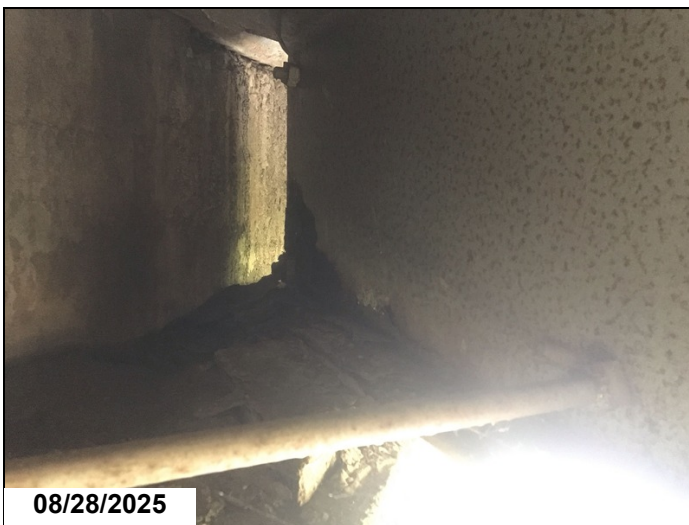
Abutment # 1, girder # 8: active corrosion, pack rust and approximately 1/8" section loss.

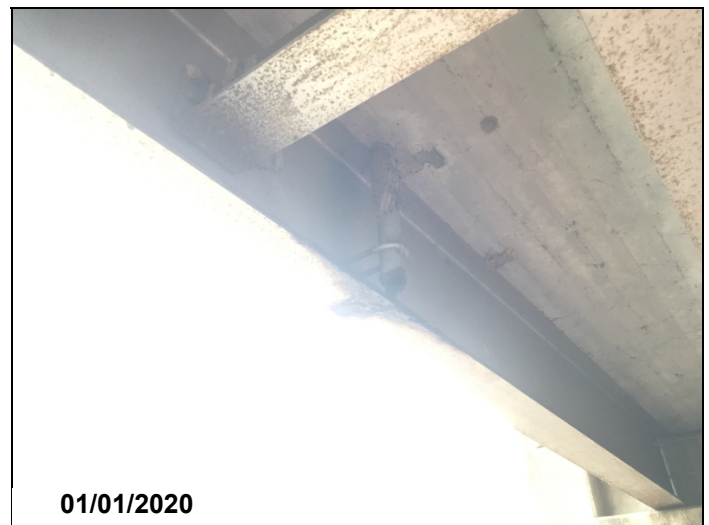
Beam # 1 adjacent to Bent # 2.

-Beam # 1 bottom flange approximately 15' from abutment # 2 has corrosion with section loss in an area approximately 14" long with 3/8" remaining section.

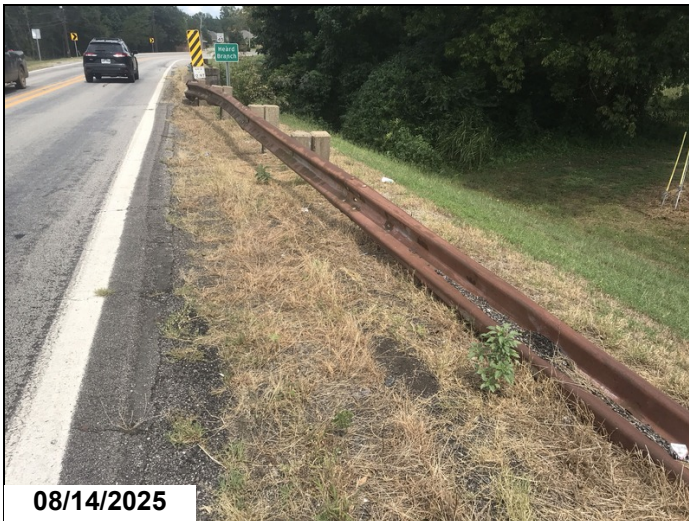
Abutment # 1 right approach guard railing has collision damage with out of plane bending.

Abutment # 1, right: approach guardrail collision damage.

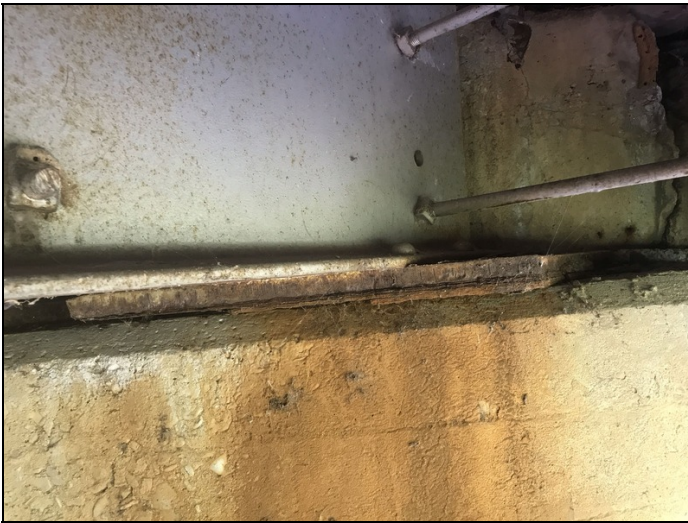
The girder ends and bearings have areas with active corrosion and layers of flaking rust.

The bearings have areas with active corrosion and layers of flaking rust.

**A-57 - Girder End and Bearing Painting Needed (Yes)**

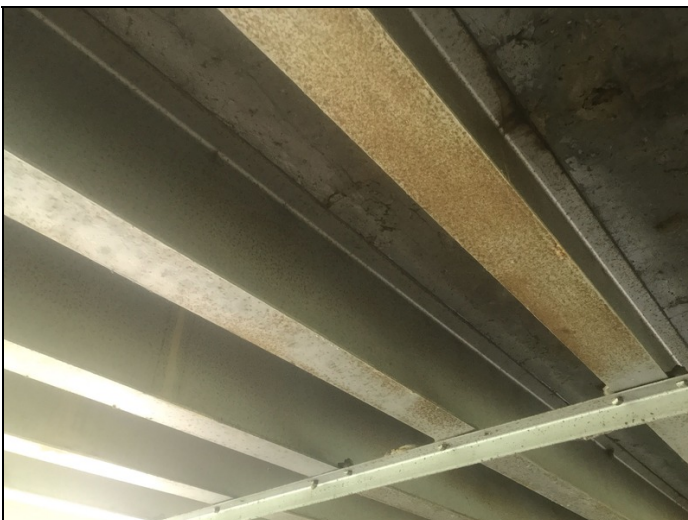
The girders have a failing paint system with freckled rust visible throughout.

Failing paint system.

**A-60 - Full Girder Painting Needed (Yes)**
