## Bridge 02283 Inspection Report

Asset #02283(Routine, Underwater type 2)

US Highway 64 over Lumis Branch

Location: 5.4 MI E HWY 64 & 71JCT

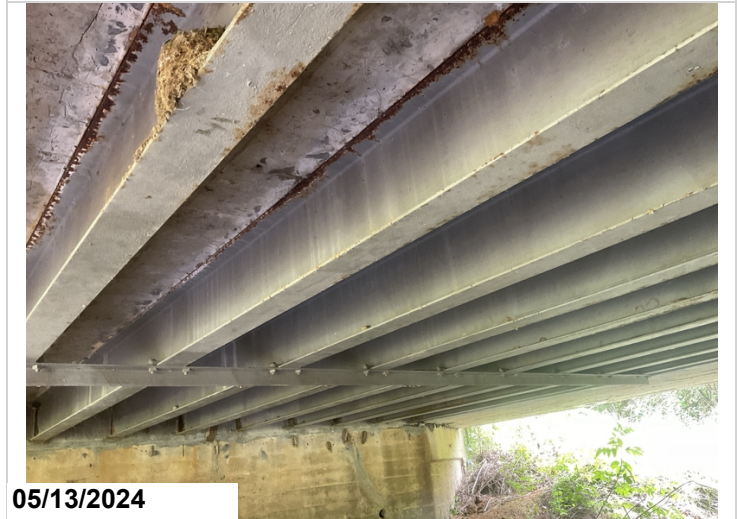
Undersurface: typical.

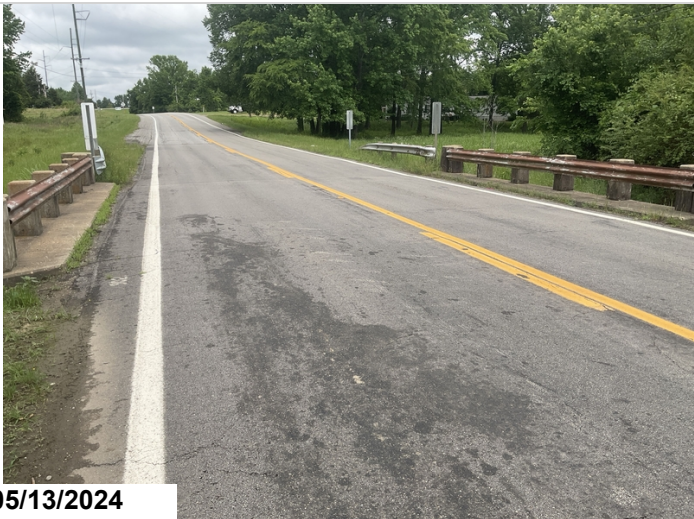
Driving surface, typical.

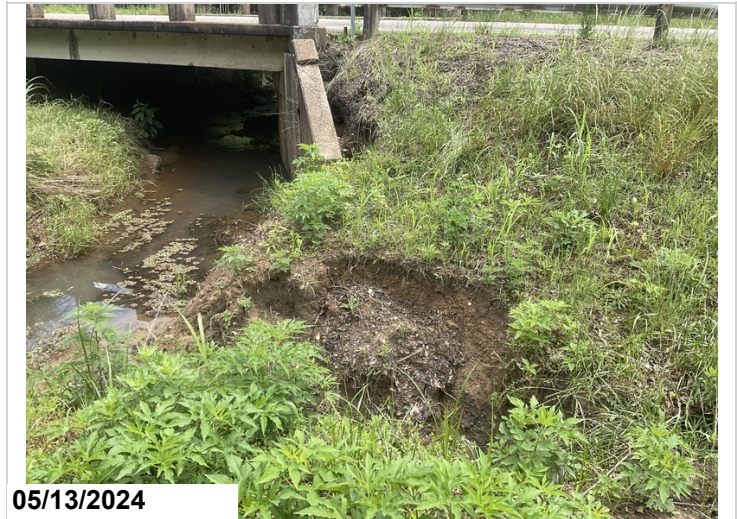
Abutment # 1, left: minor erosion adjacent to the wing wall and behind the wing wall.

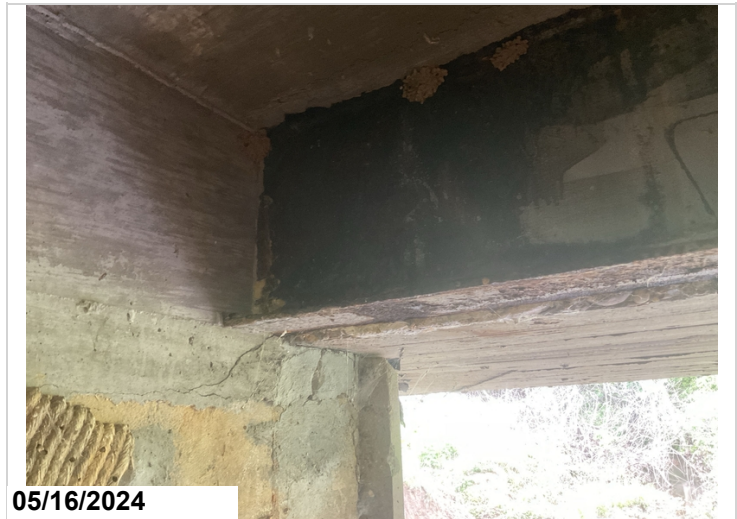
Beam # 1 at abutment # 1 has knife edge section loss to the bottom flange with heavy section loss to the web.

Abutment # 1, beam # 1: section loss to the beam end.

**A-60 - Full Girder Painting Needed (Yes)**

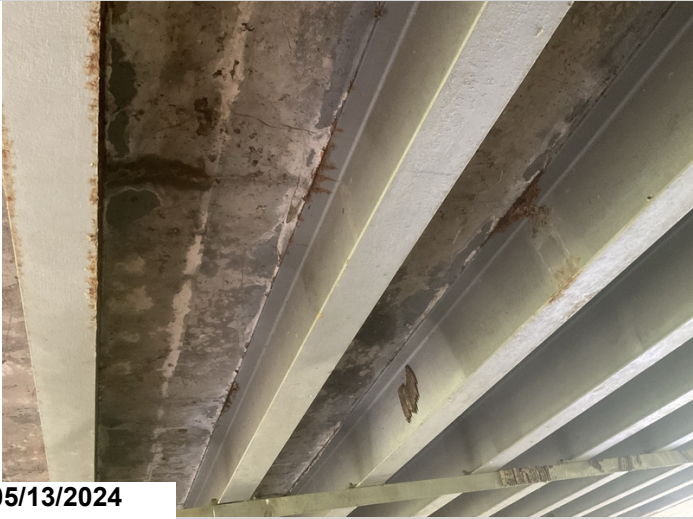
RC Deck that is generally in good condition, the driving surface has an asphalt overlay and is not visible, the undersurface has minor cracking and cracking with efflorescence.

RC Deck, undersurface: typical.

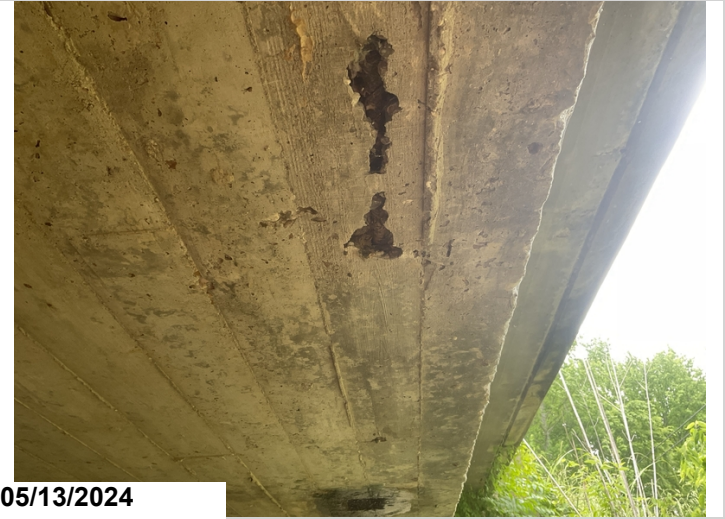
RC Slab Span, right: the exterior edge of the deck near mid span has a 12" long area of honeycombing with exposed reinforcing steel with no apparent section loss. Exposed reinforcing steel with no apparent section loss is visible in all 4 deck drains.

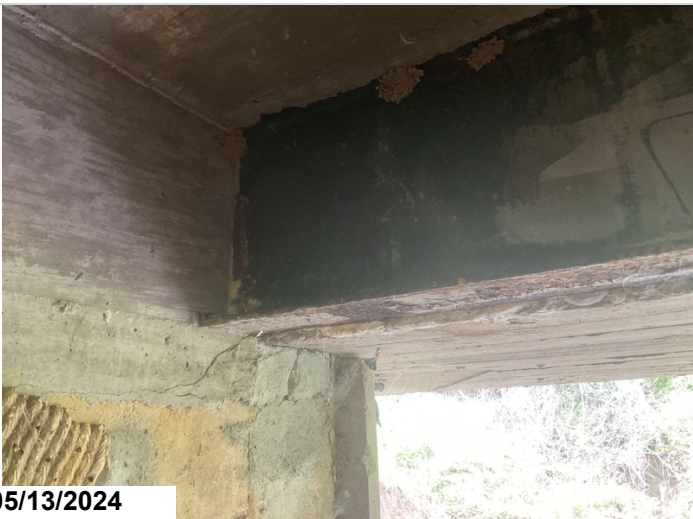
Abutment # 1, beam # 1: section loss to the beam end.

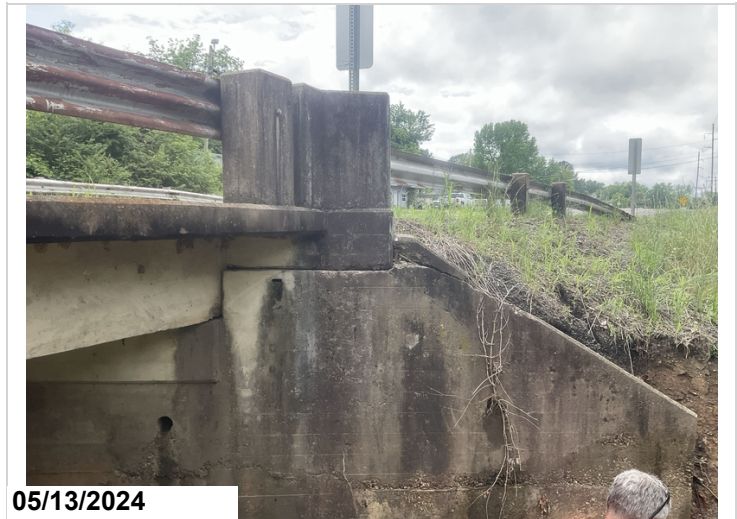
Abutment # 1, left: the wing wall is spalled adjacent to the end post.

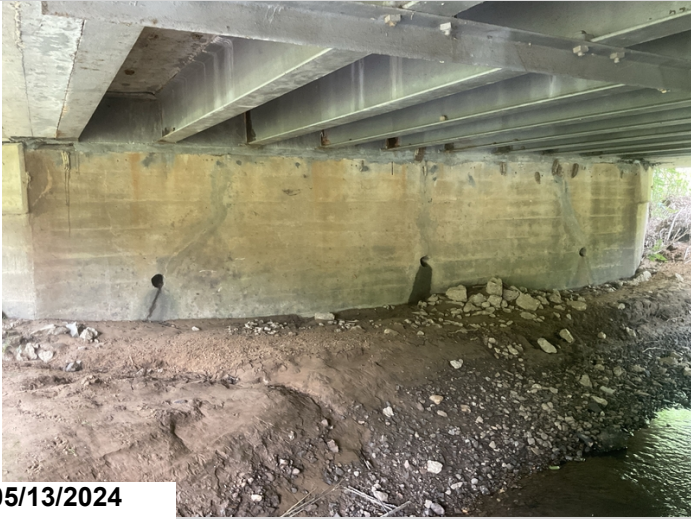
Abutment # 2: typical.

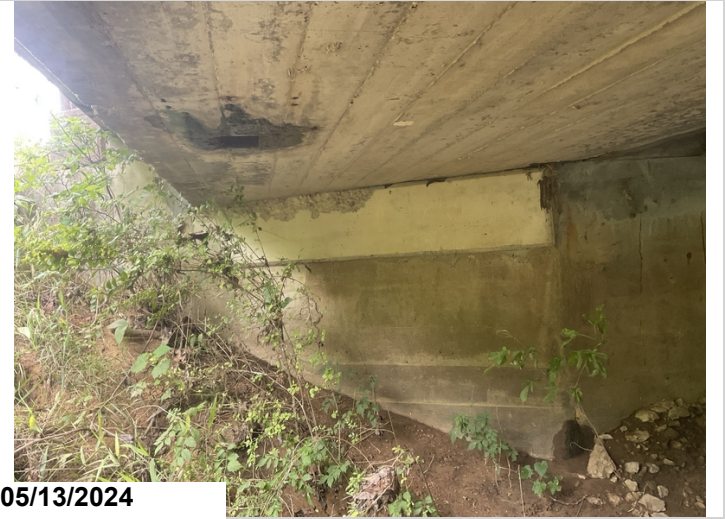
(234) Abutment # 1, cap, right: the cap has spalling in the bearing area of the concrete slab. 4LF-CS3 spalling.							
311	Movable Bearing	EA	10	0	10	0	0
1000	Corrosion	EA	10	0	10	0	0

Abutment # 1, cap, right: the cap has spalling in the bearing area of the concrete slab.

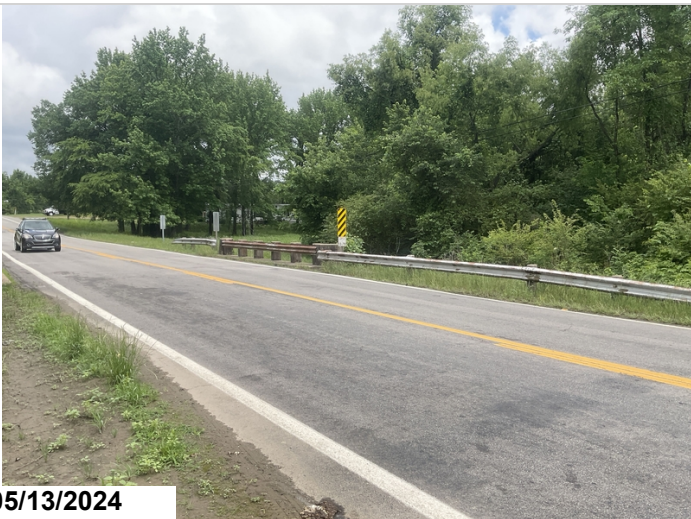
(330) Metal Bridge Rail: the rails have a failing paint system. 46LF-CS2 corrosion

Bridge rail, right: typical.

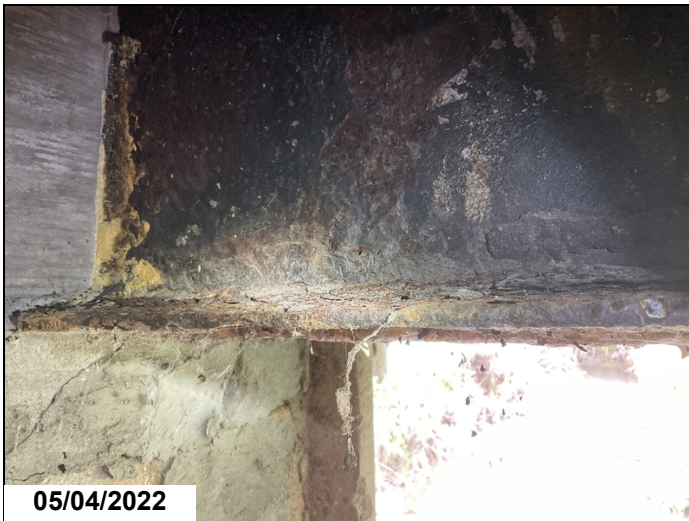
Superstructure has rust / corrosion in several locations. Maintenance Forces have applied rust inhibitor to numerous areas in the past but areas of corrosion still exists at this inspection.

Beam # 1 at abutment # 1 has knife edge section loss to the bottom flange with heavy section loss to the web.

05/13/2024 - EJW - Deficiency is now documented under routine maintenance tab A60.

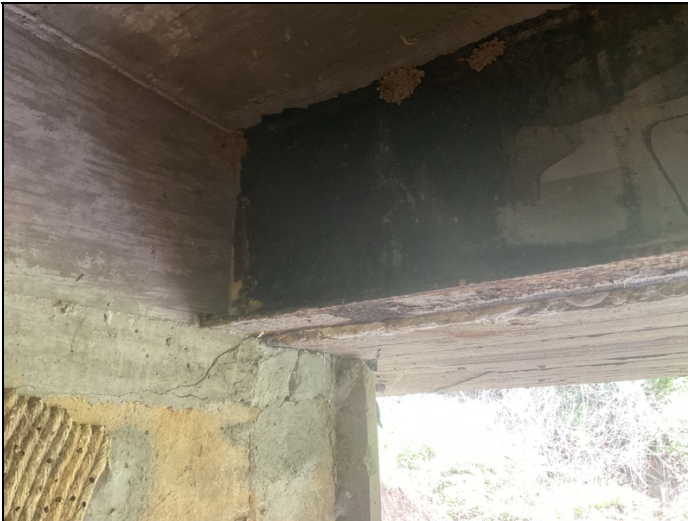
Superstructure has rust / corrosion in several locations. Maintenance Forces have applied rust inhibitor to numerous areas in the past but areas of corrosion still exists at this inspection.

Beam # 1 at abutment # 1 has knife edge section loss to the bottom flange with heavy section loss to the web.

Abutment # 1, beam # 1: section loss to the beam end.
