## Bridge 02284 Inspection Report

US Highway 64 over Morris Branch

Location: 6.2MI E JCT US 71

Team Lead: Eric West Inspection Date: 12/03/2024

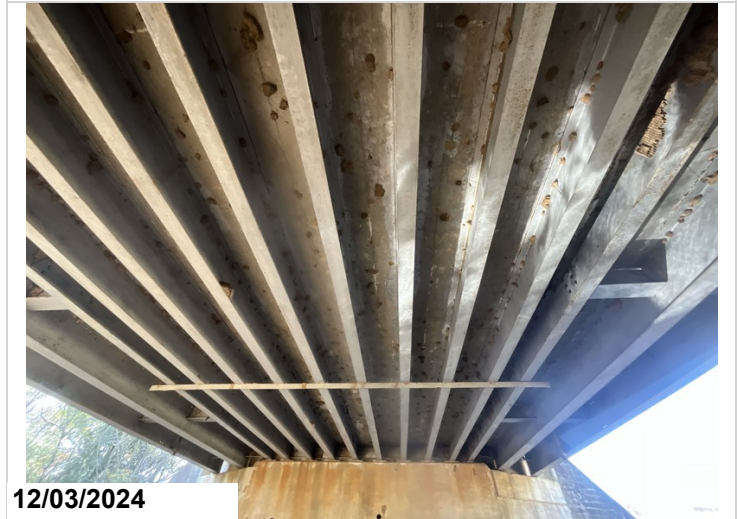
Overall, the deck is generally in satisfactory condition. The driving surface is covered with an asphalt and chip seal wearing surface. The undersurface has light cracking with efflorescence buildup. The overhangs have spalling with exposed reinforcing steel.

Undersurface: typical.

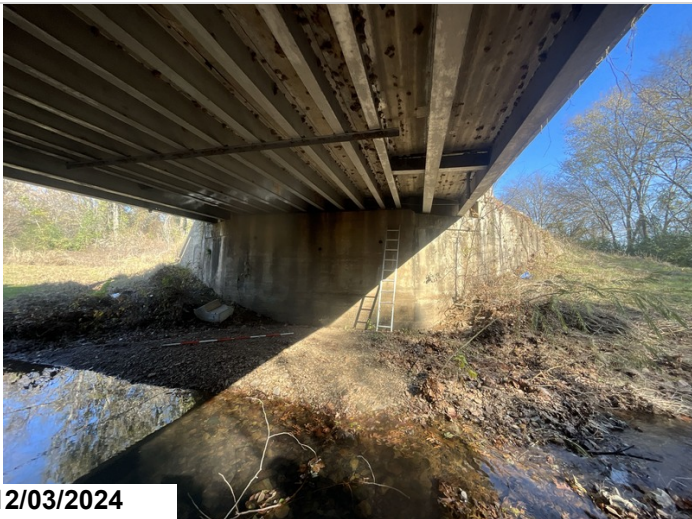
Abutment # 2: typical.

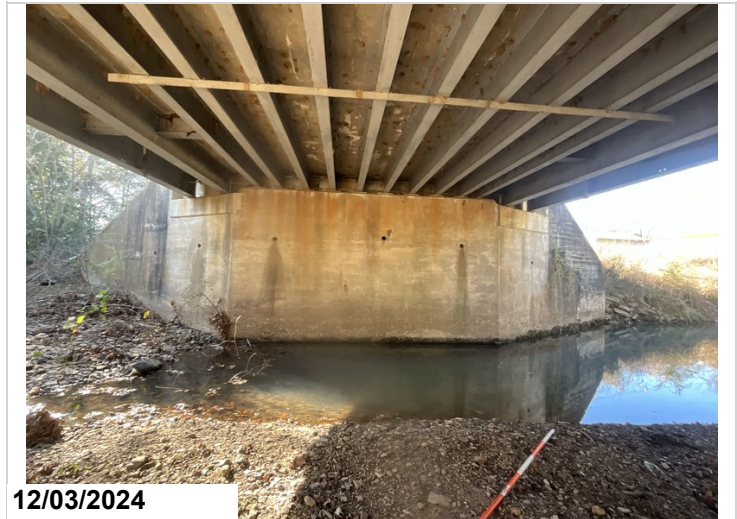
Abutment # 1: typical.

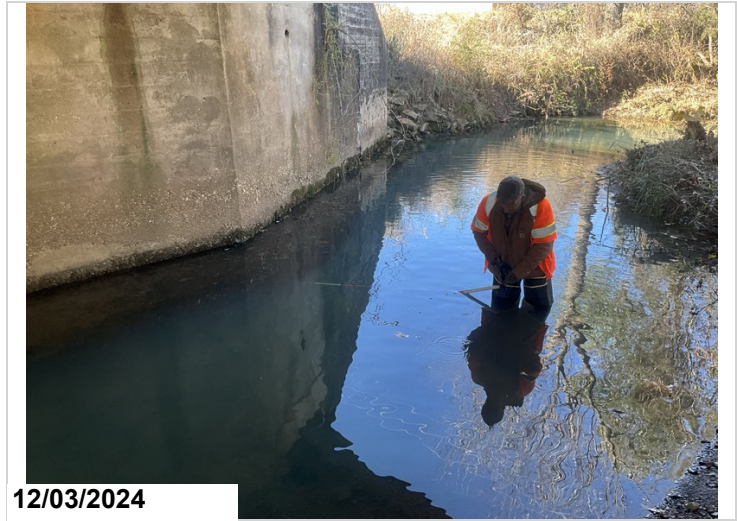
Abutment # 1 footing is exposed from the end of the left wing wall to the right wing wall junction. The footing has undermining along and under the edge of the footing with areas near the left wing wall juncture that extend to 6" of the face of the abutment stem. No voids found that extend under the footing.

(220) Abutment # 1 from approximately CL to the end of the left wing wall, is undermined. There is heavy abrasion where the footing is exposed. Abutment # 2 footing has cover and is not visible.							
311	Movable Bearing	EA	14	0	0	14	0
1000	Corrosion	EA	14	0	0	14	0
515	Steel Protective Coating	SF	14	0	0	7	7
3440	Effectiveness (Steel Protective Coatings)	SF	14	0	0	7	7

Abutment # 1, left: undermining.

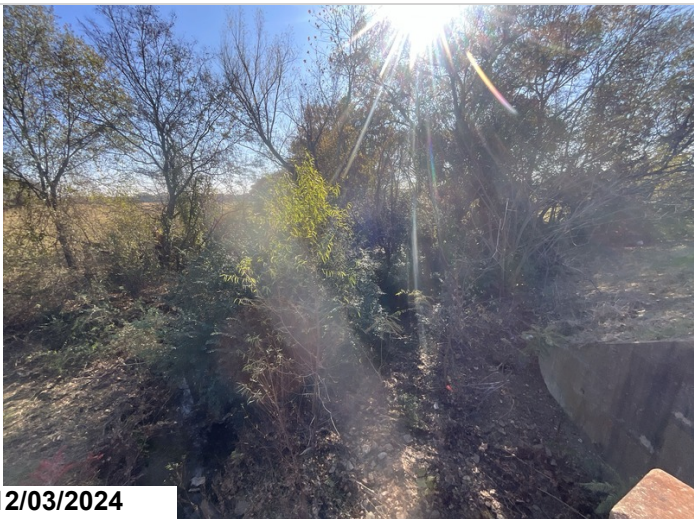
Overall, the channel is in fair condition. The banks are vegetated but have signs of past erosion and lateral migration due to apparent stream bed material accumulation. The downstream channel is restricted by trees and vegetation. The channel has poor alignment with the substructure and is directed at the left wing wall of Abutment # 1.

Downstream

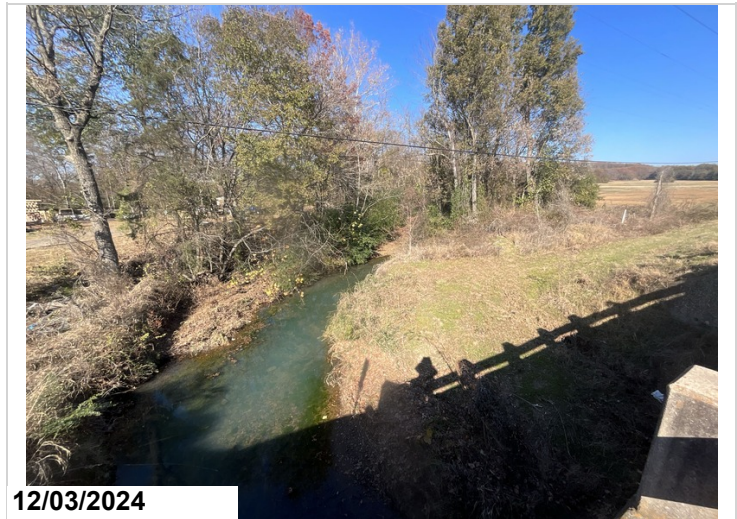
Upstream

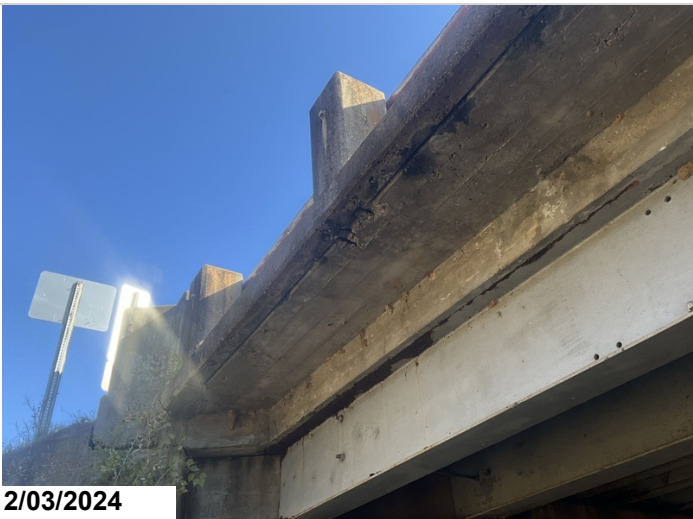
Left overhang spalling with exposed reinforcing steel.

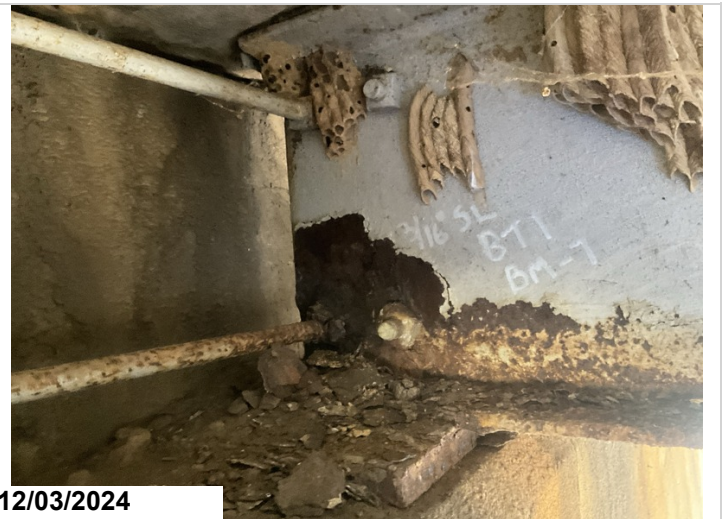
107	Steel Open Girder/Beam	LF	434	327	84	23	0
1000	Corrosion	LF	107	0	84	23	0
515	Steel Protective Coating	SF	1862	1643	0	84	135
3440	Effectiveness (Steel Protective Coatings)	SF	219	0	0	84	135
<p>(107) Abutment 2: all girder ends have flaking rust with section loss. Girders 5, 7, and 12 are the worst having moderate section loss up to 3/16" inch. There is scattered surface rust at abutment 1 and at various locations throughout girders.  Girders have flaking paint and active corrosion on the top flange in areas.</p> <p>(515-107) The paint system is beginning to fail over the abutments with scattered areas of peeling paint throughout.</p>							
215	Reinforced Concrete Abutment	LF	132	34	28	70	0
1080	Delamination/Spall/Patched Area	LF	10	0	0	10	0
1090	Exposed Rebar	LF	5	0	0	5	0
1120	Efflorescence/Rust Staining	LF	5	0	5	0	0
1130	Cracking (RC and Other)	LF	4	0	0	4	0
1190	Abrasion/Wear (PSC/RC)	LF	74	0	23	51	0

Girders 5, 7, and 12 are the worst having moderate section loss up to 3/16" inch.

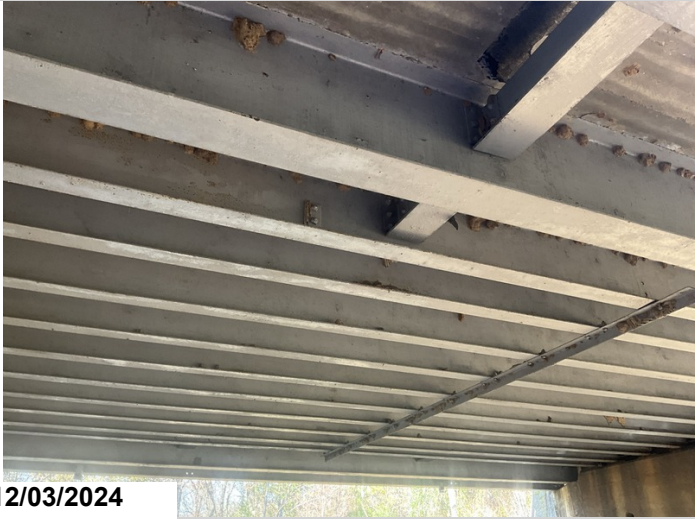
Painted steel girders have areas with active corrosion in the top flanges. The exterior girders have flaking paint. The ends of the girders over the bearing have active corrosion with flaking rust. Paint system has failed over the bearings.

Paint system: typical.

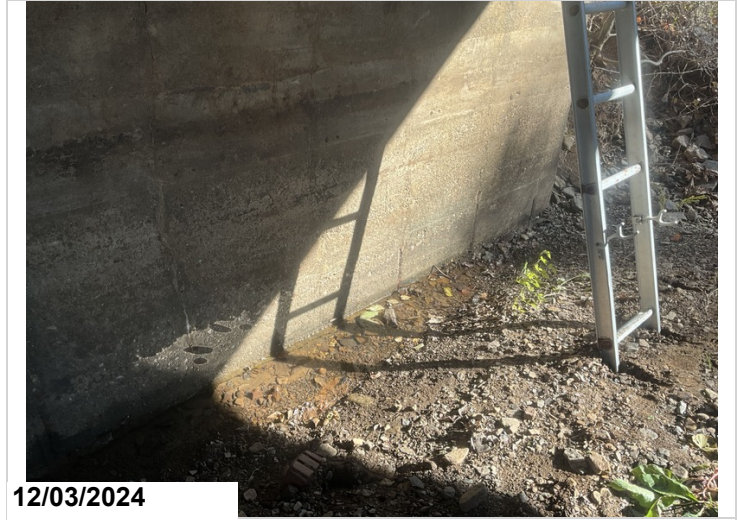
Abutment # 2: exposed reinforcing steel.

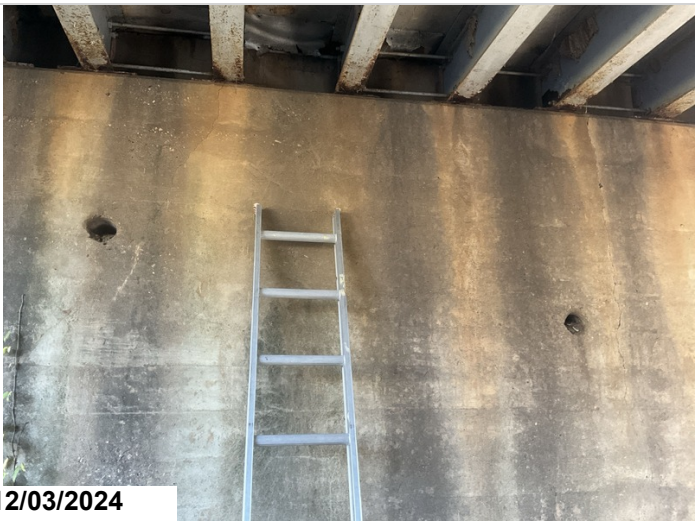
Overall, the substructure is in fair condition. the abutments have moderate with vertical cracks and concrete deterioration.

Abutment # 2 moderate width cracking.

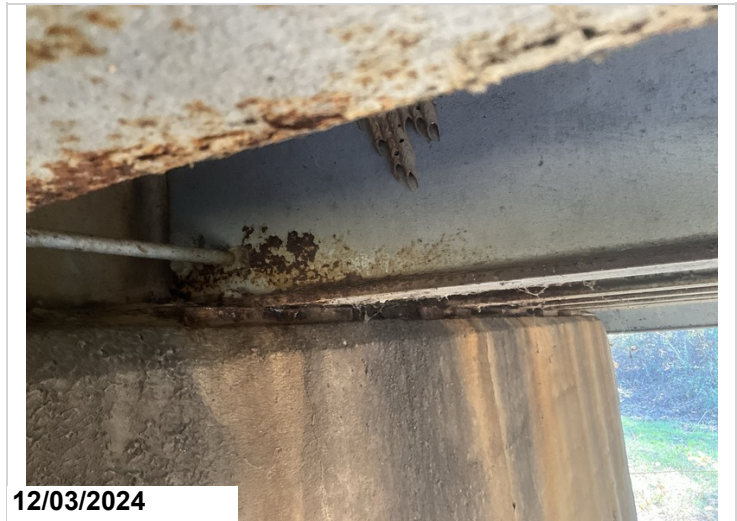
(311) East Bridge End / expansion bearings Bearings have active corrosion, pack rust and section loss.							
313	Fixed Bearing	EA	14	0	14	0	0
1000	Corrosion	EA	14	0	14	0	0
515	Steel Protective Coating	SF	14	0	0	14	0
3440	Effectiveness (Steel Protective Coatings)	SF	14	0	0	14	0

Abutment # 2 bearings with active corrosion and pack rust.

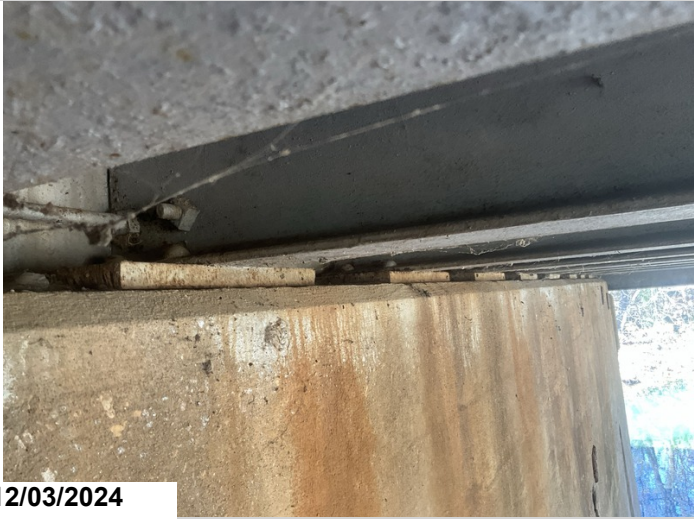
Abutment # 1: typical.

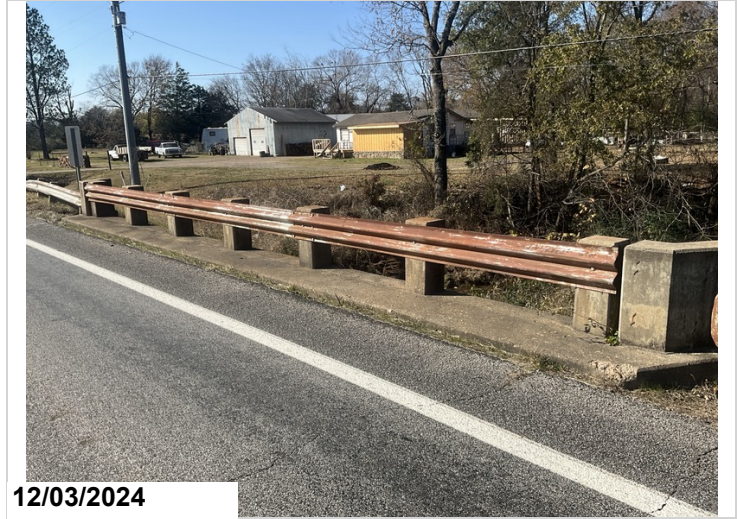
(330) Bridge railing has a light coating of rust. The left rail has minor old collision damage. 7LF-CS2

Bridge rail with a failed paint system.

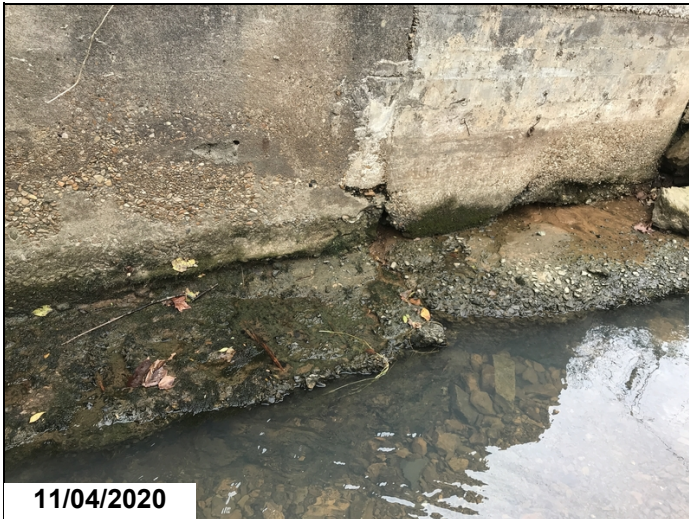
There is soft deteriorated concrete at the base of the Northwest wing wall located at the footing juncture.

Northwest wing wall and footing concrete deterioration.

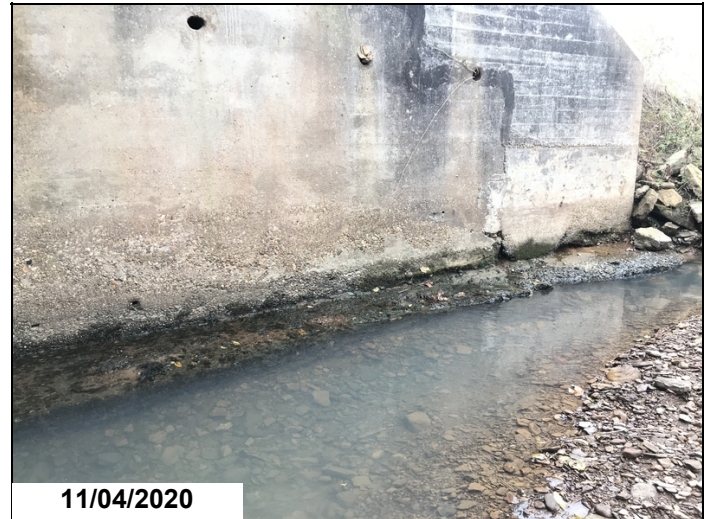
Northwest wing wall. Deteriorated concrete.

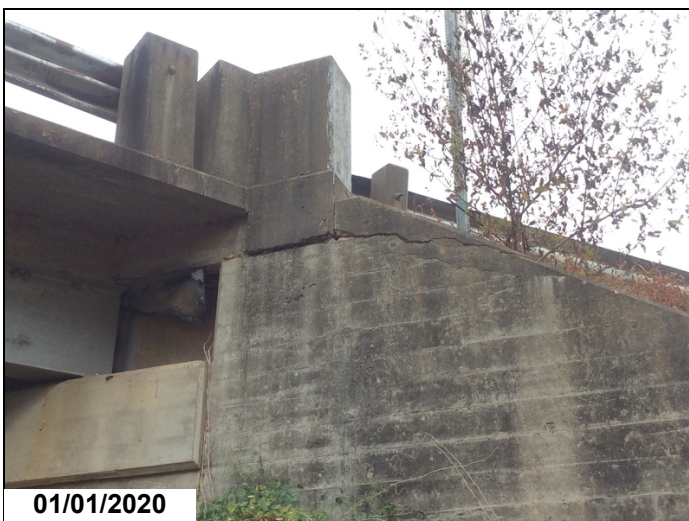
Northwest wing wall has a crack for approximately 4' along the top of the wall.

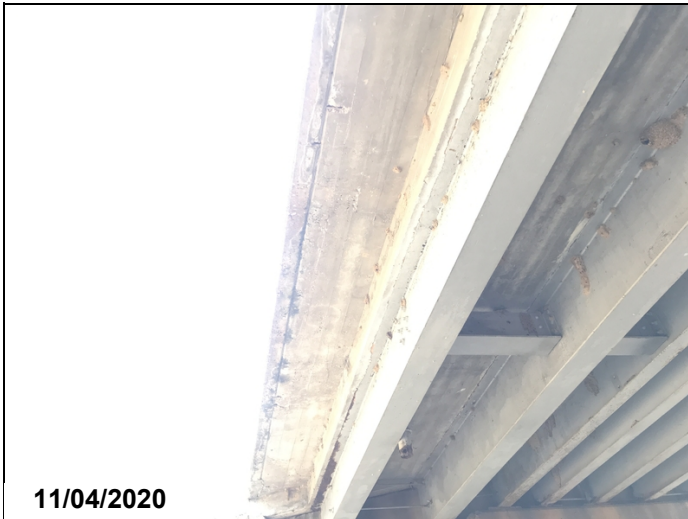
11/04/2020

Deck  
There are areas with light honeycomb and minor concrete deterioration with exposed reinforcing steel that is visible from the undersurface of the Left side of the deck adjacent to the drip groove.

Left overhang of the deck. Spall with exposed reinforcing steel.

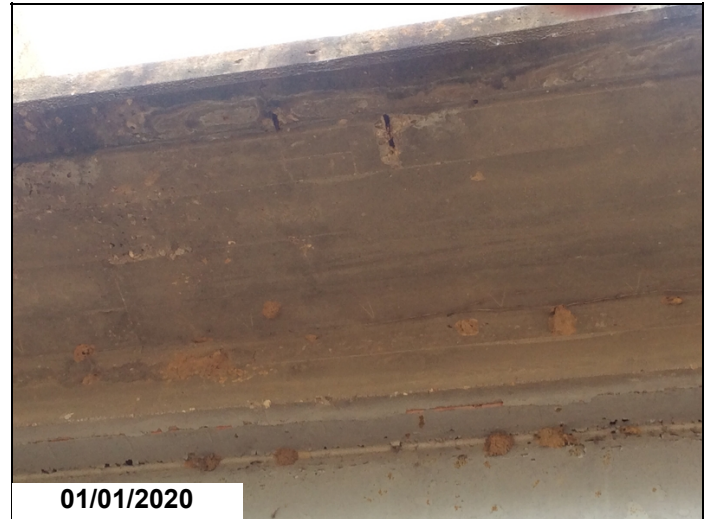
01/01/2020

There is minor concrete deterioration with exposed reinforcing steel visible from the undersurface of the Lt exterior edge of the deck.

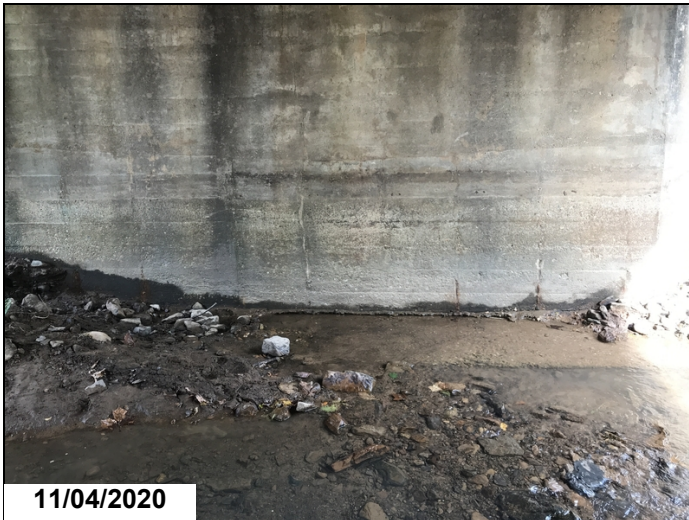
There are spalls with exposed reinforcing steel at the base of Bent # 2.

Base of Bent # 2. Exposed reinforcing steel.

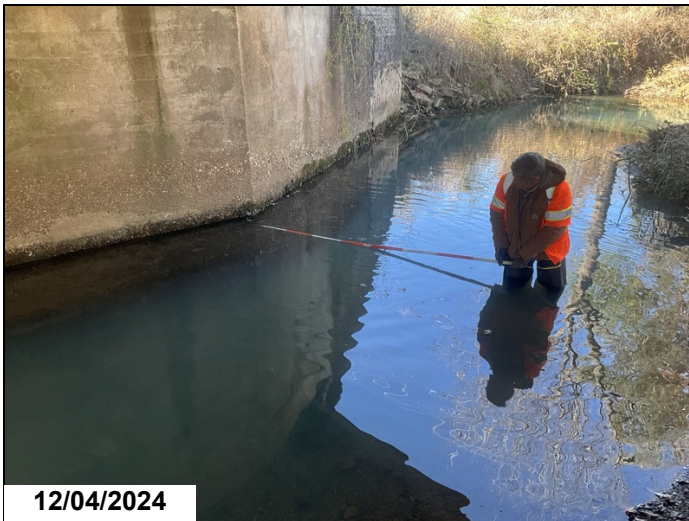
Abutment # 1 footing is exposed from the end of the left wing wall to the right wing wall junction. The footing has undermining along and under the edge of the footing with areas near the left wing wall juncture that extend to 6" from the face of the abutment stem.

Abutment # 1, left: undermining scale.

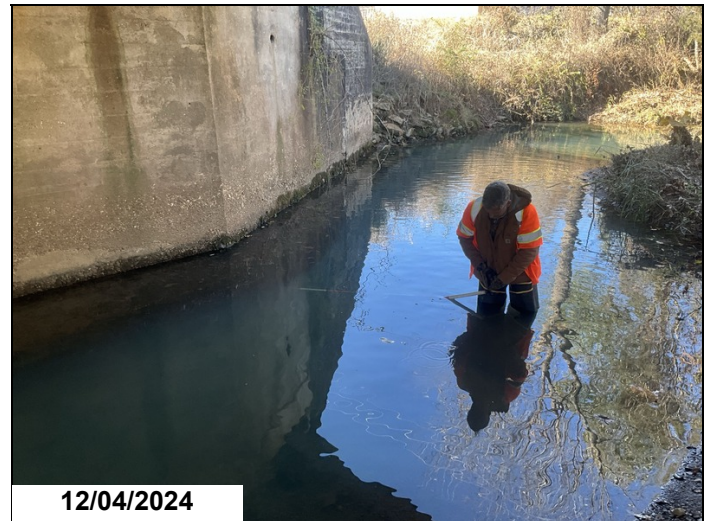
Abutment # 1, left: undermining.

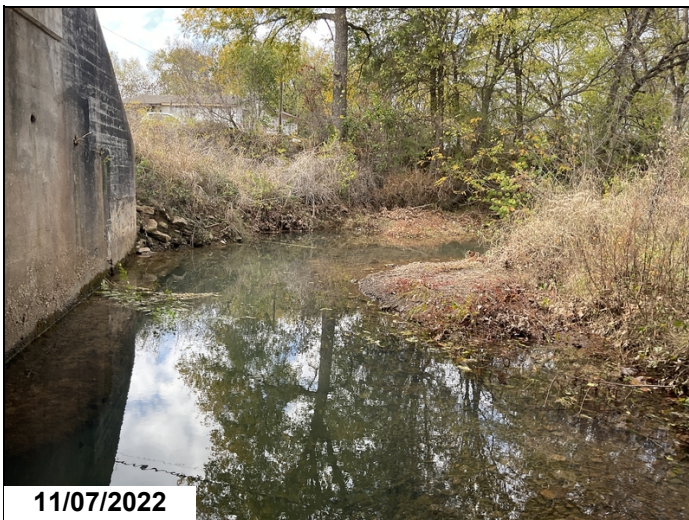
Upstream channel alignment has caused the local scour to pile cap footing at abutment 1.

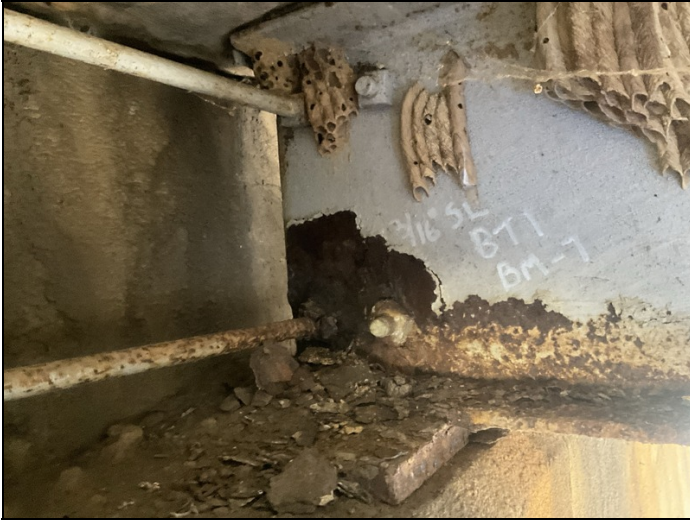
Painted steel girders have areas with active corrosion in the top flanges. The exterior girders have flaking paint. The ends of the girders over the bearing have active corrosion with flaking rust. Paint system has failed over the bearings.

Girders 5, 7, and 12 are the worst having moderate section loss up to 3/16" inch.

**A-57 - Girder End and Bearing Painting Needed (Yes)**
