Bridge 02285 Inspection Report

Asset #02285(Routine, Underwater type 2)

US Highway 64 over Lee Br. - Crawford Co.

Team Lead: Tyler Lincks Inspection Date: 11/03/2025

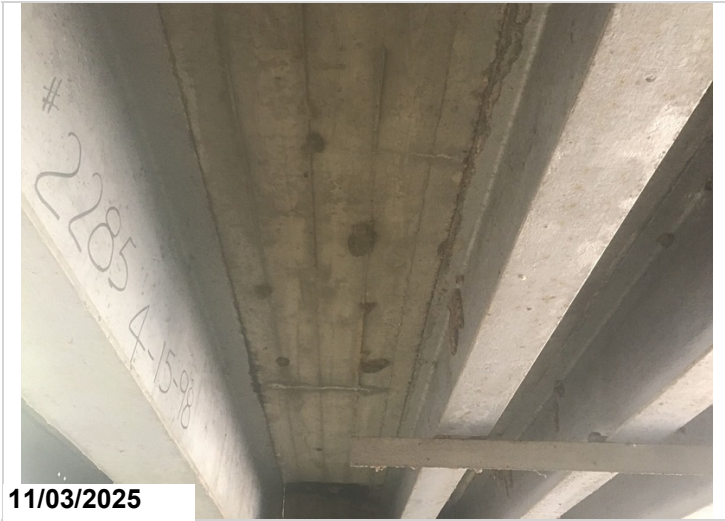
Deck undersurface, Bay 2: Transverse cracks with light efflorescence. 4SF CS2

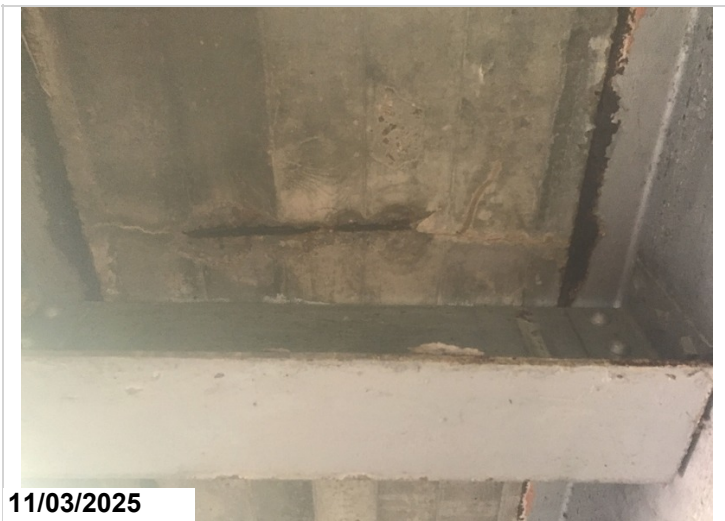
Deck undersurface, Bay 1, Adjacent to diaphragm: 14" spall with exposed reinforcing steel. 2LF CS3

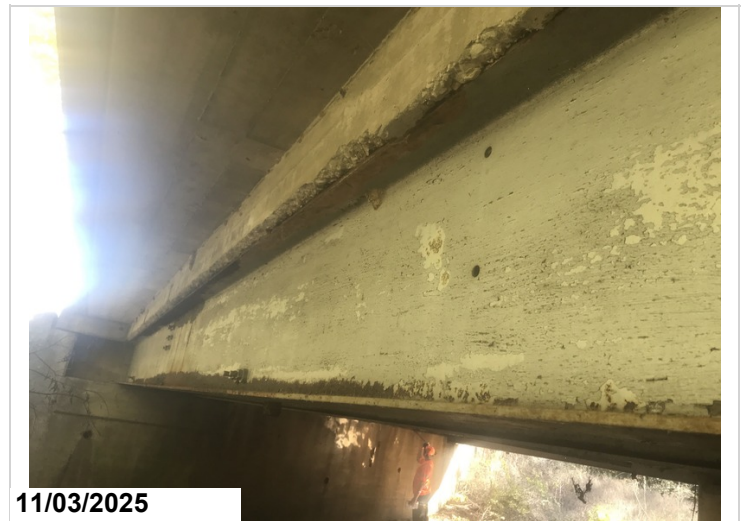
Deck is in overall satisfactory condition with an asphalt driving surface, isolated transverse short duration hairline cracks visible in the undersurface, spalls along the top flange of the North exterior beam & adjacent to abutment juncture, some with exposed reinforcing steel.

Left edge of deck, Over exterior girder: Shallow spalling. 25SF CS3

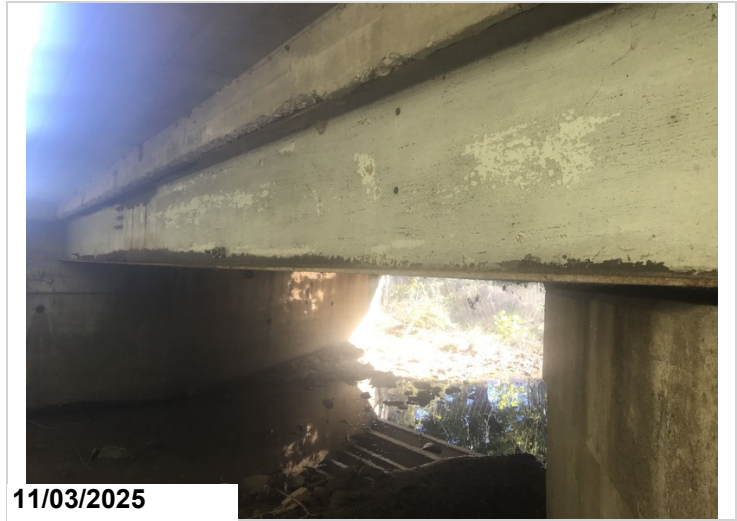
Superstructure is in overall satisfactory condition with several areas of active corrosion showing through the paint system. Girders 1 & 14, adjacent to drain scuppers have active corrosion with layers of flaking rust.

Girder 1, Exterior face: Approximately 20' long area of active corrosion with flaking rust. 20LF CS3

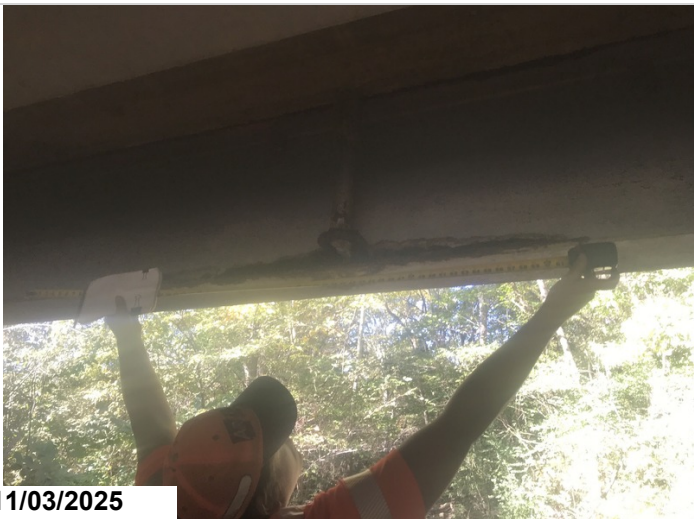
Girder 1, Adjacent to abutment 2, Under scupper: 5' area of corrosion with flaking rust and up to 1/8" section loss. 5LF CS3

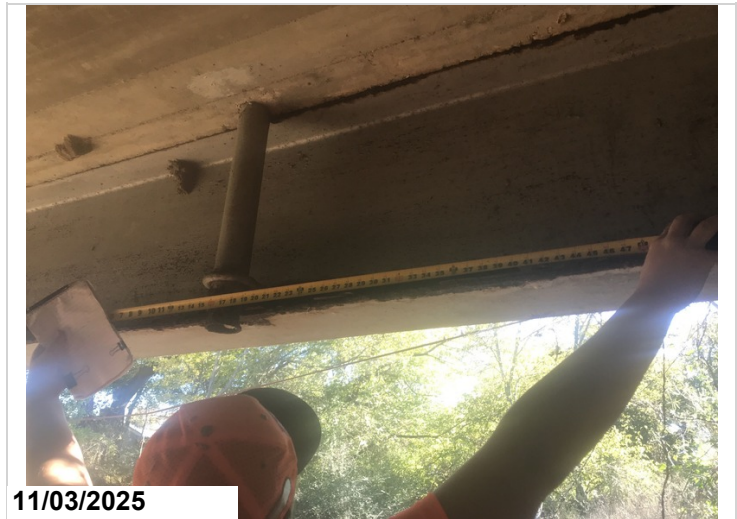
Girder 14, Adjacent to abutment 1, Under scupper: 4' area of corrosion with flaking rust and up to 1/8" section loss. 4LF CS3

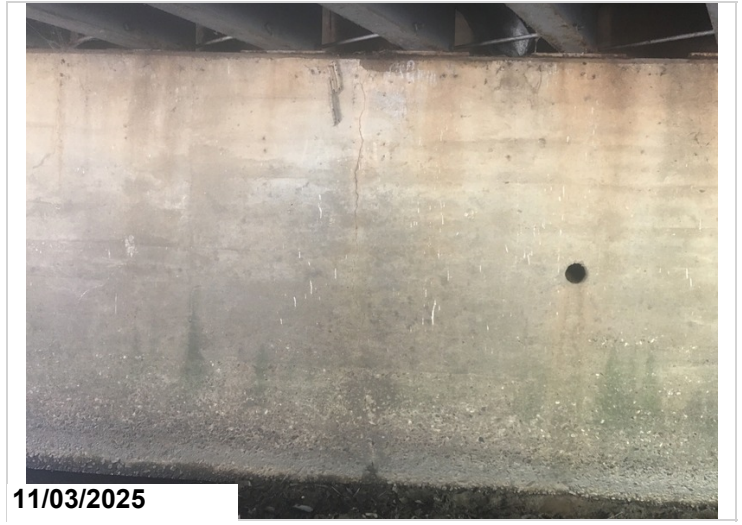
Abutment 2, Centerline: Vertical crack. 1LF CS3

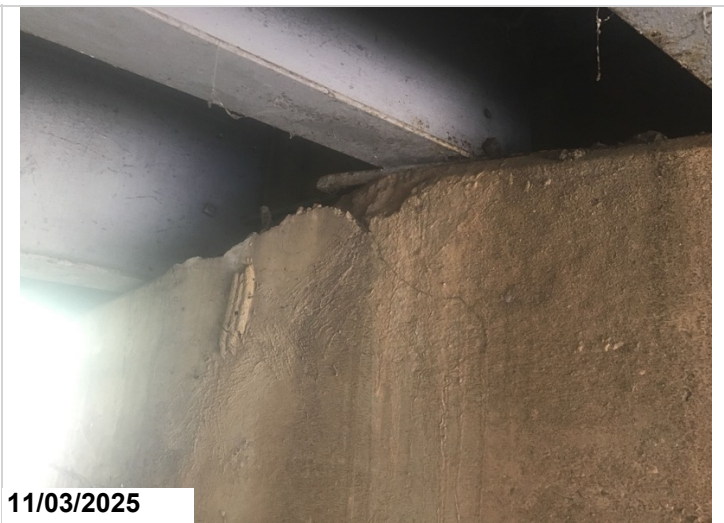
Substructure is in overall satisfactory condition with light abrasion at the base, isolated areas of hairline cracking, & an area of concrete deterioration under girder 3 where the structure was widened.

Abutment 2, Under girder 3 bearing: Concrete deterioration/spalling with approximately 2" of bearing area loss & exposed reinforcing steel. 1LF CS3 spall

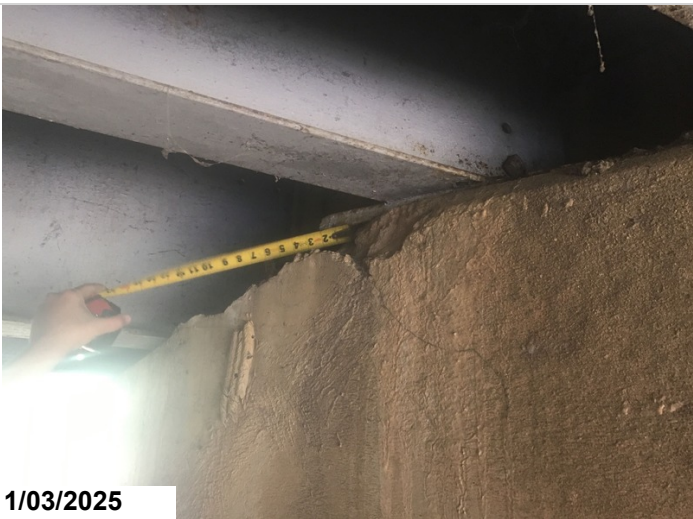
(313) Abutment 2, Girder 3 bearing: Approximately 2" of bearing area loss. 1EA CS2 Masonry plates: Areas with active corrosion and flaking rust. 8EA CS2, 5EA CS3							
330	Metal Bridge Railing	LF	55	0	55	0	0
1000	Corrosion	LF	55	0	55	0	0
515	Steel Protective Coating	SF	163	0	0	163	0
3440	Effectiveness (Steel Protective Coatings)	SF	163	0	0	163	0

Abutment 2, Girder 3 bearing: Approximately 2" of bearing area loss. 1EA CS2

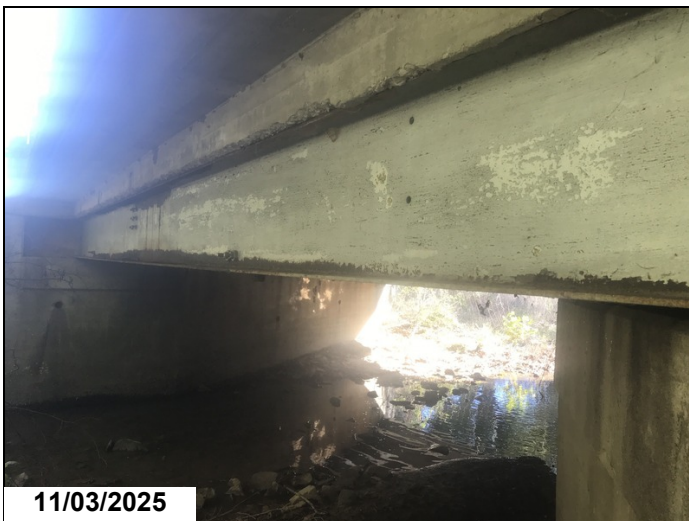
Exterior girders, Interior & exterior faces: Areas of corrosion with flaking rust, worst cases being adjacent to deck drains. Superstructure, Bottom flange: Approximately 1/8" section loss in areas.

Girder 1, Exterior face: Active corrosion with flaking rust.

Type of Work: Superstructure Repair

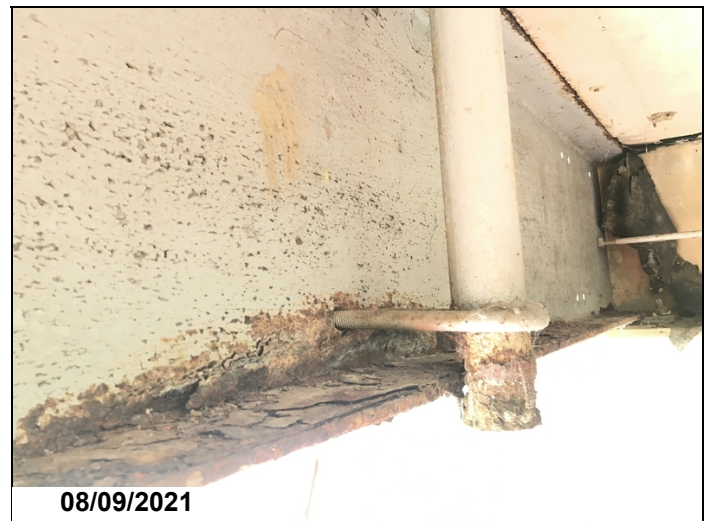
Beam # 14 corrosion.

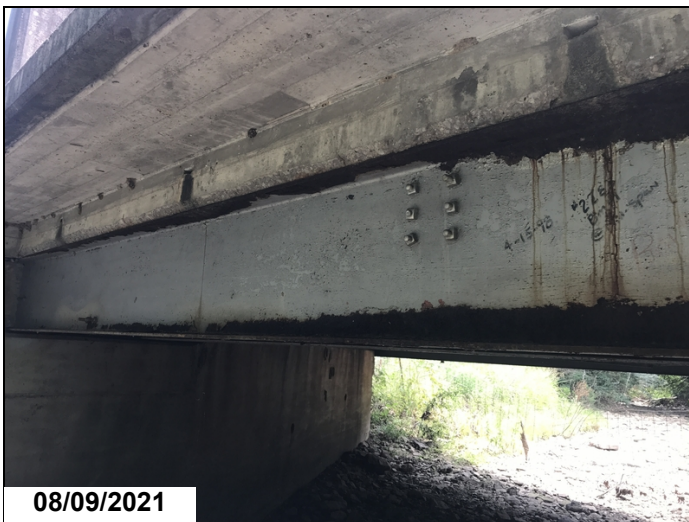
Beam # 1 corrosion.

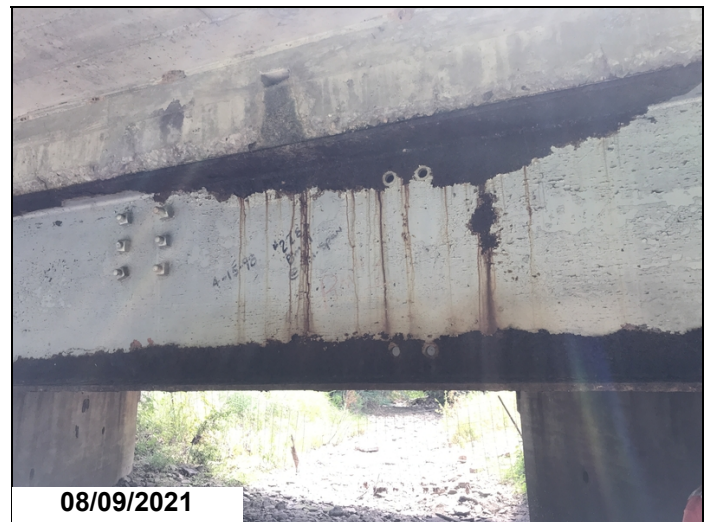
Beam # 1. Corrosion.

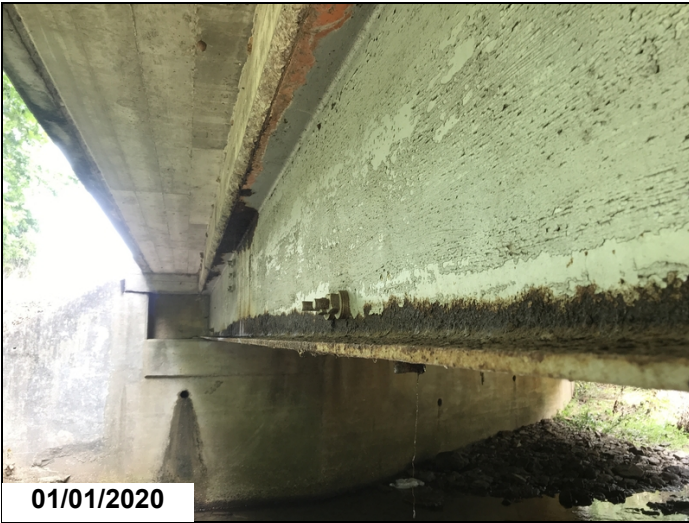
Beam # 1 with active corrosion and initial section loss.

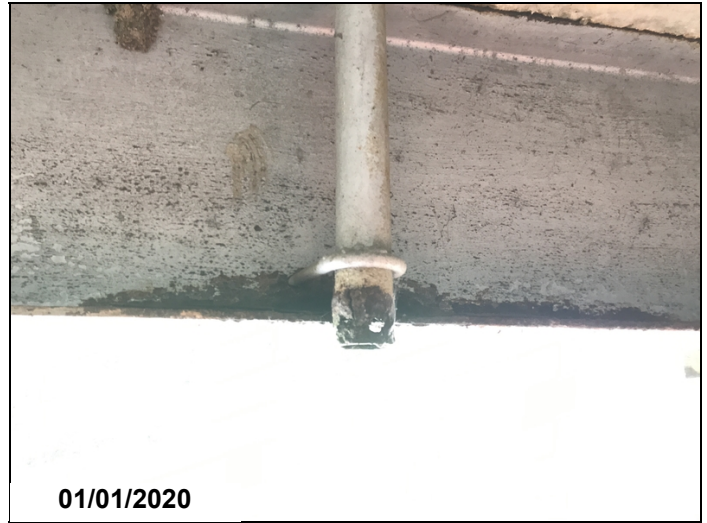
Beam # 14 adjacent to Bent # 2 has active corrosion with initial section loss.

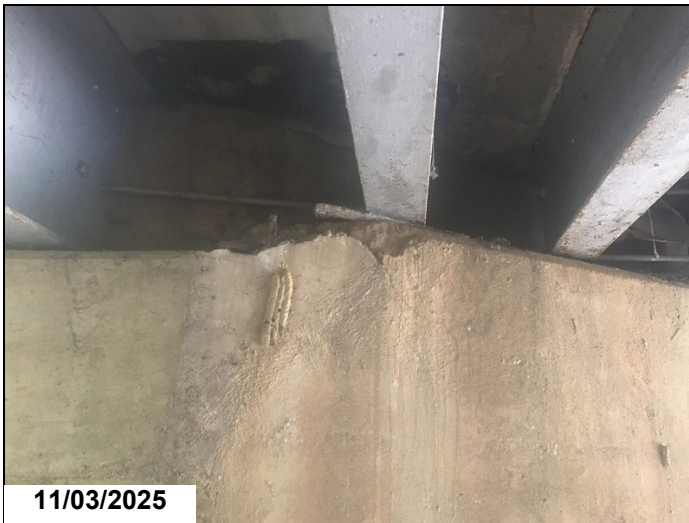
Abutment 2, Under girder 3 bearing: Concrete deterioration/ spalling with approximately 2" of bearing area loss.

Type of Work: Substructure Repair

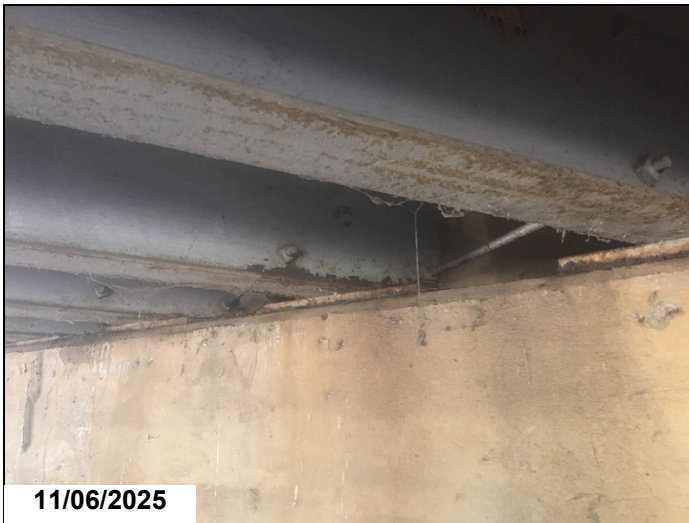
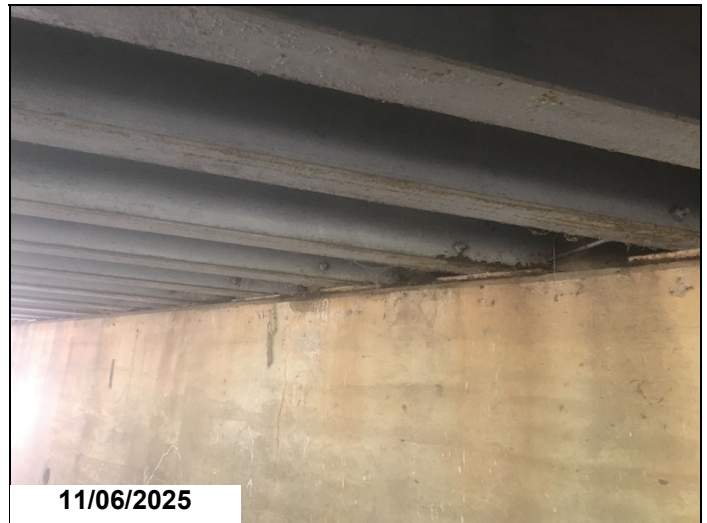
Masonry plates: Areas of active corrosion and layers of flaking rust.

Abutment 1, Girder ends and bearing.

Abutment 1, bearings typical.

Type of Work: Bearing Repair/Replacement

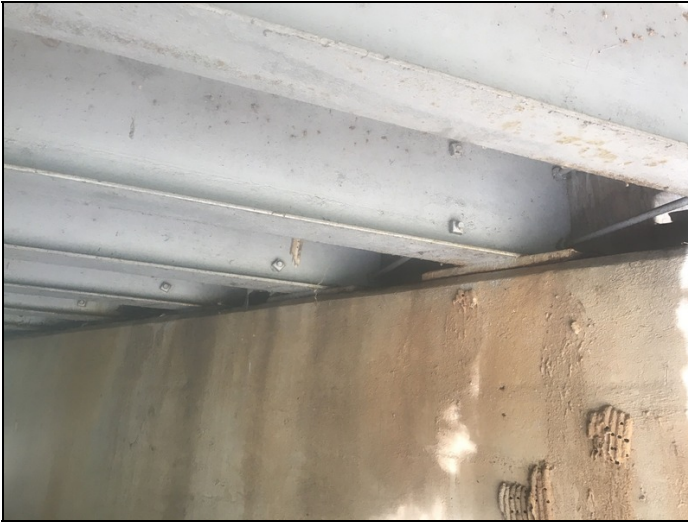
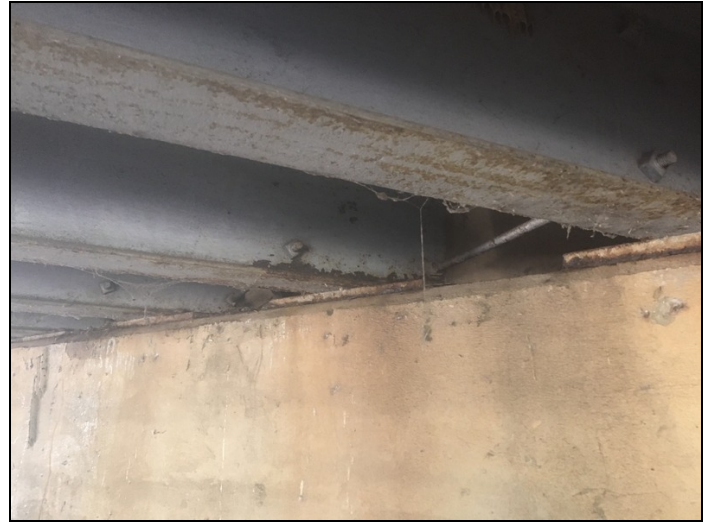
Abutment 2, girder ends and bearings.

Abutment 1, Girder ends and bearings.

A-57 - Girder End and Bearing Painting Needed (Yes)
