Bridge 02286 Inspection Report

Asset #02286(Posting Sign Verification)

US Highway 64 over Alexander Branch

Team Lead: Eric West Inspection Date: 10/21/2025

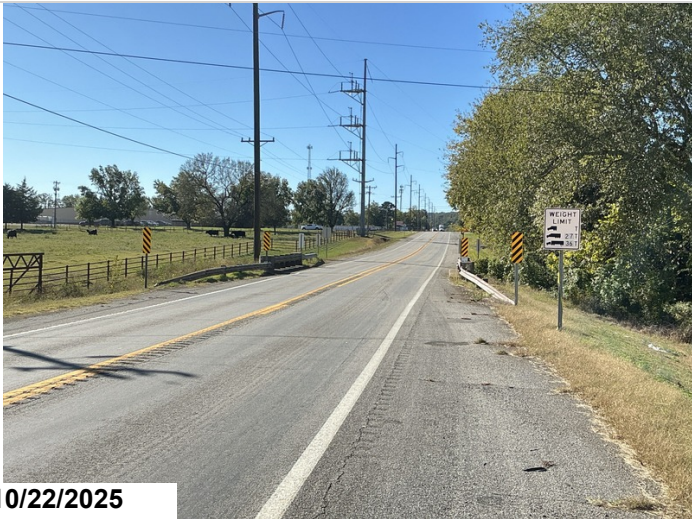
East approach load posting sign.

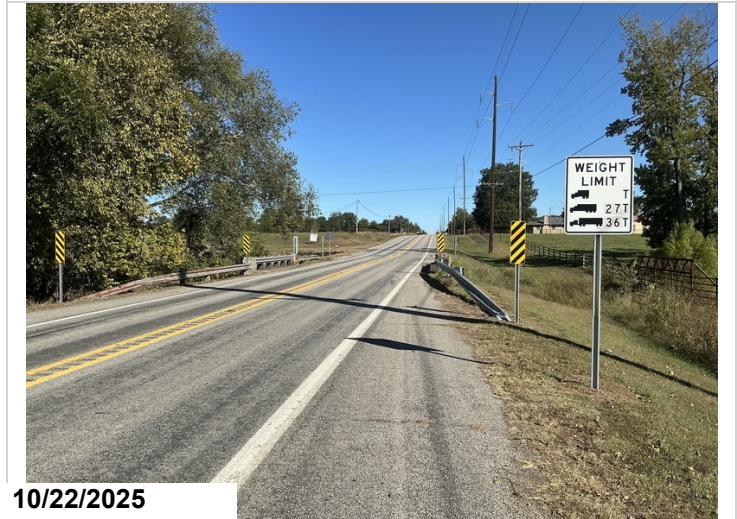
West approach load posting sign.

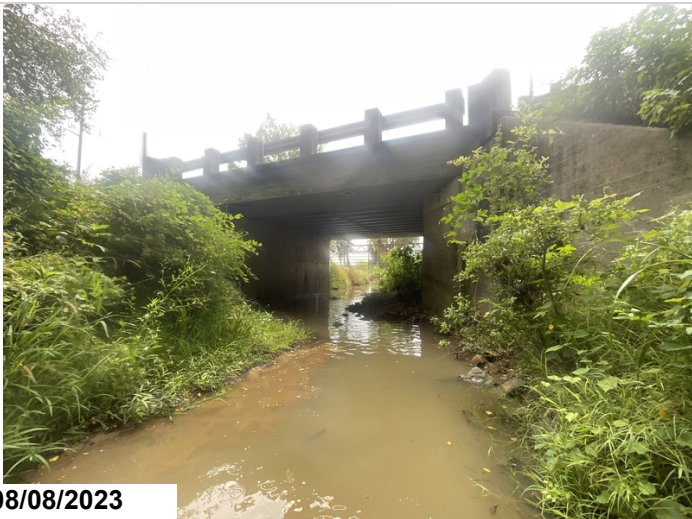
Elevation looking South

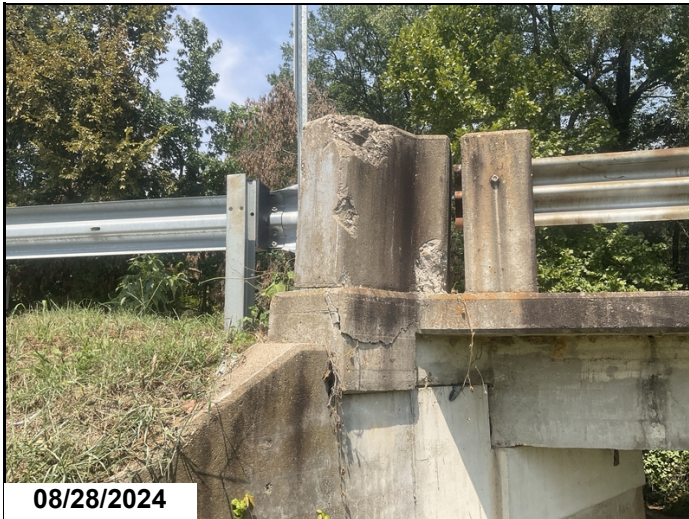
08/28/2024

Abutment # 1 right concrete end post has apparent collision damage that has created areas of light spalling with exposed reinforcing steel in the top of the end post and fractured the base of the post and curb below the post.

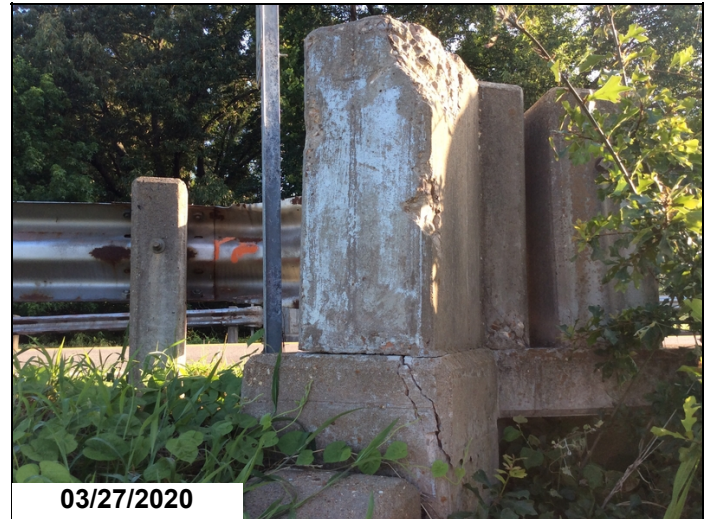
03/27/2020

Abutment # 1 right concrete end post has apparent collision damage that has created areas of light spalling with exposed reinforcing steel in the top of the end post and fractured the base of the post and curb below the post.

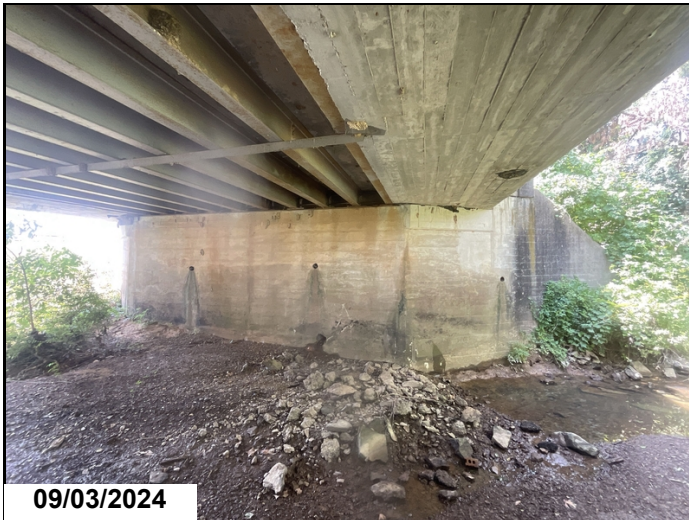
The abutments have isolated areas of concrete deterioration with section loss at the base of the stem walls.

Abutment # 1-Concrete deterioration with section loss.

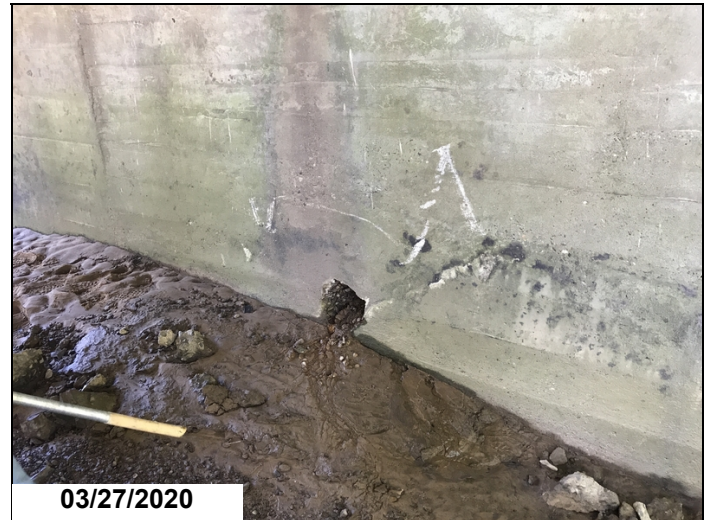
Abutment # 1-Concrete deterioration with section loss.
