Bridge 02287 Inspection Report

US Highway 64 over Little Lee Br.

Location: 7.8 E JCT US 71

Team Lead: Tyler Lincks **Inspection Date:** 11/05/2025

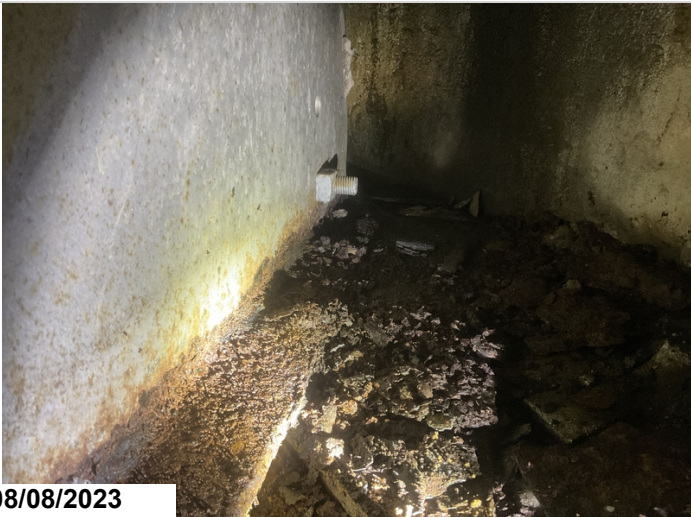
Girders and bearings have a failing paint system with corrosion / section loss.

A-57 - Girder End and Bearing Painting Needed (Y)

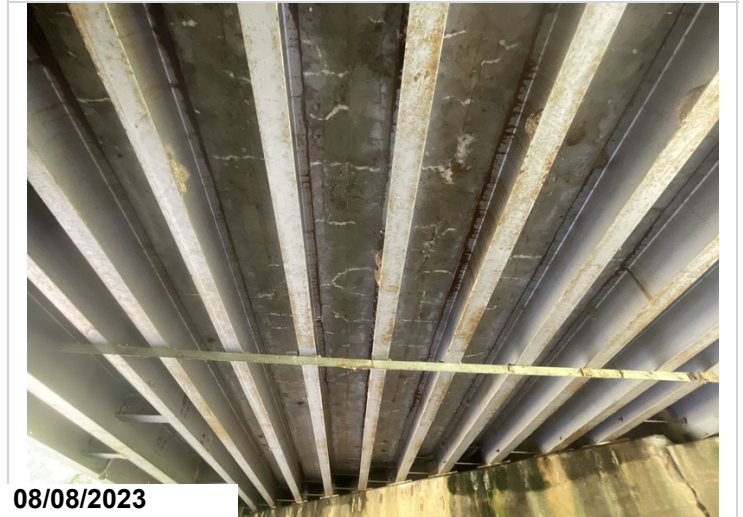
The girders have a failing paint system with freckled rust throughout.

A-60 - Full Girder Painting Needed (Y)

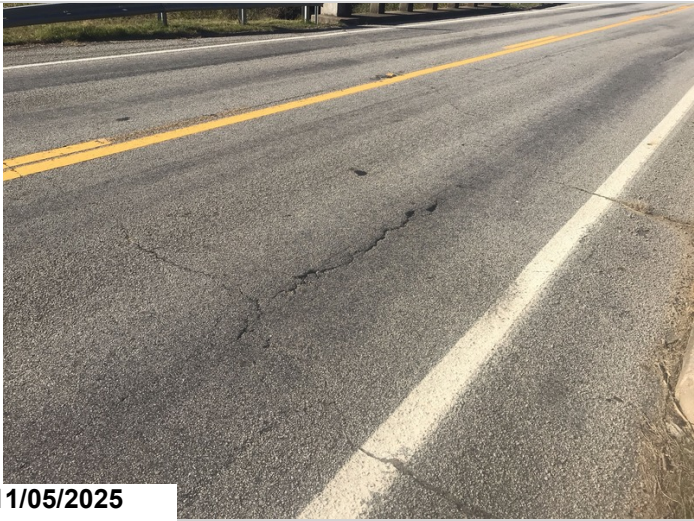
The approach roadway has wide cracking with settlement and rutting.

East bridge end: Minor settlement/ rutting.

A-66 - Approach minor pothole/leveling needed (Y)

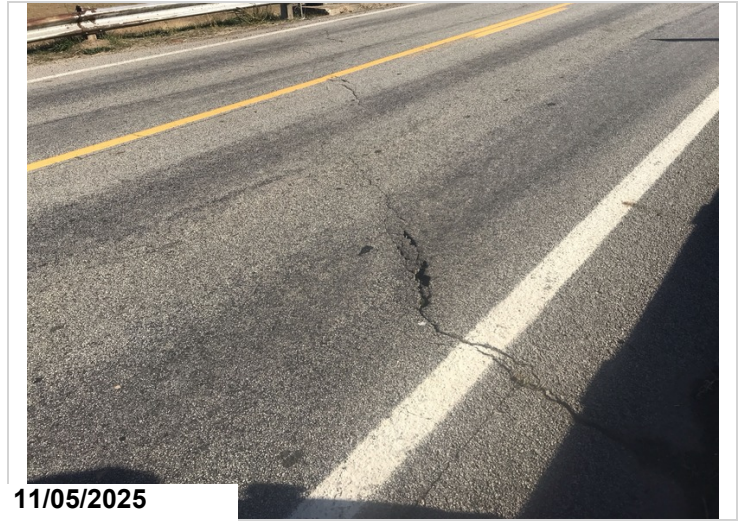
West bridge end: Minor settlement/ rutting.

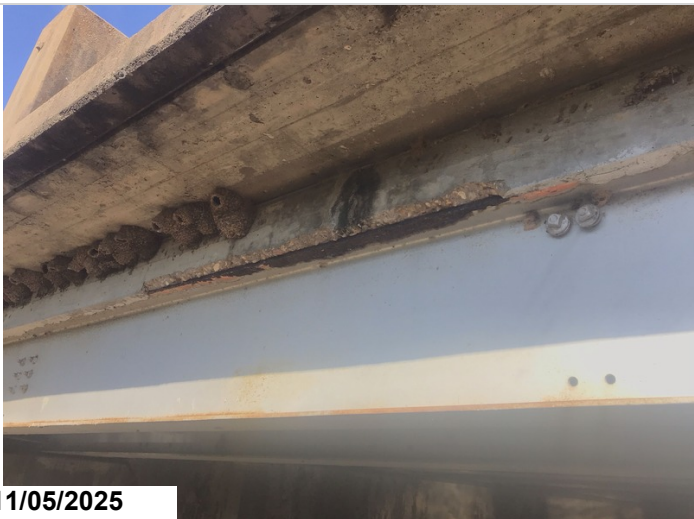
Deck undersurface, Right edge, Adjacent to girder 14: 5' long spall. 5SF CS3

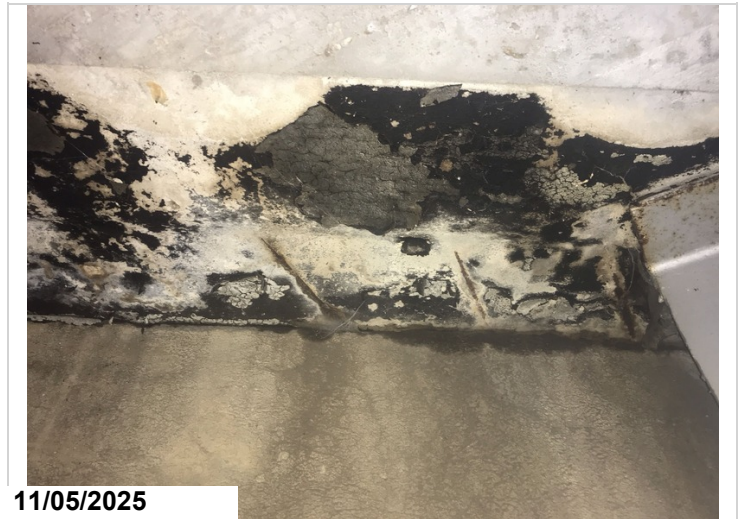
Deck is in overall satisfactory condition with areas of moderate mapcracking with efflorescence in the undersurface & a few shallow spalls with exposed reinforcing steel adjacent to abutment 2. Driving surface is covered with asphalt wearing surface.

Deck undersurface, Bay 1, Abutment 2: Three shallow 6" spalls with exposed reinforcing steel with initial section loss. 3SF CS3

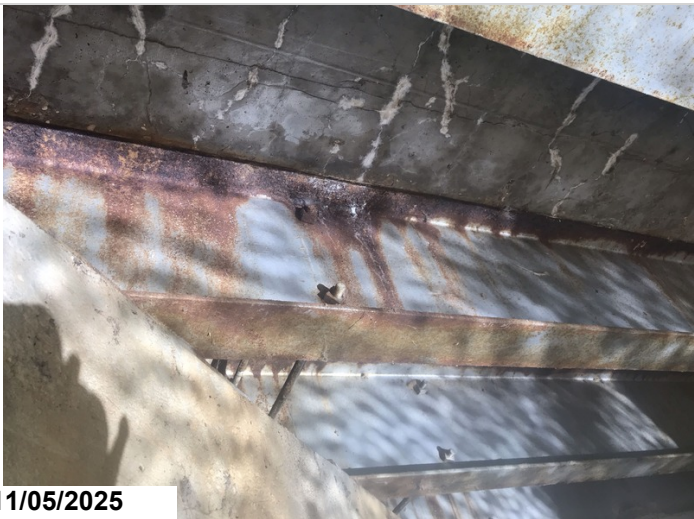
Girder 8, Top flange, Abutment 1: Active corrosion with flaking rust. 10LF CS3

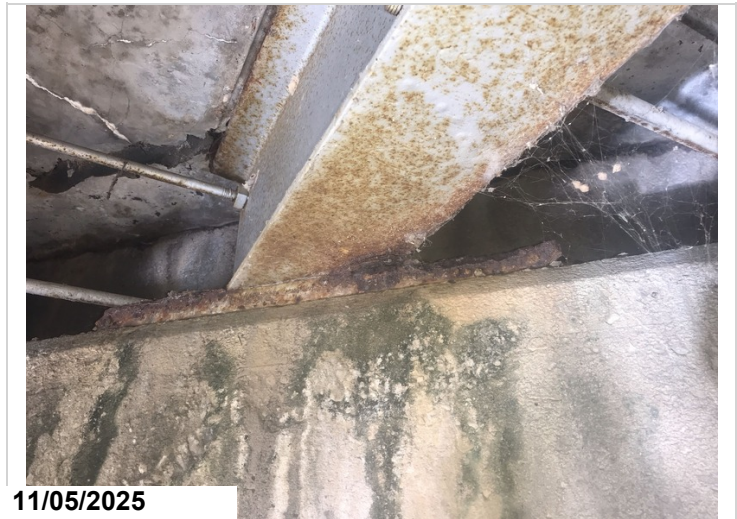
Girder 10, Abutment 1: Active corrosion with flaking rust.

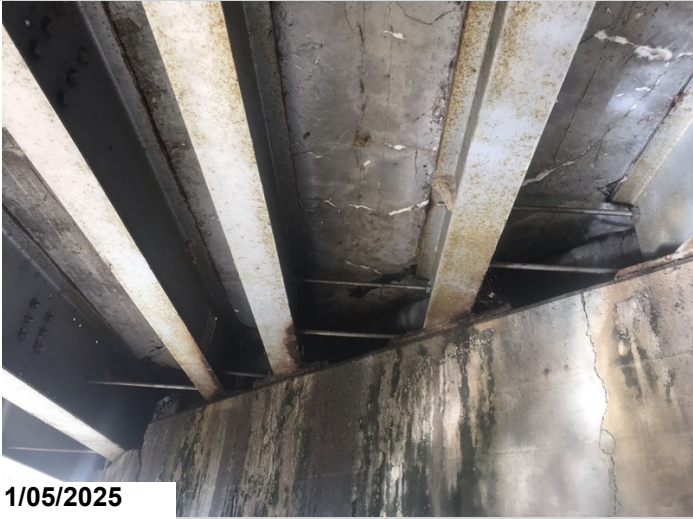
Girders 10, 11, & 12, Abutment 1: Active corrosion with flaking rust.

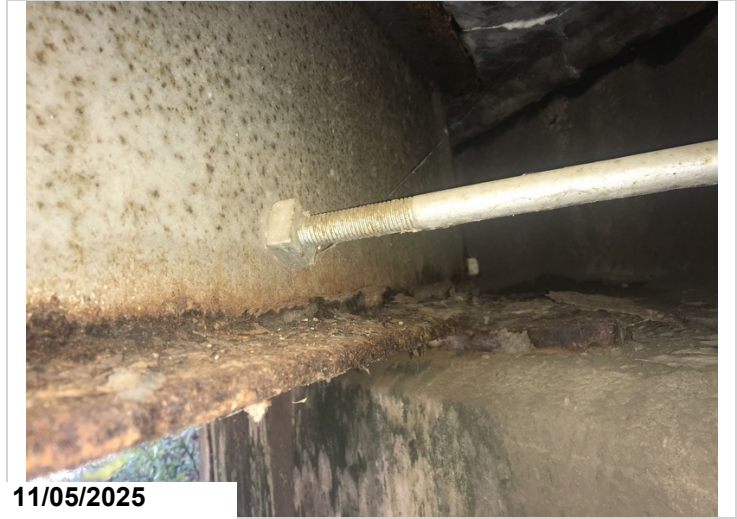
Girder 4, Abutment 2: active corrosion with flaking rust & up to approximately 1/8" section loss. 3LF CS3

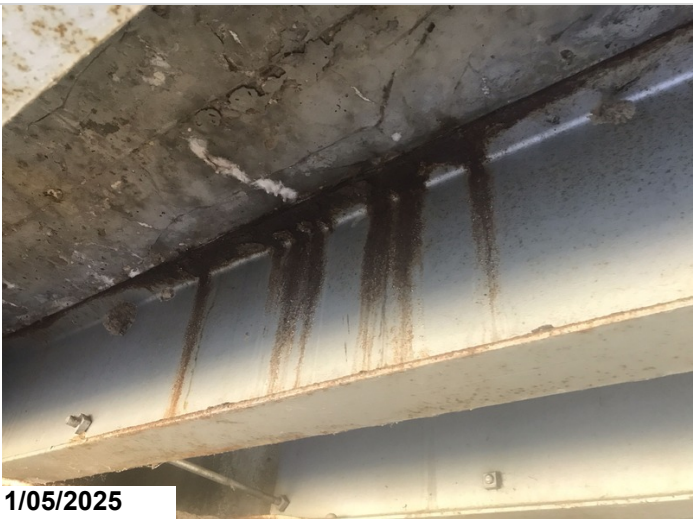
Girder 5, Top flange, Abutment 2: Active corrosion with flaking rust. 4LF CS3

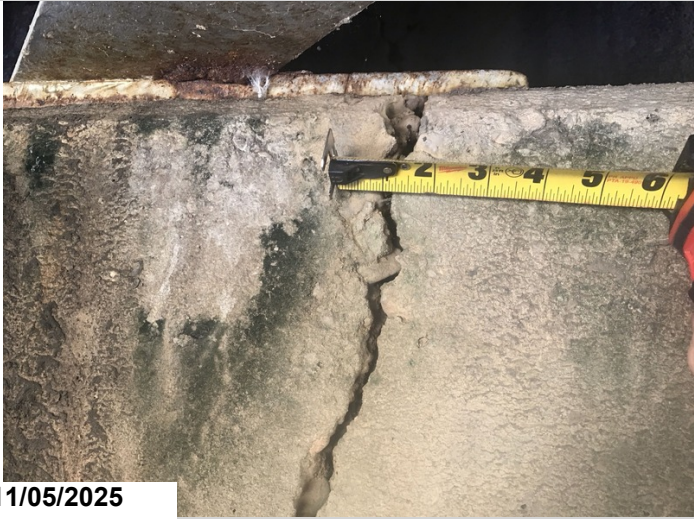
Substructure is in overall satisfactory condition with light abrasion & isolated areas of minor concrete deterioration at base, & a few full height vertical cracks. Abutment 2, Under girder 6: Full height vertical crack measures up to 3/16" wide at top & narrows to hairline at base.

Abutment 1, Under girder 6: Full height vertical crack measures 3/16" at top.

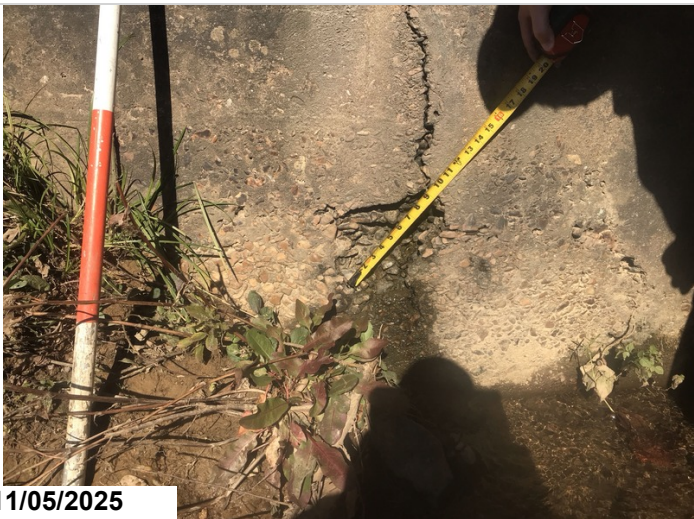
Abutment 1, Right, Under girder 13: 9"X3" deep area of concrete deterioration. 1LF CS3 Spall

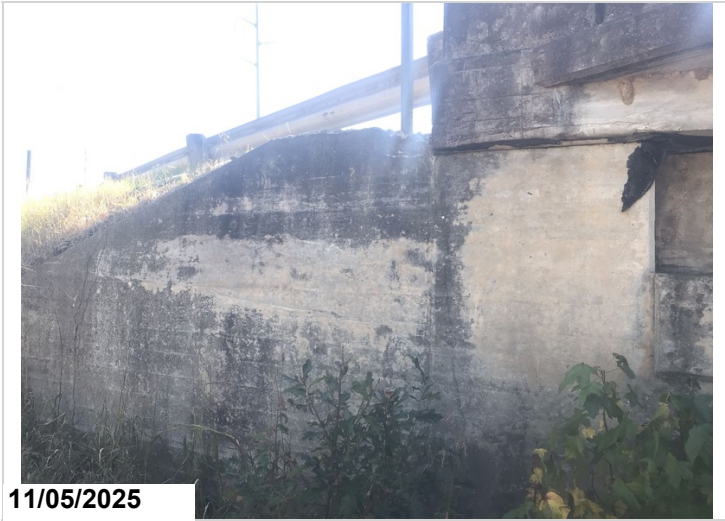
Abutment 2, Left wingwall, Top: Concrete deterioration/
spalling.

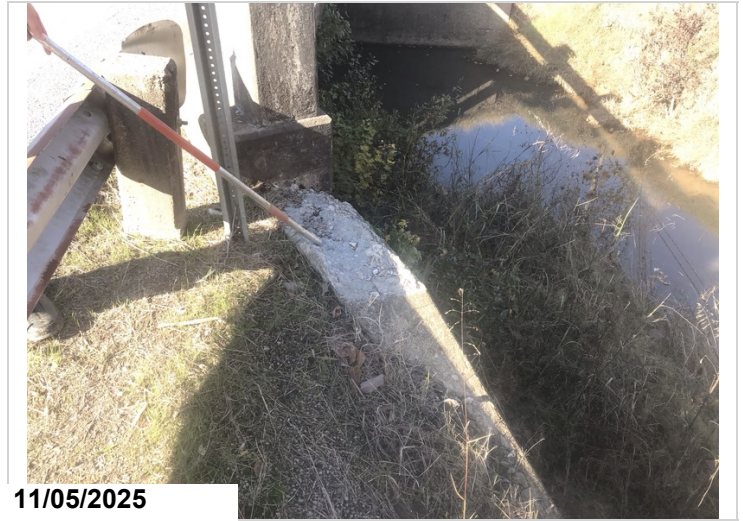
Abutment 2, Left wingwall, Top: Concrete deterioration/
spalling. 3LF CS3

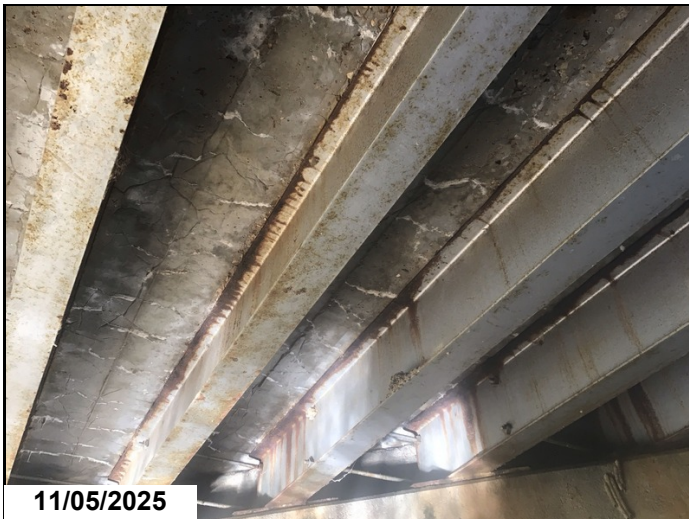
Girder ends, Base of web & bottom flange: Corrosion with flaking rust & section loss. Most notable areas, Bottom flanges, Adjacent to bearings, Girders 3, 10, 11, & 12 at abutment 1, Girders 3 & 4 at abutment 2: Up to 3' long areas of corrosion with up to 1/8" section loss & approximately 5/16" remaining section.

Top flanges, Several locations: Active corrosion & section loss.

08/08/2023 - RSM - Priority changed from "D" to "C" due to corrosion causing measurable section loss to beams.

Superstructure, Active corrosion with flaking rust.

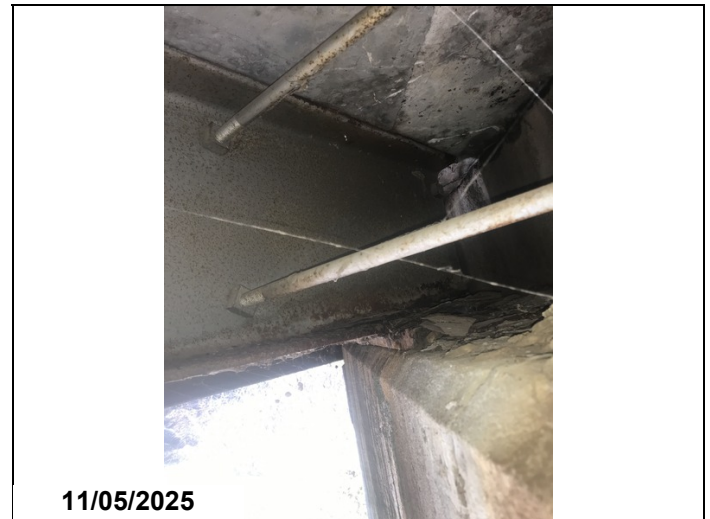
Girder 10, Abutment 1: Active corrosion with flaking rust.

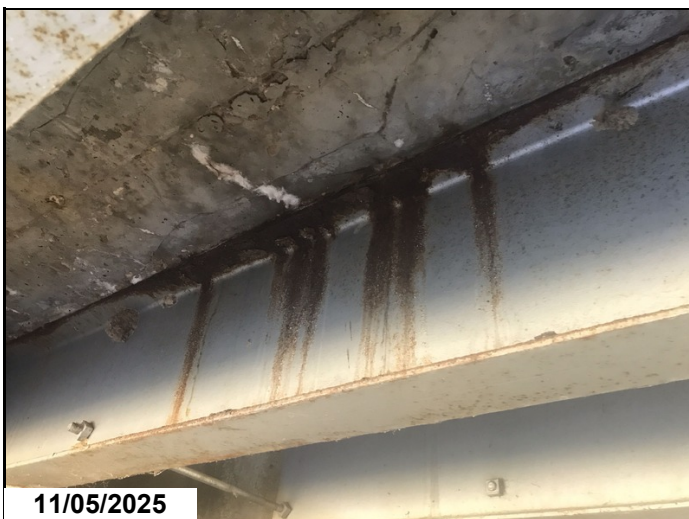
Girder 5, Top flange, Abutment 2: Active corrosion with flaking rust. 4LF CS3

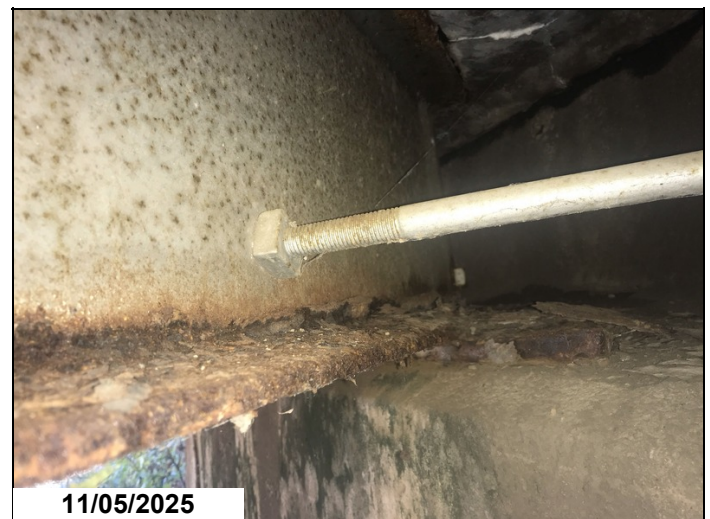
Girder 4, Abutment 2: Active corrosion with flaking rust & up to approximately 1/8" section loss. 3LF CS3

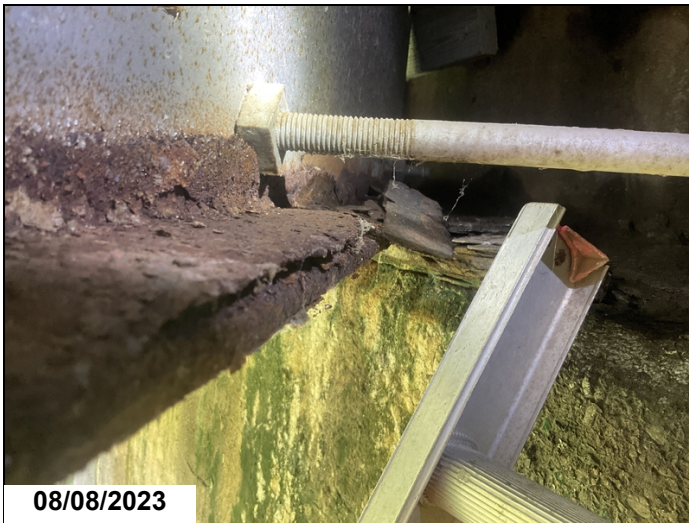
Beam # 11 at abutment # 2-Corrosion with section loss.

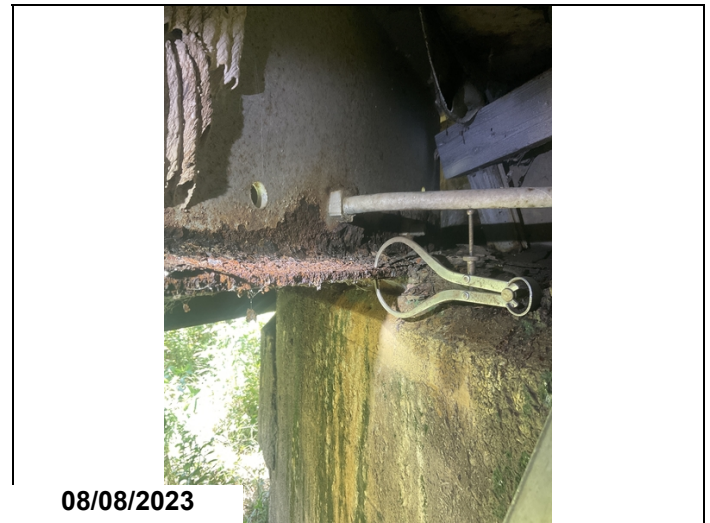
Beam # 12 at abutment # 1 has a 3' long area of corrosion with up to 1/8" section loss with 5/16" remaining section.

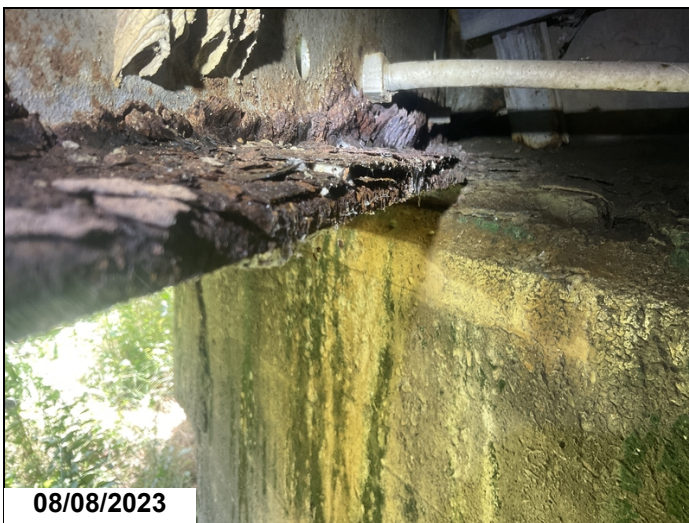
Beam # 12 at abutment # 1 has a 3' long area of corrosion with up to 1/8" section loss with 5/16" remaining section.

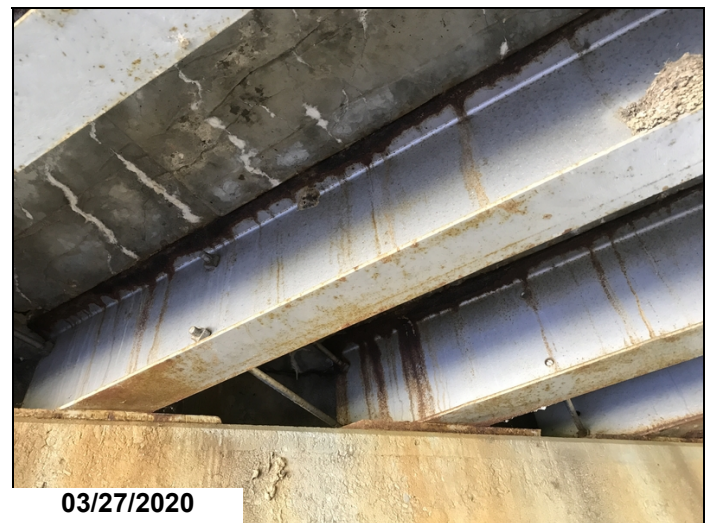
Typical active corrosion along the top flanges in areas.

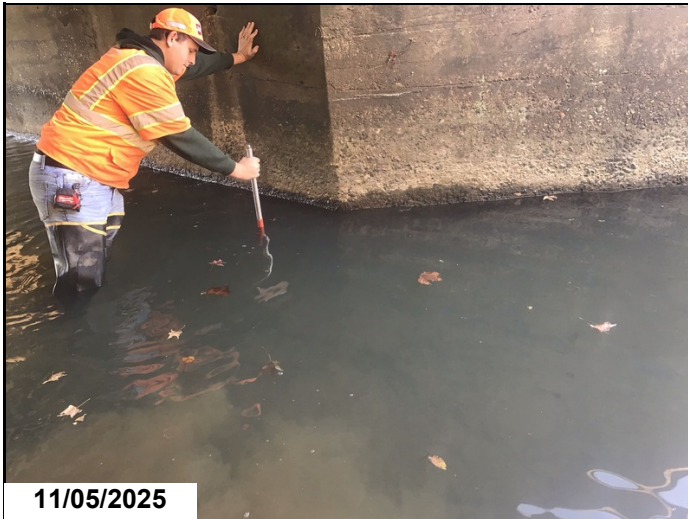
Abutment 1 footing, Top, Left: 9' long exposed area with localized scour along base of abutment which appears to be caused by streambed material accumulation & vegetation upstream directing flow into abutment. No apparent undermining detected during this inspection.

Abutment 1, Left: Top of footing exposed.

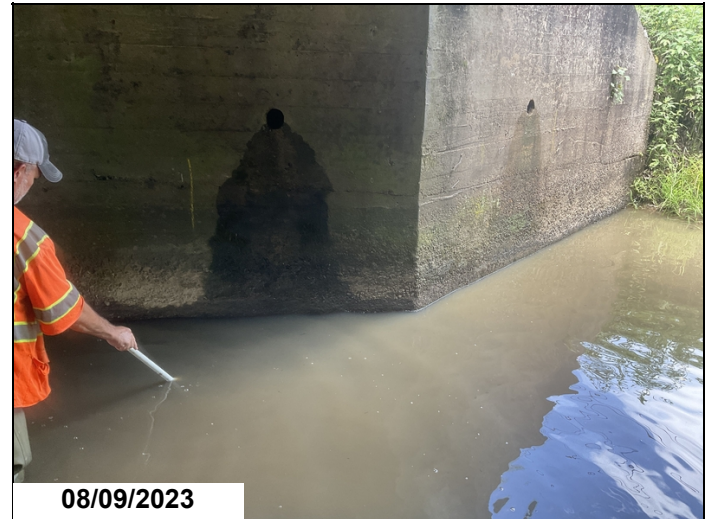
Wading and probing in turbid water conditions revealed that the top of abutment # 1 footing on the left side appears to be exposed in an area approximately 9' long with localized scour along the base of abutment. Scour appears to be caused by streambed material accumulation and vegetation in the upstream channel contributing to poor alignment directing flow into abutment # 1. No apparent undermining to the footing detected at this inspection.

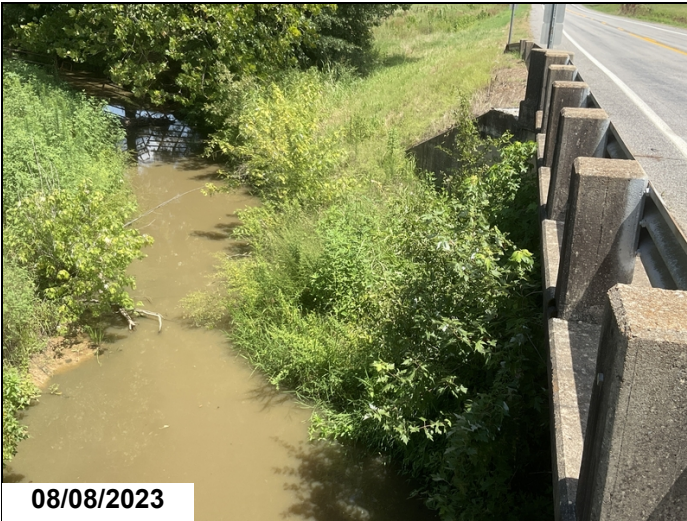
08/08/2023

Streambed material accumulation and vegetation in upstream channel directing flow into abutment # 1.

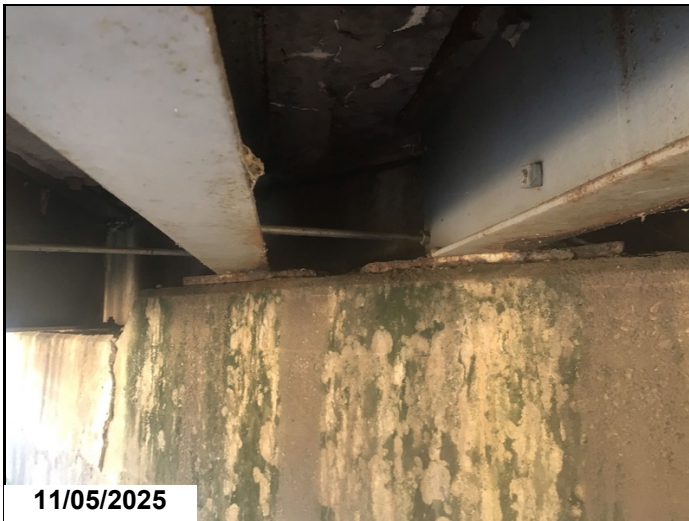
Bearings: Active corrosion layers of pack rust.

Abutment 2, Bearings: Active corrosion with flaking rust.

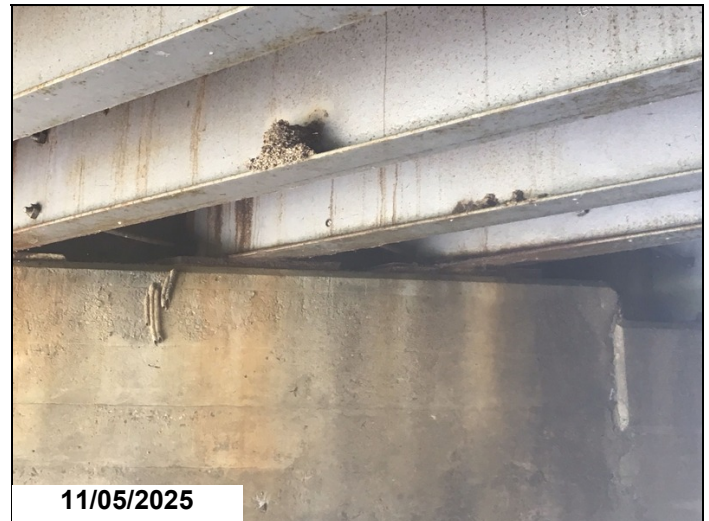
Abutment 1, Bearings: Active corrosion with flaking rust.

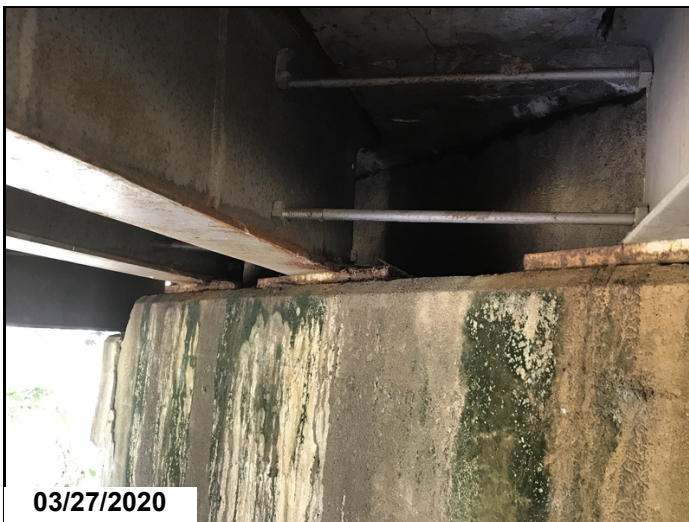
Bearings have active corrosion with pack rust.

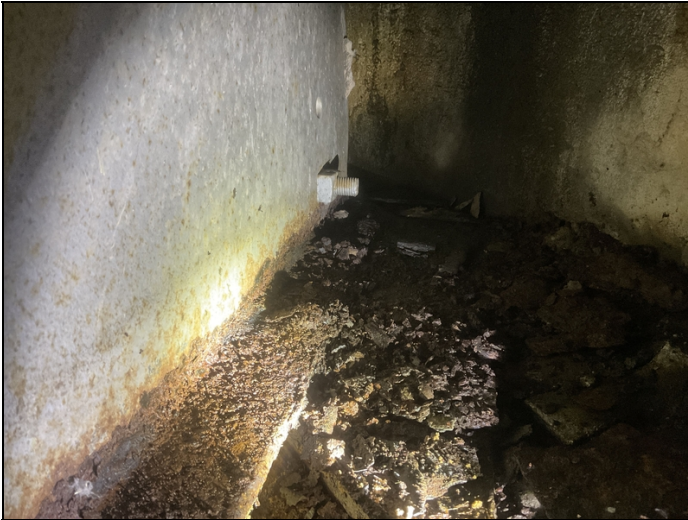
Girders and bearings have a failing paint system with corrosion / section loss.

A-57 - Girder End and Bearing Painting Needed (Yes)

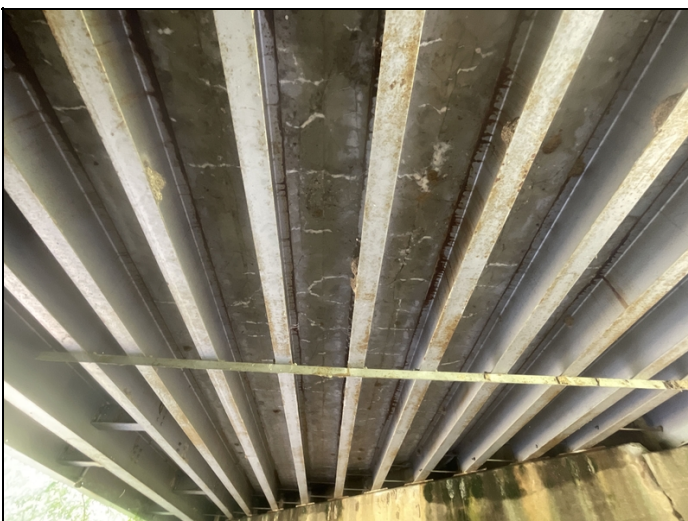
The girders have a failing paint system with freckled rust throughout.

A-60 - Full Girder Painting Needed (Yes)

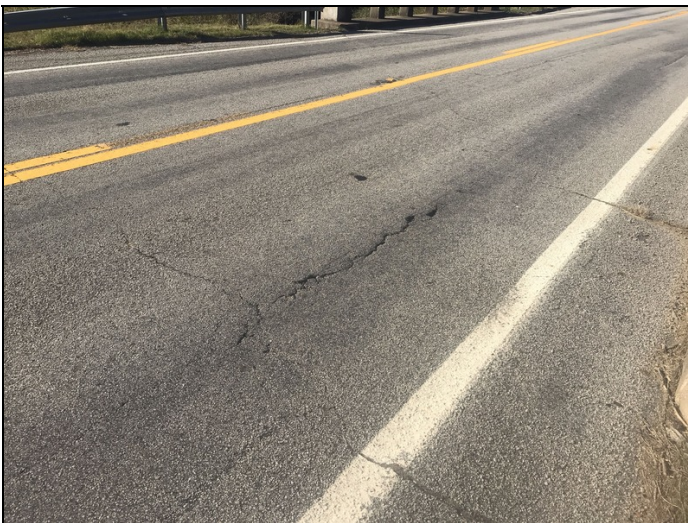
East bridge end: Minor settlement/ rutting.

A-66 - Approach minor pothole/leveling needed (Yes)

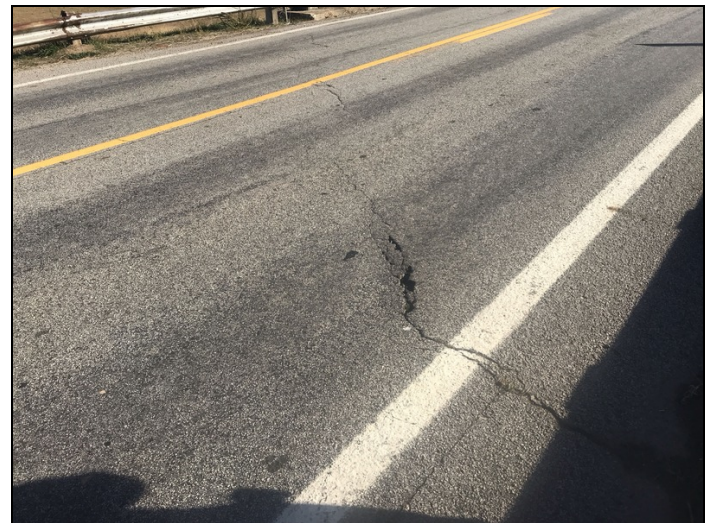
West bridge end: Minor settlement/ rutting.
