## **Bridge 01013 Inspection Report**

Route:71 Section:10 Log:4.329

| IDENTIFICATION | |
|---|--|
| (6) Features Intersected | Poteau River Relief |

Team Lead: Eric West, Inspection Date: 03/17/2025

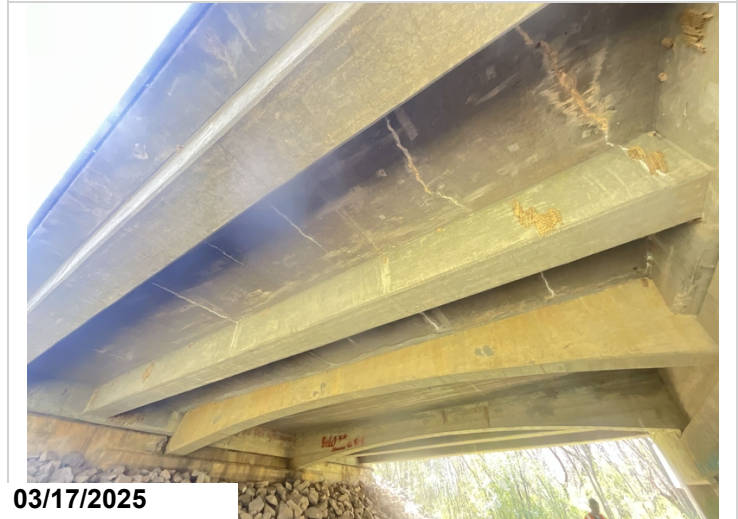
Undersurface, Span # 1: typical.

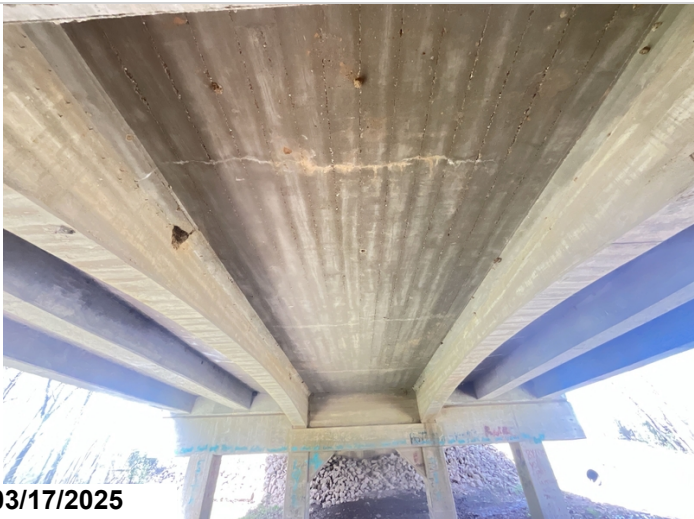
Undersurface, Span # 2: typical.

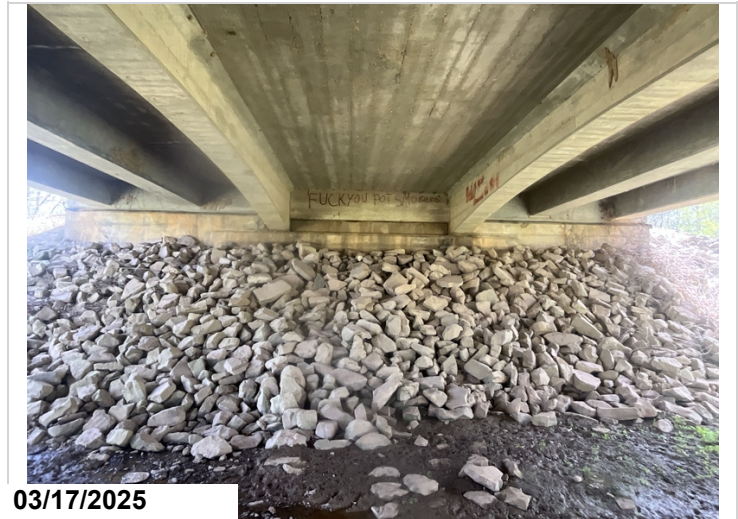
Abutment # 1: typical.

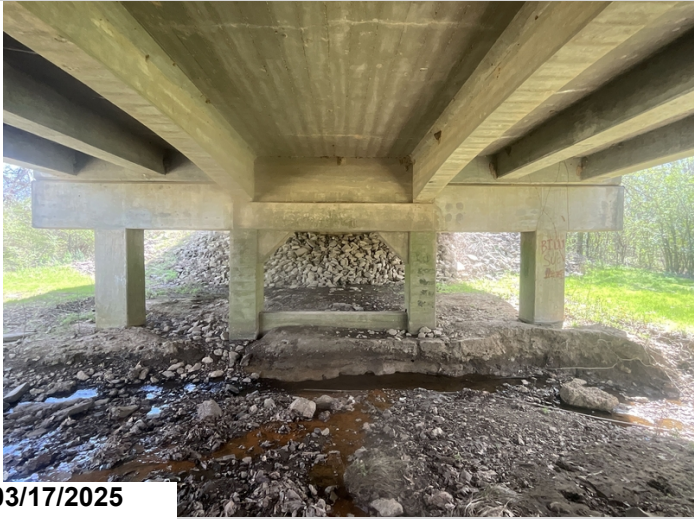
| ELEMENTS | DESCRIPTION | UNITS | TOTAL | CS1 | CS2 | CS3 | CS4 |
|---|---|---|---|---|---|---|---|
| <p>(205) RC Column:</p> <p>Bent # 2. columns # 2 &amp; 3 have light abrasion at the ground elevation.</p> <p>Total Quantities: 2EA CS2 spall, 4EA CS2 abrasion.</p> | | | | | | | |

Bent # 2: typical.

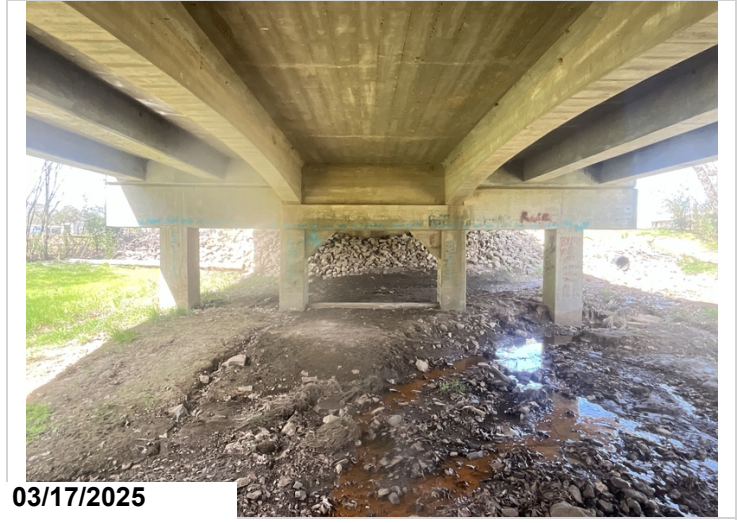
Bent # 3: typical.

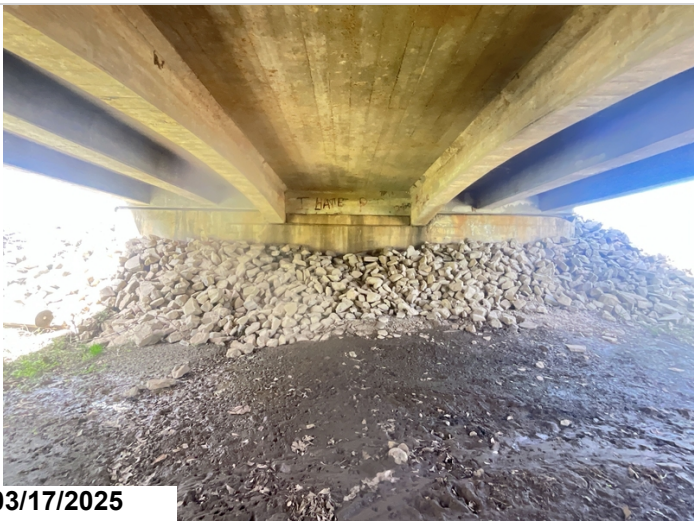
Abutment # 2: typical.

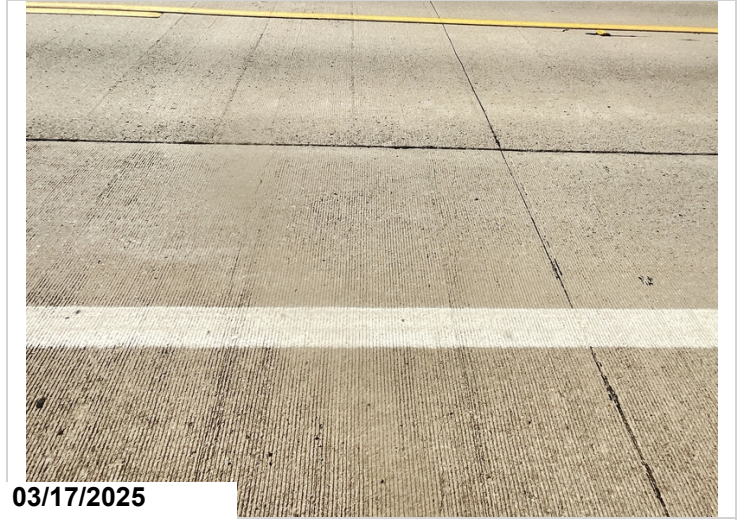
The driving surface of the deck has sealable cracking in all spans.

Sealable deck cracking.

Structure appears to be a good candidate for a polymer wearing surface.

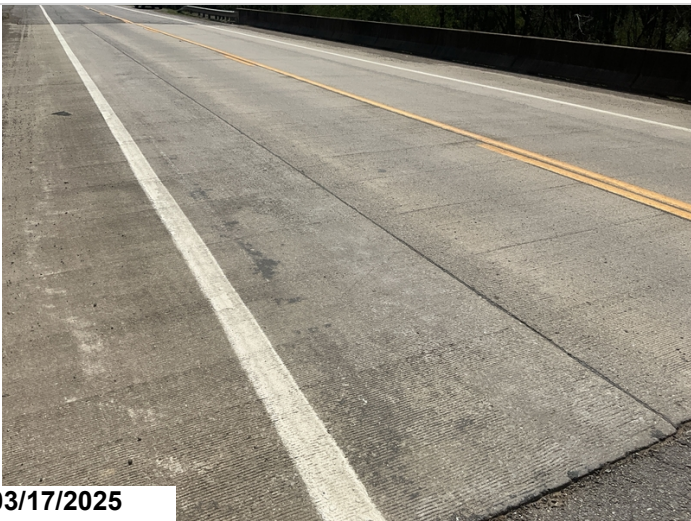
Wearing surface: typical.

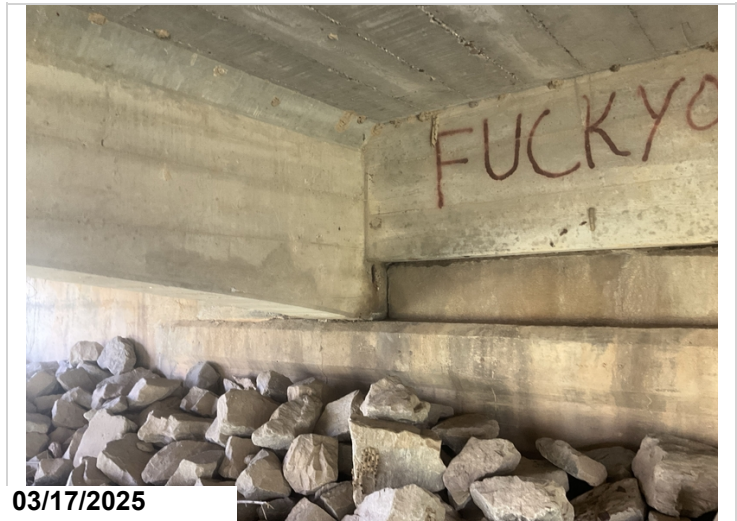
| ELEMENTS | DESCRIPTION | UNITS | TOTAL | CS1 | CS2 | CS3 | CS4 |
|---|---|---|---|---|---|---|---|
| <p>(110) RC Girders:</p> <p>Girders have hairline vertical cracks in isolated locations.</p> <p>Abutment # 1, girder # 4: girder has a 6" spall with exposed reinforcing steel.</p> <p>Abutment # 2, girder # 4: girder has a 5" spall with exposed reinforcing steel on right side and a 8" spall with exposed reinforcing steel on the left side.</p> <p>Span # 2, right: girders on right side of span # 2 have minor efflorescence in a few locations.</p> <p>Span # 3, girder # 4: girder near mid-span has isolated hoops that appear to have been placed against the forms during the construction process with no apparent section loss at this inspection.</p> <p>Total Quantities: 2LF CS2 &amp; 1LF CS3 corrosion, 4LF CS2 efflorescence, 47LF CS2 cracking.</p> | | | | | | | |

Abutment # 1, girder # 4: spalling with exposed reinforcing steel.

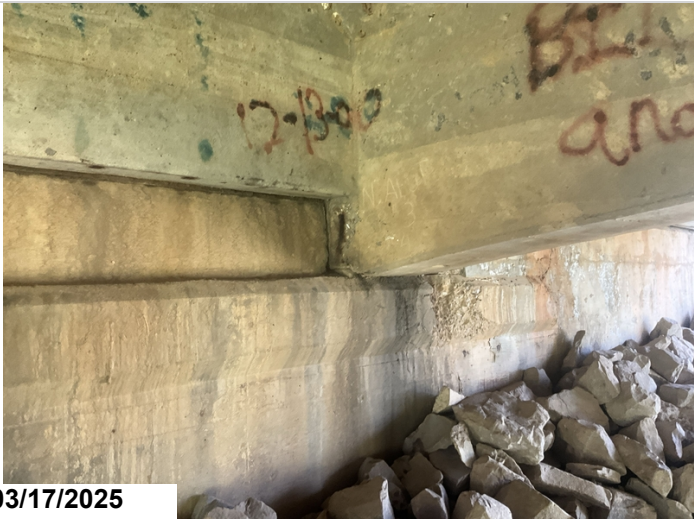
Abutment # 2, girder # 4: spalling with exposed reinforcing steel.

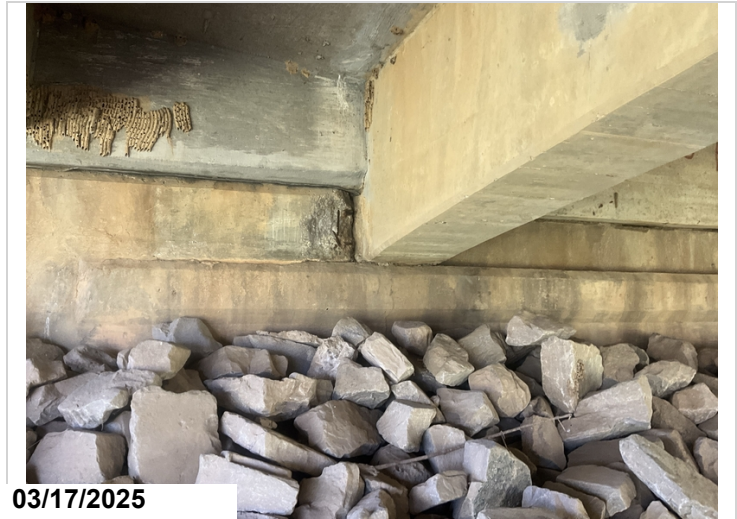
| ELEMENTS | DESCRIPTION | UNITS | TOTAL | CS1 | CS2 | CS3 | CS4 |
|---|---|---|---|---|---|---|---|
| (215) RC Abutment:<br>Abutments # 1 and # 2: abutments have a 14" x 10" spall with an area of exposed reinforcing steel adjacent to girder # 4.<br>Minor vertical cracks in the abutments.<br>Abutment # 2: has a 4" spall with exposed reinforcing steel adjacent to girder # 3.<br>Total Quantities: 1LF CS2 & 2LF CS3 spall, 4LF CS3 rebar, 3LF CS2 efflorescence, 4LF CS2 & 2LF CS3 cracking. | | | | | | | |

Abutment # 1, girder # 4: spalling with exposed reinforcing steel adjacent to girder # 4.

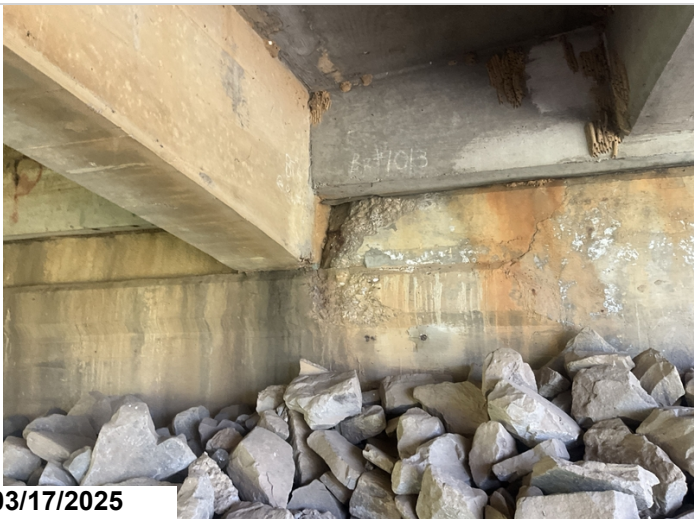
Abutment #2, girder # 4: spalling with exposed reinforcing steel adjacent to girder # 4.

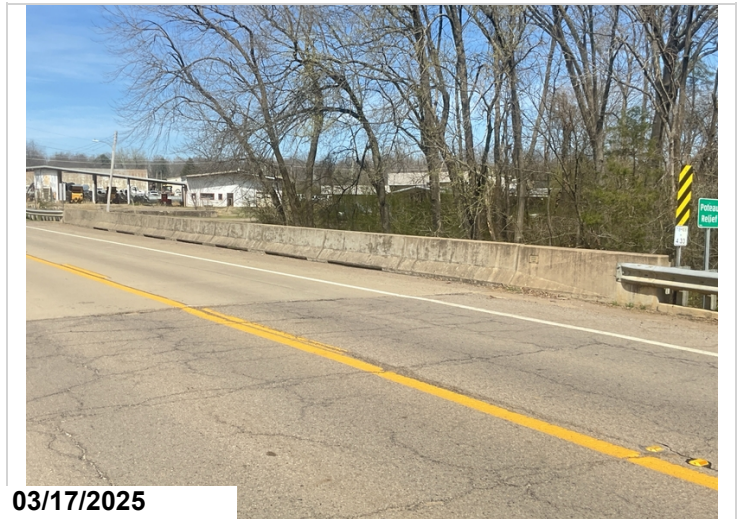
| ELEMENTS | DESCRIPTION | UNITS | TOTAL | CS1 | CS2 | CS3 | CS4 |
|---|---|---|---|---|---|---|---|
| (331) RC Bridge Rail: Vertical cracks typical at the ends of the drain openings.<br>Total Quantities: 9LF CS2 cracking. | | | | | | | |

Bridge Rail: typical.

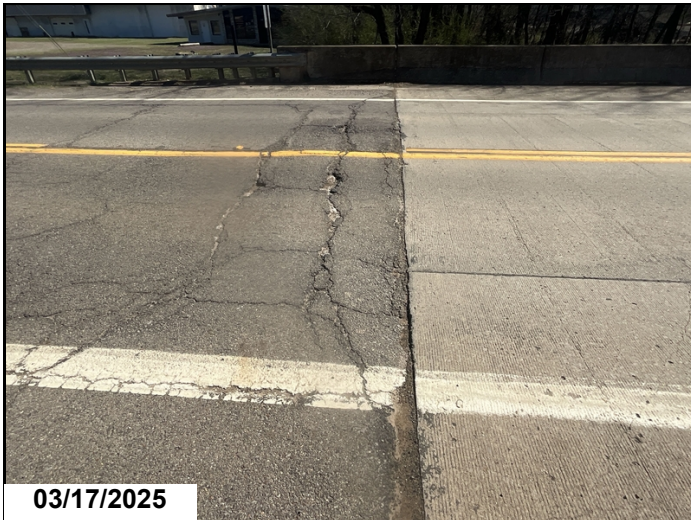
Approach Roadway-  
The asphalt approach roadway is cracked and breaking apart with potholes forming.

North approach: asphalt breaking apart with potholes forming.

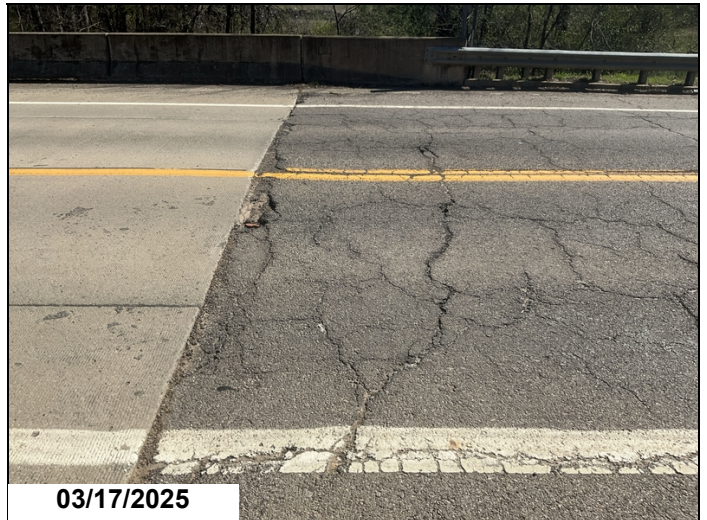
South approach: asphalt breaking apart with potholes forming.

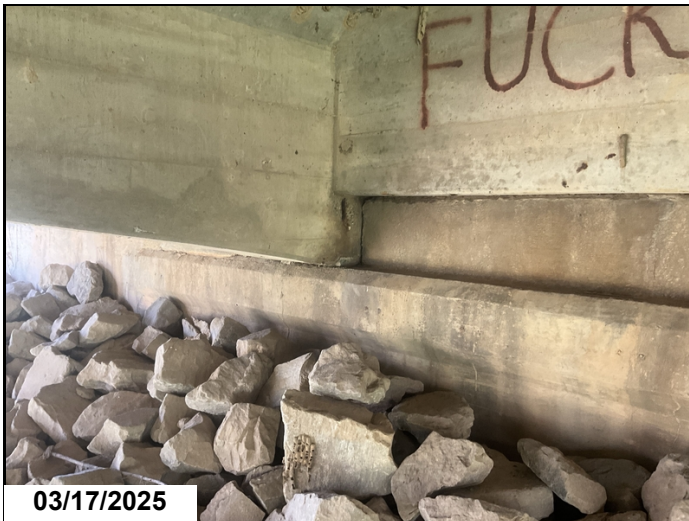
Girder # 4 at abutment # 1 has a 6" spall with exposed reinforcing steel. Girder # 4 at abutment # 2 has a moderate size spall with exposed reinforcing steel on left side and a 5" area of concrete deterioration with exposed reinforcing steel on the right side. The exposed reinforcing steel has initial section loss.

Type of Work: Superstructure Repair

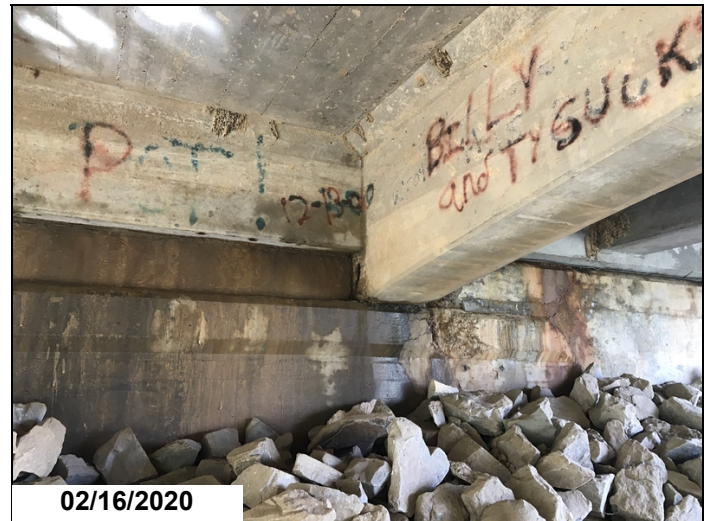
Abutment # 2, girder # 4-Spalling with exposed reinforcing steel.

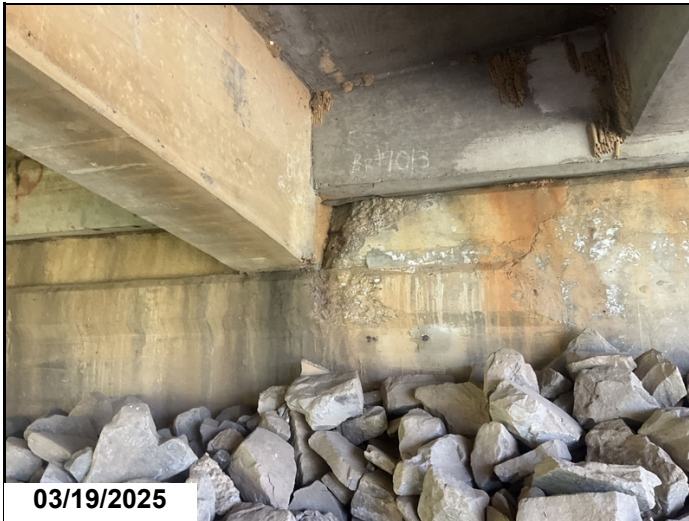
Abutments # 1 and # 2 have moderate sized spalls with a small area of exposed reinforcing steel adjacent to girder # 4. Exposed reinforcing has initial section loss during this inspection.

Abutment #2, girder # 4: spalling with exposed reinforcing steel adjacent to girder # 4.

**Type of Work:** Substructure Repair

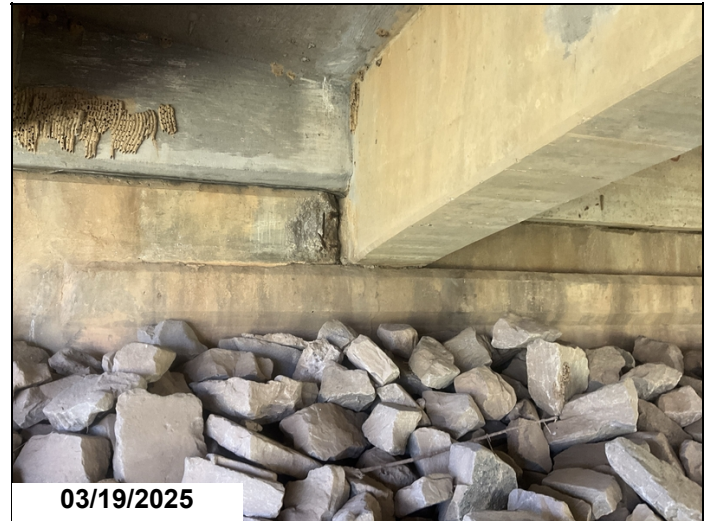
Abutment # 1, girder # 4: spalling with exposed reinforcing steel adjacent to girder # 4.

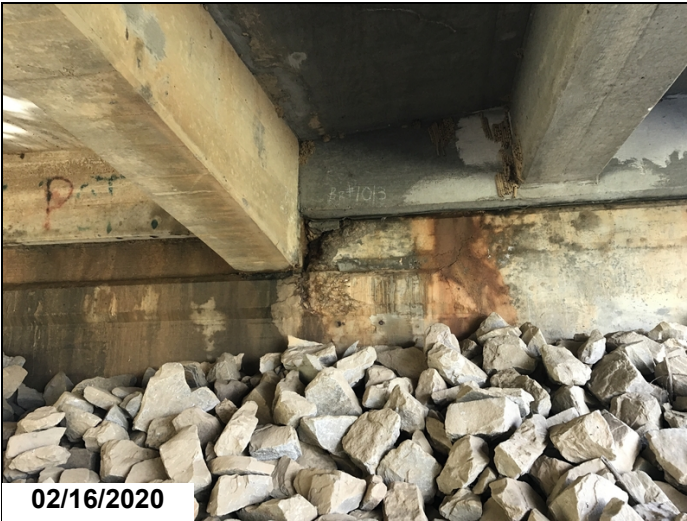
Abutments # 1 and # 2 have moderate sized spalls with a small area of exposed reinforcing steel adjacent to girder # 4. Exposed reinforcing has initial section loss during this inspection. Abutment # 1 pictured.

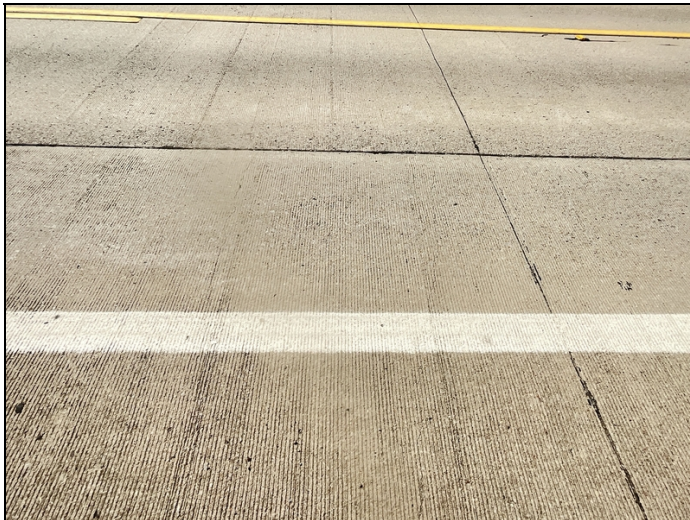
The driving surface of the deck has sealable cracking in all spans.

Sealable deck cracking.
