### Bridge 06361 Inspection Report

**Asset #06361** (Routine)

**US 71-SEC 10B over Poteau River**

**Team Lead:** Eric West **Inspection Date:** 03/17/2025

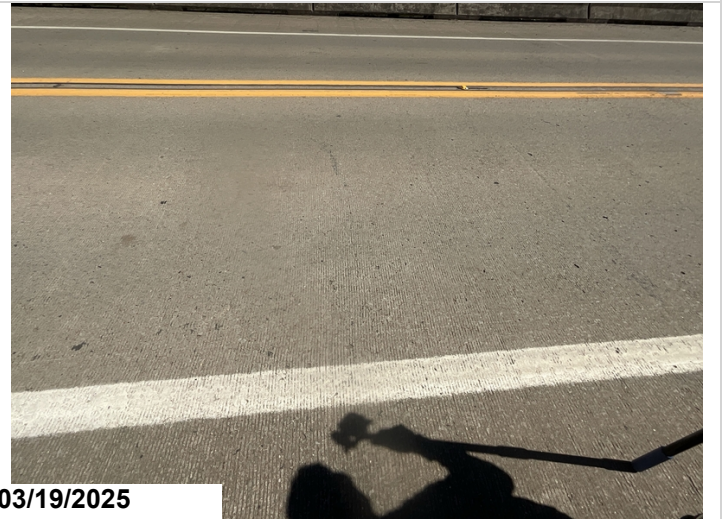
The driving surface of the deck has sealable cracking.

Sealable deck cracking.

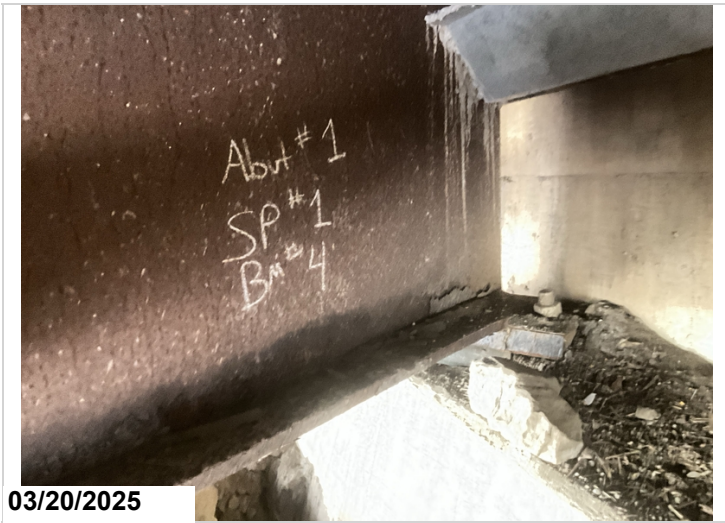
Girder ends and bearings over both abutments and over bent # 5 have active corrosion with flaking rust where the joint seals leak water onto the superstructure. The girder ends at bent # 5 appear to be the most notable area with corrosion with flaking rust and initial section loss in several locations.

Abutment # 1, girder # 4: active corrosion with flaking rust.

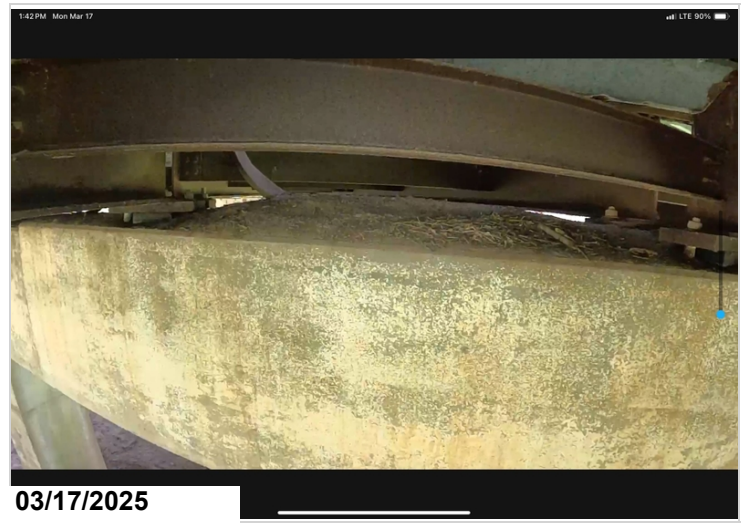
Bent caps have heavy dirt and debris accumulation due to failed expansion joint sealant.

Bent # 5 debris accumulation on the bent cap.

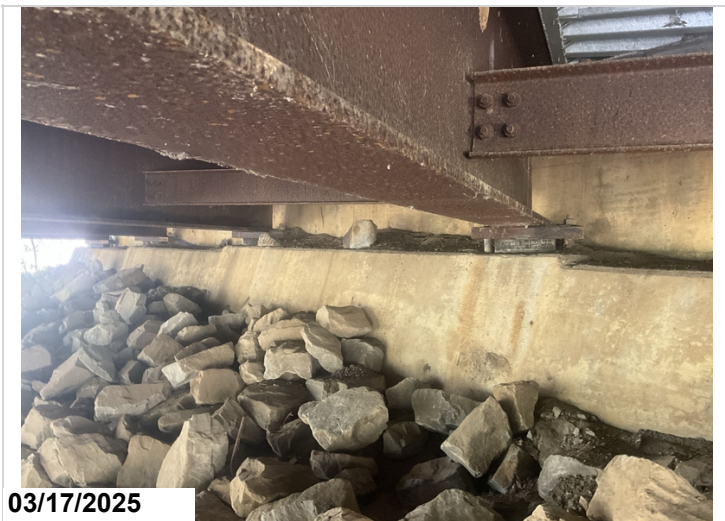
Abutment # 1 debris accumulation on the bent cap.

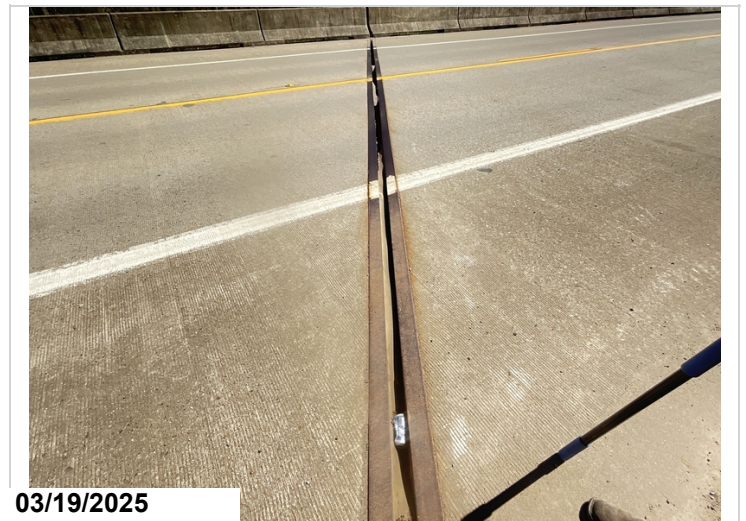
The pourable expansion joint sealant at bent # 5 has full depth adhesion failure the entire length of the joint. The deck joint seals at the abutments have adhesion failure, debris impaction and leak water on the superstructure and substructure.

Bent # 5: typical.

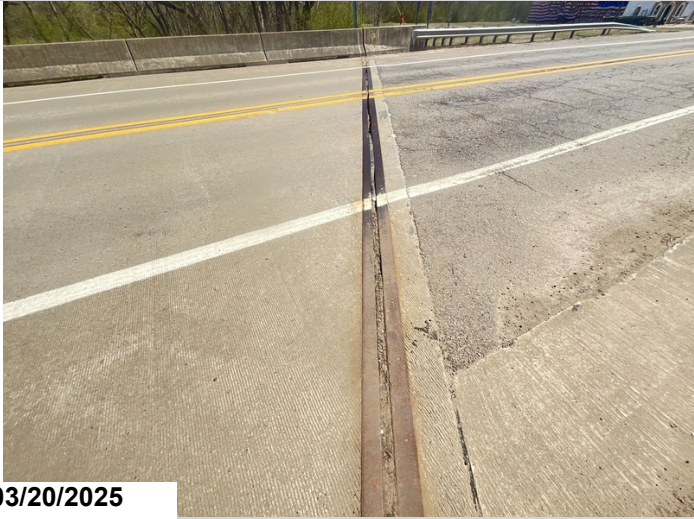
(302) Compression Joint Seal: the joint seals at the abutments have adhesion failure with portions of the seals missing and leak water on the substructure. The expansion joint assemblies in the shoulders have dirt and debris accumulation.							
310	Elastomeric Bearing	EA	54	35	14	5	0
1000	Corrosion	EA	19	0	14	5	0
515	Steel Protective Coating	SF	54	32	1	14	7
3430	Oxide Film Degradation Color/Texture Adherence(Steel Protective Coatings)	SF	21	0	1	13	7
3440	Effectiveness (Steel Protective Coatings)	SF	1	0	0	1	0

Compression Joint Seal, Abutment #1: typical.

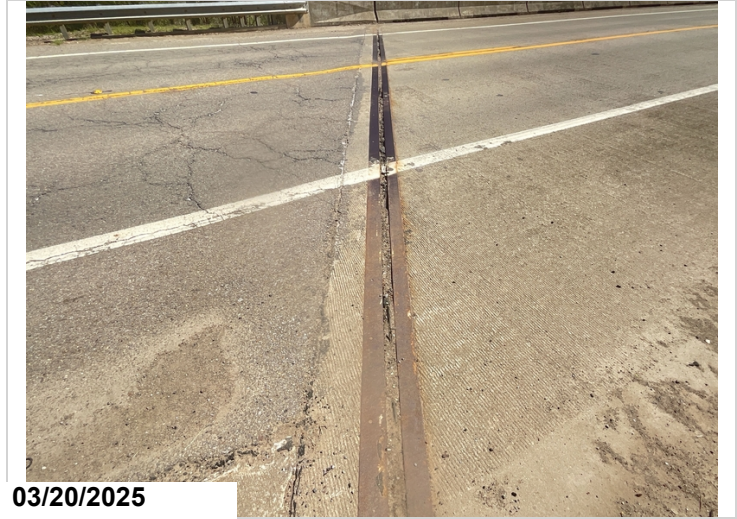
Compression Joint Seal, Abutment #2: typical.

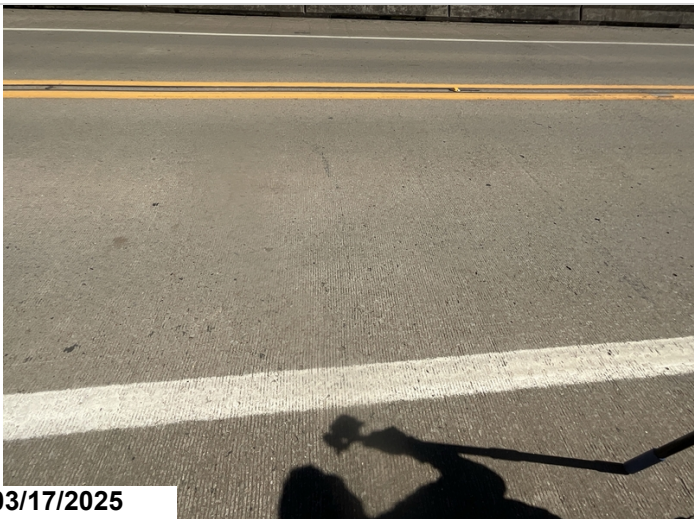
Sealable deck cracking.

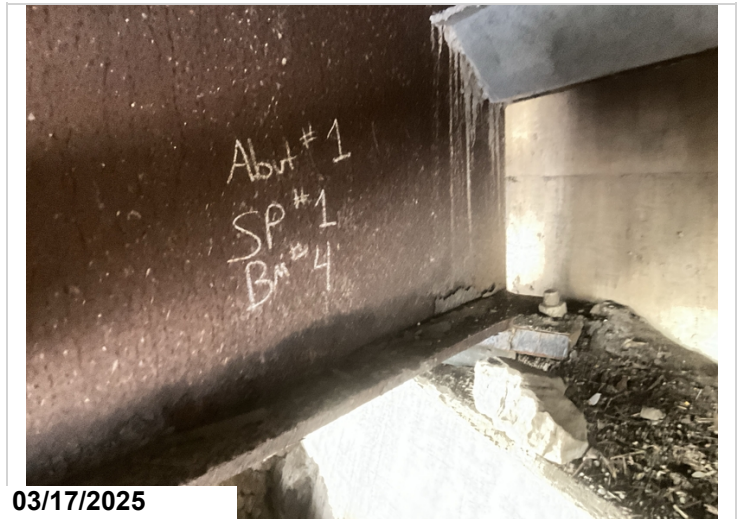
Abutment # 1, girder # 4: active corrosion with flaking rust.

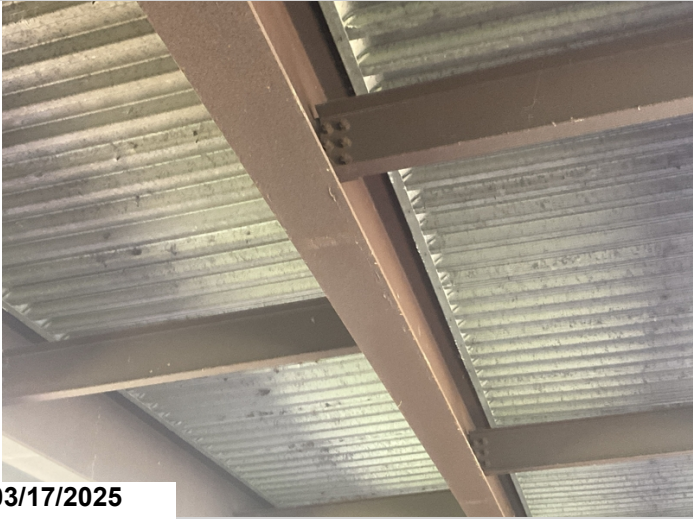
Span # 6, girder # 4: girder has a 5' areas with mill imperfections visible from the undersurface of the bottom flange at mid-span.

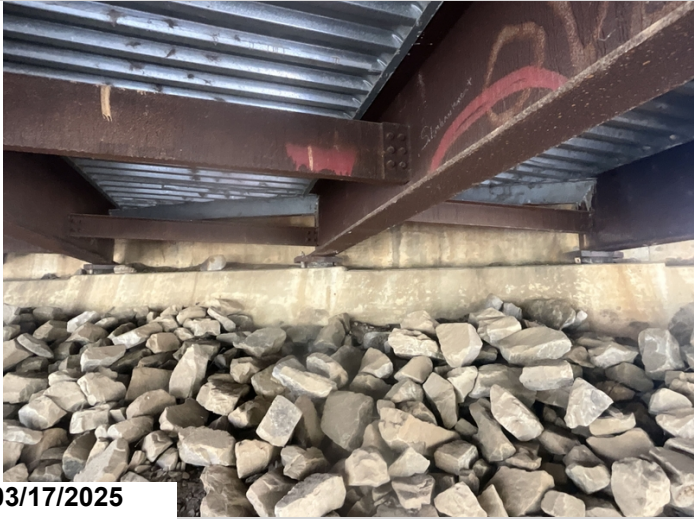
(310) Elastomeric Bearings: There is active corrosion with flaking rust in the exterior loading plates of the bearings at the abutments

Abutment # 1: active corrosion in the bearings.

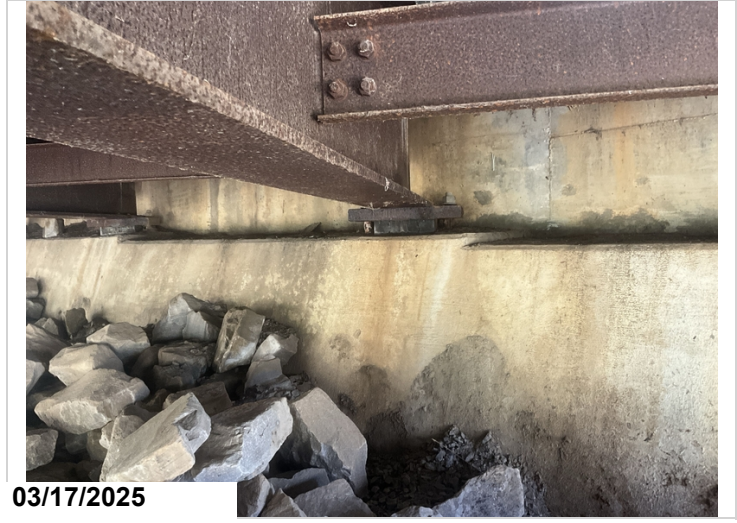
Abutment # 2, bearing # 2: active corrosion with flaking rust.

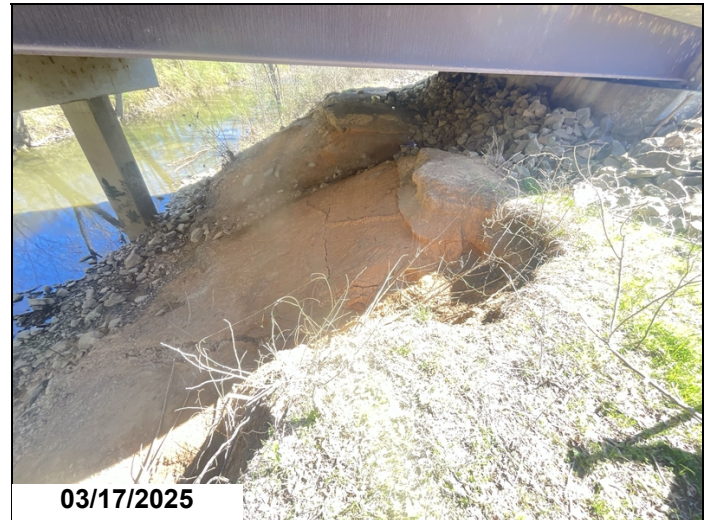
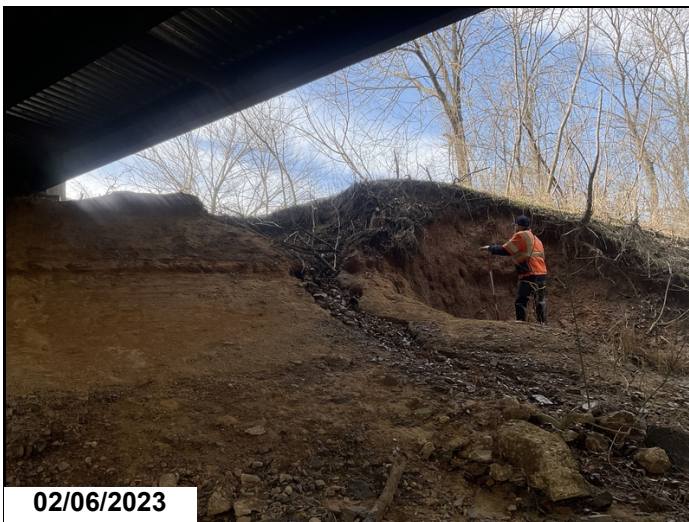
Overall the channel is in good condition, the banks are vegetated and appear stable. The Southwest embankment below abutment # 1 has a large area of erosion that does not threaten the substructure at this inspection.

South Embankment -  
The South embankment has erosion.

The South embankment has erosion.

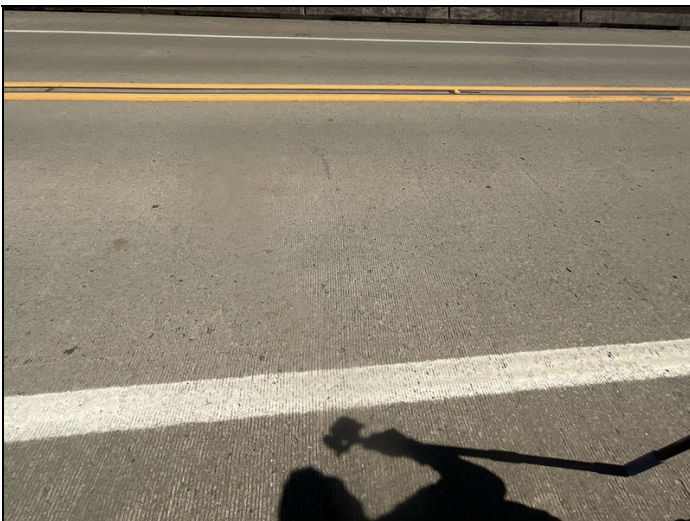
The driving surface of the deck has sealable cracking.

Sealable deck cracking.

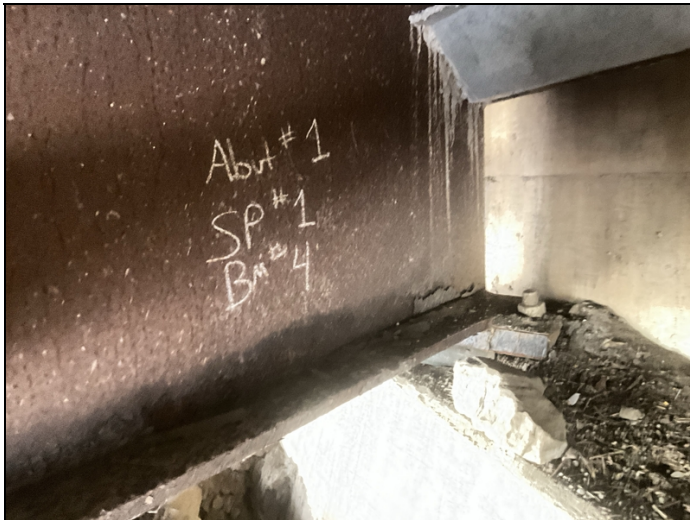
Girder ends and bearings over both abutments and over bent # 5 have active corrosion with flaking rust where the joint seals leak water onto the superstructure. The girder ends at bent # 5 appear to be the most notable area with corrosion with flaking rust and initial section loss in several locations.

Abutment # 1, girder # 4: active corrosion with flaking rust.

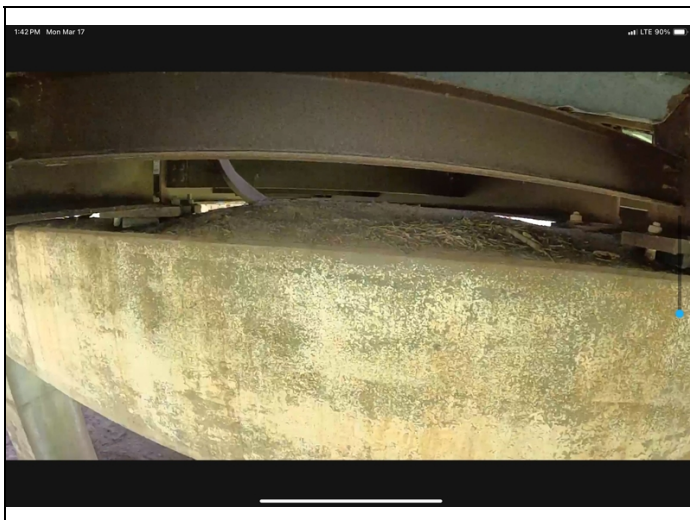
Bent caps have heavy dirt and debris accumulation due to failed expansion joint sealant.

Bent # 5 debris accumulation on the bent cap.

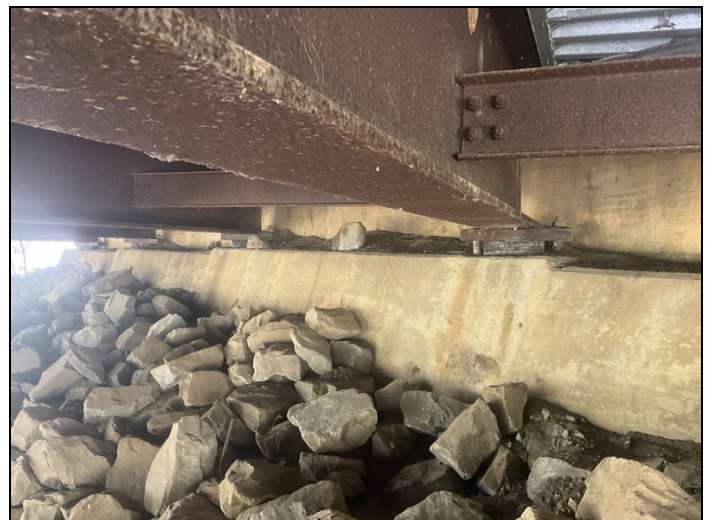
Abutment # 1 debris accumulation on the bent cap.

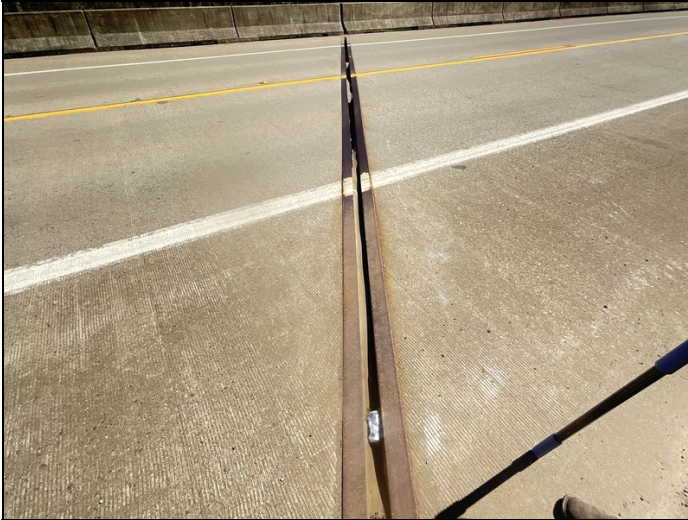
The pourable expansion joint sealant at bent # 5 has full depth adhesion failure the entire length of the joint. The deck joint seals at the abutments have adhesion failure, debris impaction and leak water on the superstructure and substructure.

Bent # 5: typical.

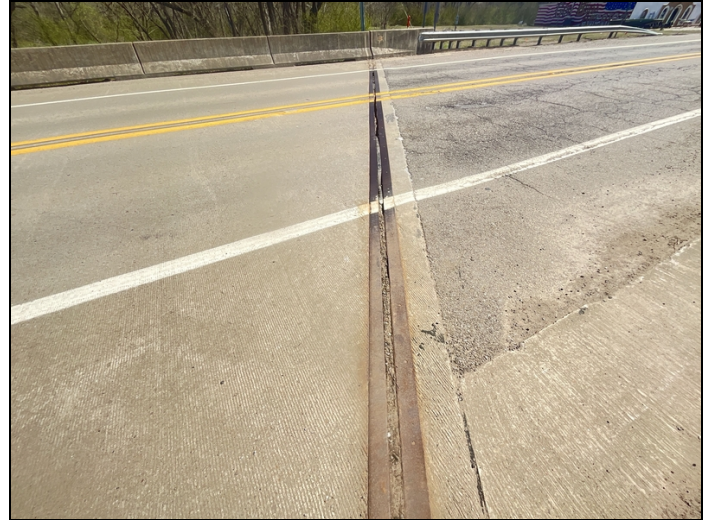
Compression Joint Seal, Abutment #1: typical.

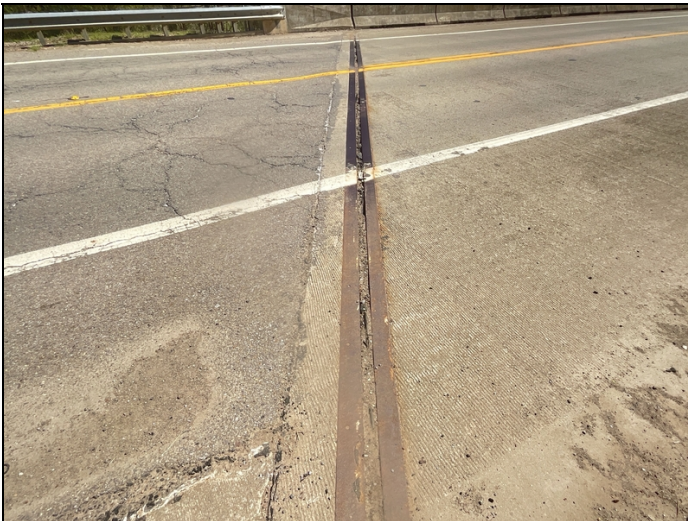
Compression Joint Seal, Abutment #2: typical.
