Bridge M1094 Inspection Report

SH 180 SEC 0 over Stream-Washington Co.

Location: 0.3 MI EAST OF SH 112

Team Lead: Eric West Inspection Date: 10/04/2023

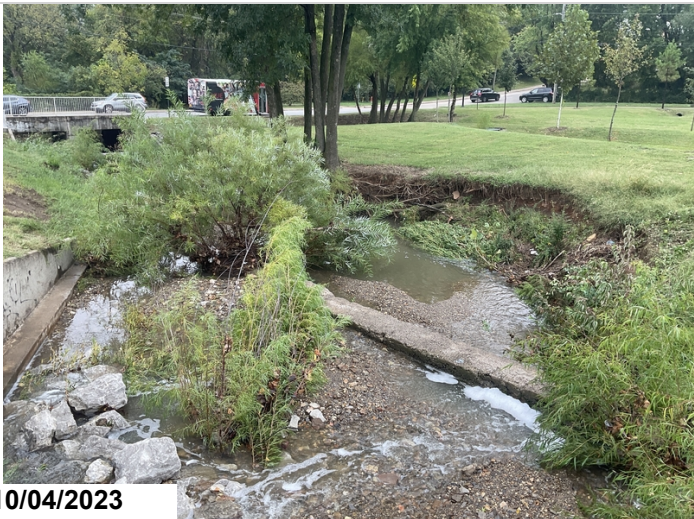
Downstream

61 - Channel/Channel Protection (6 - Bank is beginning to slump. River control devices and embankment protection have widespread minor damage. There is minor stream bed movement evident. Debris is restricting the channel slightly.)
10/04/2023 - EJW - Channel has minor lateral migration downstream of the culvert.

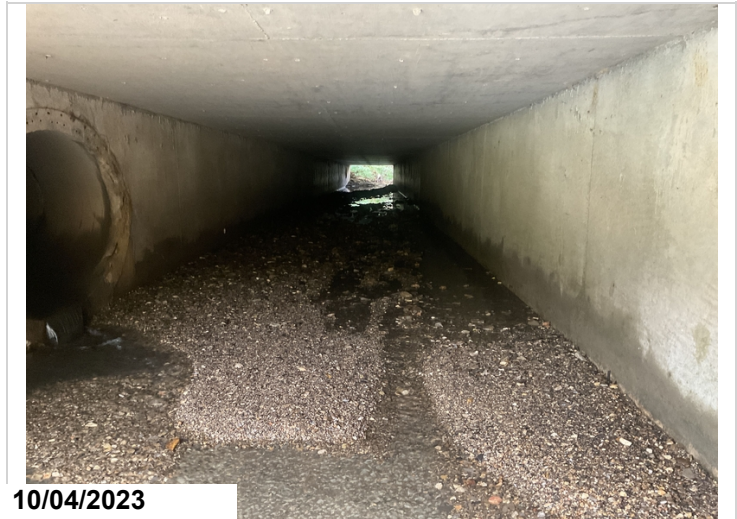
Barrel # 1 typical.

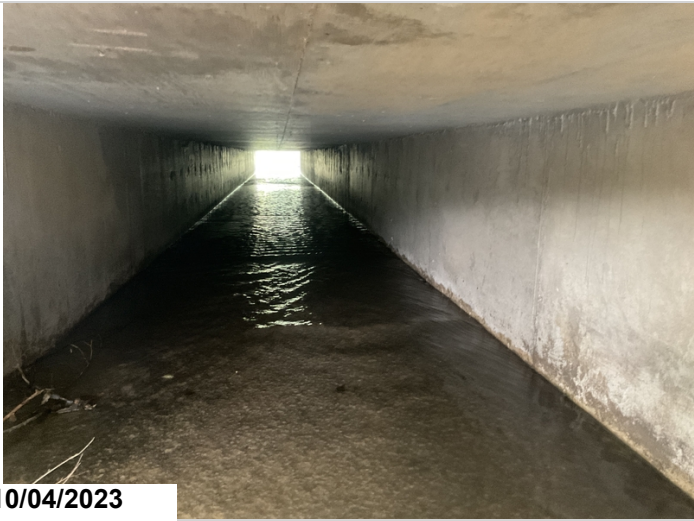
Barrel # 2 typical.

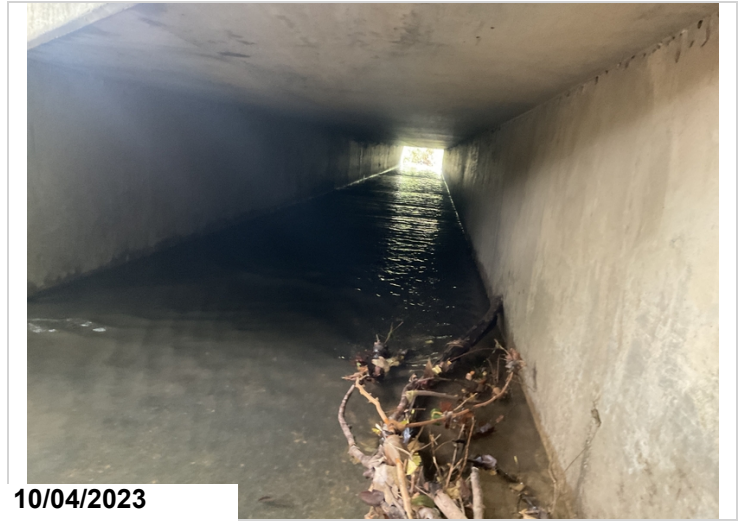
Barrel # 3 typical.

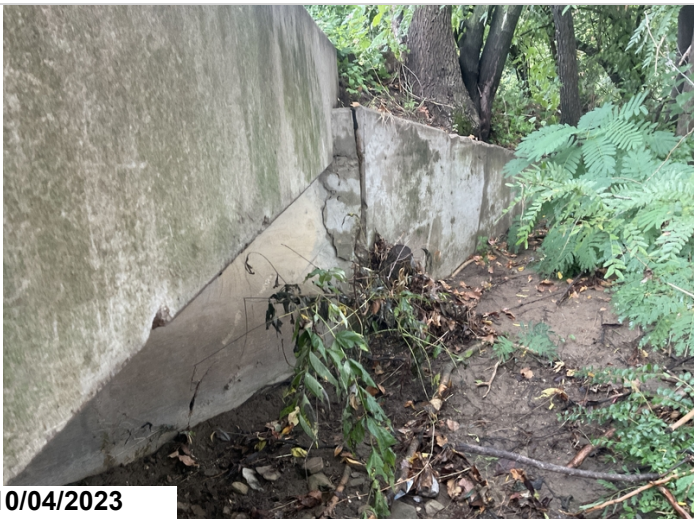
62 - Culverts (6 - Deterioration or initial disintegration, minor chloride contamination, cracking with some leaching, or spalls on concrete or masonry walls and slabs. Local minor scouring at curtain walls, wingwalls or pipes. Metal culverts have a smooth curvature, non-symmetrical shape, significant corrosion or moderate pitting.)
10/04/2023 - EJW - R.C. Box Culvert is in satisfactory condition with minor concrete delamination and spalling with exposed reinforcing steel.

Barrel # 1 Lt end of the exterior wall has a 18" tall delamination at the wing wall juncture.

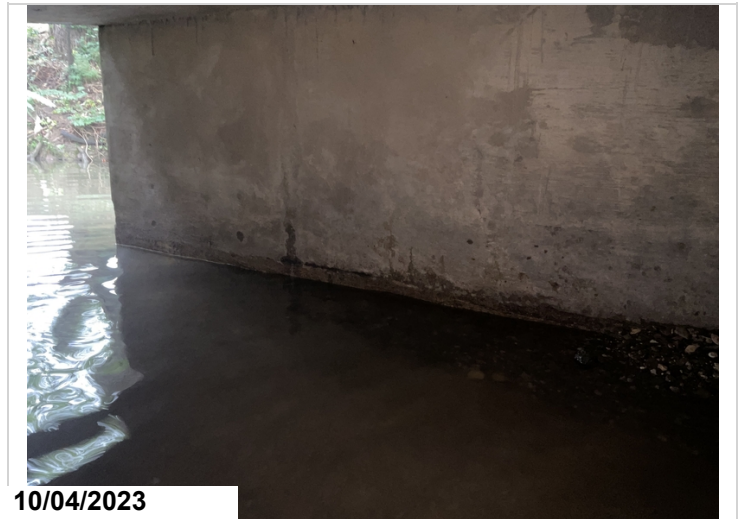
Barrel # 1 East wall has shallow spalling along the base with exposed reinforcing steel.

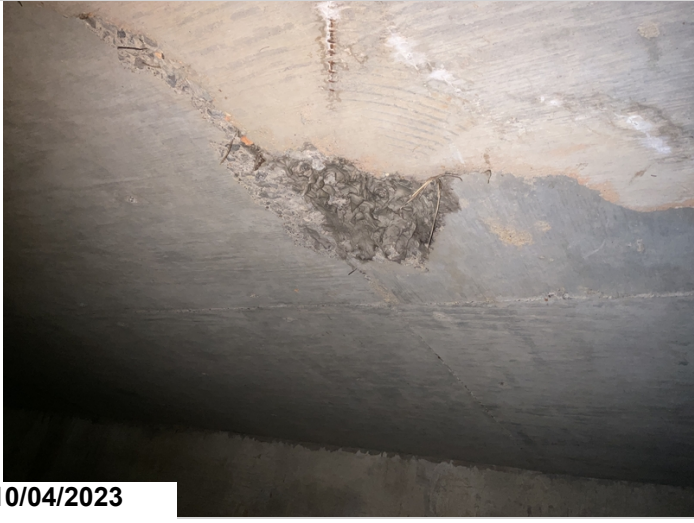
Barrel # 2 has a 14" spall with a caulking repair in the top slab construction joint.
