Bridge 05133 Inspection Report

State Highway 186 over Interstate 40 - Franklin

Location: @ JCT I 40 & 186

Team Lead: Caleb Lambert Inspection Date: 06/24/2025

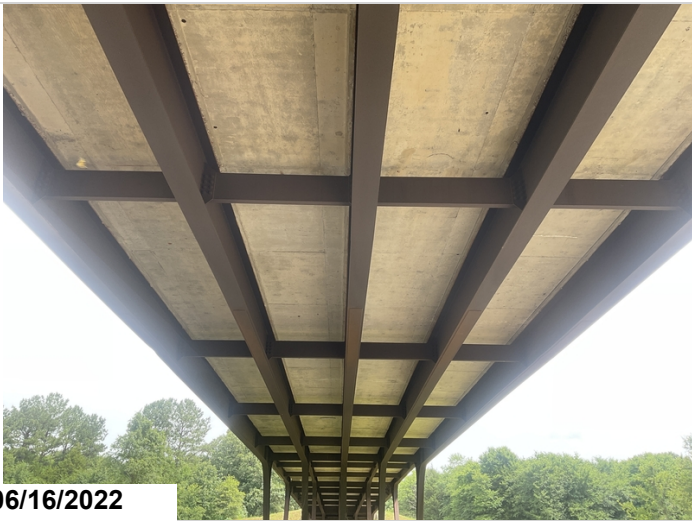
Span #2 typical undersurface of the deck.

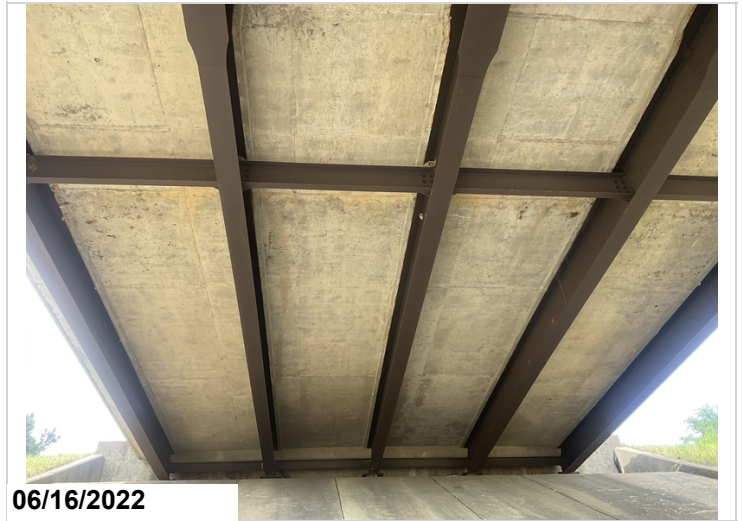
Span #1 typical undersurface of the deck.

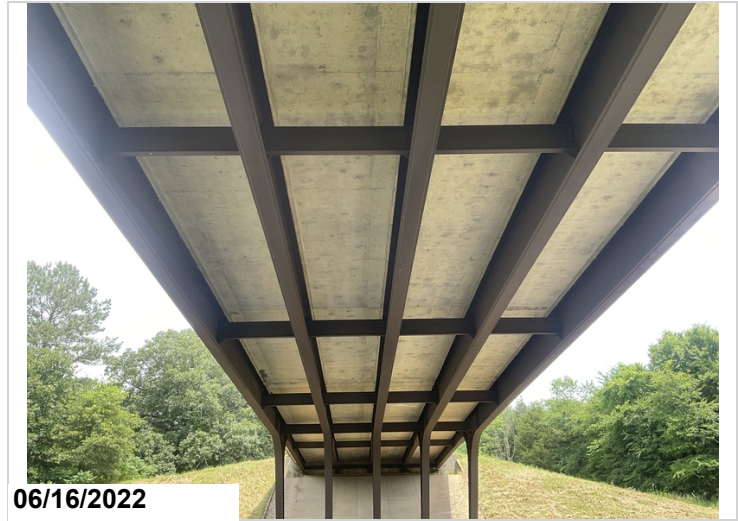
Span #4 no visible delamination over the travel lanes.

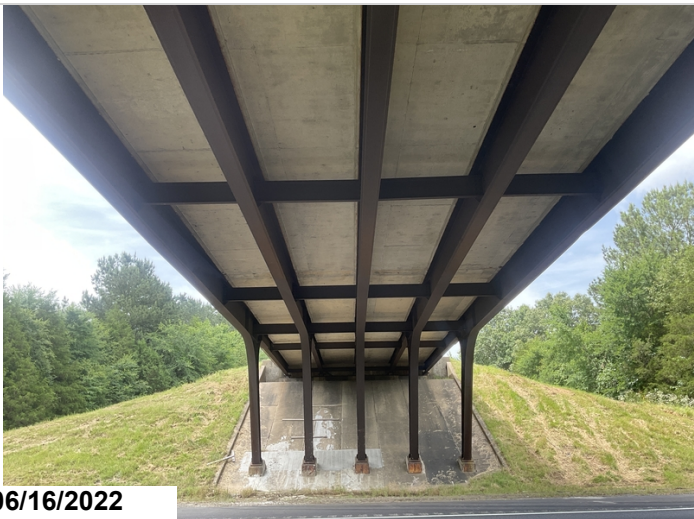
Span #2 no visible delamination over the traveling roadway.

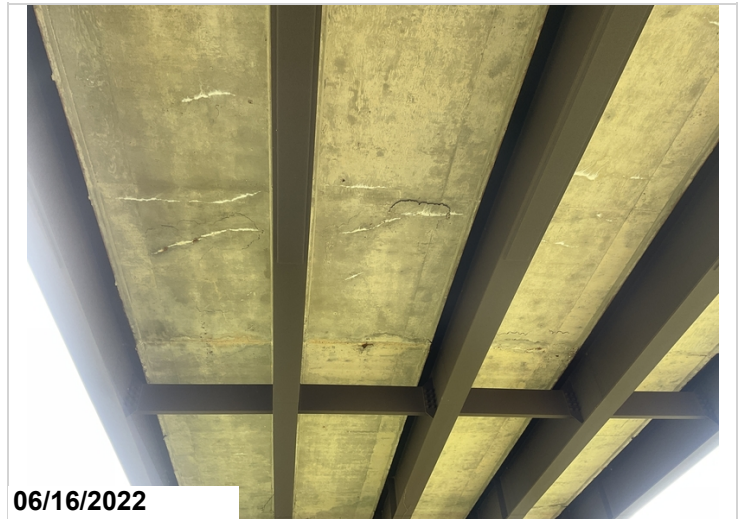
Span #2 transverse cracking with efflorescence buildup and large concrete delaminations.

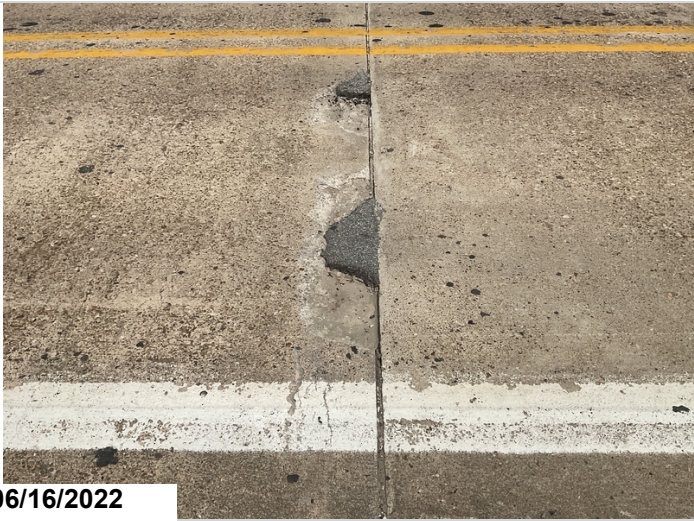
Span #4 spalling with exposed reinforcing steel.

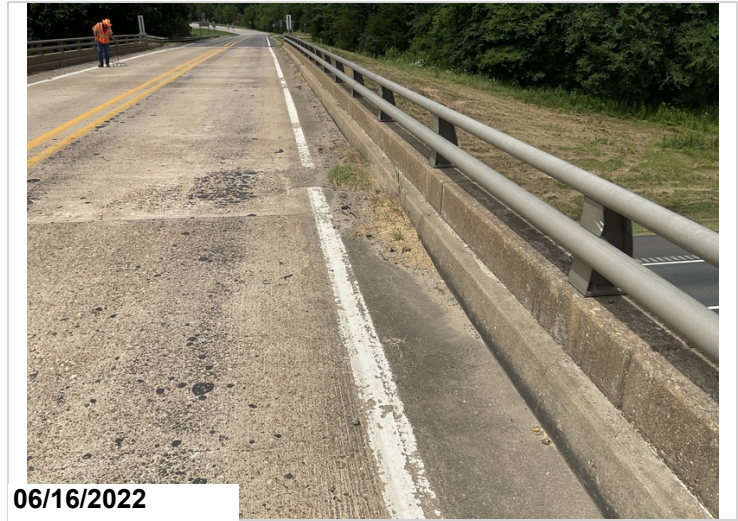
Debris accumulation in the gutters.

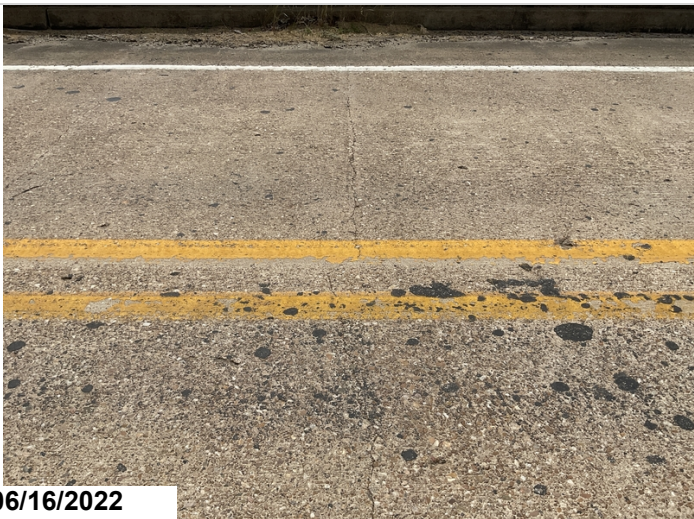
Sealable deck cracking.

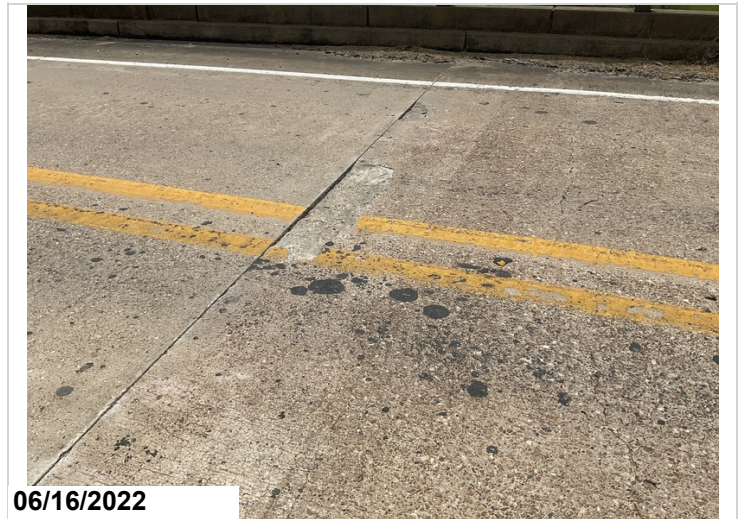
Span #3 spalling on the driving surface of the deck.

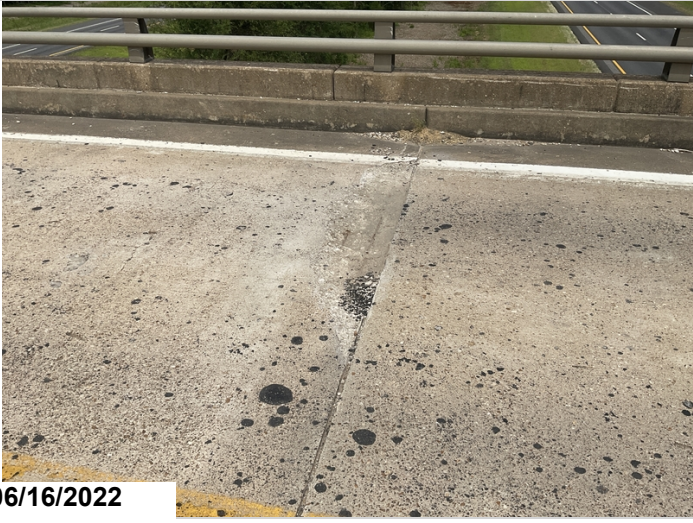
Span #2 spalling with exposed reinforcing steel.

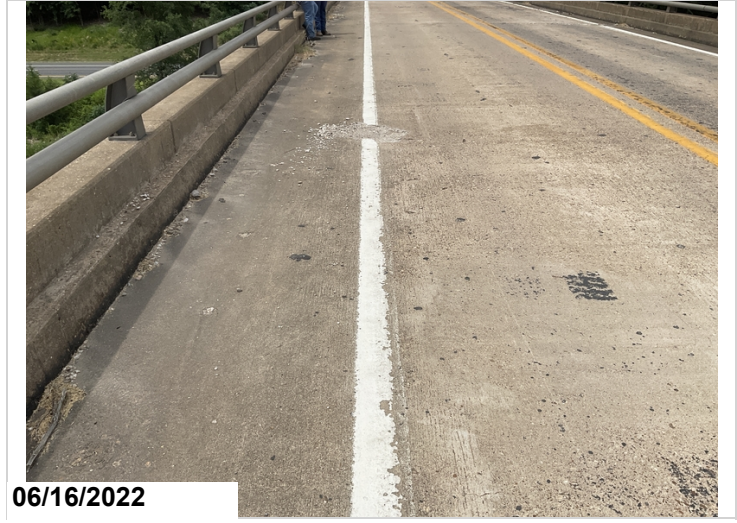
Span #2 Lt spalling in the deck.

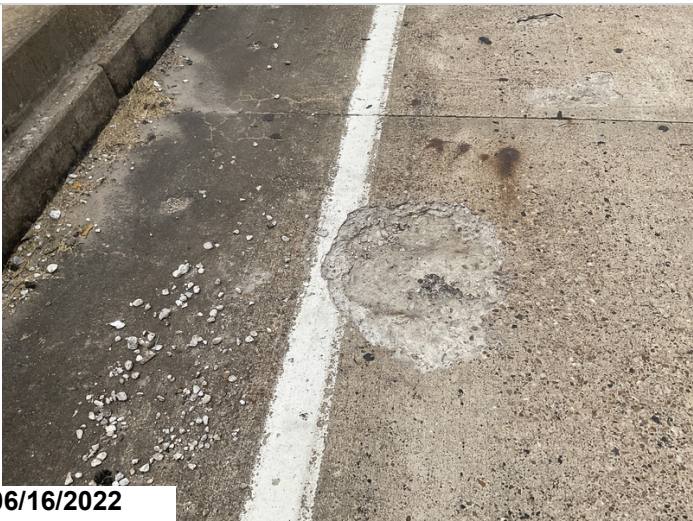
Span #1 Lt spalling with exposed reinforcing steel.

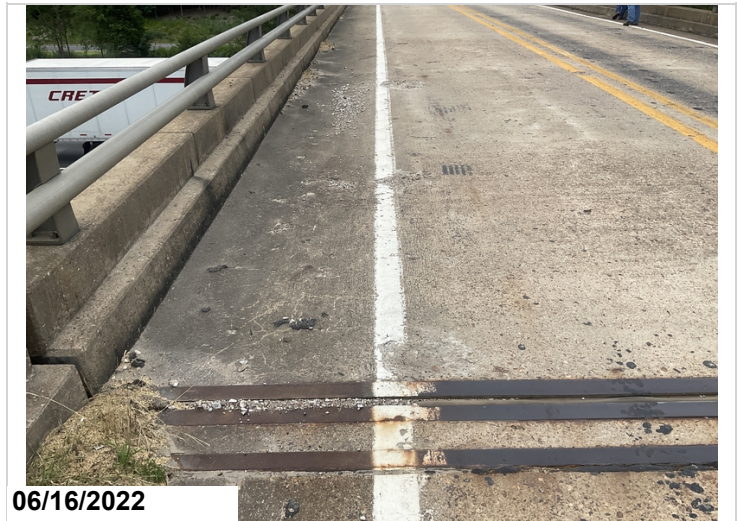
Span #1 Lt spalling in the deck.

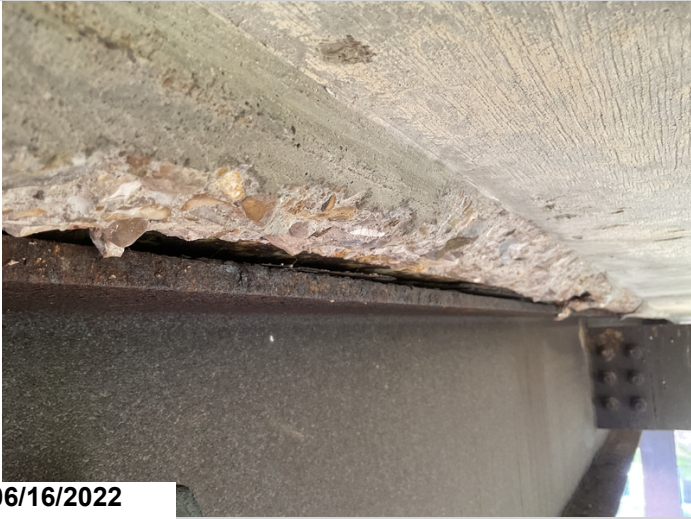
Span #3 beam #1 deck separation between the deck and beams.

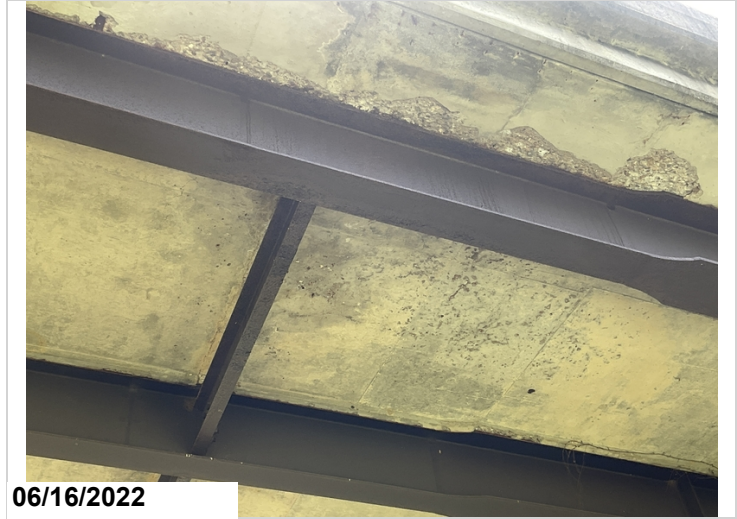
Span #3 beam #1 active corrosion with pack rust.

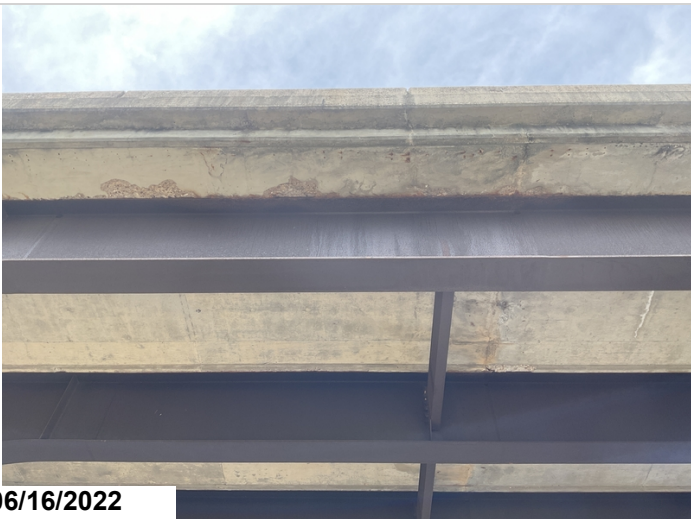
Span #2 beam #5 active corrosion with pack rust along the top flange.

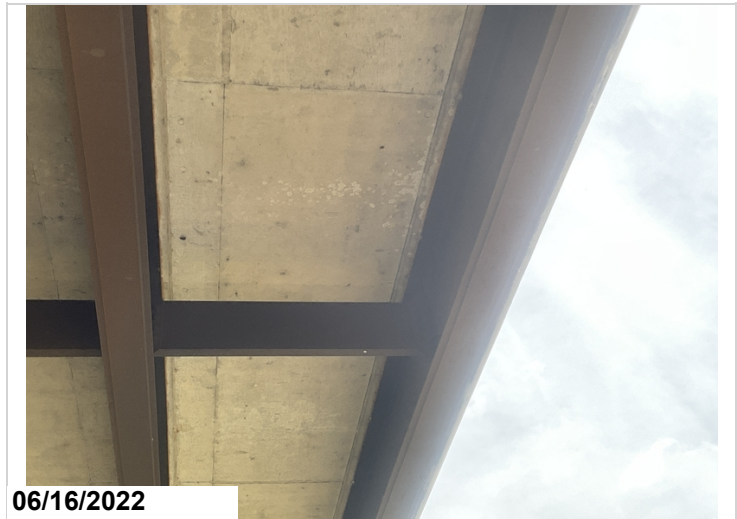
Span #2 beam #5 collision damage with no visible cracks.

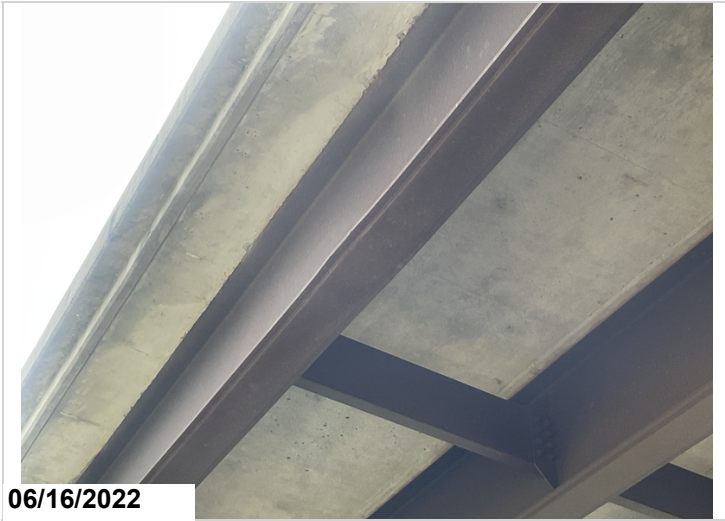
Span #2 beam #1 collision damage with no visible cracks.
06/16/2022

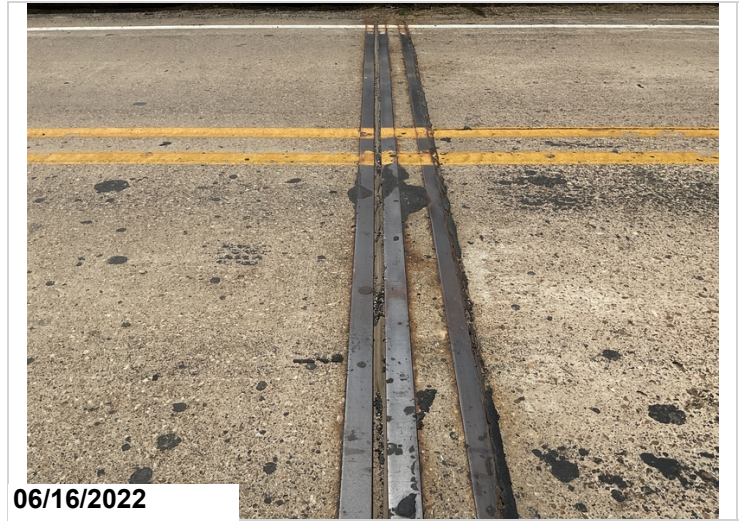
Abutment #2 poured joint seal.

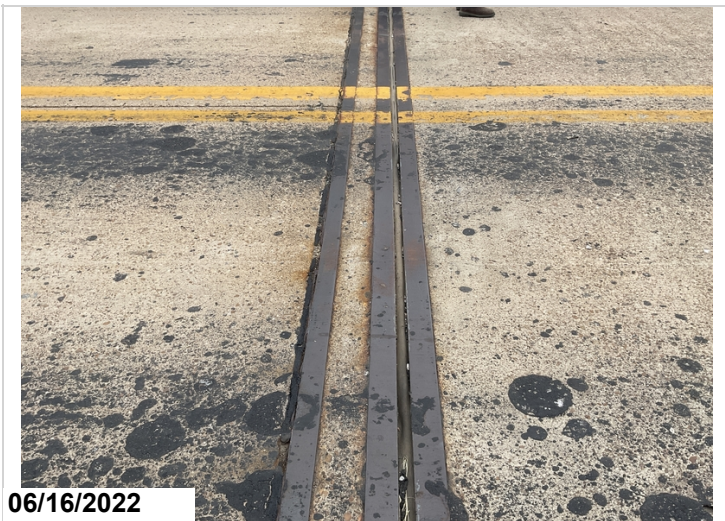
Abutment #1 poured joint seal with adhesion failure in areas.

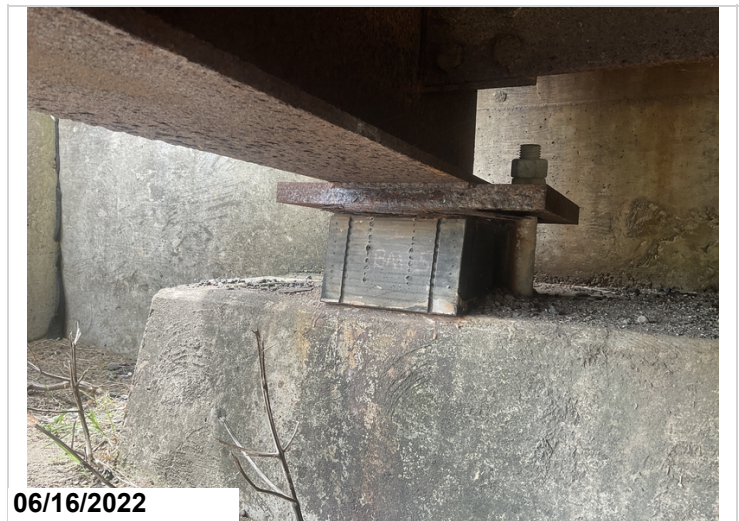
Abutment #1 bearing #5 active corrosion with pack rust.

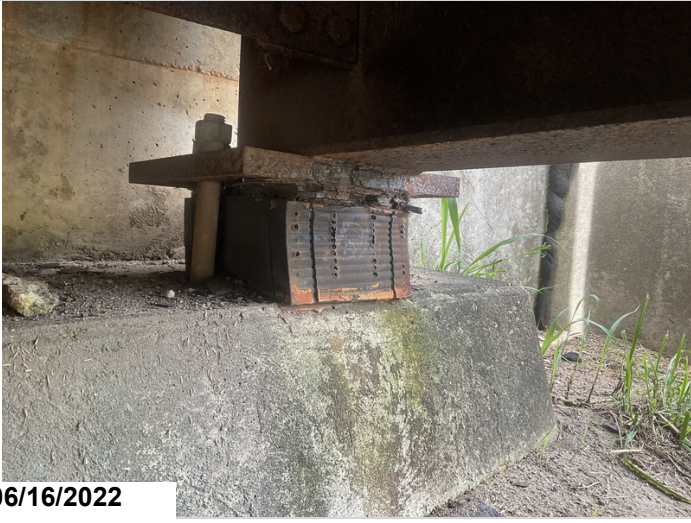
Abutment #1 bearing #1 active corrosion with pack rust.

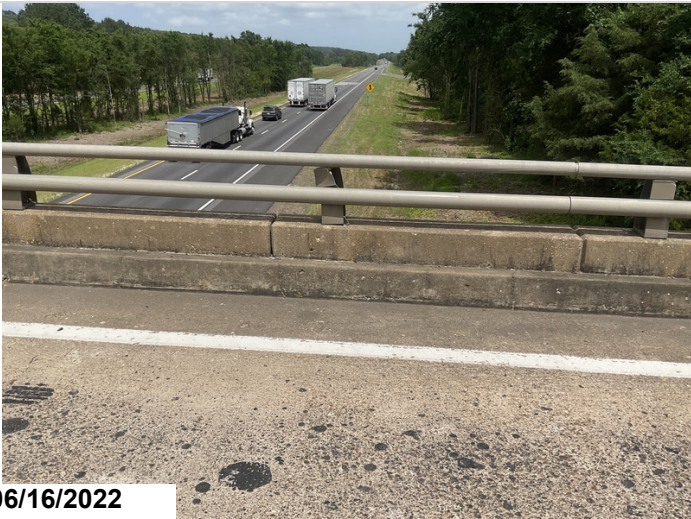
Span #1 Rt rail post with collision damage.

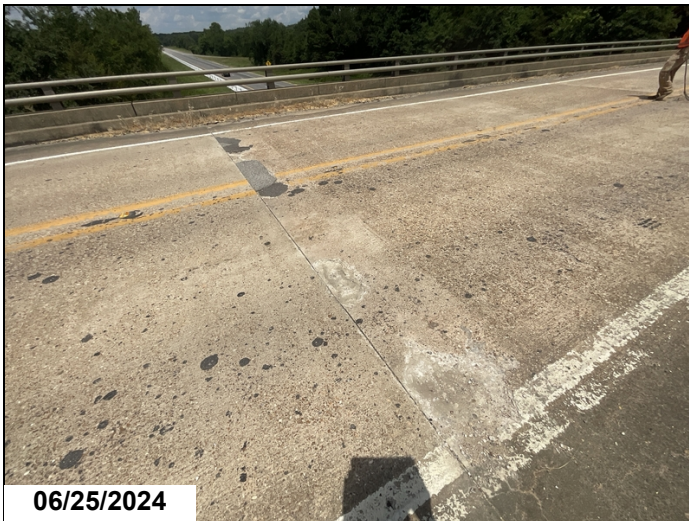
06/25/2024

Spalling with Temporary asphalt patches over Bent 4.

Type of Work: Deck Repair

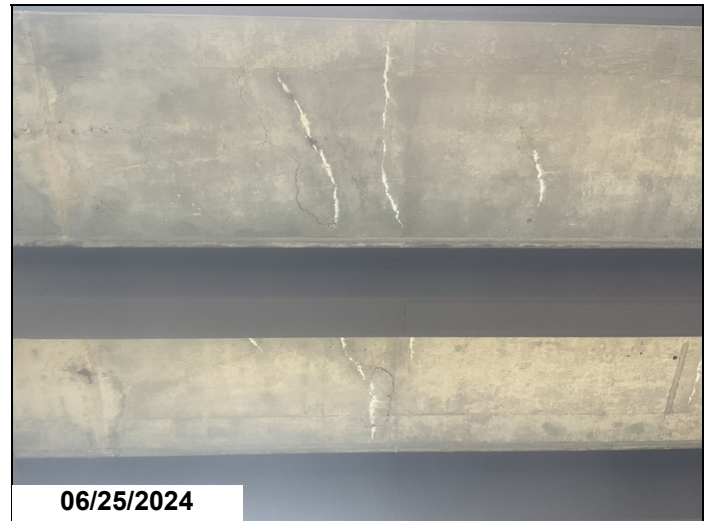
06/25/2024

Span 2, undersurface of the deck has large delaminated areas.

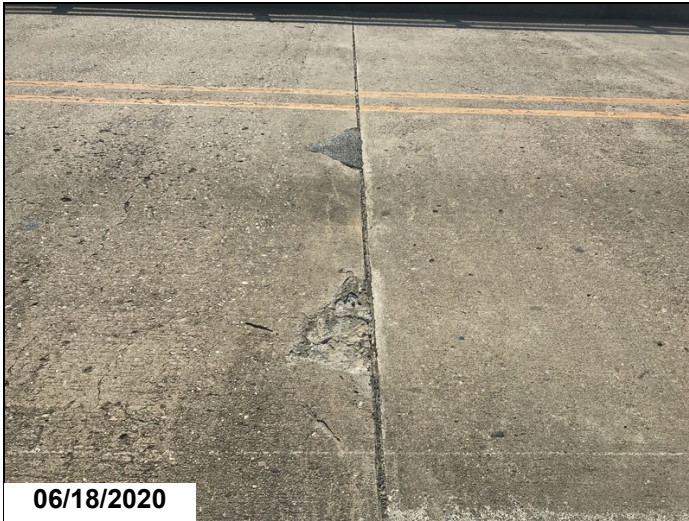
Span 5, left lane-Spalling.

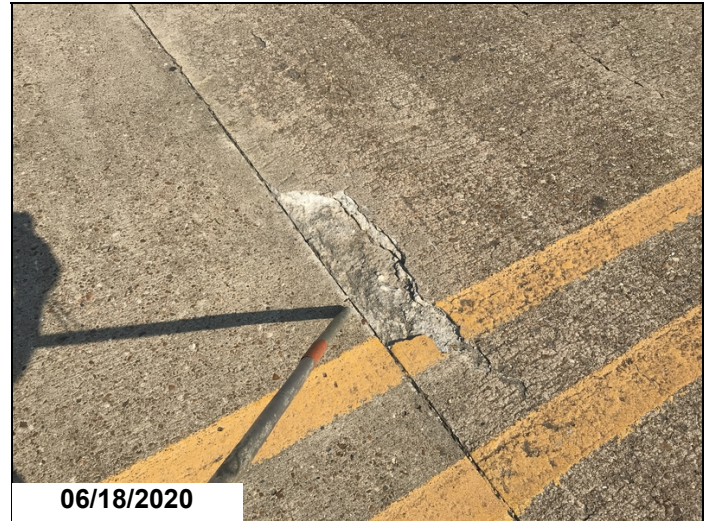
Span 3-Spall near centerline.

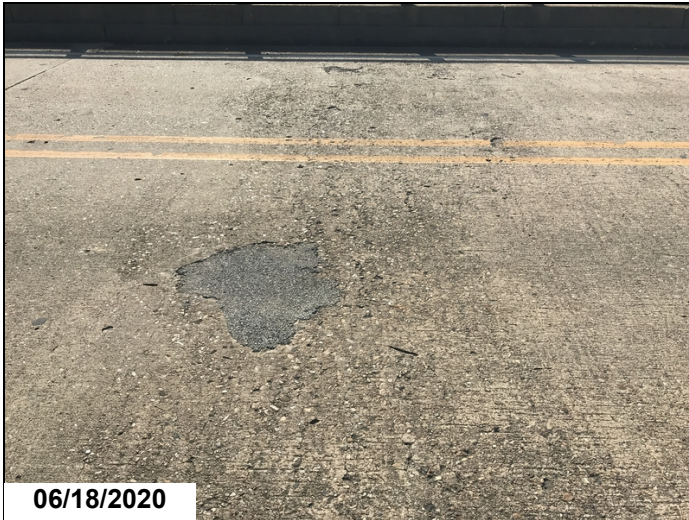
The driving surface of the deck over bent # 3 has scaling with several delaminated areas.

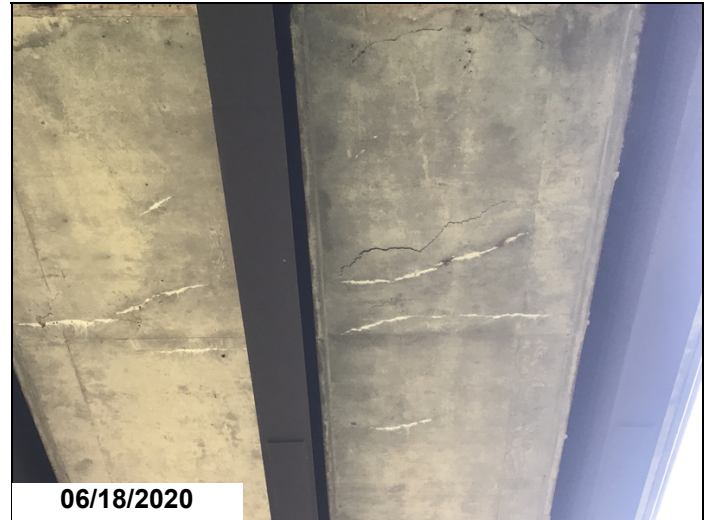
Span 2, bay 1-Delaminated area with transverse cracking with efflorescence.

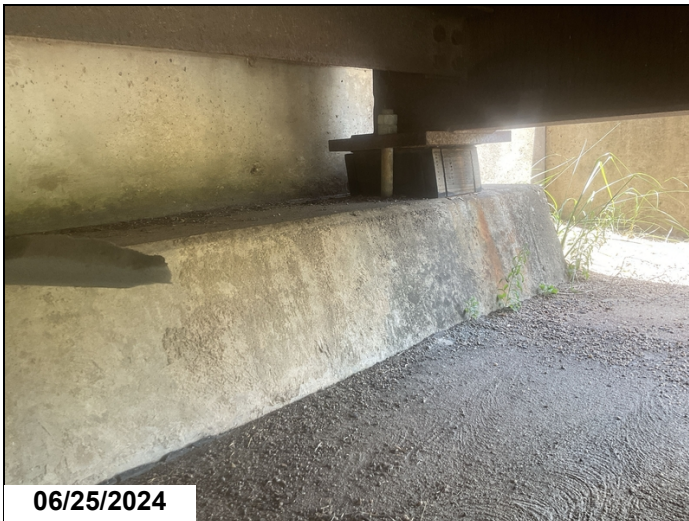
Abutment 2, Bearing 5, Active corrosion with pack rust between loading plate and bearing pad.

Type of Work: Bearing Repair/Replacement

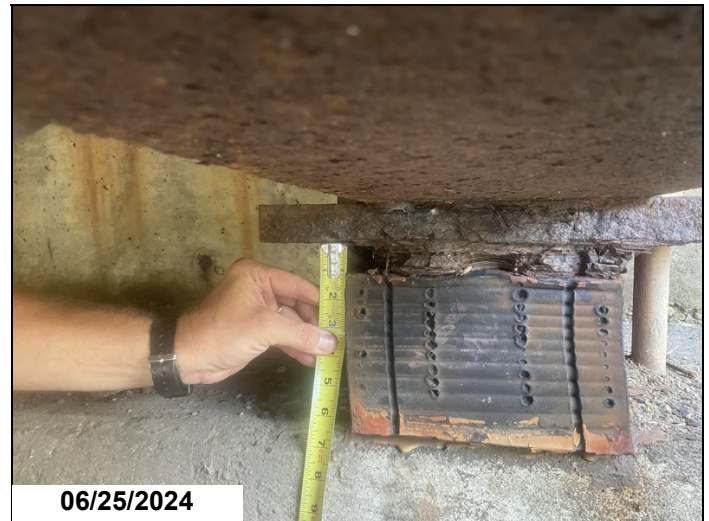
Abutment 1, Bearing 1, has 1" of pack rust between the external loading plate and bearing pad.

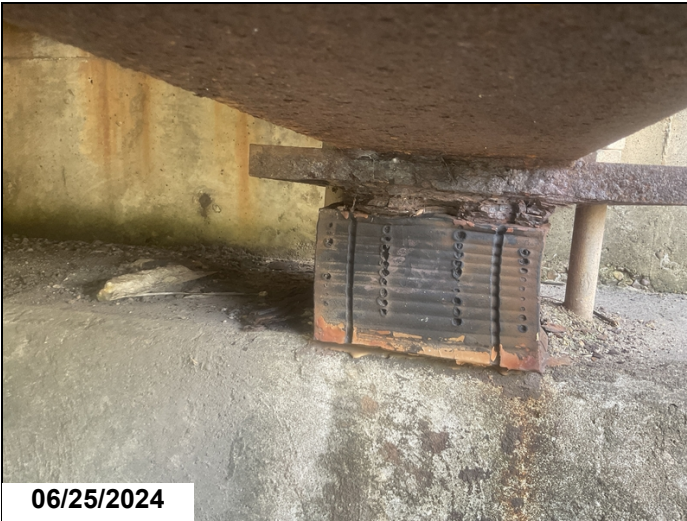
Abutment 1. Bearing 1 has 1" of pack rust between the external loading plate and bearing pad.

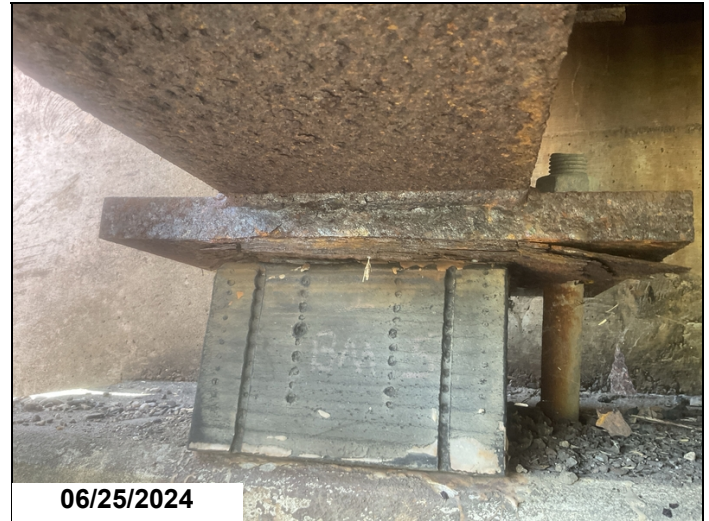
Abutment 1, Girder 5 elastomeric bearing pad has layers of flaking rust in the undersurface of the external loading pad.

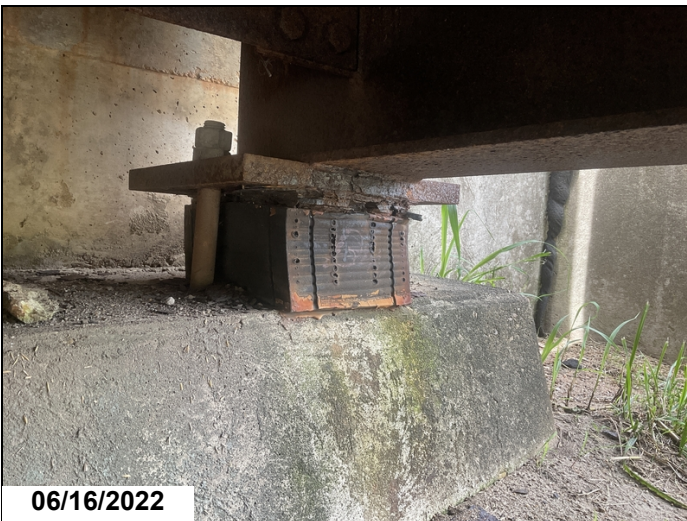
Abutment #1 bearing #1 active corrosion with pack rust.

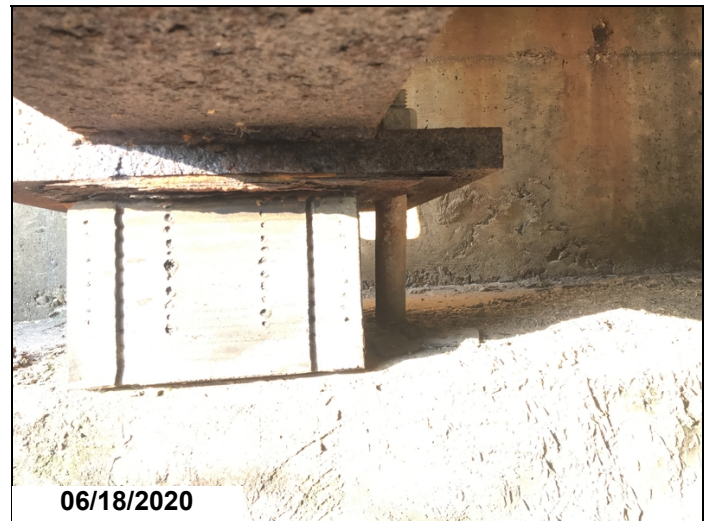
The shim plates between the sole plates and elastomeric bearing pads have active corrosion and are deteriorated. The shim plate for Girder # 1 at the South abutment has rusted into flaking pieces.

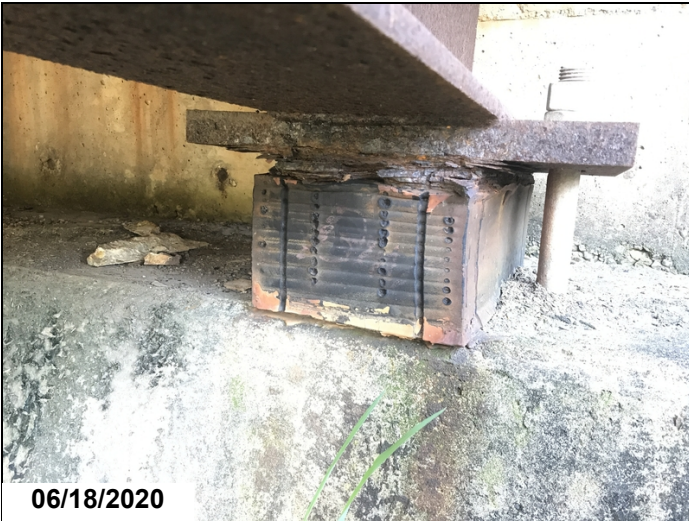
The shim plates between the sole plates and elastomeric bearing pads have active corrosion and are deteriorated. The shim plate for Girder # 1 at the South abutment has rusted into flaking pieces.

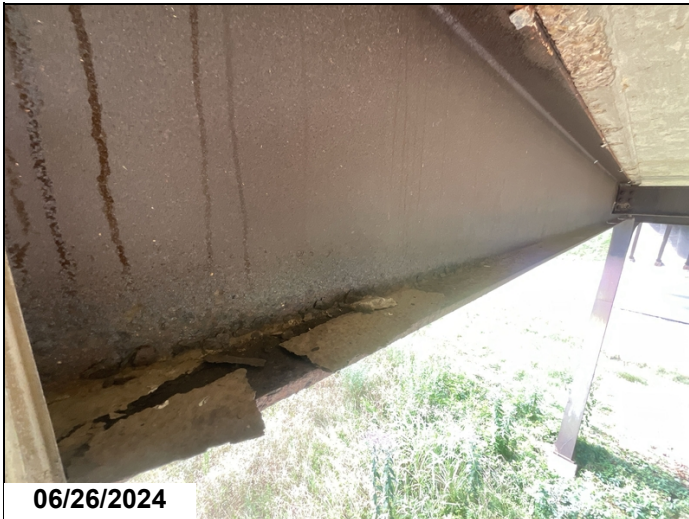
Span 3, Girder 5, Active corrosion and flaking rust on the bottom flange.

Type of Work: Superstructure Repair

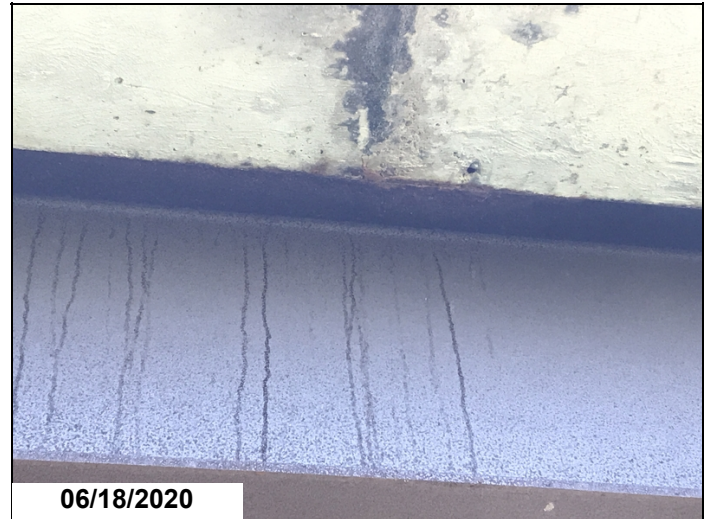
There are isolated areas with active corrosion and flaking rust where the transverse saw joints in the deck and sealable deck cracks leak water on the superstructure.

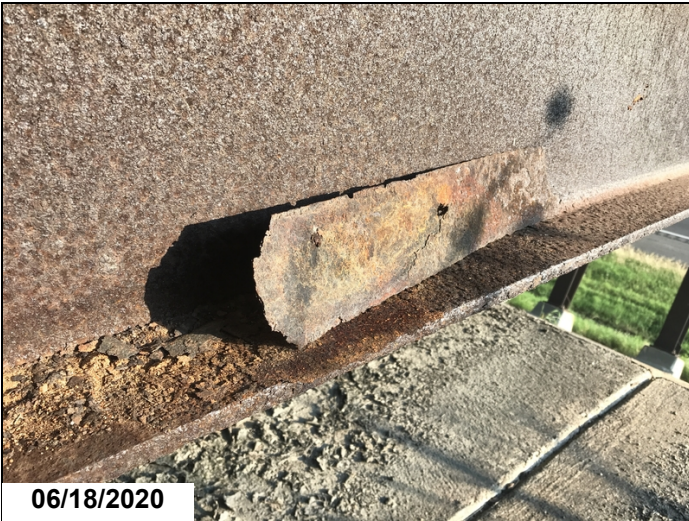
There are isolated areas with active corrosion and flaking rust where the transverse saw joints in the deck and sealable deck cracks leak water on the superstructure.

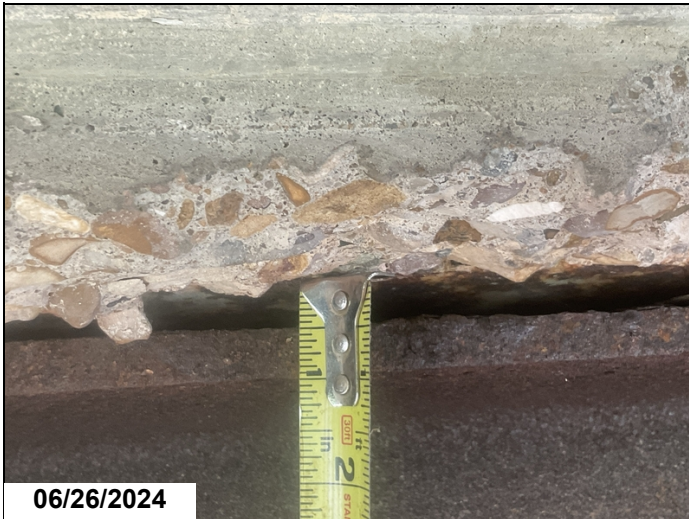
The deck in Span 3 appears to be non-composite (Garver & Garver Engineering Drawing # 13798) and has separated from the girders in areas up to 1/2".

Span 3, Girder 1, Actual field measurement indicates 1/2" air space between the top flange and the undersurface of the deck.

Type of Work: Deck Repair

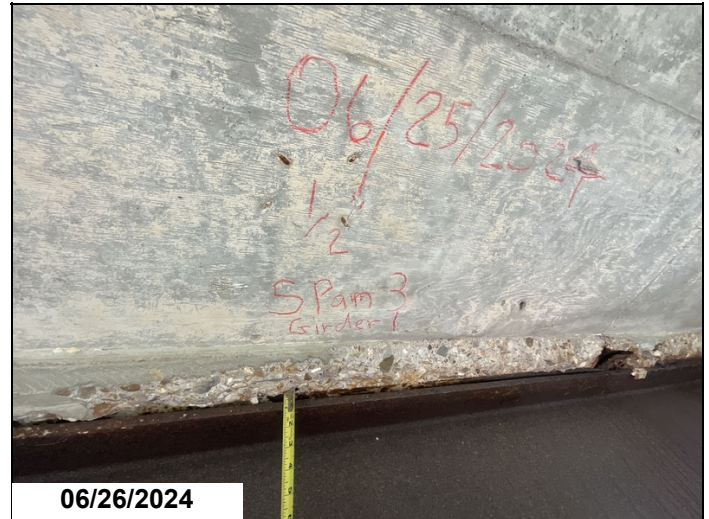
Span 3, Girder 1, Actual field measurement indicates 1/2" air space between the top flange and the undersurface of the deck.

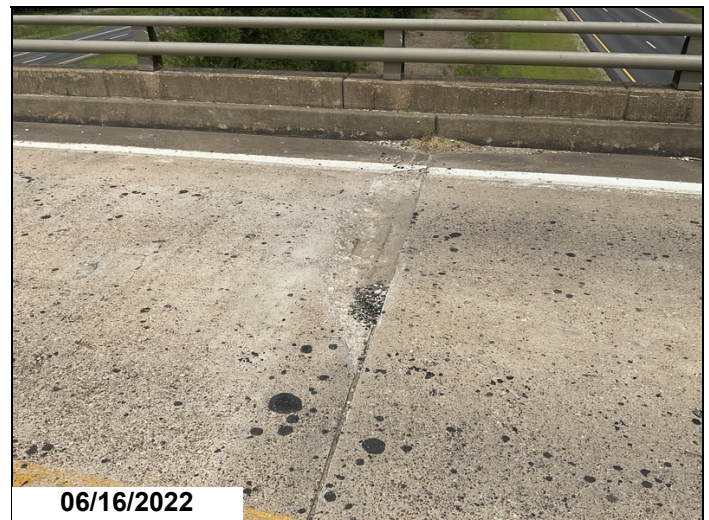
Span #2 spalling with exposed reinforcing steel.

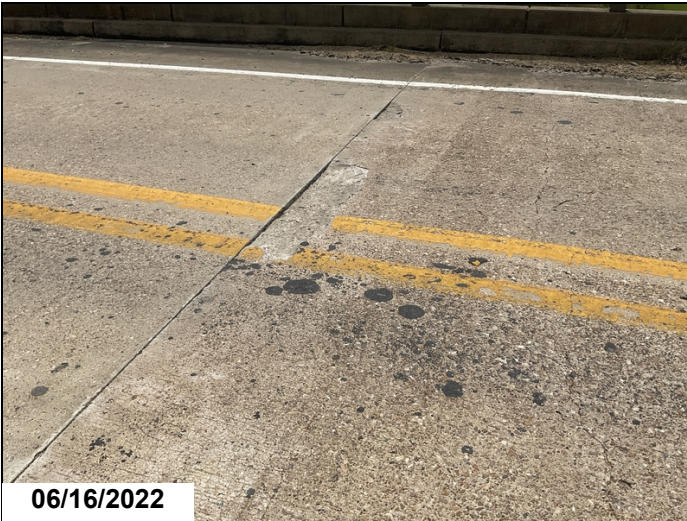
Span #3, spalling on the driving surface of the deck.

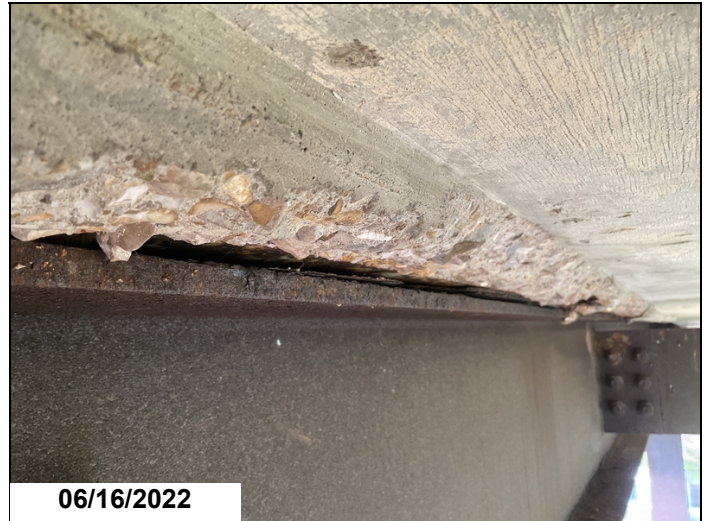
Span #3, Girder #1 deck separation between the deck and girders.

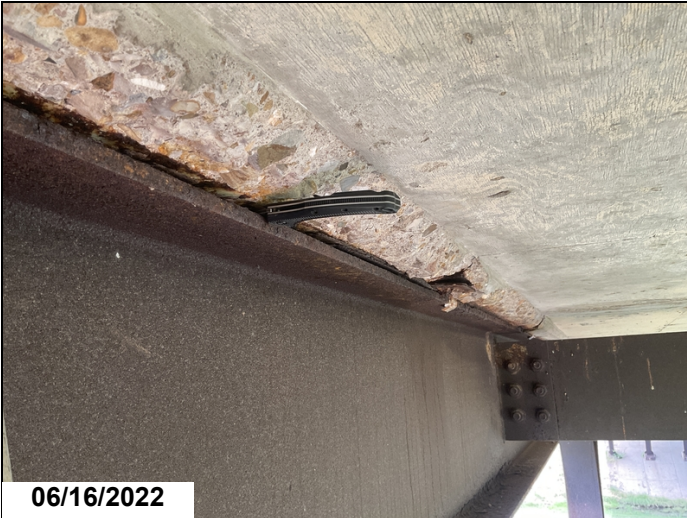
Span # 3, Girder # 1 separation between the deck and the girders.

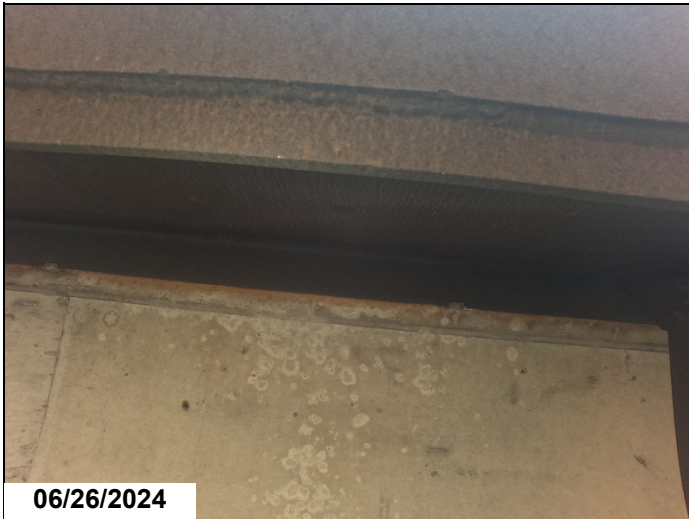
Span 2, Girders 1 & 5, Bottom flanges have have minor out of plane bending from traffic impacts. Utilizing a video pole indicated no visible cracks were apparent during this inspection. (This defect was originally documented in the 03/05/2001 Bridge Inspection Report)

Girder 5, Span 2, Bridge Strike

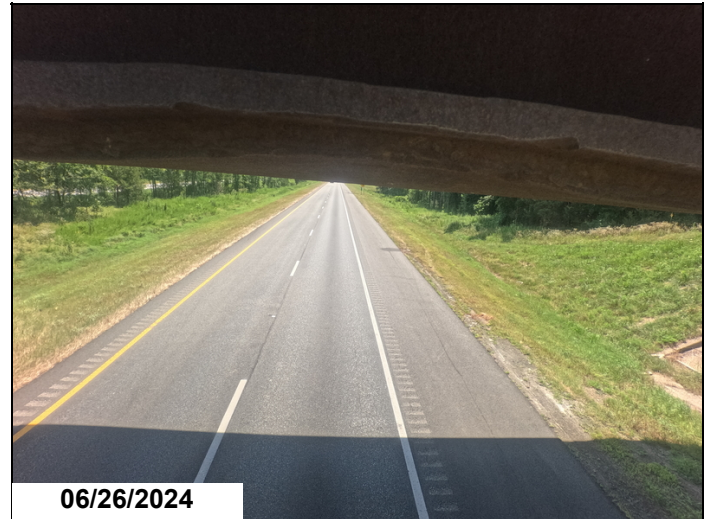
Girder 1, Span 2, Bridge Strike.

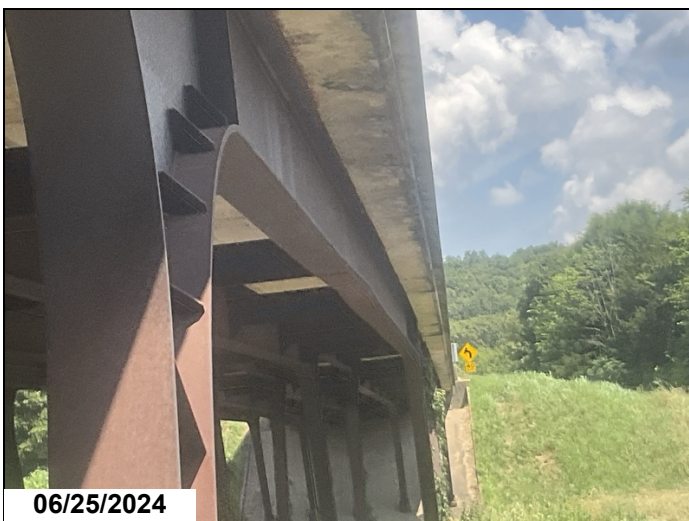
Span 2, Girder 5, out of plane bending due to traffic impact.
