# Bridge Inspection Report

**A1532**

**US 62/Fulton Co.**

**SOUTH FORK TOWN CREEK**

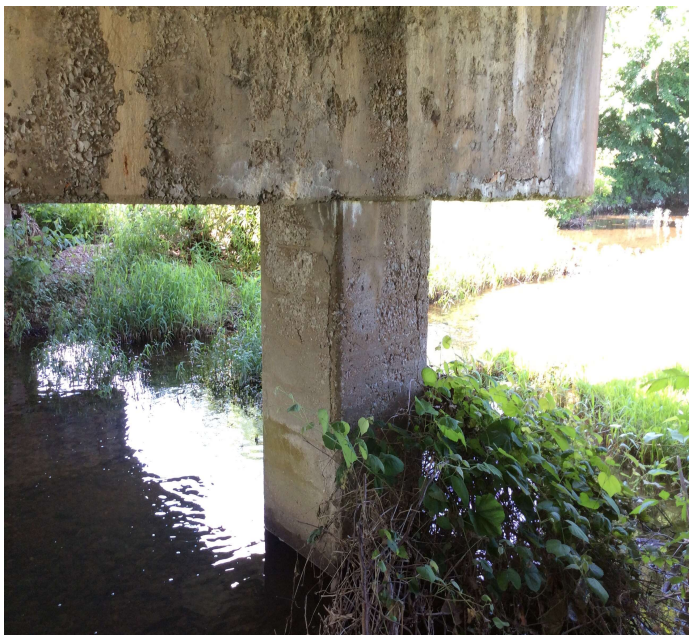
Bents 1 & 3

Right Columns have vertical cracks and efflorescent map cracking.

PHOTO 1      Description      Vertical cracks to Right column @ Bent 1.

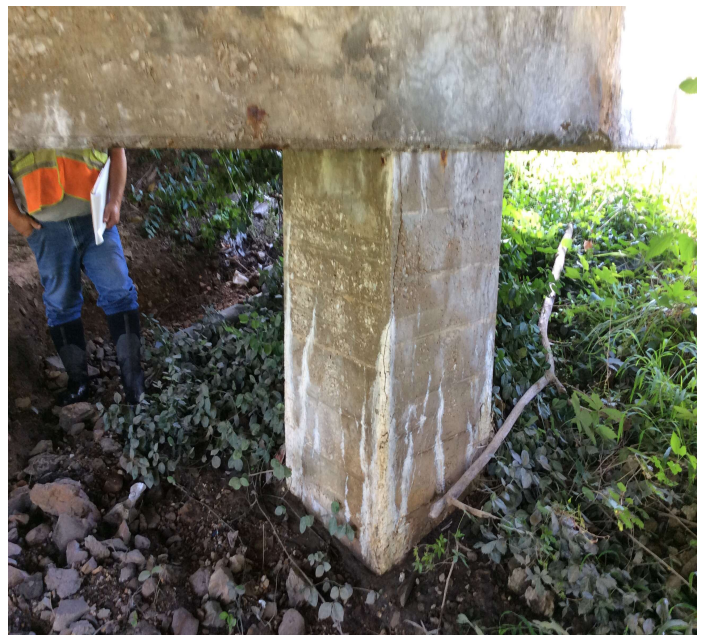
PHOTO 2      Description      Efflorescent cracking to Right column @ Bent 3.

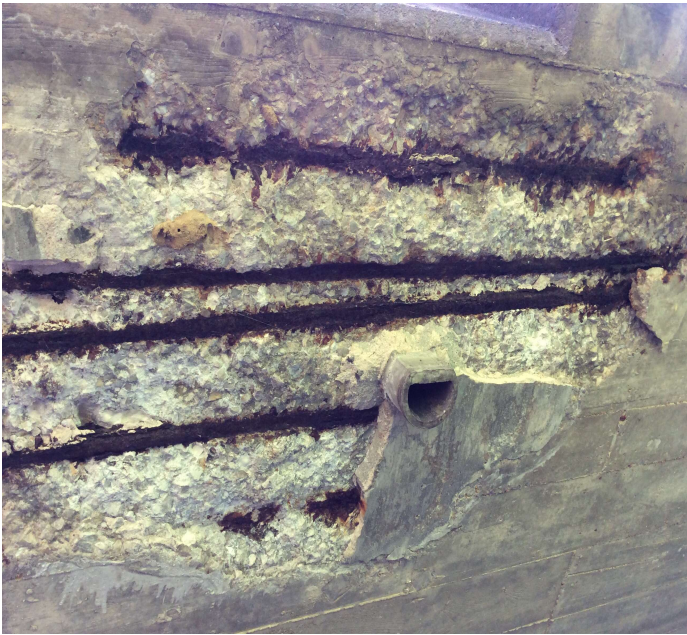
Soffit @ Spans 1, 2 & 3  
Spalls with exposed rebar.

PHOTO 1      Description      Spalls with rebar exposed to soffit @  
Right side of Span 1.

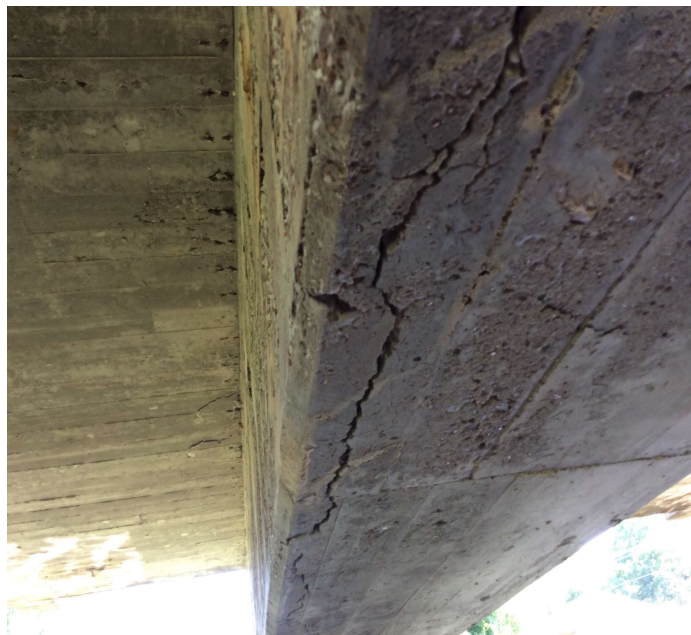
Cap @ Bent 1 has spalls with 3' of exposed rebar and large delaminated area at bottom on back side.

PHOTO 1      Description      Large delaminated area to bottom of cap @ Bent 1.

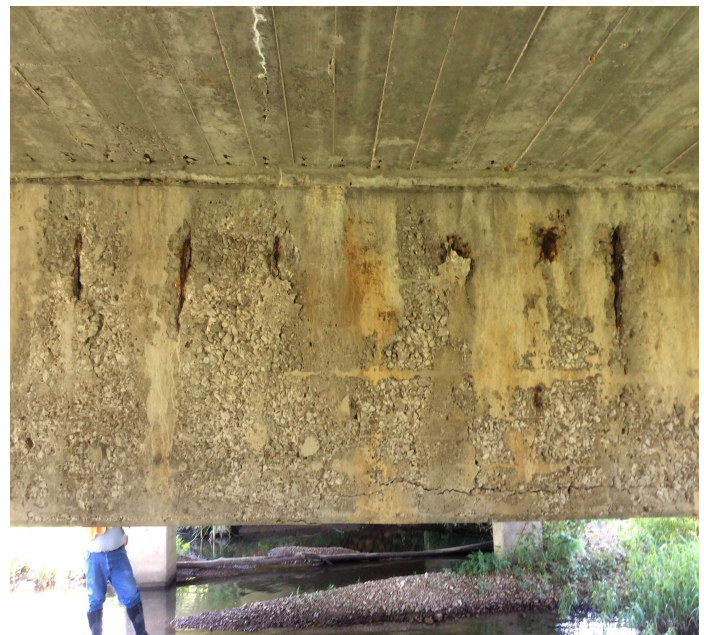
PHOTO 2      Description      Exposed rebar to backside of cap @ Bent 1.(section loss is present)

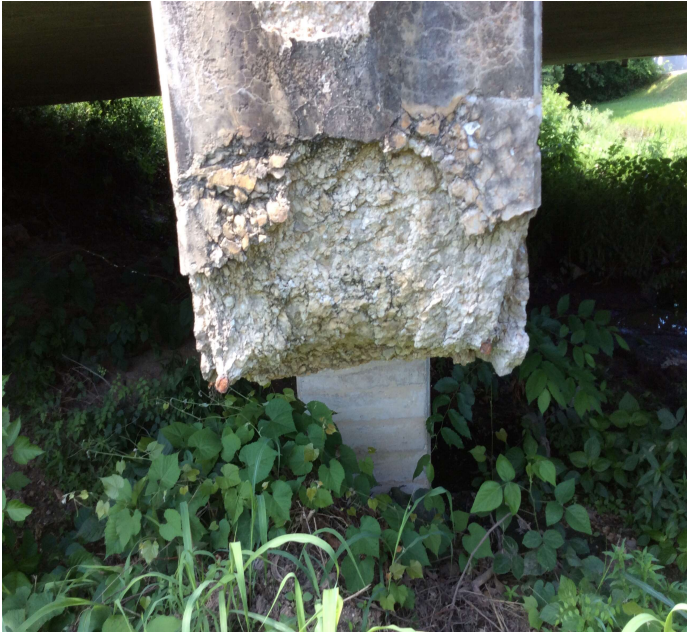
Cap @ Bent 3 has spalls & deterioration to Lt. & Rt. ends.

PHOTO 3      Description      Deep spall to Left end of Cap @ Bent 3.

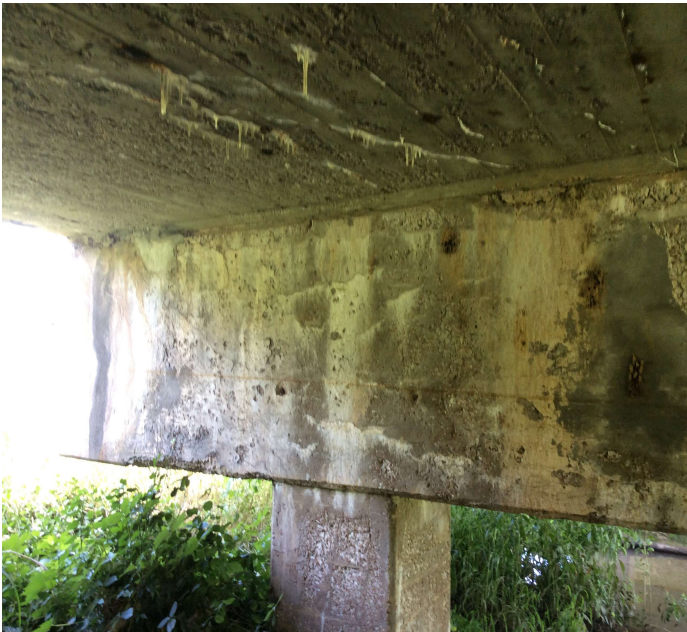
All have efflorescent cracking & heavy scaling & deterioration.

PHOTO 4      Description      Efflorescent cracking to ahead side of Cap @ Bent 3.
