Bridge #A0916(Routine)

US167 Sharp County over PINEY CREEK RELIEF

Location: 11.37 MI W INDEPENDENCE C

Team Lead: Nathan Edwards **Inspection Date:** June 18, 2021

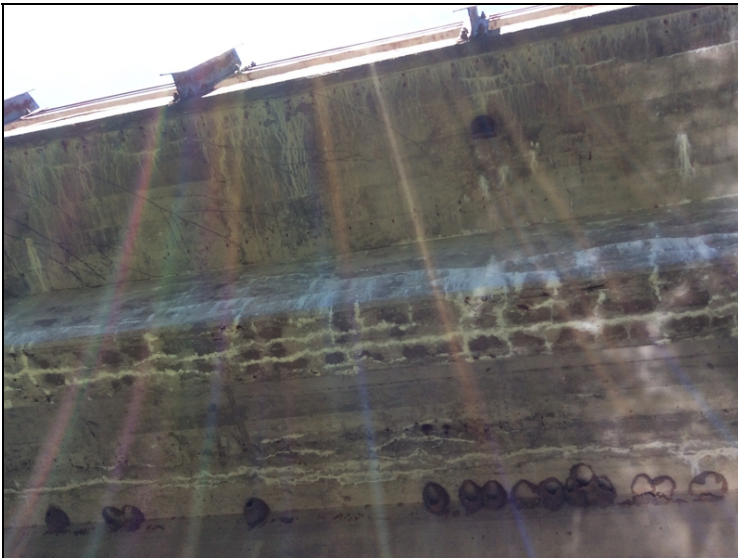
| ELEM | DESCRIPTION | UNITS | TOTAL | CS1 | CS2 | CS3 | CS4 |
|---|--|---|---|---|---|---|---|
| (110) | Span 1 - Girder 4 has heavy efflorescent map cracking entire length. Areas of delamination to outside of girder. Spall with rebar exposed to Girder 4 over Bent 1. Span 2 - Cracks & areas of delamination at concrete haunches under girders @ end of Span 2. Girder 4 has moderate efflorescent cracking. Hairline vertical flexure cracks to all girders. | | | | | | |

Heavy efflor. map cracking to girder #4 at span #1.

Efflor map cracking span #1 girder #4

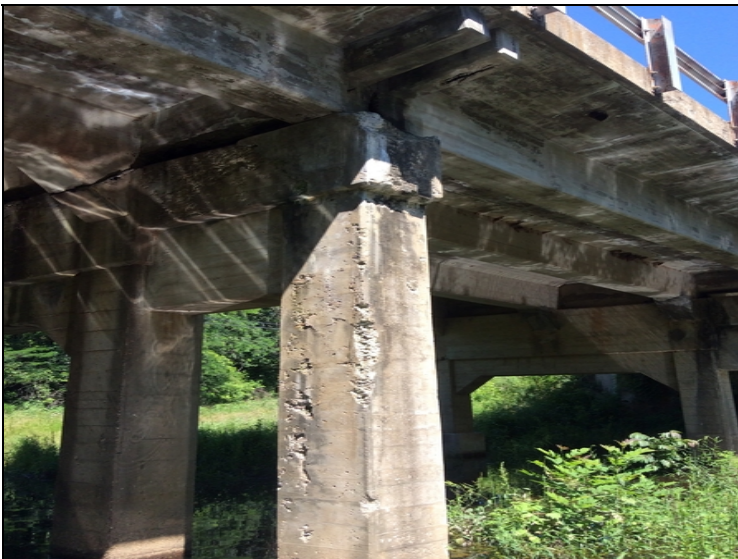
Spall w/ 6" of rebar exposed to column #1.

Spalls w/ 1' of rebar exposed to Rt. end of cap and 1.5' on ahead side.

Spalling with deterioration to Rt. end of cap @ Bent
#1

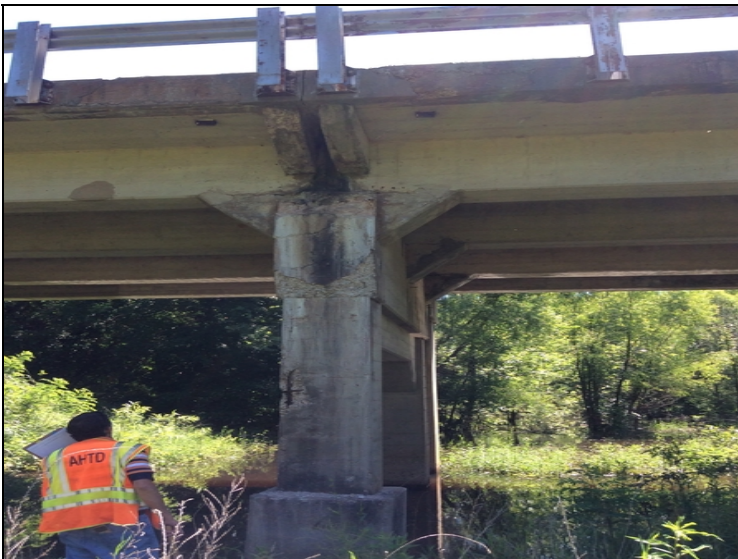
Full height vertical crack & spalls w/ 2' of rebar exposed at column #1.

Efflor. map cracking & chemical deterioration to Lt. end of cap.

Bent #2 column #1 and Lt. end of cap has spalls heavy deterioration with 2' rebar exposed.

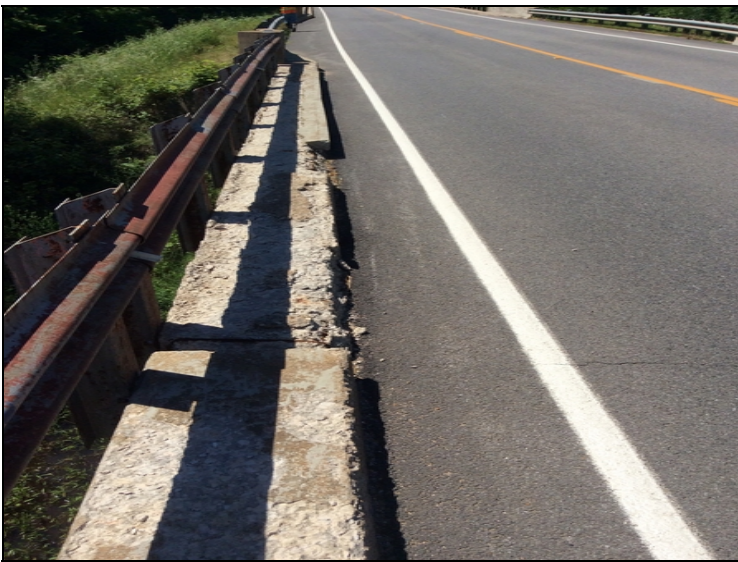
Cracks, delaminated areas, and spalls w/ rebar exposed to Lt. and Rt. curbs at all spans.

Heavy spalling & deterioration to left & right curbs.

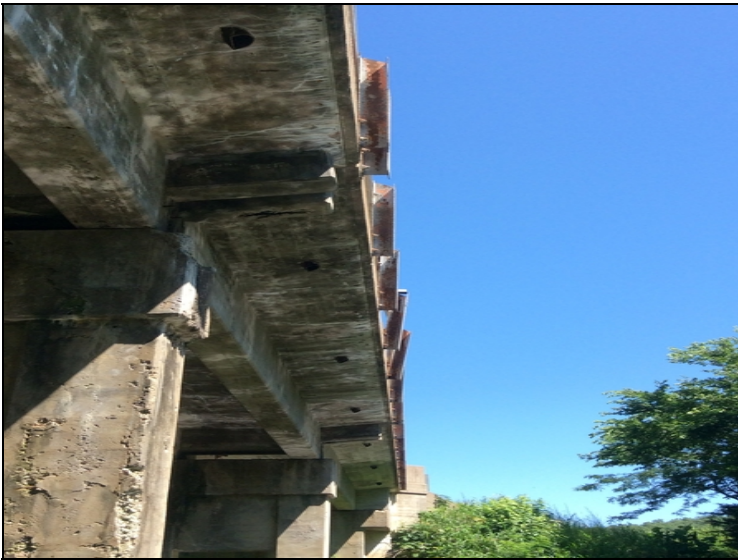
| ELEM | DESCRIPTION | UNITS | TOTAL | CS1 | CS2 | CS3 | CS4 |
|---|---|---|---|---|---|---|---|
| Right rail is bent outward @ Span 2. Minor corrosion to Left & Right rails throughout. | | | | | | | |

Bridge rail is bowed on Rt. side at span #2.

Guardrail bowed @ Span #2 Rt. side

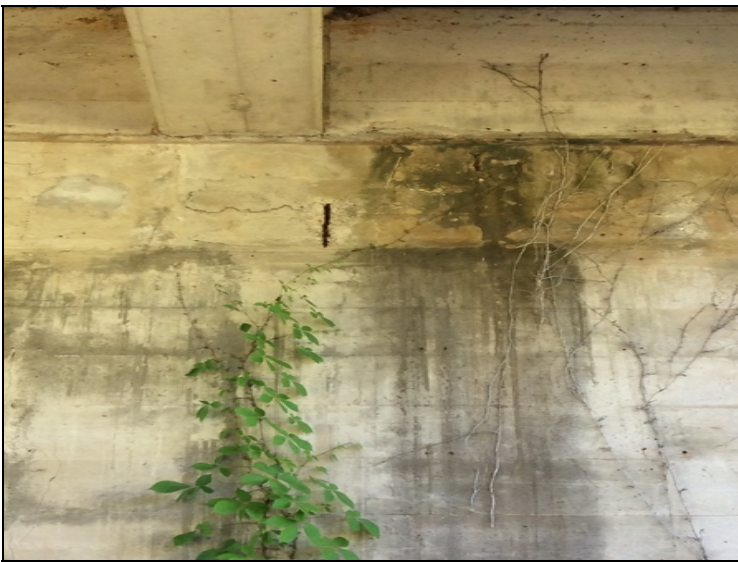
| ELEM | DESCRIPTION | UNITS | TOTAL | CS1 | CS2 | CS3 | CS4 |
|---|---|---|---|---|---|---|---|
| Full height vertical cracks with rust stains and random efflorescent cracking at Abutments 1 and 2. Spalls with 3" of rebar exposed to Abutments 1 and 2. Abutment 2 has delaminated areas on Right end. Approach roadway has visible settlement at Abutment 2. | | | | | | | |

Abutments #1 and #2 have spalls w/10" of rebar exposed.

Spall with rebar exposed @ Abut. #1 & #2
