Bridge #03665(Routine, Underwater type 2)

SH 9/Stone County over LICK CREEK

Location: 5.85 MI NE VANBUREN CO LN

Team Lead: Nathan Edwards **Inspection Date:** November 17, 2020

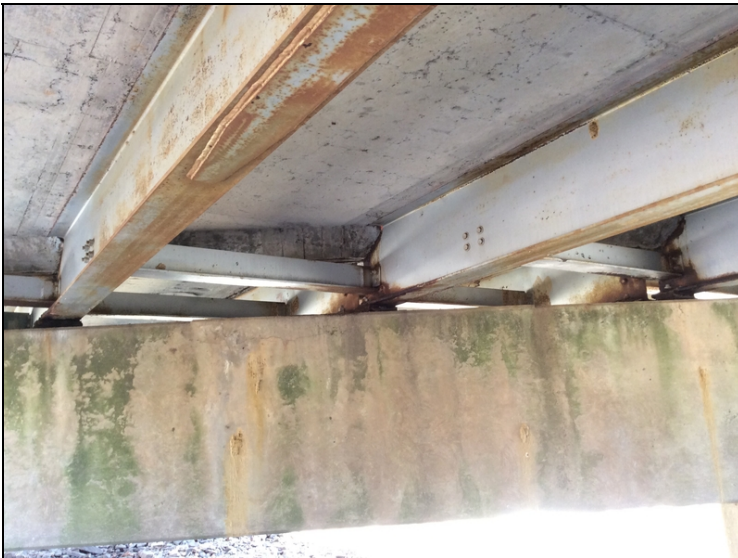
Rust with moderate to severe section loss to ends of girders at web below haunch, diaphragm connections, and bottom flange over Bents 1 & 2.

Rust with moderate to severe section loss to ends of girders at web below haunch, diaphragm connections, and bottom flange over Bent 1.

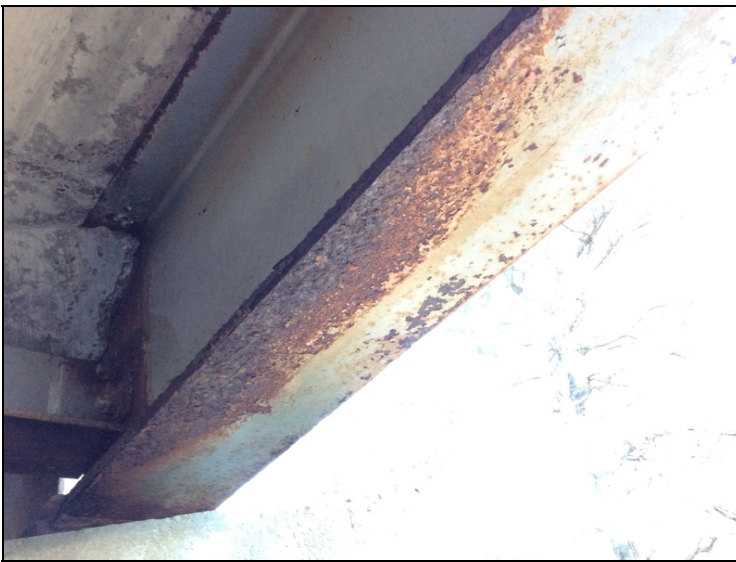
Areas of rust to bottom flanges of Girders at Spans 1 thru 3.

Rust to bottom flange of Girder 5 @ end of Span 2.

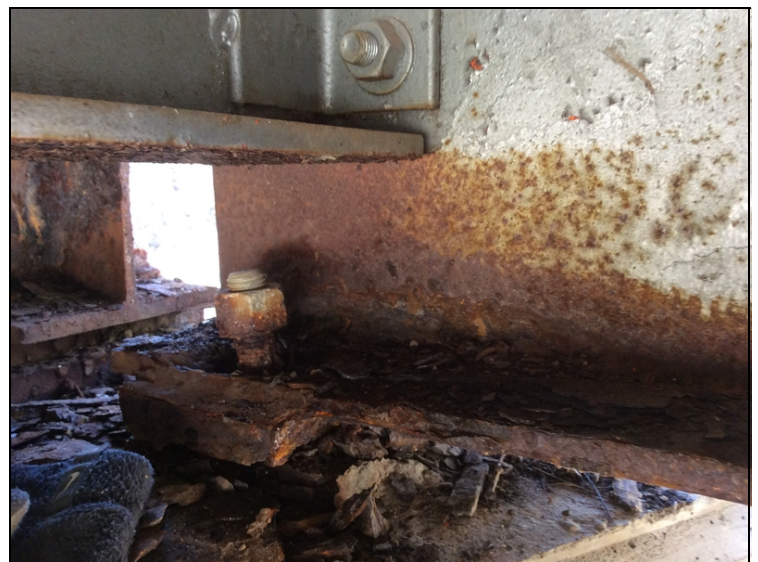
Girder 1 @ beginning of Span 3.

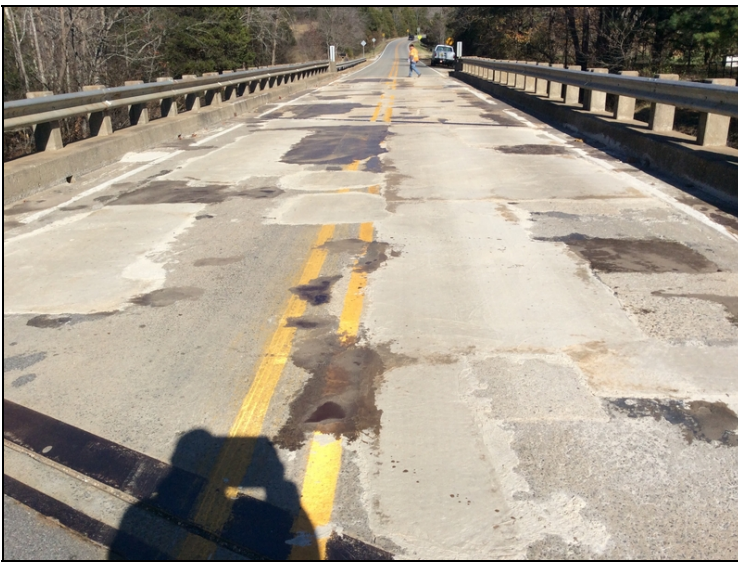
Unsealed cracks, small spalls, and delaminated areas to deck at all spans.

Deck photo with Log Mile.

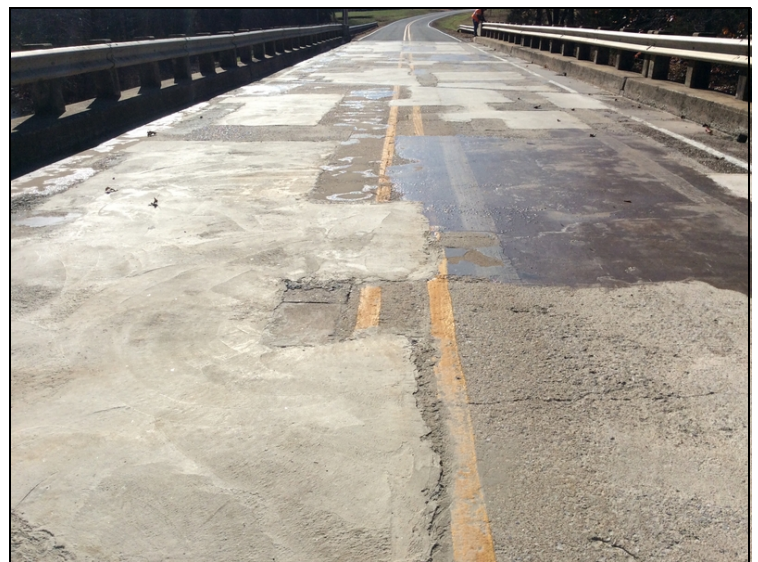
Deck photo against Log Mile.

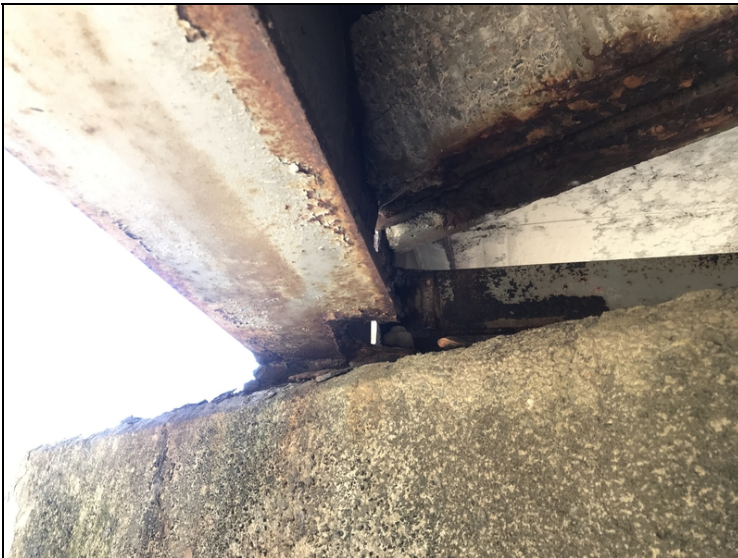
Girder 5 has heavy section loss with hole to bottom flange.

Section loss with large hole to bottom flange @
Girder 5 @ beginning of Span 3.(#4)

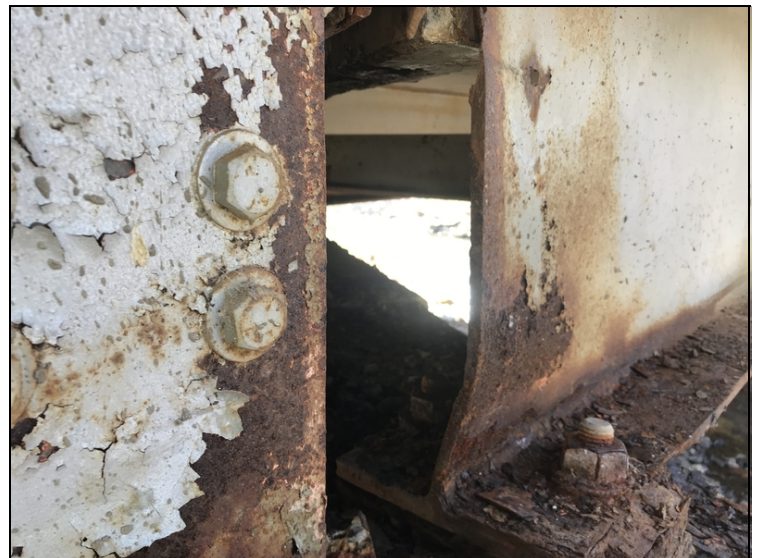
Girder 1 has severe section loss with holes in web & bottom flange & is crushing over Bearing @ end of span.

Crushing to Girder 1 @ end of Span 2.(#4)

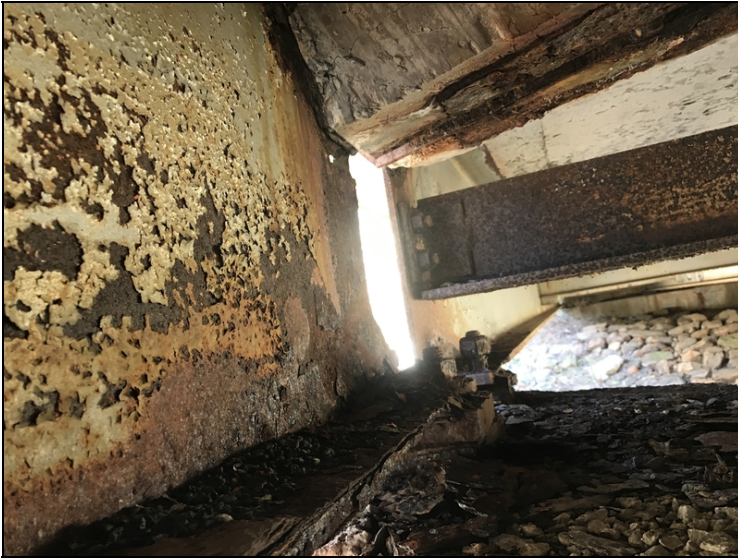
Section loss to bottom flange with hole in web &
Crushing to Girder 1 @ end of Span 2.(#4)

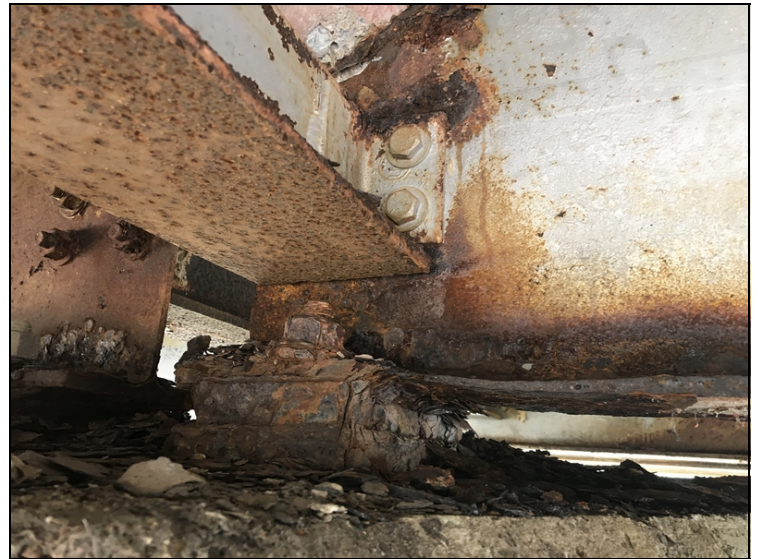
Girder 2 has severe section loss with holes & knife edge to bottom flange & is beginning to crush @ end of span.

Girder 2 @ end of Span 2 has heavy s/l with holes
& is beginning to crush.

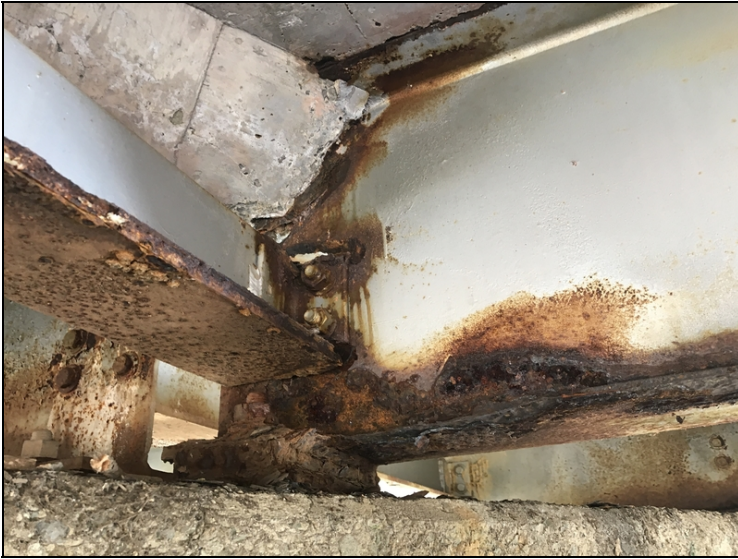
Girders 3 & 4 have severe section loss with holes in webs & Girder 4 is beginning to crush.

Girder 3 @ end of Span 2 has heavy s/l with holes & is beginning to crush.

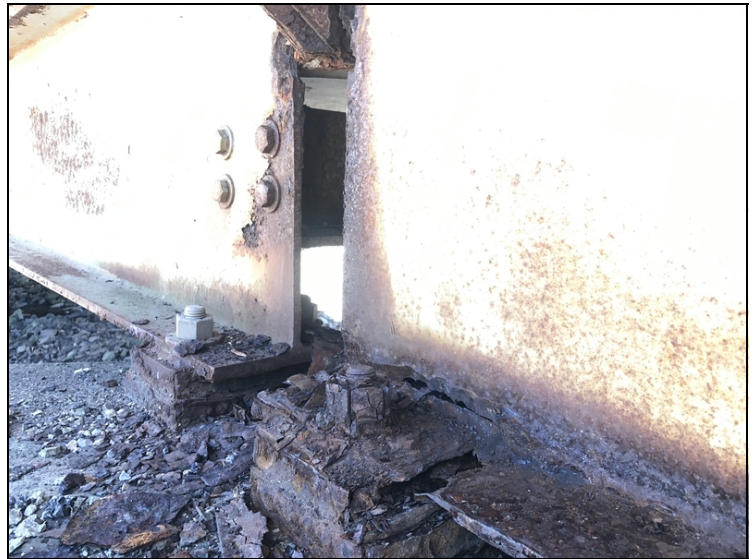
Girder 1 has severe section loss with holes & cracks & is beginning to crush @ end of span.

Girder 1 @ end of Span 1 has heavy s/l with holes, cracks & is beginning to crush.

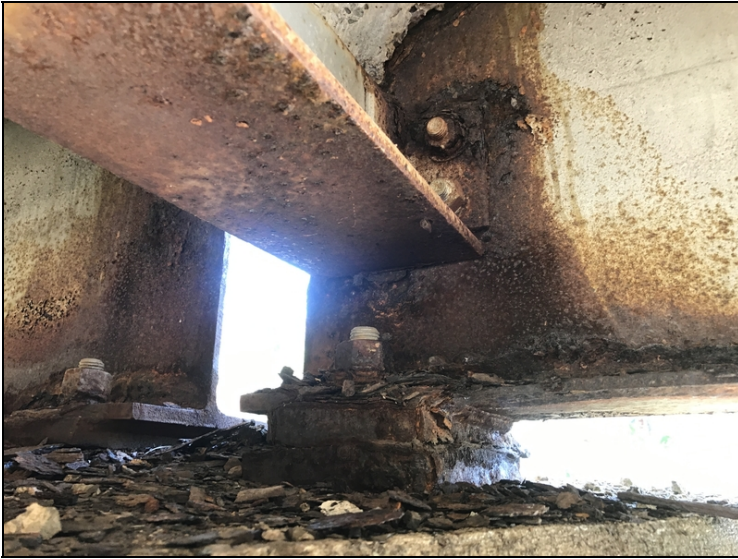
Girder 5 @ end of Span 2 has heavy s/l with knife edge.

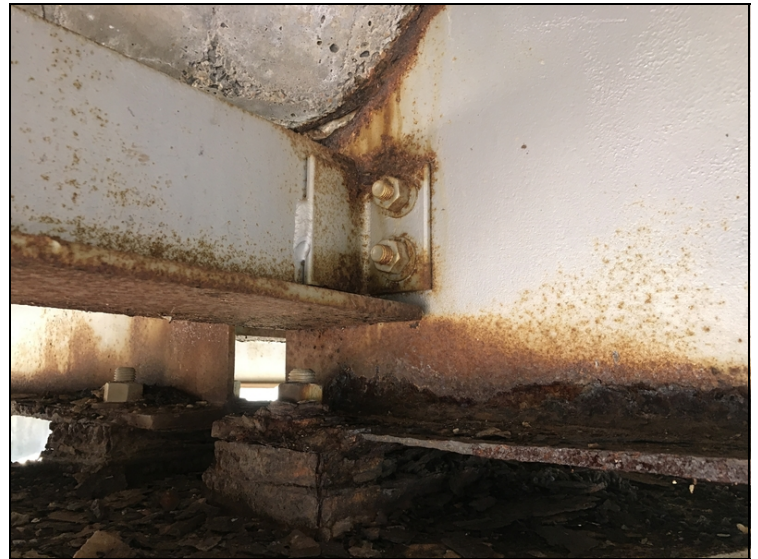
Girders 2, 3 & 4 have severe section loss with holes in web & knife edge to bottom flange @ end of span.

Girder 2 @ end of Span 1 has heavy s/l to bottom flange with holes in web below haunch.(typical to Girders 3 & 4)
