Bridge #03666(Routine)
SH 9/Stone County over BRUSHY CREEK
Location: 7.9 MI NE VANBUREN CO LN

Team Lead: Kerry Little **Inspection Date:** December 14, 2021

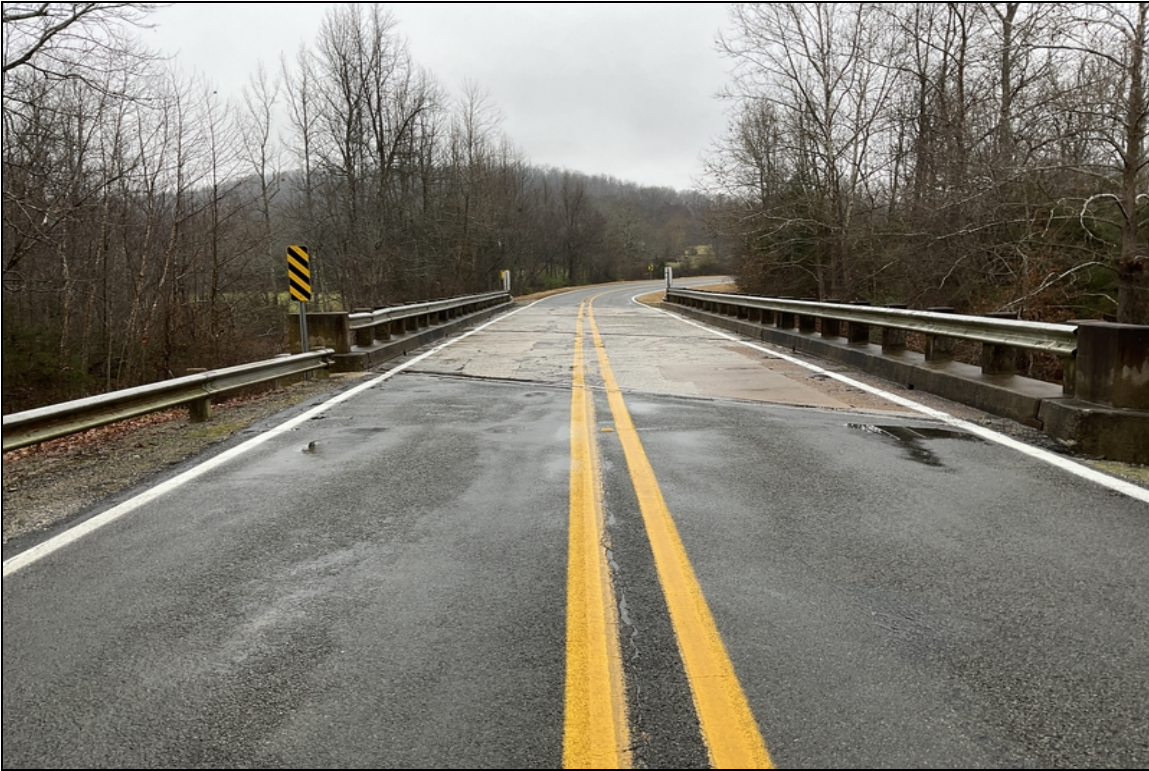
Roadway with log mile looking north.

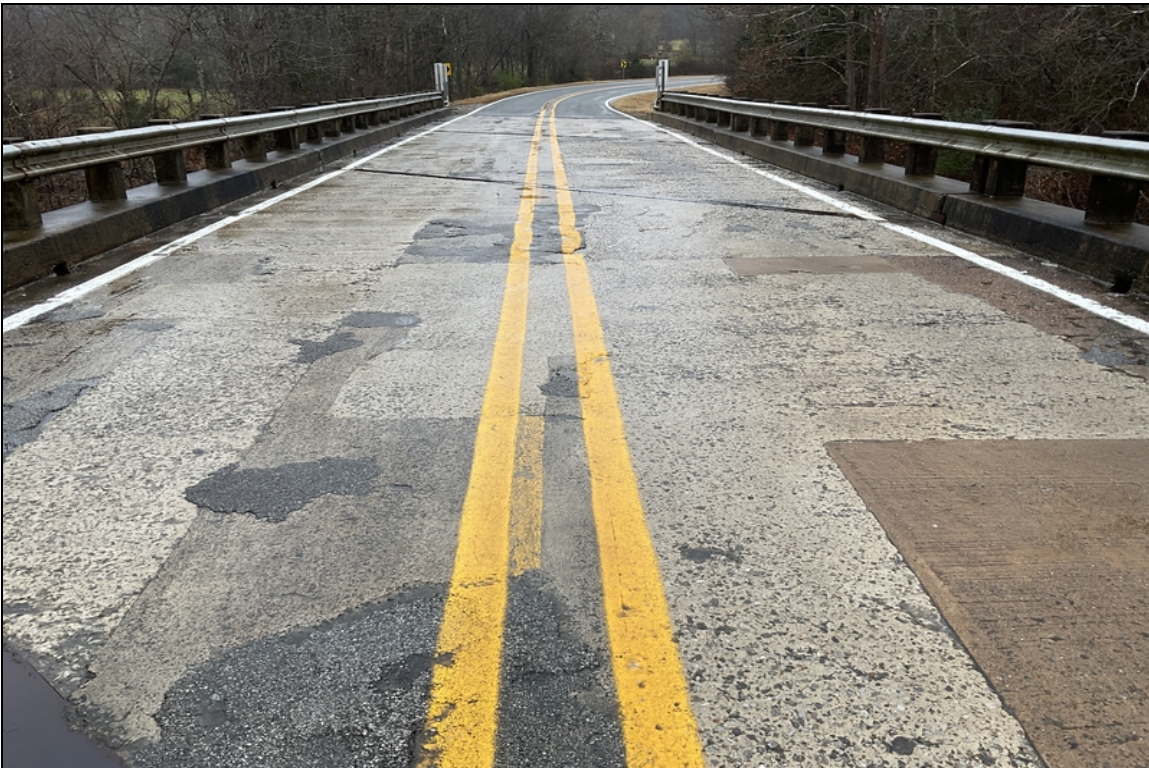
Overall deck.

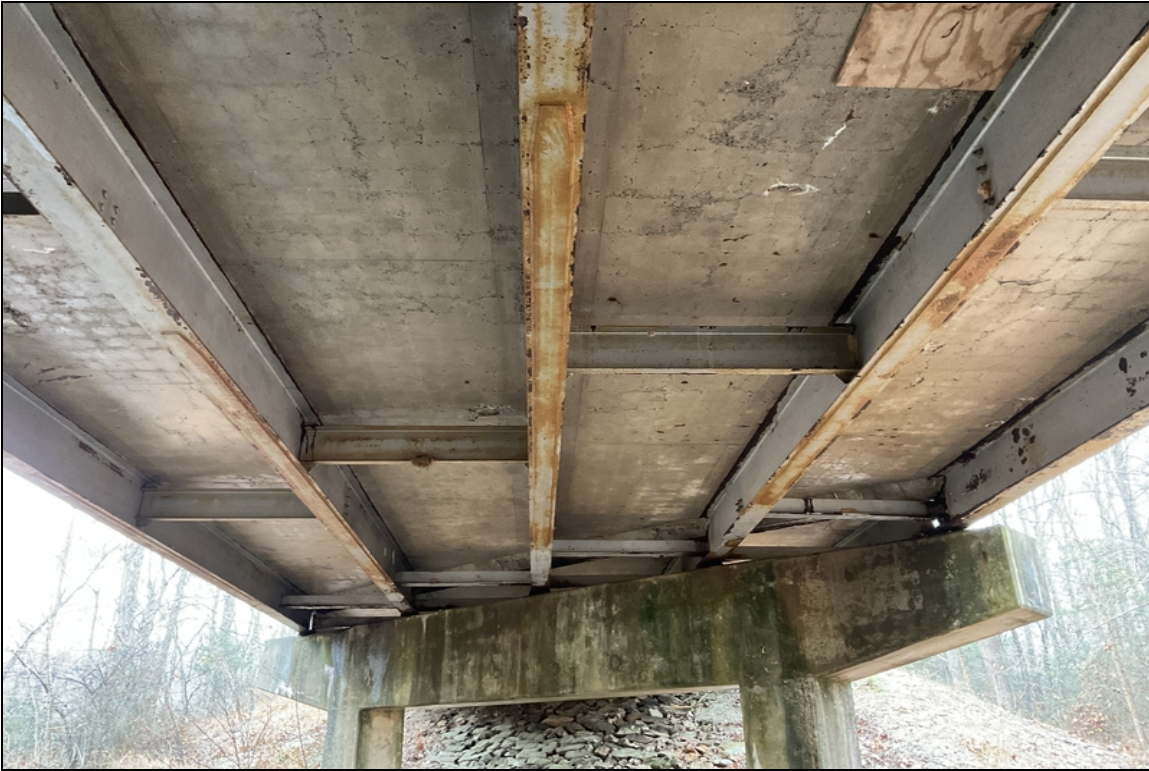
Overall soffit @ span 2.

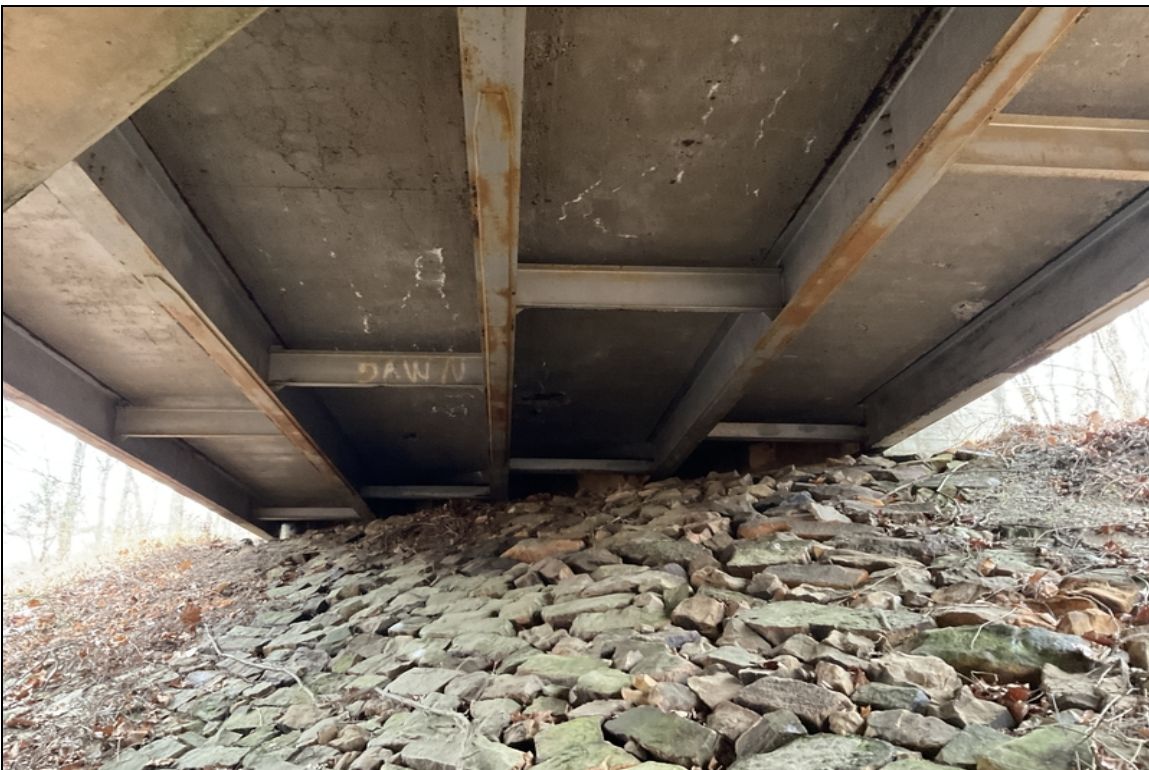
Overall soffit @ span 3.

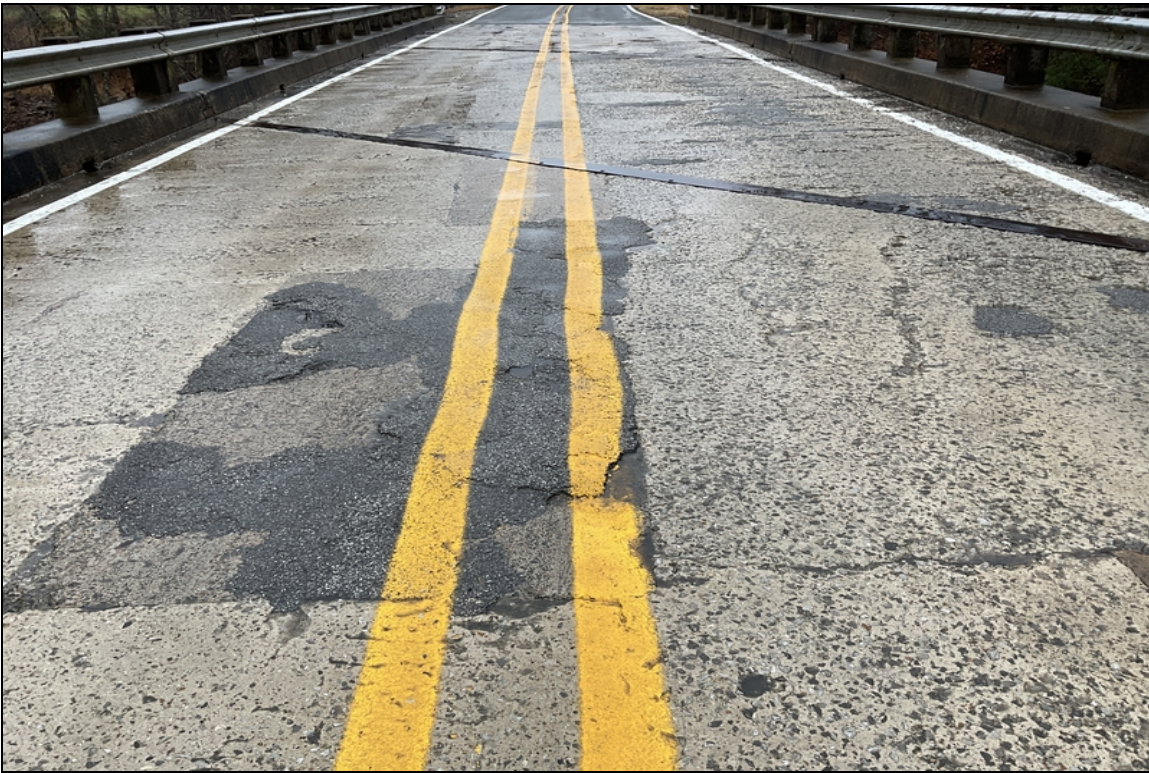
(12)	Entire area of Deck is Patched or has areas of heavy scaling and spalled areas with exposed rebar and cracks. Spalls to soffit, some with rebar exposed with & without section loss @ all spans. Random areas of efflorescence with some map cracking to soffit.						
107	Steel Open Girder/Beam	LF	600	210	330	57	3
1000	Corrosion	LF	390	0	330	57	3
515	Steel Protective Coating	SF	3210	0	2150	1000	60
3440	Effectiveness (Steel Protective Coatings)	SF	3210	0	2150	1000	60

Typical patched areas throughout deck.

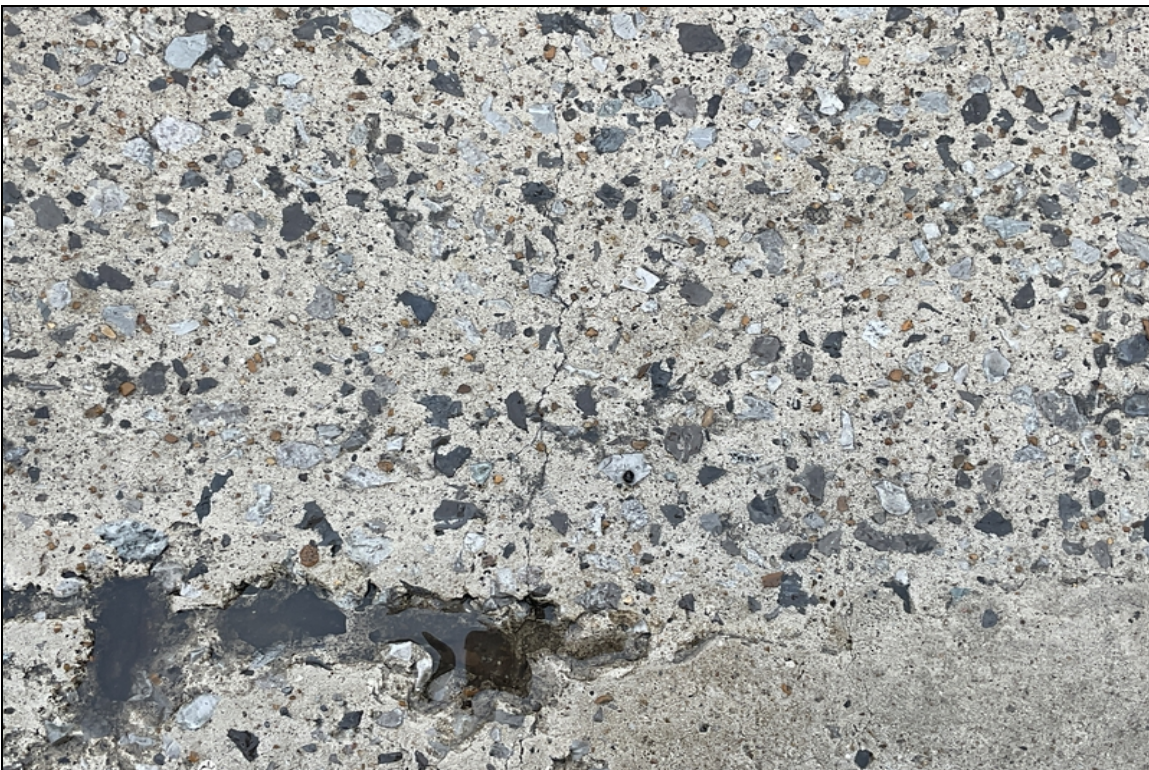
Typical cracks to deck @ all spans.

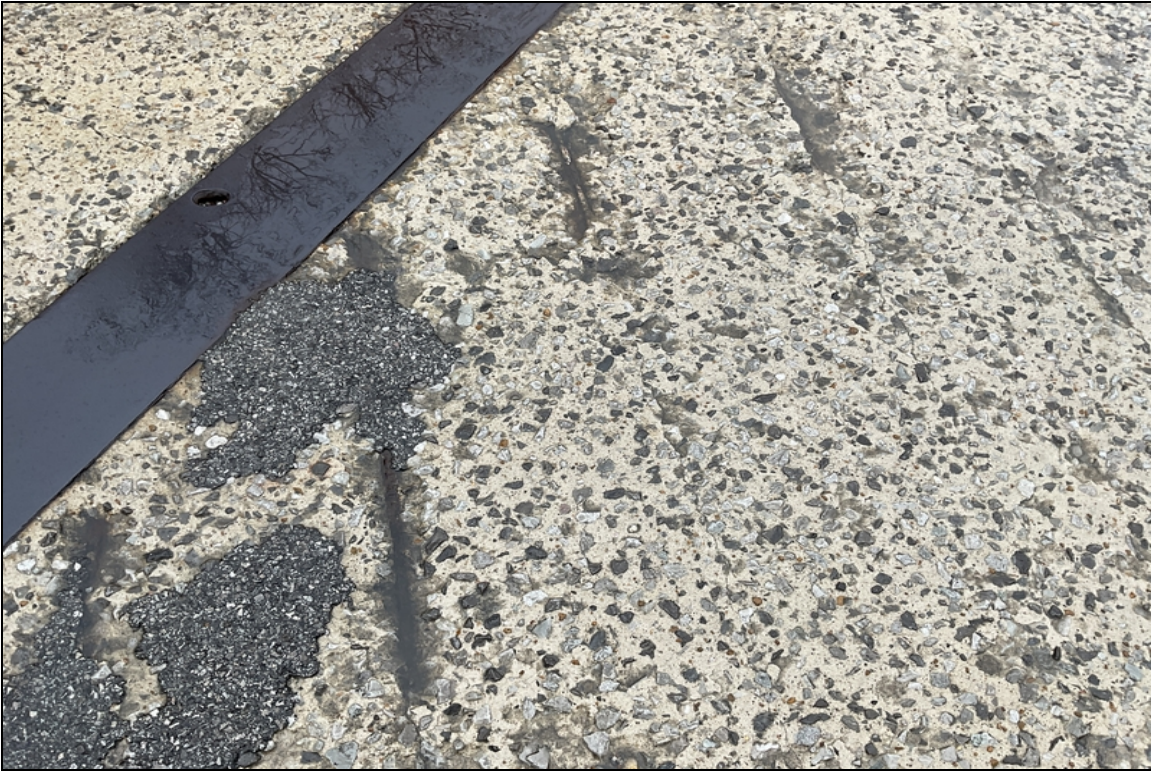
Typical spalls with rebar exposed to to deck @ all spans.

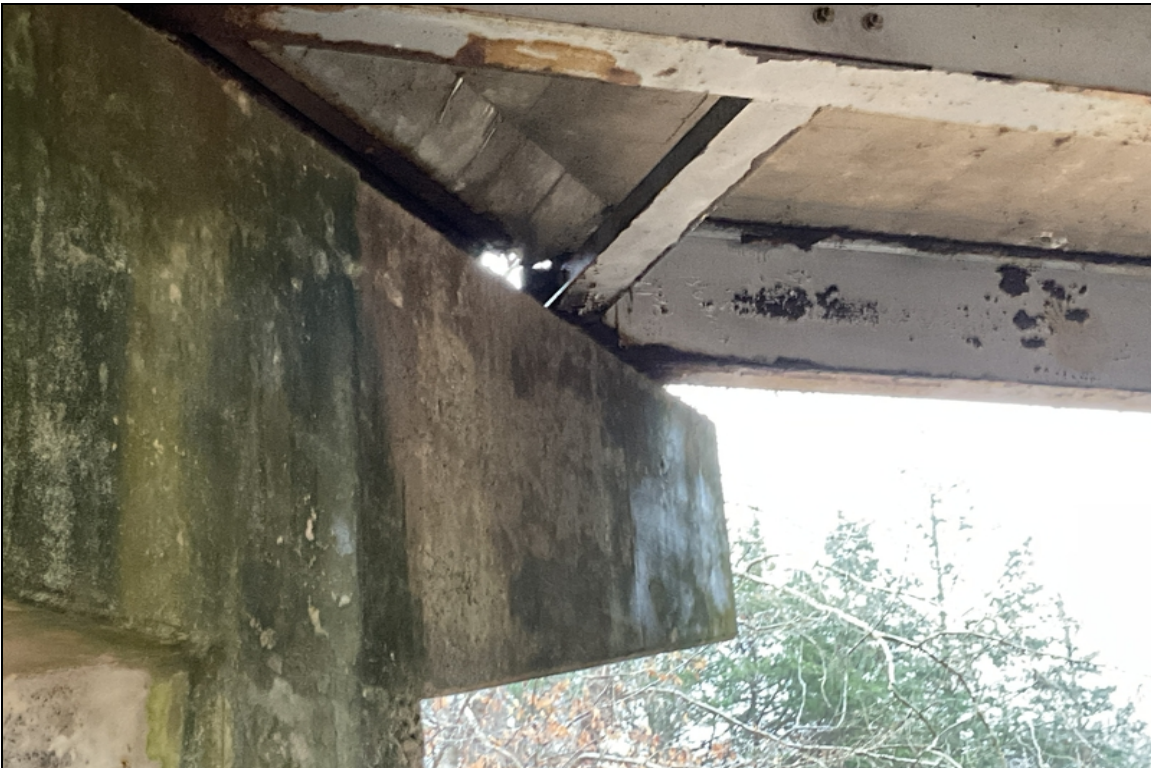
(107)	3' of ends of all Girders have rust with minor section loss. Girders 1 & 5 at drain openings have rust and minor section loss. Girders 1 through 5 have flaking rust throughout at all Spans. Holes in web below haunch @ Girders 2, 4 & 5 @ end of Span 2.						
205	Reinforced Concrete Column	EA	4	0	3	1	0
1120	Efflorescence/Rust Staining	EA	3	0	3	0	0
1130	Cracking (RC and Other)	EA	1	0	0	1	0

Hole to web @ girder 5, end of span 2.

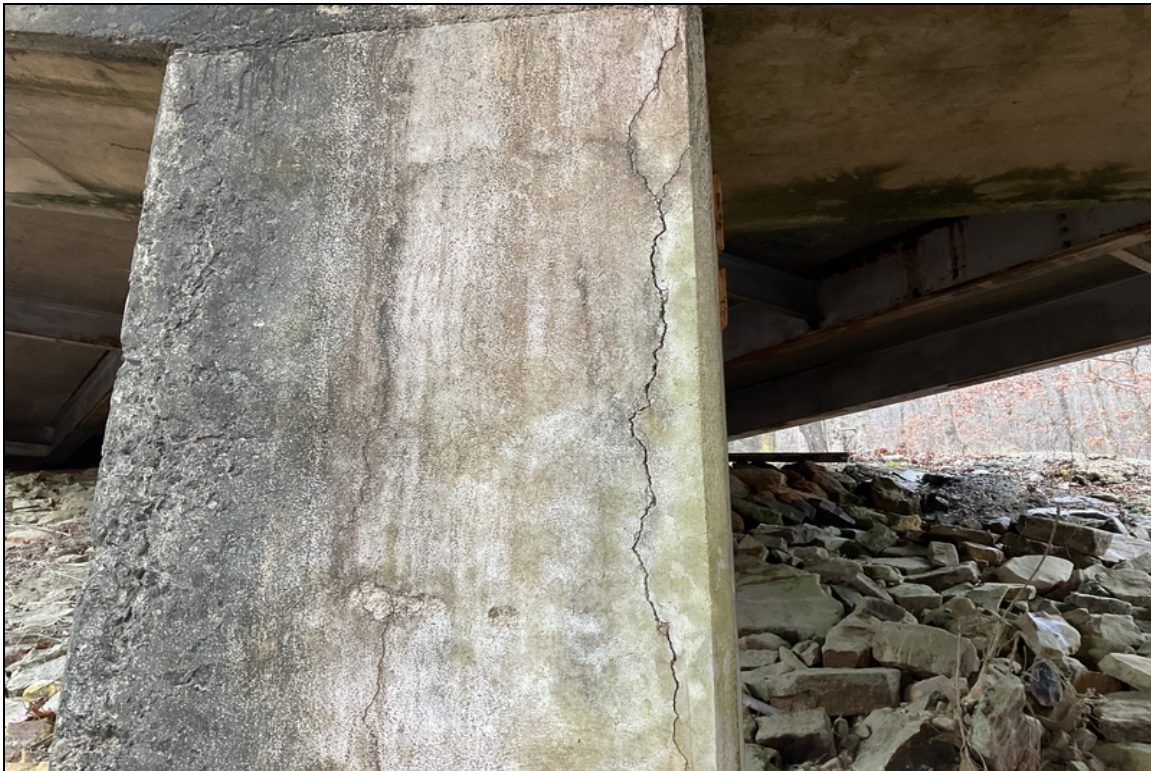
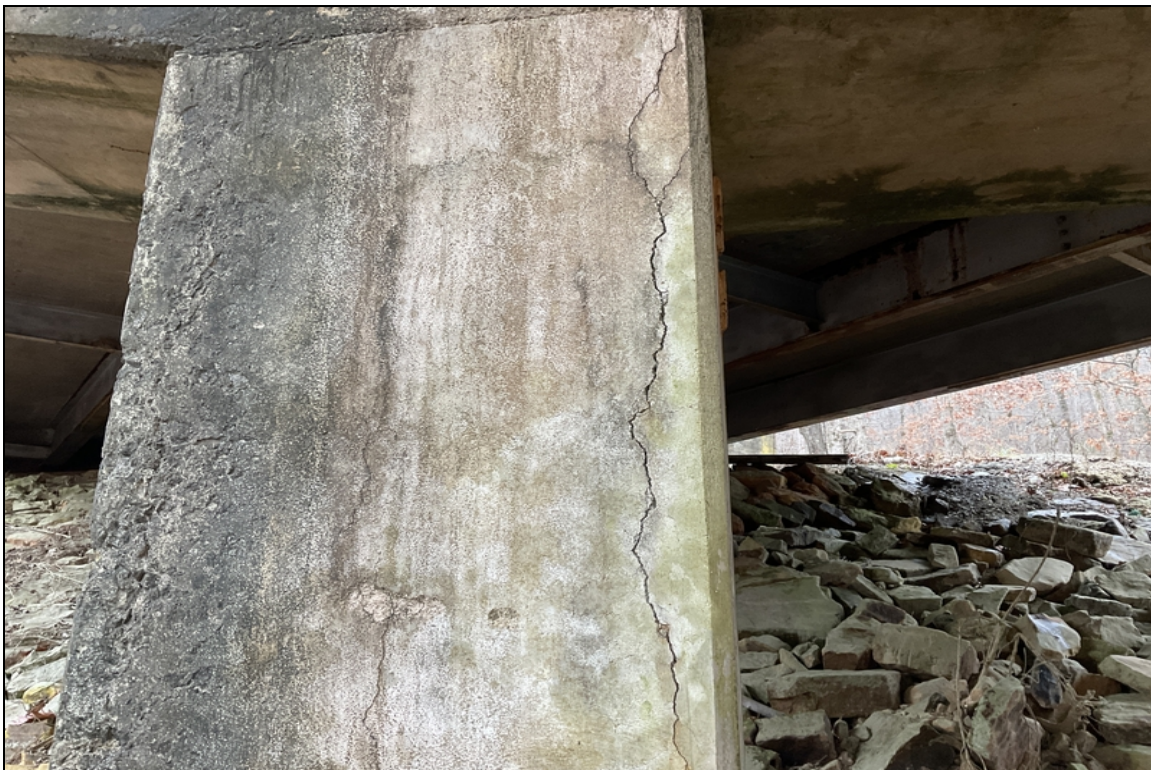
(205)	Bent 1 - Minor abrasion to bottom of Column 1. Efflorescent cracking to Column 2 @ Bents 1 & 2. Cracking to Column 1 @ Bent 2.						
215	Reinforced Concrete Abutment	LF	72	54	10	8	0
1130	Cracking (RC and Other)	LF	18	0	10	8	0

Large crack to ahead side of column 2 @ bent 1.

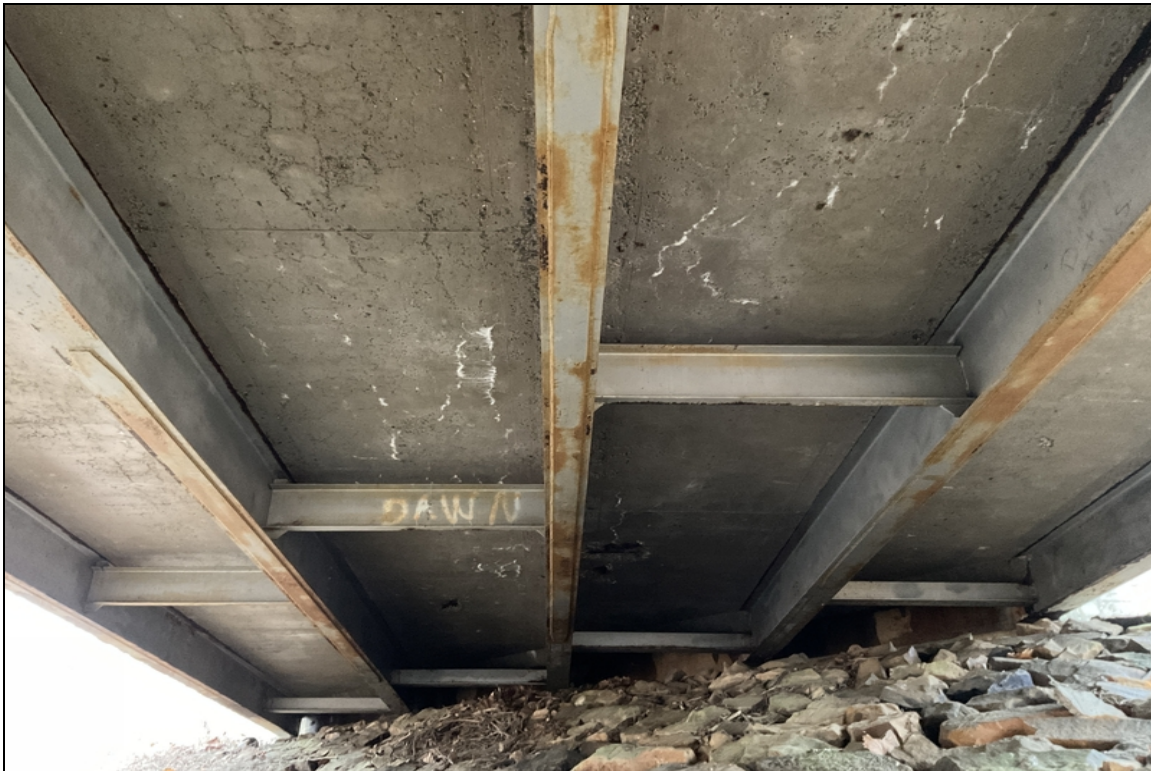
Typical efflor cracks to soffit @ all spans.

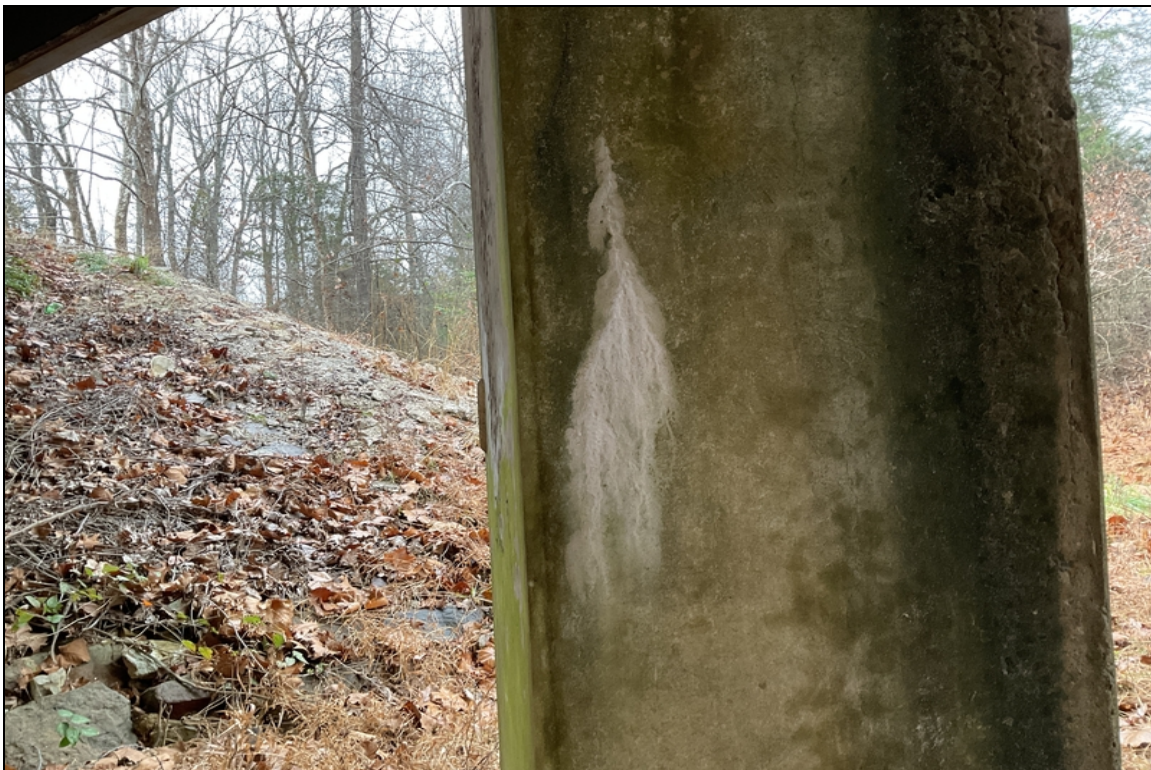
Efflor crack to backside of column 2 @ bent 2.

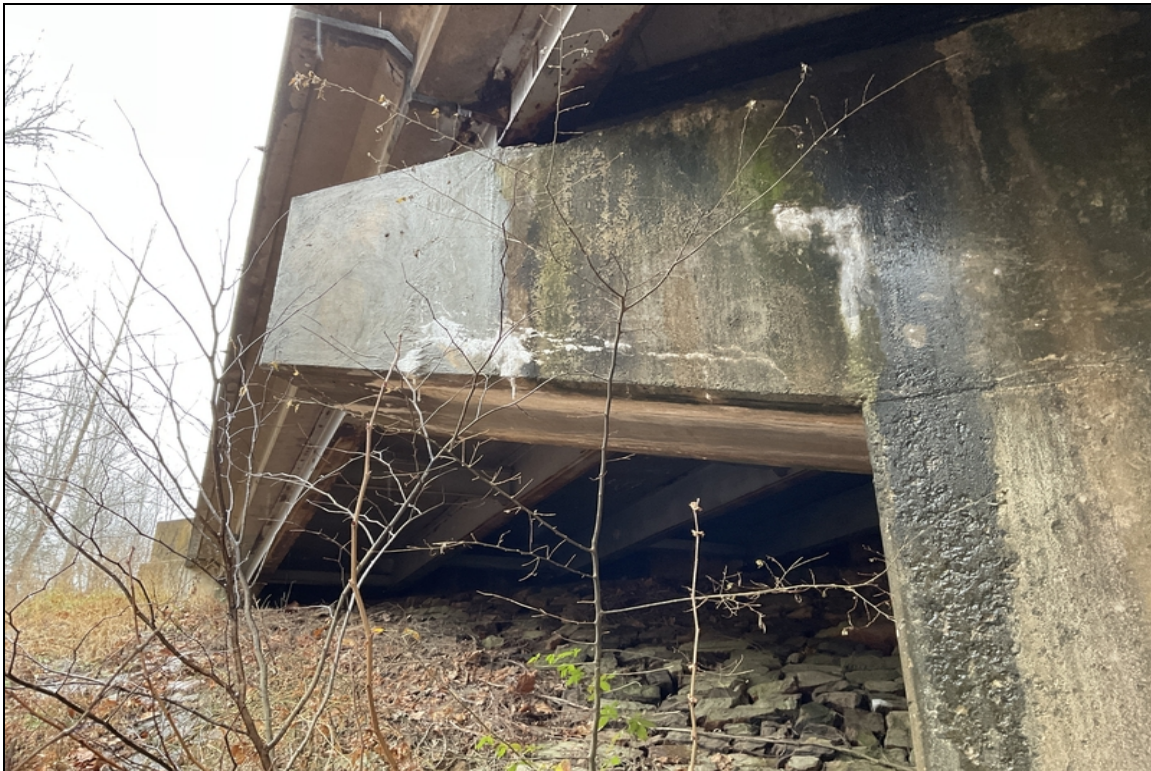
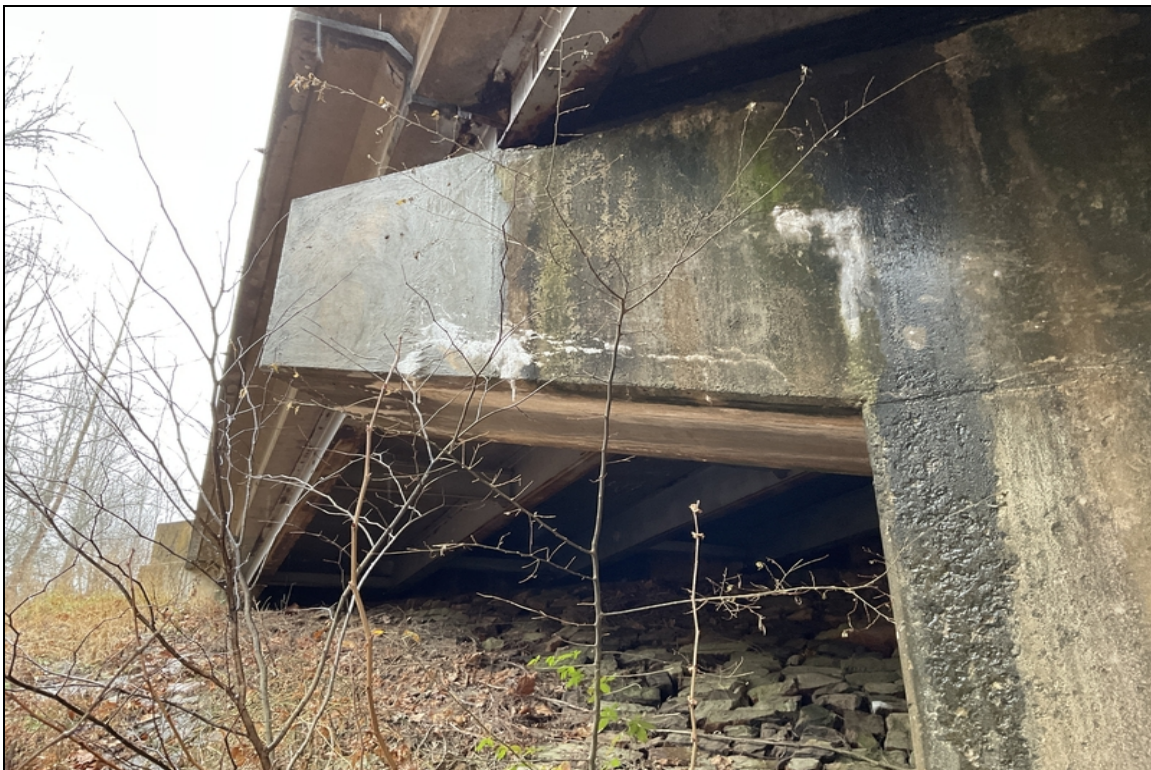
ELEM	DESCRIPTION	UNITS	TOTAL	CS1	CS2	CS3	CS4
1130 (234)	Cracking (RC and Other)	LF	2	0	0	2	0
Bent 1 - 6' horizontal efflorescent cracks to cap. Bent 2 - 4' spall & 6' efflorescent cracks to cap. Cracking to Left end of cap @ Bent 1 & Right end of Bent 2.							
303	Assembly Joint with Seal	LF	136	136	0	0	0
311	Movable Bearing	EA	15	0	0	15	0
1000	Corrosion	EA	15	0	0	15	0
515	Steel Protective Coating	SF	30	0	0	0	30
3440	Effectiveness (Steel Protective Coatings)	SF	30	0	0	0	30

Typical efflor to caps @ bents 1 & 2.
Backside of bent 2.

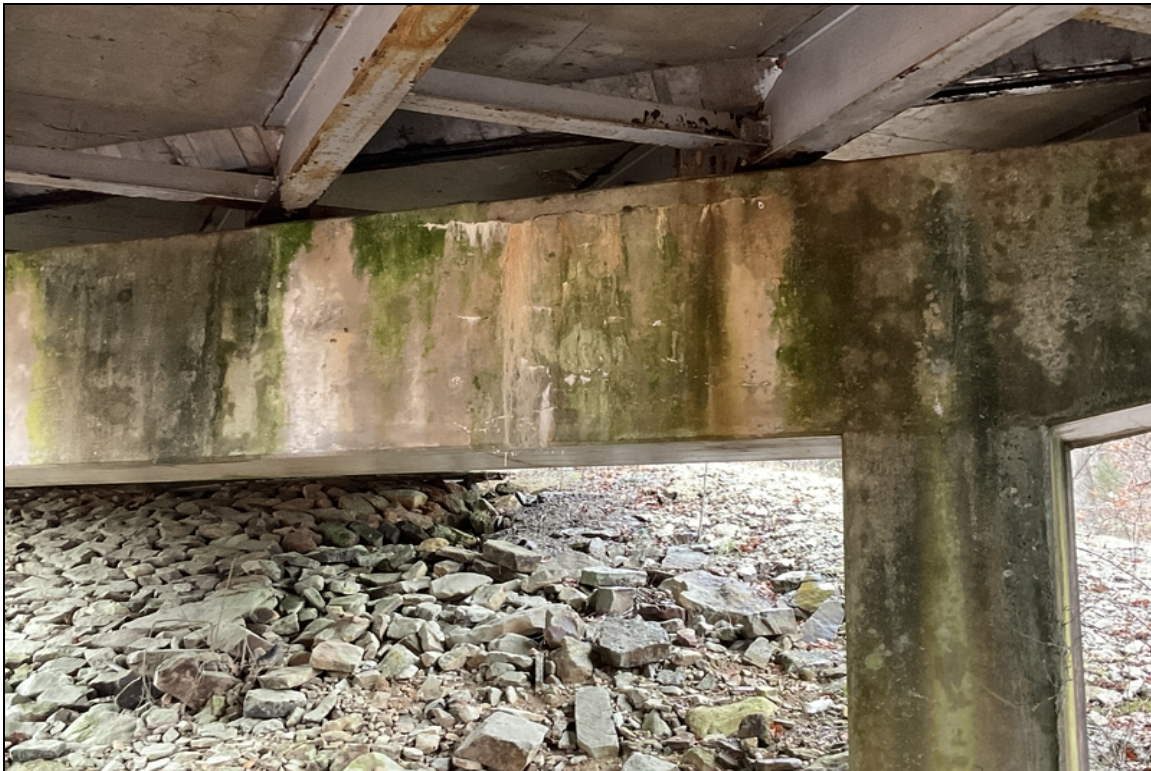
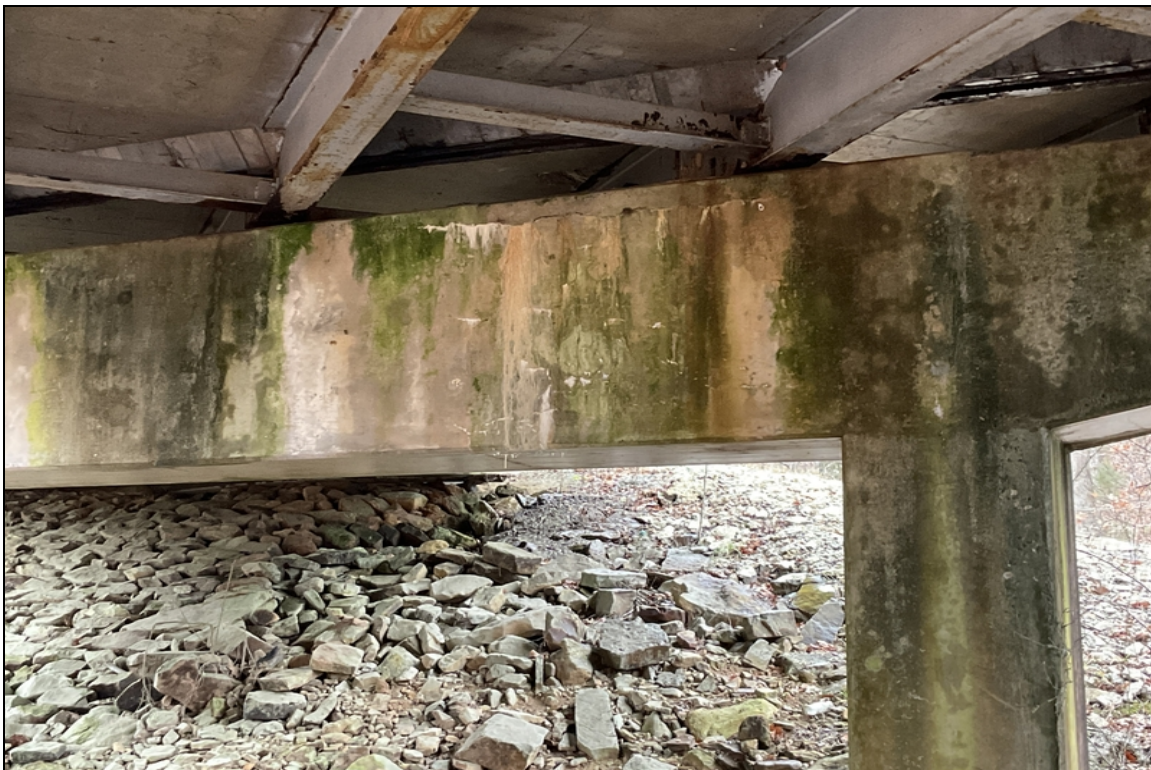
Typical efflor to caps @ bents 1 & 2.
Backside of bent 1.

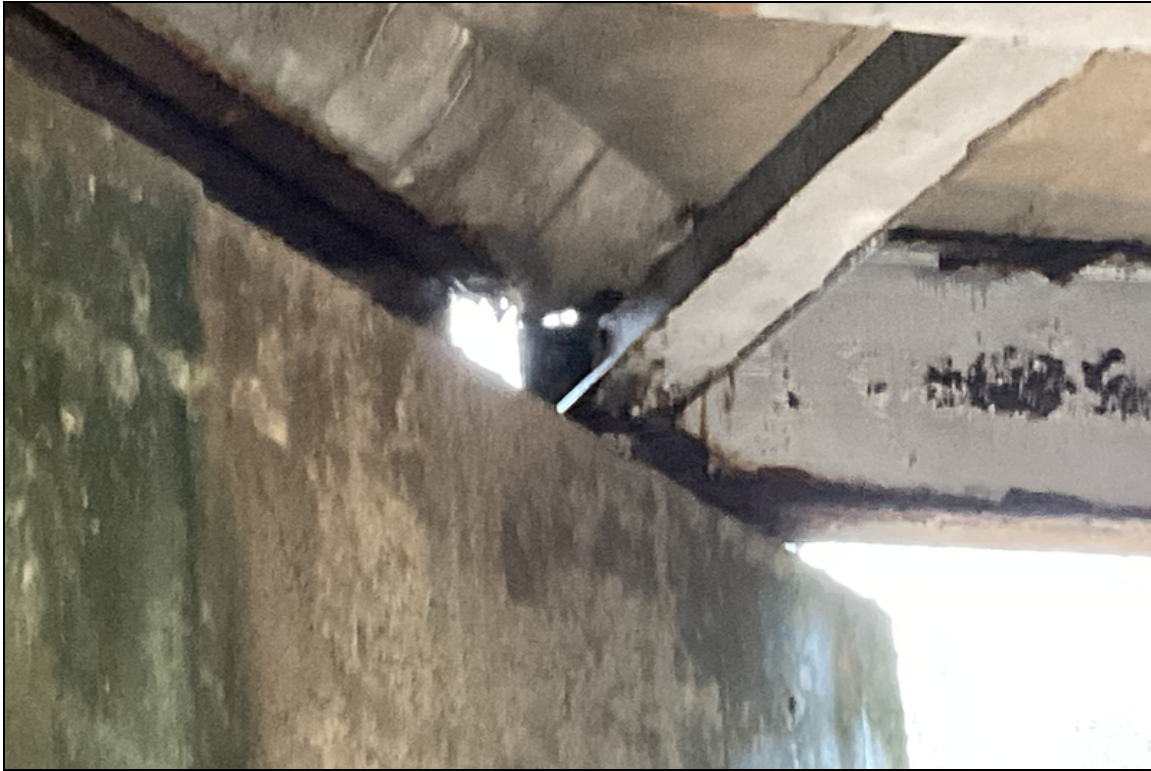
Rust and section loss to girder 5 at Spans 1 & 2.
Hole to web, below paving haunch @ girder 5, end of span 2.

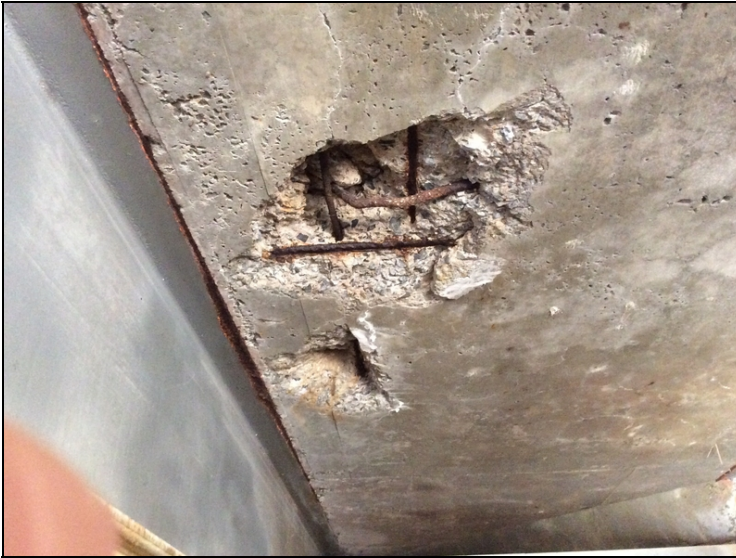
Deep spalls with rebar exposed to deck below at All Spans.

Spalls between Girders 3 & 4 at Span 3.

Type of Work: Repair

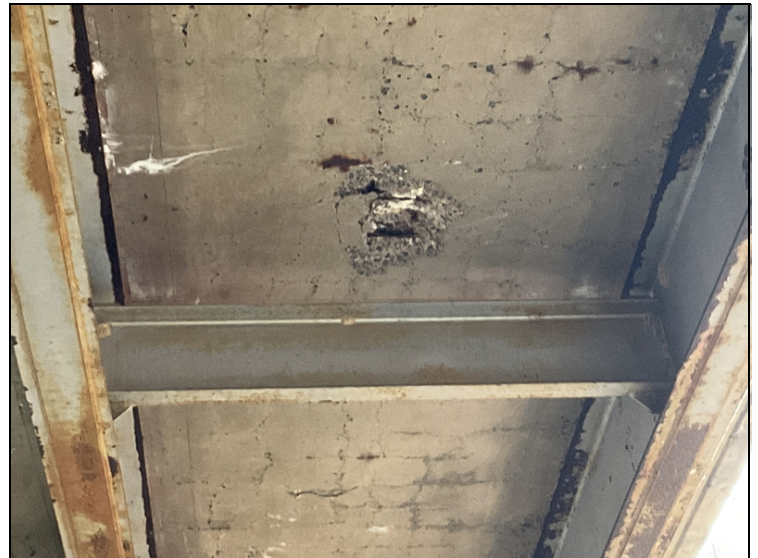
Deep spalls with rebar exposed to deck below at
All Spans.
Span 2.

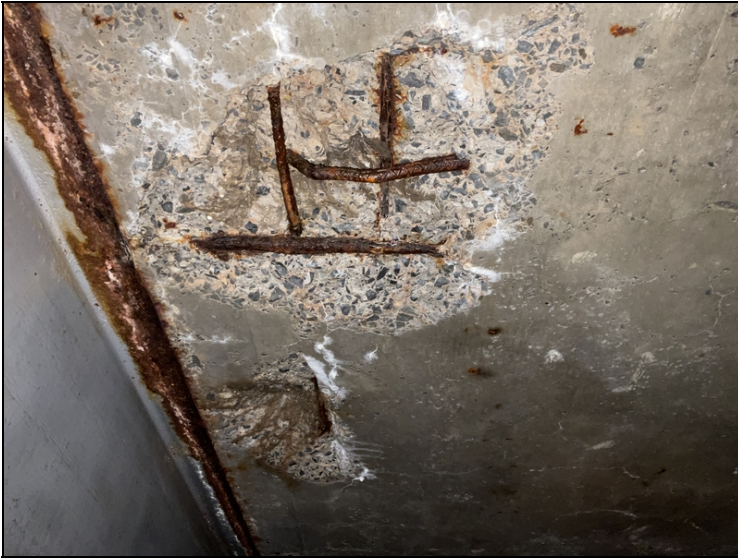
Deep spalls with rebar exposed to deck below at
All Spans.
Span 3, between girders 2 & 3.

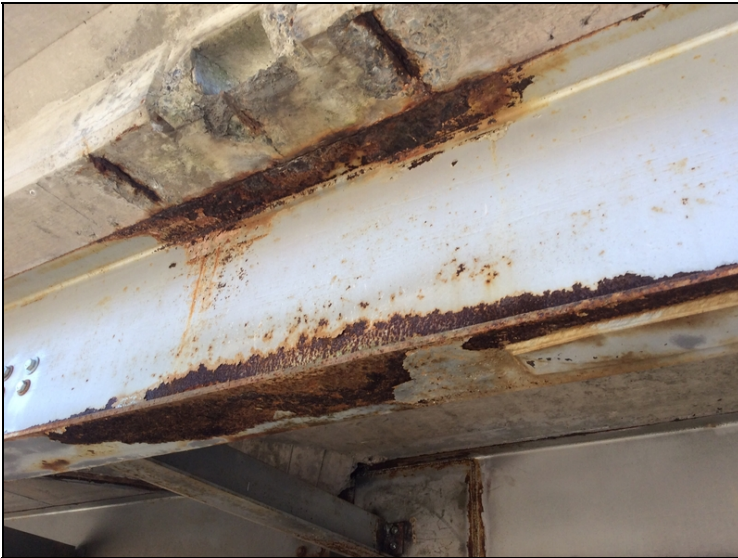
Rust to all girders at Spans 1 through 3.
Rust and section loss to girder 5 at Spans 1 & 2.
Rust and section loss to girder 3 at Span 3

Span 1 Girder 1 at drain.

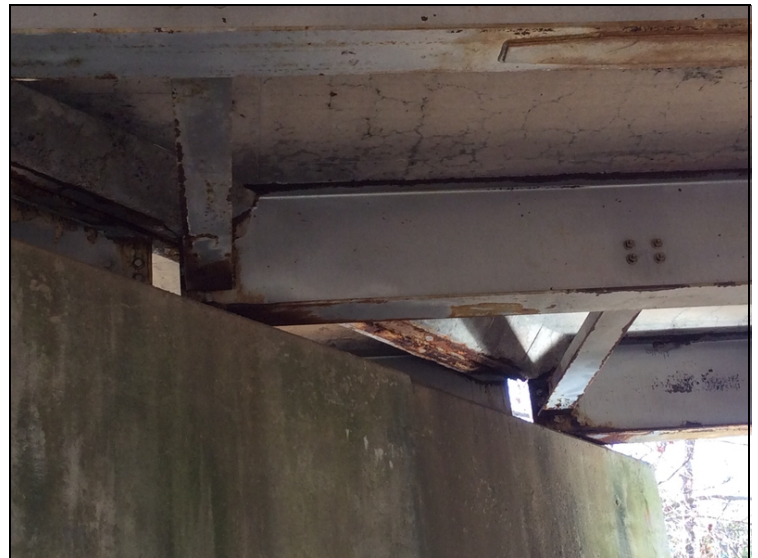
2' of end of all Girders have rust with some minor section loss.

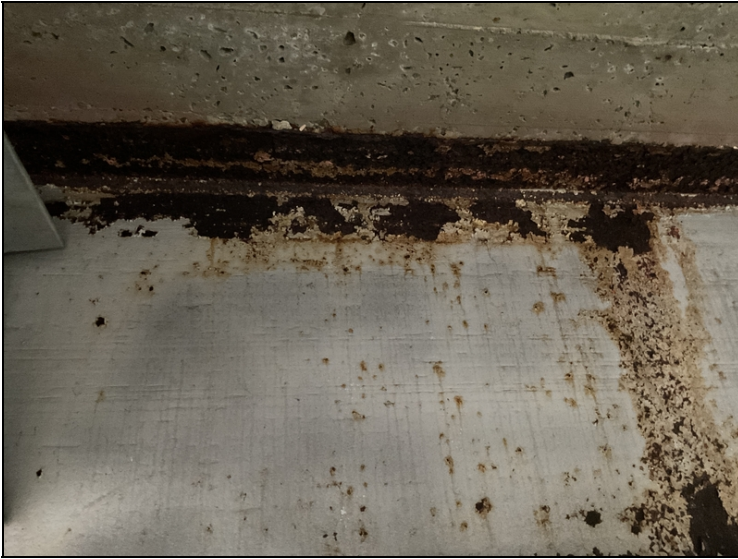
Rust to all girders at Spans 1 through 3.

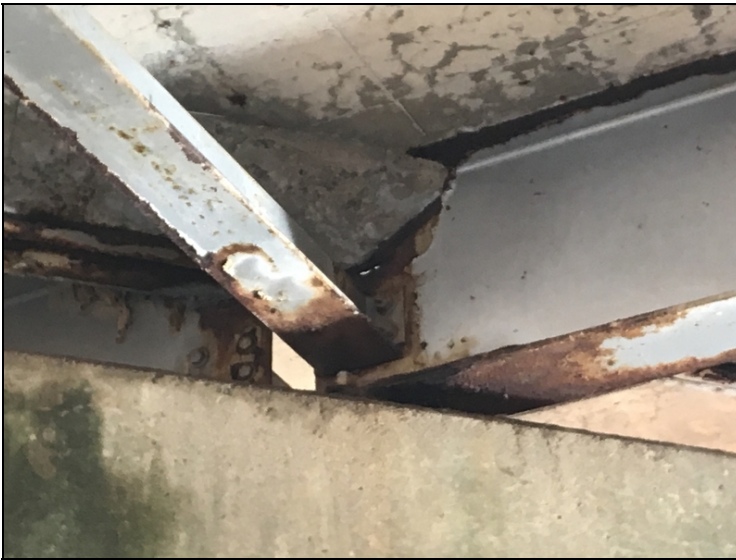
Holes in web below haunch @ Girders 2, 4 & 5 @ end of Span 2.

Hole in web below haunch @ Girder 4 @ end of Span 2.

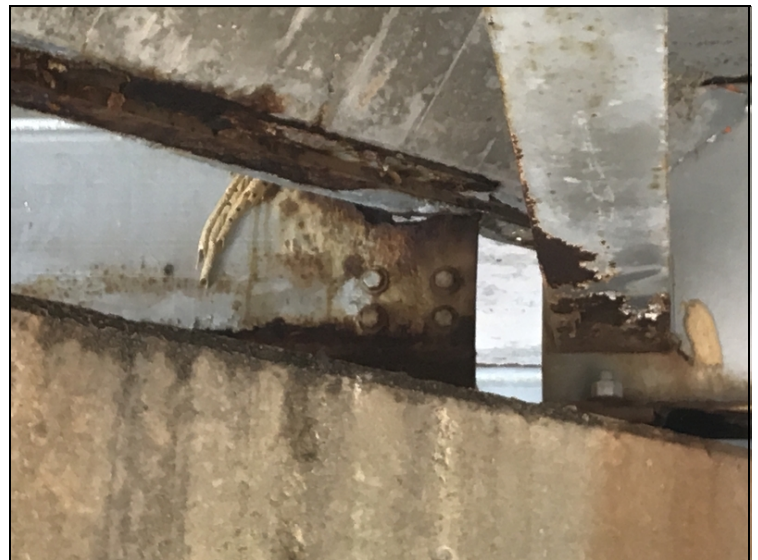
Hole in web below haunch @ Girder 2 @ end of Span 2.

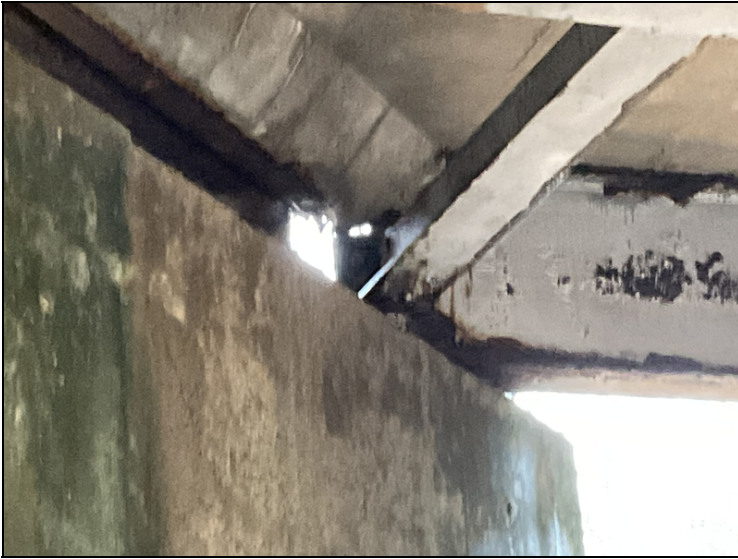
Rust and section loss to girder 5 at Spans 1 & 2.
Hole to web, below paving haunch @ girder 5, end
of span 2.
