Bridge #05186(Routine, Underwater type 2)

SH 9/Stone County over TURKEY CREEK

Team Lead: Nathan Edwards Inspection Date: November 17, 2020

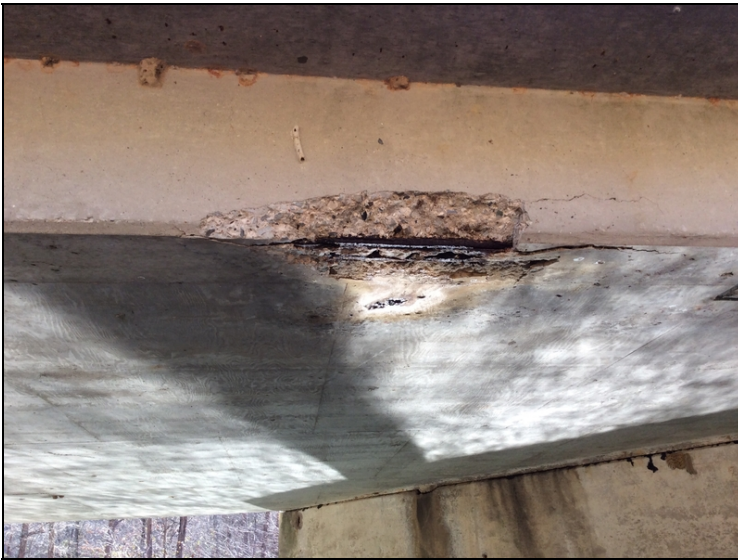
Spans 1 thru 6 have spalls with rebar exposed to soffit around drain openings & edges of deck.

Spall with rebar exposed to Left edge of deck @ Span 5.

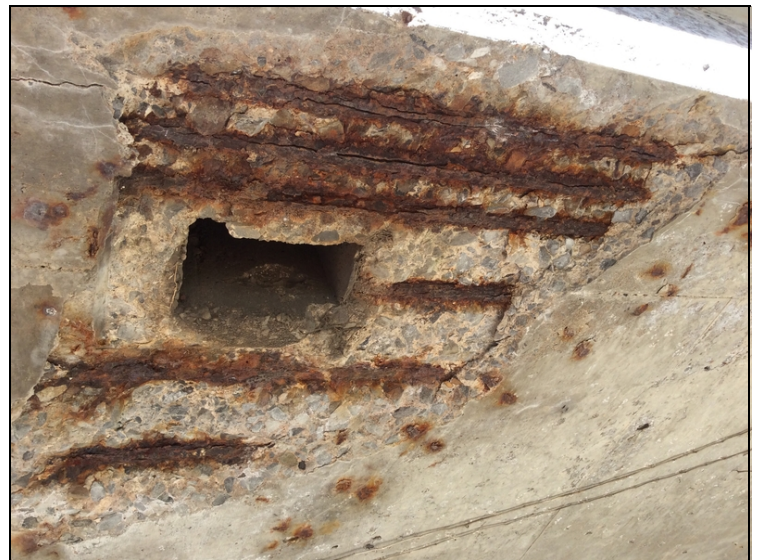
Spalls with rebar exposed to soffit @ Right drain opening @ Span 6.

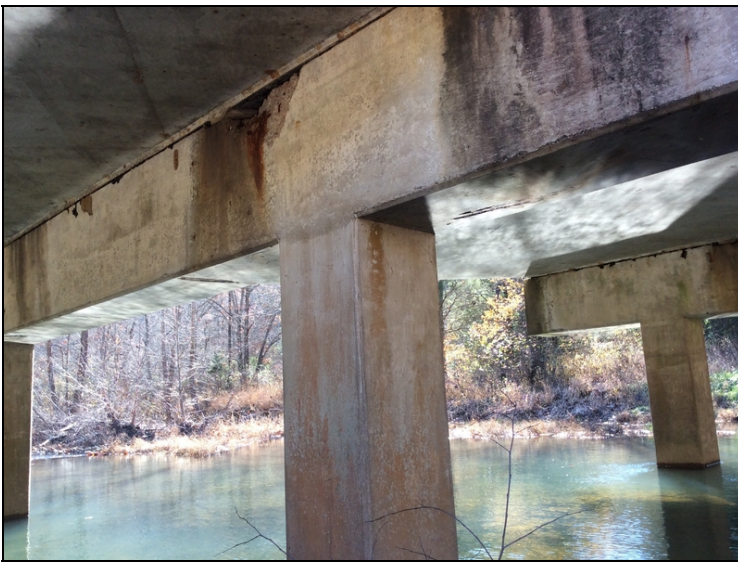
Caps @
Bents 1, 2, and 4 have spalls with rebar exposed.

Spalls with rebar exposed to cap @ Bent 4.

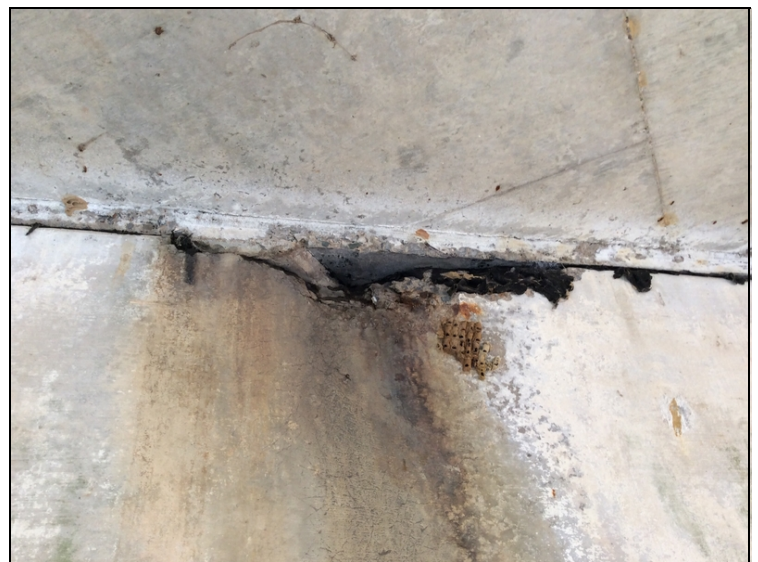
Spalls with rebar exposed to ahead side of cap @ Bent 1.

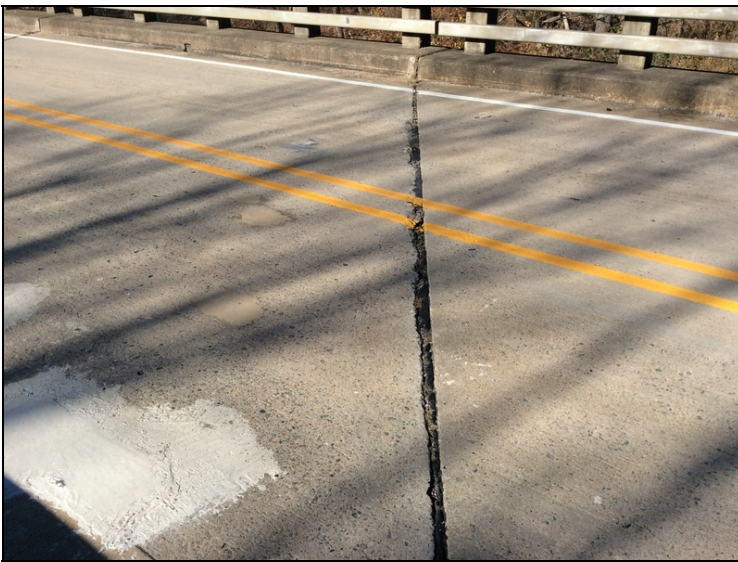
All poured joints are cracked, deteriorated, and leak.

Joint seal @ Bent 3.

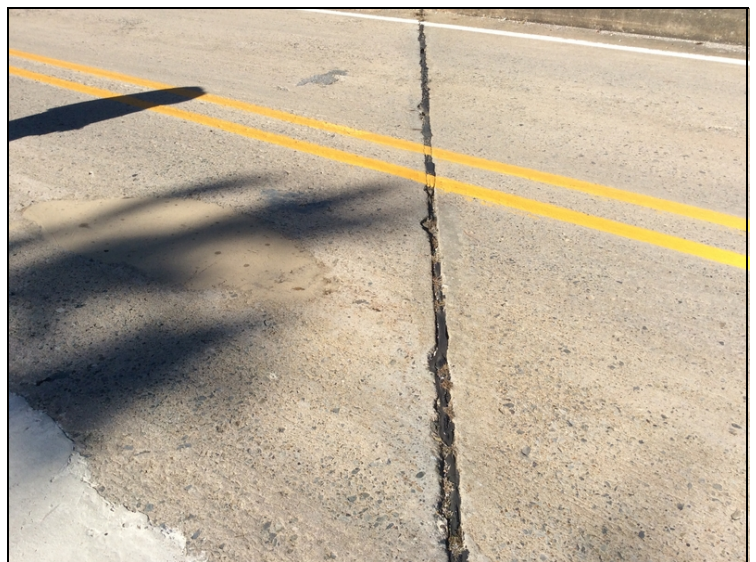
Joint seal @ Bent 2.

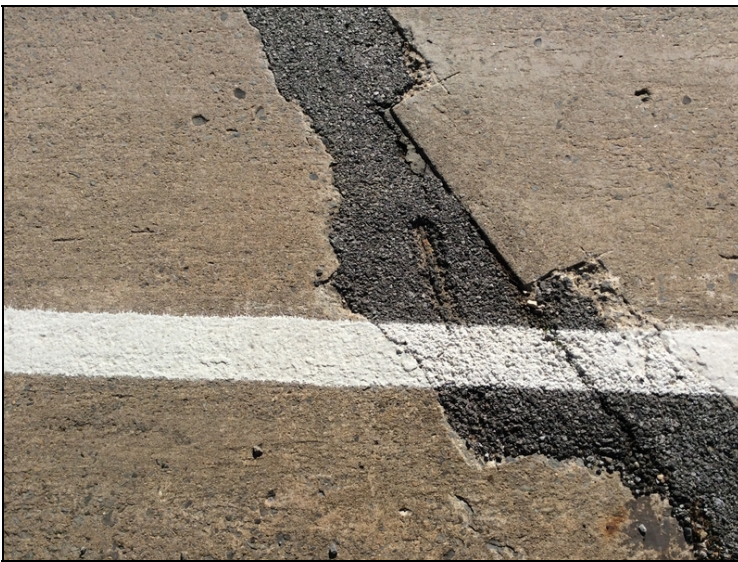
Spall with rebar exposed to deck @ beginning of Span 6 Left lane.

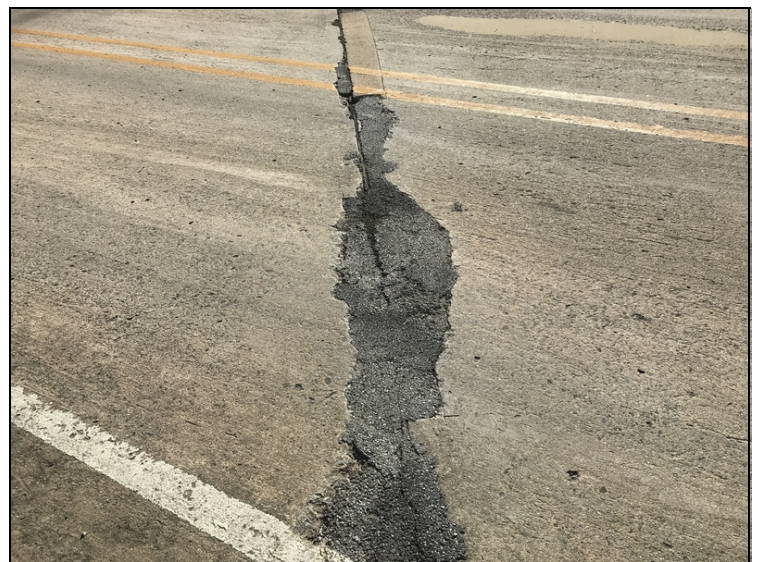
Rebar is no longer visible. Remove
