Bridge #05552(Routine, Underwater type 2)

SH 9/Stone County over WHITE RIVER

Location: 0.1 MI NE JCT SH 5

Team Lead: Nathan Edwards **Inspection Date:** October 27, 2020

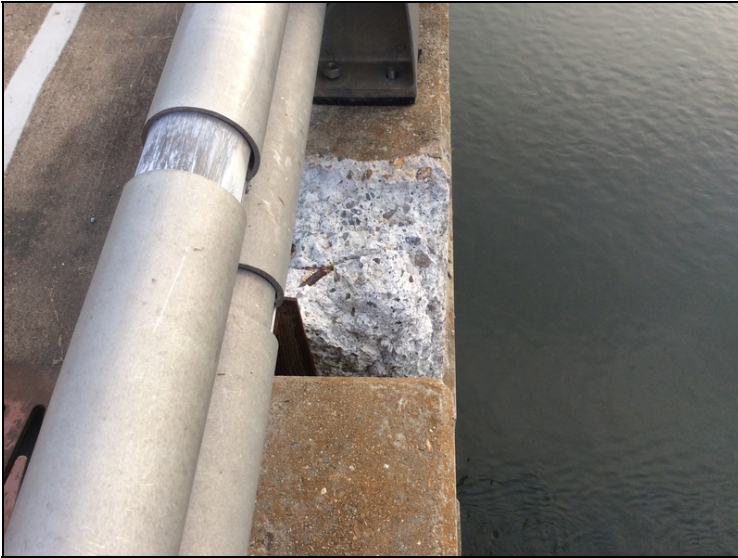
Large spall to Right concrete bridge rail @ finger joint.

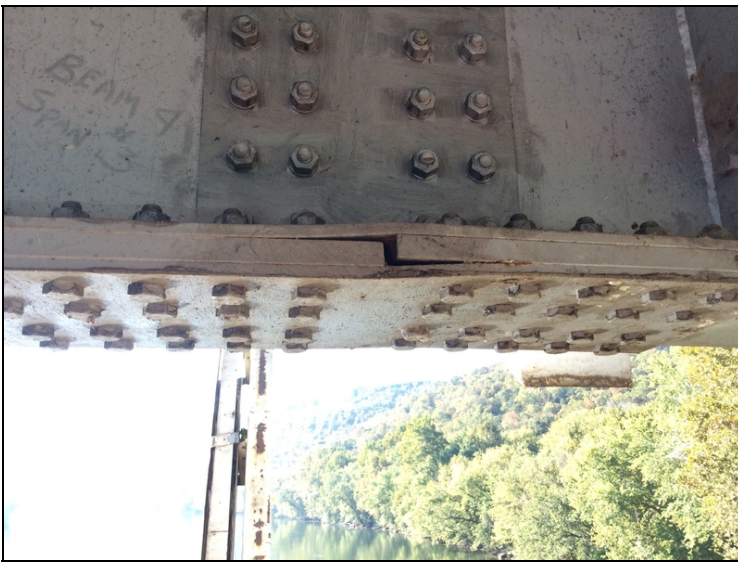
Bottom splice plate is bent 1/4"@ Span 3 Girder 4 & Span 5 Girder 3.

Bottom splice plate is bent 1/4"@ Span 3 Girder 4.

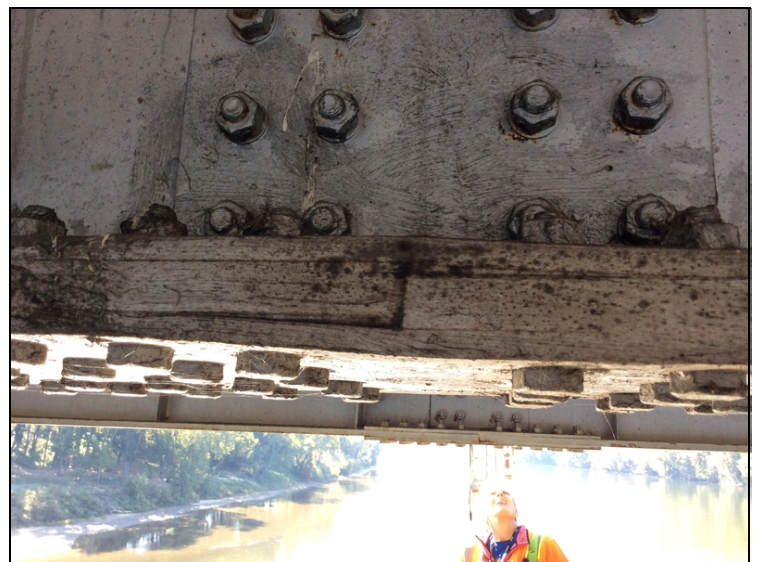
Bottom splice plate @ Girder 3

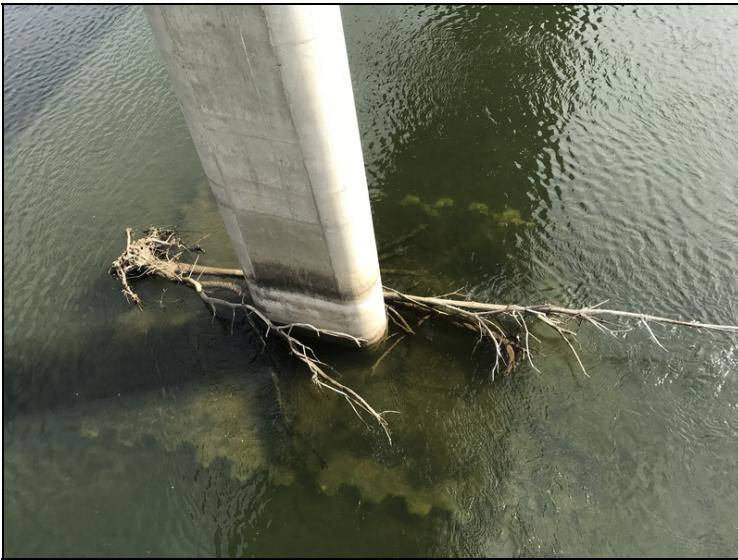
Bents 3, 5 & 6 have drift.

Bent 3 has Drift.

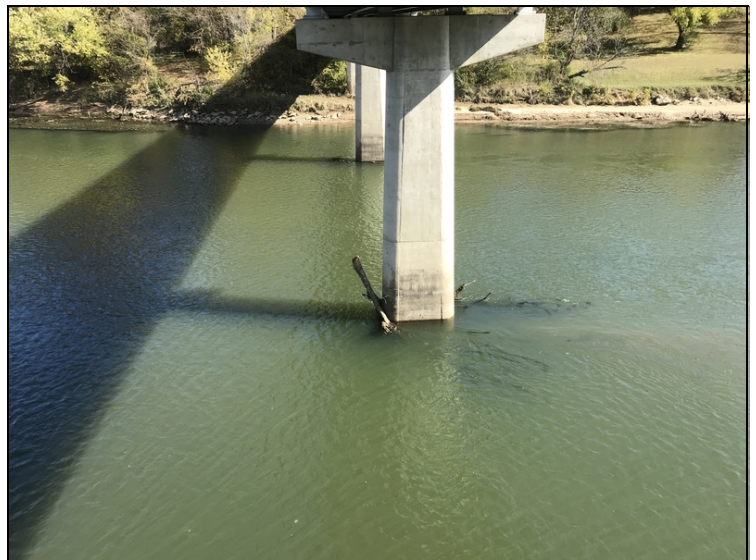
Drift @ Bents 5 & 6.

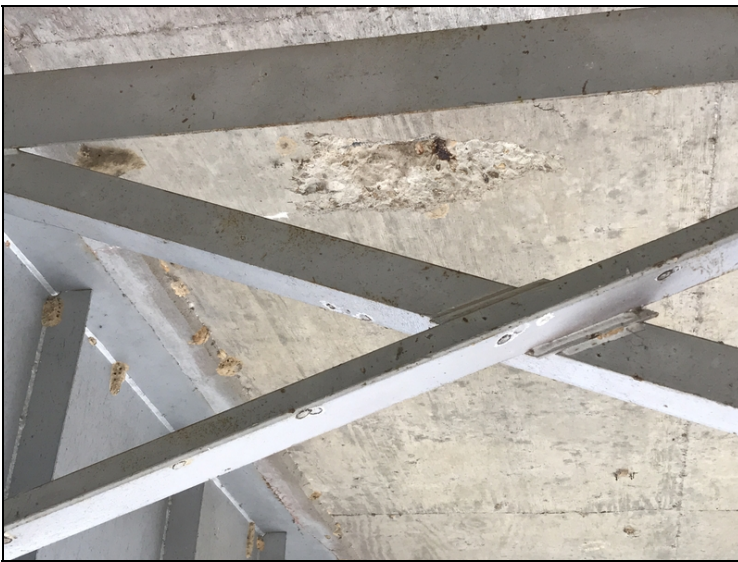
Span 7 - Deep spall with 1.5' rebar exposed to deck below between Girders 2 & 3.

Span 7 between Girders 2 & 3 has Large spall to Soffit.

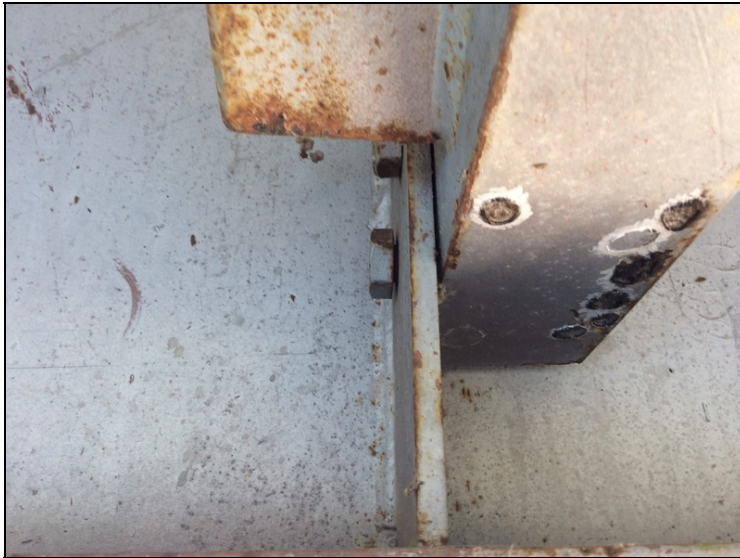
Loose bolt @ bottom splice plate @ Girder 4 Span 4.
1st diaphragm ahead of Bent 3 has loose bolt @ Girder 3.
Bent 1 Girder 2 - has loose bolt at bearing pad to bottom of Girder.

1st diaphragm ahead of Bent 3 has loose bolt @ Girder 3.

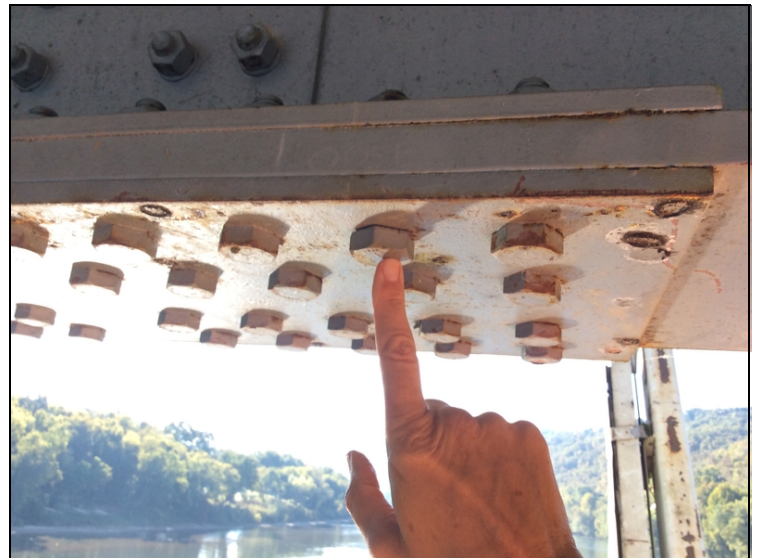
Loose bolt @ bottom splice plate @ Girder 4 Span 4.
