Route:69 Section:03 Log:6.46

Bridge #05858(Routine)
SH 69/Indepen Co. over MO. & NO. AR. RR
Location: 2.0 WEST OF SULPHUR ROCK

Team Lead: Kerry Little Inspection Date: March 01, 2022

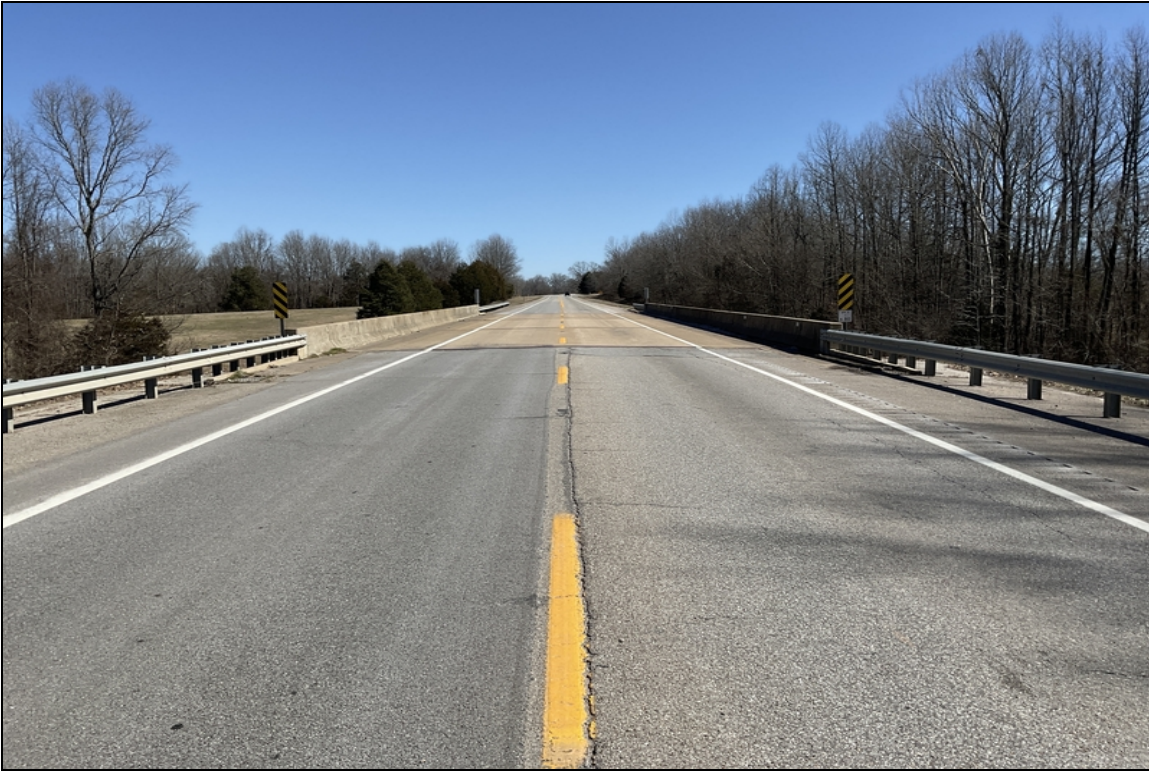
Roadway with log mile looking east.

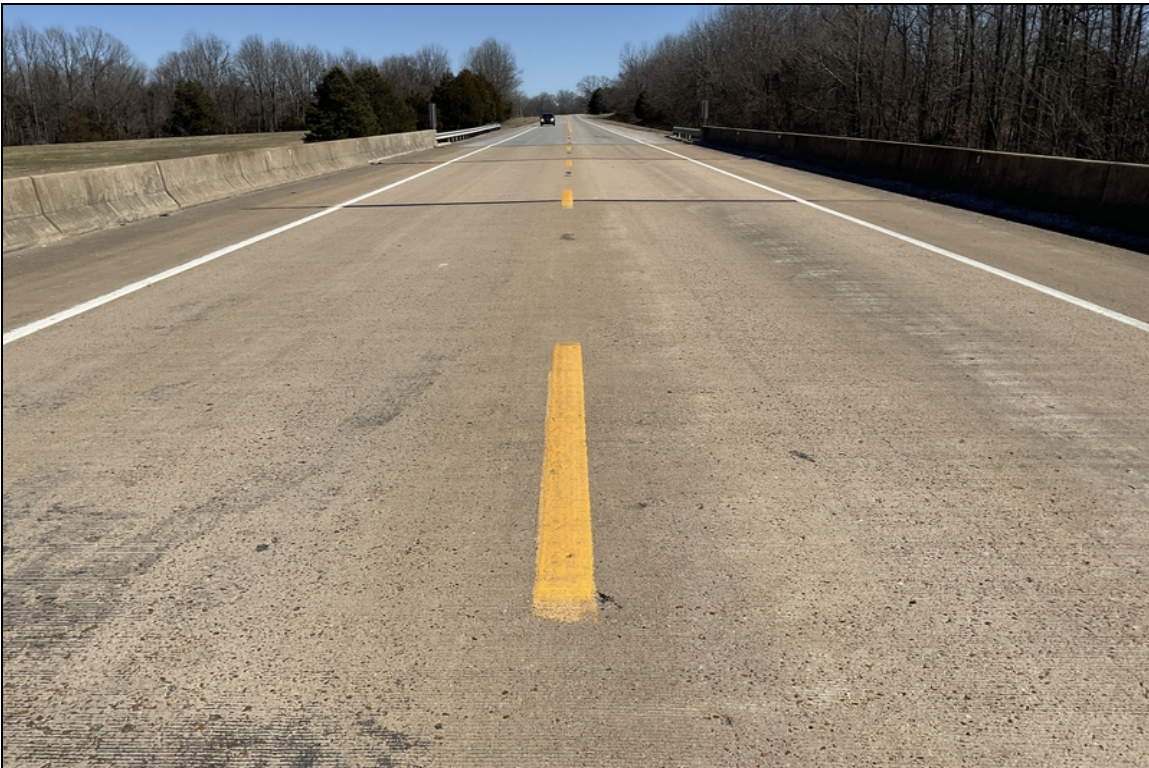
Overall deck @ span 1.

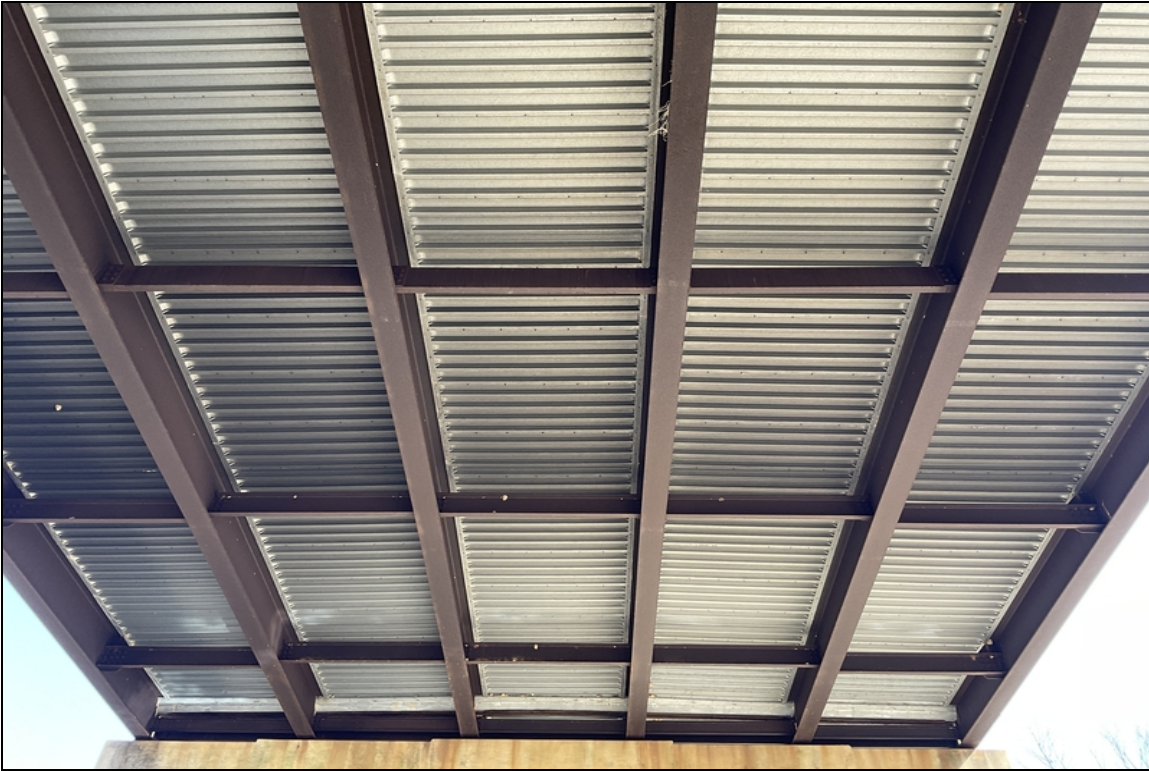
Overall deck below @ span 2.

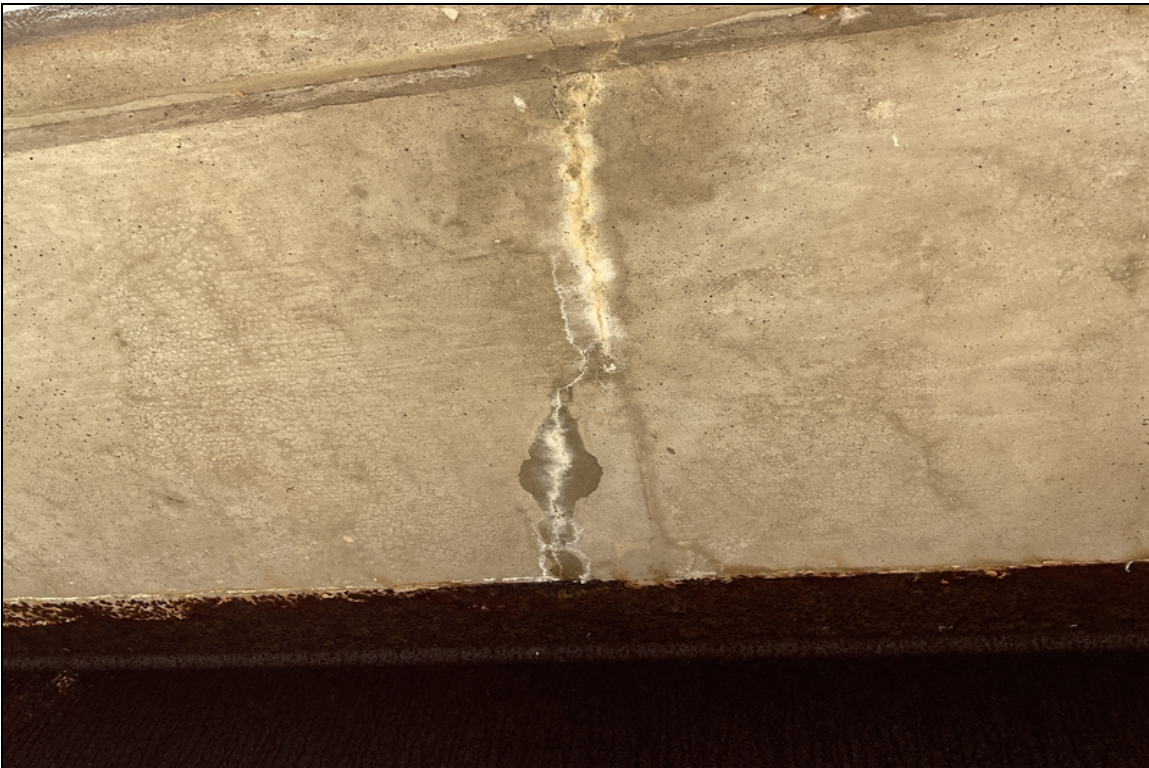
(12)	Several efflorescent cracks to Left & Right overhangs @ all spans. Transverse @ longitudinal cracking to deck @ all spans.						
107	Steel Open Girder/Beam	LF	864	864	0	0	0
515	Steel Protective Coating	SF	5936	5936	0	0	0
205	Reinforced Concrete Column	EA	4	2	2	0	0
1130	Cracking (RC and Other)	EA	2	0	2	0	0

Typical efflor cracks to Lt & Rt overhangs.

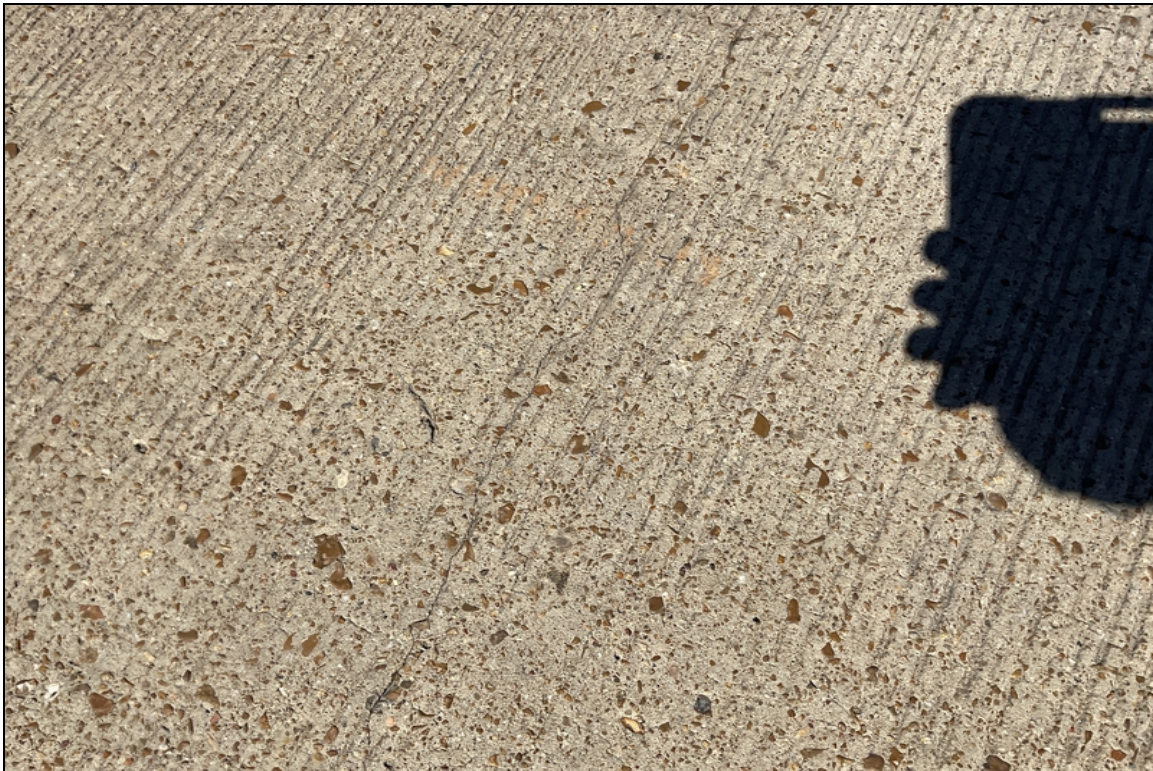
Typical cracks to deck @ all spans.

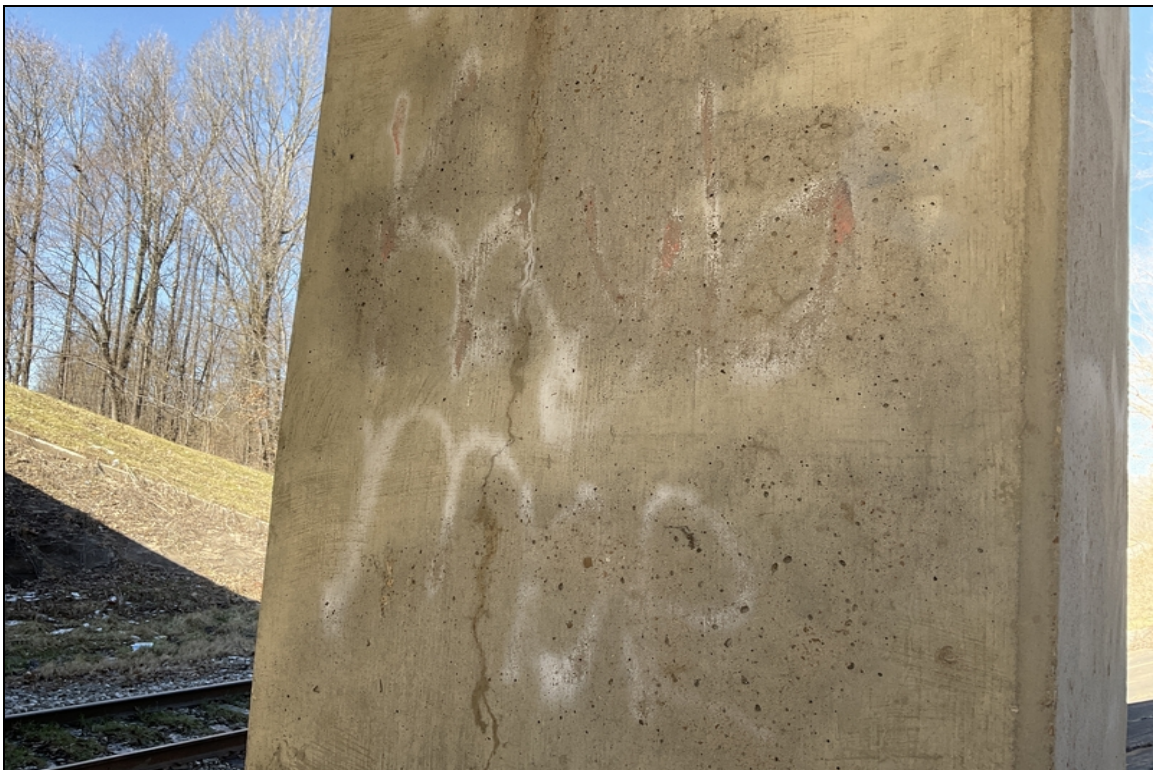
(205)	Vertical cracking to Columns 1 & 2 @ Bent 2.						
210	Reinforced Concrete Pier Wall	LF	44	32	12	0	0
1080	Delamination/Spall/Patched Area	LF	3	0	3	0	0
1090	Exposed Rebar	LF	1	0	1	0	0
1130	Cracking (RC and Other)	LF	8	0	8	0	0

Vertical crack to column 1 @ bent 2.

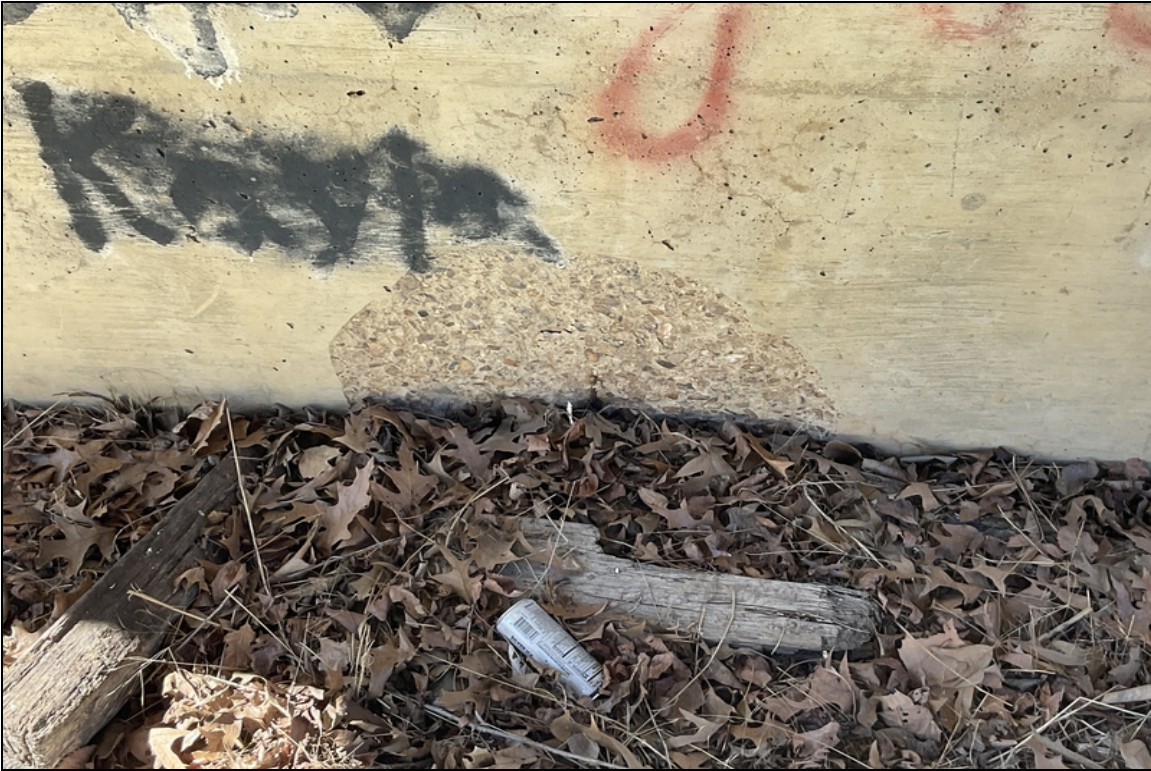
(210)	Minor cracking to Pier Walls @ Bents 1 & 2. Spall with rebar exposed no s/l to Pier wall @ Bent 2 ahead.						
215	Reinforced Concrete Abutment	LF	126	102	10	14	0
1120	Efflorescence/Rust Staining	LF	14	0	0	14	0
1130	Cracking (RC and Other)	LF	10	0	10	0	0

Spall to pier wall @ ahead side of bent 2.

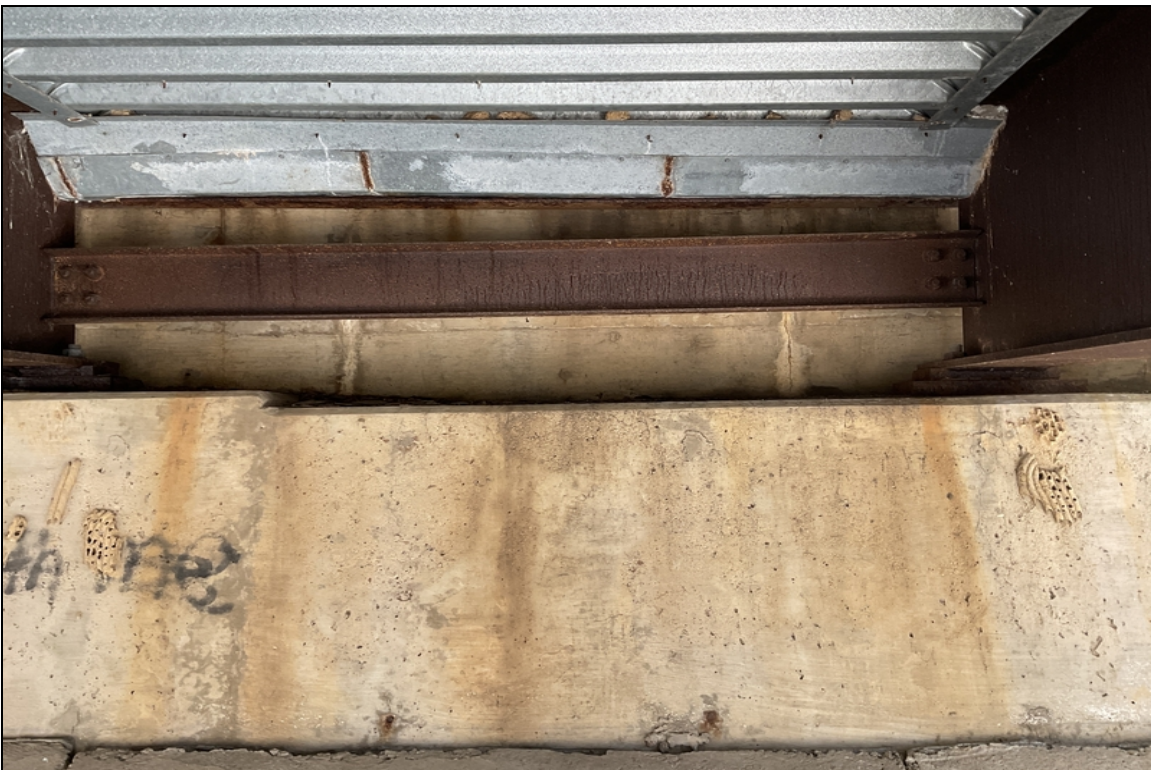
(215)	7 efflorescent cracks with rust stains to back wall @ Abutment 1. 6 cracks to Abutment 1. 7 efflorescent cracks with rust stains to back wall @ Abutment 2. 4 cracks to Abutment 2						
234	Reinforced Concrete Pier Cap	LF	82	81	1	0	0
1120	Efflorescence/Rust Staining	LF	1	0	1	0	0

Vertical efflor cracks to back wall @ abutments 1 & 2.

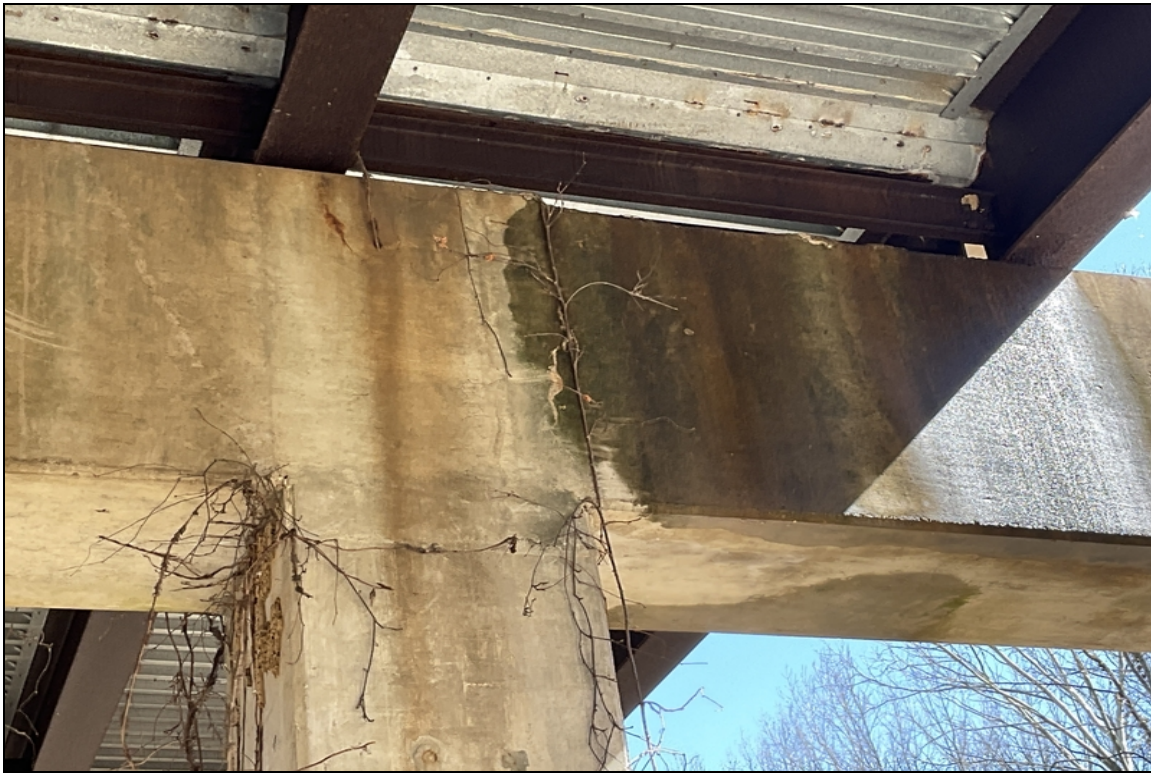
(234)	Efflorescent crack to Right end of cap @ Bent 1 backside.						
302	Compression Joint Seal	LF	172	147	0	25	0
2340	Seal Cracking	LF	25	0	0	25	0

Efflor crack to cap, rt side @ backside of bent 1.

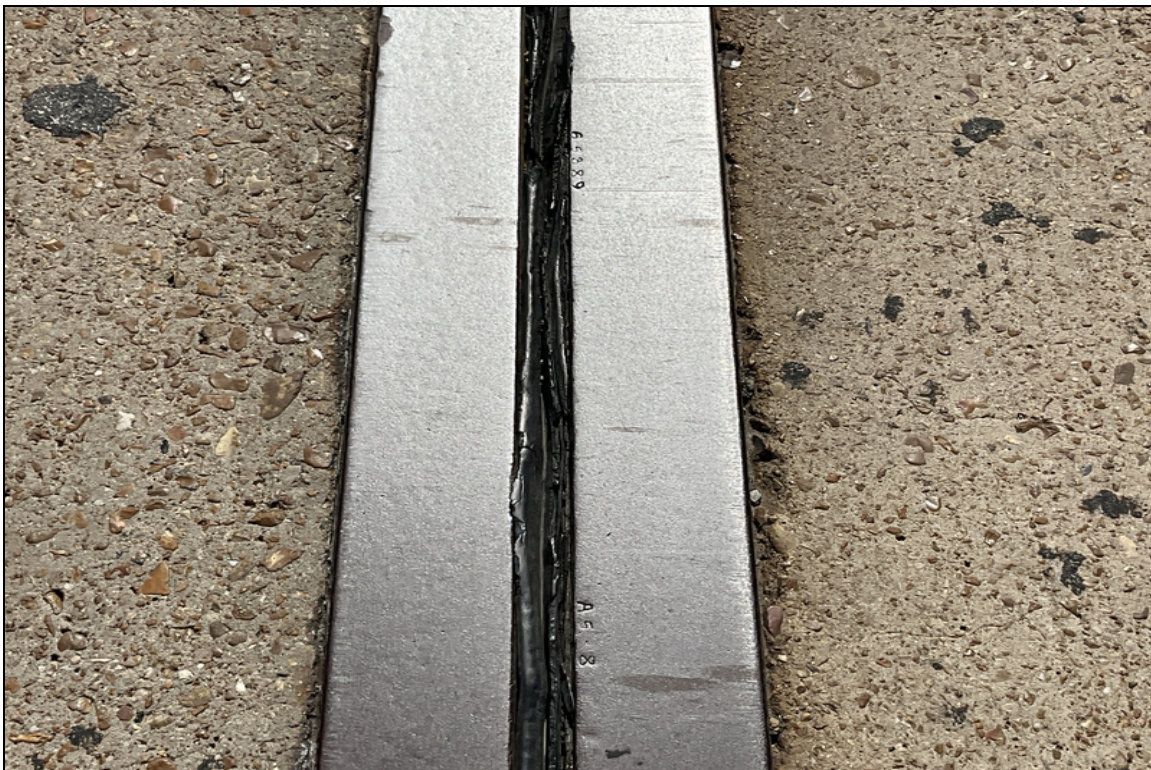
ELEM	DESCRIPTION	UNITS	TOTAL	CS1	CS2	CS3	CS4
(302)							
Joint seal @ Bent 2 is deteriorated & cracking. Minor debris @ all joints.							
311	Movable Bearing	EA	18	18	0	0	0
515	Steel Protective Coating	SF	36	36	0	0	0
313	Fixed Bearing	EA	18	18	0	0	0
515	Steel Protective Coating	SF	36	36	0	0	0
331	Reinforced Concrete Bridge Railing	LF	292	254	38	0	0
1130	Cracking (RC and Other)	LF	38	0	38	0	0
(331)							
Vertical cracking to parapets.

Cracking to joint seals @ all bents.
