Bridge #06771(Routine)

SH 69/Independ Co. over RR Track

Team Lead: Kerry Little Inspection Date: September 21, 2021

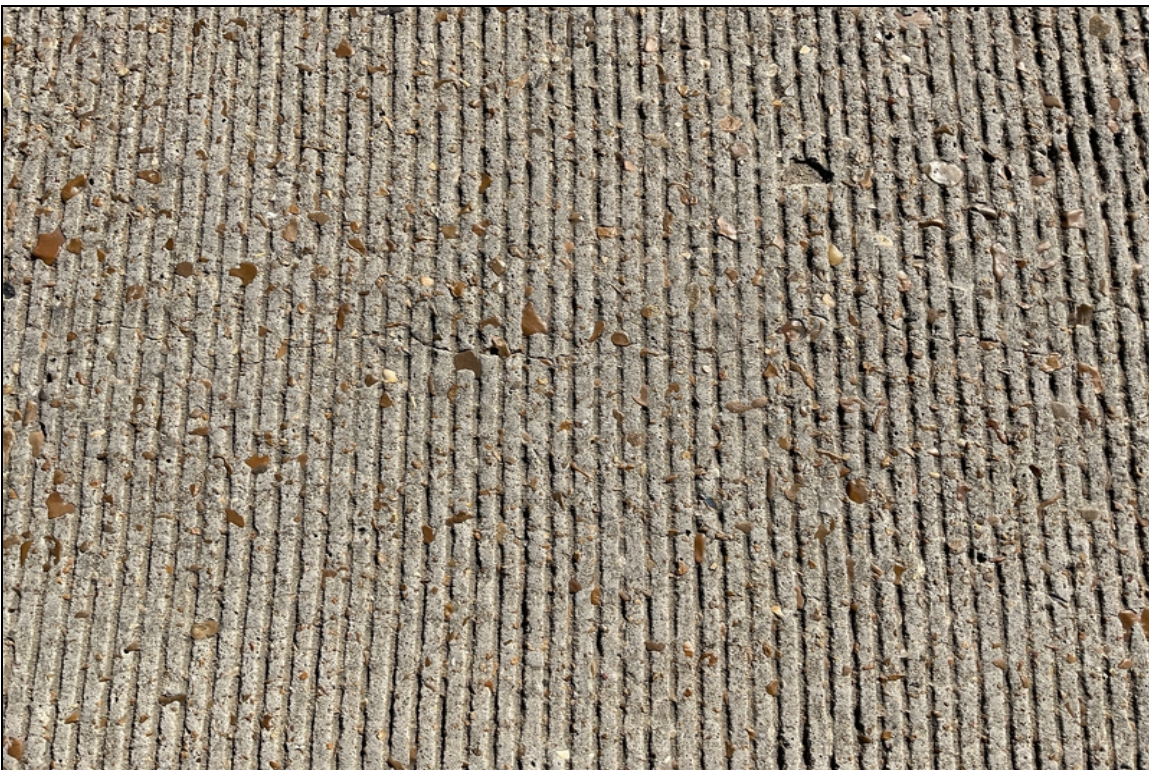
(12)	Transverse efflorescent cracks to overhangs and outside edge of deck @ all spans. Unsealed cracks to deck.						
107	Steel Open Girder/Beam	LF	4529	4529	0	0	0
515	Steel Protective Coating	SF	40036	40036	0	0	0
205	Reinforced Concrete Column	EA	26	26	0	0	0
210	Reinforced Concrete Pier Wall	LF	20	20	0	0	0
215	Reinforced Concrete Abutment	LF	127	112	15	0	0
1120	Efflorescence/Rust Staining	LF	15	0	15	0	0

Typical cracks to deck @ all spans.

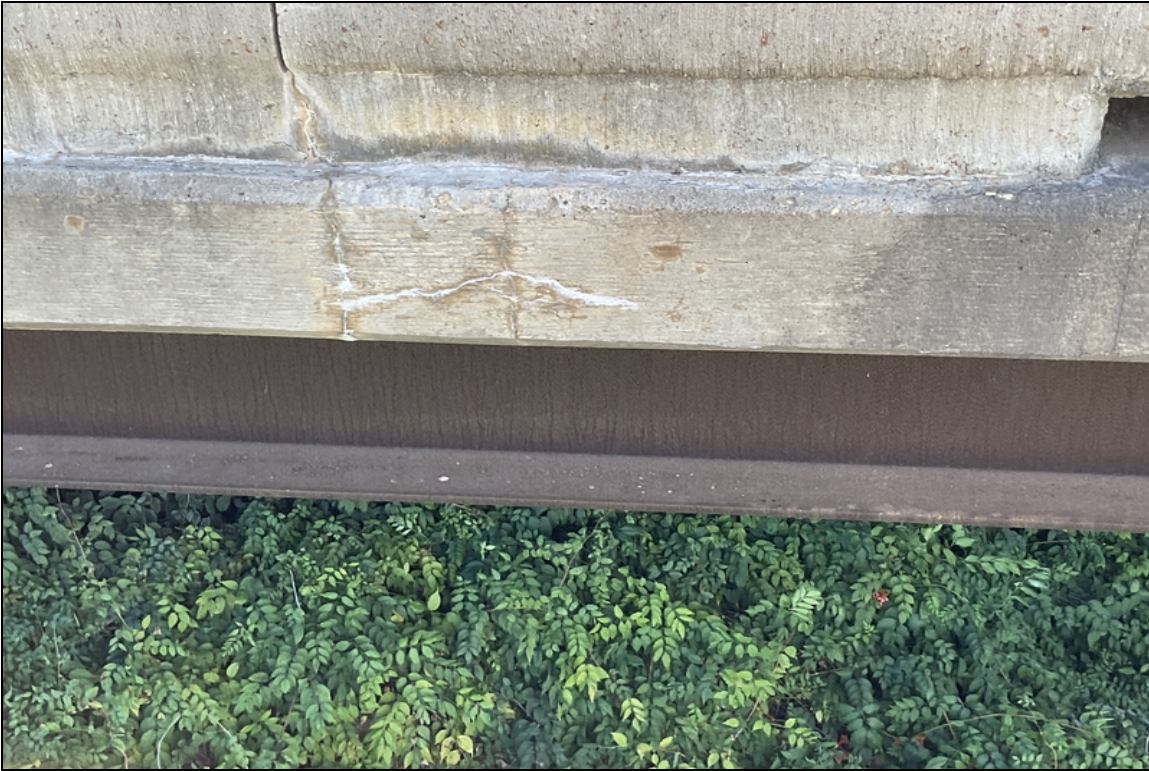
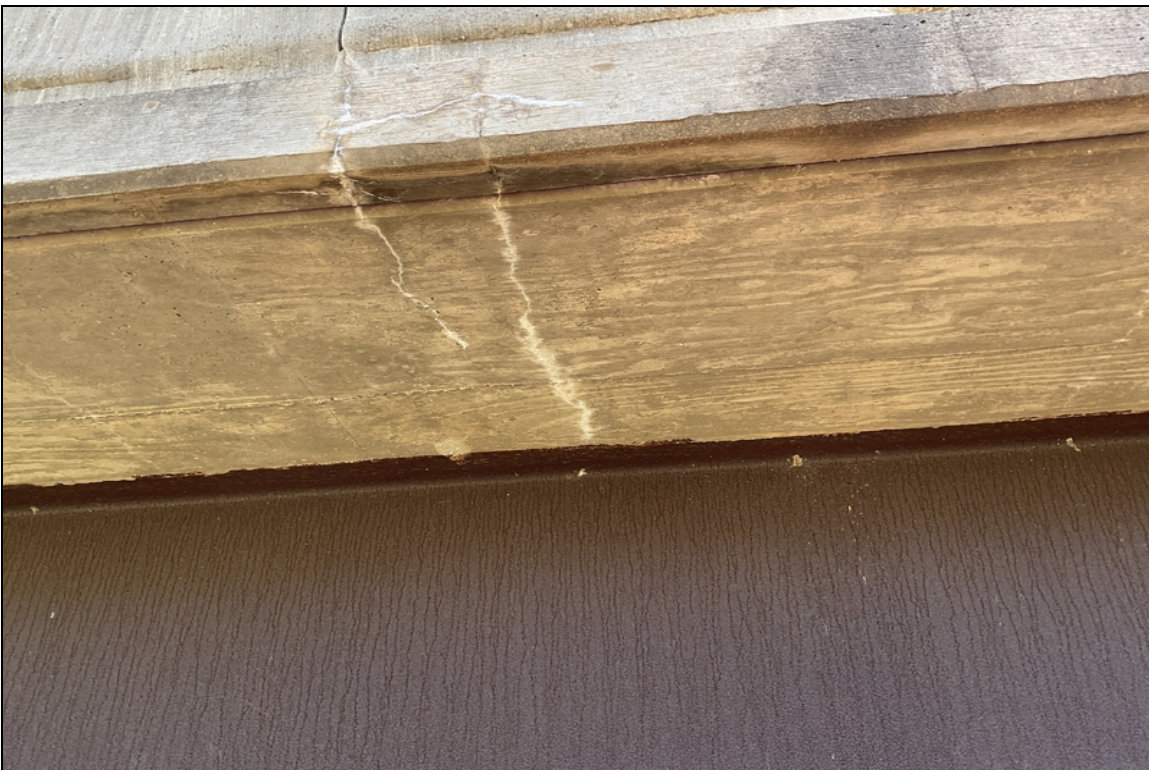
Typical efflor cracks to Lt & Rt overhangs.

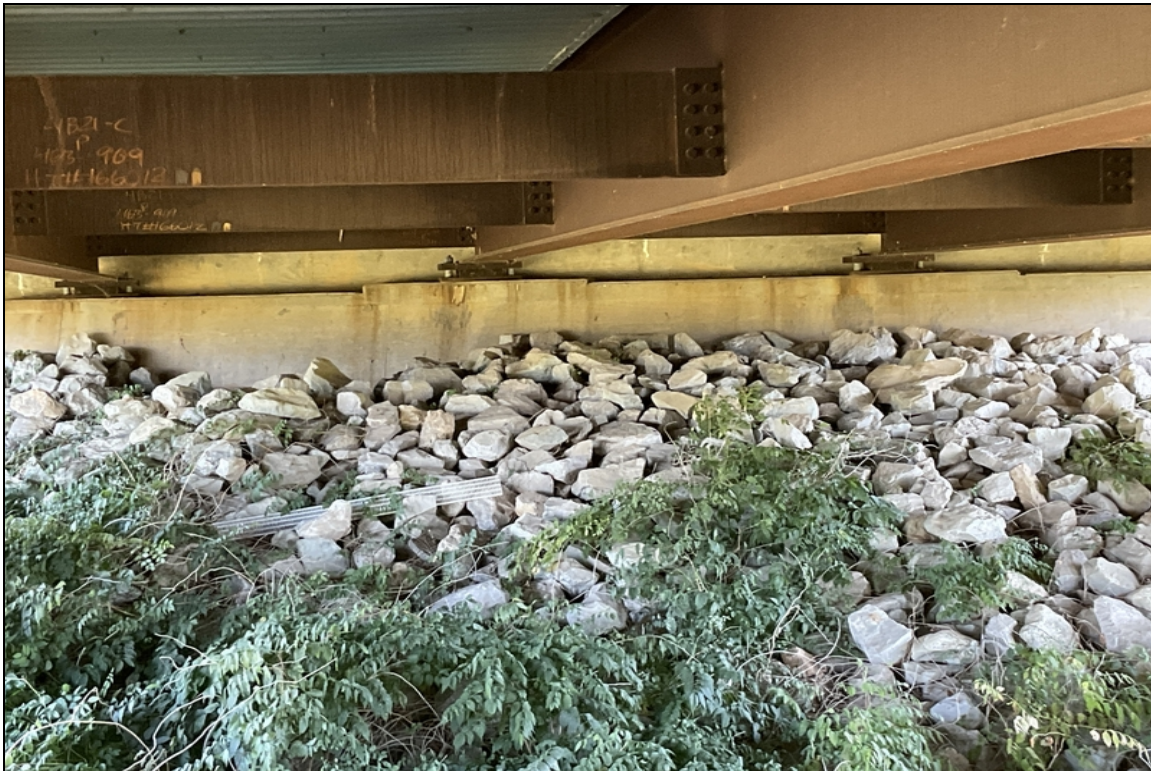
(215)	6 efflorescent cracks to back wall @ Abutment 1. 9 efflorescent cracks to back wall @ Abutment 2.						
234	Reinforced Concrete Pier Cap	LF	537	534	3	0	0
1010	Cracking	LF	3	0	3	0	0

Efflor cracks @ abutment 1.

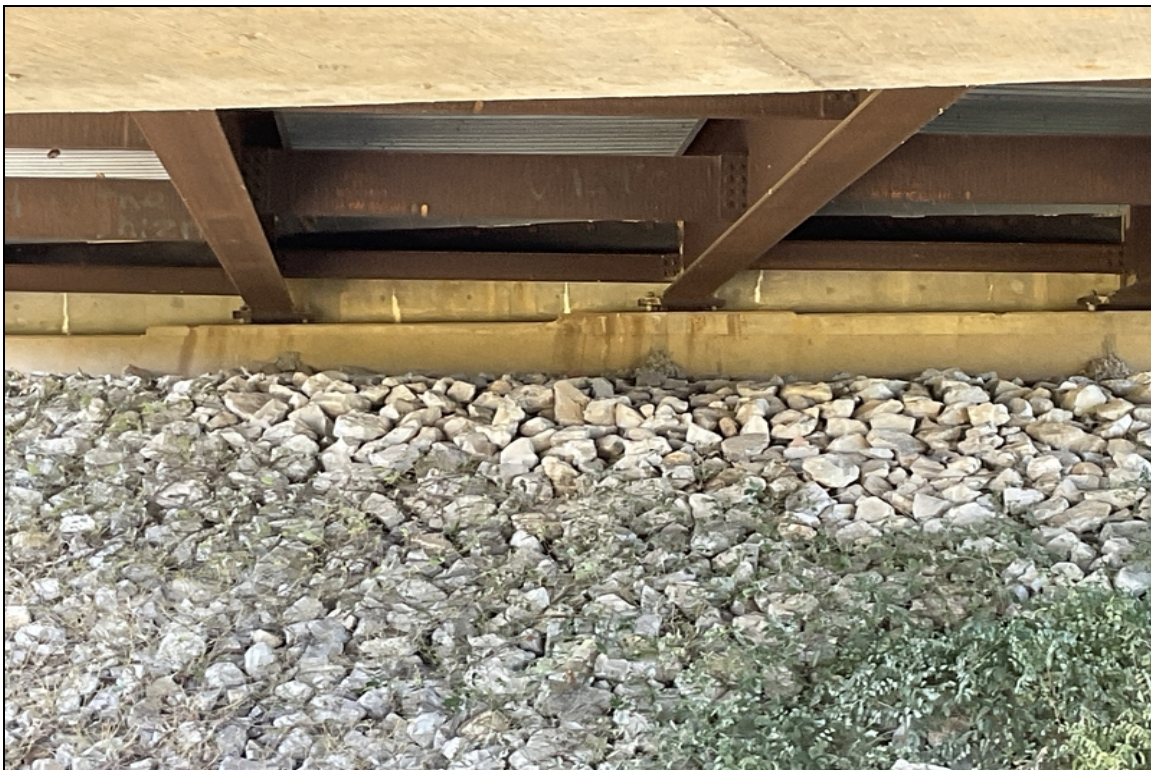
Efflor cracks @ abutment 2.

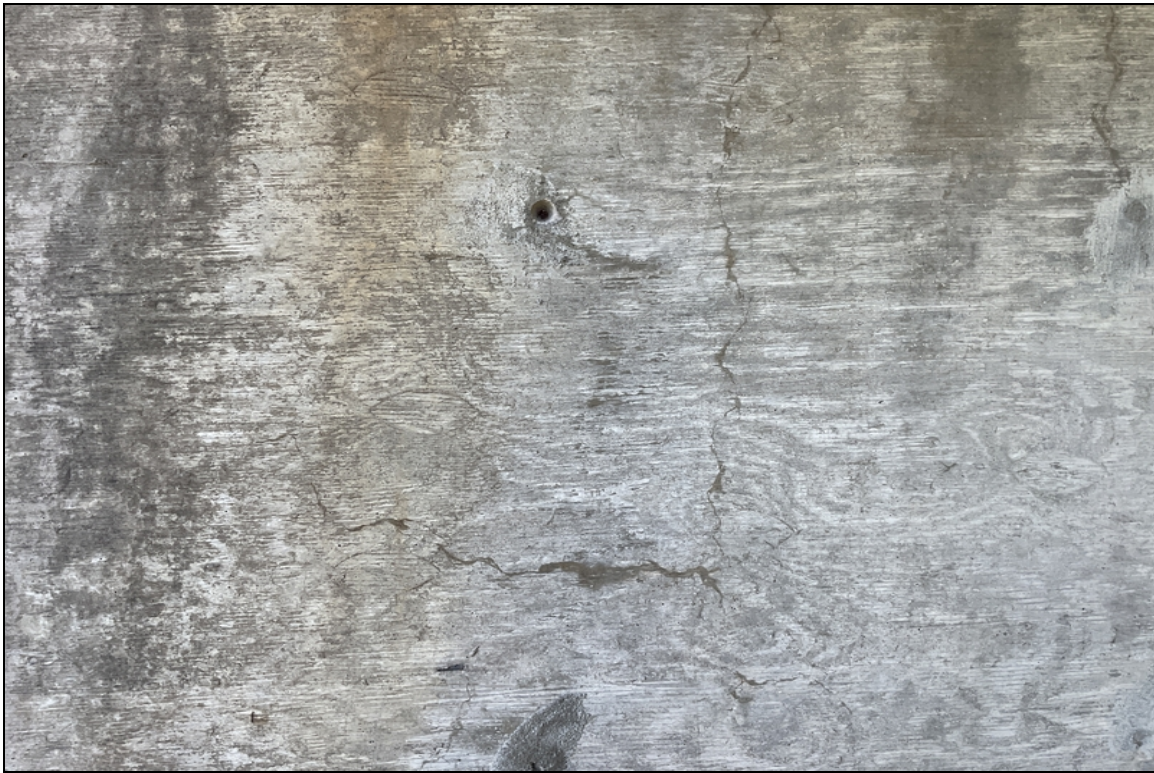
(234)	A few minor vertical cracks to cap, some with minor efflorescence. Bent 8 - 3' of efflor. cracking near Rt. end, ahd. side of cap.						
303	Assembly Joint with Seal	LF	222	0	222	0	0
2350	Debris Impaction	LF	222	0	222	0	0

Minor cracks to rt side of cap @ bent 8.

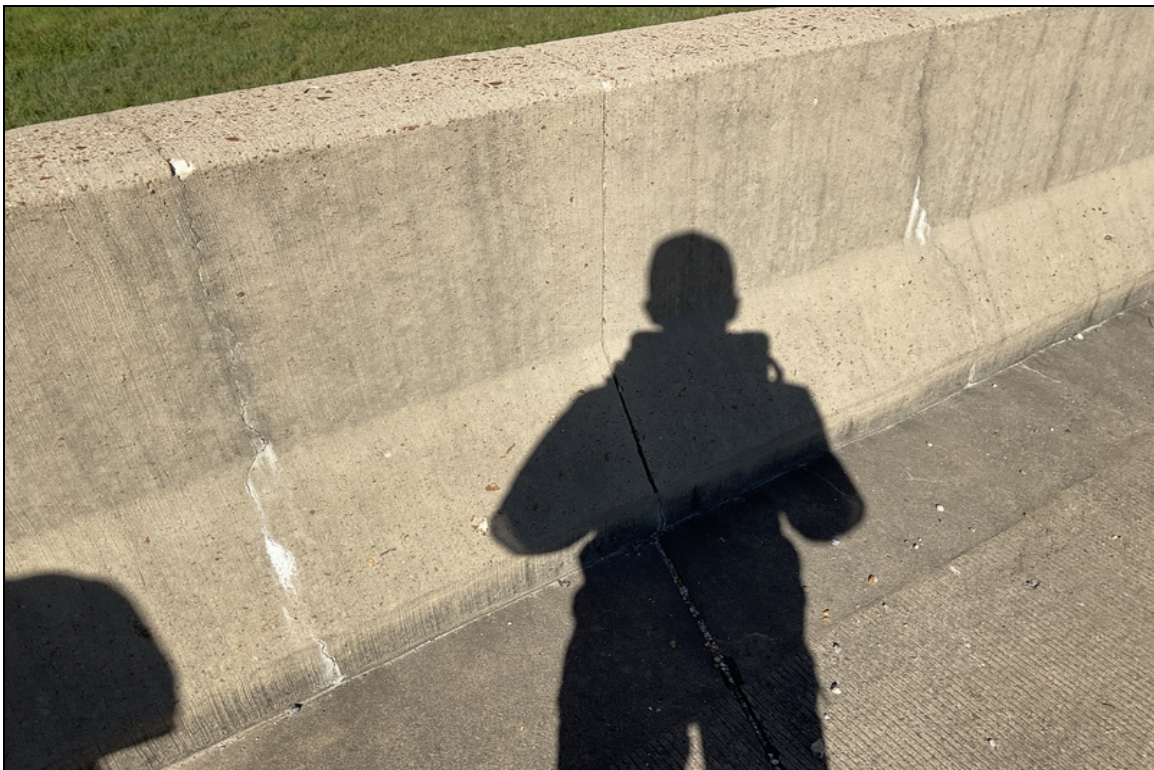
ELEM	DESCRIPTION	UNITS	TOTAL	CS1	CS2	CS3	CS4
1130	Cracking (RC and Other)	LF	100	0	100	0	0
(331)	Minor transverse efflorescent cracks with some map cracking to parapet walls @ all spans. Spall with 1' rebar exposed no rebar to Right parapet wall @ Span 11.

Typical efflor cracks to Lt & Rt parapet wall.

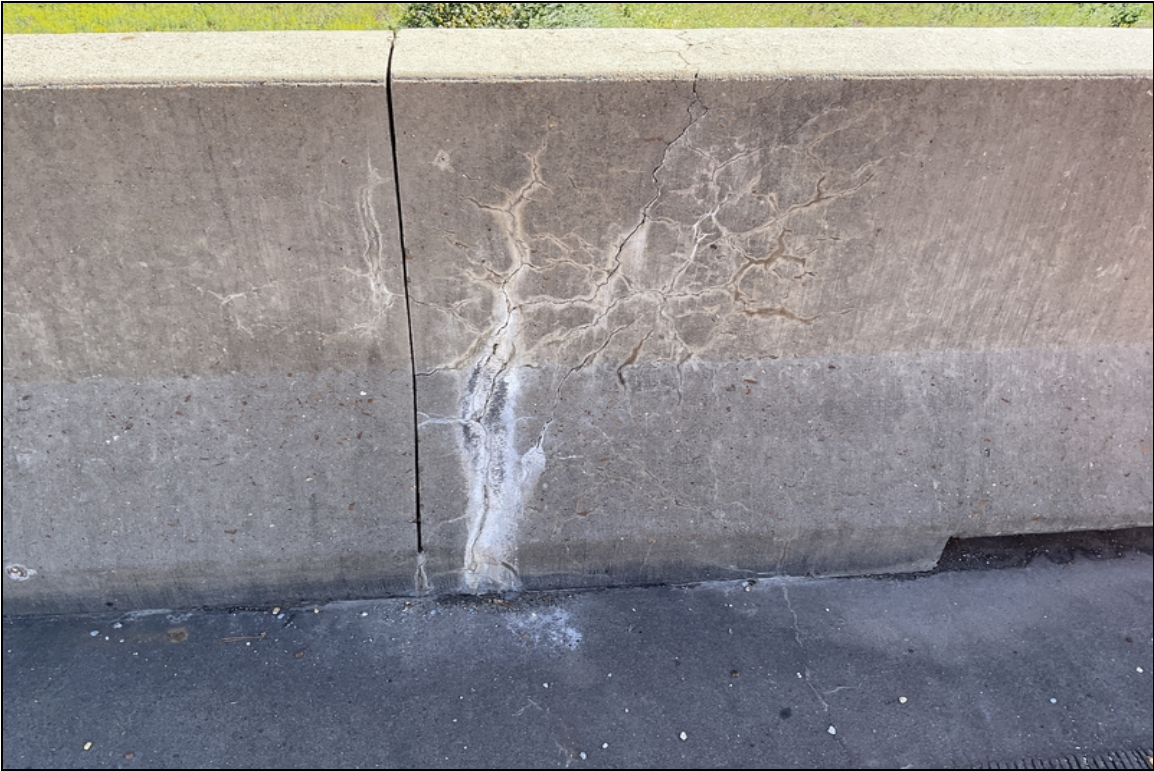
Efflorescence map cracking to Lt parapet wall @ spans 2 & 3.

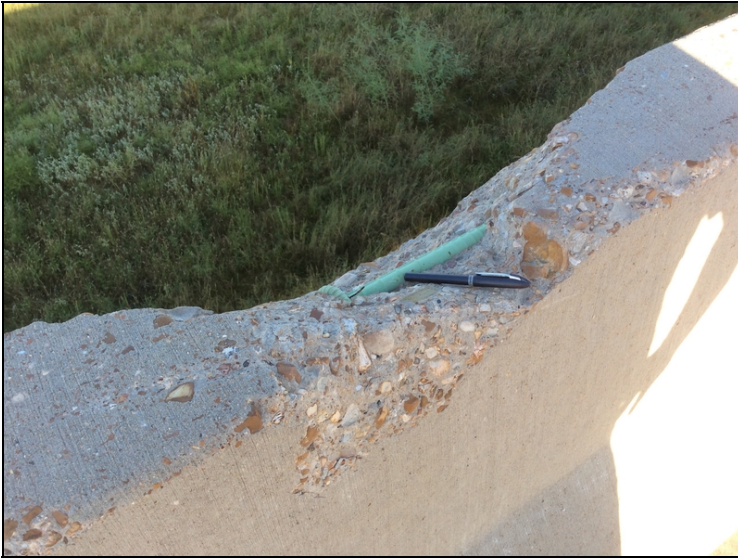
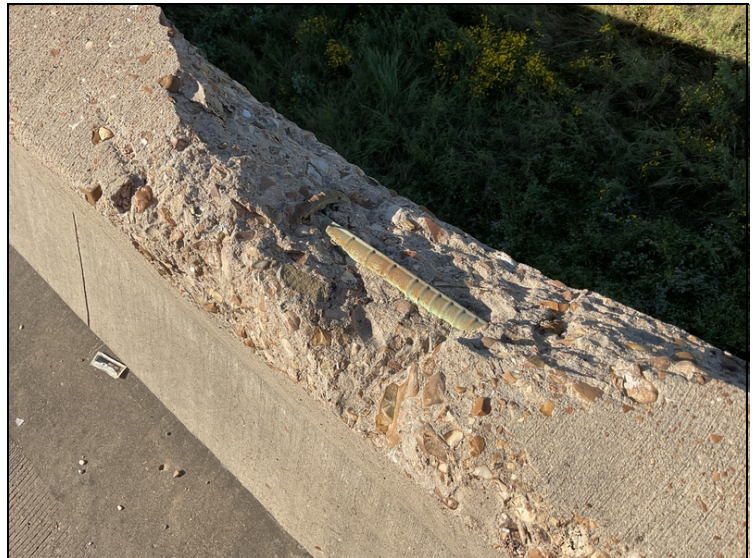
Large spall with 1' rebar exposed to Right parapet wall @ Span 11.

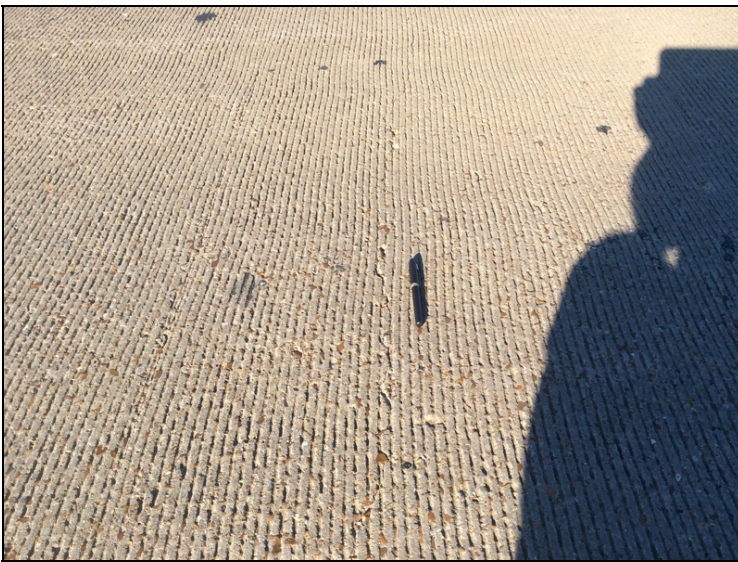
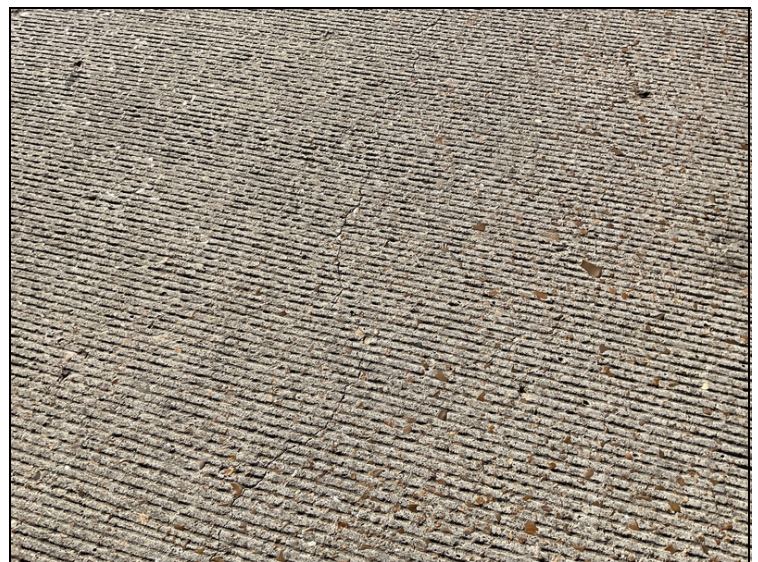
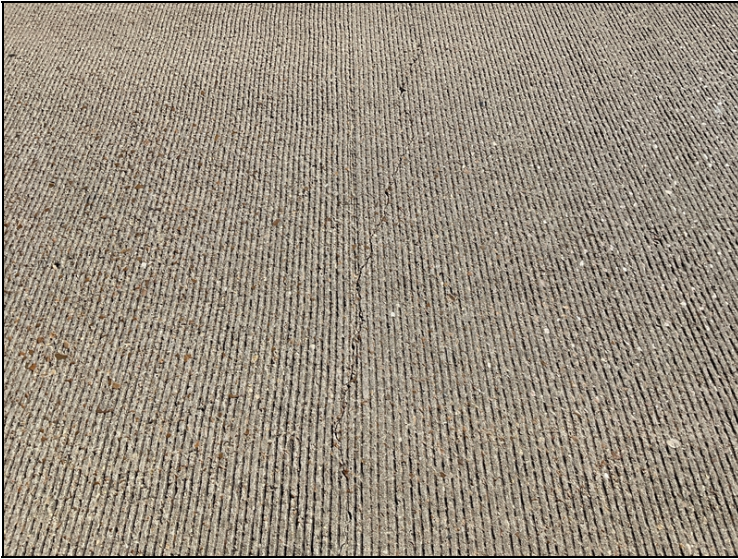
Unsealed cracks to deck @ all Spans.

Typical unsealed cracks to deck @ all spans.

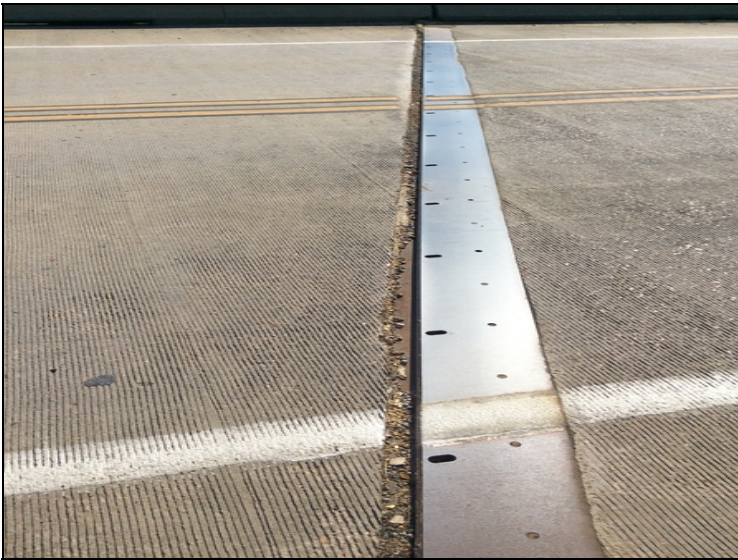
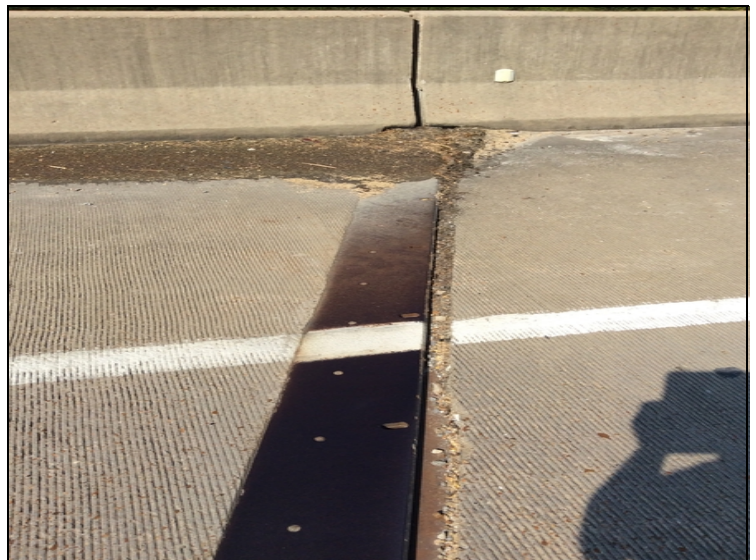
(303)	All joints are full of debris. (movement still possible @ this time.)						
310	Elastomeric Bearing	EA	90	89	1	0	0
1020	Connection	EA	1	0	1	0	0
515	Steel Protective Coating	SF	270	270	0	0	0

Debris in all joints.
