Bridge #02528(Routine)
SH 17/Jackson Co. over OVERCUP DITCH
Location: SOUTH EDGE OF TUPELO

Team Lead: Kerry Little **Inspection Date:** December 13, 2021

IDENTIFICATION	
(1) State Names	Arkansas
(8) Structure Number	02528
(5) Inventory Route	17
(2) Highway Agency District	05
(3) County Code	67-Jackson County, Arkansas

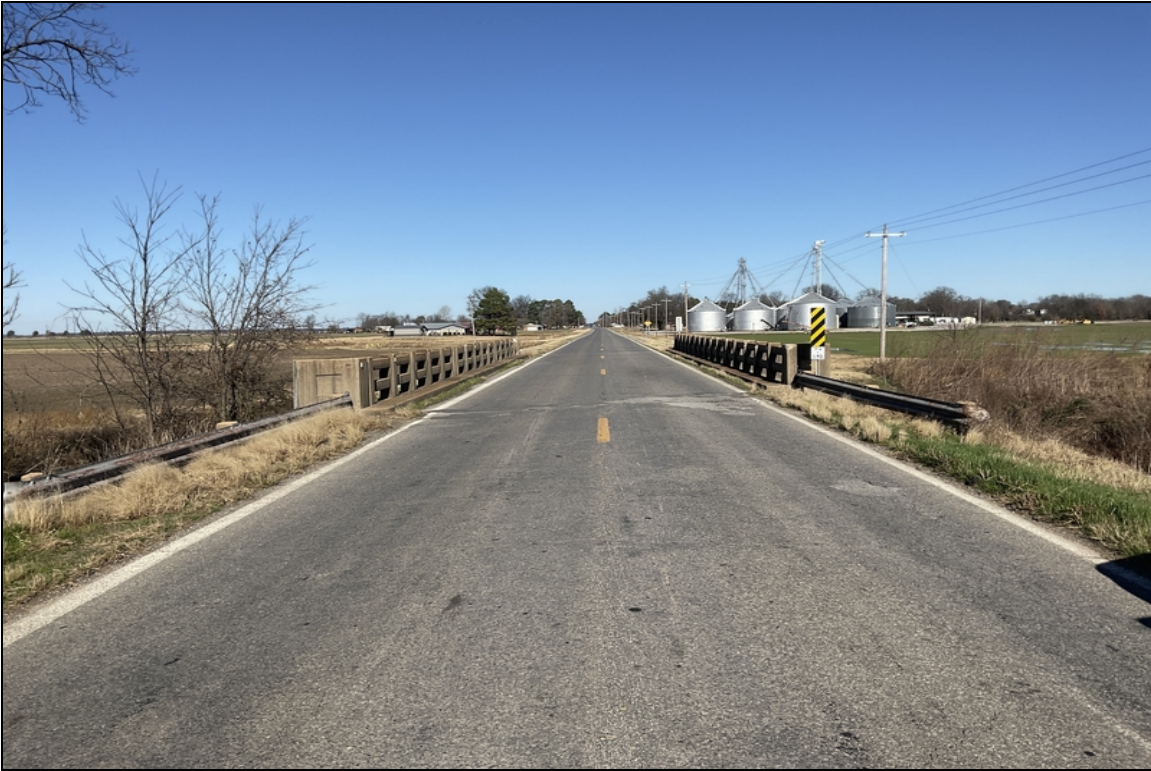
Roadway with log mile looking north.

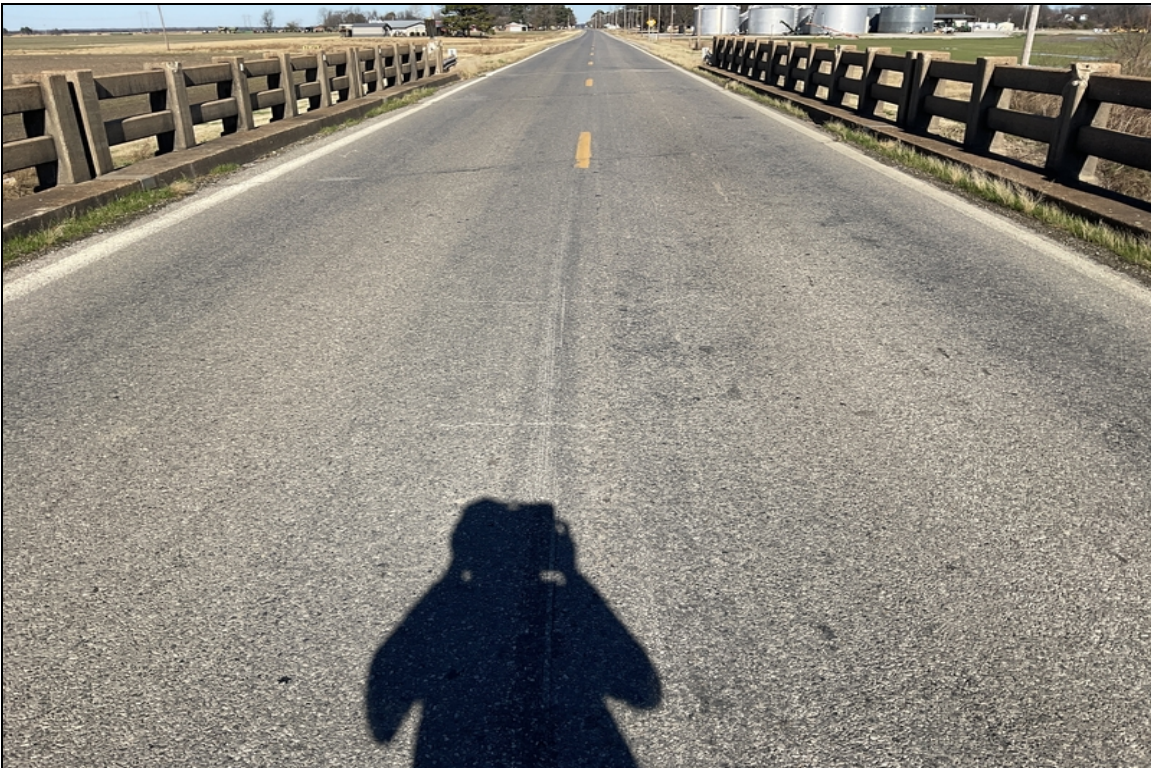
Overall deck.

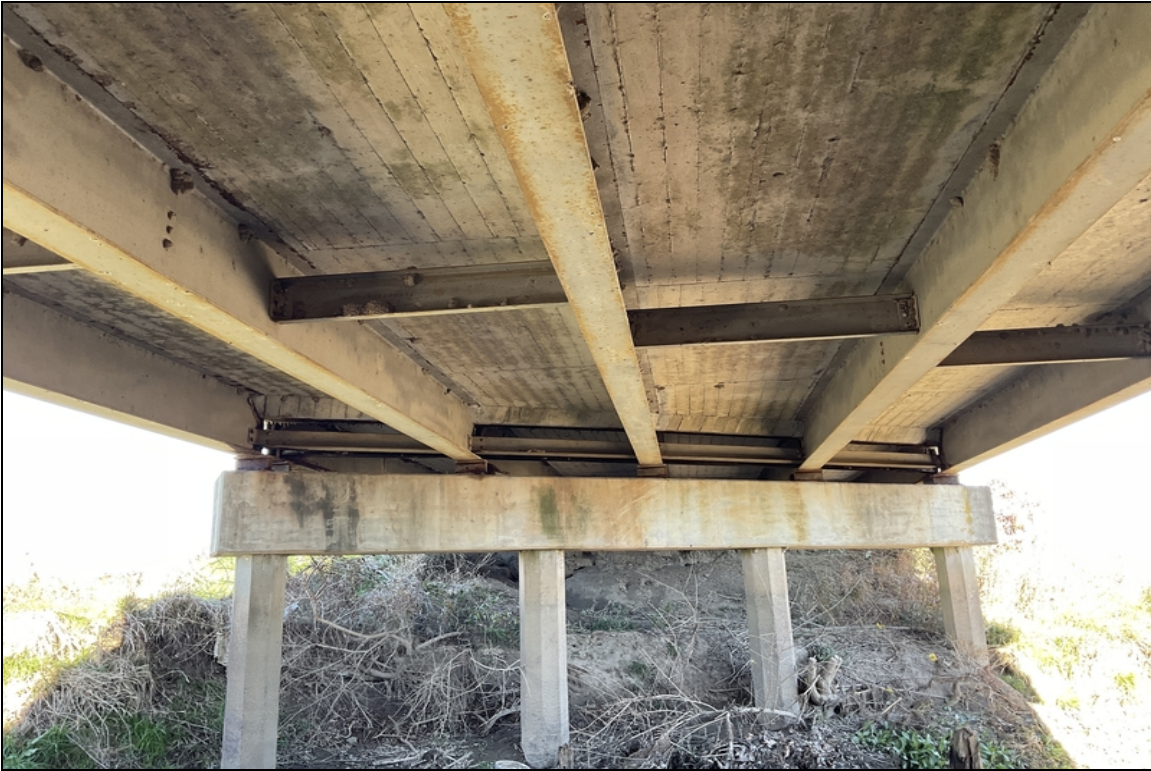
Overall soffit @ span 2.

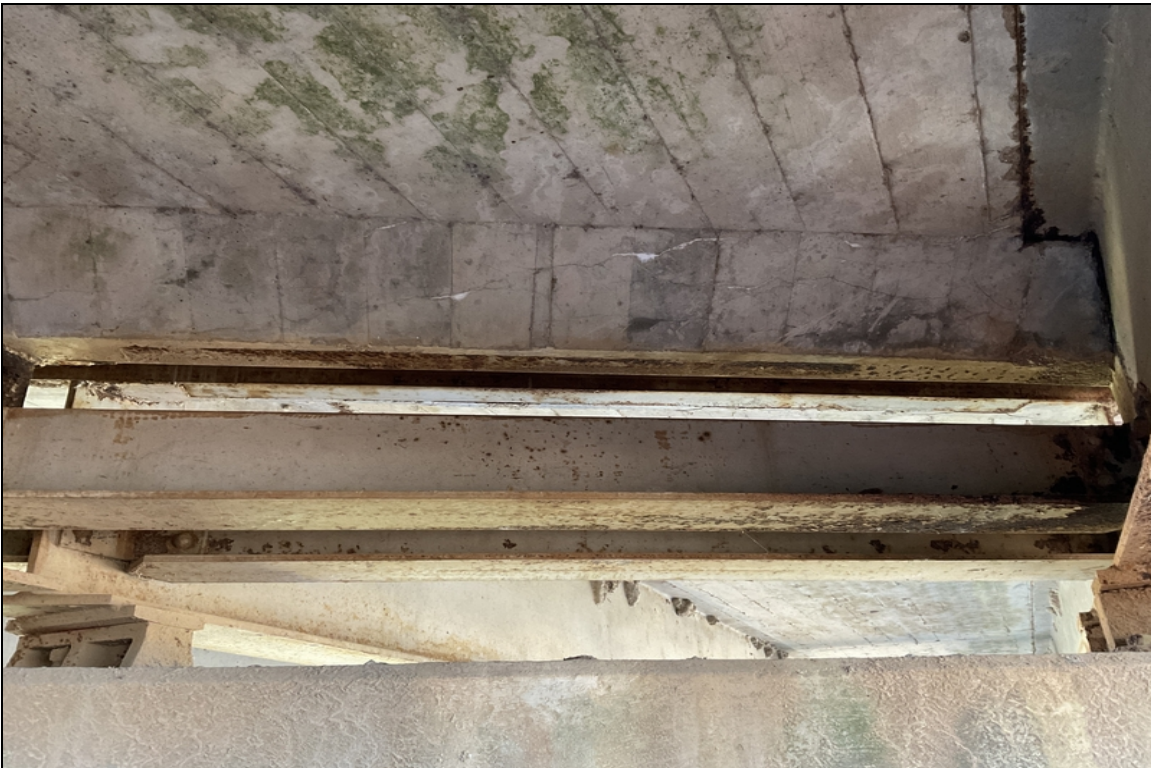
(12)							
Transverse cracks to Left and Right curbs. Efflorescent cracks to Left & Right overhangs and to Concrete haunch between ends of girders. Asphalt overlay cracked at Joints and minor cracking to all spans. Asphalt overlay @ Span 2 is beginning to pothole.							
107	Steel Open Girder/Beam	LF	515	172	250	91	2
1000	Corrosion	LF	342	0	250	90	2
1900	Distortion	LF	1	0	0	1	0
515	Steel Protective Coating	SF	3157	1737	1000	200	220
3440	Effectiveness (Steel Protective Coatings)	SF	1420	0	1000	200	220

Efflorescent cracks to Left & Right overhangs and to Concrete haunch between ends of girders.

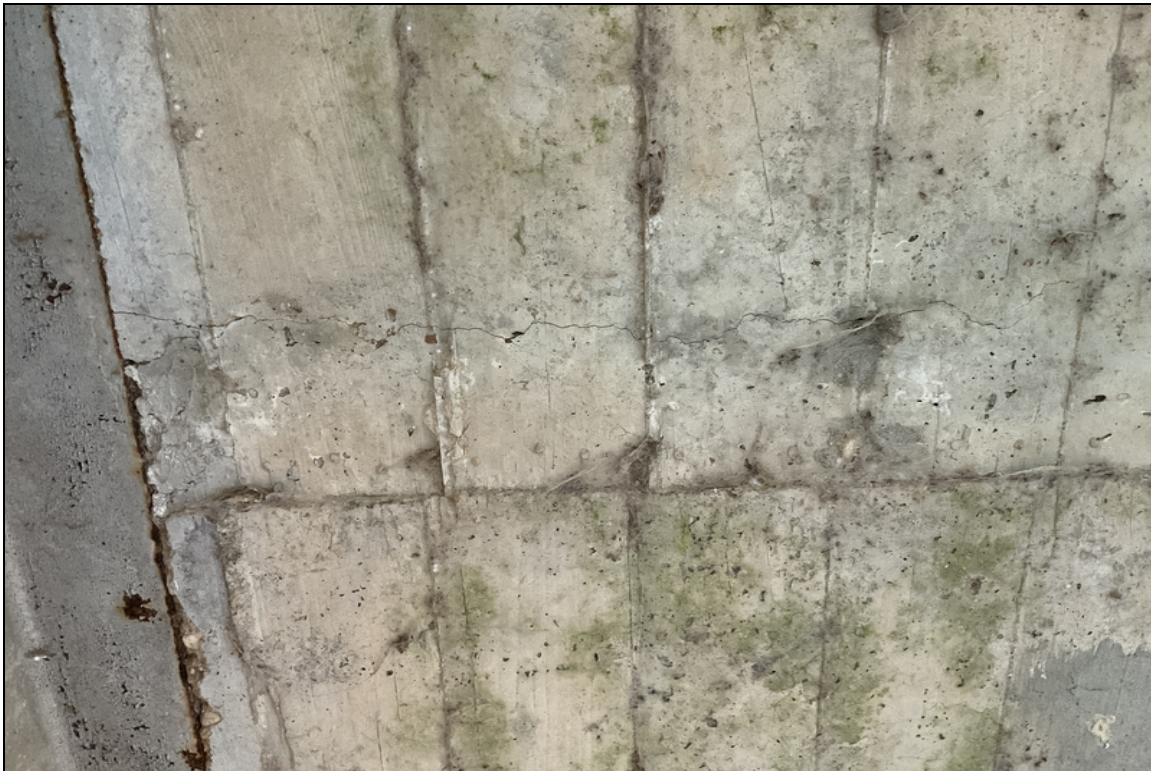
Typical cracks to soffit.

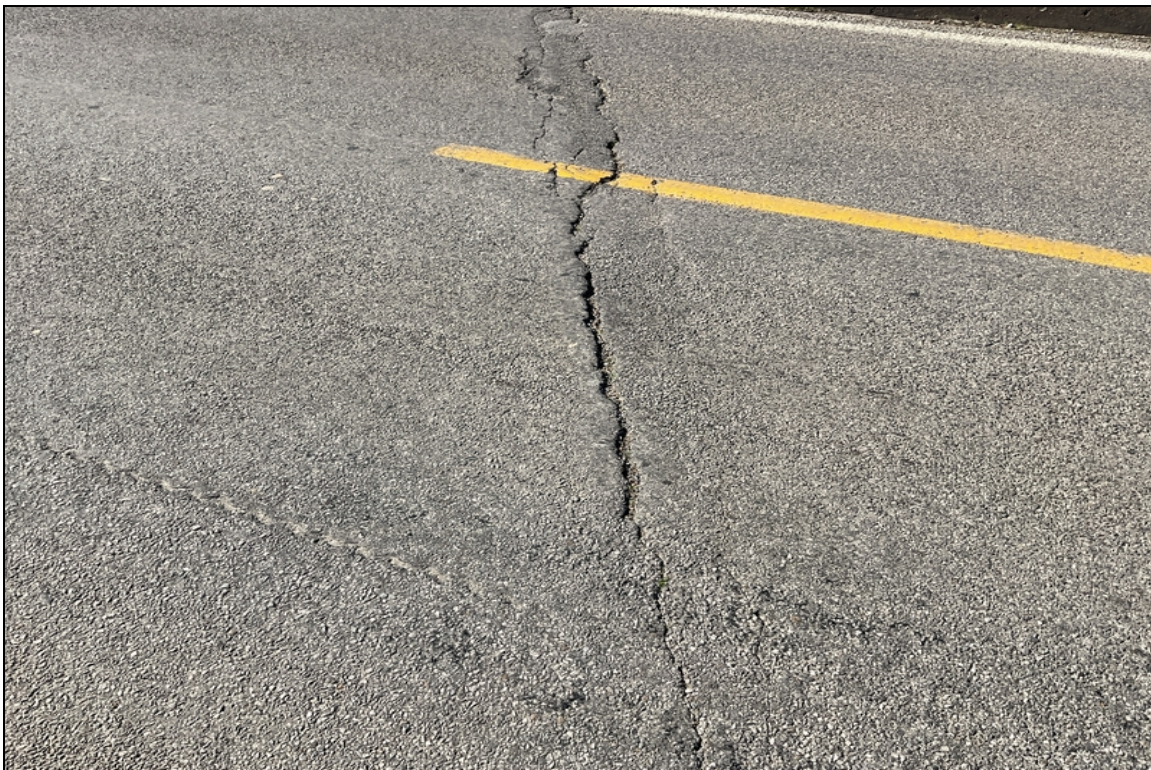
Typical cracks to wearing surface @ all joints.

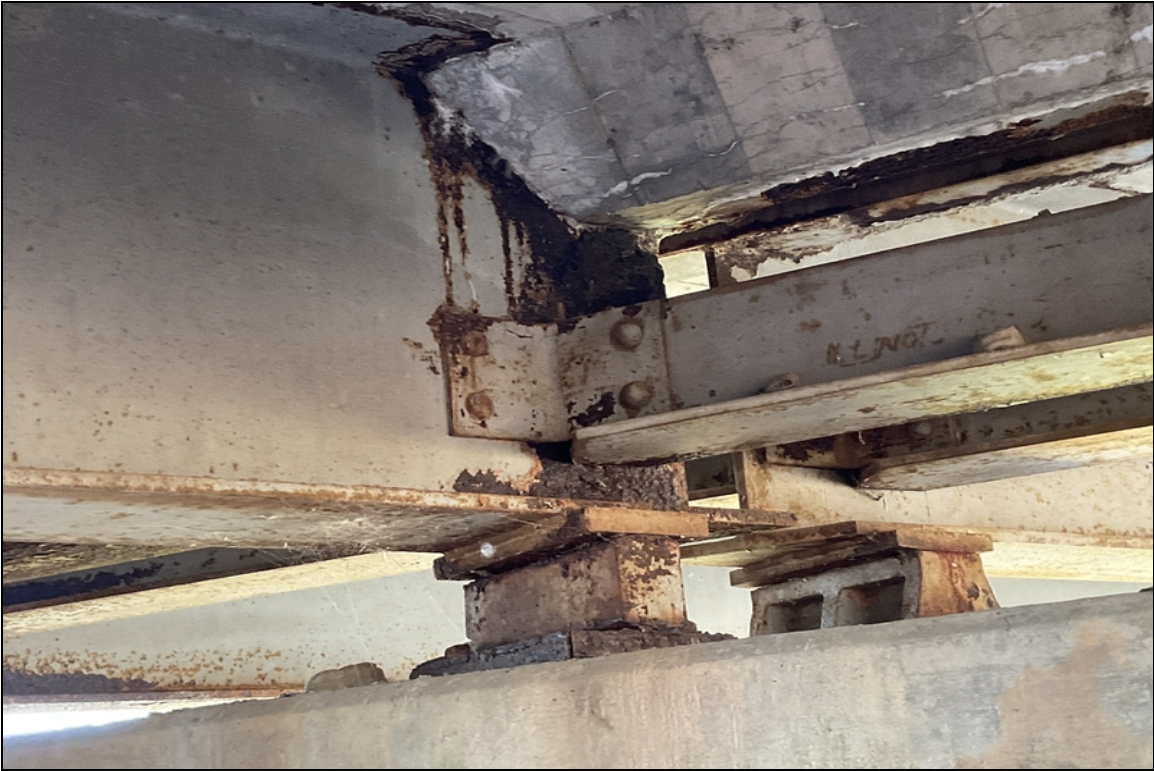
(107)							
Rust to ends of girders with moderate to severe section loss to webs @: Span 1 - Girder 1 & 5 @ beg. & end of span. Span 2 - Girder 1 & 5 @ beg. & end of span. Span 3 - Girder 1 & 5 @ beg. of span. Span 3 - Girders 2 & 4 have large holes in web below haunch @ beginning of span. Hole in diaphragm between Girders 1 & 2 @ beginning of Span 3.							
215	Reinforced Concrete Abutment	LF	80	68	12	0	0
6000	Scour	LF	12	0	12	0	0

Typical corrosion to girders @ all spans.

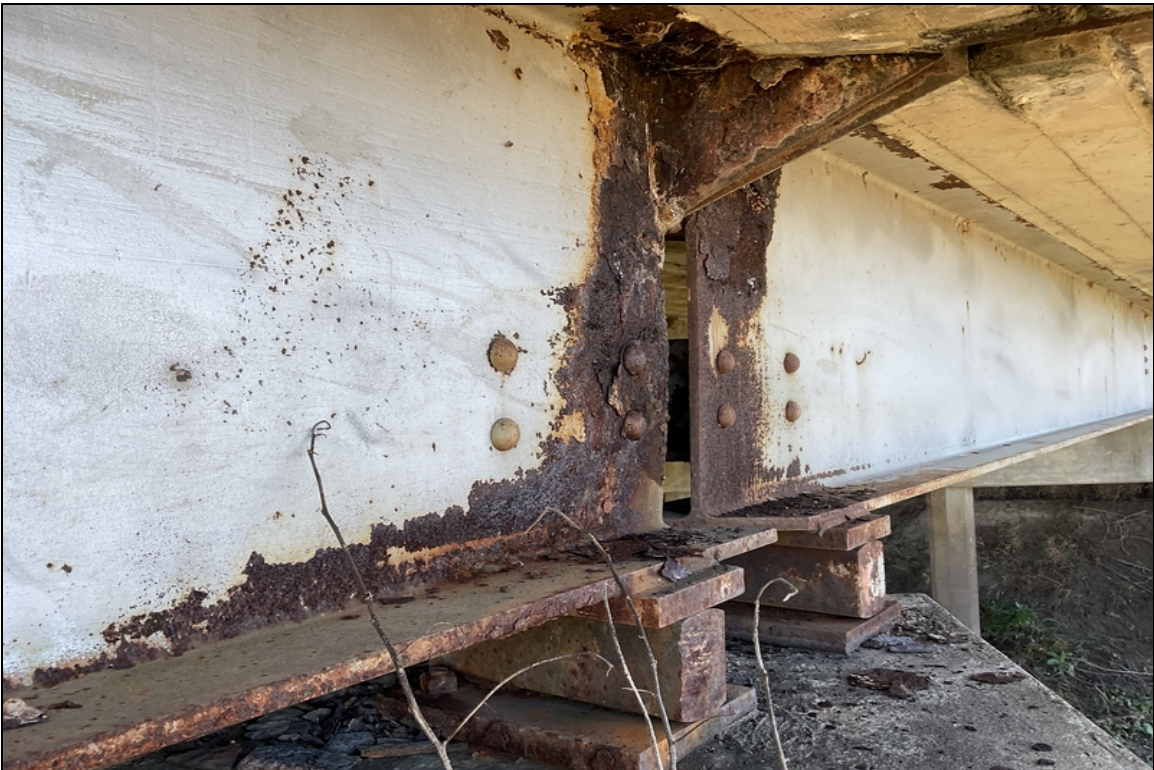
Girder 1 @ beginning of span 3 has out of plane bending & severe sections loss.

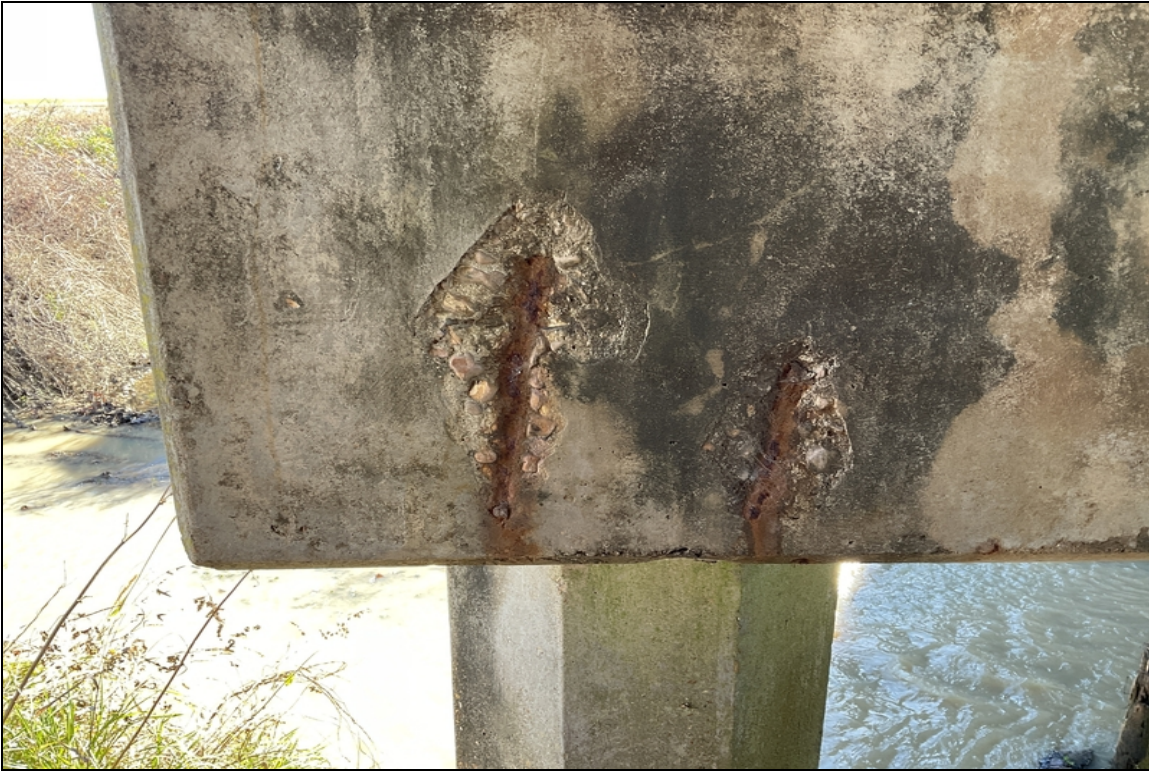
ELEM	DESCRIPTION	UNITS	TOTAL	CS1	CS2	CS3	CS4
Bent 2 has Spalls with 2' of exposed rebar to the Right end of Cap and 6" to the bottom Left end.							
305	Assembly Joint without Seal	LF	122	0	0	122	0
2350	Debris Impaction	LF	122	0	0	122	0

Spalls with rebar exposed to Lt & Rt ends of bent 2.

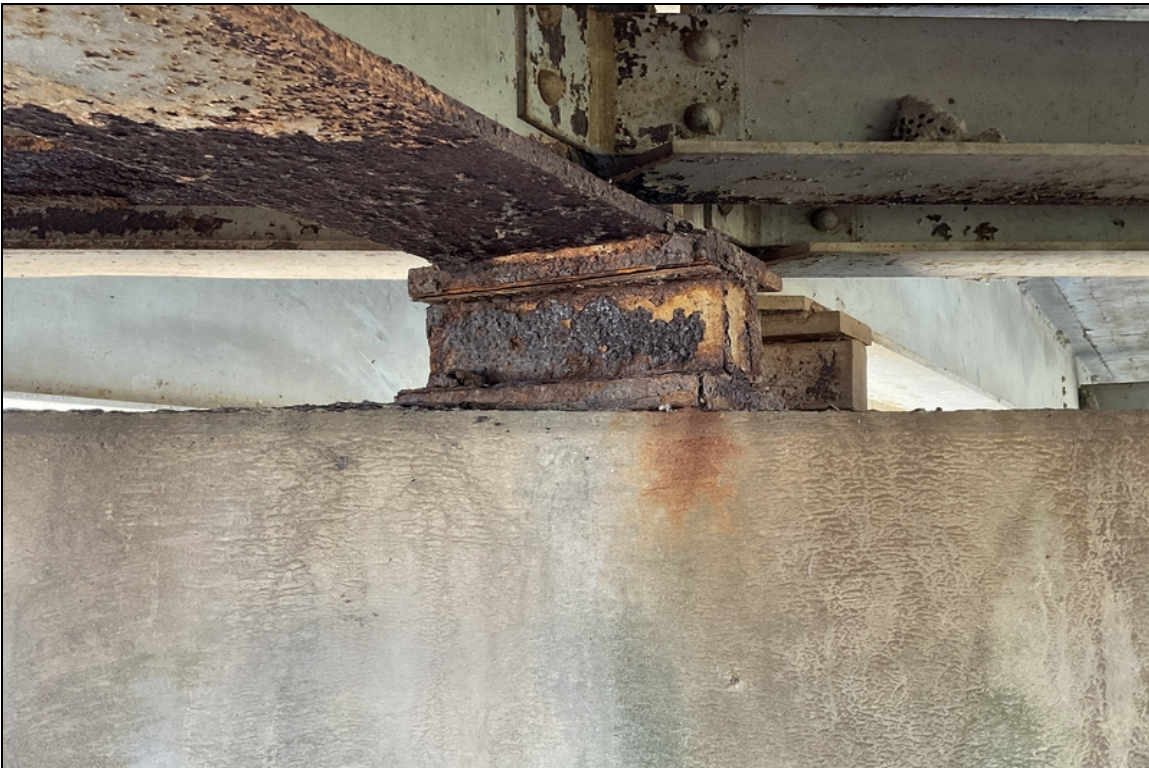
(311)							
Bearings are beginning to rust with minor section loss.							
313	Fixed Bearing	EA	15	0	11	4	0
1000	Corrosion	EA	15	0	11	4	0
515	Steel Protective Coating	SF	30	0	10	10	10
3440	Effectiveness (Steel Protective Coatings)	SF	30	0	10	10	10

Typical corrosion to bearings @ all bents.

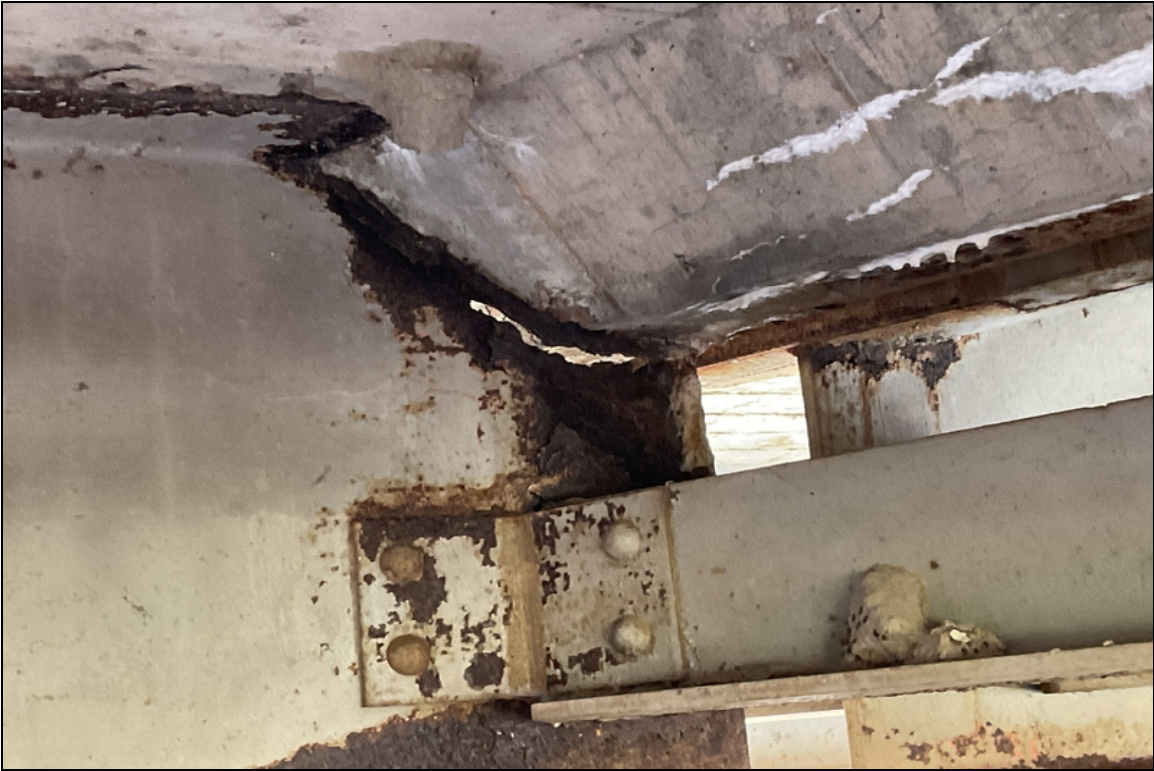
Span 3 - Girders 2 & 4 have large holes in web below haunch @ beginning of span.
Girders 4

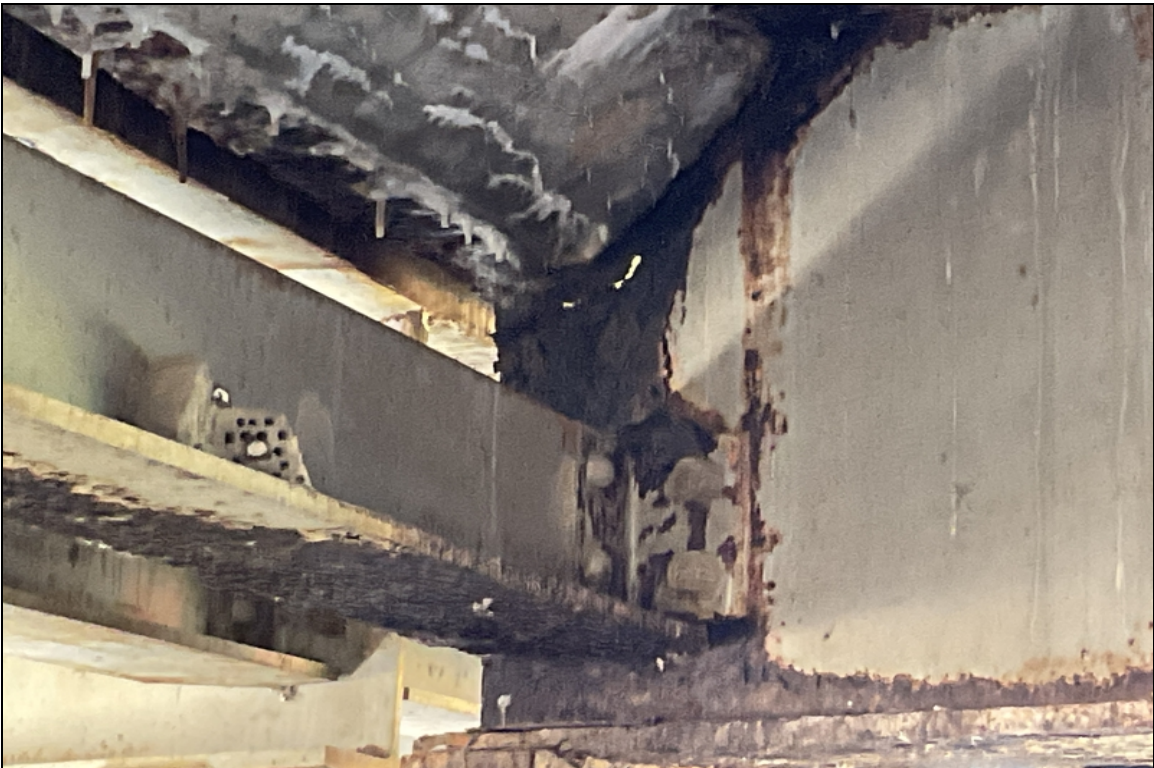
Span 3 - Girders 2 & 4 have large holes in web below haunch @ beginning of span.
Girder 2.

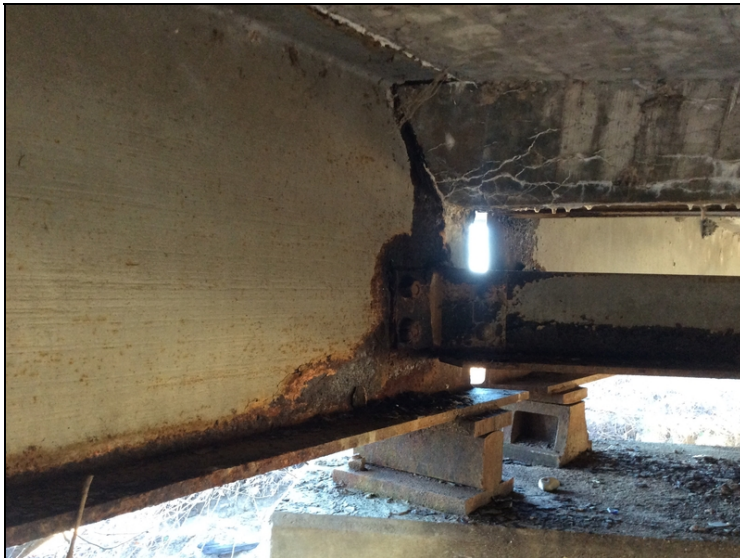
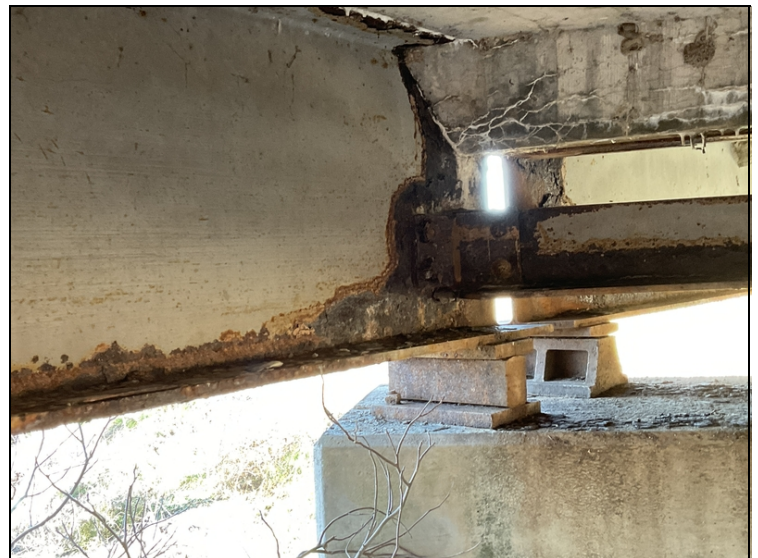
Girder Ends over Bent 1
Rust with minor to moderate section loss.

Date Reported: 01/10/2012
Priority: D- Routine
Type of Work: Repair
Status: Monitor
Component:

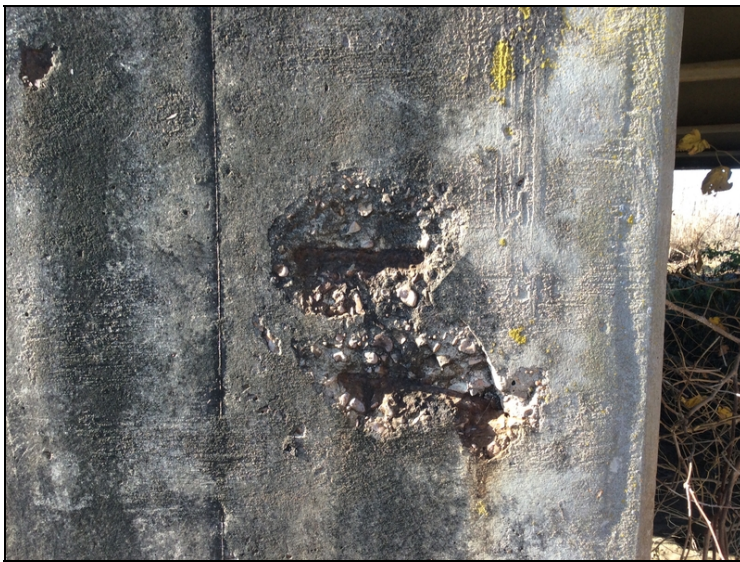
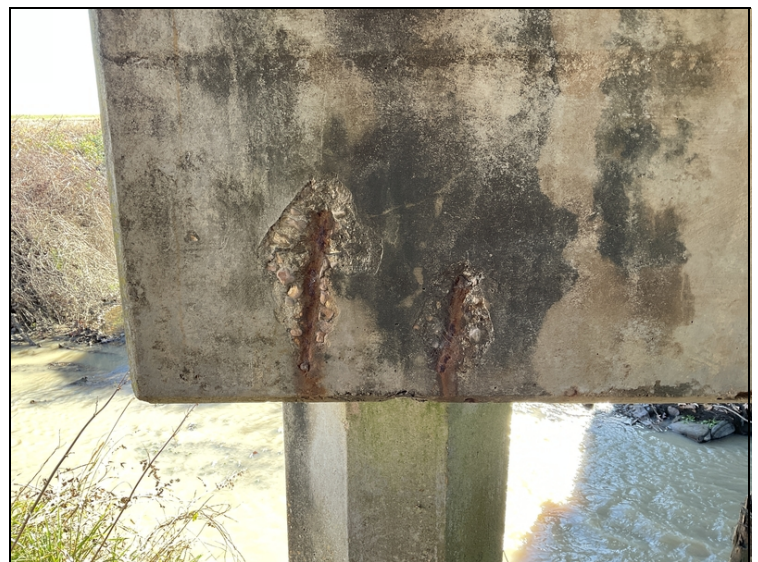
Bent 2 Cap
Spall with 2' of exposed rebar to Right end & 6" to Left end.

Bent 2 Right end.

Date Reported: 01/10/2012
Priority: D- Routine
Type of Work: Repair
Status: Monitor
Component:

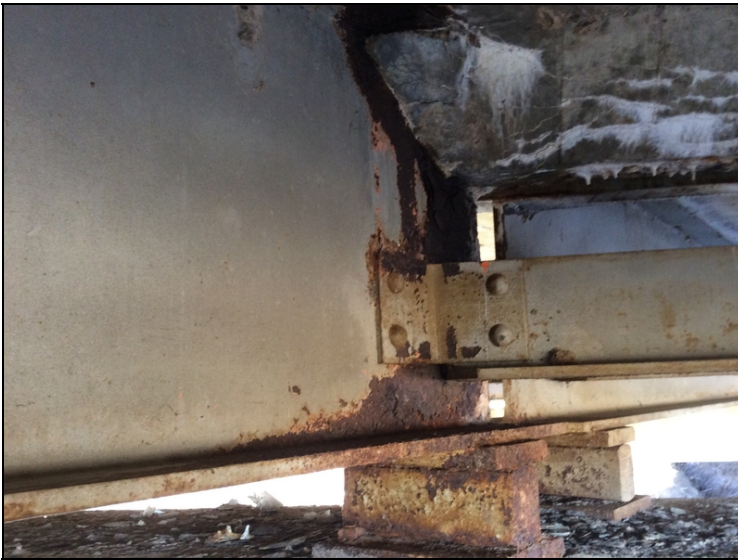
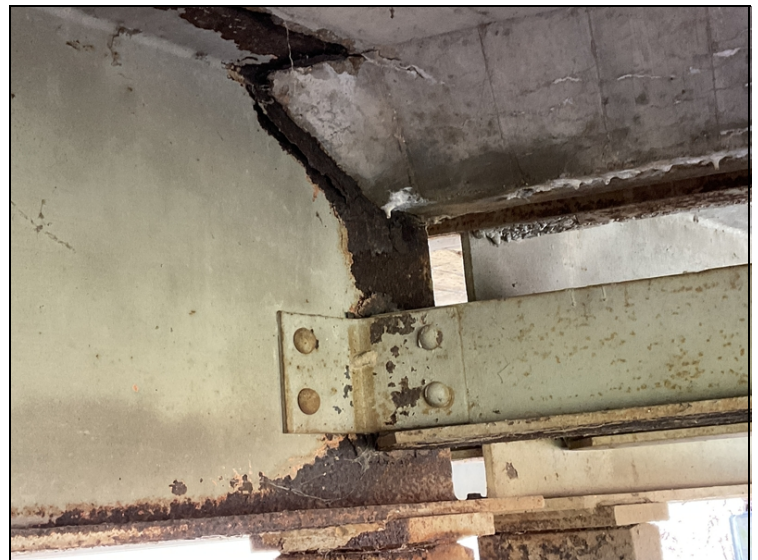
Girders over Bent 2 near paving haunch have Rust with moderate to severe section loss.

Girder 2 @ Bent 2.

Date Reported: 01/03/2014
Priority: C - Important
Type of Work: Repair
Status: Assigned
Component:

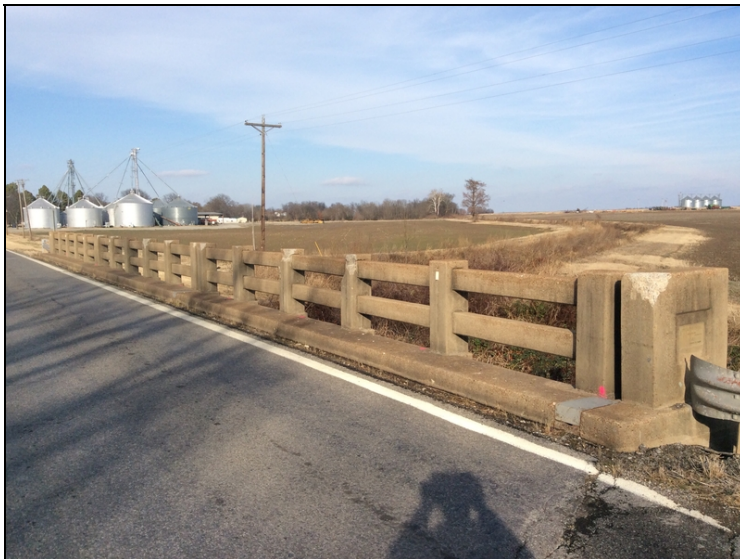
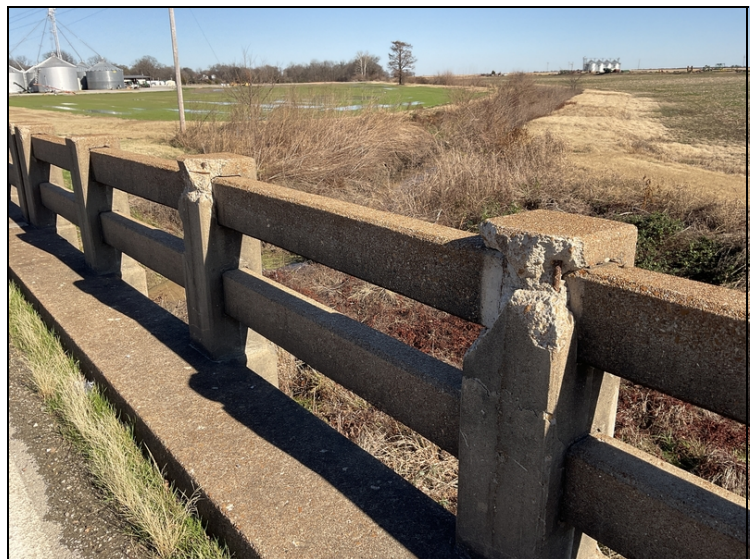
Typical spalls to concrete post @:
Span 1 (Rt) Post 3, 4, 5 & 6
Span 2 (Lt) Post 2 (Rt) Post 1, 2, 3, 5 & 6.
Span 3 (Lt) Post 1 & 2

Typical spalls to concrete post at :
Span 1 (Rt) Post 3, 4, 5 & 6
Span 2 (Lt) Post 2 (Rt) Post 1, 2, 3, 5 & 6.
Span 3 (Lt) Post 1 & 2

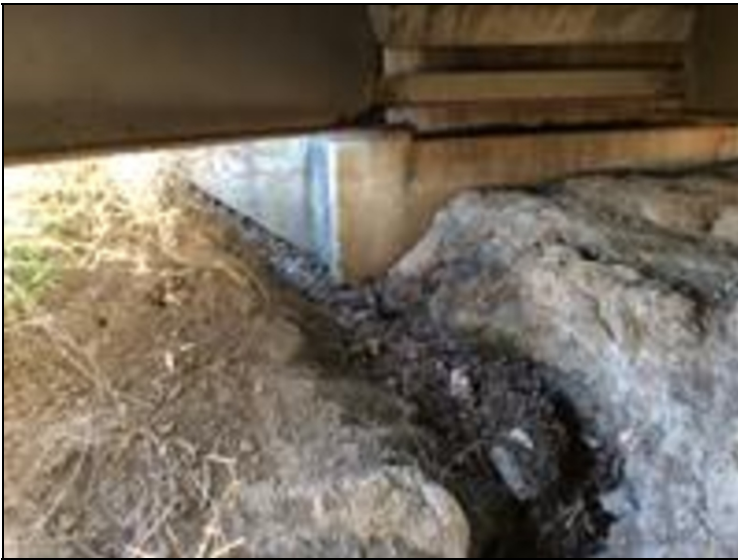
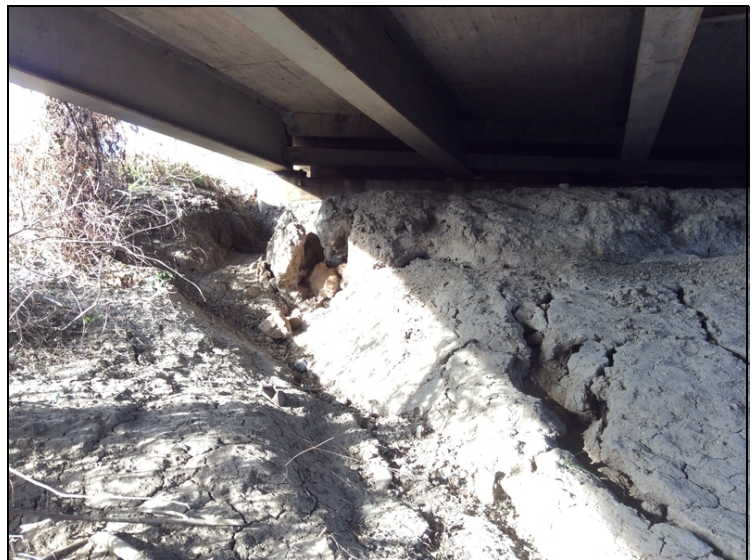
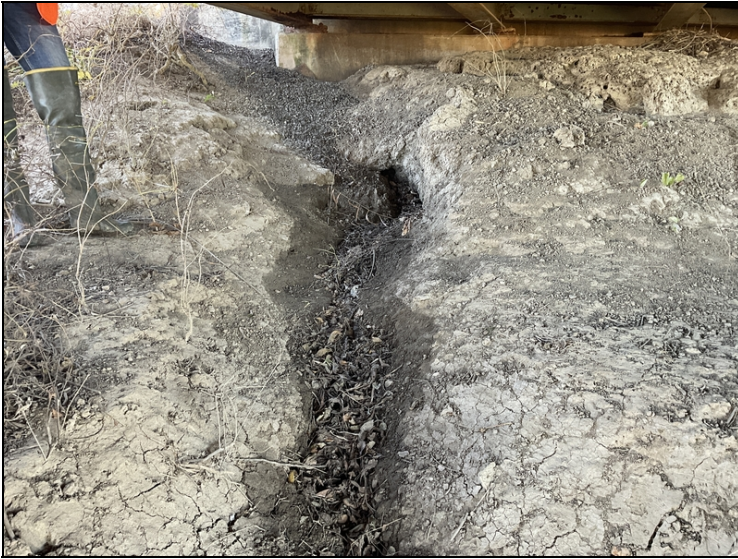
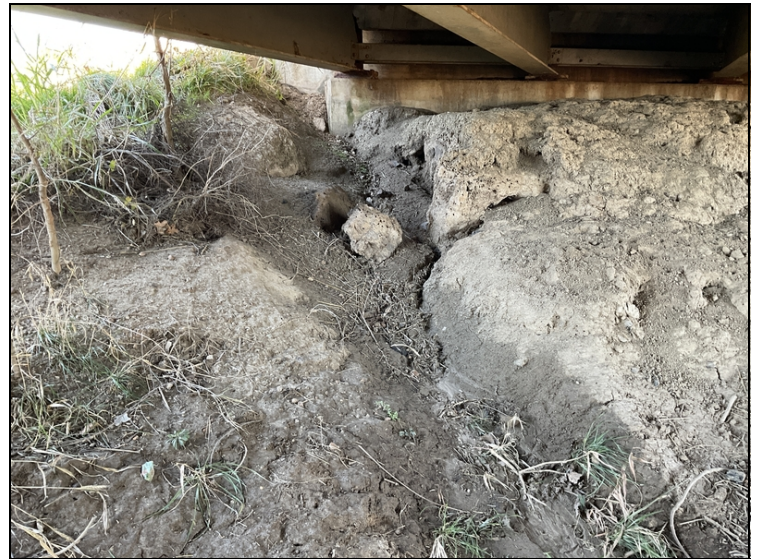
Erosion to slope at Spans 1 & 3.

Erosion to slope at Span 1.

Erosion at Abutment 2 Left side.

Erosion to slope at Spans 1 & 3.
Span 1.

Erosion to slope at Spans 1 & 3.
Span 3.

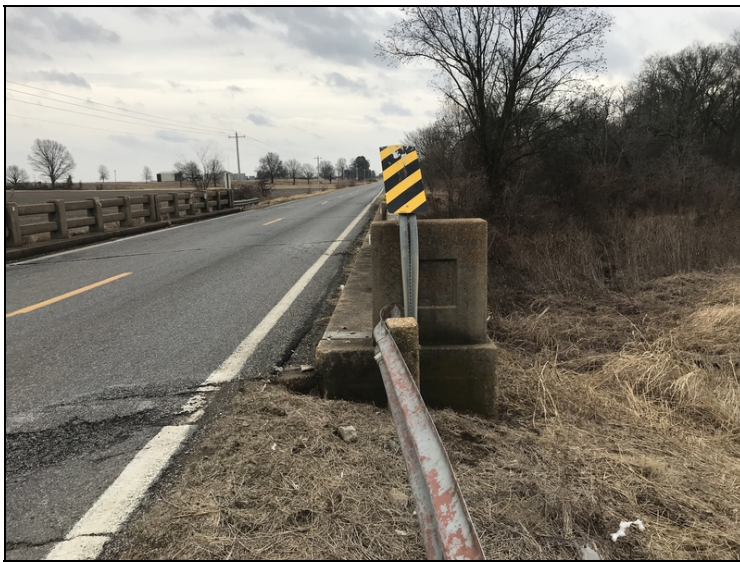
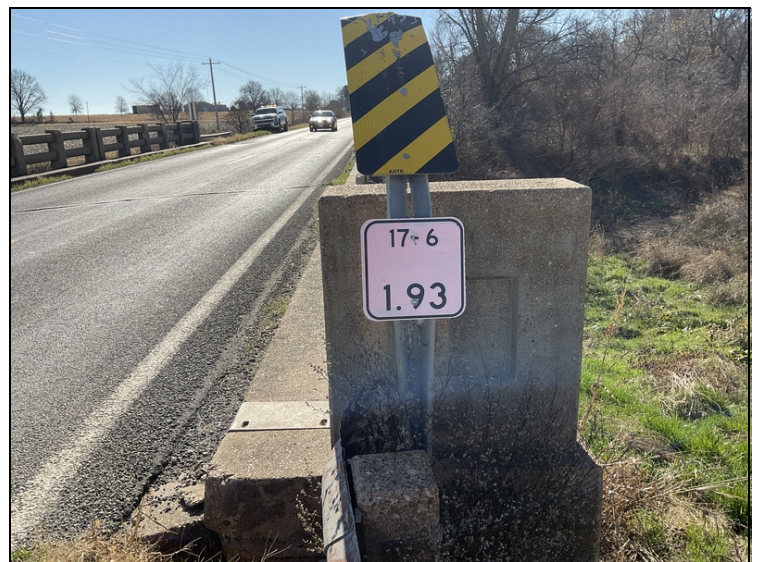
Log Mile sign is missing @ Abutment 2. Should read 1.93.
Repaired.

Log Mile sign is missing @ Abutment 2. Should read 1.93.

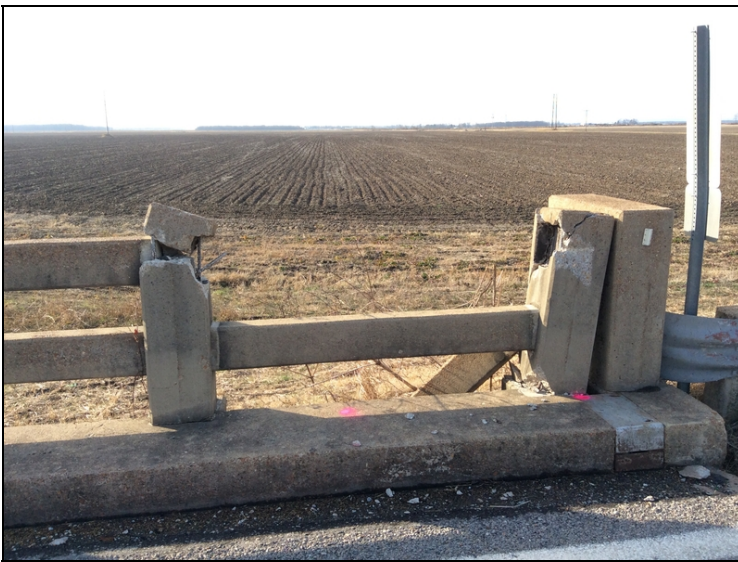
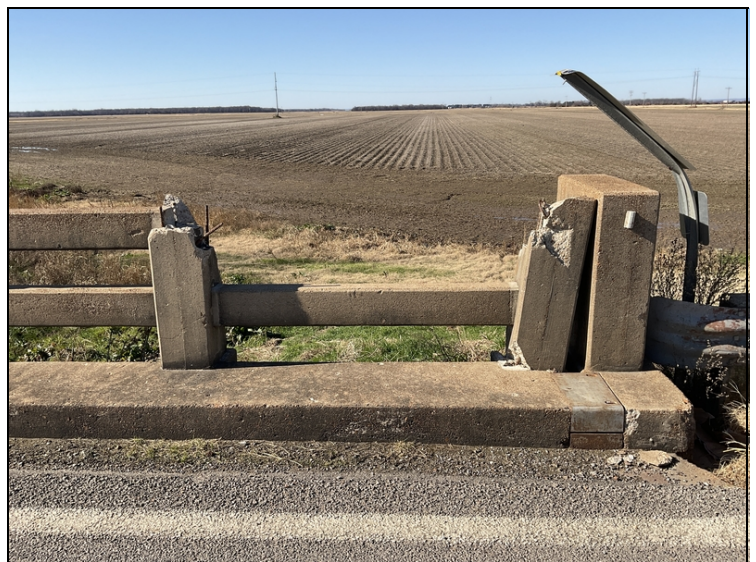
Span 3 - Top concrete guard rail is missing & Post 5 & 6 on Left side at Abutment 2 are broke due to collision damage.

Span 3 - Top concrete guard rail & Post 5 & 6 on Left side at Abutment 2 are broke or missing from collision damage.

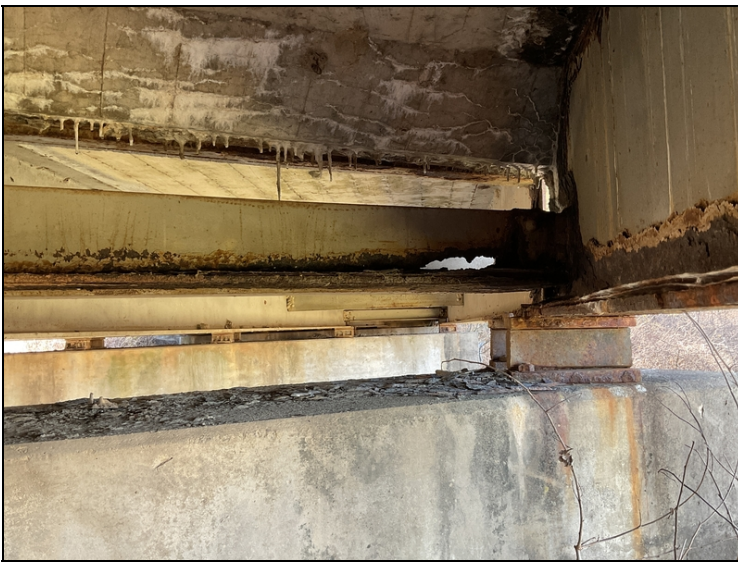
Span 3 - Girders 2 & 4 have large holes in web below haunch @ beginning of span.
Hole in diaphragm between Girders 1 & 2 @ beginning of Span 3.

Hole in diaphragm between Girders 1 & 2 @
beginning of Span 3.

Date Reported: 12/13/2021
Priority: B - Pressing; 6 month completion goal
Type of Work: Repair
Status: Open
Component: Bridge

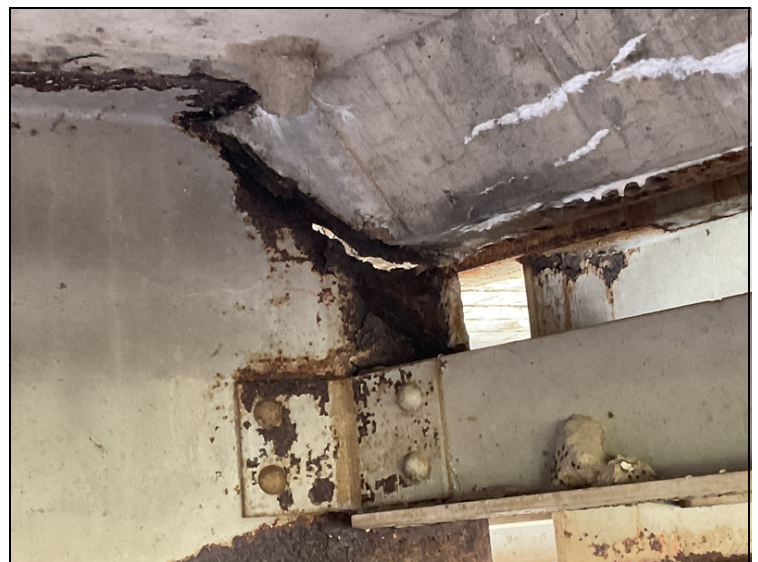
Span 3 - Girders 2 & 4 have large holes in web
below haunch @ beginning of span.
Girders 4

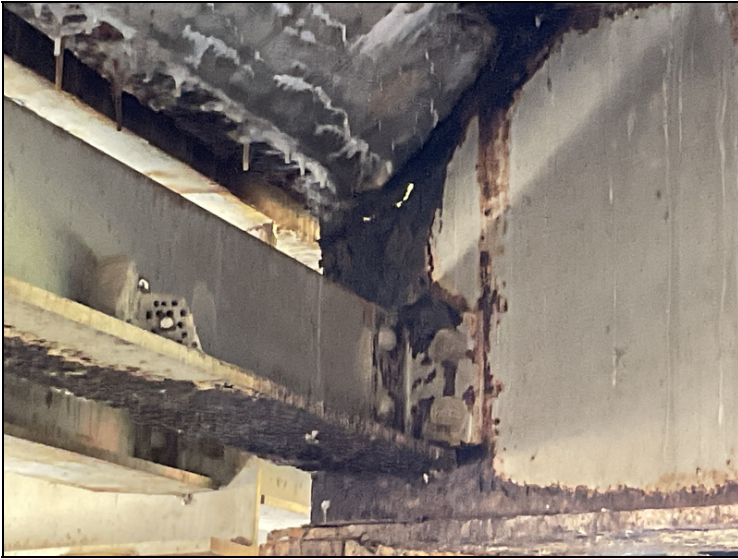
Span 3 - Girders 2 & 4 have large holes in web
below haunch @ beginning of span.
Girder 2.
