Bridge #02734(Routine)

Jackson Co. / SH 17 over OVERCUP DITCH

Team Lead: Kerry Little Inspection Date: June 07, 2021

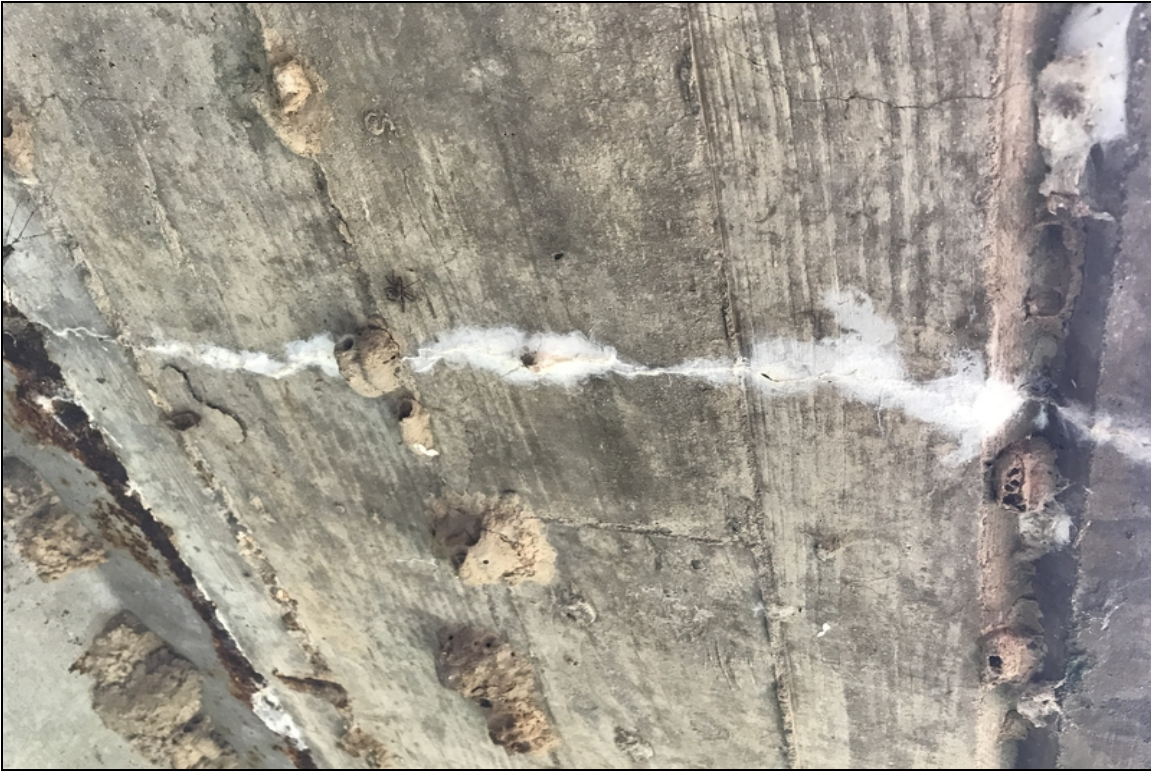
Typical cracks to Lt & Rt overhangs.

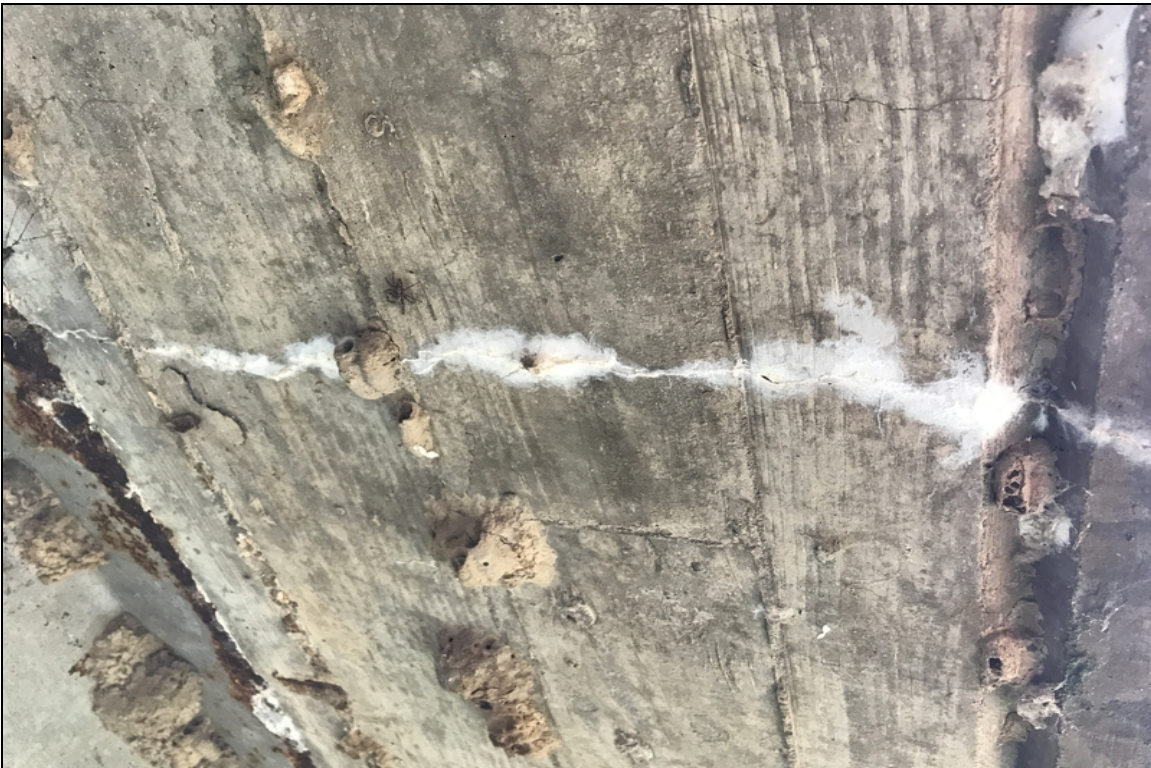
Typical cracks to Lt & Rt overhangs.

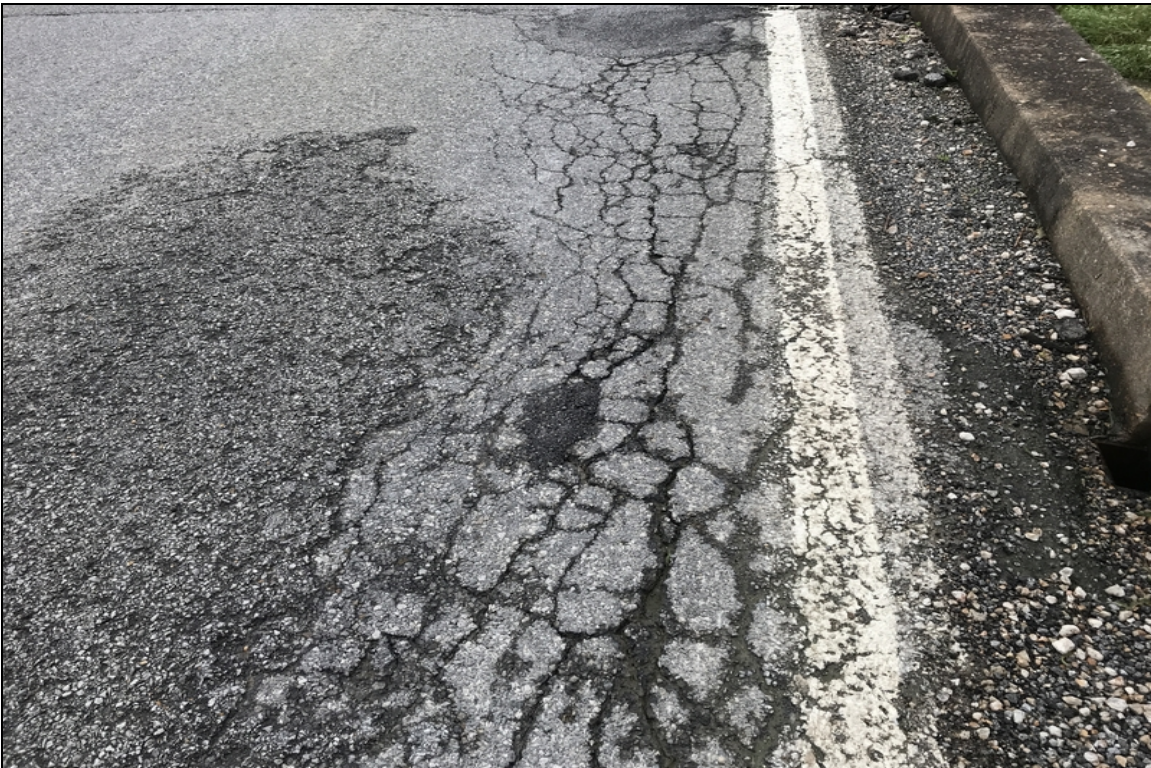
(303)							
Not visible due to asphalt overlay.							
304	Open Expansion Joint	LF	48	48	0	0	0
(304)							
Not visible due to asphalt overlay. Asphalt overlay is cracked @ joints.							
311	Movable Bearing	EA	15	0	15	0	0
1000	Corrosion	EA	15	0	15	0	0
515	Steel Protective Coating	SF	60	0	0	0	60
3440	Effectiveness (Steel Protective Coatings)	SF	60	0	0	0	60

Typical cracks to a/c overlay @ all spans.

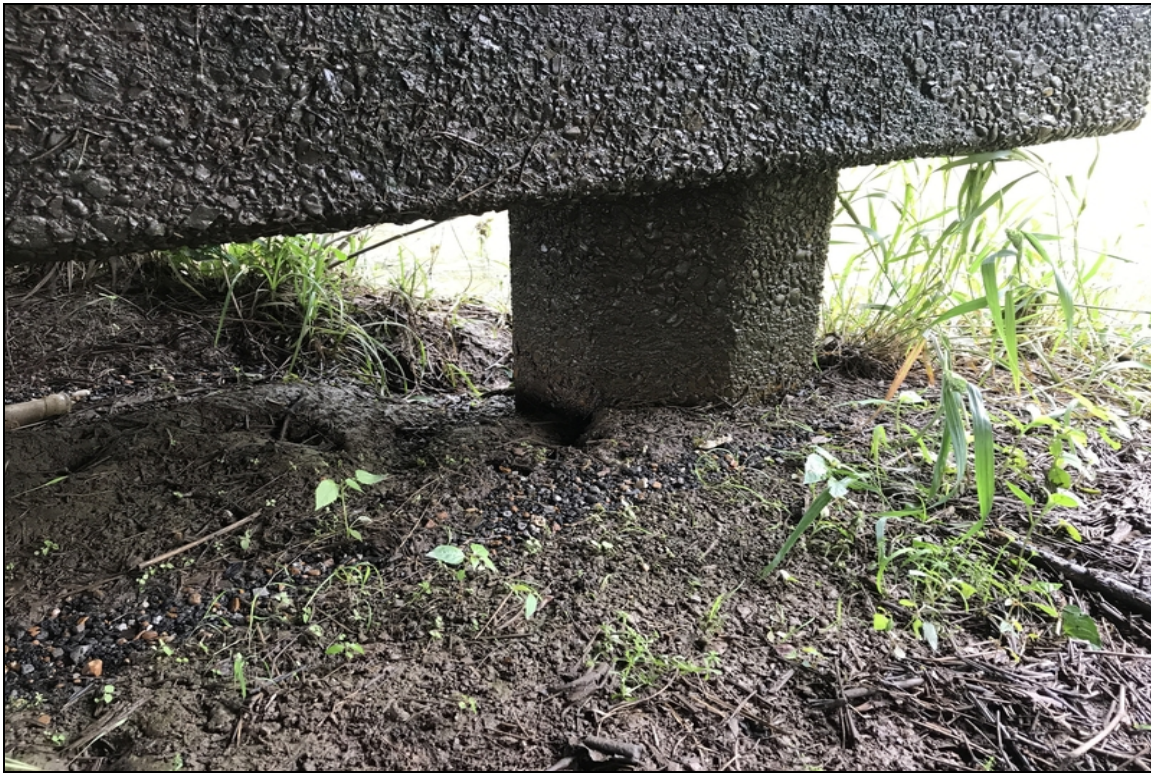
(227)							
Minor to moderate abrasion to all piles.							
234	Reinforced Concrete Pier Cap	LF	49	49	0	0	0
(234)

Typical abrasion to all piles.

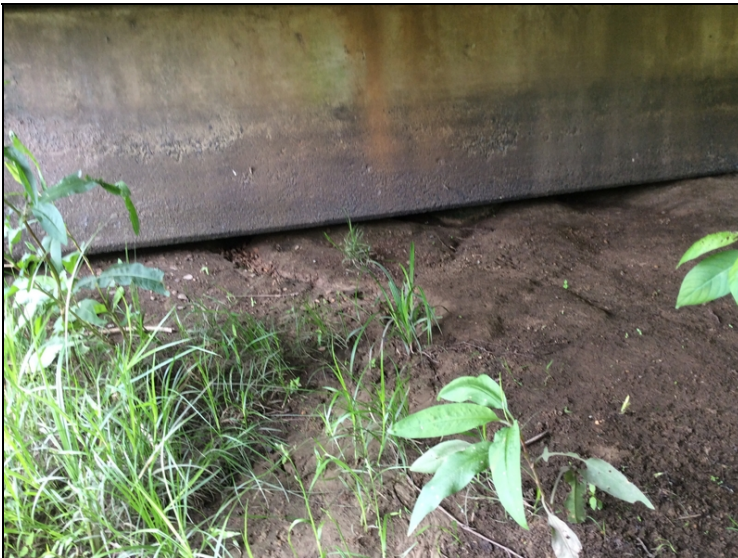
Undermining @ Abutment 2 with 1 pile exposed.

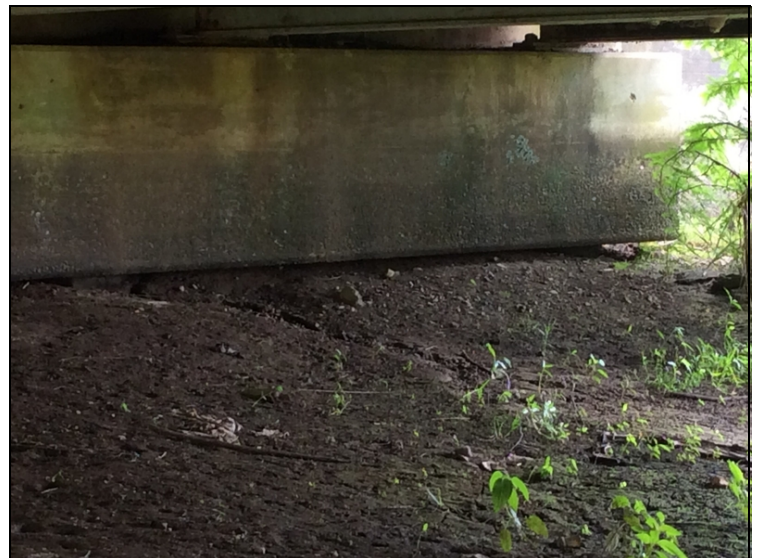
(215)							
Abut. 1 - Undermining to abutment with 2 piles exposed. Abut. 2 - Undermining to abutment with 1 pile exposed.							
227	Reinforced Concrete Pile	EA	11	0	3	8	0
1190	Abrasion/Wear (PSC/RC)	EA	8	0	0	8	0
6000	Scour	EA	3	0	3	0	0

Undermining @ Abutment 1 with 2 piles exposed.

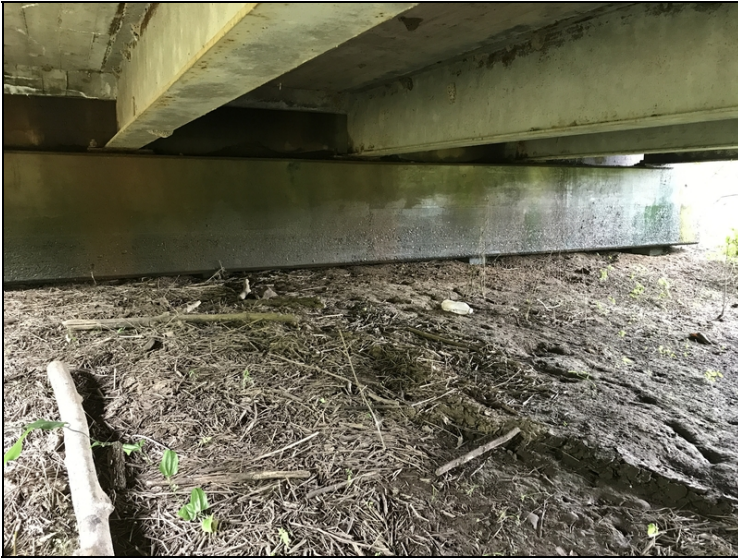
Undermining @ Abutment 1 with 3 piles exposed.

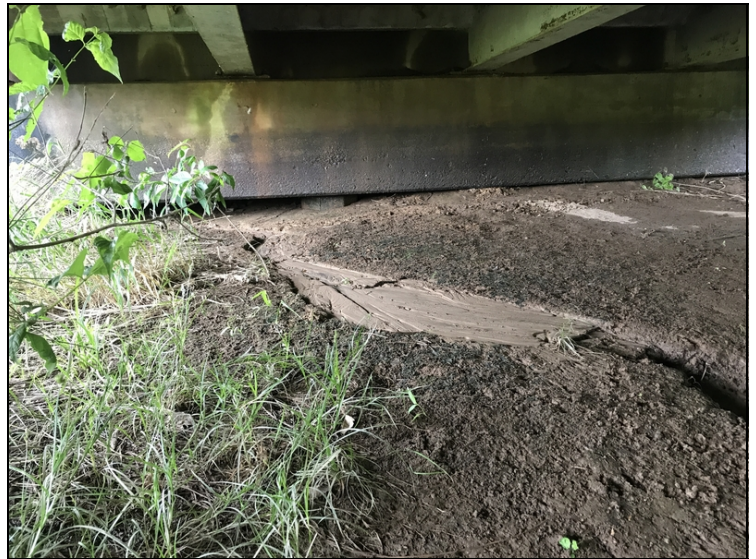
Undermining @ Abutment 2 with 1 pile exposed.

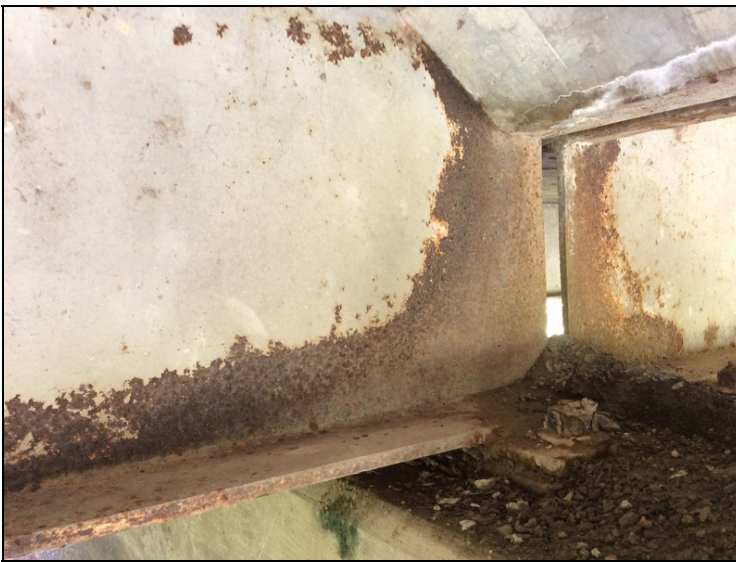
(107)							
1' of all girder ends have rust with minor pitting & some with minor section loss. Span 1 - 3" of lower web & bottom flange of Girders 1 & 5 have 5' of rust to each end of girder. Span 3 - 3" of lower web & bottom flange of Girders 1 & 5 have 5' of rust to each end of girder.							
215	Reinforced Concrete Abutment	LF	81	50	31	0	0
6000	Scour	LF	27	0	27	0	0
7000	Damage	LF	4	0	4	0	0

(311)							
Rust and minor corrosion to all bearings. Paint has failed on bearings.							
313	Fixed Bearing	EA	15	11	4	0	0
1000	Corrosion	EA	4	0	4	0	0
515	Steel Protective Coating	SF	60	30	30	0	0
3440	Effectiveness (Steel Protective Coatings)	SF	30	0	30	0	0

Typical condition of Girders & Bearings.

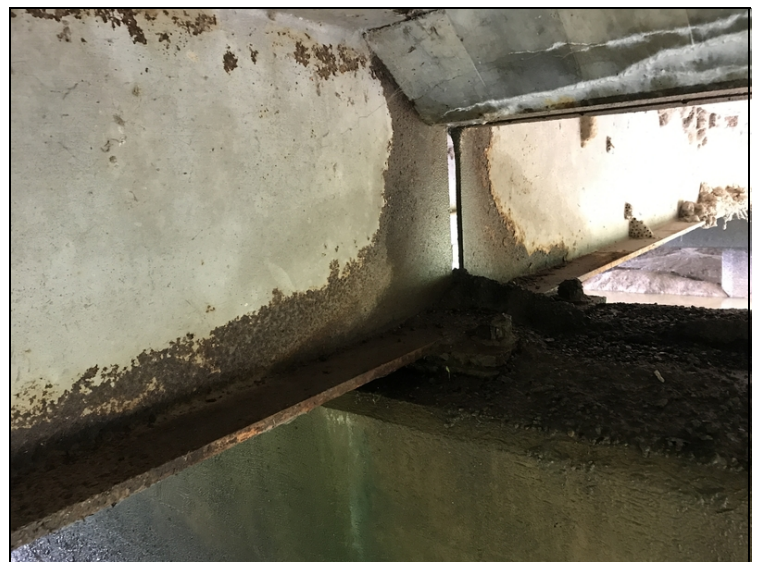
Rust to ends of all girders & bearing assemblies @ all spans.

Type of Work: Clean

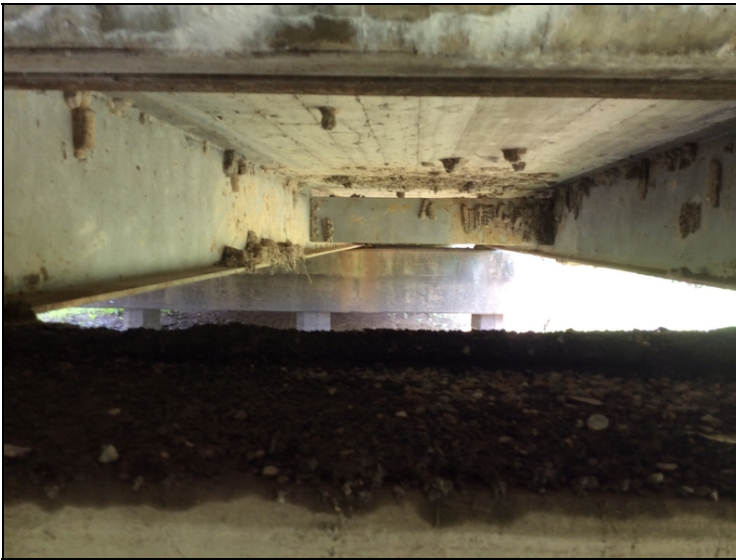
Debris on caps.

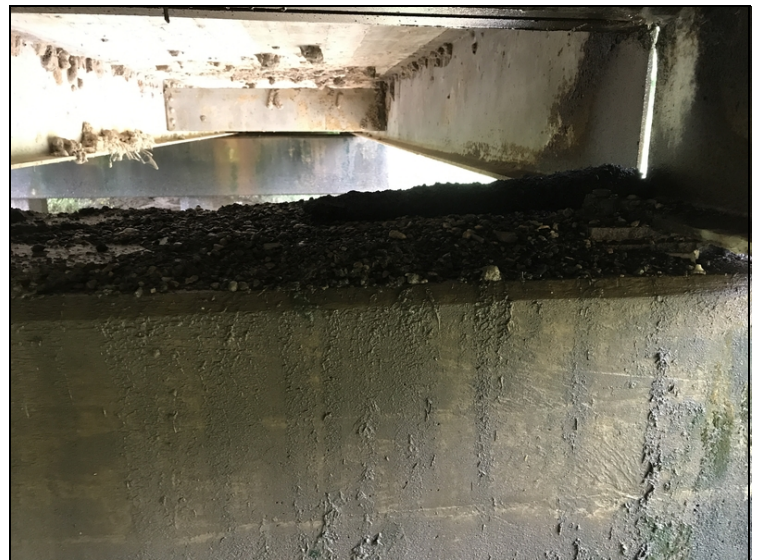
Debris on all caps.
