Asset #01895(NSTM, Routine)

SH 5 White County over EAST CADRON CREEK

Location: 1.53 MI S OF CLEBURNE CO

Team Lead: Nathan Edwards, Inspection Date: 08/11/2022

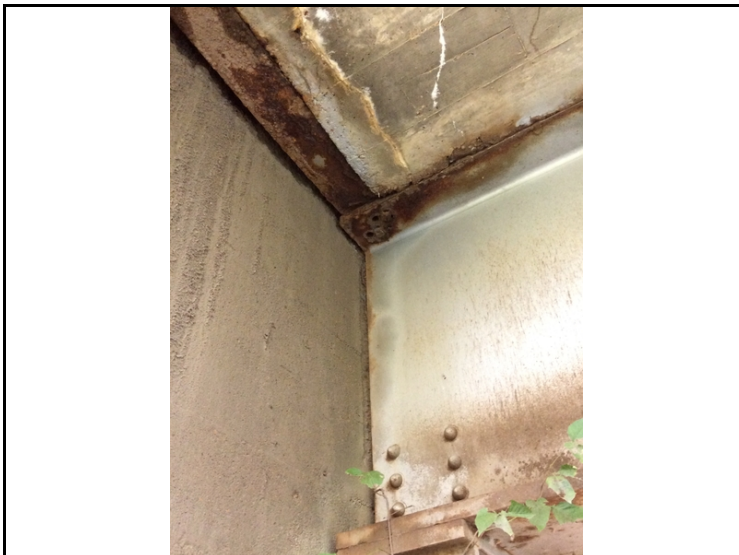
Bolts connecting top flange & road iron have sheared at Abutment 2 allowing deck to float under traffic.

Bolts connecting top flange & road iron have sheared at Girder 1 & 2 at Abutment 2 allowing deck to float under traffic.

Date Reported: 08/03/2015
Priority: D- Routine
Type of Work: Replace (General)
Status: Monitor
Component:

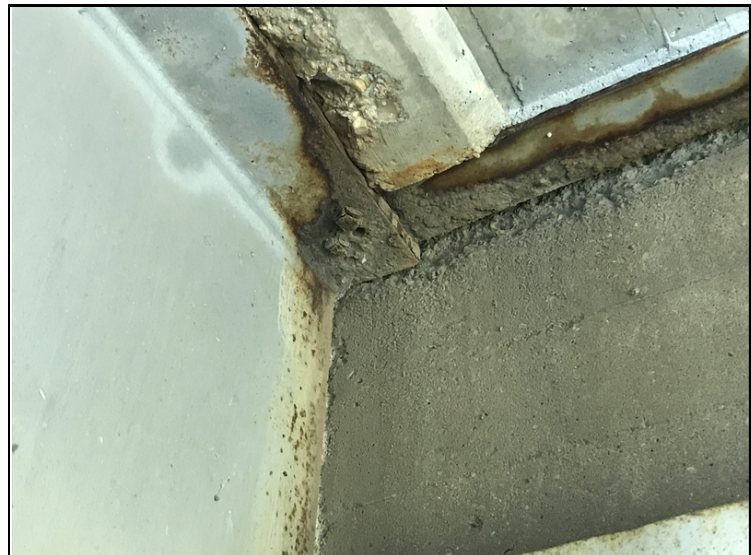
Bolts connecting top flange & road iron have sheared at Abutment 2 allowing deck to float under traffic.

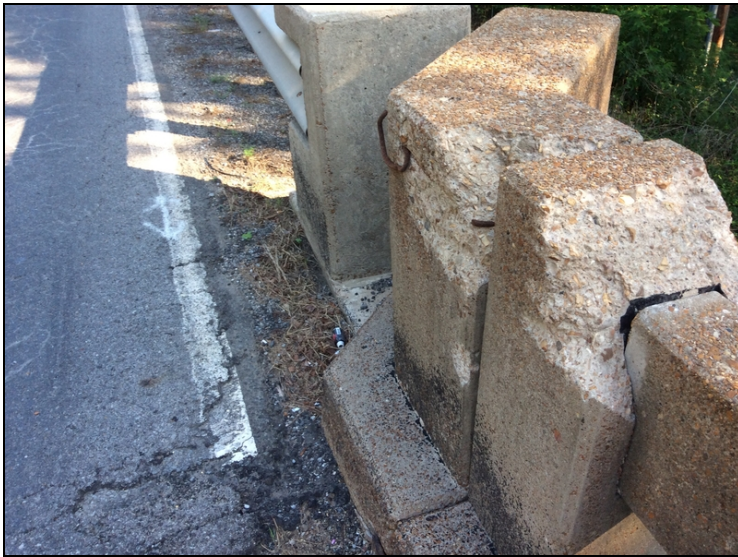
(331) Abutments 1 & 2: Large spalls to end posts with rebar exposed at both Abutments. Abutment 1: Top half of concrete Post 1 on Right, is missing w/t rebar exposed. Span 3: Concrete posts 1, 3, 5 - 8 on Right have cracks & spalls. Cracking to Left & Right curbs. 150' of spalls to concrete curb on Left & Right, with some rebar exposed. Several concrete posts are spalled/cracked with rebar exposed.

Large spalls to end posts some with rebar exposed at Abutments 1 & 2.

Abutment 2 typical of : Large spalls to end posts,
some with rebar exposed at
Abutments 1 & 2.

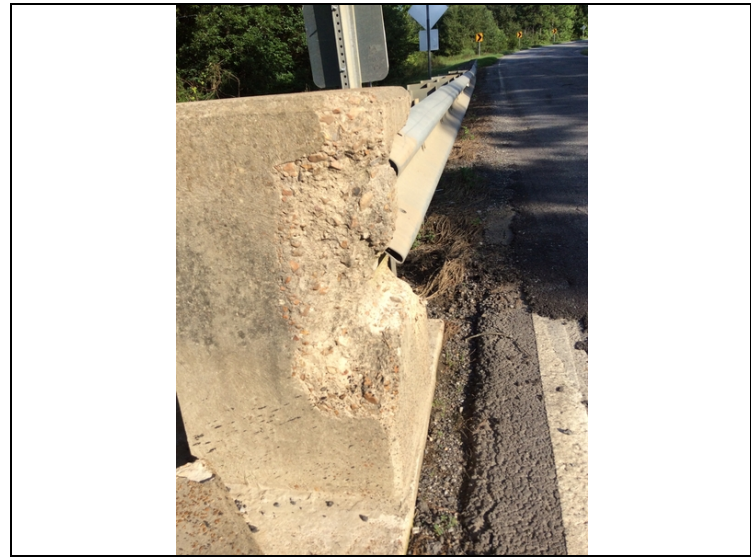
Abutment 2. Large spalls to end posts, some with
rebar exposed at
Abutments 1 & 2.

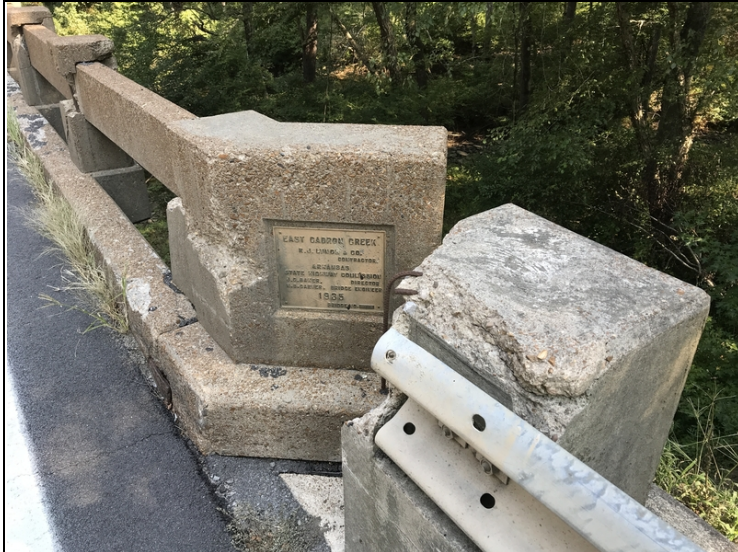
Large spalls to end posts some with rebar exposed at Abutments 1 & 2.

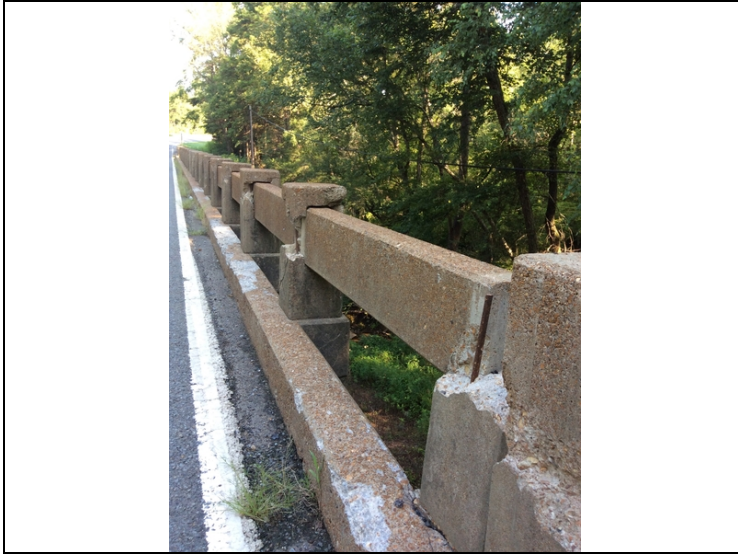
Several concrete posts are spalled and/or cracked at all spans.

Abutment 1, right side: Several concrete posts are spalled and/or cracked at all spans.

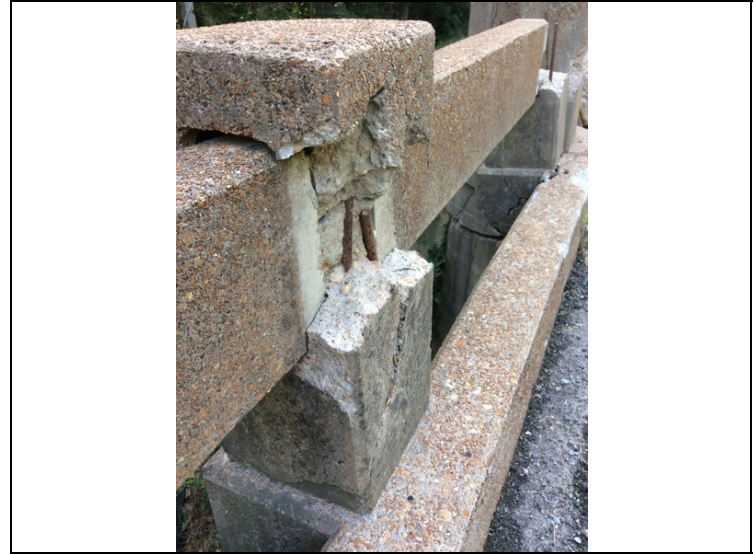
Several concrete posts are spalled and/or cracked at all spans.

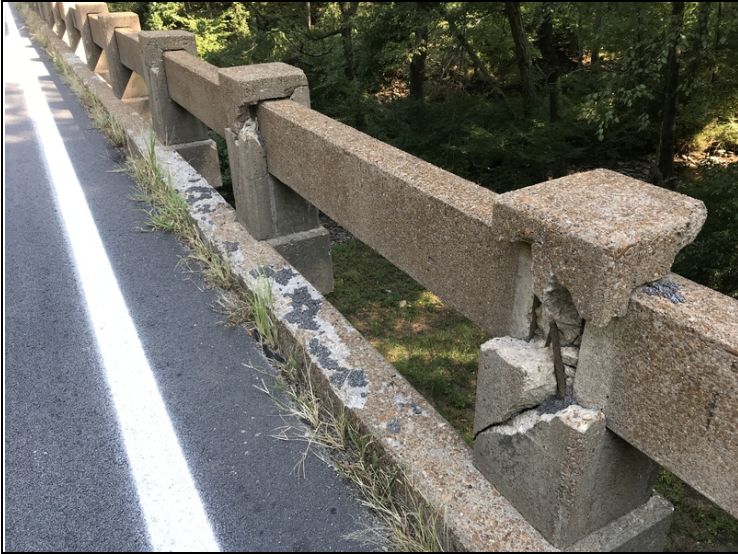
Several concrete posts are spalled and/or cracked at all spans.

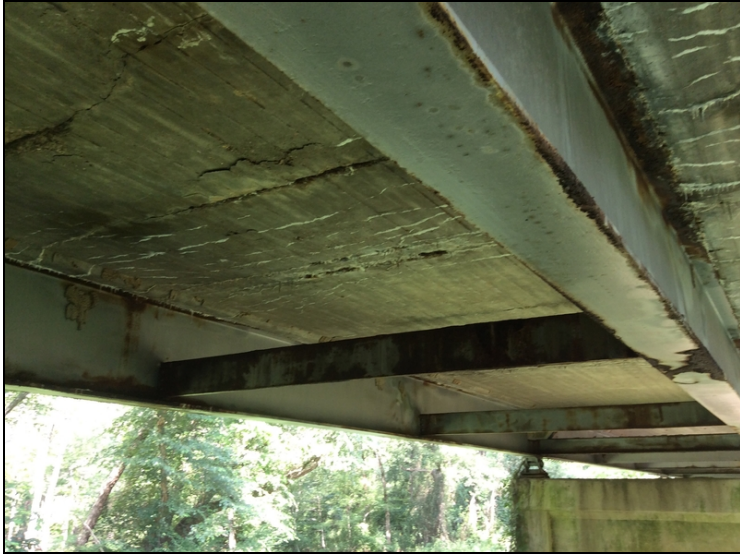
(107) Rust & corrosion to top & bottom flanges & diaphragms at all Spans. Rust with section loss, with some holes to all diaphragms.							
205	Reinforced Concrete Column	EA	4	1	1	2	0
1090	Exposed Rebar	EA	2	0	0	2	0
1190	Abrasion/Wear (PSC/RC)	EA	1	0	1	0	0

Rust with section loss to lower web & bottom flanges &/or diaphragm connections at all spans. Heavy section loss to flange of Diaphragm's 1 and 3 at Span 1.

Rust with section loss to lower web and bottom flanges and/or diaphragm connections at all spans.
Heavy loss to flange of Diaphragm 1, at Span 1.

Date Reported: 08/03/2015
Priority: C - Important
Type of Work: Repair (General)
Status: Monitor
Component:

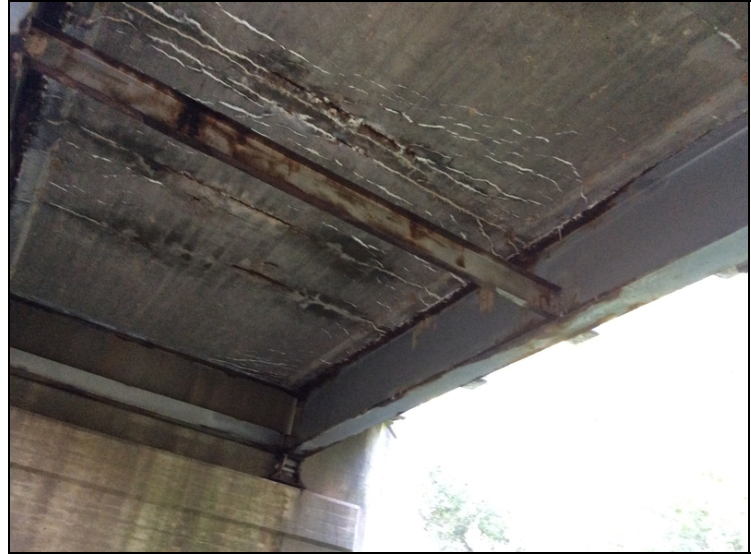
Rust with section loss to lower web & bottom flanges &/or diaphragm connections at all spans.
Heavy section loss to flange of Diaphragm's 1 & 3 at Span 1.

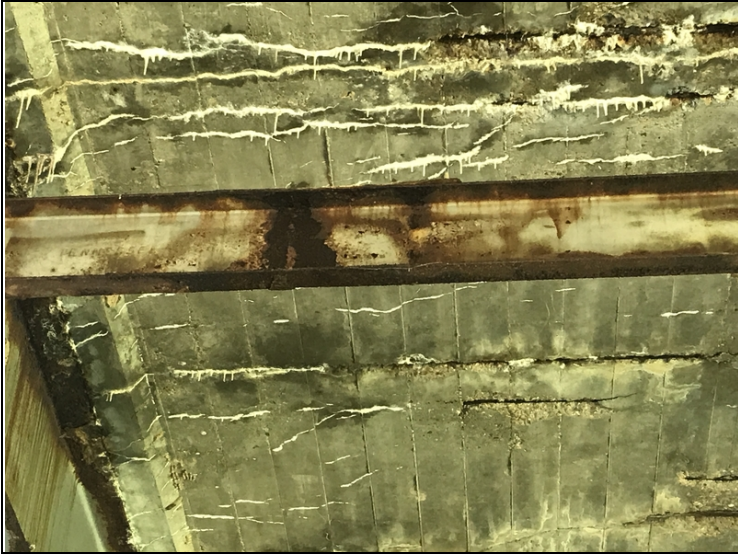
Rust with section loss to lower web & bottom flanges &/or diaphragm connections at all spans. Heavy section loss to flange of Diaphragm's 1 and 3 at Span 1.

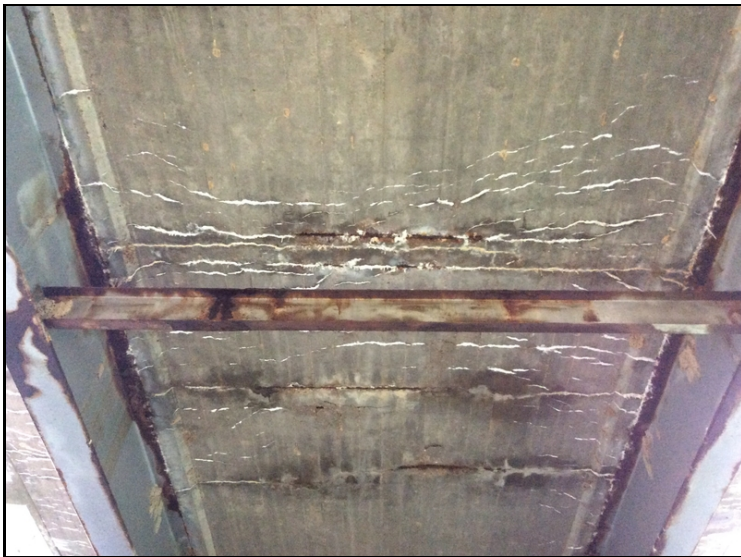
(12) Heavy efflorescent cracking to overhangs & soffit at Spans 1, 2, & 3. Span 1 - Spalls with 14' rebar exposed to soffit. Bent 1 - Spalls with 32' rebar exposed to diaphragm. Span 2 - Spalls with 15' rebar exposed to soffit. Bent 2 - Spalls with 25' rebar exposed to diaphragm. Span 3 - Spalls with 23' rebar exposed to soffit. Delaminated areas to soffit @ Spans 2 & 3. Minor cracking to asphalt overlay. Bolts connecting top flange & road iron have sheared at Abutment 2 allowing deck to float under traffic. (510-12) Minor cracking to asphalt overlay.							
107	Steel Open Girder/Beam	LF	300	135	90	75	0
1000	Corrosion	LF	165	0	90	75	0
515	Steel Protective Coating	SF	2675	2407	50	0	218
3440	Effectiveness (Steel Protective Coatings)	LF	268	0	50	0	218

Spalls with rebar exposed & transverse efflorescent cracks to soffit & overhangs at all spans.

Span 1, typical of all spans. Spalls with rebar exposed & transverse efflorescent cracks to soffit & overhangs at all spans.

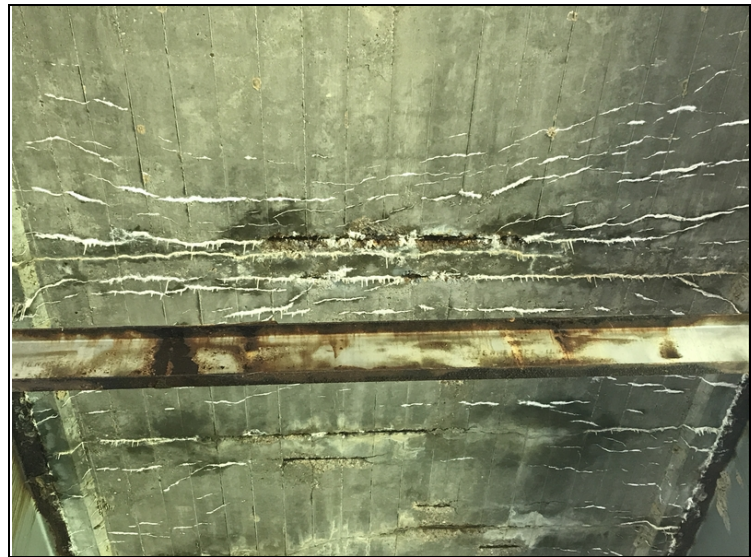
Spalls with rebar exposed & transverse efflorescent cracks to soffit & overhangs at all spans.

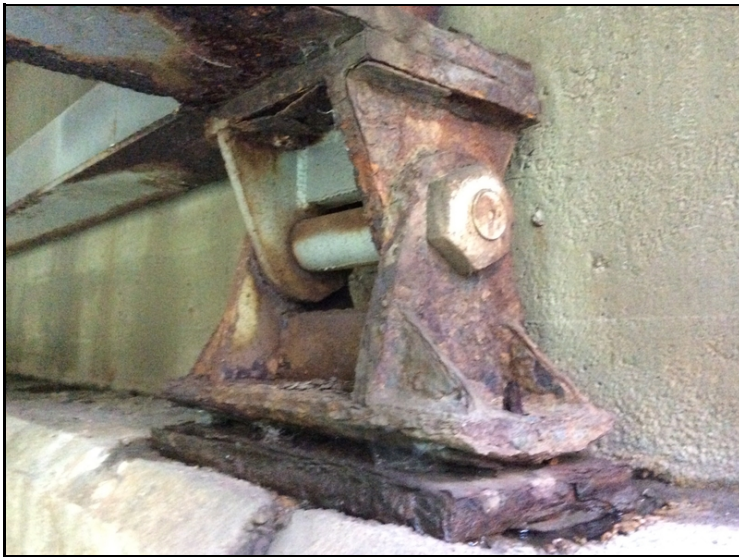
(311) Abutments 1 & 2: Bearings are rusting, flaking & some with section loss. Abutment 1: Moveable Bearing 1 has anchor bolt missing & Moveable Bearing 2 has both anchor bolt nuts missing. Abutment 2 : Moveable Bearings 1 & 2 have section loss to anchor bolts with nuts missing. Moveable Bearings @ Bent 1 have Light rust.							
313	Fixed Bearing	EA	2	0	2	0	0
1000	Corrosion	EA	2	0	2	0	0
515	Steel Protective Coating	SF	4	4	0	0	0

Rust with section loss to bearing assemblies at Abutments 1 & 2 with one anchor bolt missing on Bearing 1 & two anchor bolt nuts missing at Bearing 2 at Abutment 1 and on Bearings 1 & 2 at Abutment 2.

Abutment 1. Typical of section loss to bearing assemblies & missing anchor bolt nuts at Abutments 1 & 2.

Date Reported: 08/09/2011
Priority: C - Important
Type of Work: Repair (General)
Status: Monitor
Component:

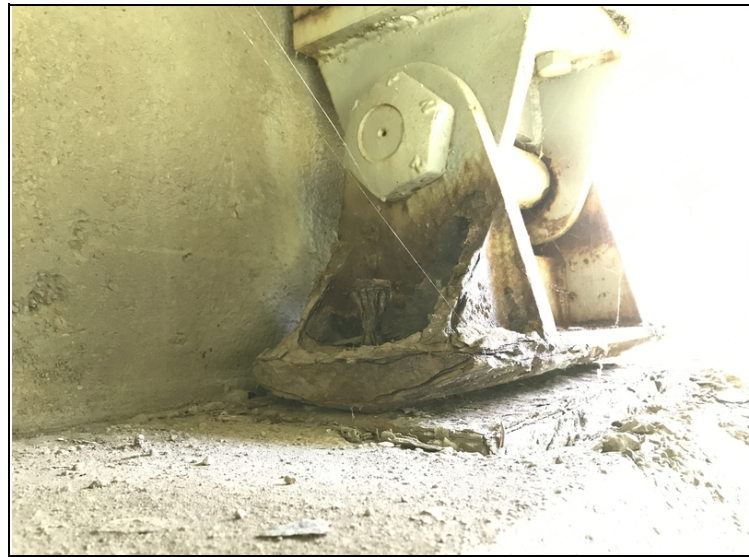
Rust with section loss to bearing assemblies at Abutments 1 & 2 with anchor bolt nuts missing on Bearing 1 at Abutment 1 and on Bearings 1 & 2 at Abutment 2.
