Asset #A3288(Routine)

I 55-12SB-LM 44.54 over UPPER SANDY BAYOU

Location: 0.1 MI NO JCT SH 181

Team Lead: Richard Jones, Inspection Date: 07/19/2022

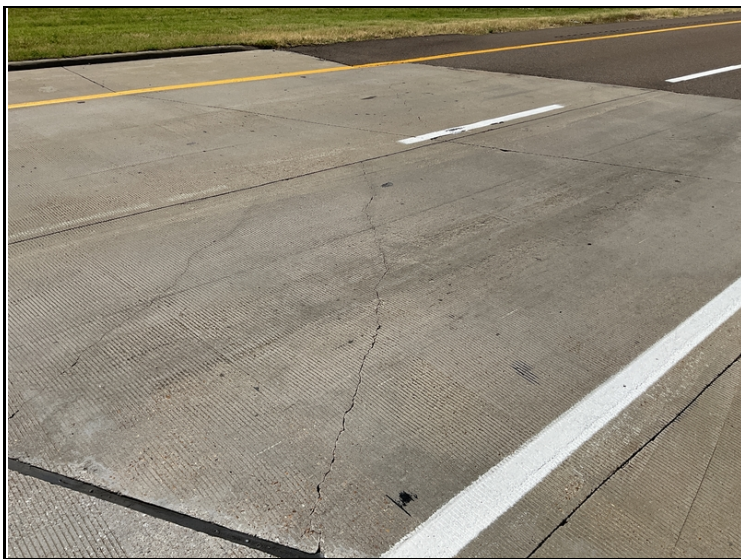
Beginning approach slab

Concrete approach slabs have several unsealed cracks.

Some cracks are sealed on bent 5 end.

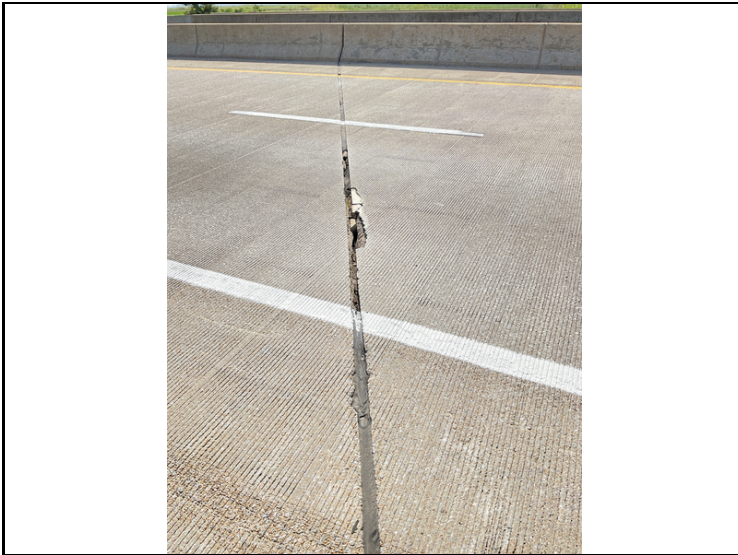
Bent 4 joint

Span 3 has a 4' spall along joint over bent 4.

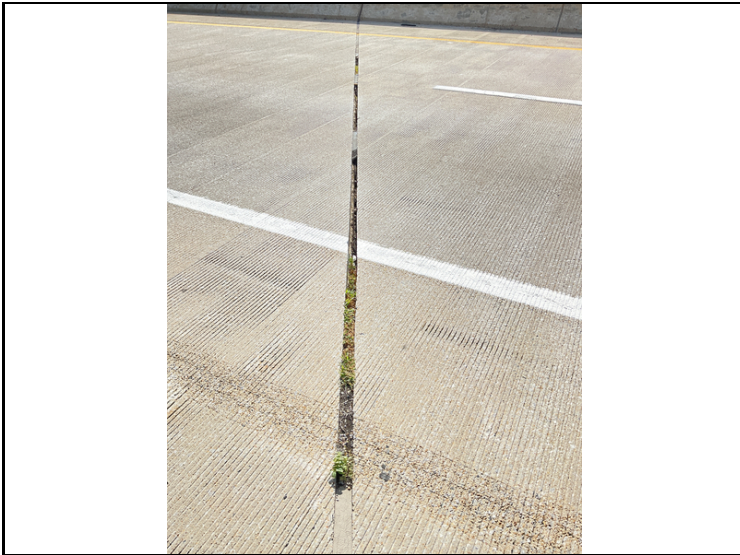
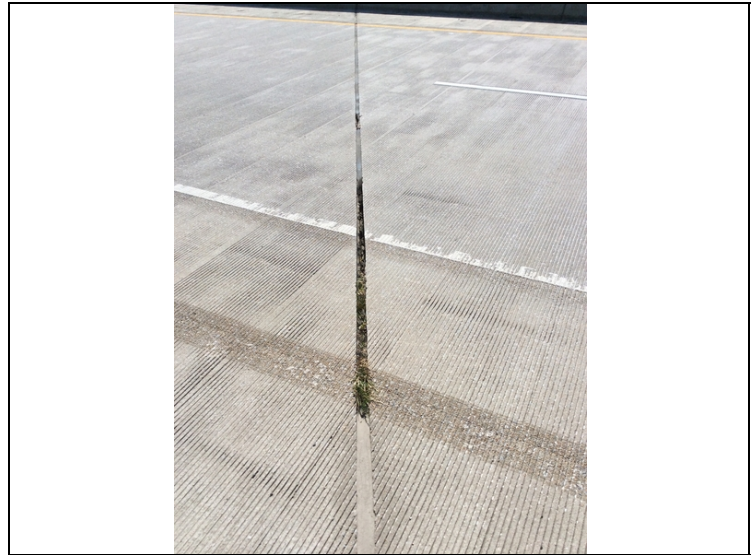
Bent 3 joint

Poured joint seals have lost adhesion with a few areas missing.

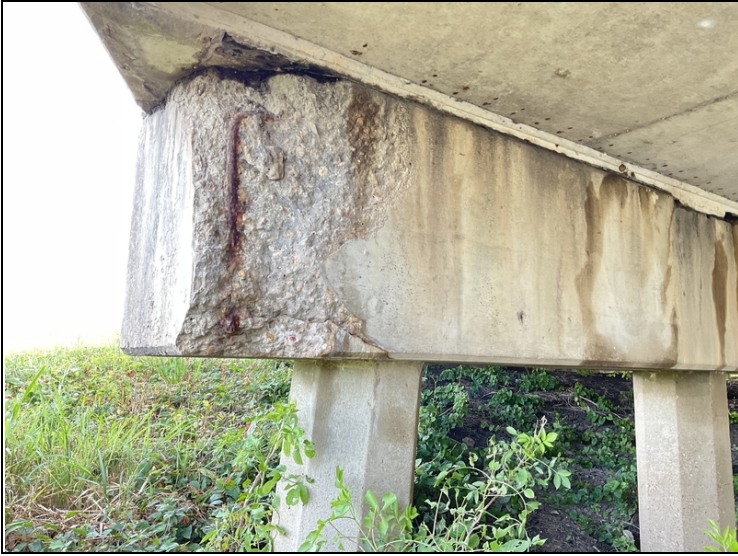
Bent 4 Lt

Bent 4 has a deep spall with exposed rebar on corner on Lt end. Ahead face of cap has a moderate vertical crack with efflorescence at keyway.
