Asset #B3288(Routine)

I-55NB-12-LM 44.55 over UPPER SANDY BAYOU

Location: 0.1 MI NO JCT SH 181

Team Lead: Richard Jones, Inspection Date: 07/19/2022

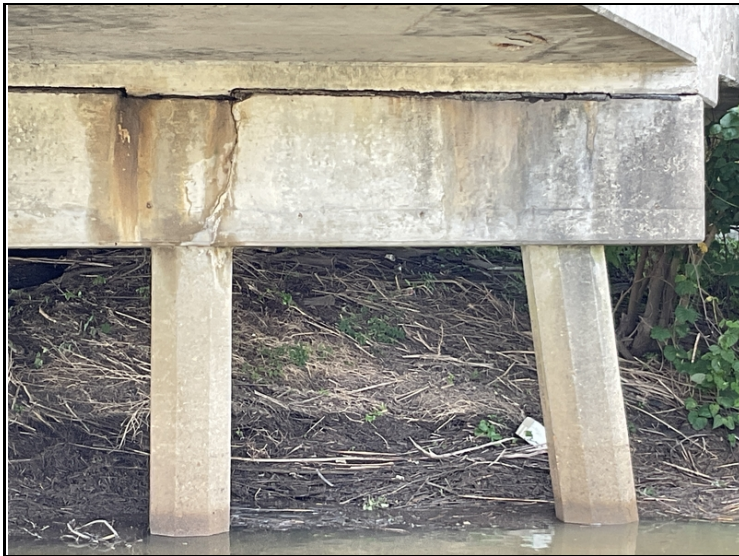
Bent 2 over pile 2

Caps and abutments have a few minor cracks or spalls near key ways. Some cracks have efflorescence. Bent 2 cap has a moderate vertical crack with efflorescence over pile 2. (possible settlement crack)

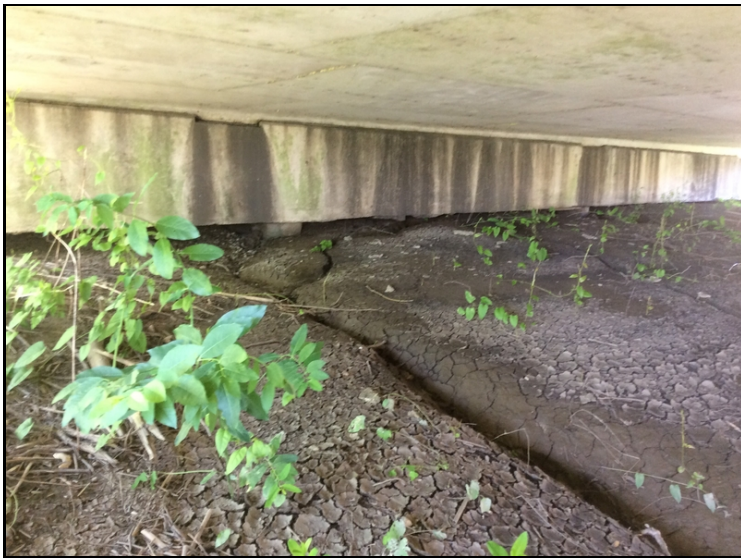
Bent 1 and 5 abutments have some undermining up to 1' below and 2' back under.

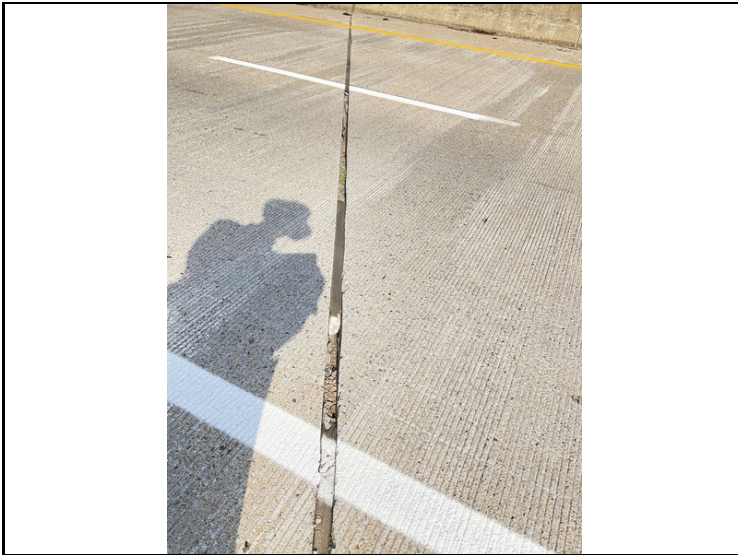
Bent 3 joint

Poured joint seals have lost adhesion with a few areas missing.

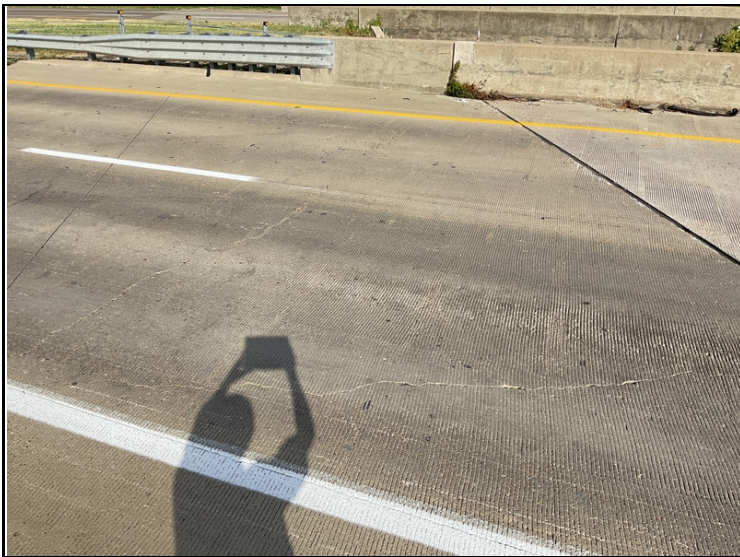
Beginning approach slab

Concrete approach slabs have numerous unsealed cracks.

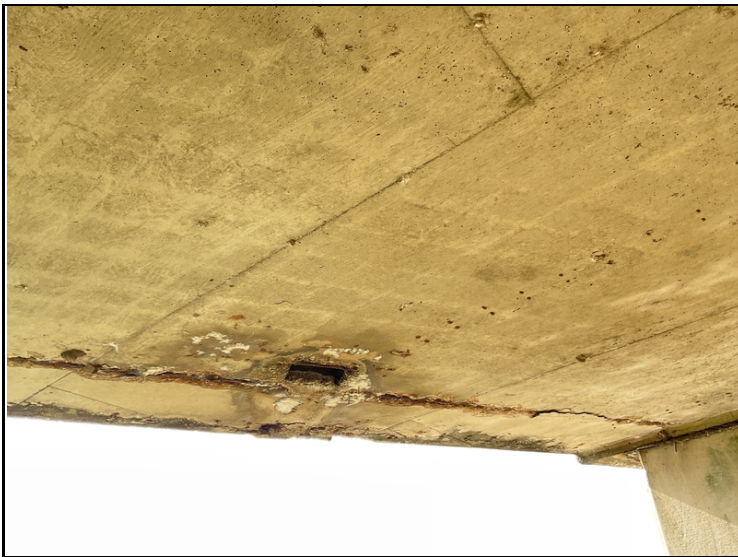
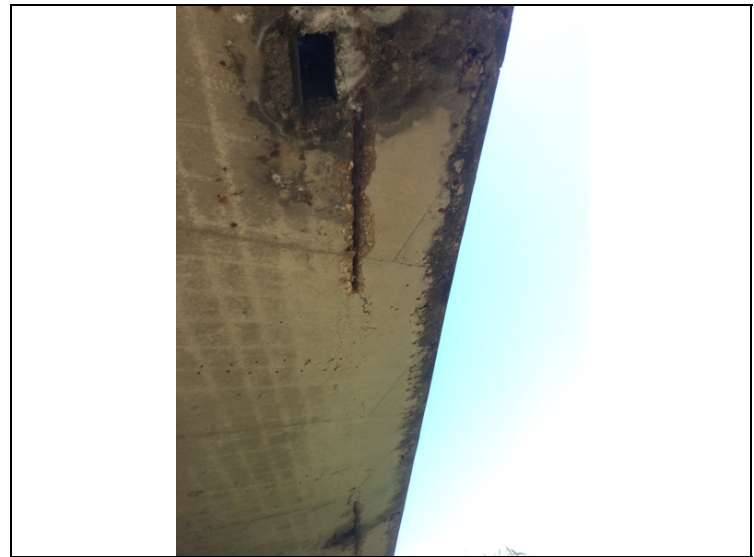
Span 3 Rt

Soffit has a few delaminated areas or spalls with exposed rebar, mostly near drain openings.

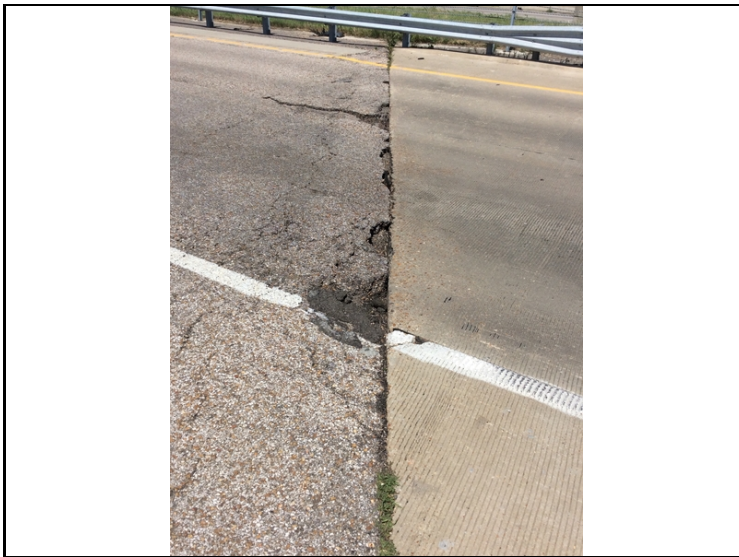
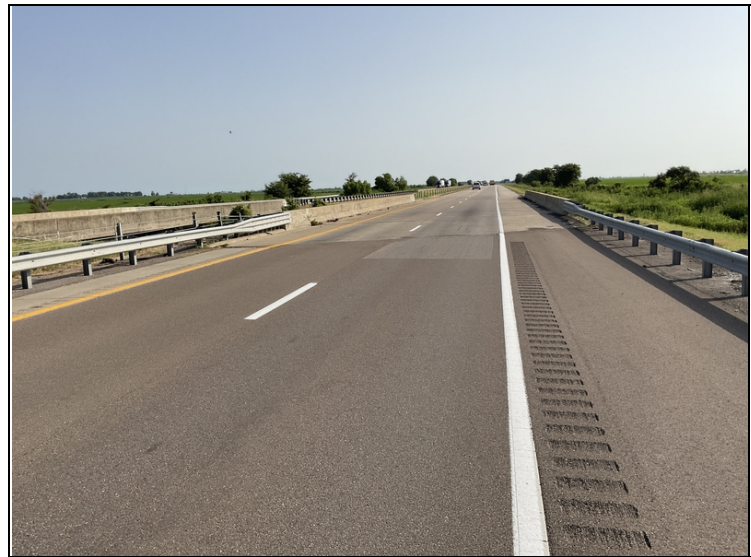
Approach at beg

Approach roadway asphalt at south end has several spalls, 2' x 4" deep.

Approach roadway was rehabbed sometime in the past.
