Asset #A3289(Routine)

I 55-SB-12- 48.27 over SH 140-SEC 2

Location: JCT I-55 & SH 140

Team Lead: Richard Jones, Inspection Date: 10/27/2022

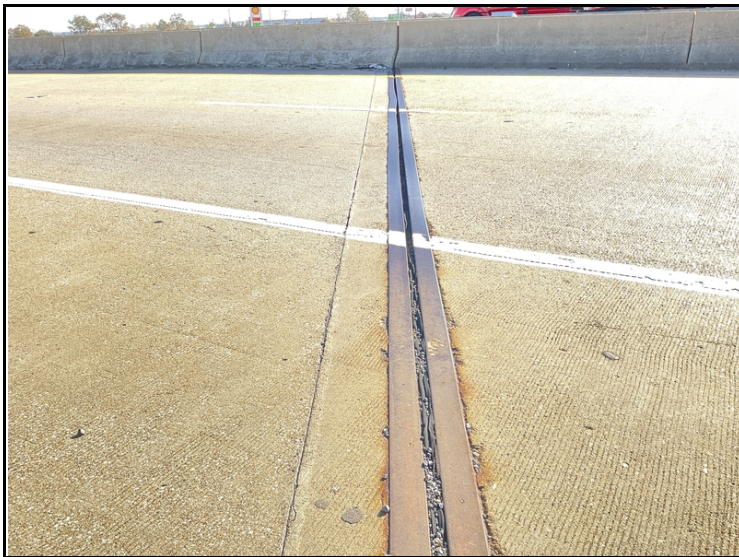
Bent 2 joint

Compression seals are ripped and torn with some areas losing adhesion. Some are pulled out or missing.

Date Reported: 10/22/2012
Priority: C - Important
Type of Work: Replace (General)
Status: Monitor
Component: Element

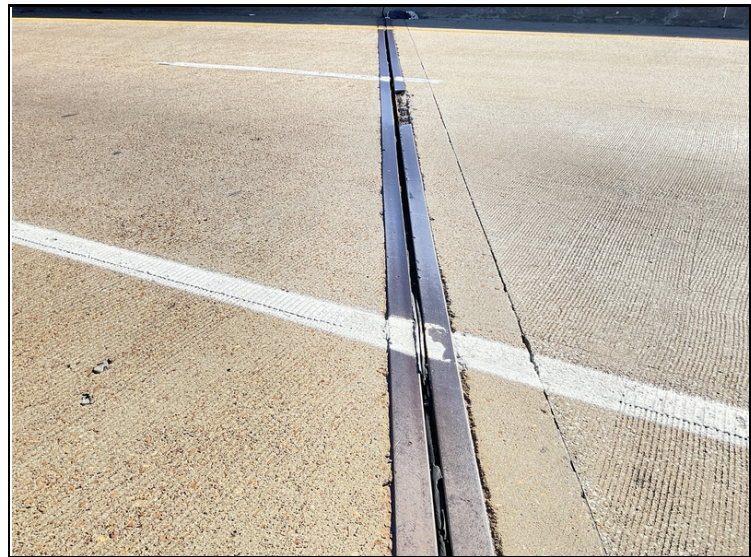
Bent 3 joint has had some of road iron removed.

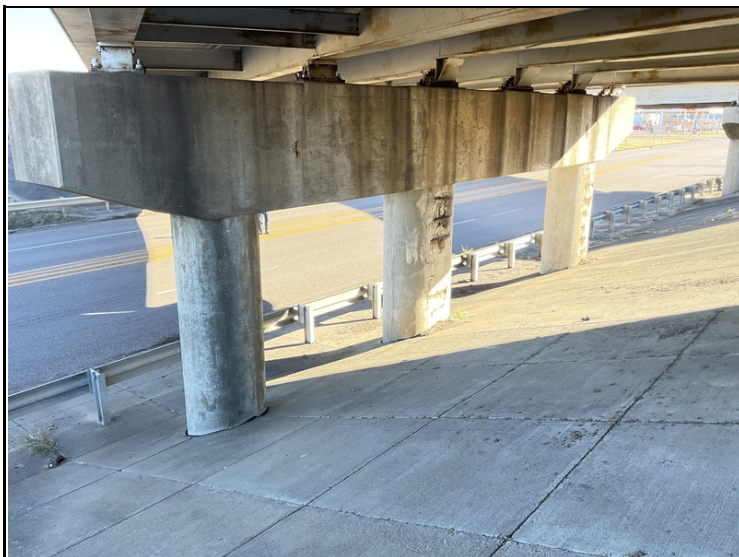
Bent 2 columns 2 and 3 have several spalls with exposed rebar.

Bent 2 columns 2 and 3 have several spalls with exposed rebar.
Bent 3 columns 2 and 3 have spalls with exposed rebar.

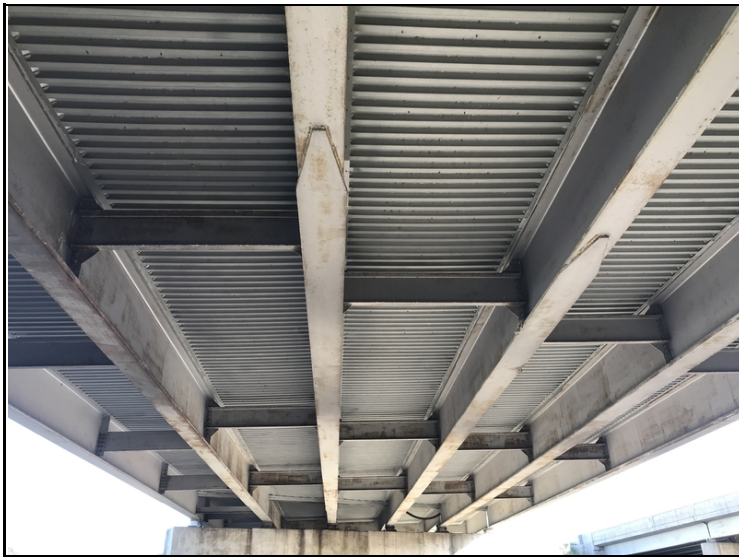
Span 2

Girders have scattered areas of freckled surface rust. Girders have a few areas of minor pitting, especially on bottom flange.

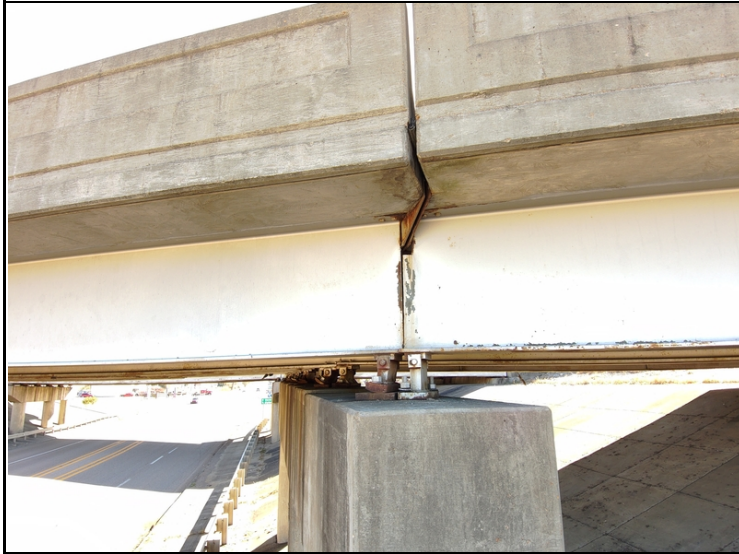
Girder 1 over bent 2

Span 2 bent 2 bearing 1 is rotated back. Girder is butted up against girder 1 in span 1.

Type of Work: Repair (General)
Status: Open
Component: Superstructure

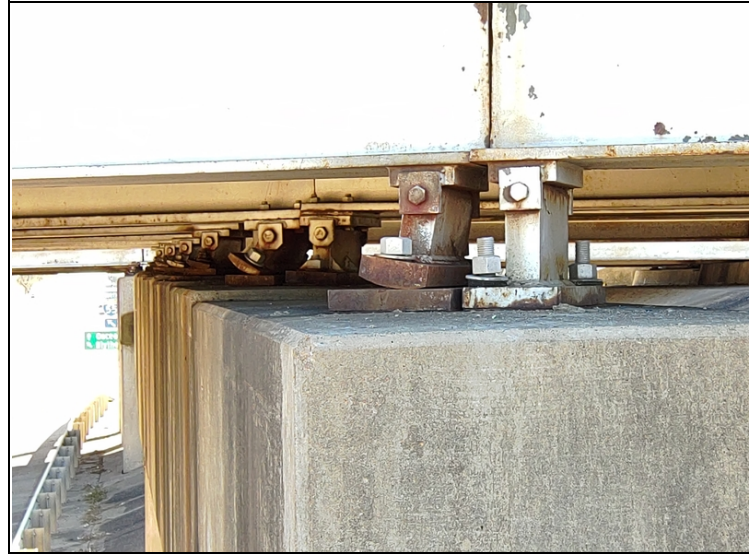
Span 2 bent 2 rocker bearings

Span 2 bent 2 bearings are rotated back.

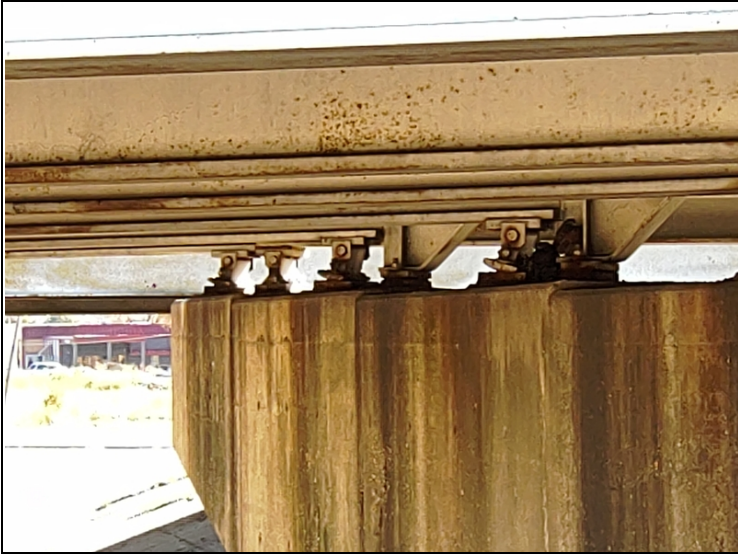
Span 2 bent 2 rocker bearings 3 - 6

Span 2 bent 2 bearings 3 - 6 are near max rotation.

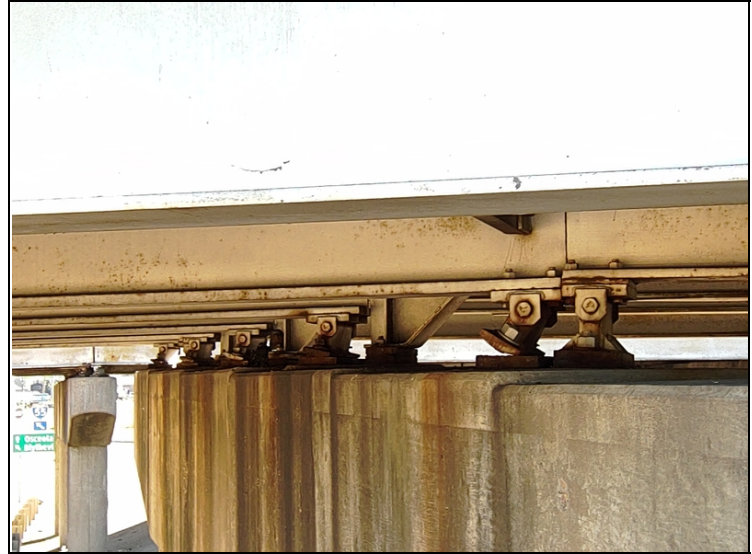
Span 2 bent 2 bearing 2 is rotated beyond maximum limit. Anchor bolts are sheared off. Girder is butted up against girder 2 in span 1.

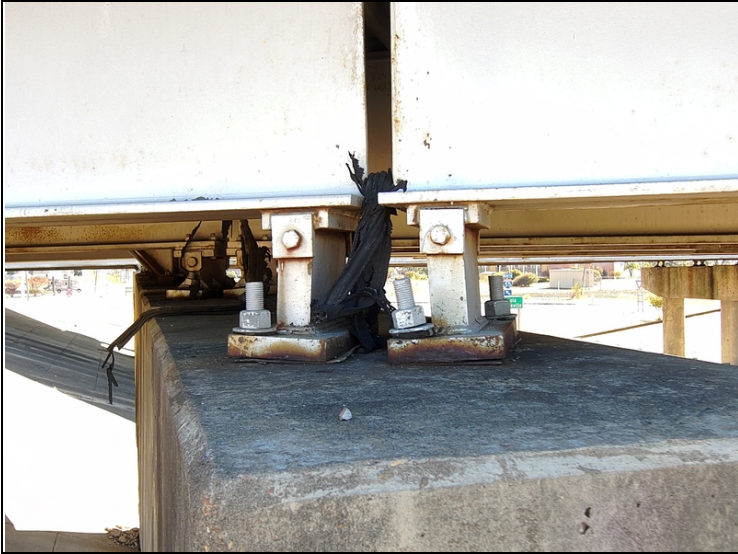
Span 2 bent 3 bearing 1 Rt side cap screw is protruding out of bearing. Bearing is rotated ahead and has a gap between masonry plate and cap on back side.

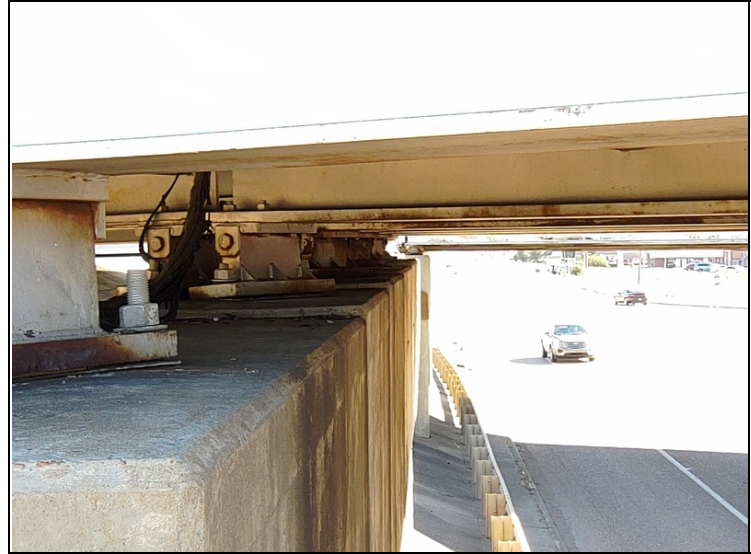
Span 2 bent 3 bearing 2 is rotated ahead and has a gap between cap and masonry plate on back side.

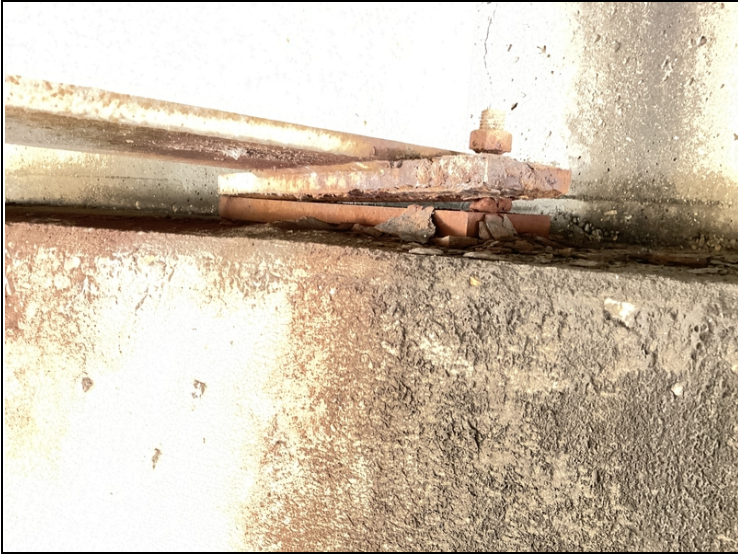
Span 3 bent 4 bearing 3 has a $\frac{3}{4}$ " gap between masonry and sole plates on 1 side.

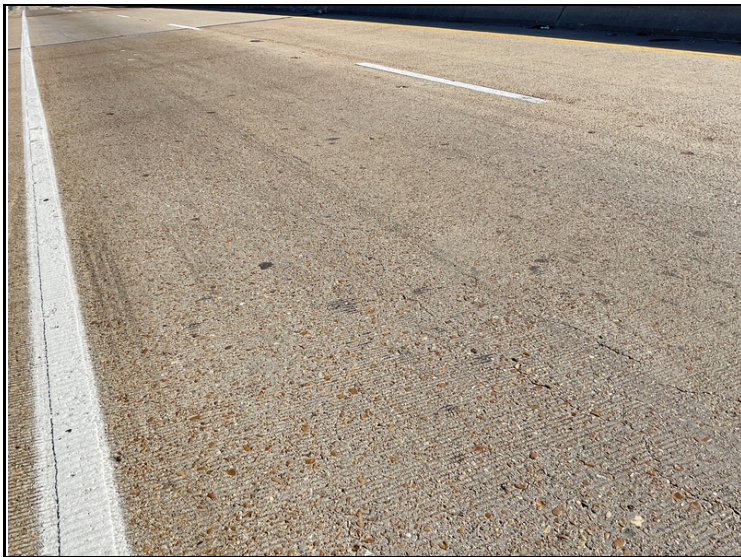
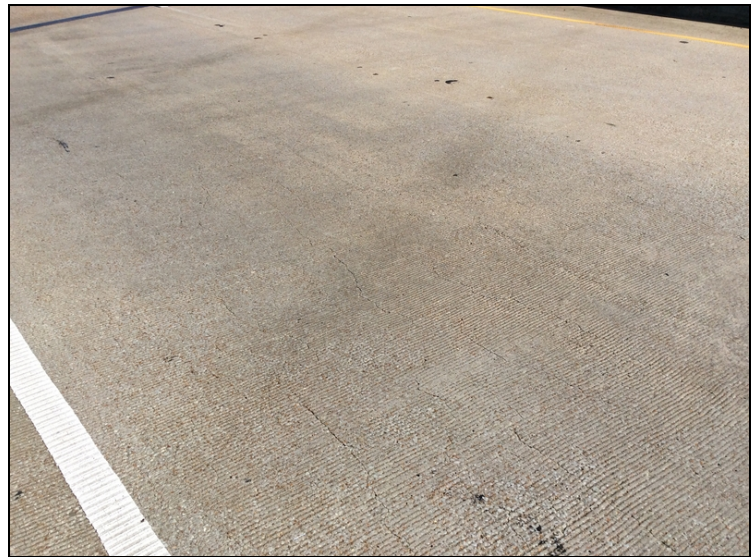
Span 1 longitudinal cracks

Deck has several unsealed longitudinal and transverse cracks.

Date Reported: 10/22/2012
Priority: C - Important
Type of Work: Repair (General)
Status: Monitor
Component: Deck

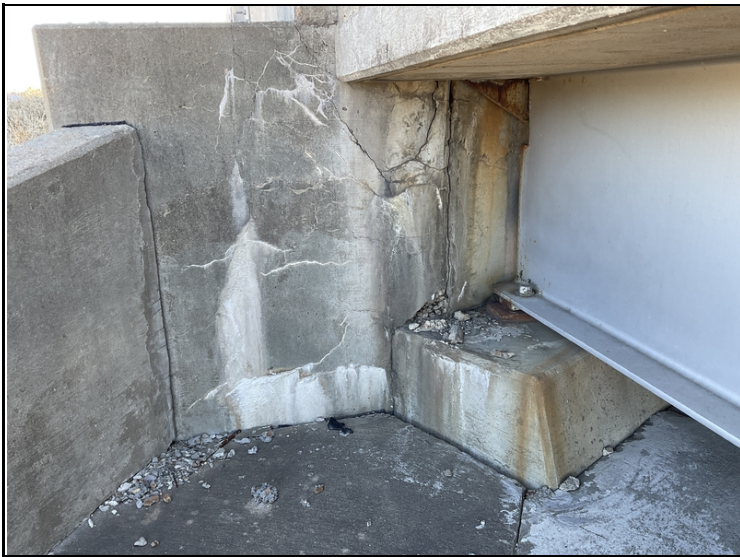
Bent 4 Lt

Bents 1 and 4 abutments have a few vertical cracks. Backwalls have efflorescence and some rebar exposed. Bent 4 back wall has 4' of cracks with efflorescence on Lt end.

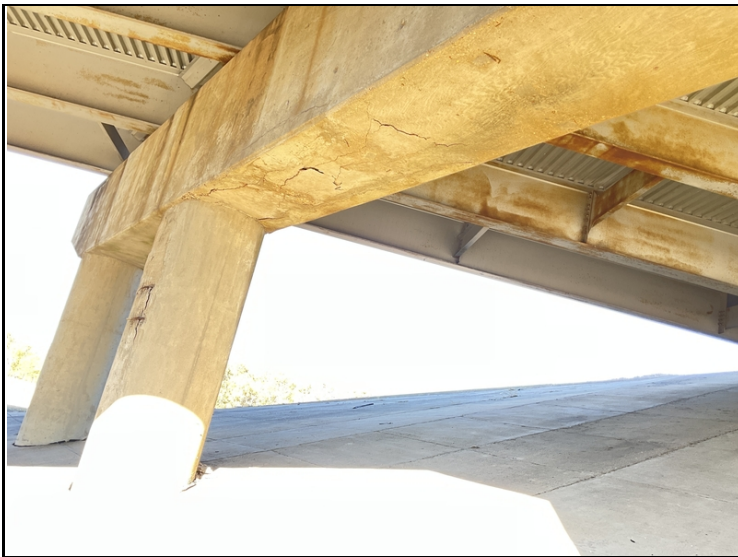
Bent 3 cap has cracked and delaminated areas along bottom of cap between columns 2 and 3.

Date Reported: 10/09/2018
Priority: D- Routine
Type of Work: Repair (General)
Status: Monitor
Component: Substructure

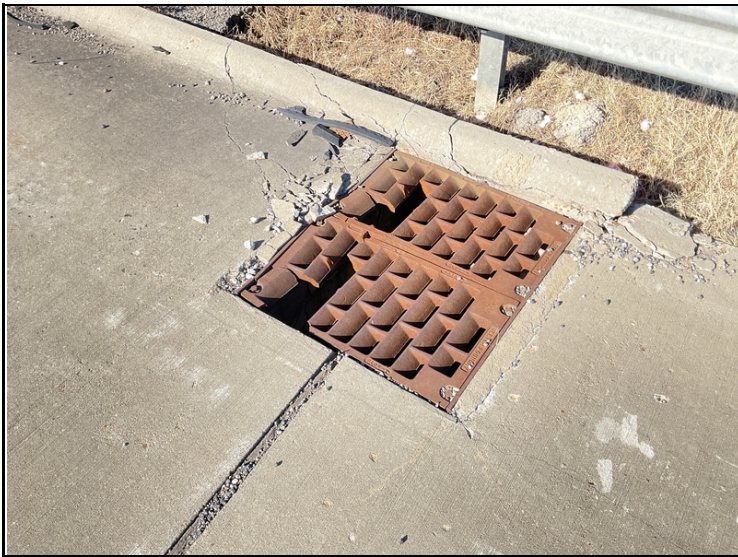
Bent 4 Lt approach gutter

Lt approach rail end post at bent 4 is cracked and spalled. Lt approach gutter and curb are cracked and spalled at dop inlet. Metal grate over drain is cracked/broken.

Date Reported: 10/23/2020
Priority: C - Important
Type of Work: Repair (General)
Status: Open
Component: Approach
