Asset #06064(Routine)

SH 275 S-3 LM5.54 over MORO CREEK

Team Lead: Rickie Bratton, Inspection Date: 06/02/2022

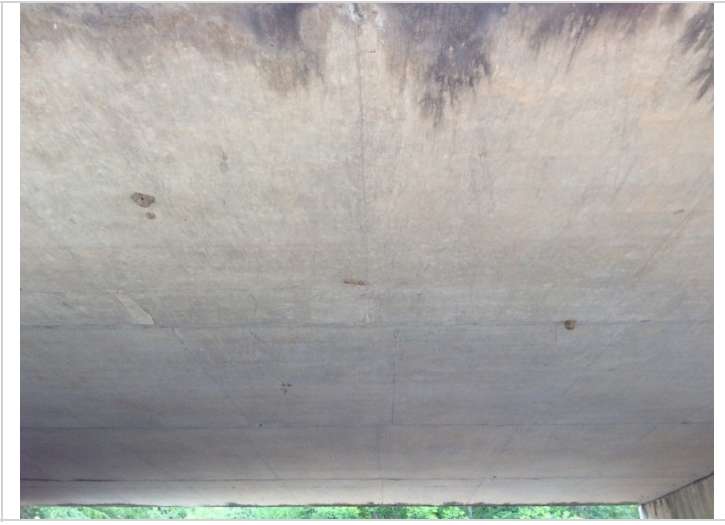
Soffit overview.

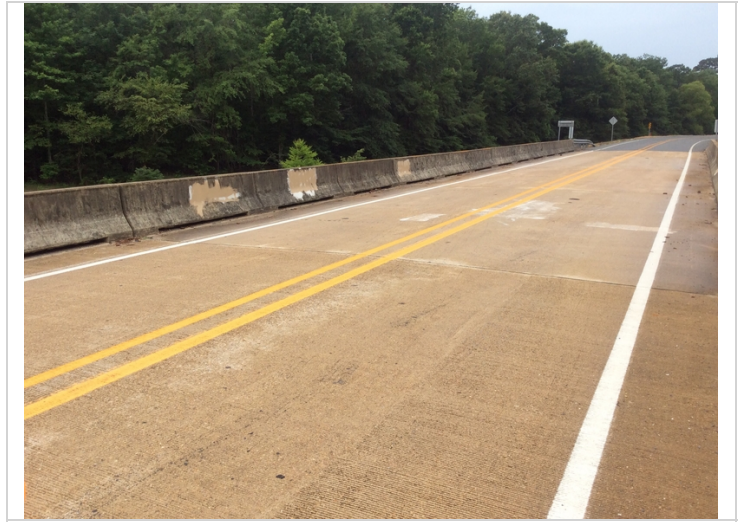
Deck overview.

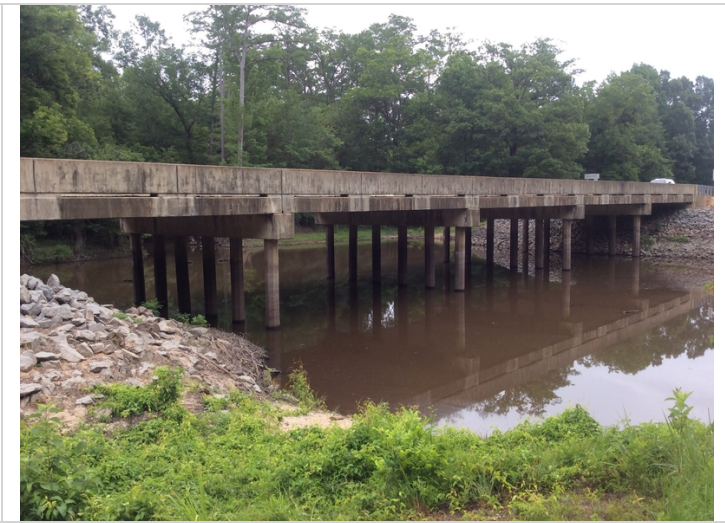
Elevation.

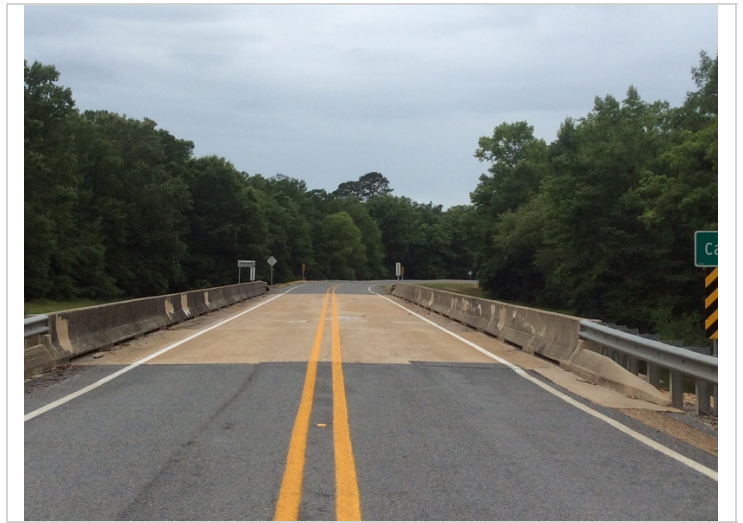
Approach roadway.

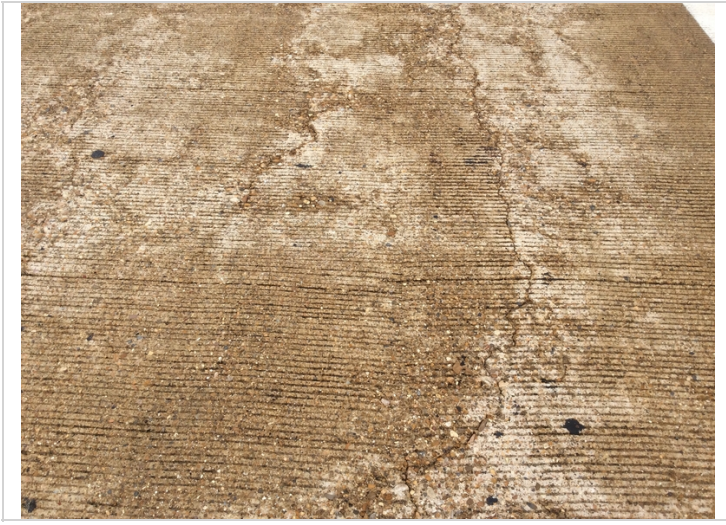
ELEMENTS	DESCRIPTION	UNITS	TOTAL	CS1	CS2	CS3	CS4
38	RC Slab	SF	5397	4962	435	0	0
1120	Efflorescence/Rust Staining	SF	15	0	15	0	0
1130	Cracking (RC and Other)	SF	420	0	420	0	0
(38) All bents, both sides of the bridge have shear cracks from top of deck to the top of concrete caps. There are 30' of shear cracks. Span 1 -- 35' of deck crack & span 5 -- 35' of deck crack.

Span 5, longitudinal cracks.

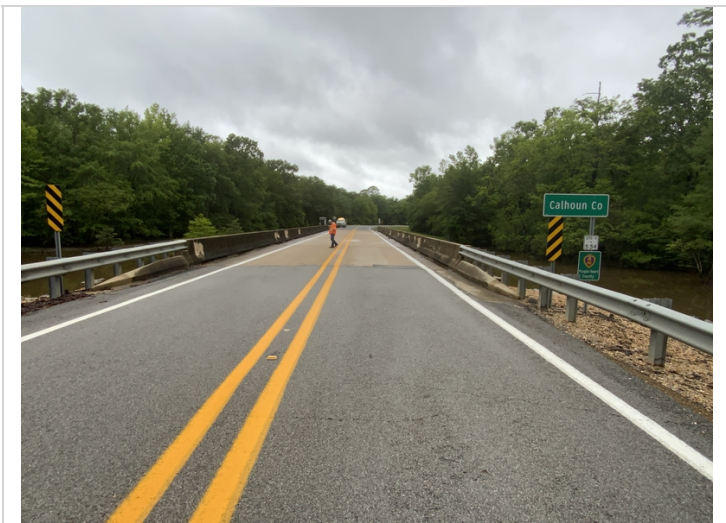
Approach roadway Westbound.

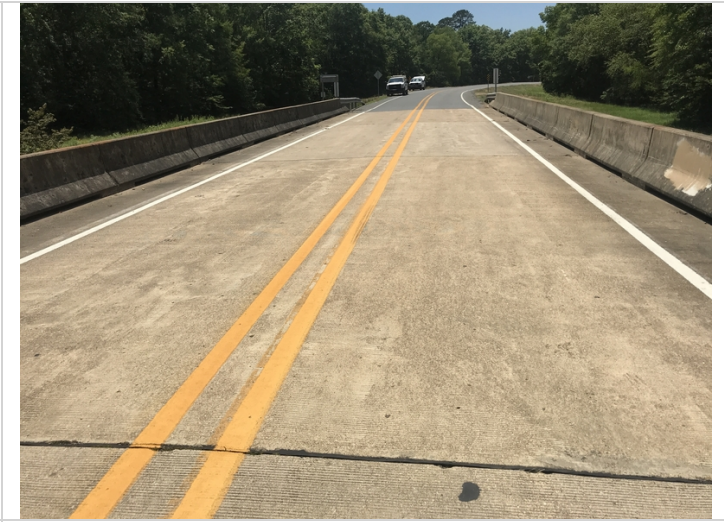
Span 3 looking ahead @ the deck.

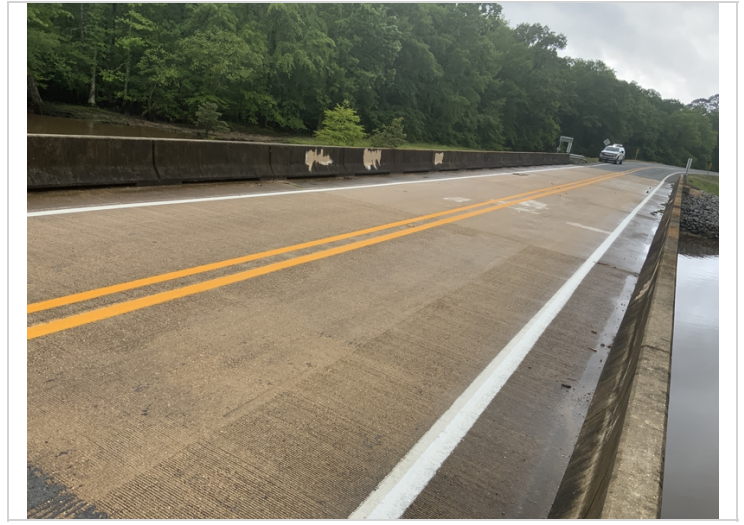
Deck overview.

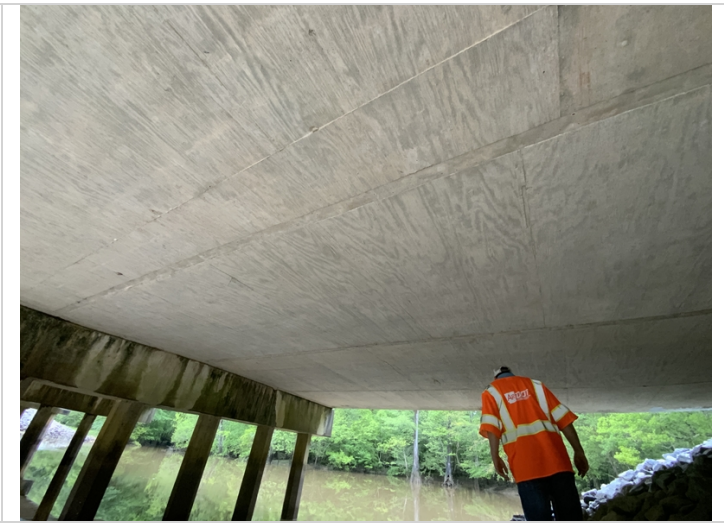
Span 1 soffit overview.

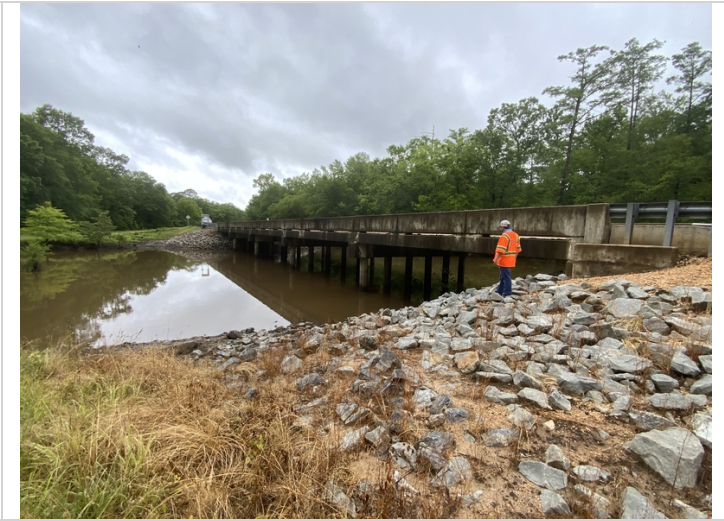
Elevation.

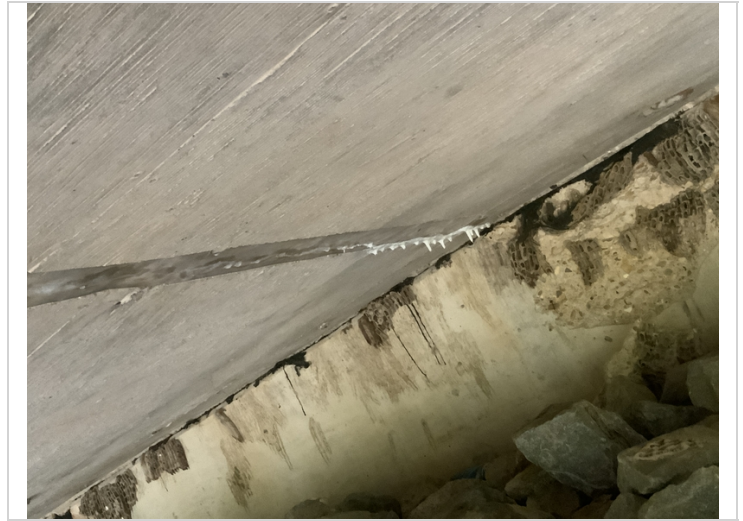
Span 1 soffit has cracks with efflorescence.

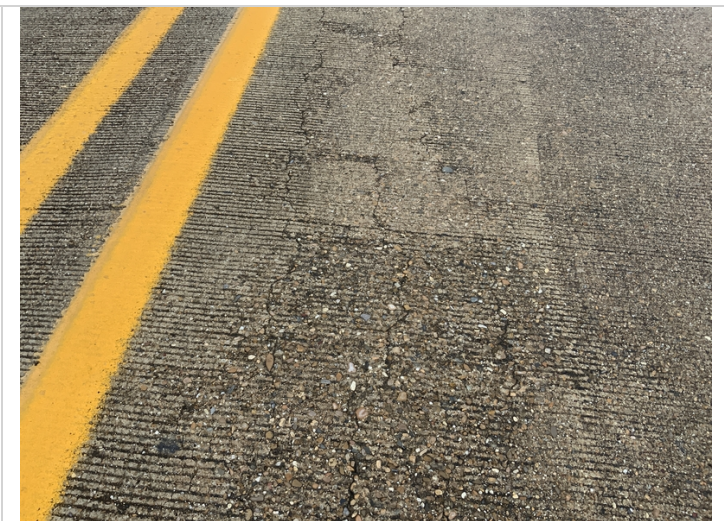
Deck span 1 has longitudinal cracks.

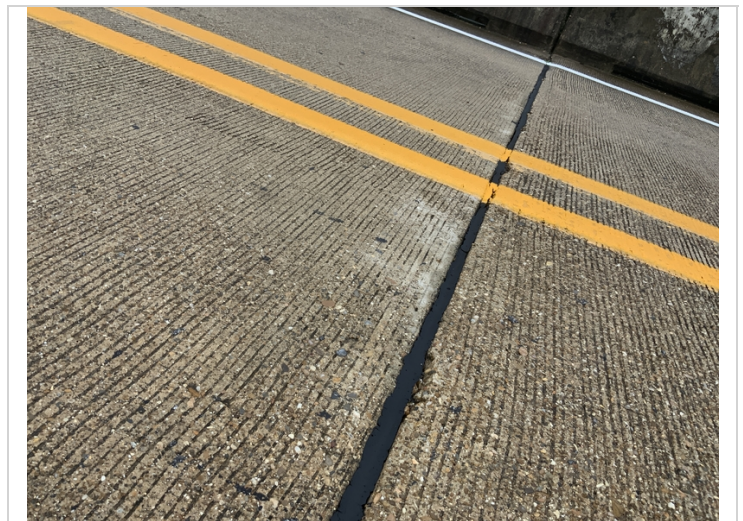
Bent 5 joint seal loss of bond, common all joints.

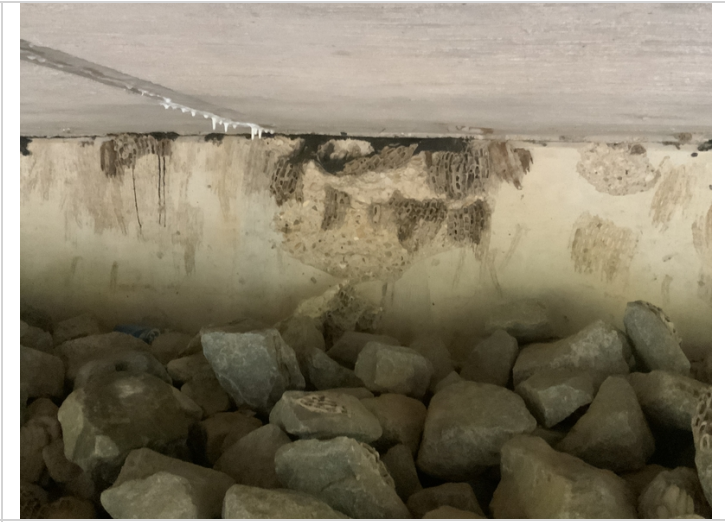
ELEMENTS	DESCRIPTION	UNITS	TOTAL				
				CS1	CS2	CS3	CS4
215	Reinforced Concrete Abutment	LF	89.2	87.2	2	0	0
1080	Delamination/Spall/Patched Area	LF	2	0	2	0	0
227	Reinforced Concrete Pile	EA	24	0	24	0	0
1190	Abrasion/Wear (PSC/RC)	EA	24	0	24	0	0
(227) All piles have light abrasion.							
234	Reinforced Concrete Pier Cap	LF	126.7	126.7	0	0	0

Bent 1 abutment has spall.
