Asset #05002(Routine, Underwater type 2)
SH 11 White County over GUM SPRINGS CREEK

Location: .95 MI E JCT SH 367

Team Lead: Nathan Edwards, Inspection Date: 05/10/2022

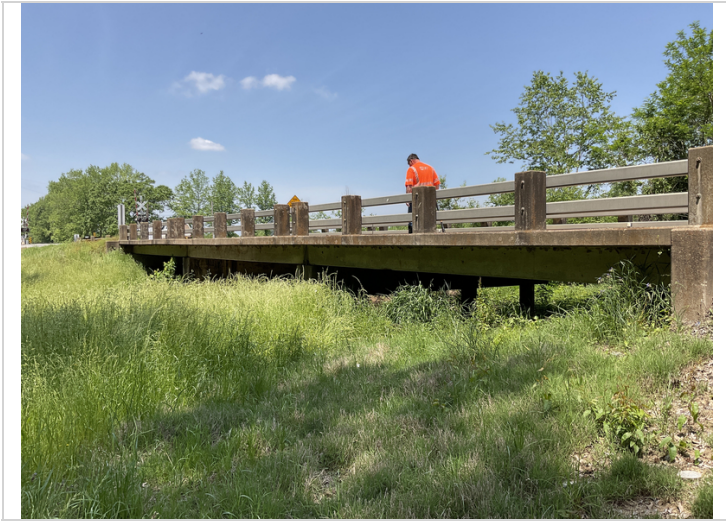
Elevation with Log Mile running to the Left.

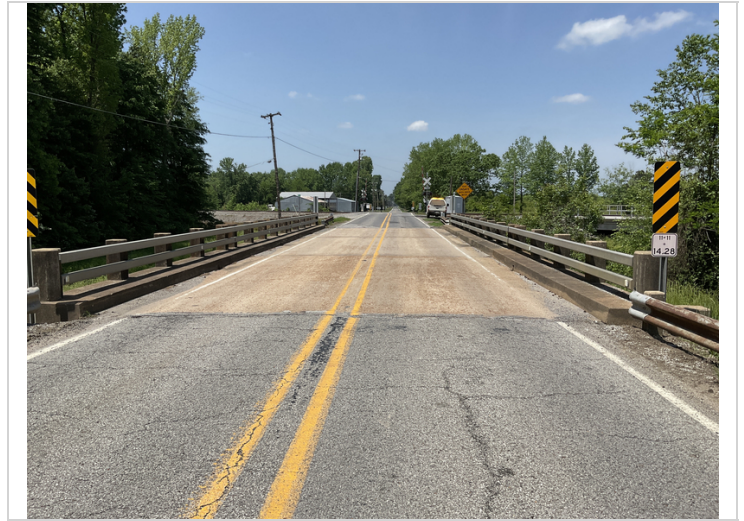
Roadway with Log Mile running East to West.

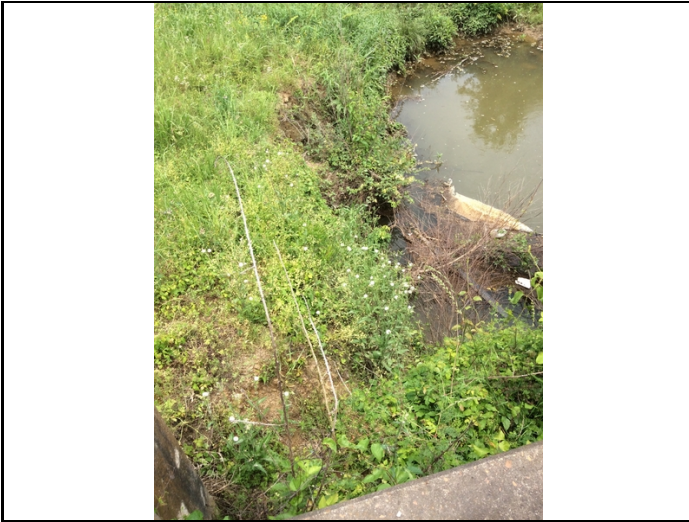
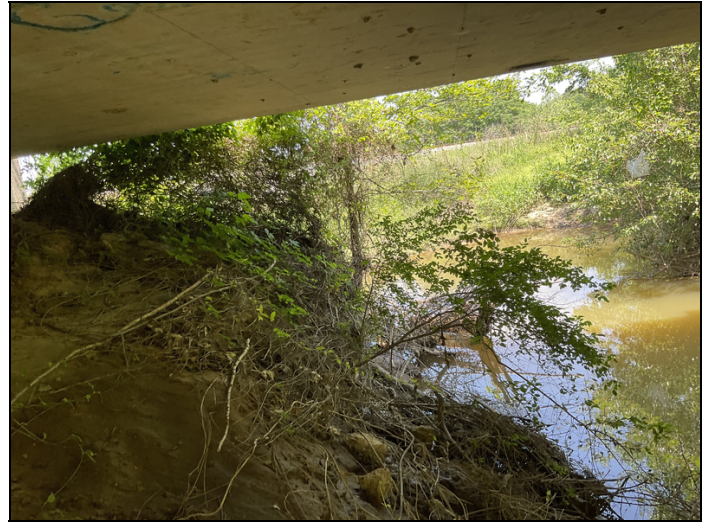
Erosion to embankment on Right side of Abutment 2.

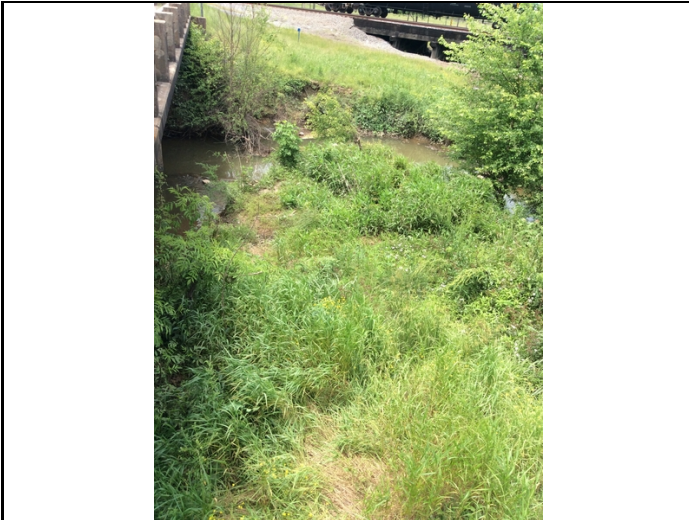
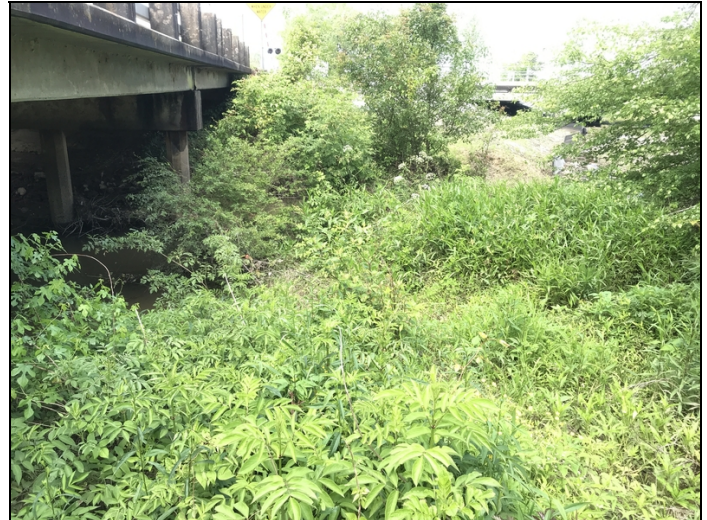
Sediment buildup on Right side of Span 2 restricting flow and realigning channel.

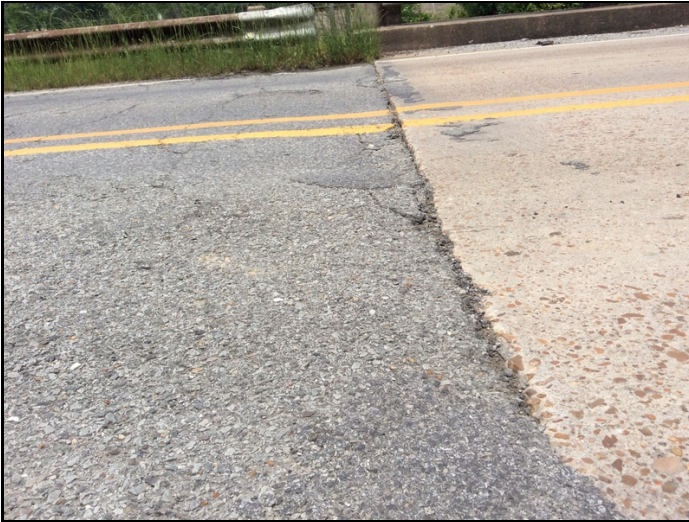
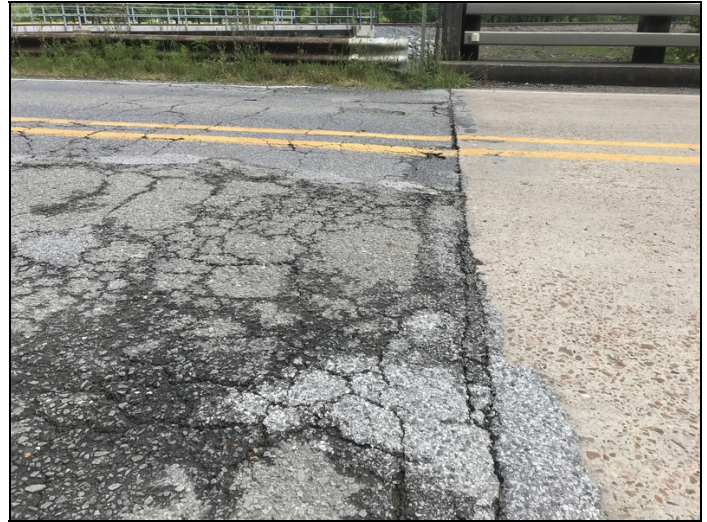
Visible settlement to Roadway at Abutment 2.

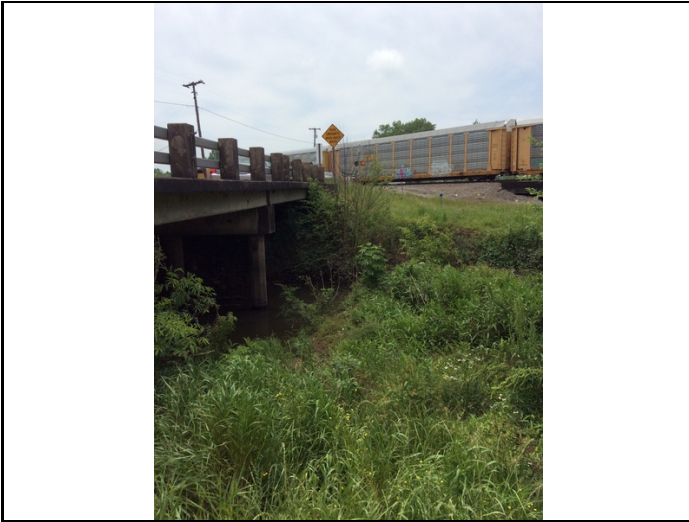
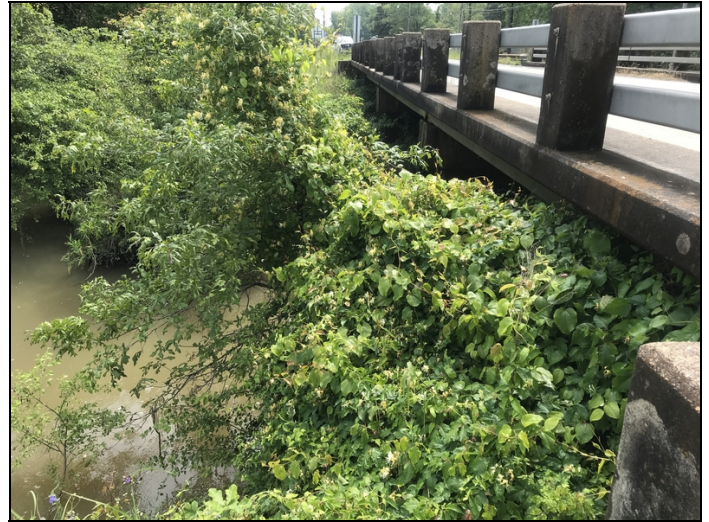
Heavy vegetation on Right side of Abutment 2.

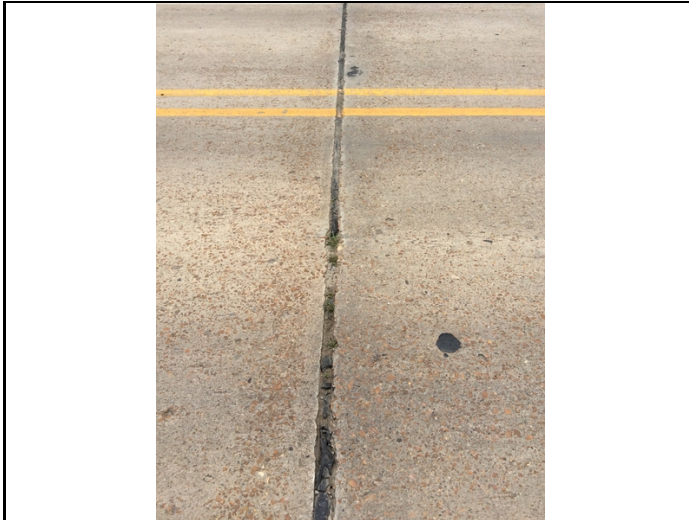
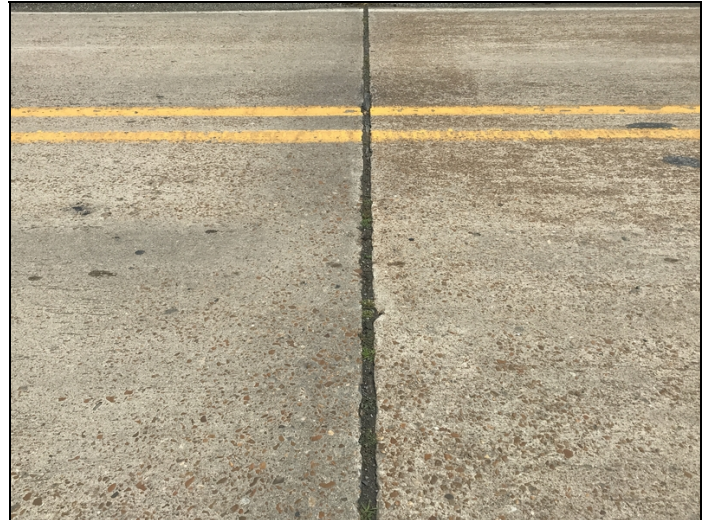
(301) Pourable joint seal has lost adhesion & is missing @ Bent 1 Left curb area.(typical to Right.) Pourable joint seal is losing adhesion @ Bents 1 & 2.							
330	Metal Bridge Railing	LF	360	360	0	0	0
515	Steel Protective Coating	SF	720	720	0	0	0

All poured joint seals are deteriorated & leak.

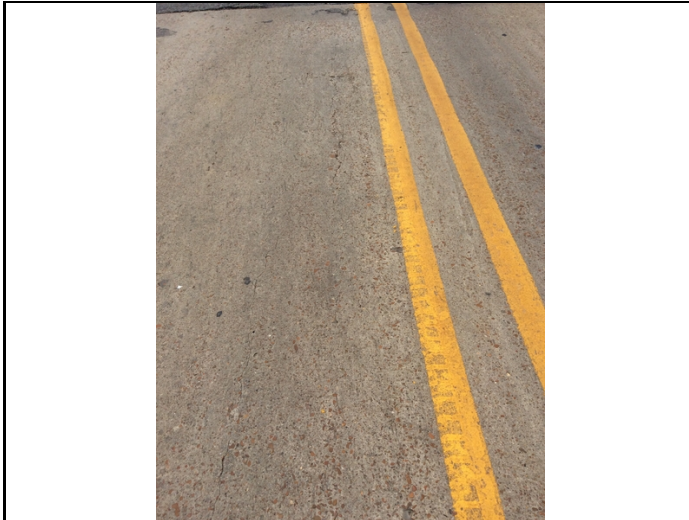
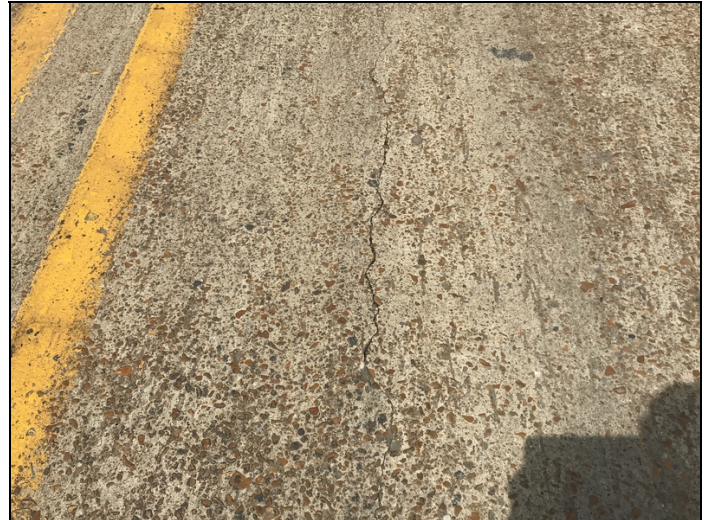
Unsealed cracks to Deck at Span 1, 2, & 3.

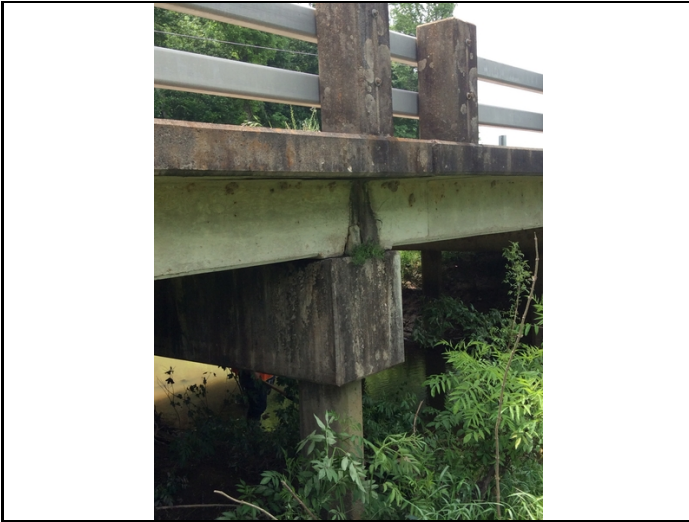
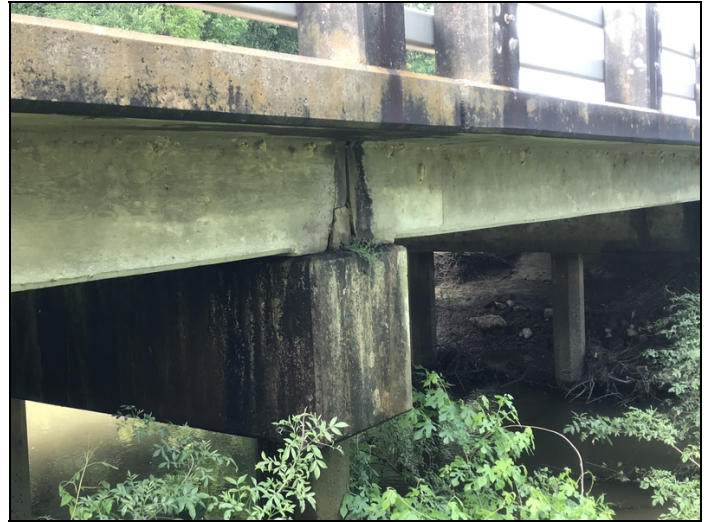
Cracks to Left & Right outside edge of Deck at Bent 1.

Cracking/spalls to Left & Right outside edge of Deck at Bent 1.

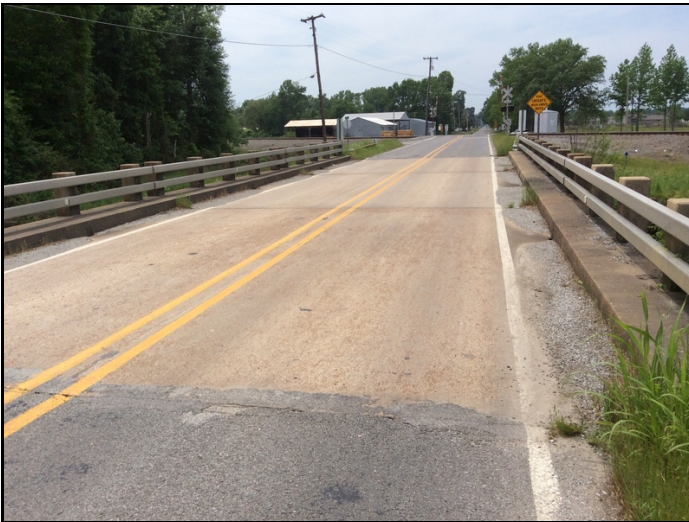
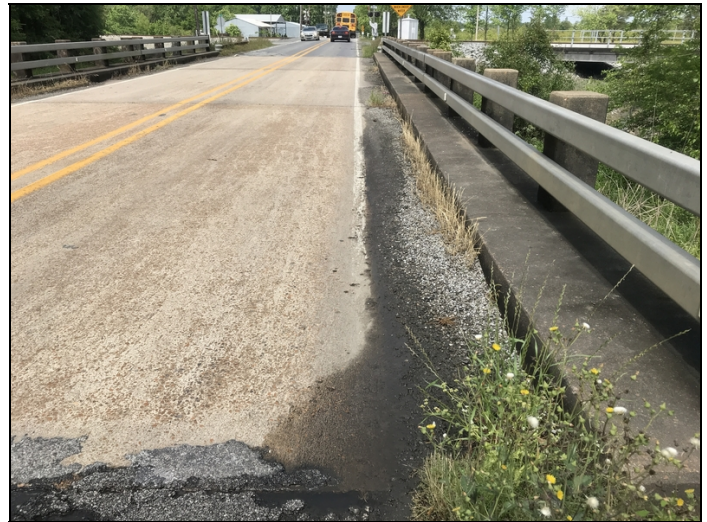
Debris in gutters at all spans.
