Asset #03060(Routine)

SH 37/Jackson Co. over VILLAGE CREEK

Location: 3.60 MI E JCT OF US 67

Team Lead: Kerry Little, Inspection Date: 06/09/2021

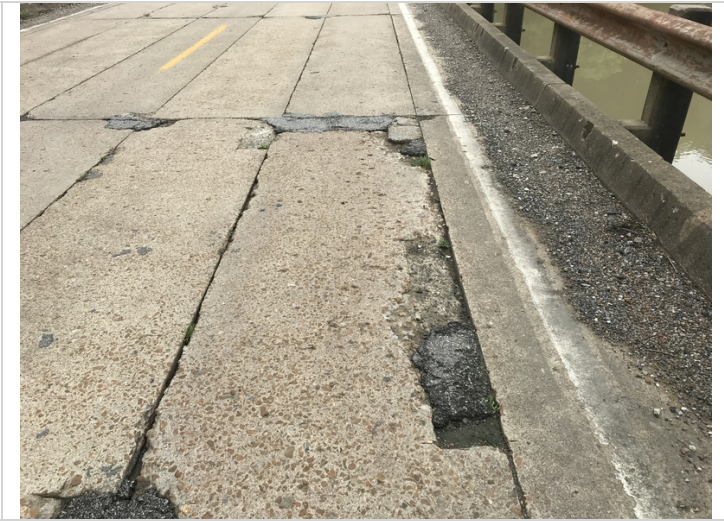
Typical spalls with rebar exposed to units @ all spans.

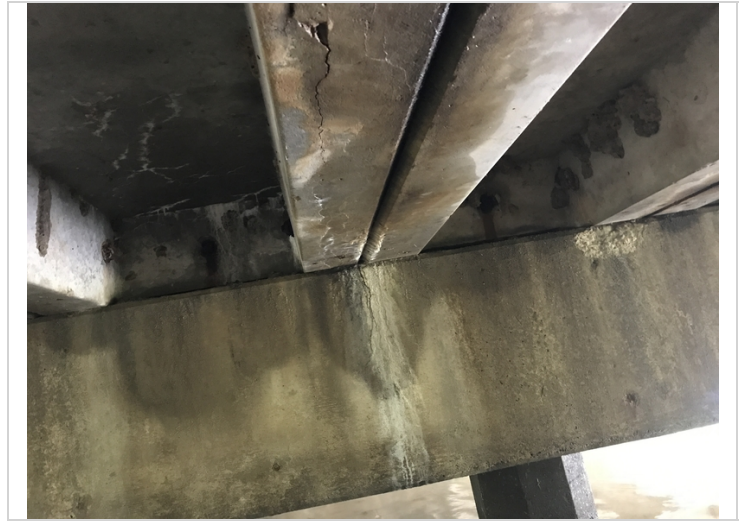
Areas of efflor cracks to girders @ all span.

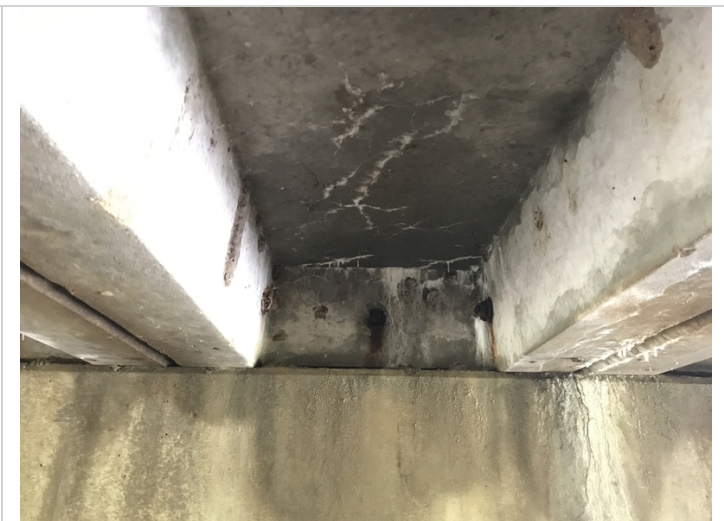
Efflor cracks to soffit @ girder 5.

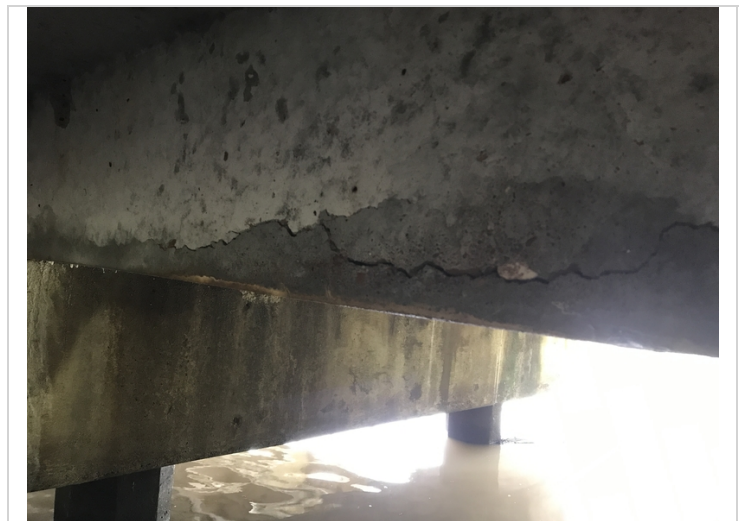
Typical cracks to girders @ all spans.

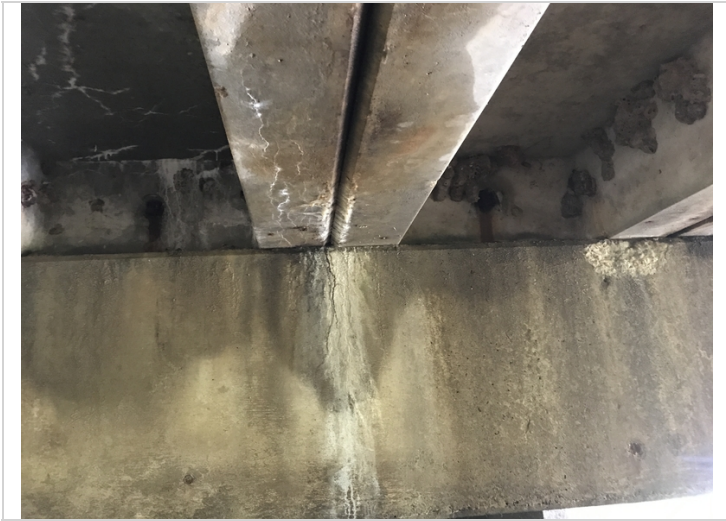
Areas of efflor to girders @ all spans.

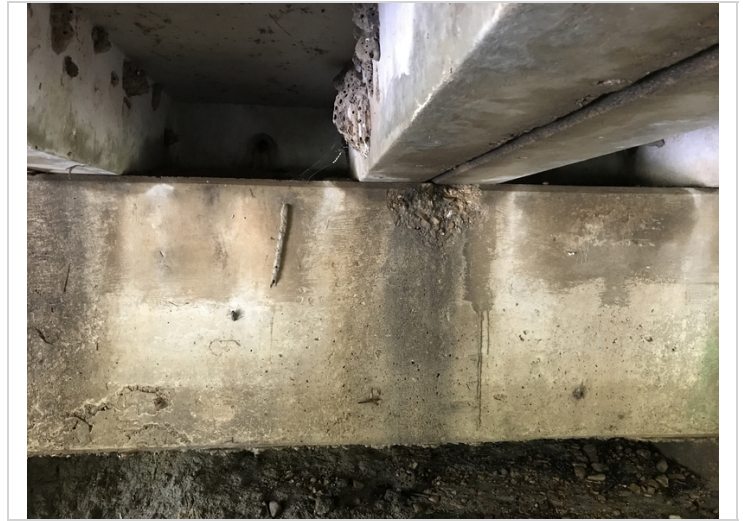
Spalls to abutment 2 with no rebar exposed @ girders 3 & 5.

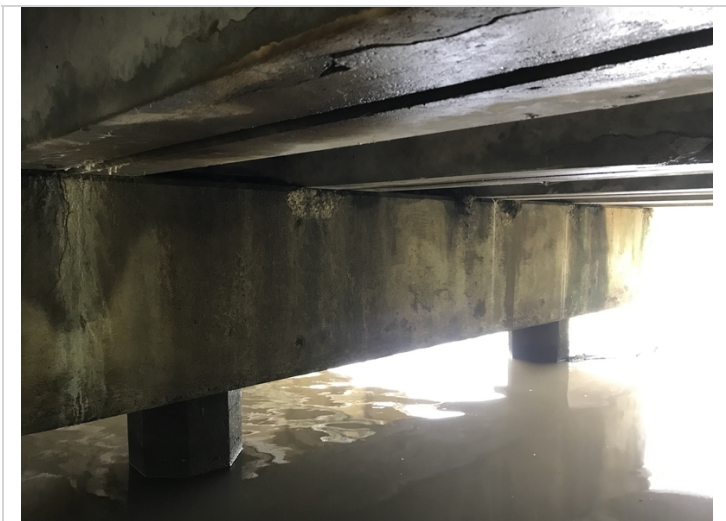
Spalls to ahead side of cap @ bent 17 @ girders 1 - 7.

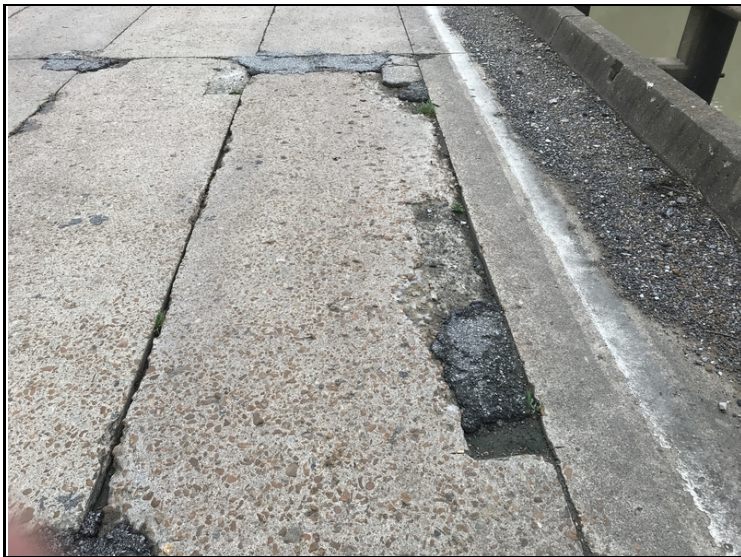
Typical spalls of random units with some rebar exposed to:

Spalls with rebar exposed to unit 6 @ span 1.

Date Reported: 06/09/2021
Priority: C - Important
Type of Work: Repair (General)
Status: Open
Component: Bridge

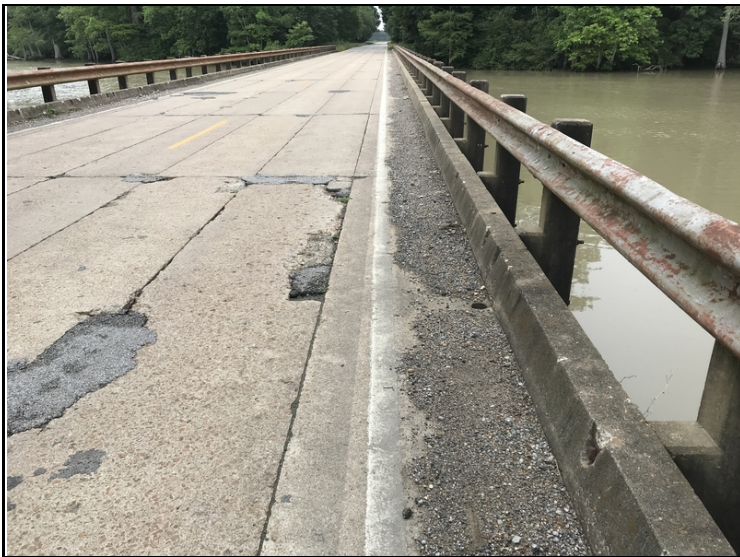
Debris buildup in Rt & Lt gutter line @ all spans.

Date Reported: 06/09/2021
Priority: D- Routine
Type of Work: (Inactive) (Inactive) 1 - Clean
Status: Open
Component: Bridge

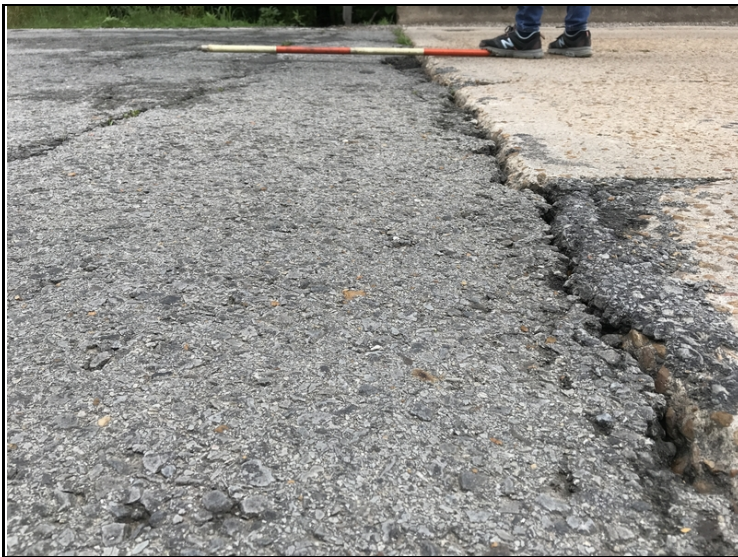
Visible Roadway settlement @ abutment 1.

Date Reported: 06/09/2021
Priority: C - Important
Type of Work: Repair (General)
Status: Open
Component: Bridge

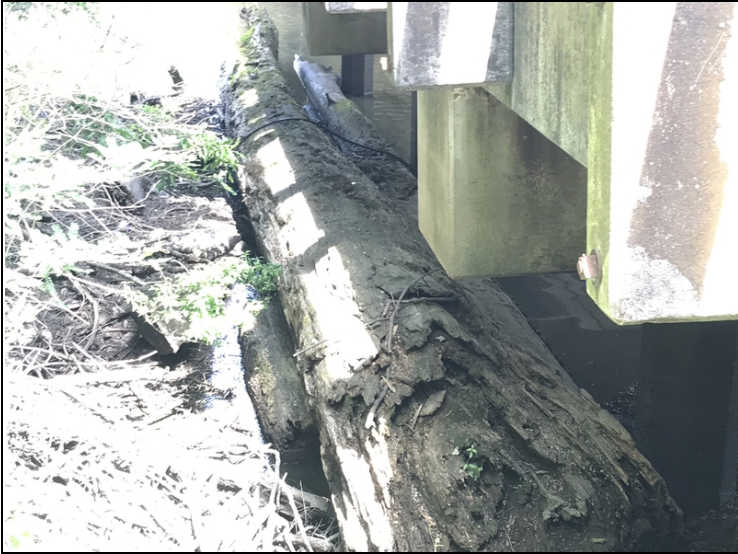
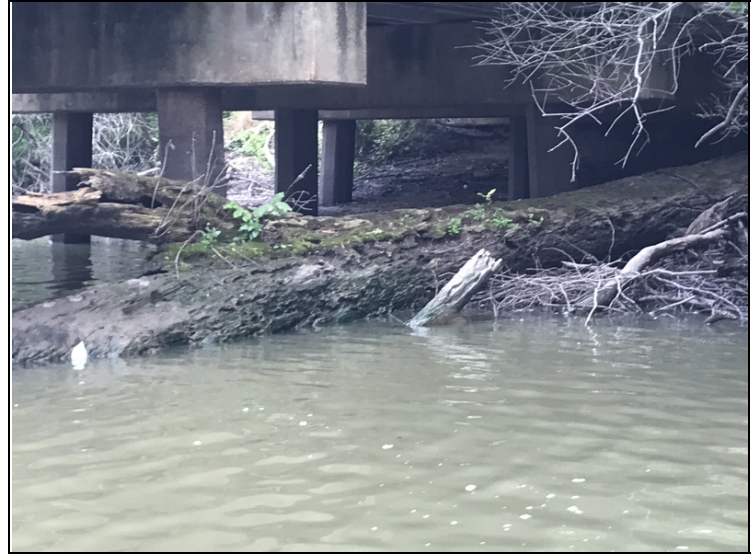
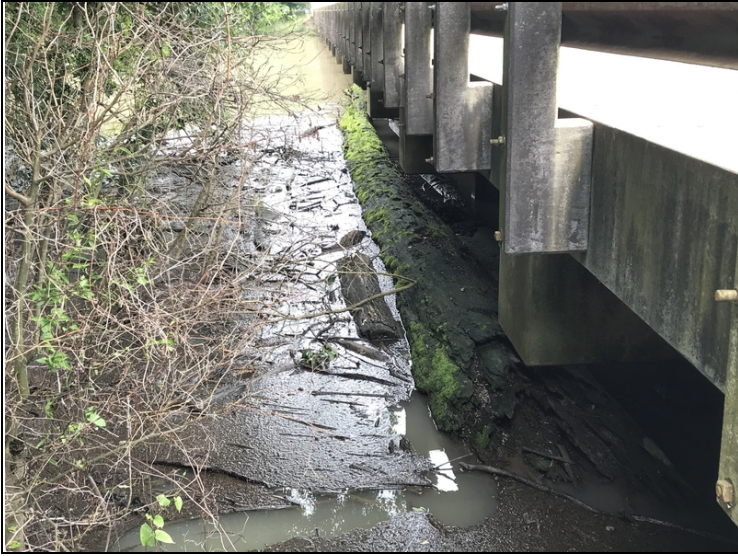
Large tree against Bents 11 - 15.

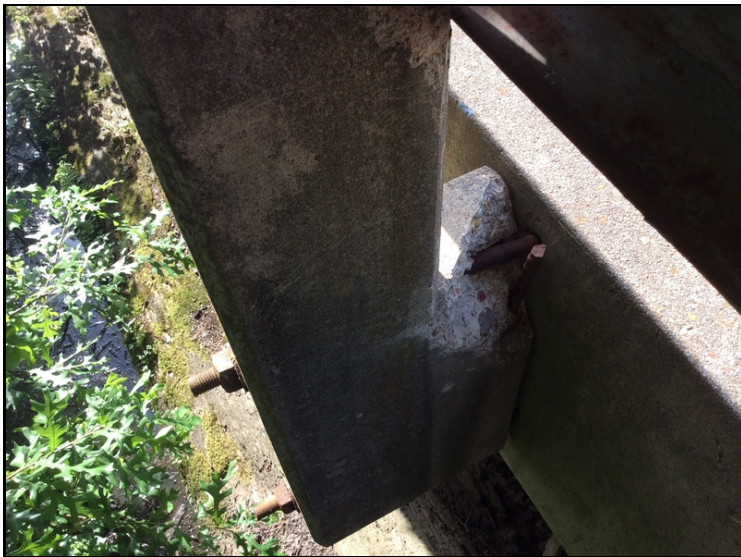
1st post on right side Span 14.

1st concrete guardrail post on Right side of Span 4, 5, 6 & 14 have spalls with rebar exposed.

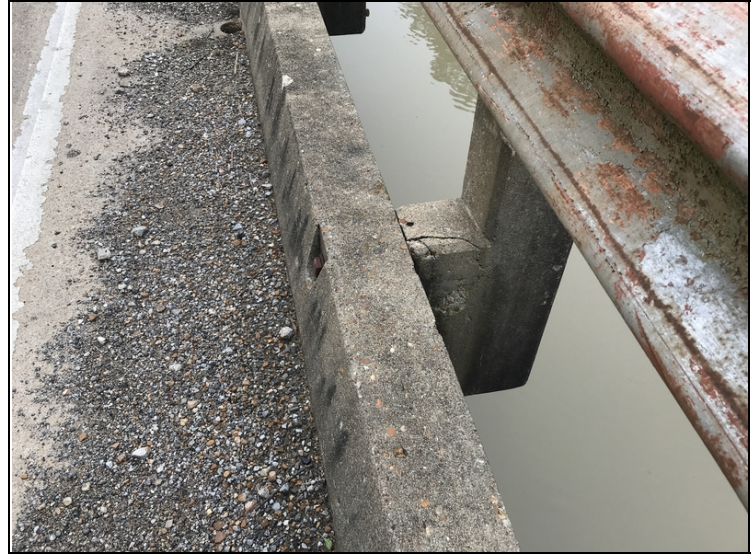
1st concrete guardrail post on Right side of Span 4,
5, 6 & 14 have spalls with rebar exposed.
Span 4

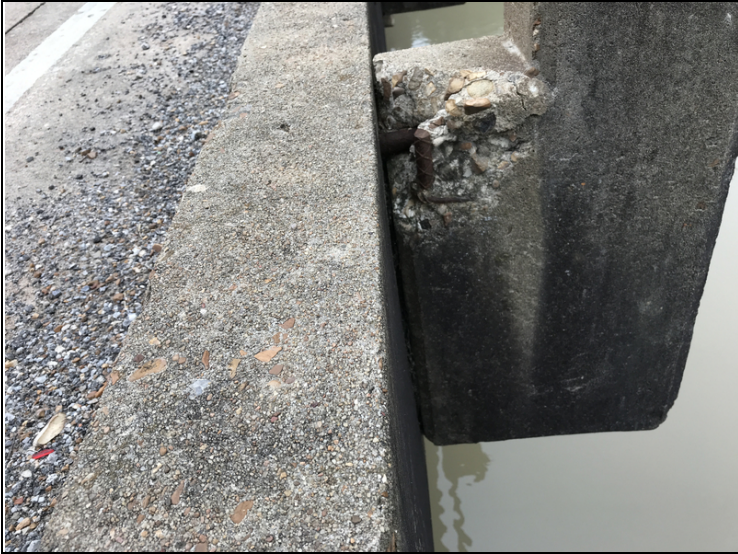
1st concrete guardrail post on Right side of Span 4,
5, 6 & 14 have spalls with rebar exposed.
Span 5.

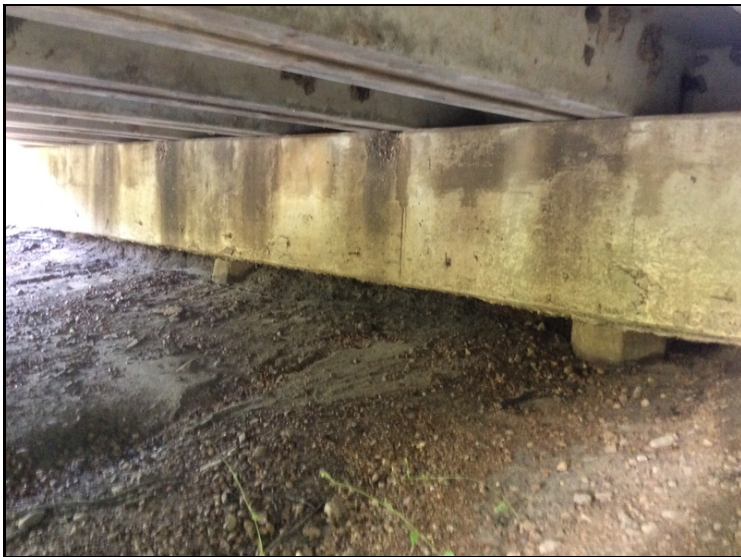
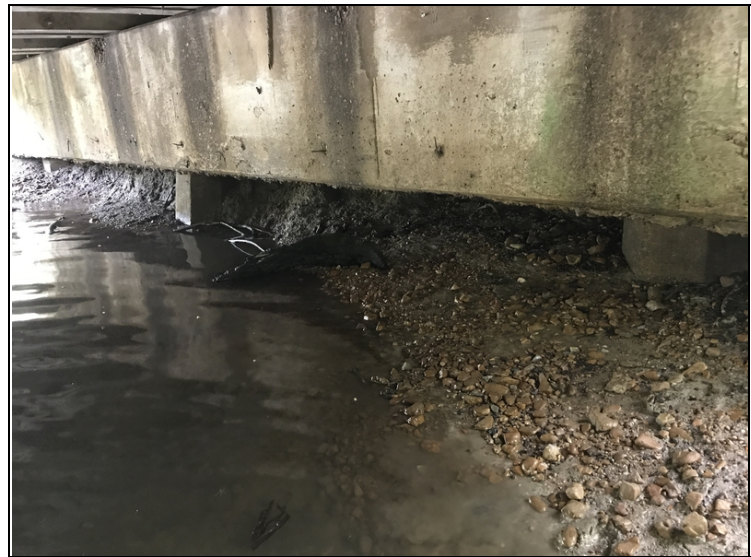
(215) Undermining 1' down & 2' back under Abutment 2 with 3 piles exposed. See attached Form III for details of deficiencies.							
227	Reinforced Concrete Pile	EA	45	0	44	1	0
1130	Cracking (RC and Other)	EA	3	0	3	0	0
1190	Abrasion/Wear (PSC/RC)	EA	42	0	41	1	0

Undermining 1' down & 2' back under Abutment 2 with 3 piles exposed.

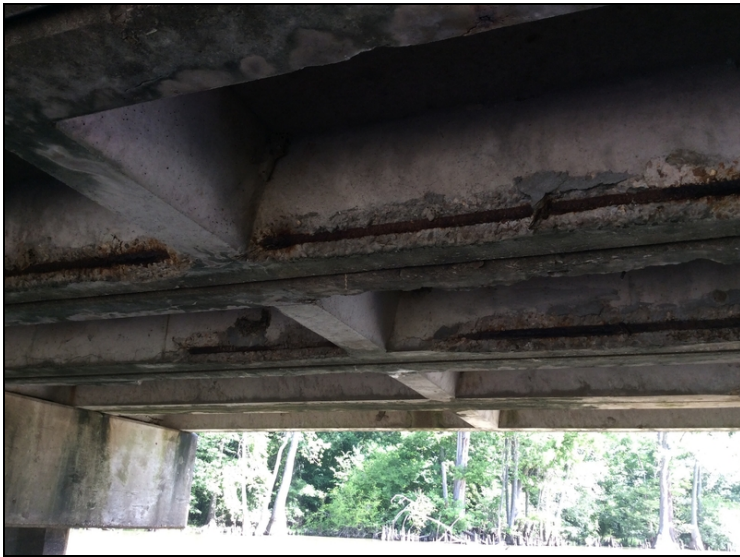
Span 6 Units 4 & 5.

Spalls with rebar exposed to girders @ all spans. Some with section loss.

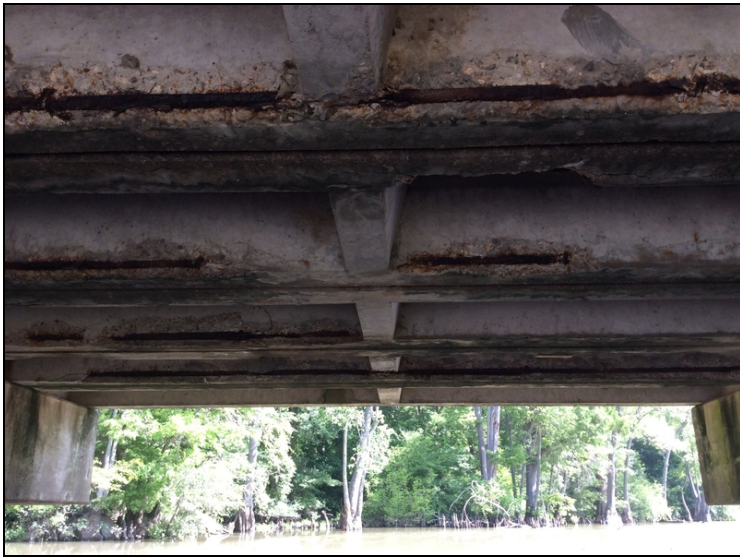
Span 9 Units 3, 4, 5 & 6.

(110) Span 9 Units 3 through 6 have section loss to rebar and 6' of rebar is separated from Unit 6. Span 10 Unit 5 has 3' of exposed rebar with section loss. Span 14 Unit 6 has 16' of exposed rebar with section loss. Several longitudinal cracks to Units at all Spans. See attached Form III for details of deficiencies.							
215	Reinforced Concrete Abutment	LF	71	30	41	0	0
1080	Delamination/Spall/Patched Area	LF	2	0	2	0	0
1090	Exposed Rebar	LF	2	0	2	0	0
1130	Cracking (RC and Other)	LF	1	0	1	0	0
6000	Scour	LF	36	0	36	0	0

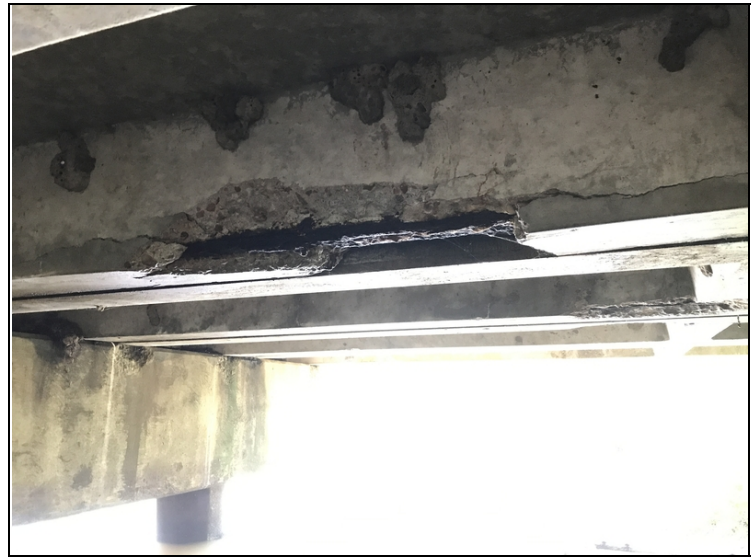
Spalls with rebar exposed to girders @ all spans.
Some with section loss.
(See Form III)
