Asset #M4074(Routine)
SH 37/Jackson Co. over SWAN POND
Location: 1.7 MI E JCT US 67-37

Team Lead: Kerry Little, Inspection Date: 11/15/2021

Asset #M4074(Routine)

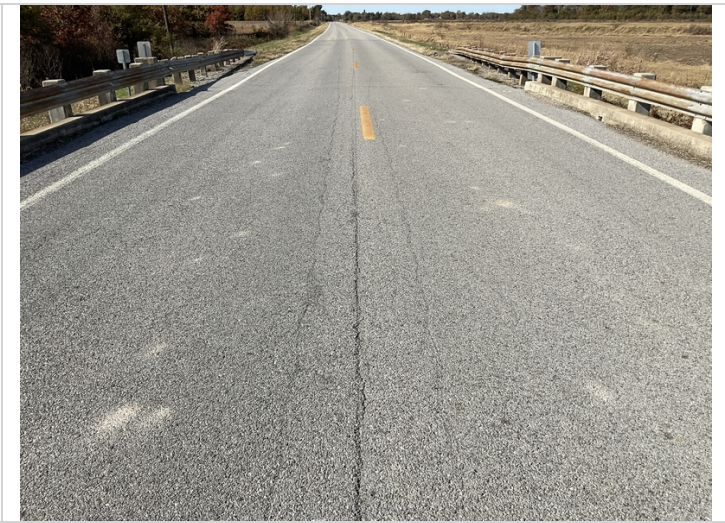
ELEMENTS	DESCRIPTION	UNITS	TOTAL	CS1	CS2	CS3	CS4
16	Reinforced Concrete Top Flange	SF	1224	1224	0	0	0
510	Wearing Surfaces	SF	1224	1154	60	10	0
3220	Crack (Wearing Surface)	SF	70	0	60	10	0
(16) Minor cracking to asphalt overlay.

Overall deck.

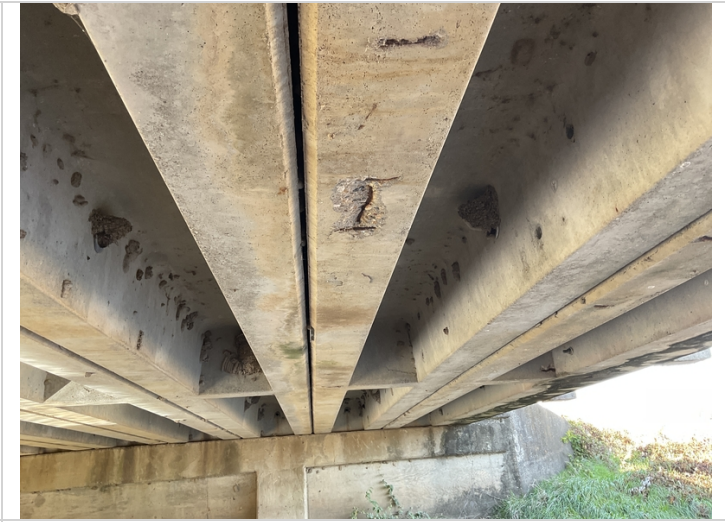
(110) Unit 1 - Spall with rebar exposed no s/l to girder. Unit 2 - Spall to girder. Unit 4 - Spall to girder. Unit 6 - Delam. to diaph. near mid span. Unit 8 - Minor delaminated areas to girder Unit 9 - Minor spalls with rebar exposed no s/l to Girder.							
215	Reinforced Concrete Abutment	LF	115	115	0	0	0

Spall with rebar exposed to unit 1, 2 , & 8.

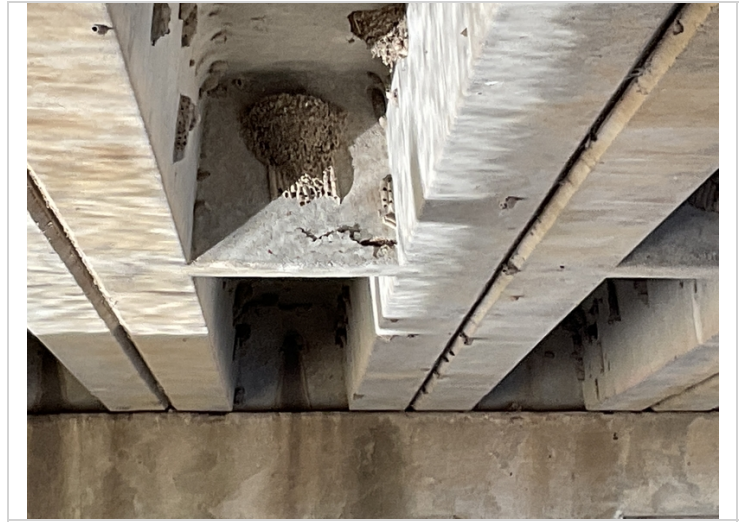
Delam to diaphragm @ unit 6.
