Asset #07437(Routine)

AR Hwy 56 over Strawberry River

Location: 1.4 MI E JCT SH 289N

Team Lead: Nathan Edwards, Inspection Date: 11/29/2021

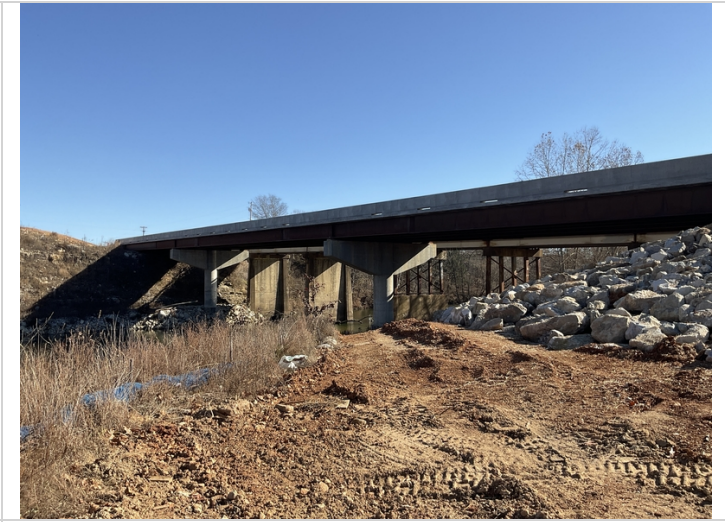
Elevation with Log Mile running to the Left.

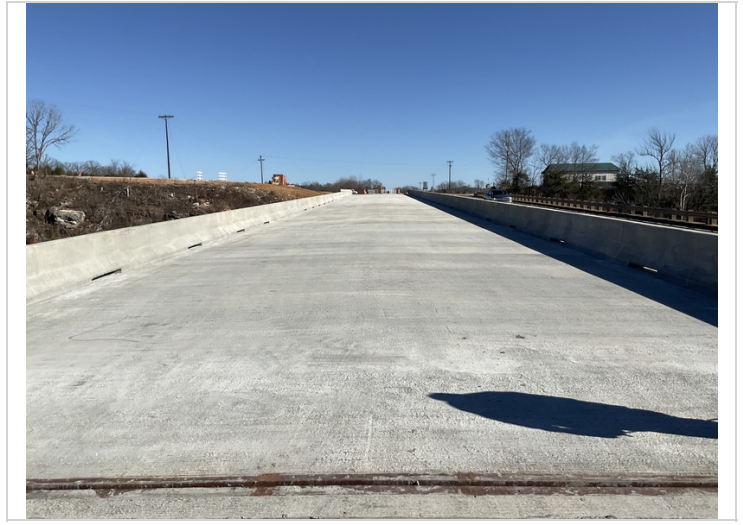
Roadway with Log Mile running West to East.

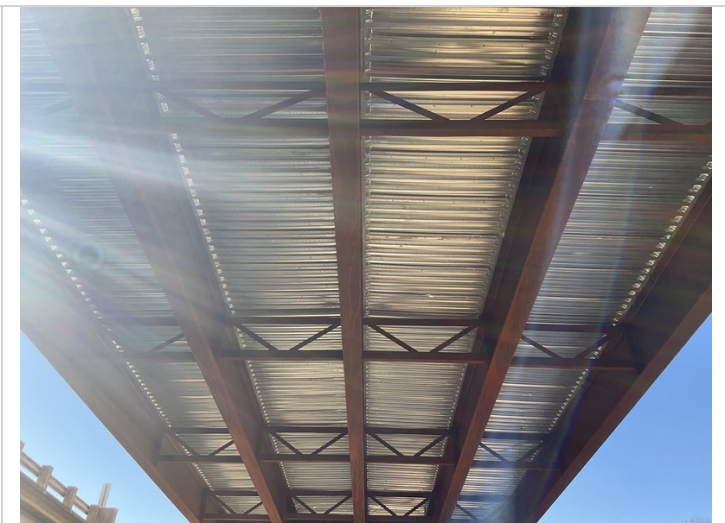
Soffit photo.

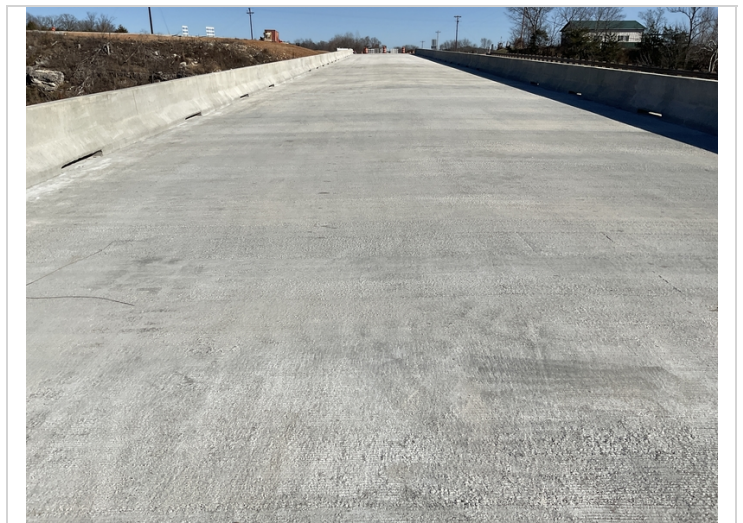
Deck photo.

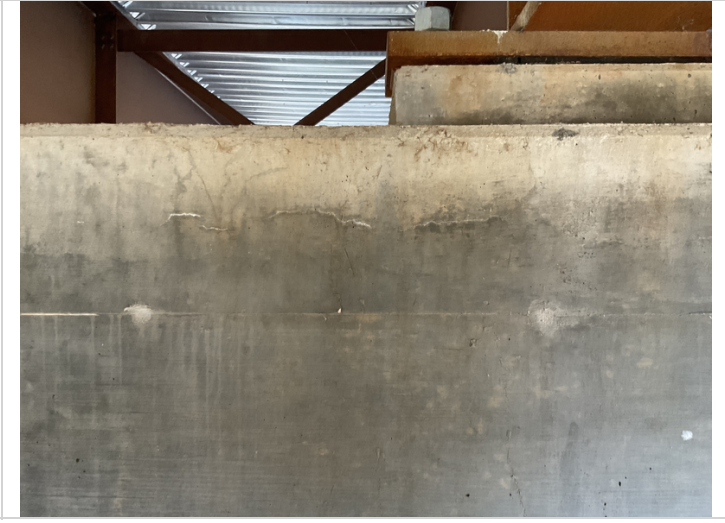
ELEMENTS	DESCRIPTION	UNITS	TOTAL	CS1	CS2	CS3	CS4
205	Reinforced Concrete Column	EA	2	2	0	0	0
215	Reinforced Concrete Abutment	LF	122	122	0	0	0
234	Reinforced Concrete Pier Cap	LF	72	69	3	0	0
1120	Efflorescence/Rust Staining	LF	3	0	3	0	0
(234) Horizontal efflorescent cracking to ahead side of cap @ Bent 1.(#2

Horizontal efflorescent cracking to ahead side of cap @ Bent
1.(#2)

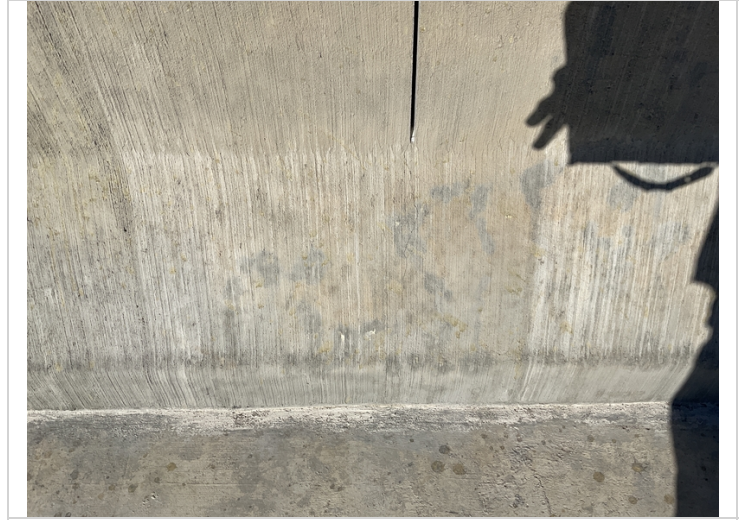
ELEMENTS	DESCRIPTION	UNITS	TOTAL	CS1	CS2	CS3	CS4
12	Reinforced Concrete Deck	SF	12462	12462	0	0	0
107	Steel Open Girder/Beam	LF	1675	1675	0	0	0
515	Steel Protective Coating	SF	207281	207281	0	0	0
205	Reinforced Concrete Column	EA	2	2	0	0	0
215	Reinforced Concrete Abutment	LF	122	122	0	0	0
234	Reinforced Concrete Pier Cap	LF	72	69	3	0	0
1120	Efflorescence/Rust Staining	LF	3	0	3	0	0
(234) Horizontal efflorescent cracking to ahead side of cap @ Bent 1.(#2							
301	Pourable Joint Seal	LF	68	68	0	0	0
310	Elastomeric Bearing	EA	20	20	0	0	0
515	Steel Protective Coating	SF	60	60	0	0	0
321	Reinforced Concrete Approach Slab	SF	1606	1606	0	0	0
331	Reinforced Concrete Bridge Railing	LF	670	609	61	0	0
1130	Cracking (RC and Other)	LF	61	0	61	0	0
(331) Vertical cracking to Left & Right parapets.

Vertical cracking to parapets.(#2 typical)
