Asset #M1025(Routine, Underwater type 2)

SH 56 Izard County over CREEK

Location: 0.1 MI W JCT SH 289 & 56

Team Lead: Nathan Edwards, Inspection Date: 05/05/2022

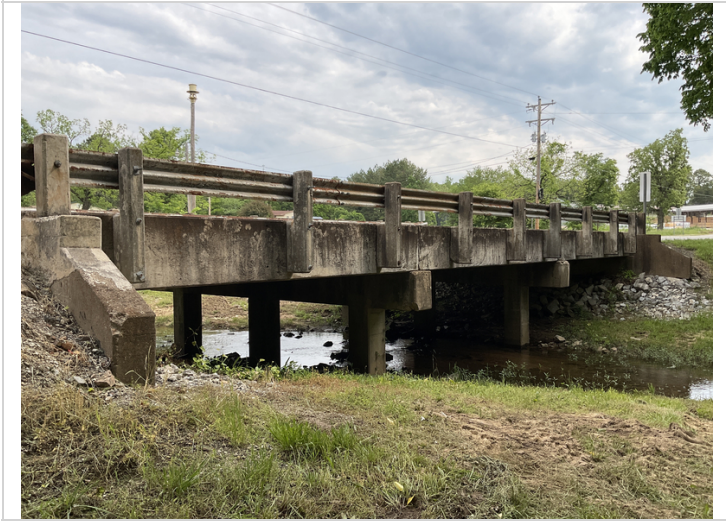
Elevation with Log Mile running to the Right.

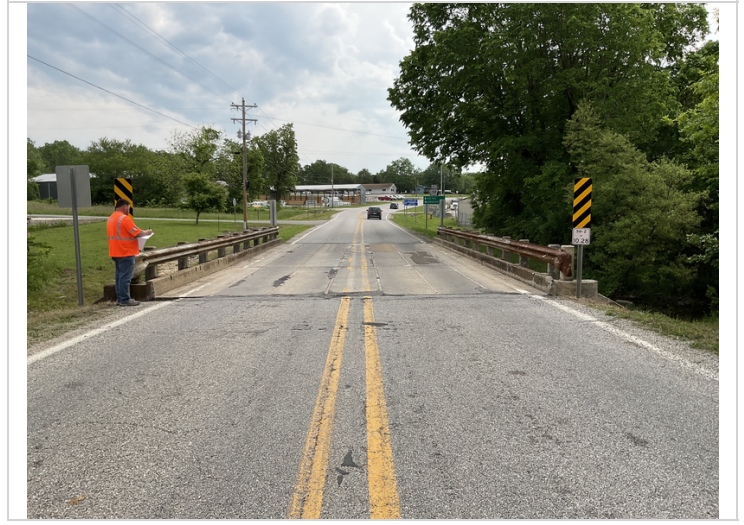
Roadway with Log Mile running West to East.

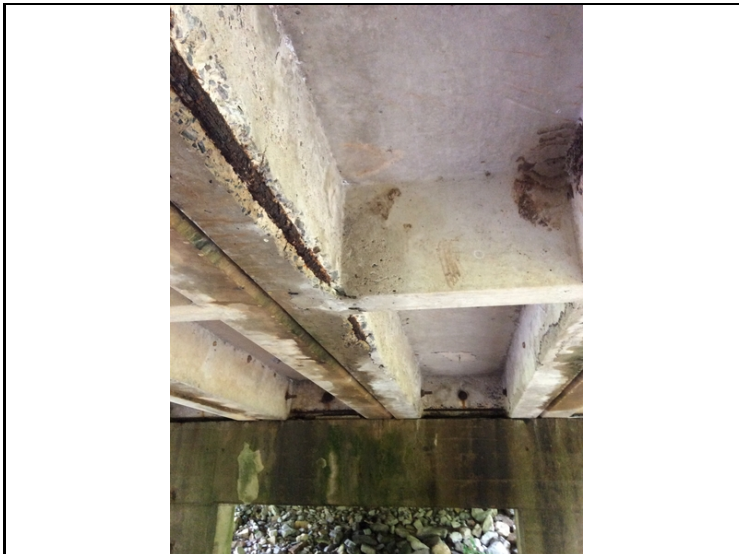
Spalls with rebar exposed to girders/diaph. of Units 1,2,5 & 7 @ Span 1.
Spalls with rebar exposed to girders/diaph. of Units 1 - 7 @ Span 2.
Spalls with rebar exp. to girders/diaph. of Units 2 & 5 @ Span 3.

Spalls with rebar exposed to girders/diaph. of Units 1 & 7 @ Span 1.
Spalls with rebar exposed to girders/diaph. of Units 1, 2, 5, 6 & 7 @ Span 2.
Spalls with rebar exp. to girders/diaph. of Unit 5 @ Span 3.

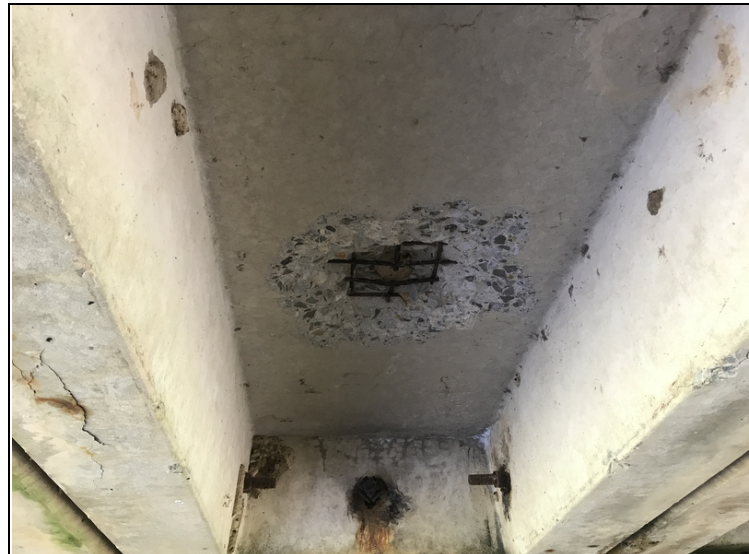
Spalls with wire mesh exposed to deck below @ all spans.

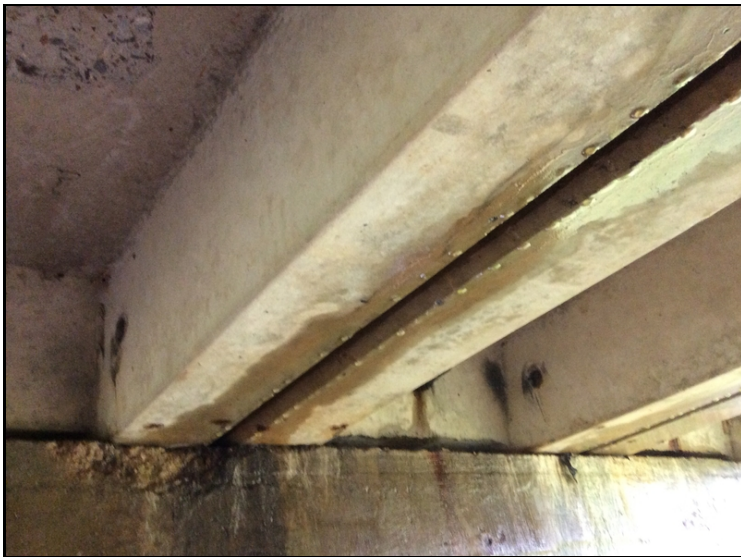
Units 1-2 & 2-3 are not bolted transversely @ beginning of Span 3

Units 1-2 & 2-3 are not bolted transversely @
beginning of Span 3.

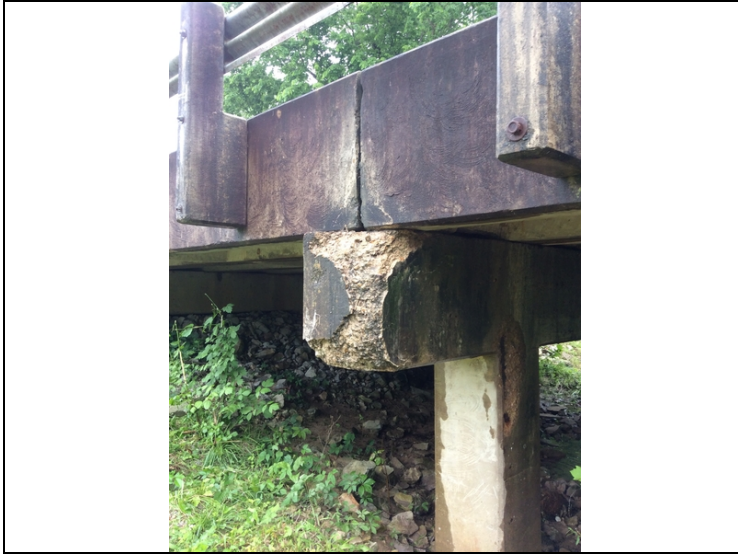
Spalling with rebar exposed & areas of delam. to caps @ Bents 1 & 2.
Heavy deterioration to left end of cap @ Bent 2

Heavy deterioration to left end of cap @ Bent 2

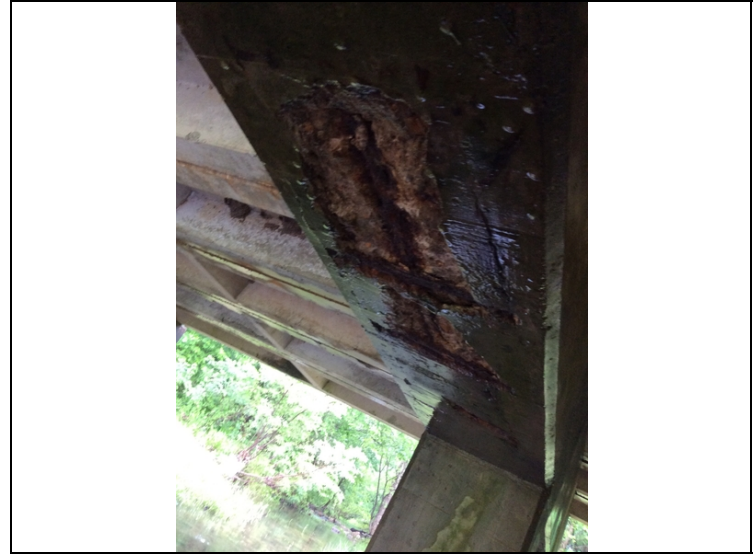
(234) Bent 1 - Spalls with 5' rebar exposed & areas of delaminating. Bent 2 - Heavy deterioration & efflorescent map cracking & spalling to Left end of cap. 2' minor horizontal cracks @ top of cap between Column 1 & 2.							
330	Metal Bridge Railing	LF	114	0	114	0	0
1000	Corrosion	LF	114	0	114	0	0
515	Steel Protective Coating	SF	342	0	114	114	114
3440	Effectiveness (Steel Protective Coatings)	LF	342	0	114	114	114

Spalling with rebar exposed & areas of delamination to Caps @ Bents 1 & 2.

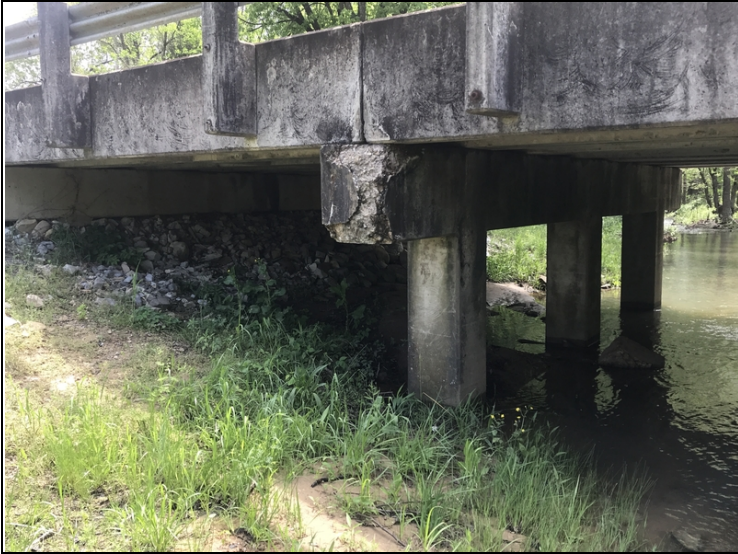
Heavy deterioration to left end of cap @ Bent 2

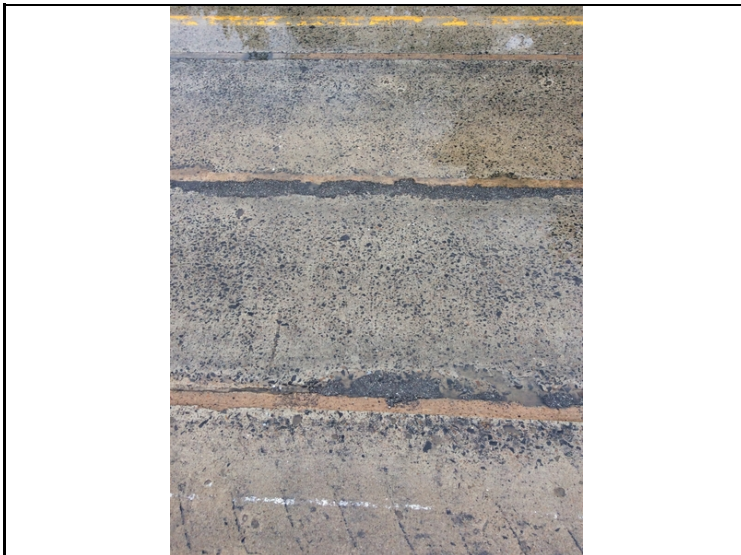
Transverse cracks to deck at all spans.

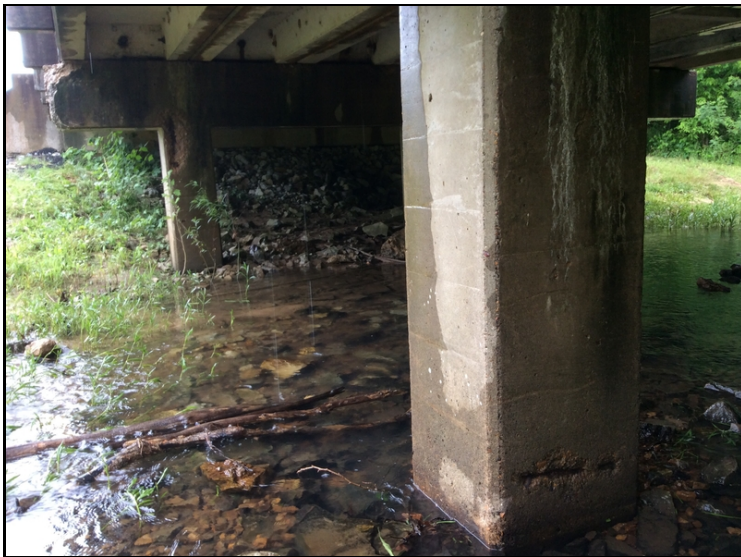
Cracking & spalls (some with reb. exposed) to Column 1-3 @ Bent 1 & 2.

Cracking & spalls (some with rebar exposed) to
Columns 1-3 @ Bents 1 & 2.

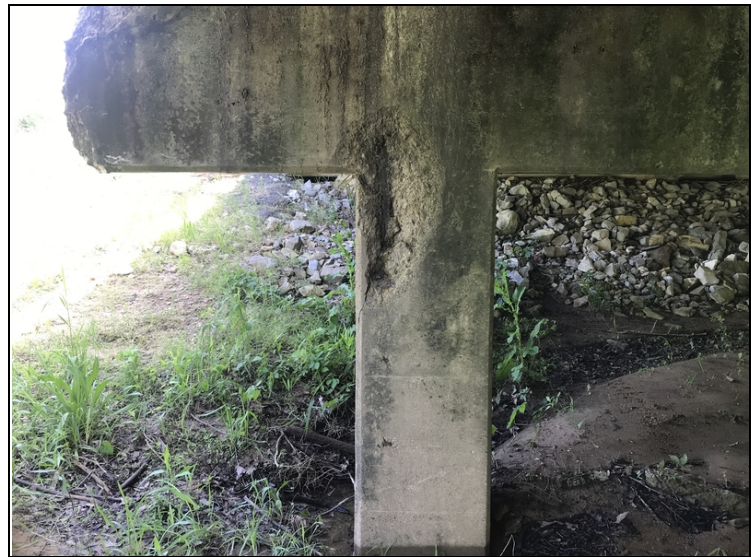
Cracking & spalls (some with reb. exposed) to
Column 1-3 @ Bent 1 & 2.

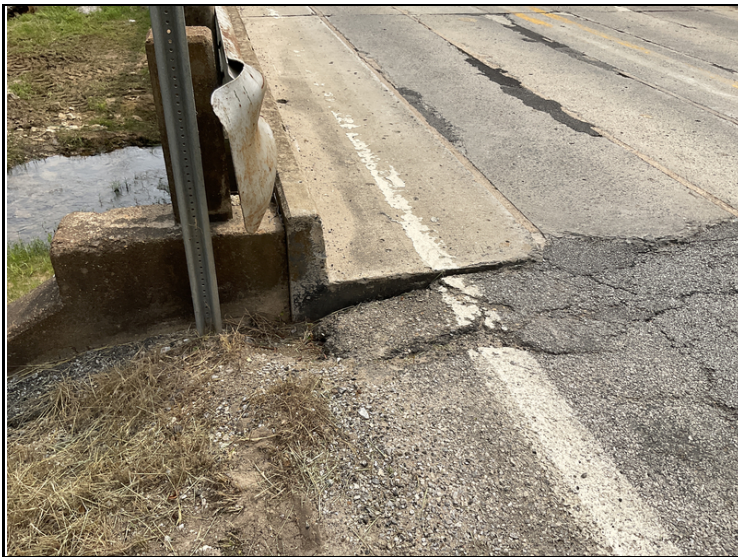
Erosion into Left edge of roadway behind Abutment 1.

Erosion into Left edge of roadway behind Abutment
1.
