Asset #M1026(Routine)

SH 56 Izard County over CREEK

Location: 2.6 MI E JCT SH 289 & 56

Team Lead: Nathan Edwards, Inspection Date: 11/15/2022

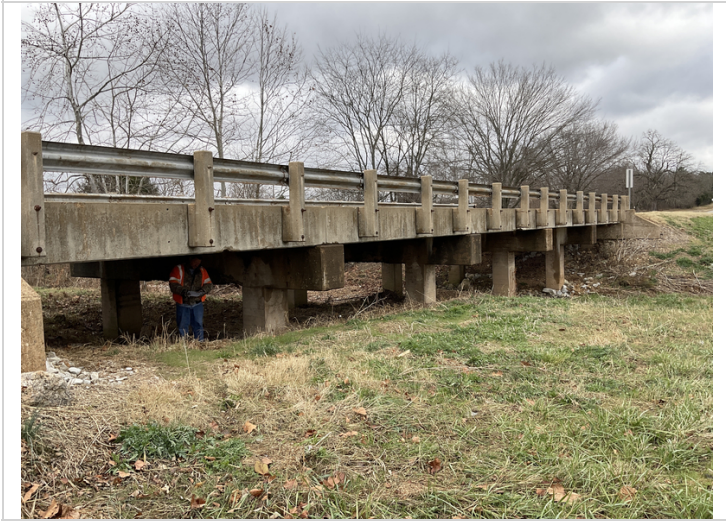
Elevation with Log Mile running to the Right.

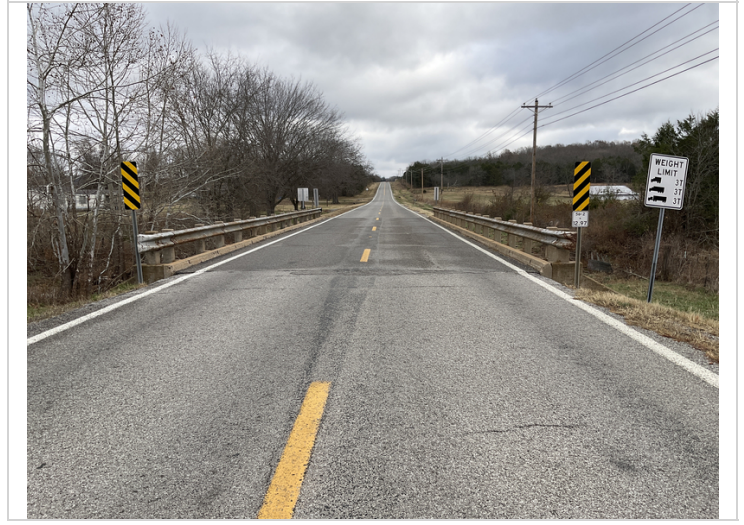
Roadway with Log Mile running West to East.

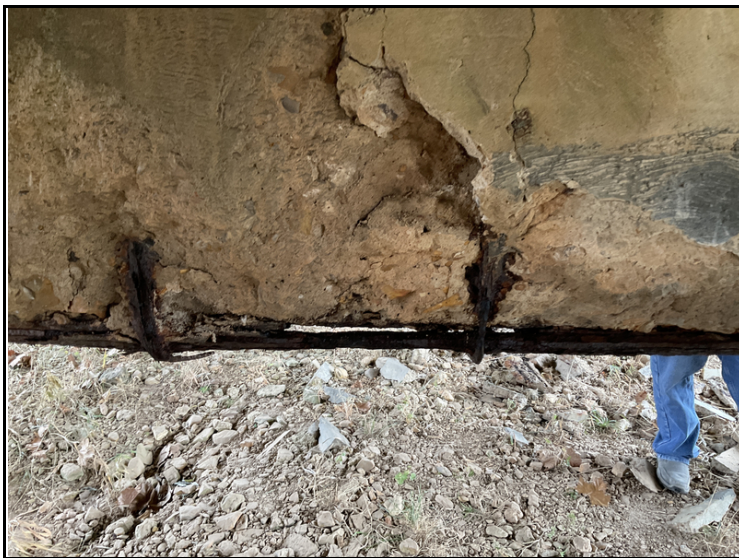
Spalls with rebar exposed with s/l & areas that are not adhered to concrete @ bottom of cap @ Bent 1.(#4)

Date Reported: 11/29/2012
Priority: A - Safety deficiency; requires prompt action
Type of Work: Repair (General)
Status: Assigned
Component: Element

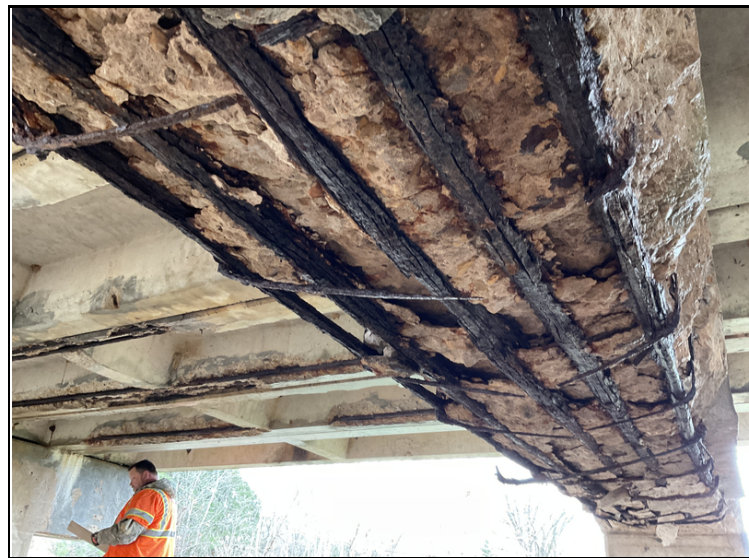
Spalls with rebar exposed with 100% s/l to bottom of cap @ Bent 1.(#4)

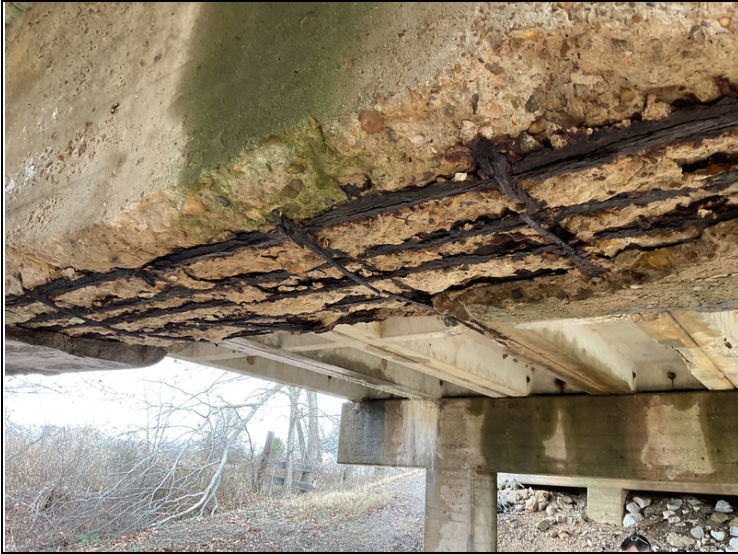
Spalls with rebar exposed with 100% s/l to bottom of cap @ Bent 3.(#4)

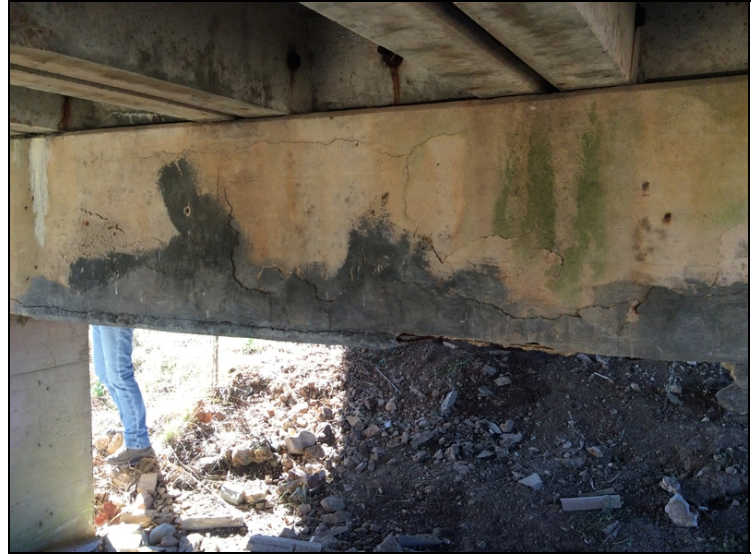
Typical of Caps at Bents 1, 2, & 3 have delaminated areas, cracks & heavy spalls with rebar exposed. (Ahead side Bent 1)

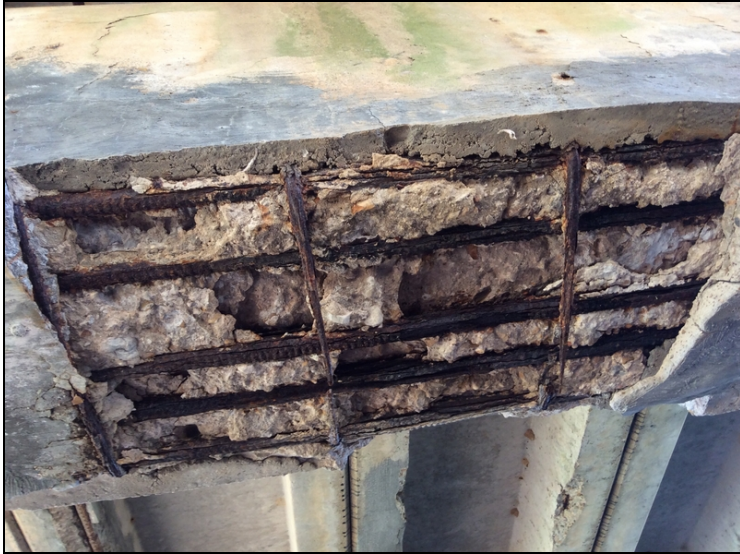
Delaminating areas with large deep spalls with rebar exposed to bottom of cap between columns at Bents 1, 2, & 3.(Bottom of cap Bent 1)

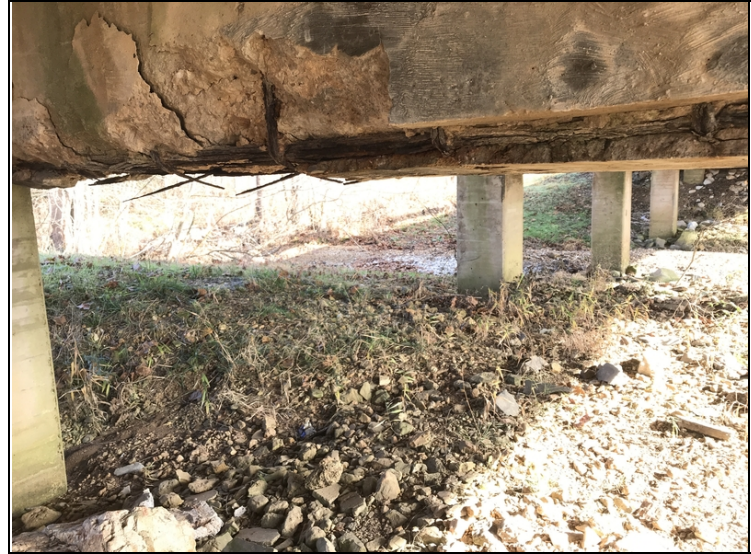
Areas of delamination, large deep spalls with rebar exposed & heavy cracking to concrete caps at Bent 1, 2, 3, & 4.
Bent 1.

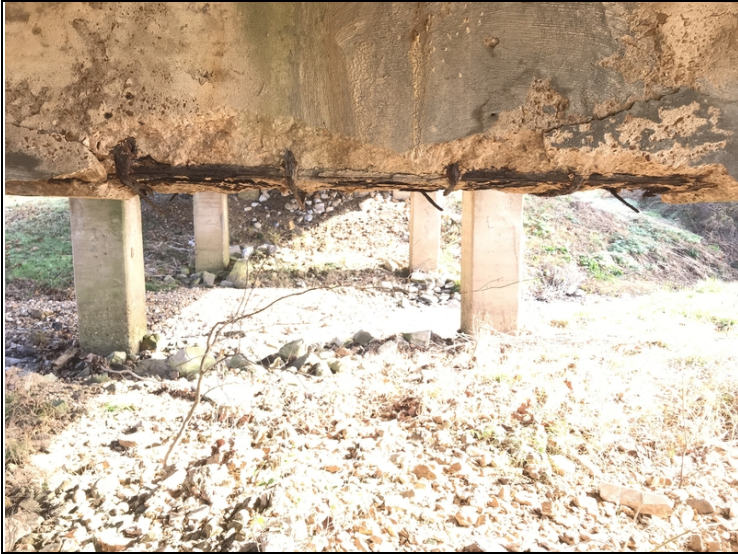
Areas of delamination, large deep spalls with rebar exposed & heavy cracking to concrete caps at Bent 1, 2, 3, & 4.
Bent 2.

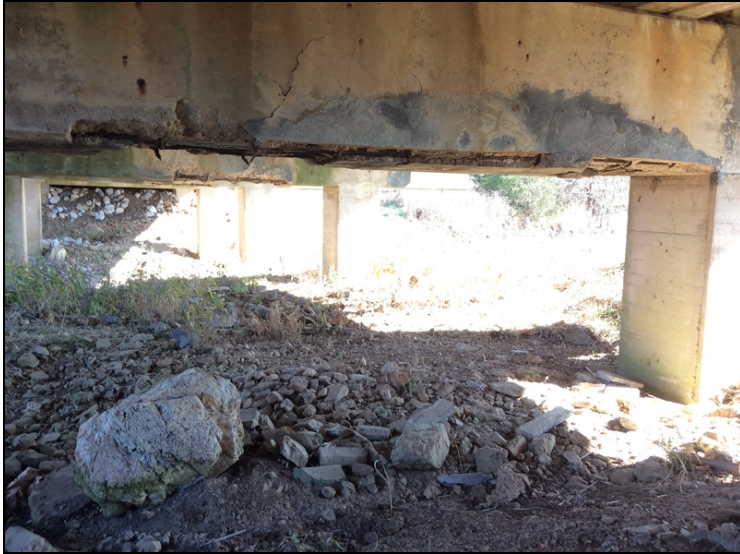
Typical of Delaminating areas with large deep spalls with rebar exposed to bottom of cap between columns at Bents 1, 2, & 3.

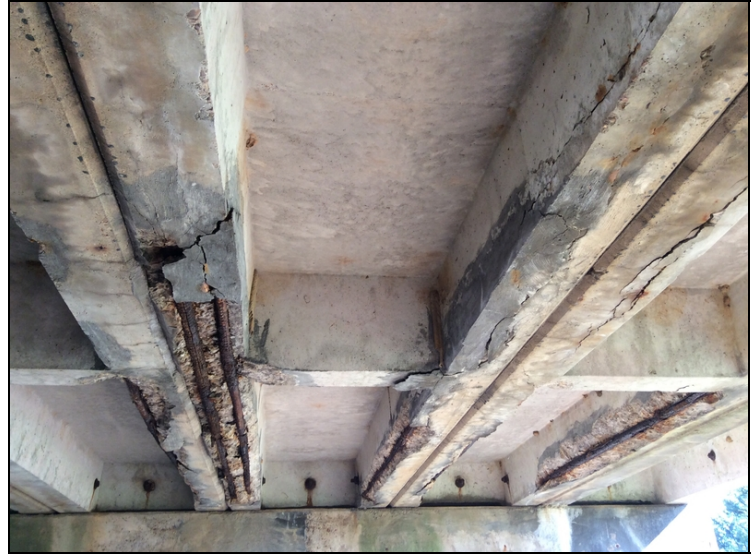
Typical of Spalls with rebar exposed to:
Units 2, 4, 5, & 6 at Span 1.
Units 3, 4, 5, & 6 at Span 2.
Units 1 thru 7 at Span 3.
Units 3, 4, 5, & 6 at Span 4.
(Unit 5 Span 2)

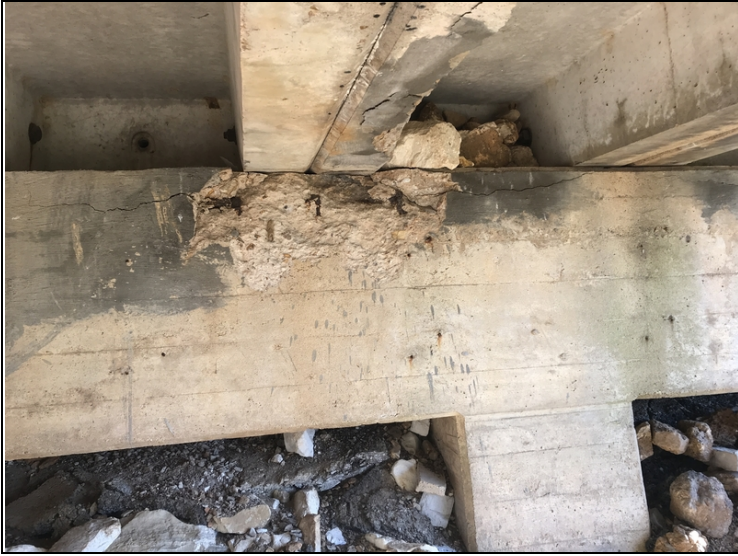
Spalls & cracking to Abutment 2

Spalls & cracking to Abutment 2.

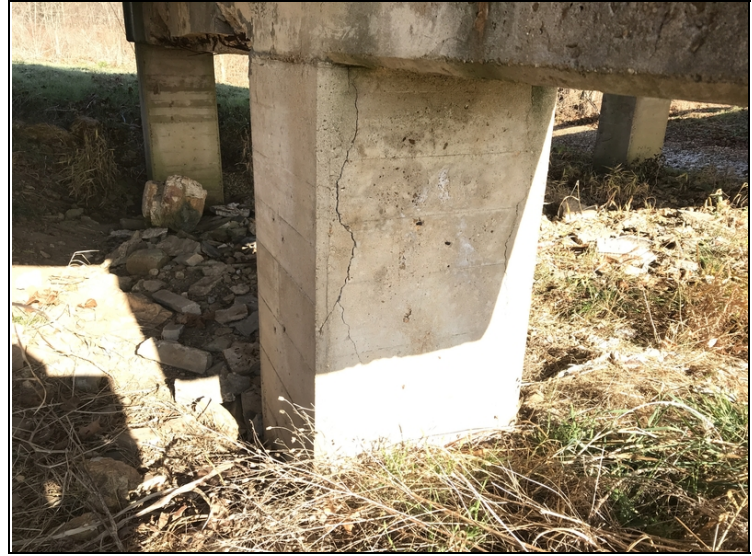
Vertical cracks to all columns at Bents 1 thru 4.

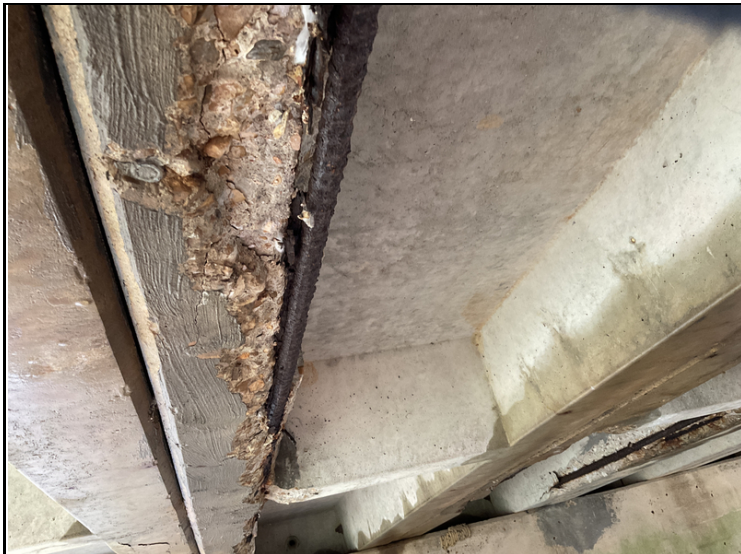
Span 1 - Units 2, 3, 4, 5, 6, 7, with areas of concrete not adhered to rebar @ Units 4, 5 & 6.

Spalls with rebar exposed with s/l @ areas not adhered to concrete @ Unit 6 @ Span 1.

Date Reported: 11/29/2012
Priority: A - Safety deficiency; requires prompt action
Type of Work: Repair (General)
Status: Assigned
Component: Element

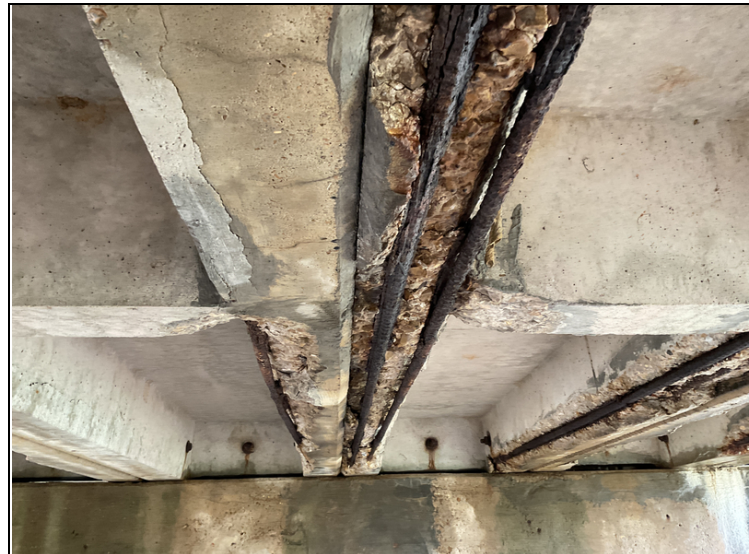
Span 2 - Units 3, 4, 5, 6, with areas of concrete not adhered to rebar @ Units 4, 5 & 6.

Spalls with rebar exposed with s/l @ areas not adhered to concrete @ Units 4 & 5 @ Span 2.

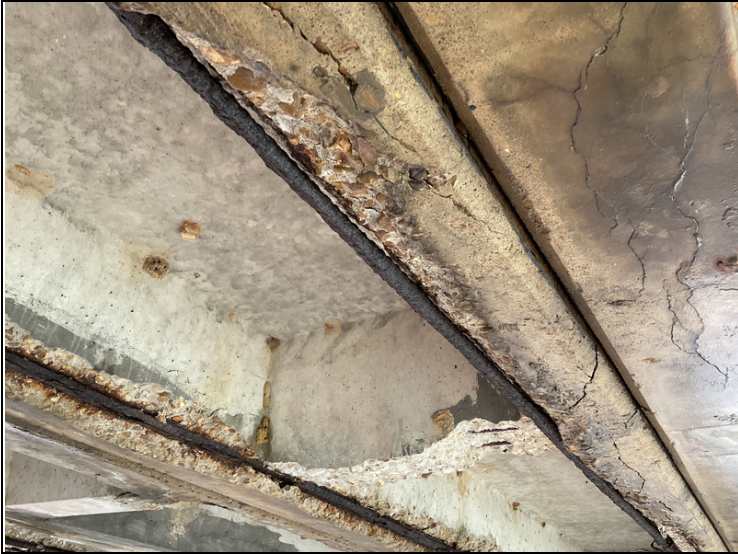
Span 3 - Units 1, 2, 3, 4, 5, 6, 7, with areas of concrete not adhered to rebar @ Units 4 & 6.

Spalls with rebar exposed with s/l @ areas not adhered to concrete @ Unit 6 @ Span 3.

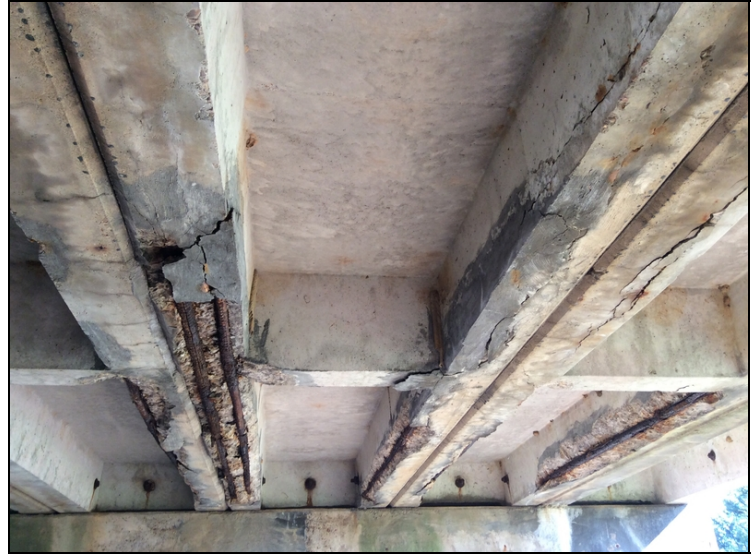
Typical of Spalls with rebar exposed to:
Units 2, 4, 5, & 6 at Span 1.
Units 3, 4, 5, & 6 at Span 2.
Units 1 thru 7 at Span 3.
Units 3, 4, 5, & 6 at Span 4.
(Unit 5 Span 2)

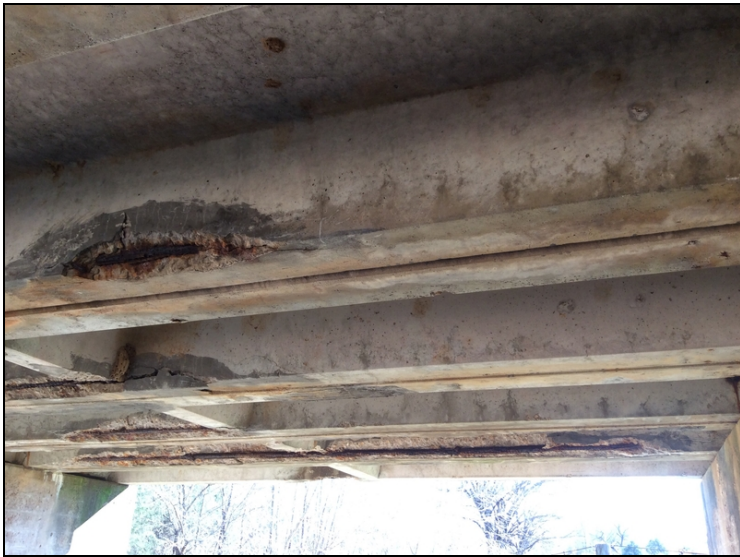
Typical of Spalls with rebar exposed to:
Units 2, 4, 5, & 6 at Span 1.
Units 3, 4, 5, & 6 at Span 2.
Units 1 thru 7 at Span 3.
Units 3, 4, 5, & 6 at Span 4.
(Span 3)

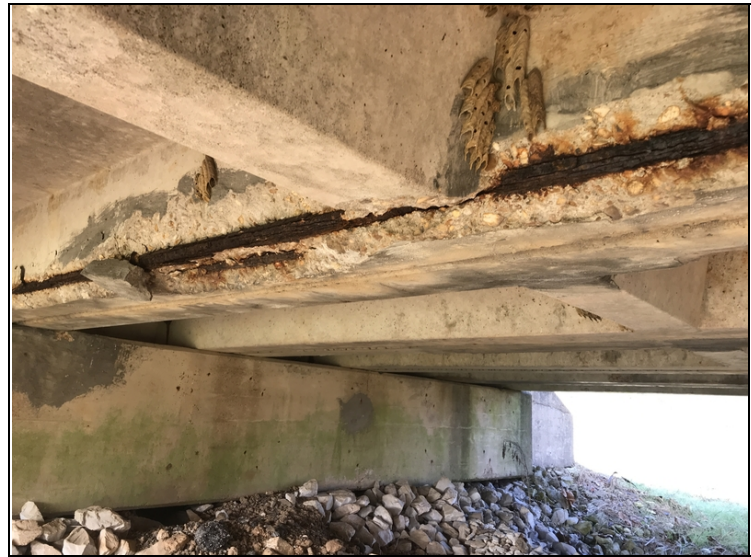
Large spalls with rebar exposed to girders:
Span 1 - Units 2, 3, 4, 5, 6, 7.

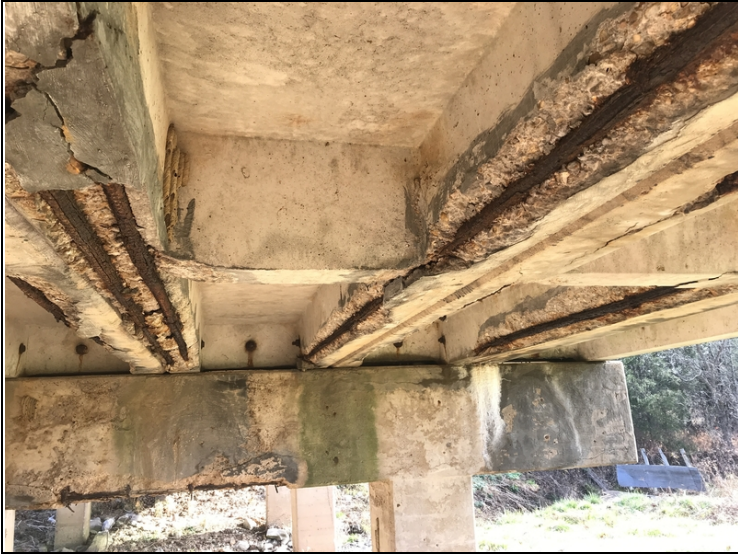
Large spalls with rebar exposed to girders:
Span 2 - Units 3 ,4, 5, 6.
