Asset #M1027(Routine)
SH 56 Izard County over HARS CREEK
Location: 4.8 MI W JCT US 167 & 56

Team Lead: Nathan Edwards, Inspection Date: 11/15/2022

Asset #M1027(Routine)

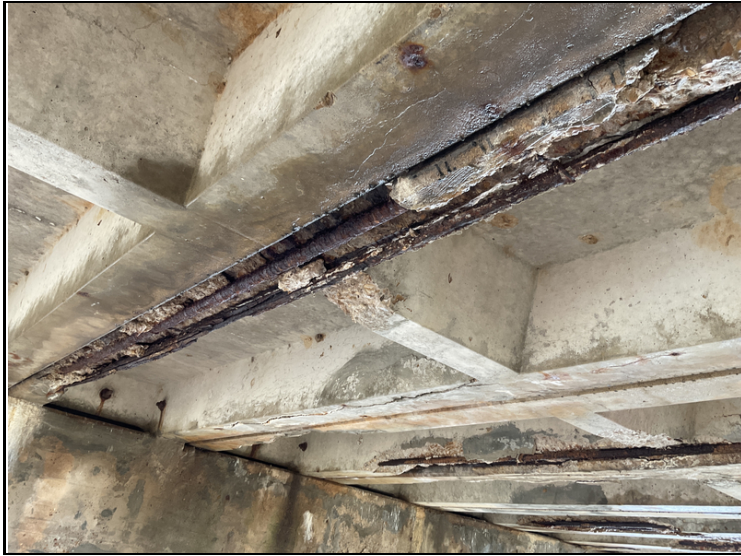
Spalls with rebar exposed with s/l & areas that are not adhered to concrete girders @ Unit 2 @ Span 2.

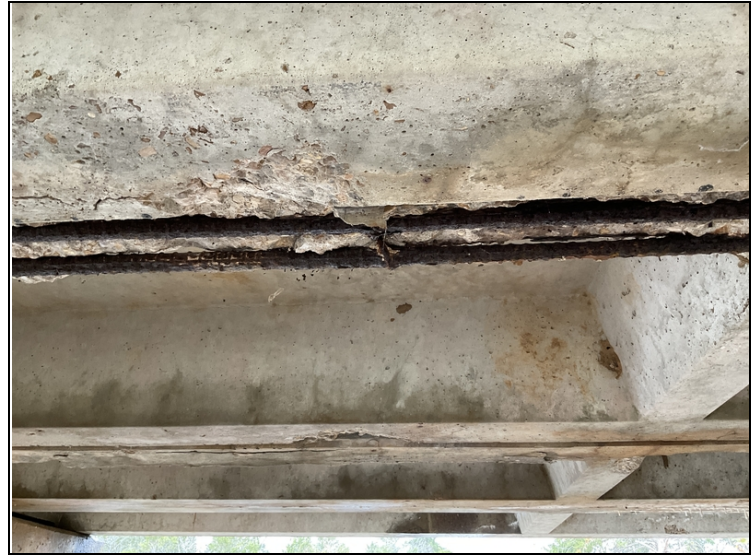
Spalls with rebar exposed with s/l & areas that are not adhered to concrete girders @ Unit 3 @ Span 5.

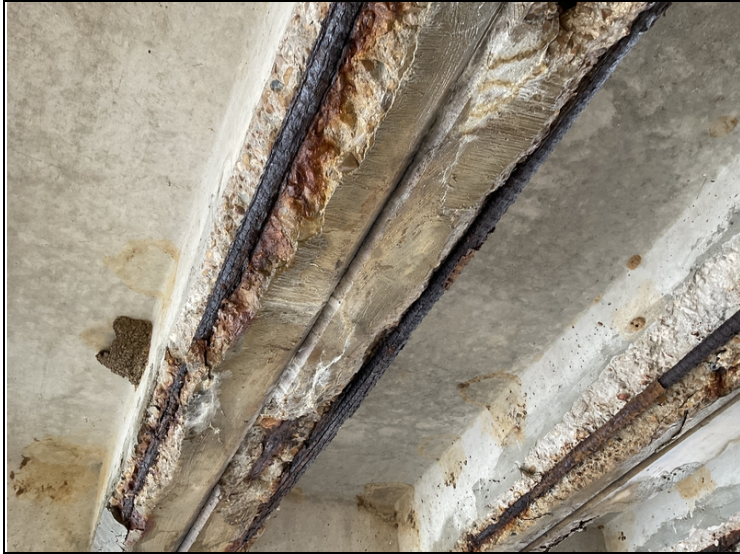
Spalls with rebar exposed with s/l & areas that are not adhered to concrete girders @ Unit 5 @ Span 4.

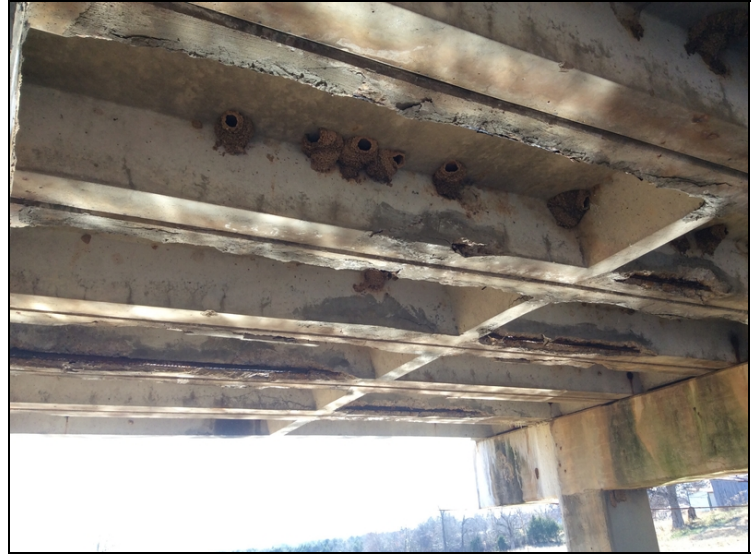
Typical of Spalls with rebar exposed to :
Unit 4 at Span 1
Units 3, 4, 5, 6, & 7 at Span 2.
Units 4, 5, 6, & 7 at Span 3.
Units 2 thru 7 at Span 4
Units 2, 3, 4, 5, 6, & 7 at Span 5.
(Span 4)

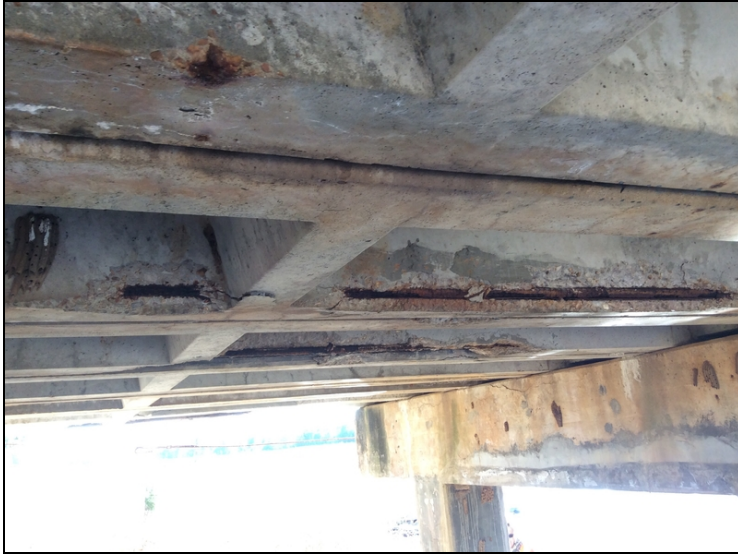
Typical of Spalls with rebar exposed to :
Unit 4 at Span 1.
Units 3, 4, 5, 6, & 7 at Span 2.
Units 4, 5, 6, & 7 at Span 3.
Units 2 thru 7 at Span 4.
(Span 5)
Units 2, 3, 4, 5, 6, & 7 at Span 5.

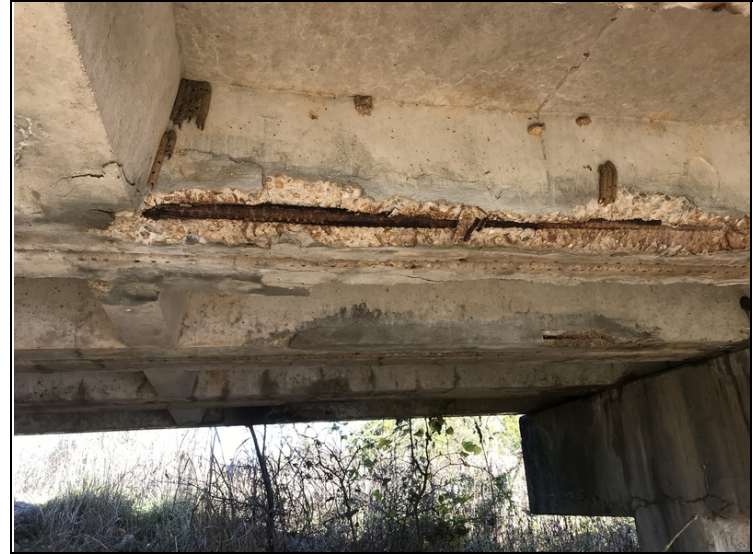
Spalls with rebar exposed or cracking to girders at:
Span 1 - Units 1 - 7.
Span 2 - Units 2 - 7, with areas of concrete not adhered to rebar @ Units 2, 3 & 5.
Span 3 - Units 1 - 7.
Span 4 - Units 1 - 7, with areas of concrete not adhered to rebar @ Units 4 & 5.
Span 5 - 1 - 7, with areas of concrete not adhered to rebar @ Units 2, 3 & 7.

Spalls with rebar exposed or cracking to girders at:
Span 1 - Units 1 - 7.
Span 2 - Units 2 - 7.
Span 3 - Units 1, 2, 4 - 7.
Span 4 - Units 1 - 7.

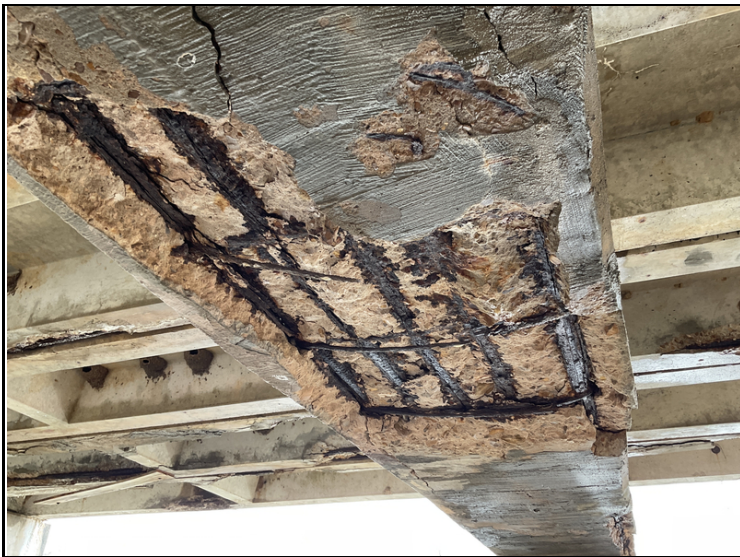
Spalls with rebar exposed with 100% s/l to bottom of cap @ Bent 2.

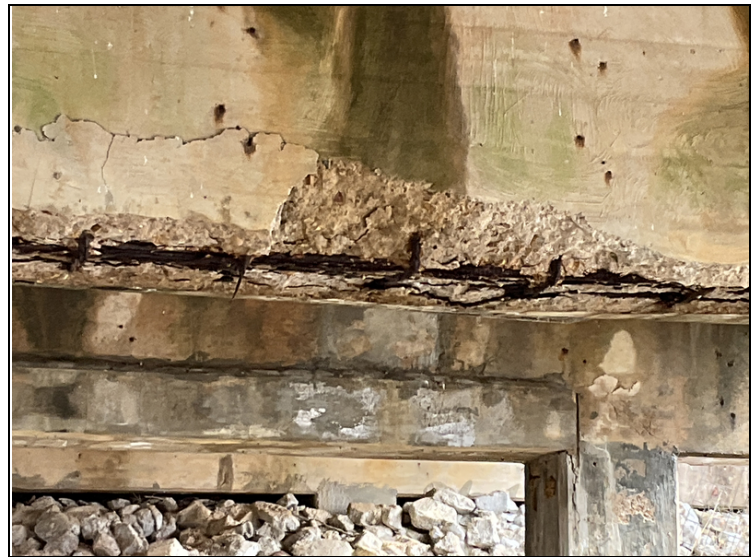
Spalls with rebar exposed with 100% s/l to bottom of cap @ Bent 3.

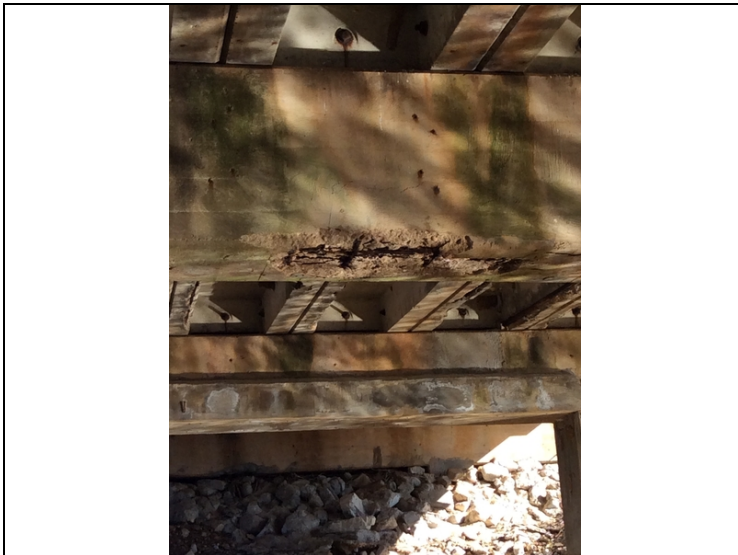
Areas of delaminating, cracking &/or spalls with rebar exposed to caps at Bents 1 - 4.

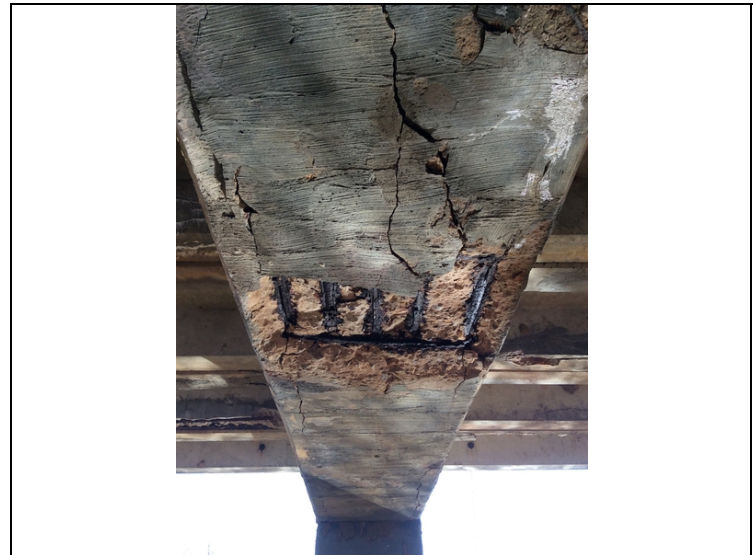
Areas of delaminating, cracking &/or spalls with rebar exposed to caps at Bents 1 - 4.

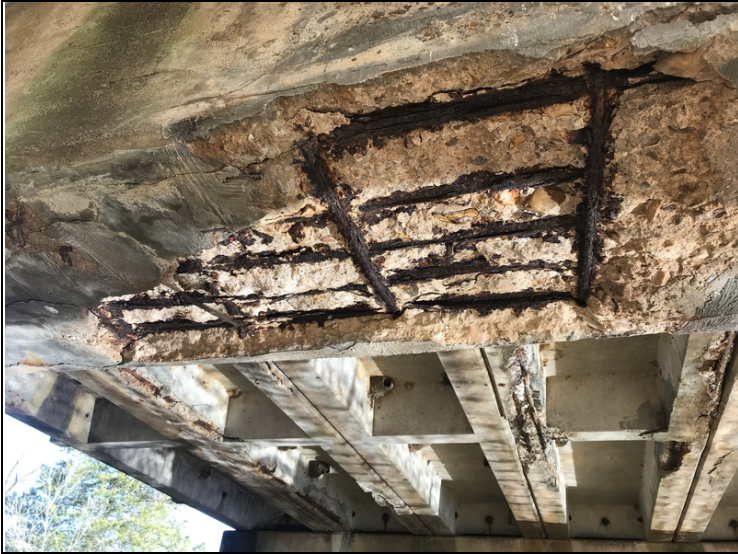
Areas of delaminating, cracking &/or spalls with
rebar exposed to caps at Bents 1 - 4.
Bent 1.
