Asset #M3313(Routine)

SH/56 Izard County over LITTLE PINEY CREEK

Location: 5.9 MI E OF BROCKWELL

Team Lead: Kerry Little, Inspection Date: 03/13/2023

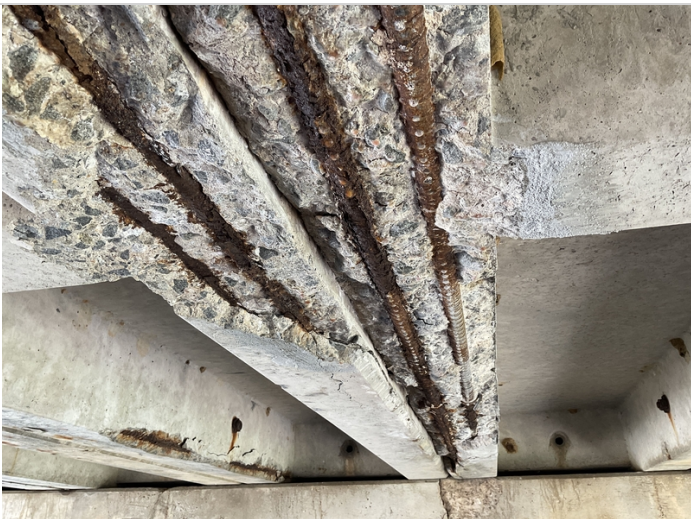
Span 2 has most units with cracks, large spalls with rebar exposed to most units.

Span 2 - Large spalls with rebar exposed to Girders.

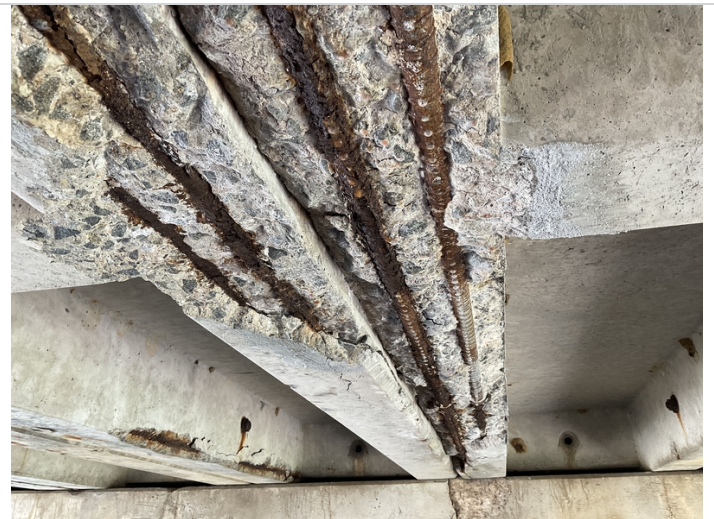
Span 2 - Large spalls with rebar exposed to Girders.

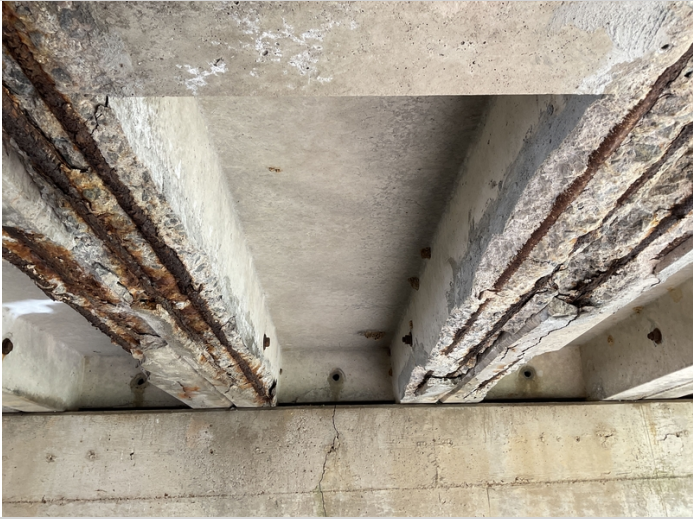
Span 2 - Large areas of delamination & cracks with rust stains to Units 1 - 7.

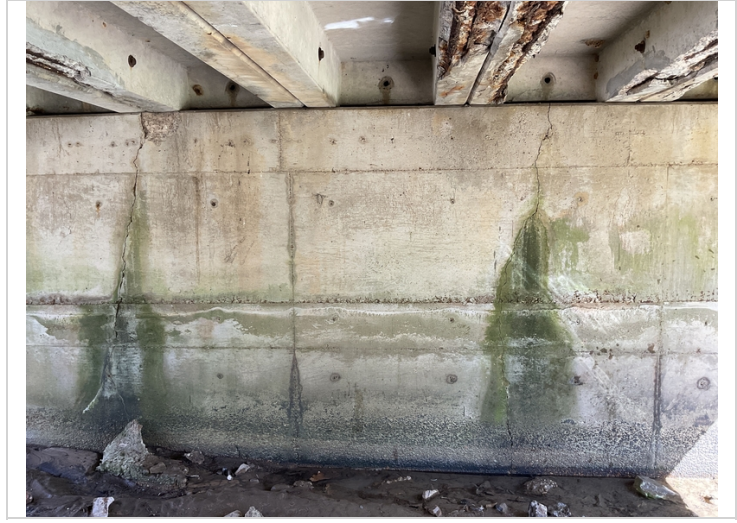
(215) 6 FH vertical cracks to Abutment 1. 5 FH vertical cracks to Abutment 2. Some cracks have minor efflorescence. Abrasion along bottom of Abutment 2. Erosion behind Left & Right wings @ Abutment 1.							
220	Reinforced Concrete Pile Cap/Footing	LF	32	8	23	1	0
1130	Cracking (RC and Other)	LF	1	0	0	1	0
6000	Scour	LF	23	0	23	0	0

2 Full height vertical crack @ abutment 2.

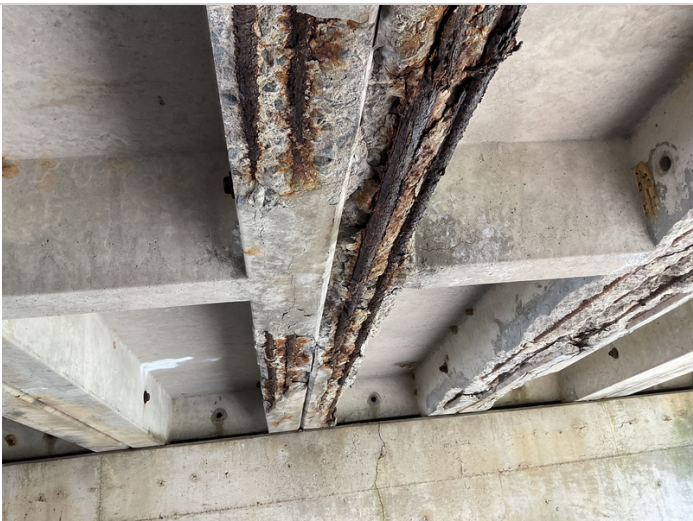
Spalls with rebar exposed to units 1 - 6.

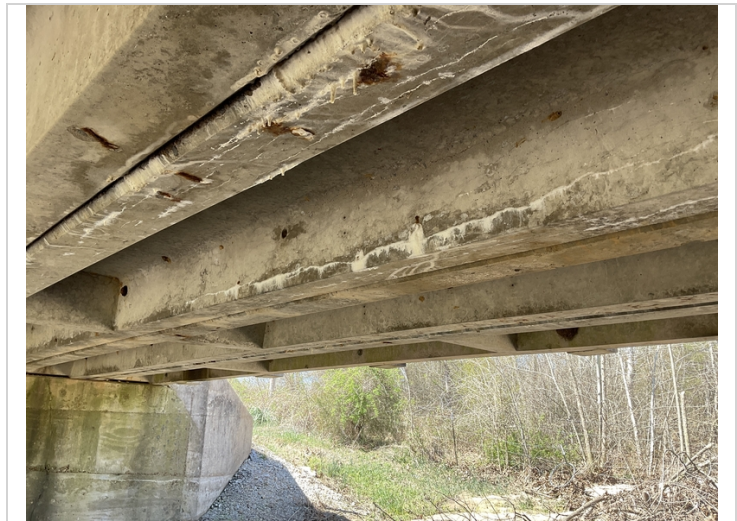
Efflorescent map cracking to girder @ Unit 3 @ Span 1.

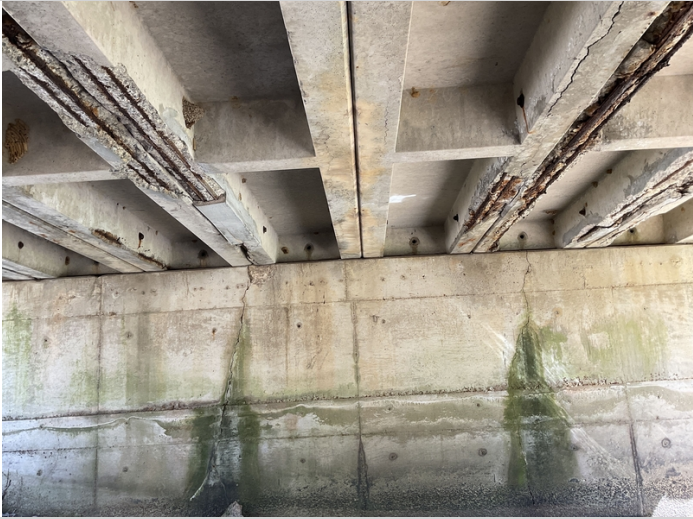
Overall soffit @ span 2.

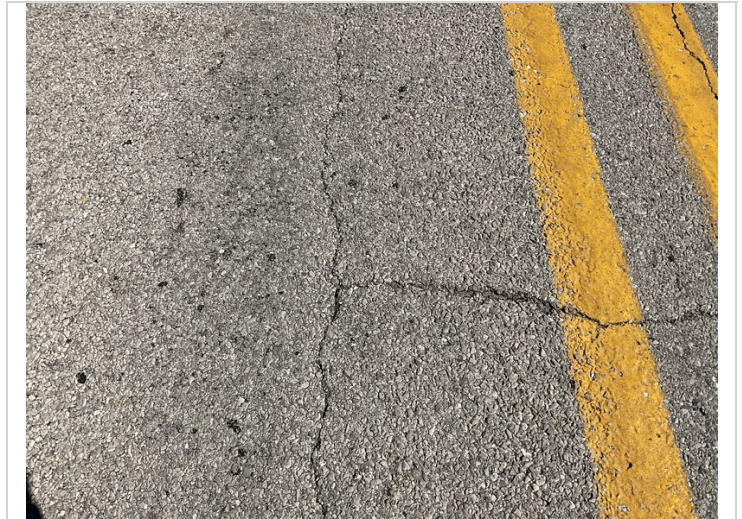
Typical cracks to wearing surface.

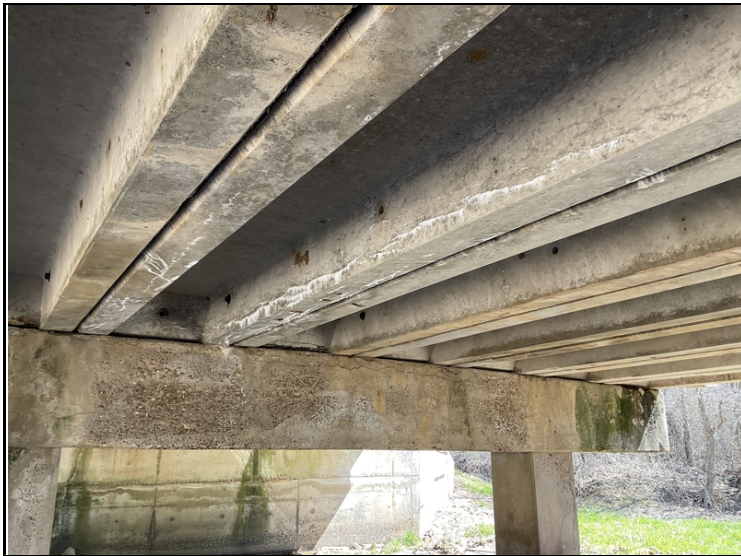
Span 1 - Longitudinal cracks with heavy efflorescence to Girders of Unit 3.

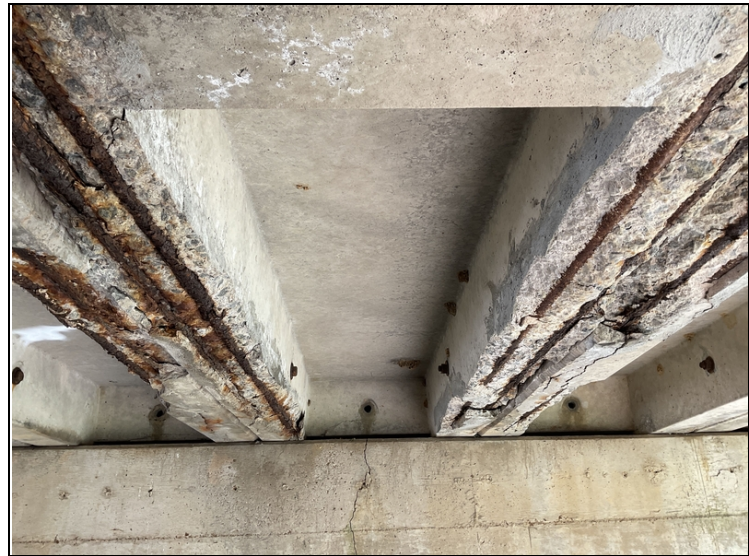
Span 2 - Large areas of delamination & cracks with rust stains to Units 1 - 7.

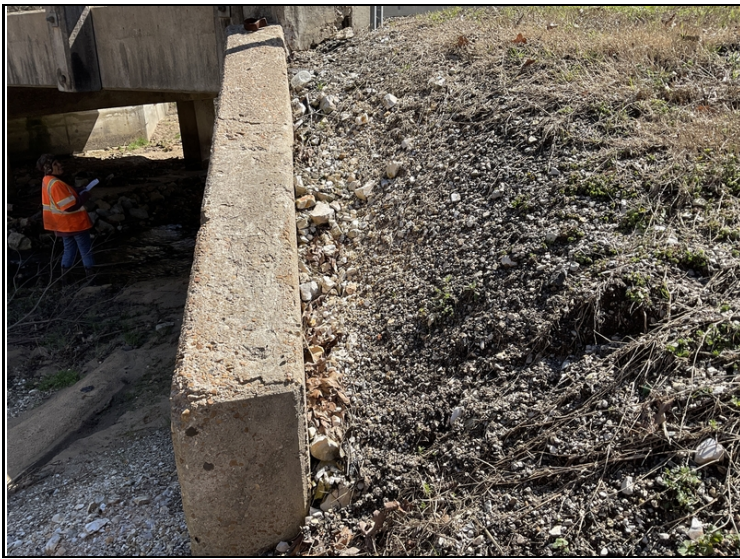
Erosion behind Left & Right wings @ Abutment 1.

**Date Reported:** 03/22/2018  
**Priority:** C - Important  
**Type of Work:** Repair (General)  
**Status:** Monitor  
**Component:** Bridge

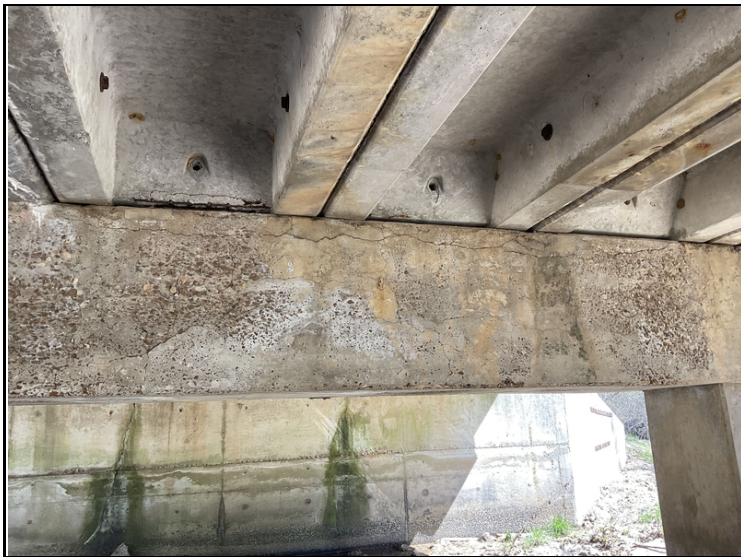
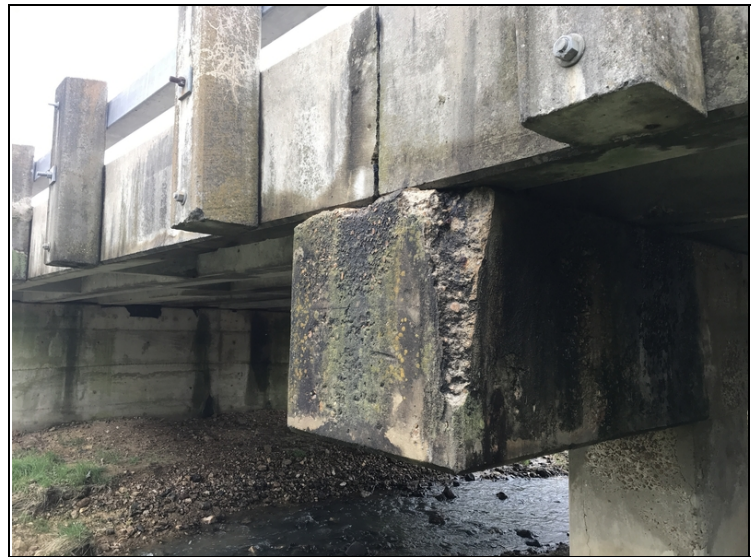
(234) Several horizontal and vertical cracks and delaminated areas to Cap at Bent 1. (light rust stains to vertical cracks) 1.5' of spalls and deterioration to Left and Right ends of Cap.

Cracking, Spalls and delaminated areas to Cap at Bent 1.

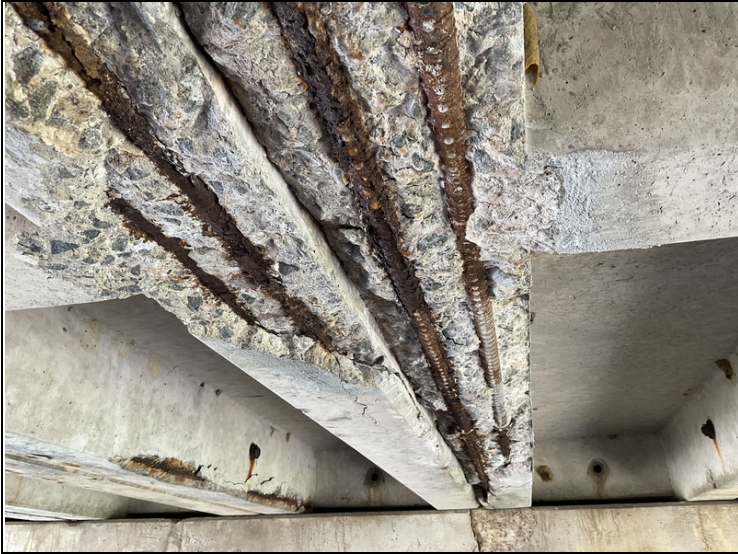
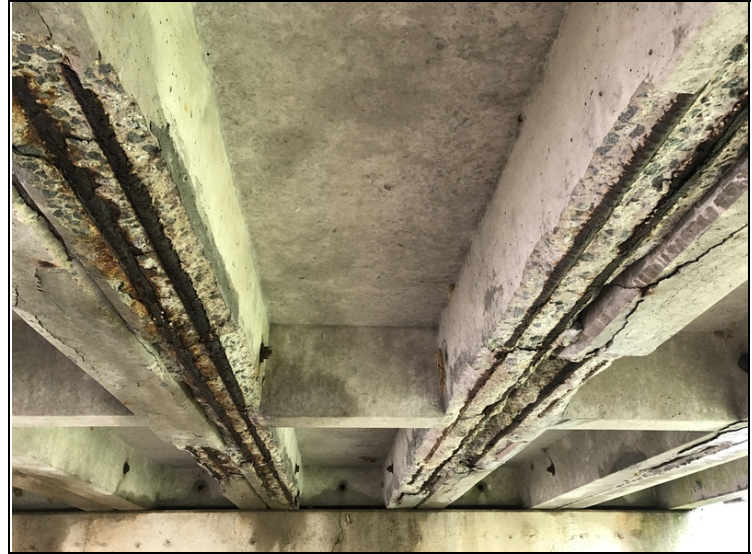
Span 2 - Large spalls with rebar exposed to Girders.

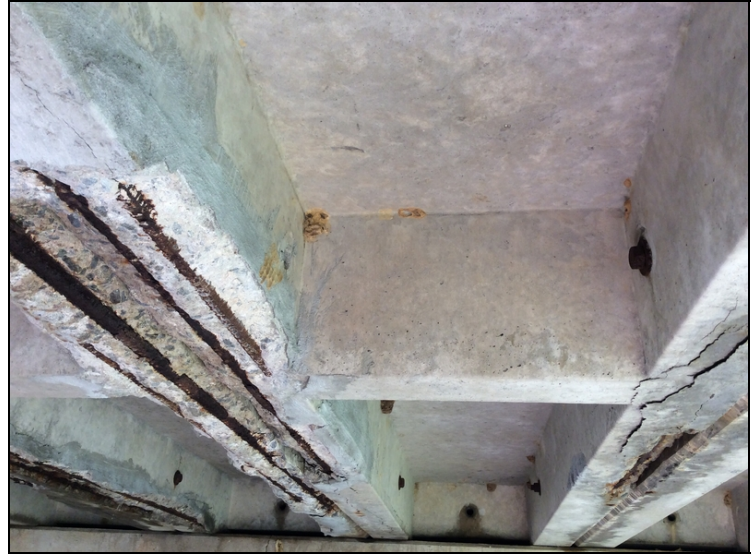
Unit 7 - Spall with 8' rebar exposed.

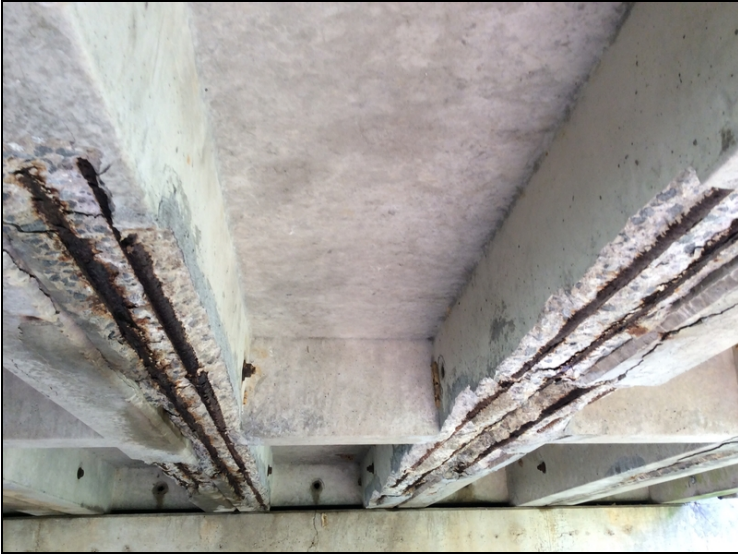
Unit 6 - Spall with 36' rebar exposed.

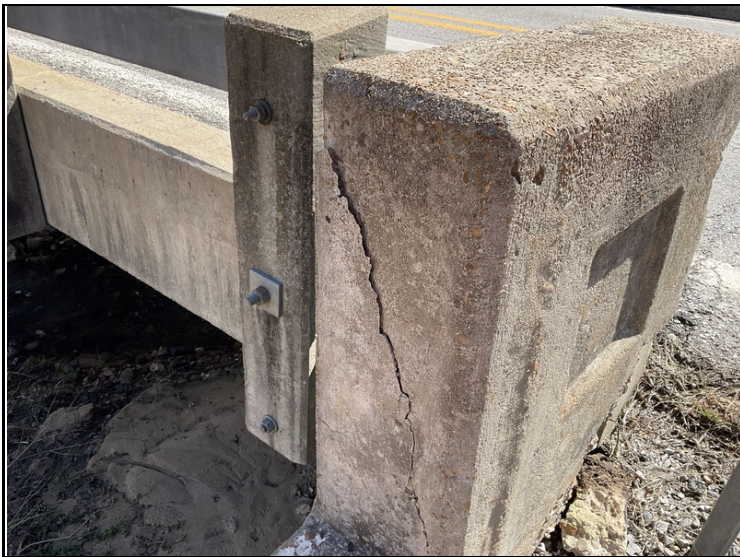
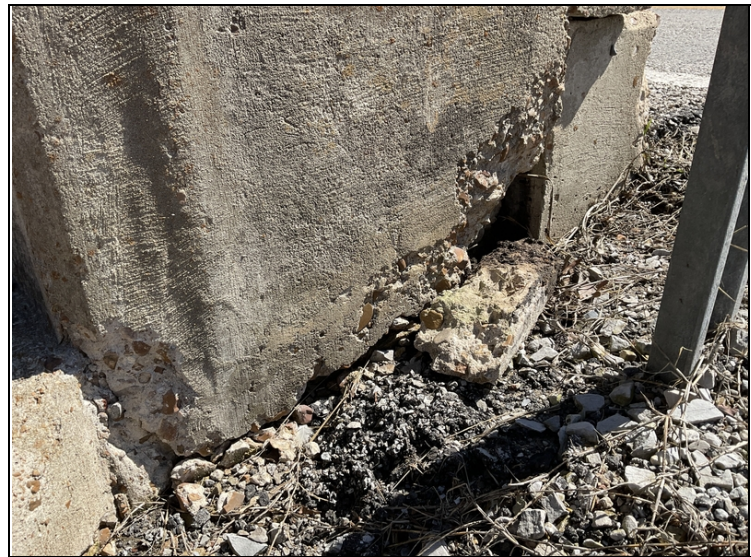
(330) End post on Lt. side @ Abut. 1 & 2 are broke off. Few cracks and spalls to concrete posts.

All concrete posts on Left side have collision damage.

**Date Reported:** 04/02/2021  
**Priority:** D- Routine  
**Type of Work:** Repair (General)  
**Status:** Monitor  
**Component:** Bridge
