Asset #05502(Routine)

SH 69/Jackson Co. over VAN ASCHE ST., RR

Location: .41 MI N JCT SH 367

Team Lead: Kerry Little, Inspection Date: 05/11/2022

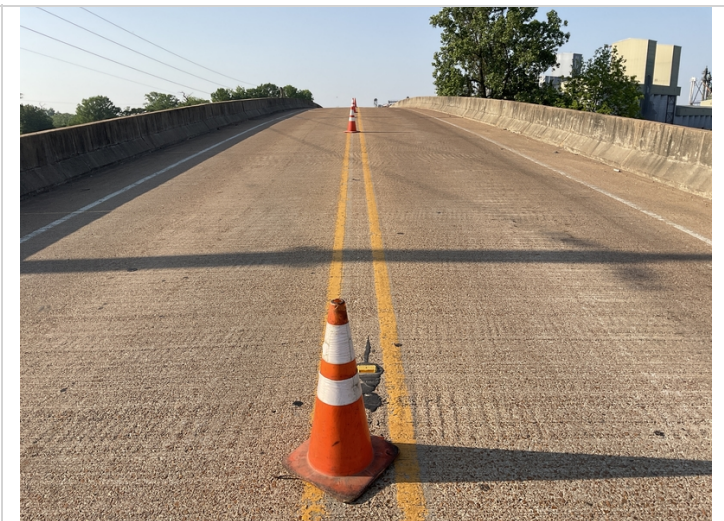
Overall deck @ span 2.

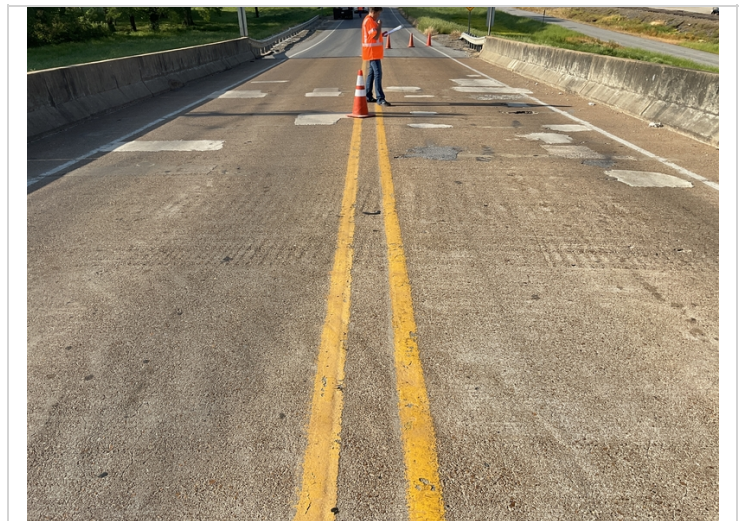
Overall deck @ span 8.

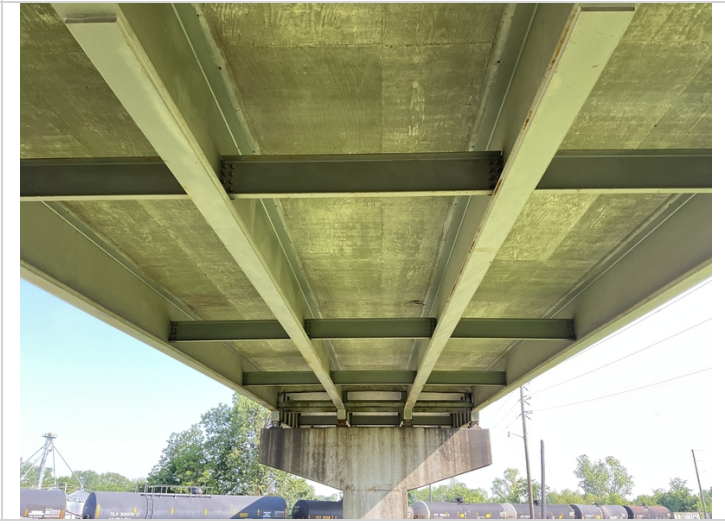
Overall soffit @ span 6.

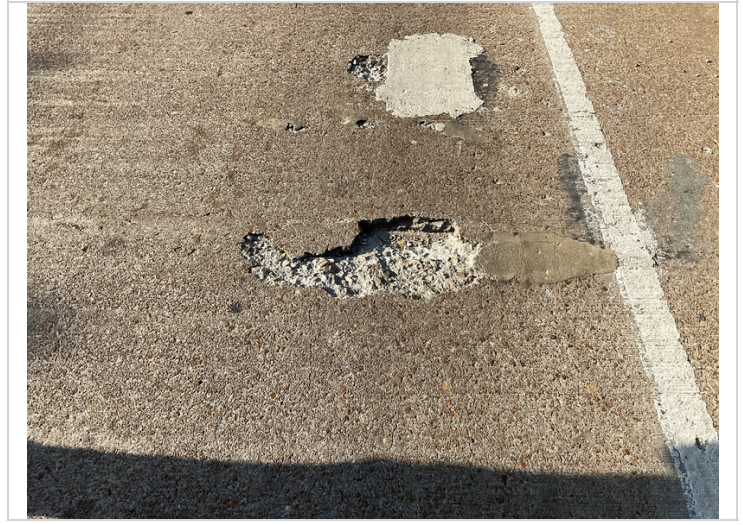
Spalls with no rebar exposed @ span 8.

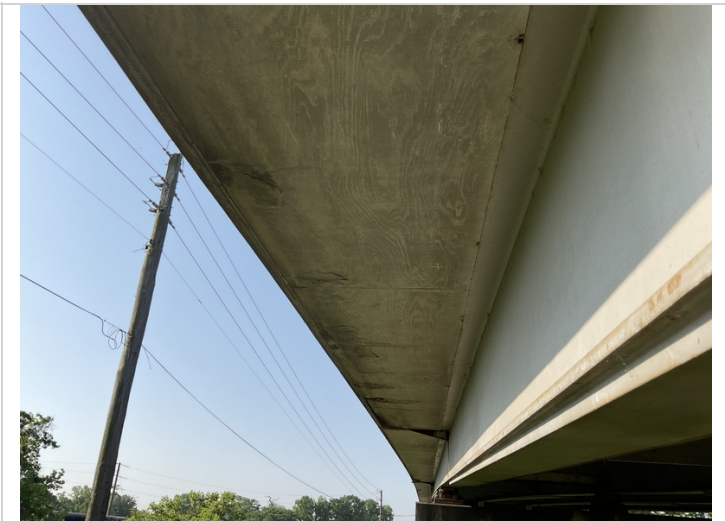
Few minor delays to rt overhang @ span 1.

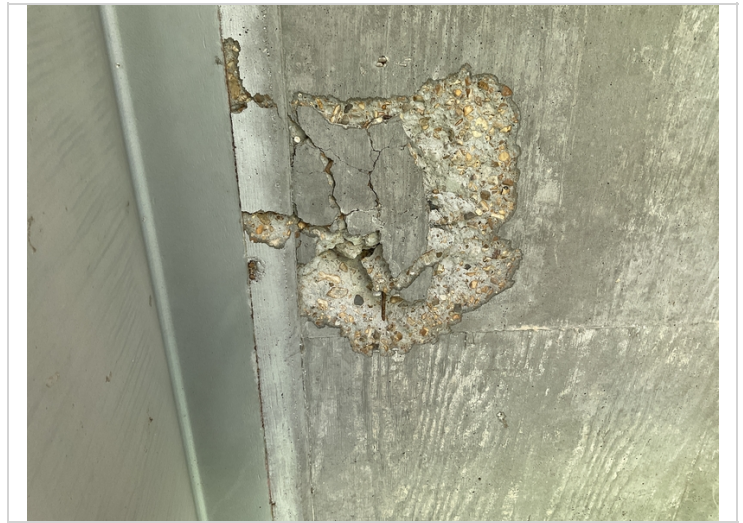
Spall to soffit between girders 2 & 3 @ span 6.

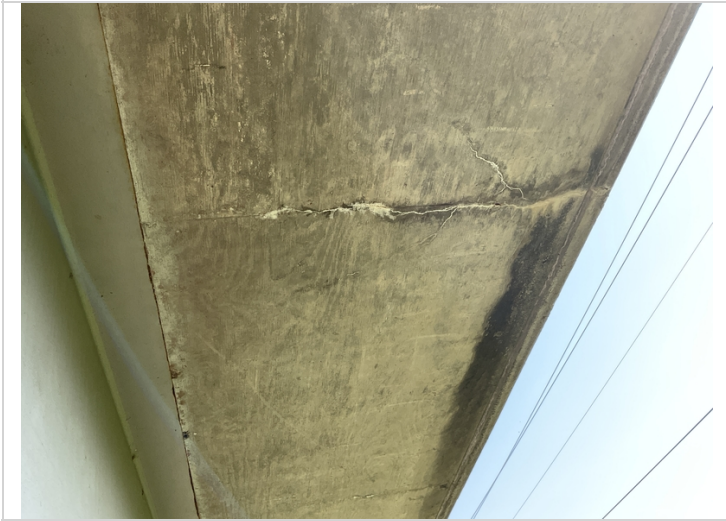
Typical efflor cracks to Lt & Rt overhangs.

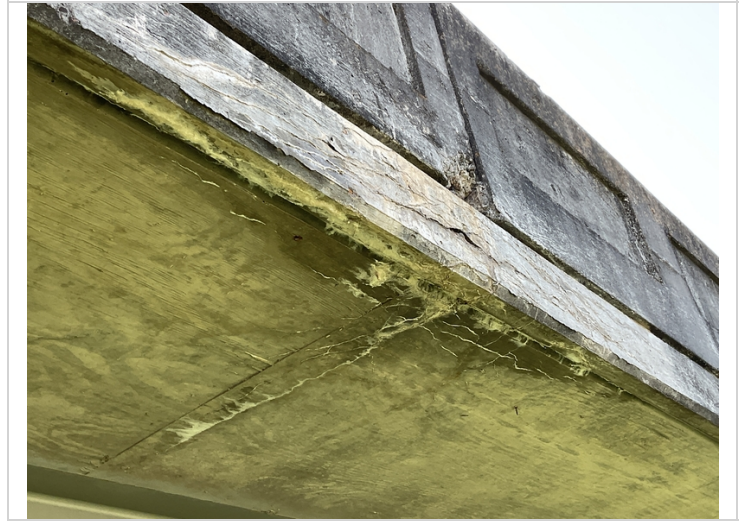
Efflor map cracking to rt overhang @ span 2.

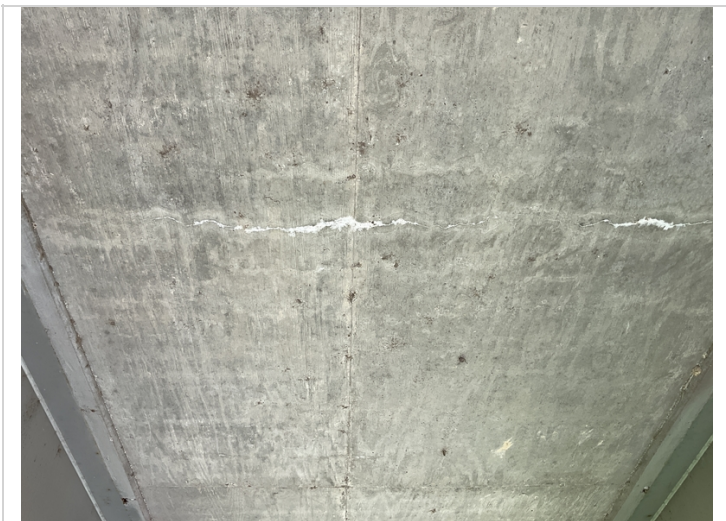
Typical efflor cracks to soffit @ all spans.

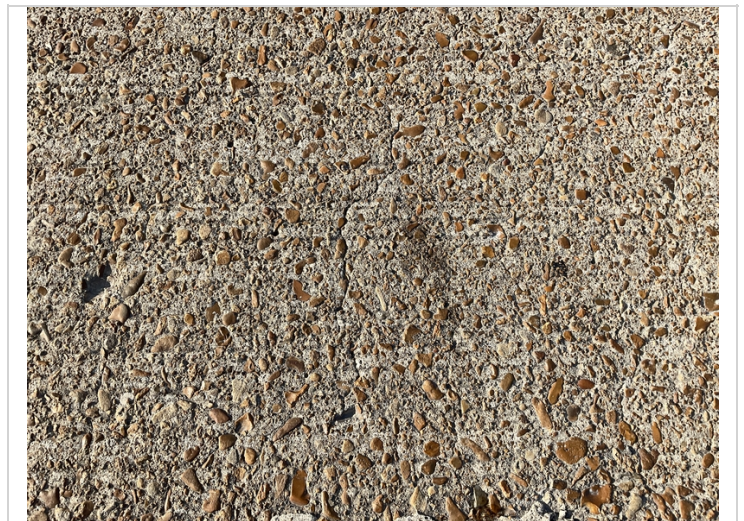
Typical cracks to deck @ all spans.

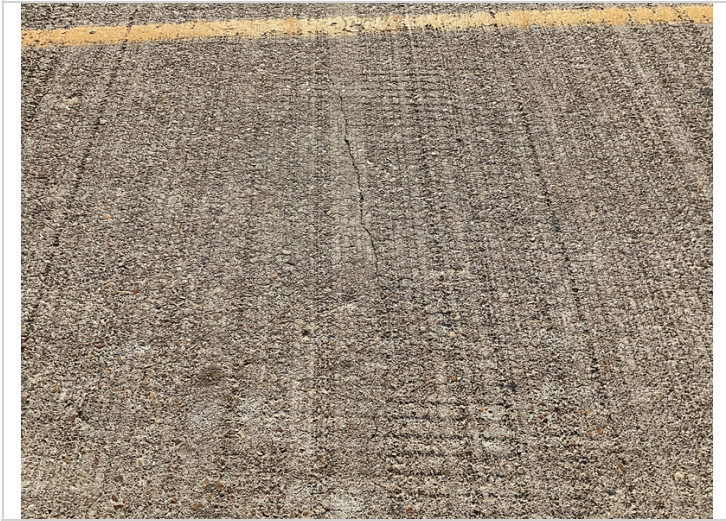
Typical cracks to deck @ all spans.

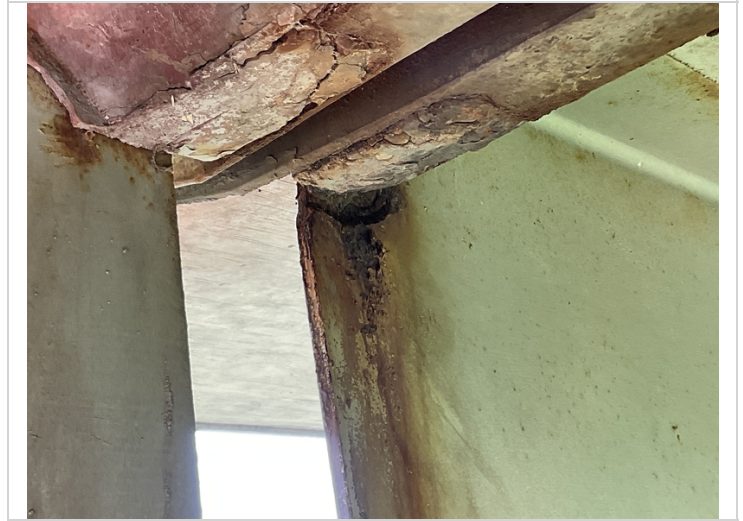
Corrosion to ends of girders @ all spans.

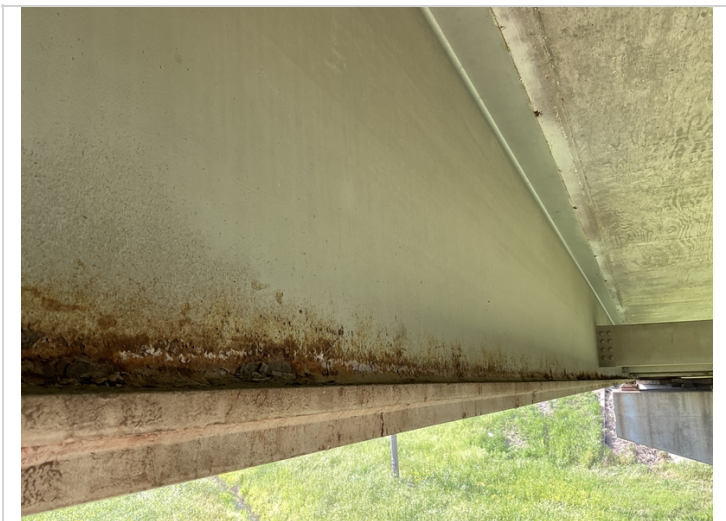
Typical Freckled to bottom flanges @ all girders.

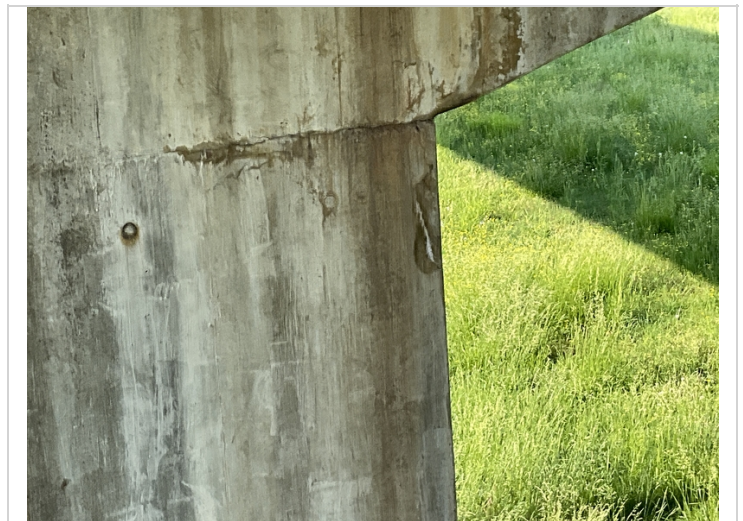
Efflor crack to column @ backside of bent 1.

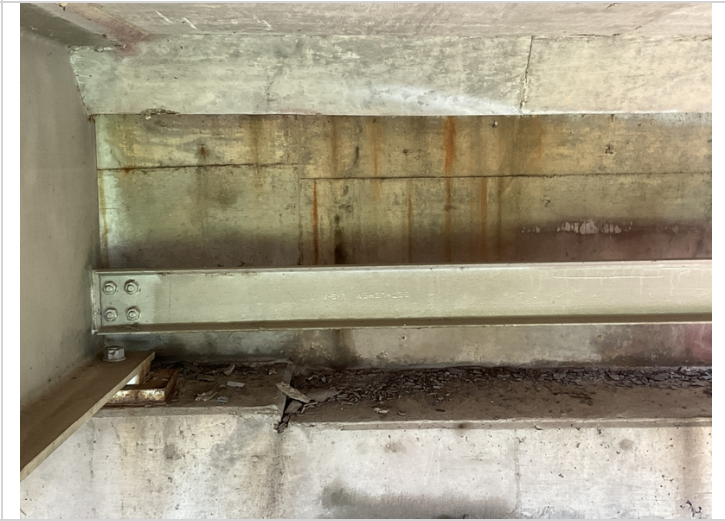
Efflor cracks to back wall @ abutment 1.

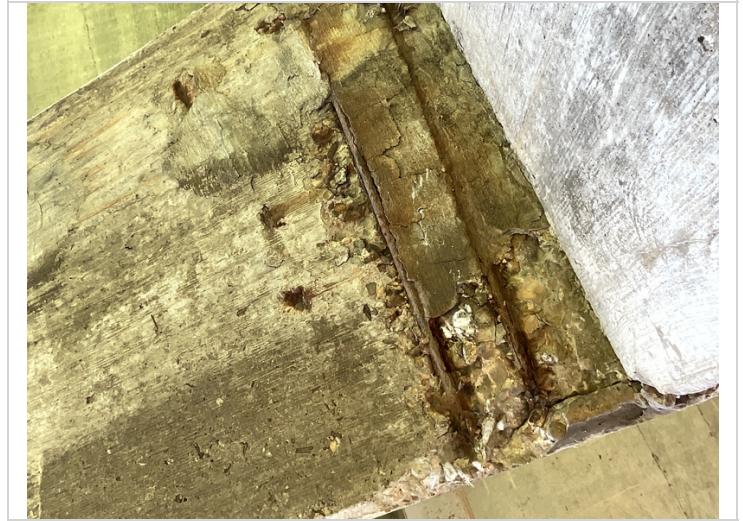
Spall with rebar exposed bottom rt side of cap @ bent 1.

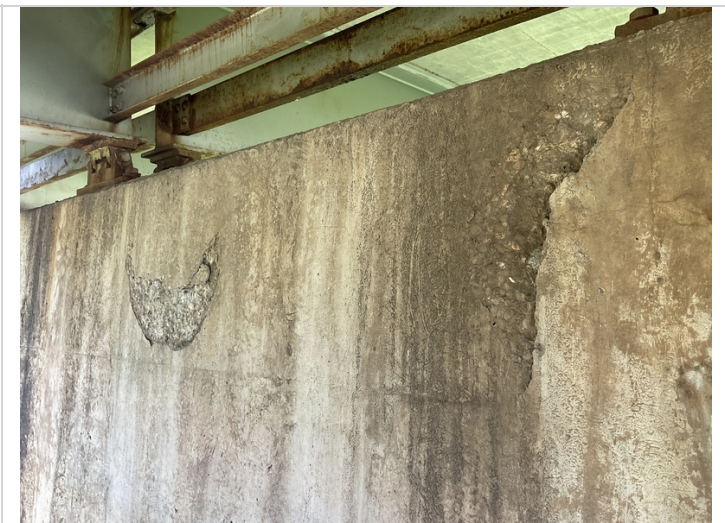
Large spalls to backside of cap @ bent 1.

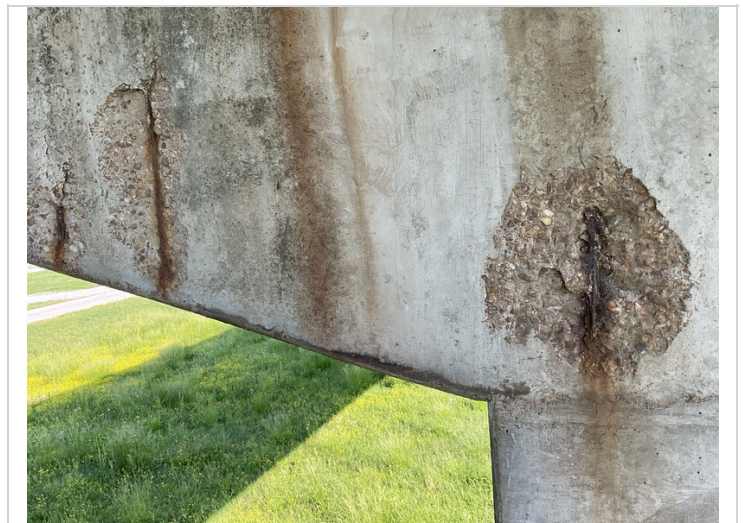
Spalls with rebar exposed to backside of cap @ bent 2.

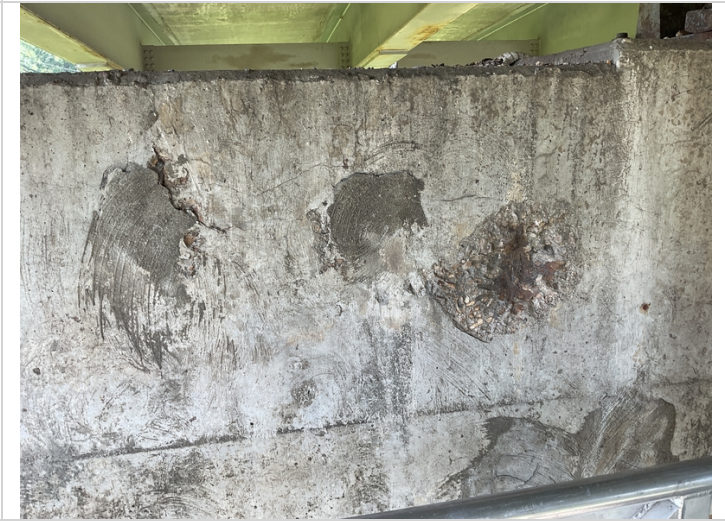
Spall to backside of cap with rebar exposed @ bent 4.

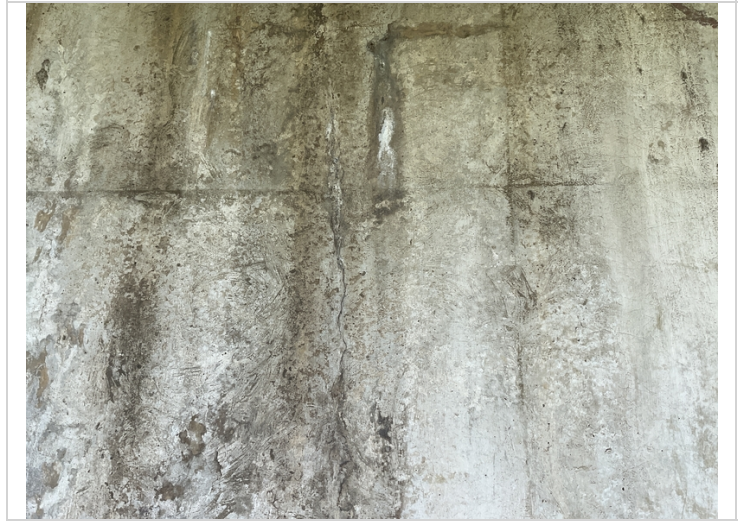
Vertical efflorescent cracking to ahead side of cap @ Bent 5.

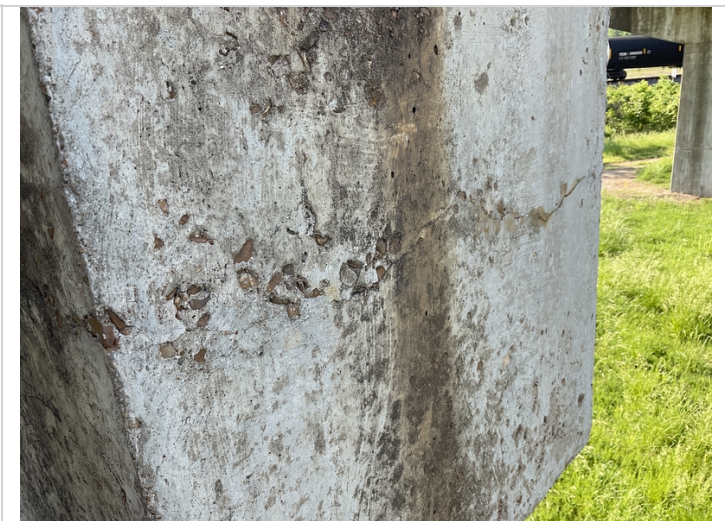
Horizontal crack to right side of cap @ bent 1.

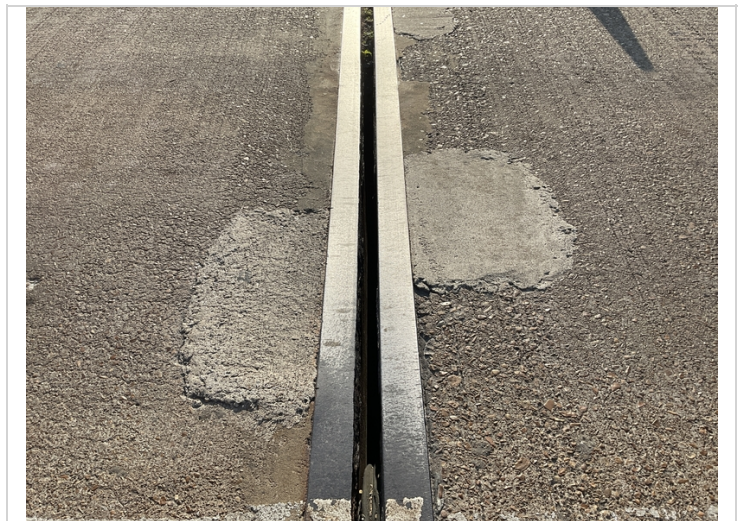
10' of compression joint seal missing @ bent 1.

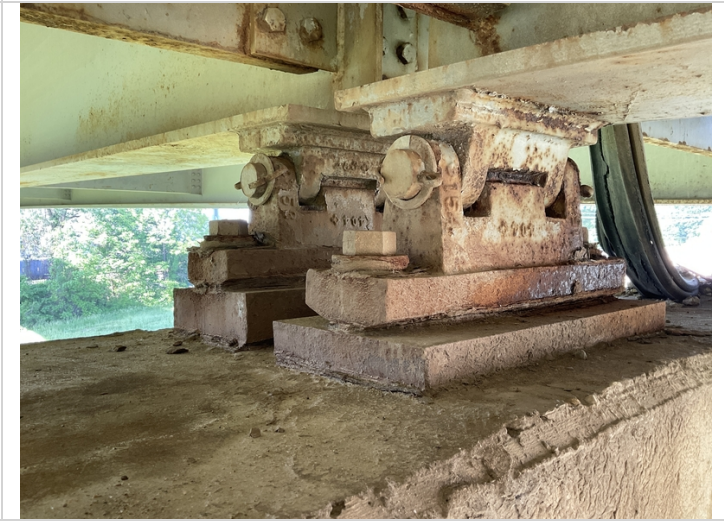
Typical rust with section loss to bearings @ all bents

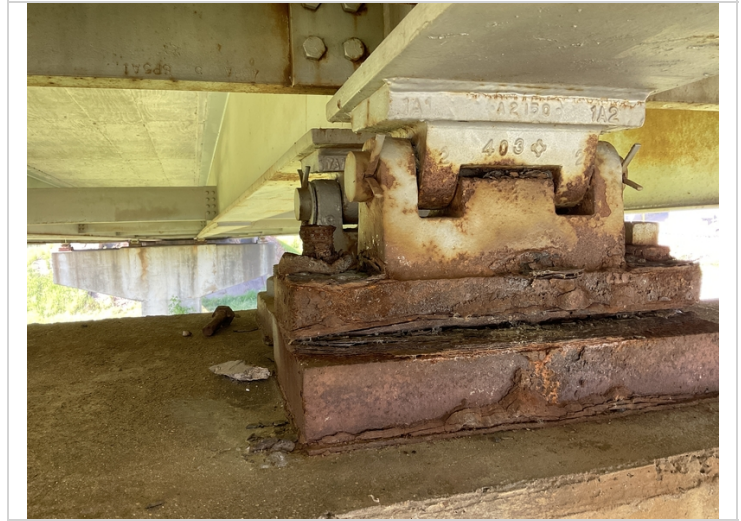
Missing bolt @ Moveable Bearing 3 @ Bent 6.

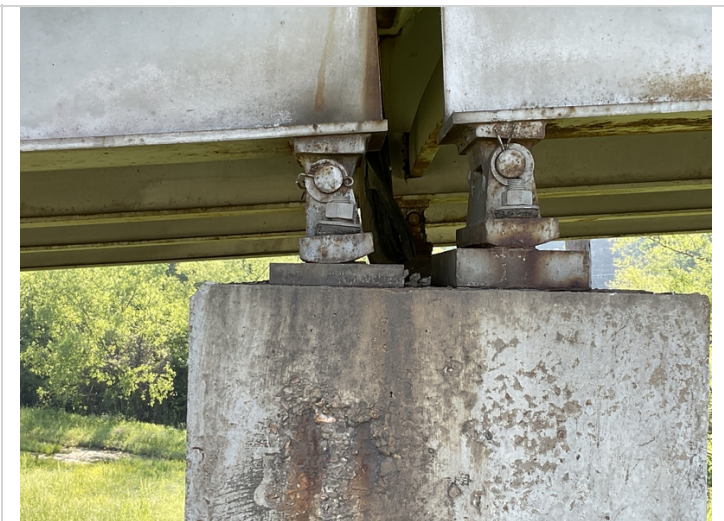
Moveable bearings have rotated back @ bent 1.

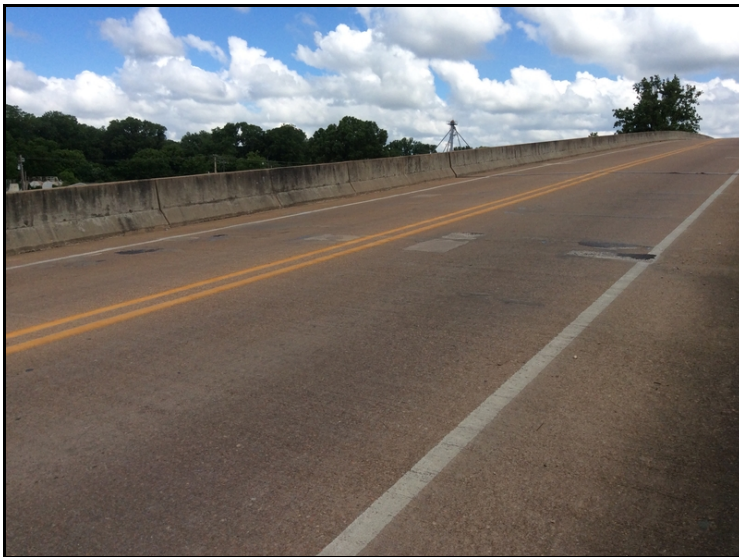
Spans 1, 2, 6 & 8 has spalls to deck with no rebar exposed.

Span 8 - 10 ' of Spalls exposed to deck with no rebar exposed.

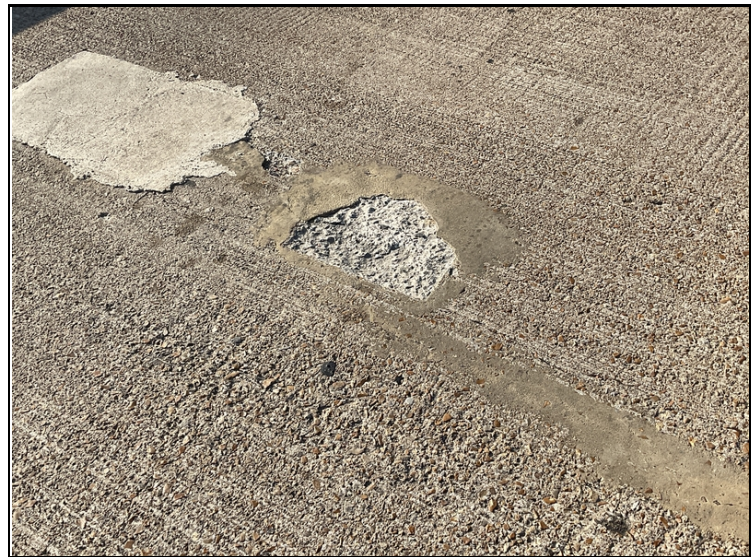
Spans 1, 2, 6 & 8 has spalls to deck with no rebar exposed.
Span 2, Lt side.

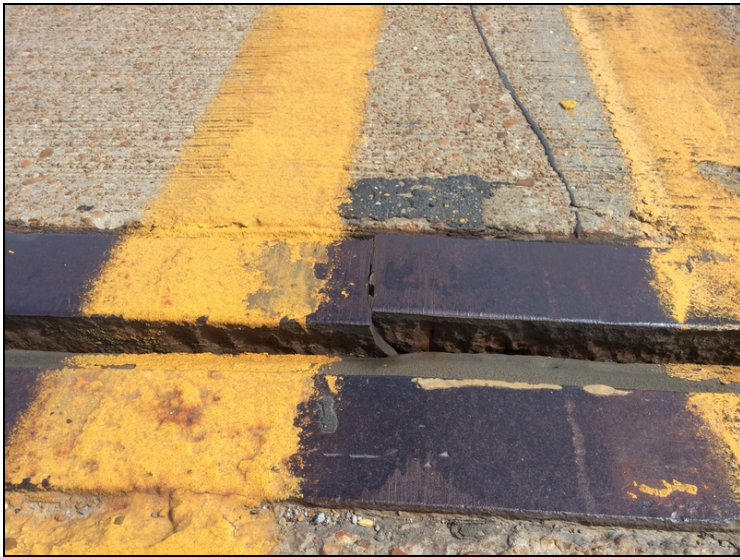
Road iron on back side of joint at Bent 2 broke and pulled out of place at center line.

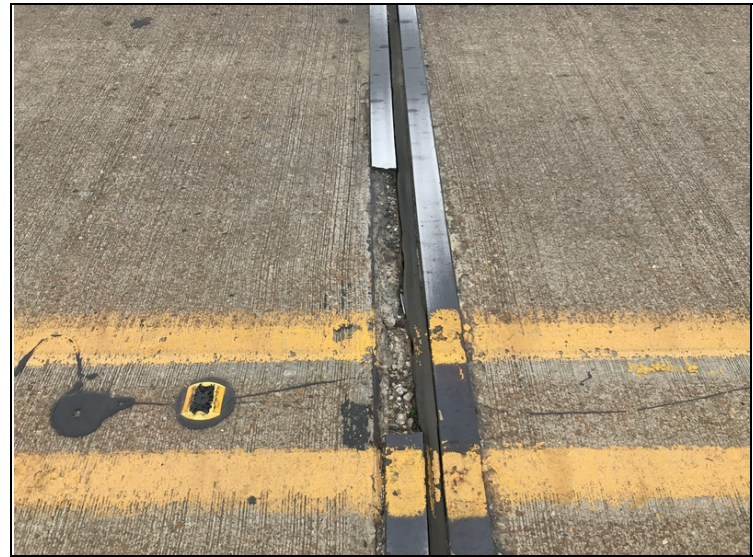
Bent road iron has been removed. (Remove maintenance need)

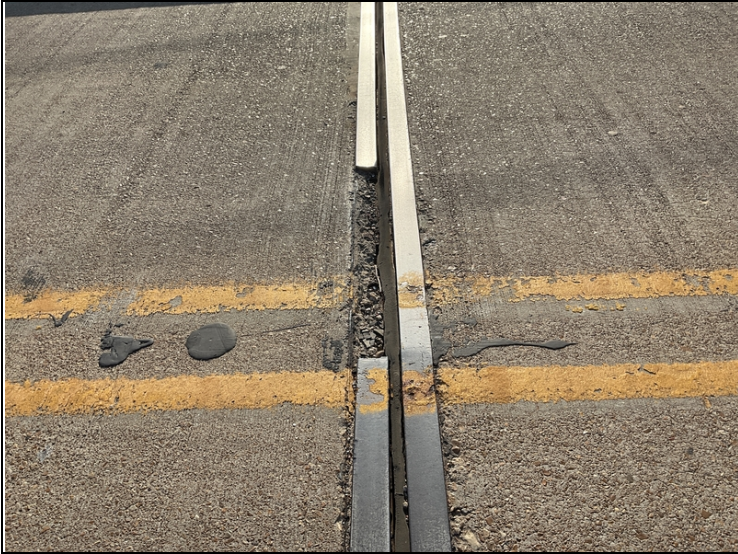
Bent 2 - Road iron on back side of joint is broke
and pulled out of place at
center line.
Repaired.

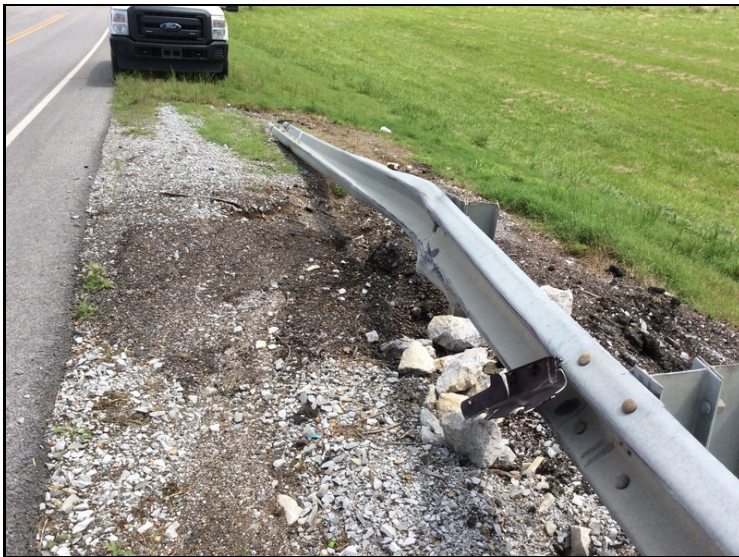
Collision damage to Left Approach guardrail @
Abutment 1.

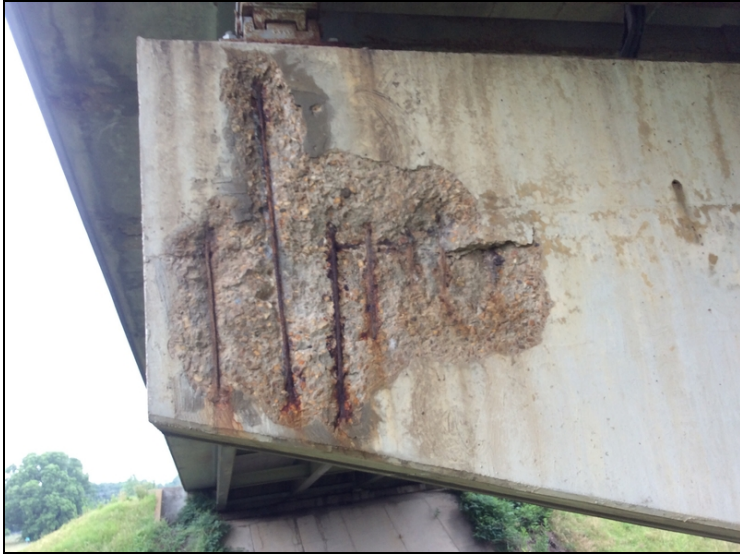
Spalls with rebar exposed and delaminated areas to caps.

Spalls with rebar exposed to ahead side of Cap @ Bent 1.

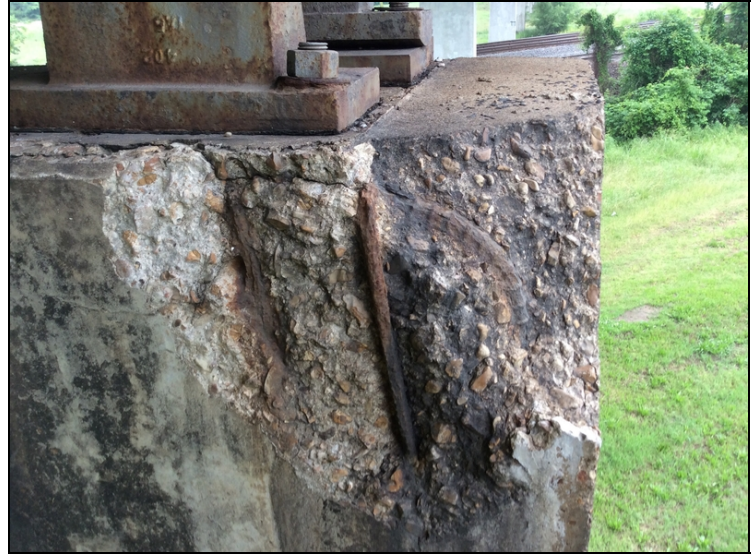
Deep spall with rebar exposed to top of Cap @ Bent 2. Right side.

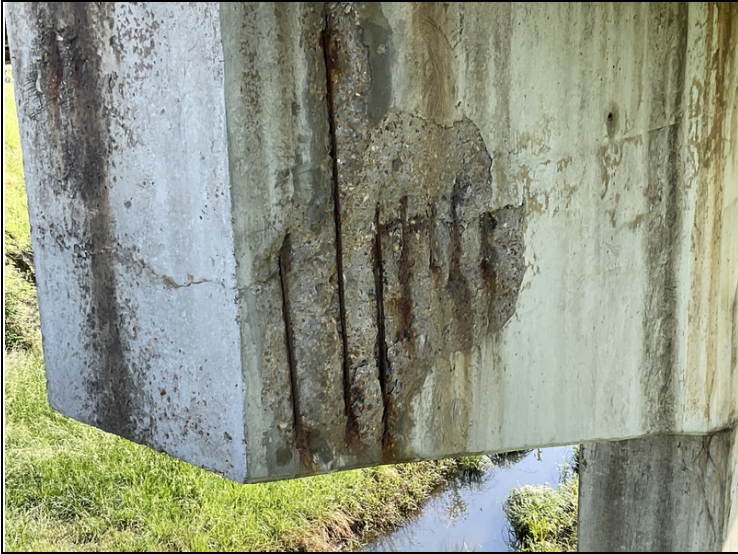
Backside of bent 1.

**Spalls with rebar exposed and delaminated areas
to caps.**

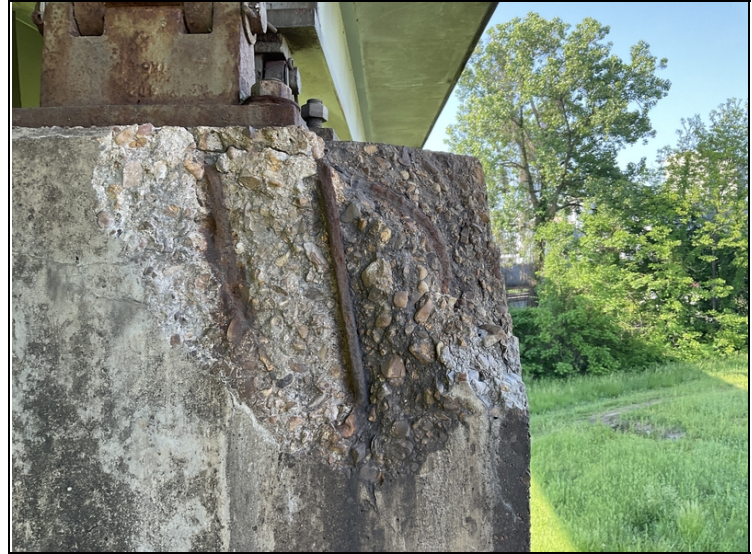
Rt side bide bent 2.

**Spalls with rebar exposed and delaminated areas
to caps.**

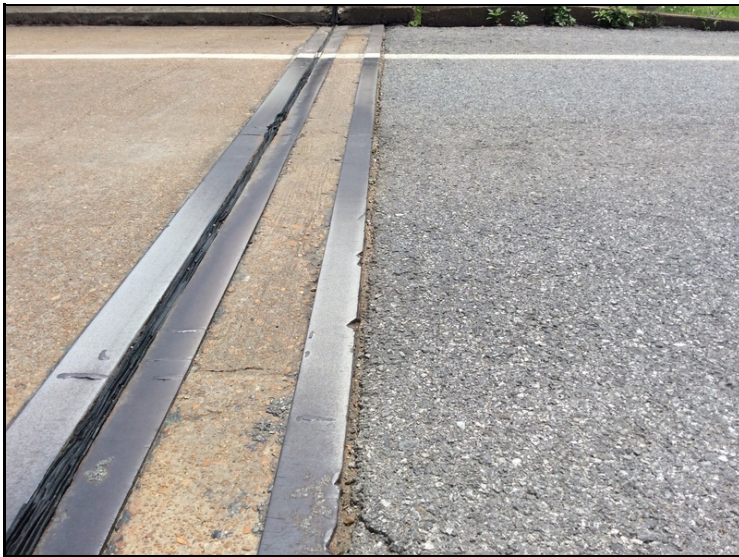
Approach roadways have minor settlement @ Abutments 1 and 2.

Minor Approach roadway settlement @ Abutment 2.

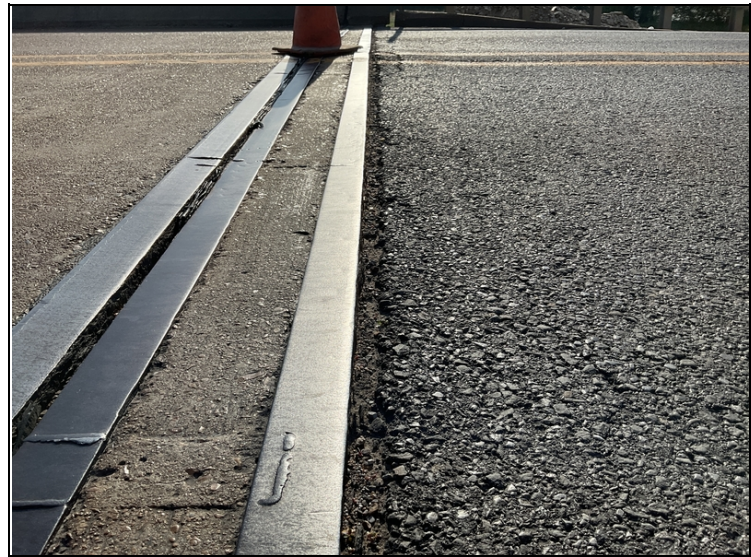
Approach roadways have minor settlement @ Abutments 1 and 2.
Abutment 2.

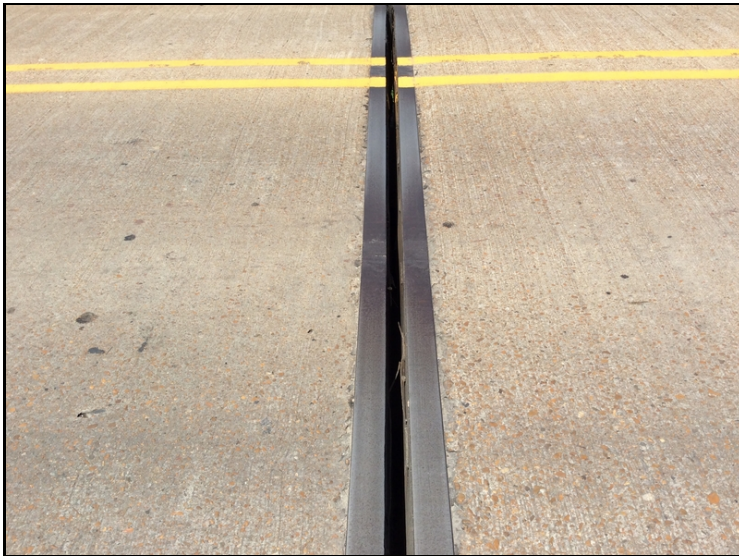
Joint seals are cracked, deteriorated, and leak. Joints have failed at Bents 1, 5 and 6.

Pourable joint seal @ Bent 5.

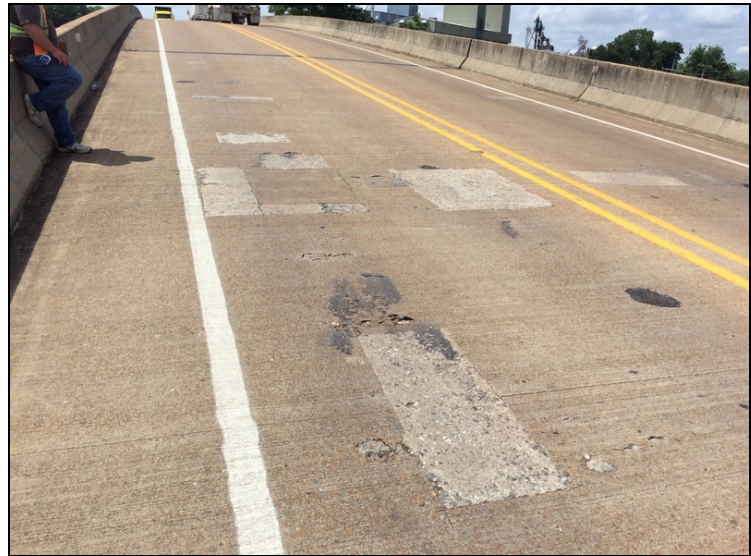
Spans 1 - 8
Spalls and delaminated areas to deck.

Spalls & delaminated areas to deck @ Span 1.

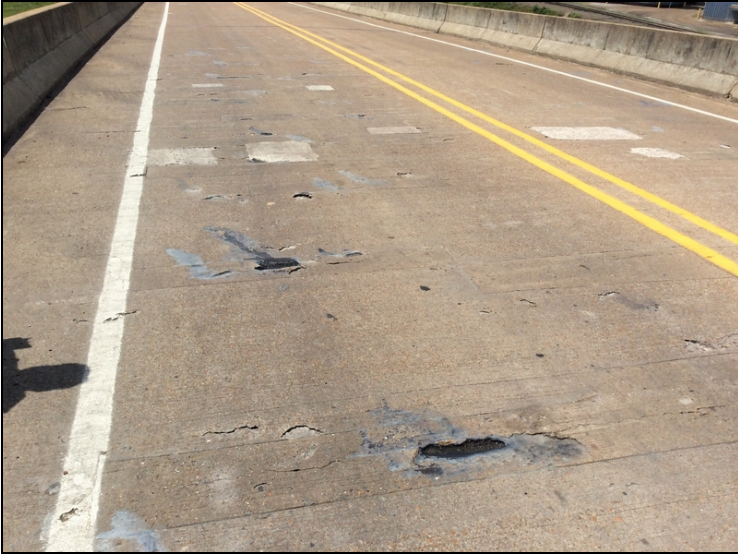
Spalls & delaminated areas to deck @ Span 6 Left lane.

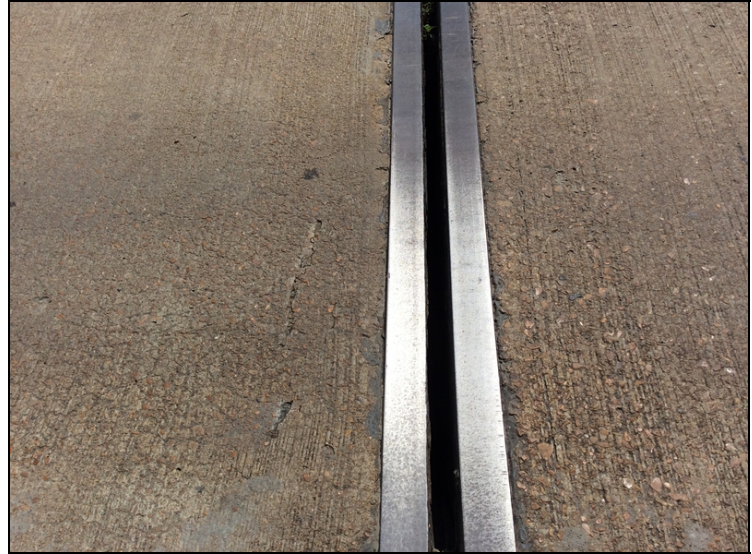
Compression joint seal is missing @ Bent 1.

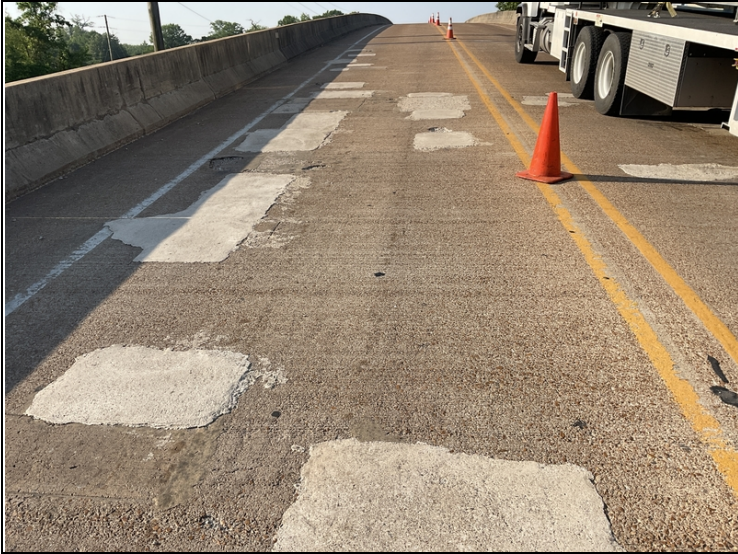
Spans 1 - 8
Spalls and delaminated areas to deck.

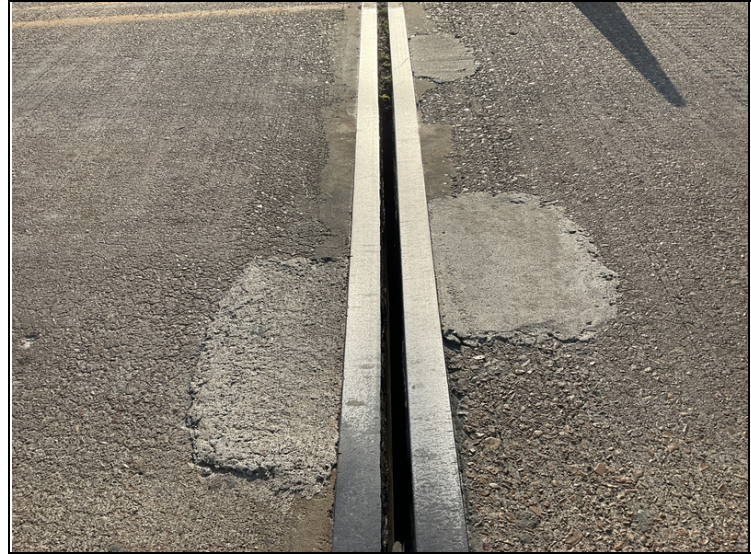
Joint seals are cracked, deteriorated, and leak.
Joints have failed at Bents 1, 5 and 6.
Bent 1.

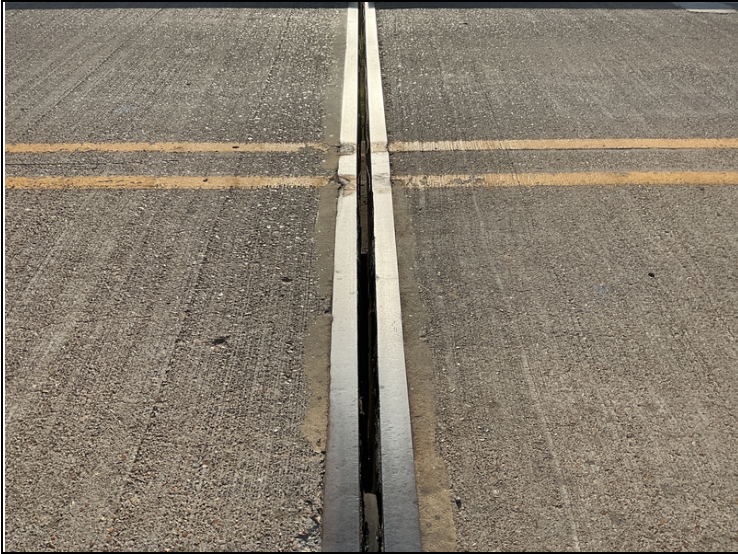
Joint seals are cracked, deteriorated, and leak.
Joints have failed at Bents 1, 5 and 6.
Bent 5.

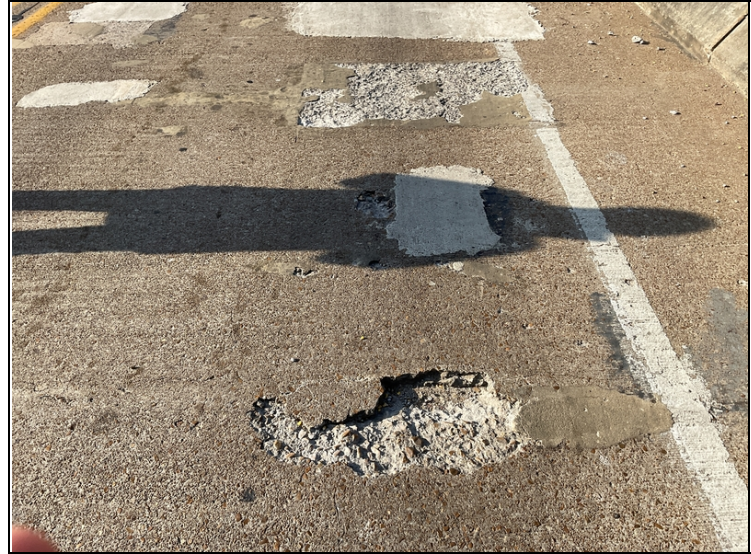
Spans 1 - 8
Spalls and delaminated areas to deck.
Span 8.

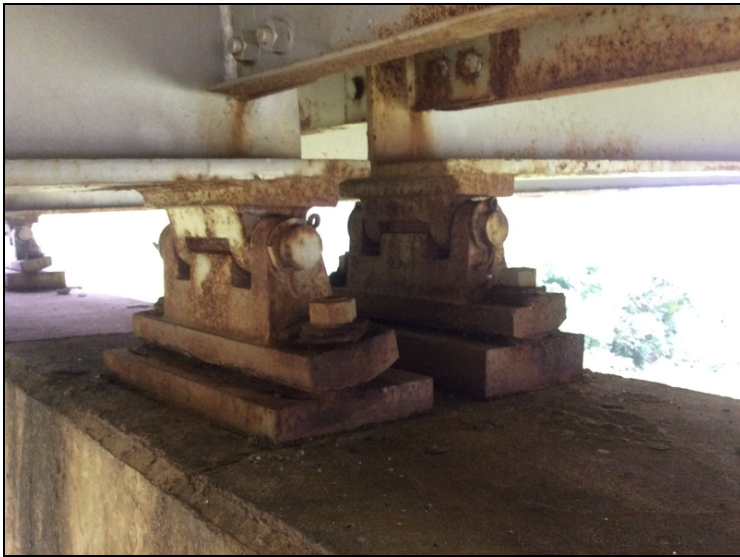
All bearings
Rust and corrosion to all bearings

Bearing condition @ Bent 1.

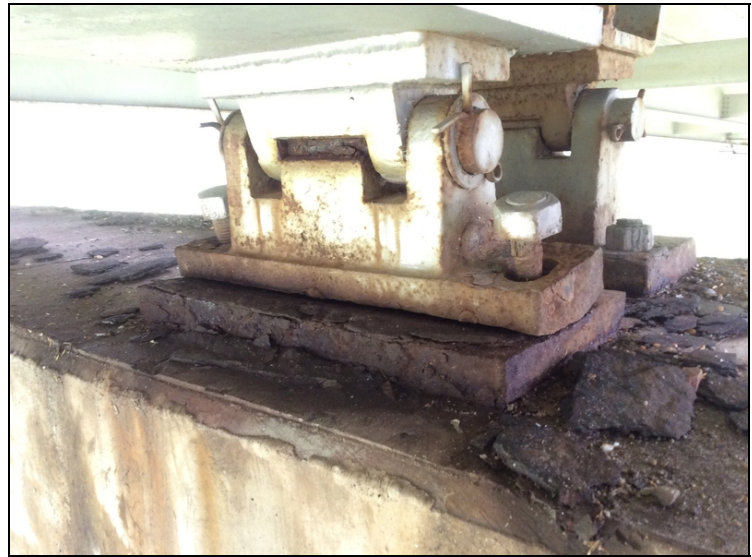
Bearing 3 over Bent 5.

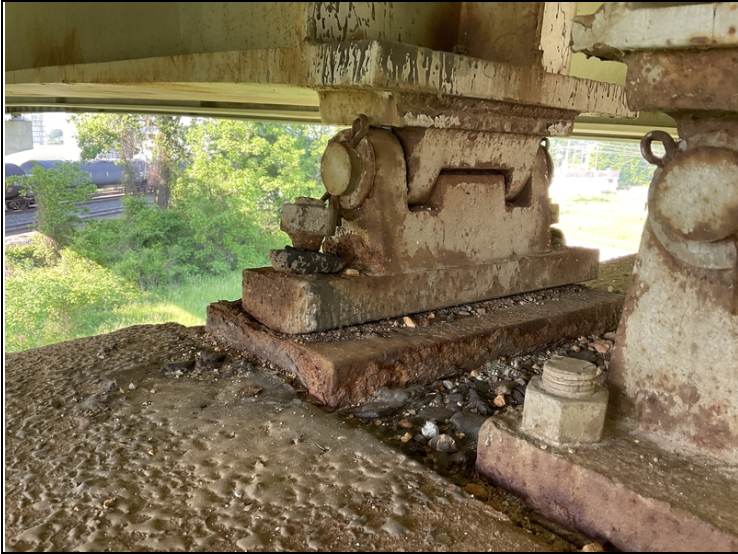
All bearings
Rust and corrosion to all bearings

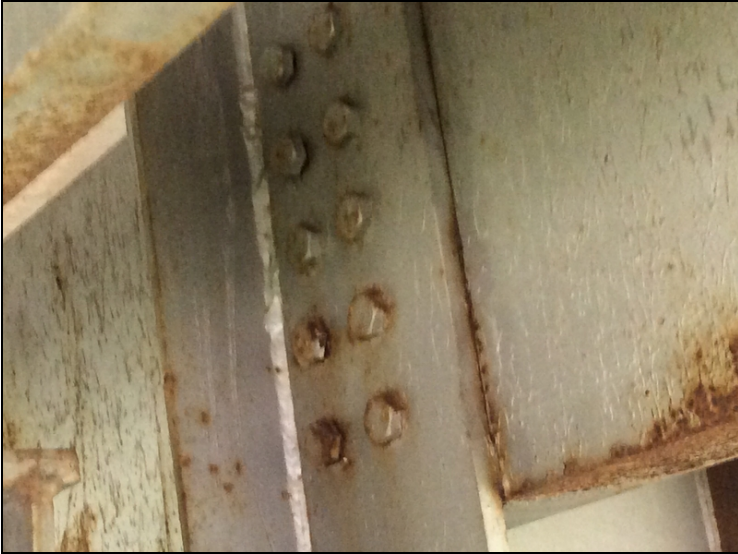
Spans 3, 4
Few loose bolts at diaphragm connections and / or diagonal braces.

Loose bolts @ Diaphragm connection @ Girder 2
@ BOS 3.

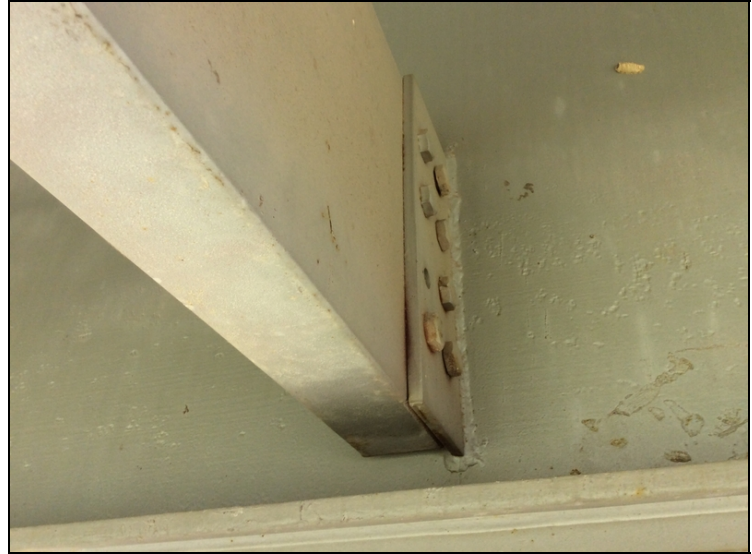
Loose bolts @ 3rd diaphragm connection between
Girders 1 & 2 @ Span 6.

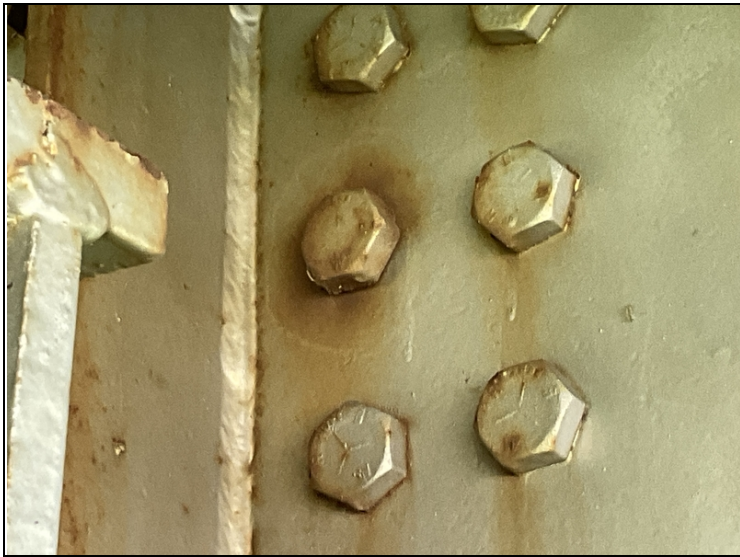
Spans 3, 4, and 6
Few loose bolts at diaphragm connections and / or
diagonal braces.
Span 3 between girders 3 & 4.

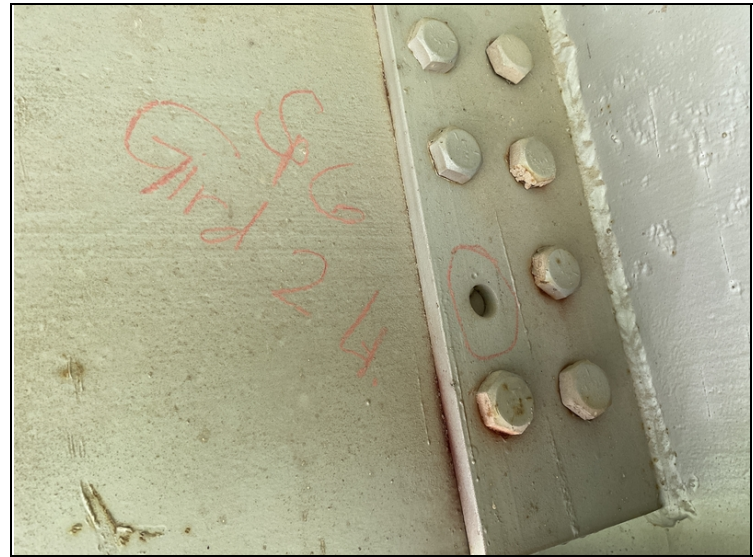
Span 6,
4th diaphragm connection between girders 1 & 2 has missing bolt.

Span 6,
4th diaphragm connection between girders 1 & 2
has missing bolt.
