Asset #05899(Routine)

SH 69/Jackson Co. over BLACK RIVER

Location: 1.65 MI W JCT SH 17

Team Lead: Kerry Little, Inspection Date: 09/12/2022

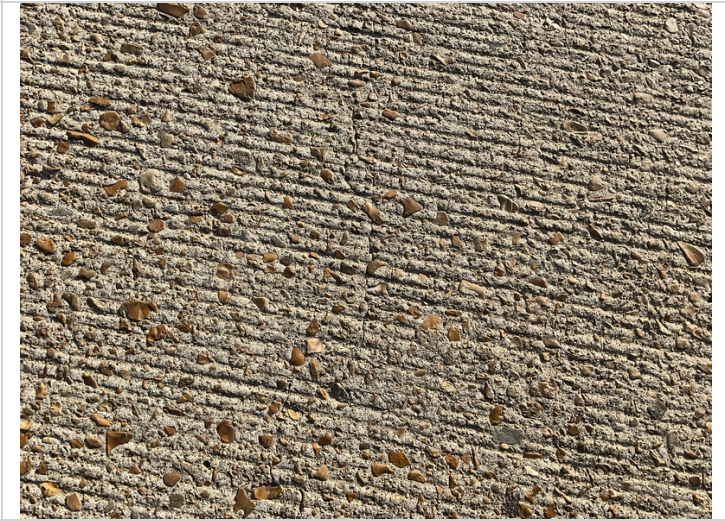
Typical cracks to deck @ all spans.

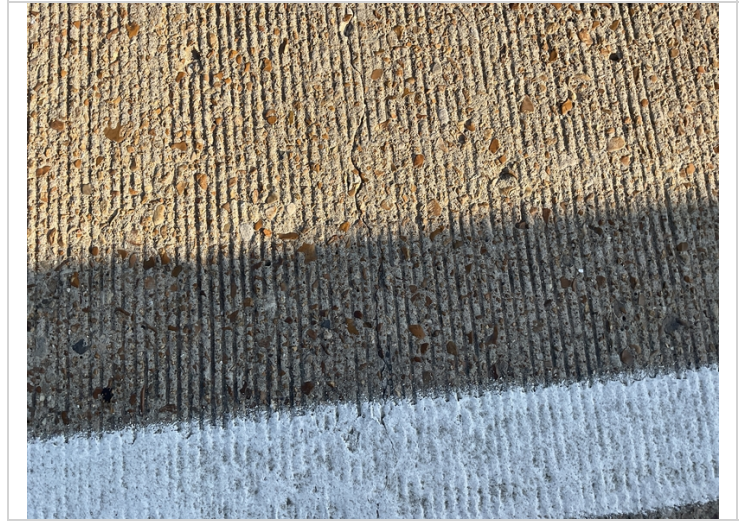
Typical cracks to deck.

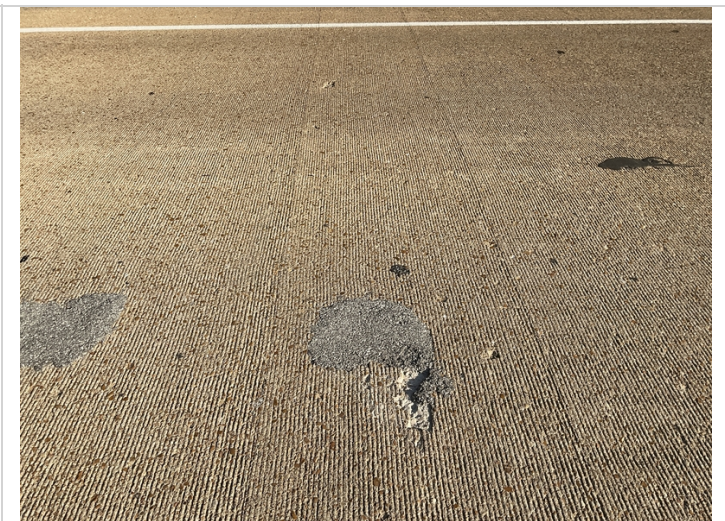
Few minor spalls with no rebar throughout deck.

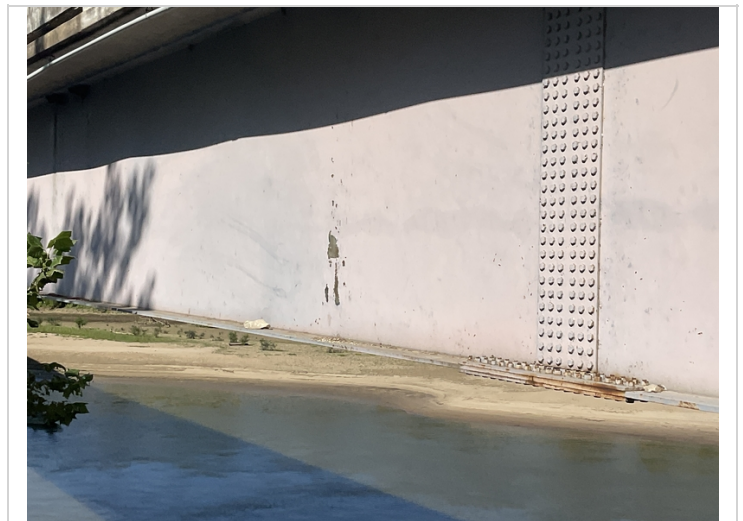
Peeling paint to outside of girder 4 @ span 8.

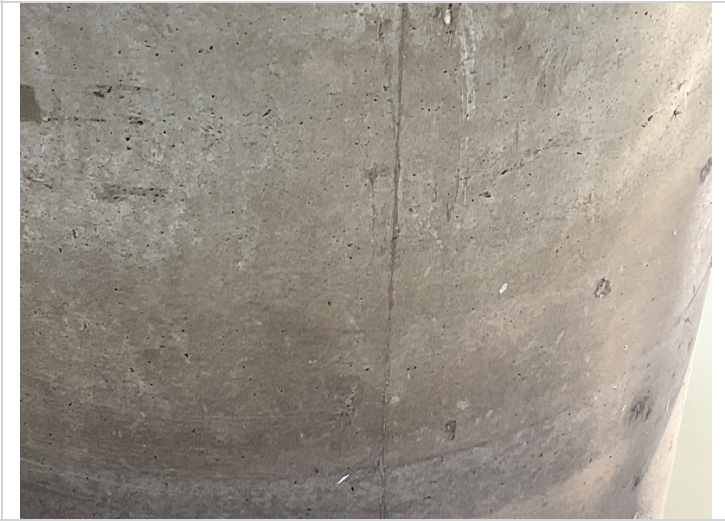
Cracking to column @ bent 7.

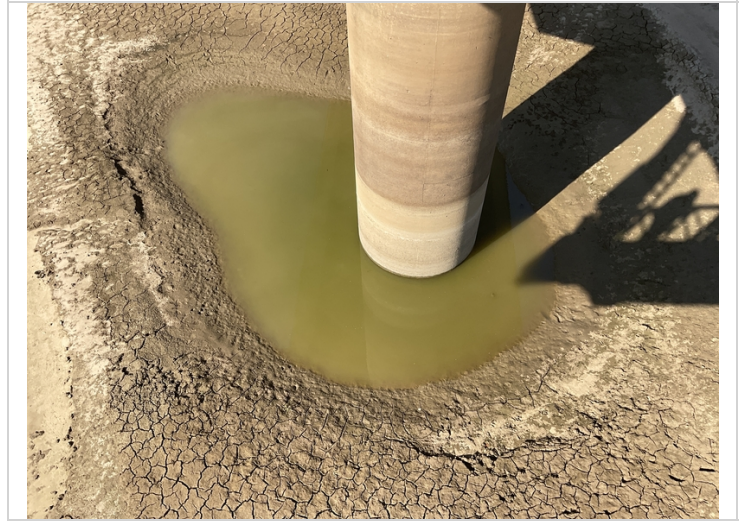
Local scour to bent 6.

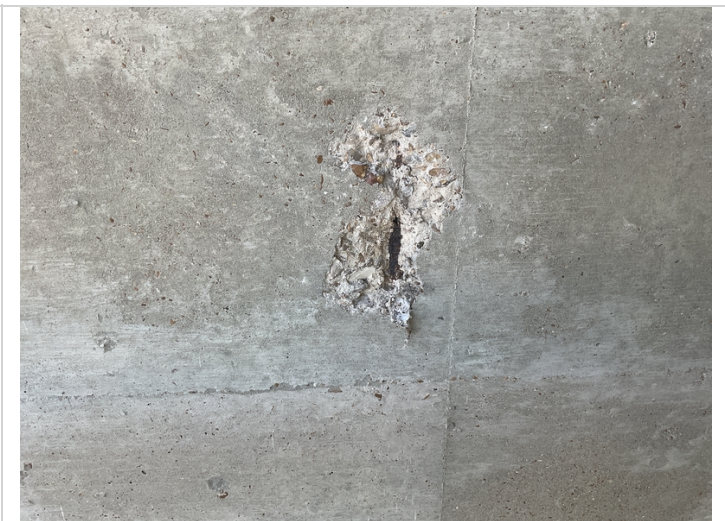
Spall with rebar exposed to back side of cap @ bent 8.

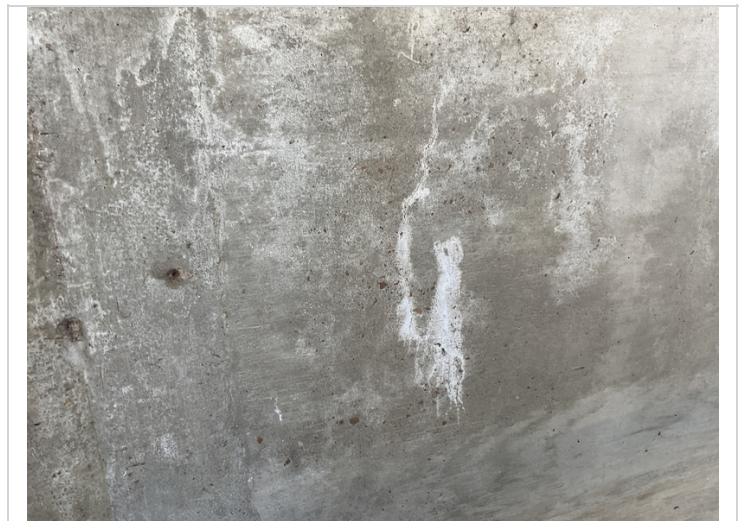
Efflor crack to back side of back @ bent 8.

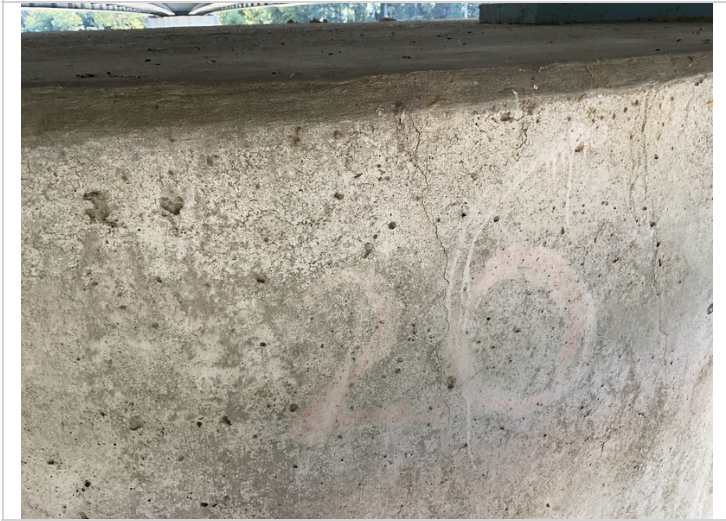
Cracking to backside of bent 6.

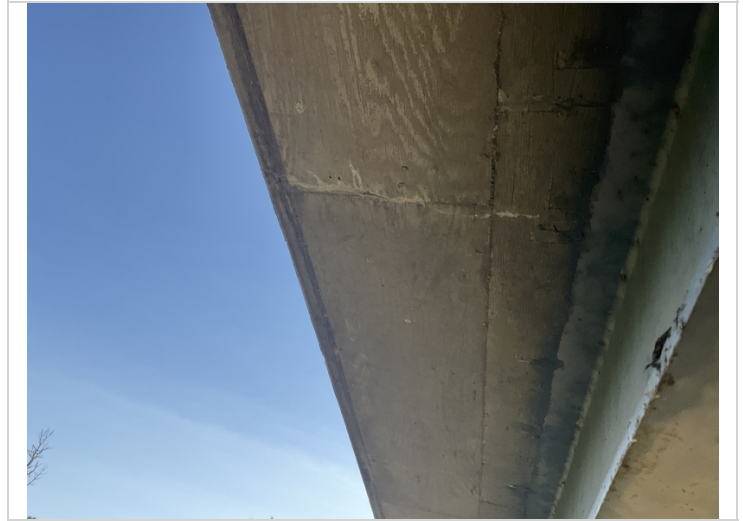
Typical cracks to Lt & Rt overhangs.

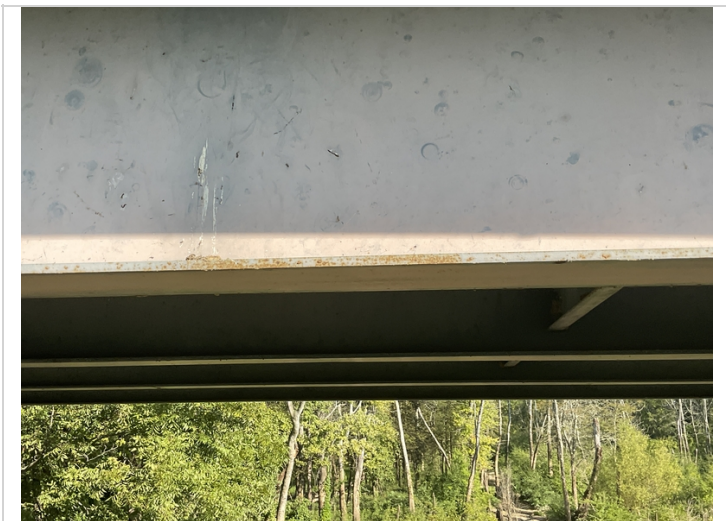
Typical Rust to bottom flange of girders.

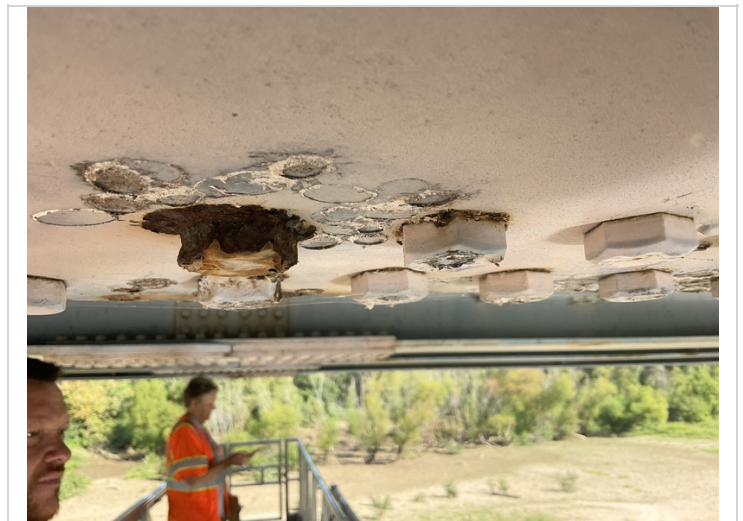
Rust to bolt @ first splice plate to girder 4, span 7.

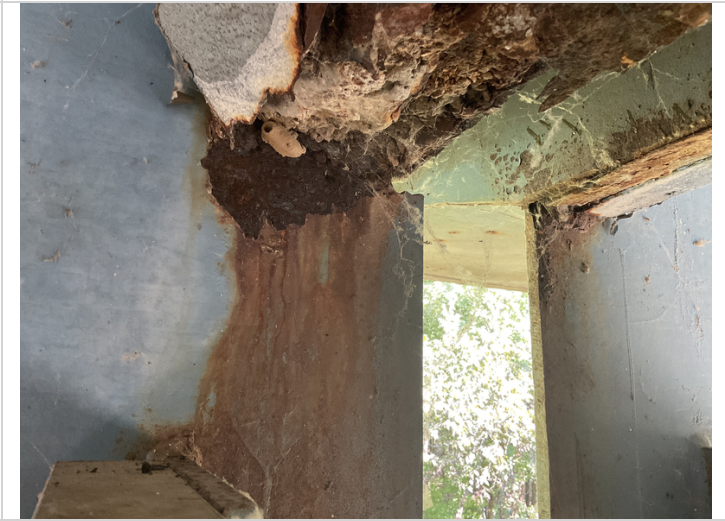
Hole to web, below paving haunch to girder 1 @ end of span 17.

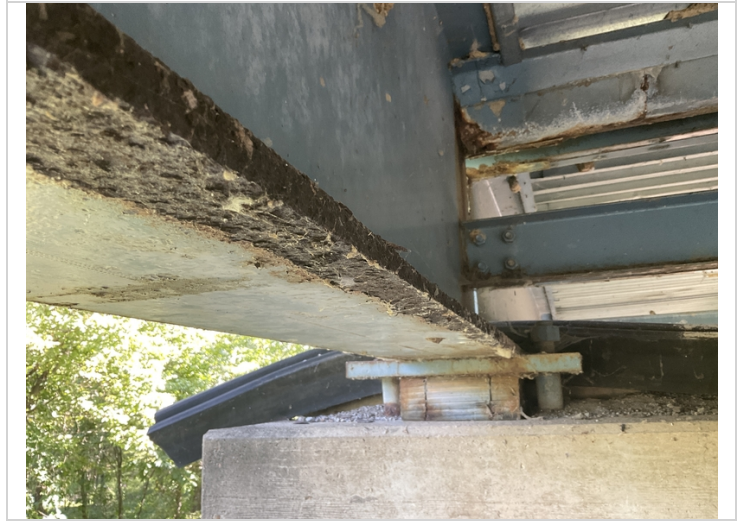
Areas of peeling paint to ends of girders 1 - 4 @ bent 13.

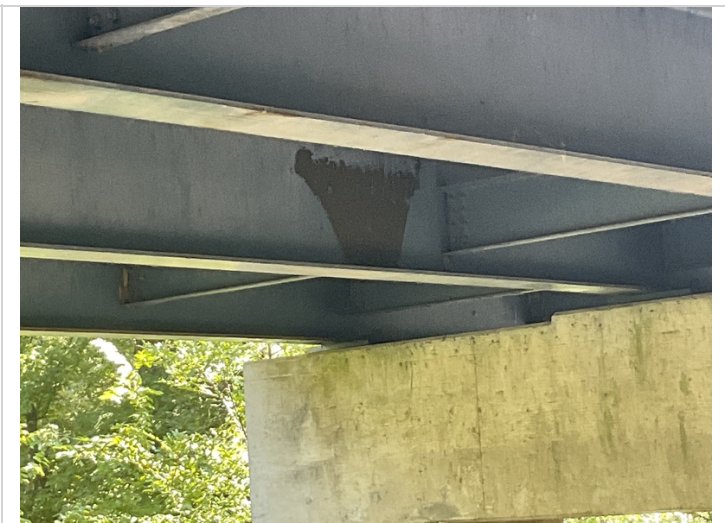
Peeling paint to end of girder 2 @ end of span 14.

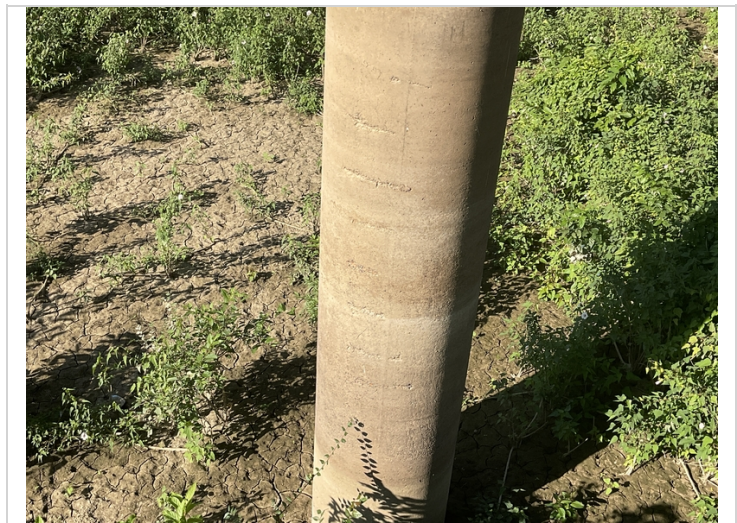
Spalls with rebar exposed to ahead side of column 2 @ bent 4.

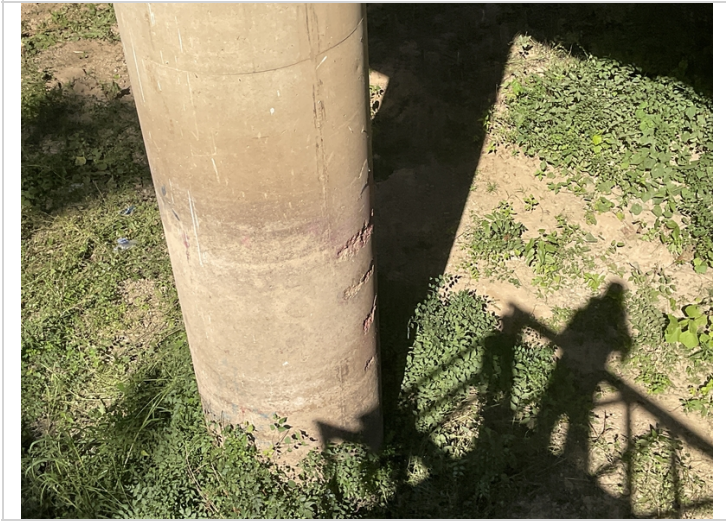
Spalls with rebar exposed to column 2 @ bent 17.

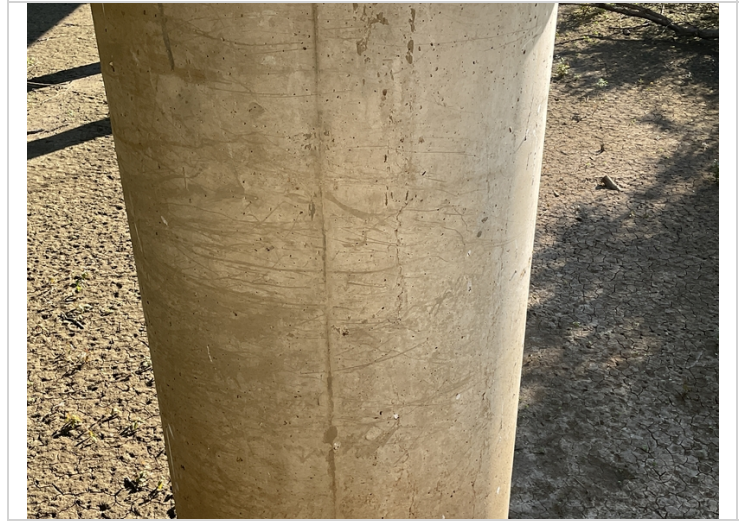
Vertical crack to column 2, backside of bent 2.

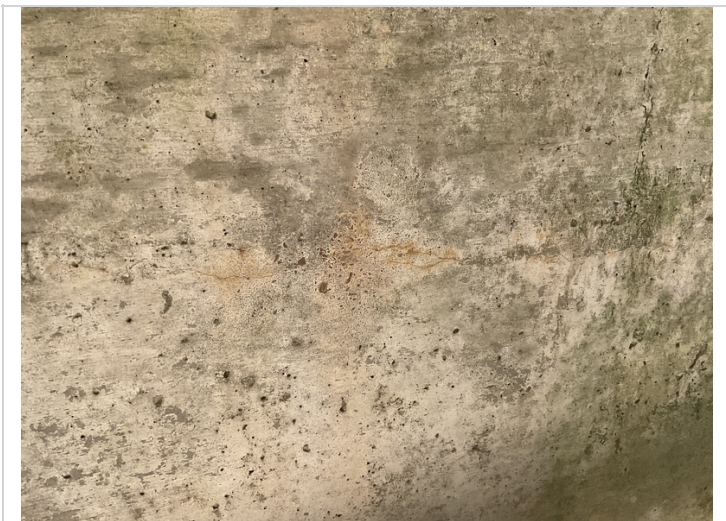
Rust stain crack to backside of cap @ bent 21.

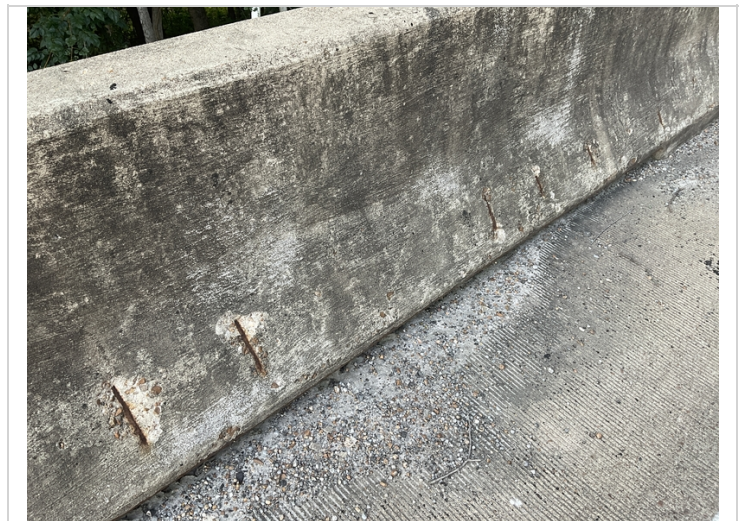
Typical spalls with rebar exposed to parapet wall.

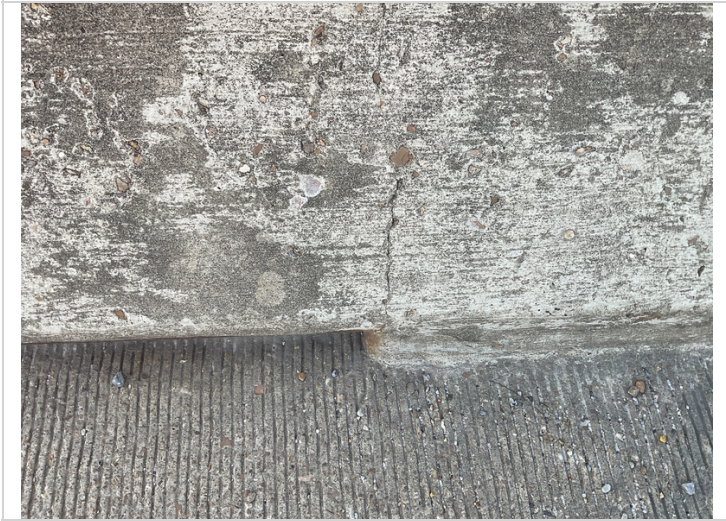
Typical vertical cracks to parapet wall.

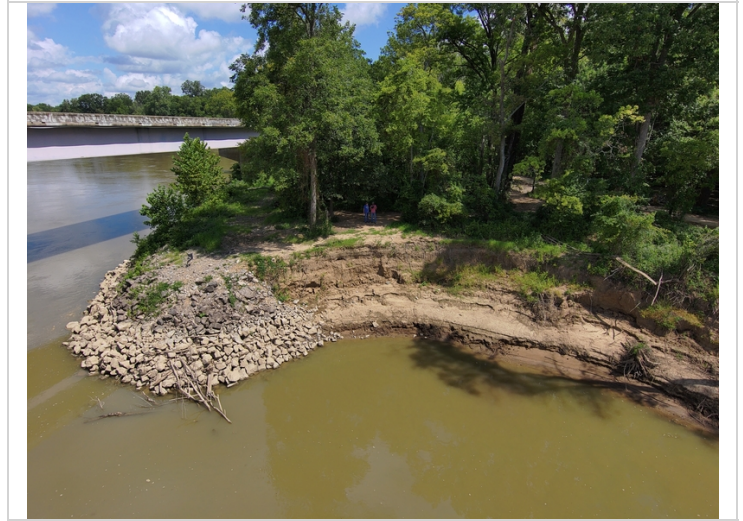
Typical Rip Rap repair made in the past. Up stream & down photos.

Down stream Photo of erosion of embankment at the end of Rip Rap repair.

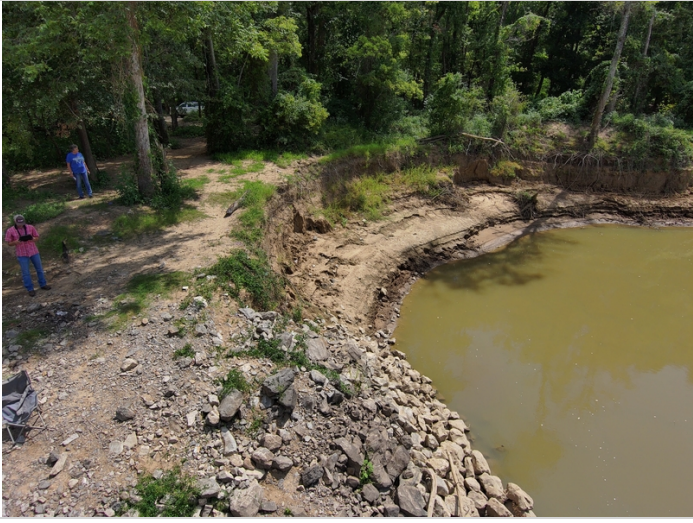
Typical Rip Rap repair made in the past. Up stream & down photos.

Down stream Photo of erosion of embankment at the end of Rip Rap repair.

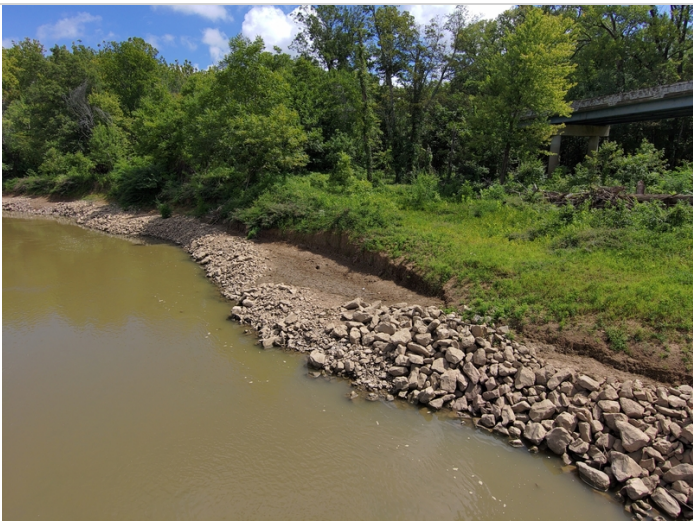
Up stream photo of rip rap has slid down embankment.

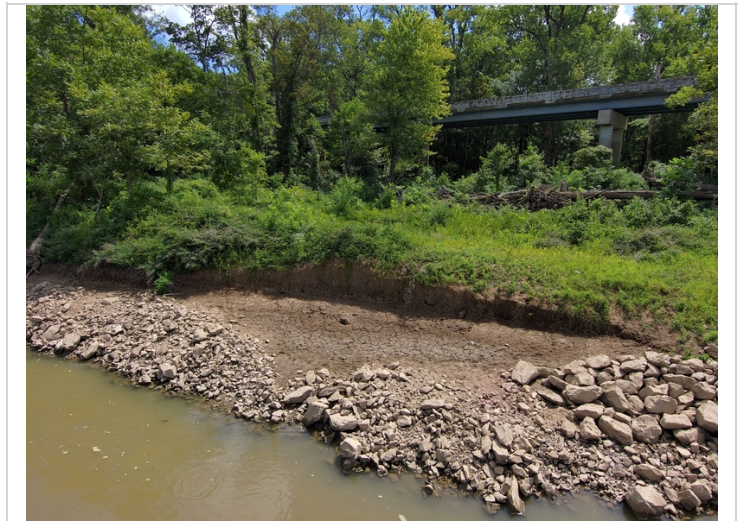
Up stream photo of rip rap has slid down embankment.

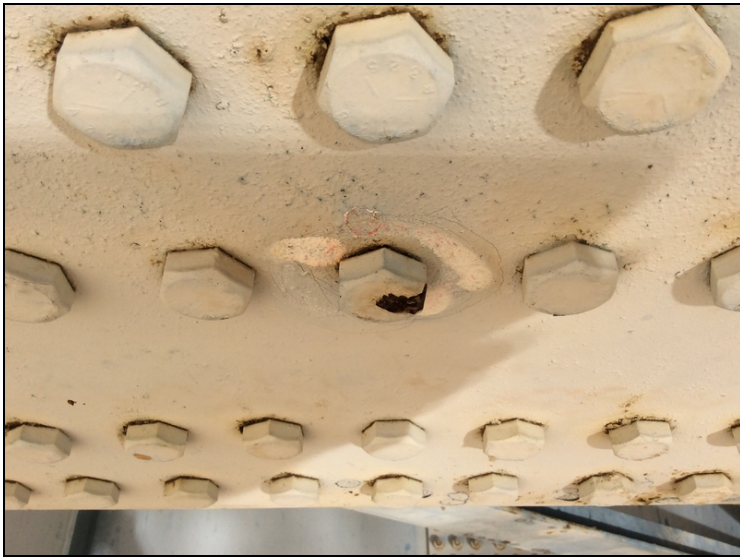
Loose bolt at field splice on Girder 2 at Span 6. Missing nut at 1st field splice of Girder 3 @ Span 6.

Loose bolt @ 2nd field splice @ Girder 2 Span 6.

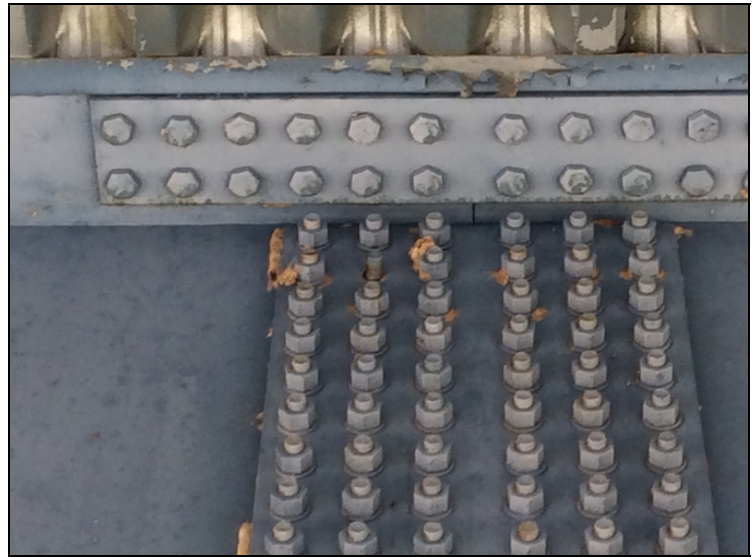
Missing nut @ first field splice of Girder 3 @ Span 6.

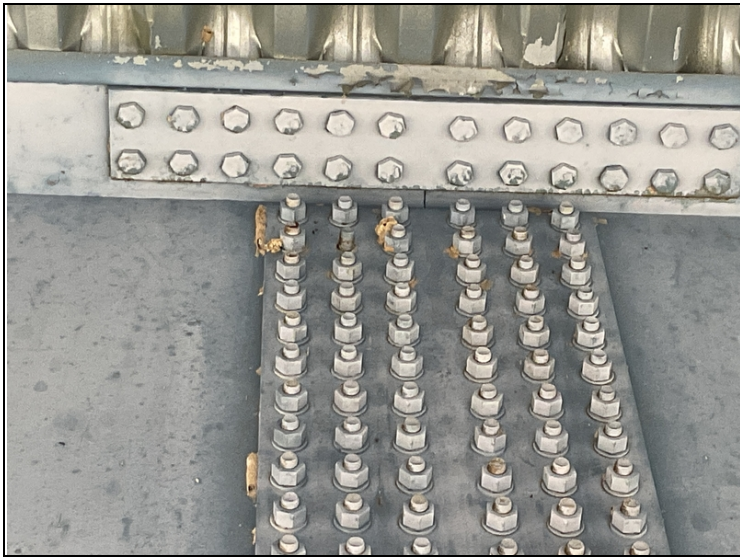
Missing nut at 1st field splice of Girder 3 @ Span 6.

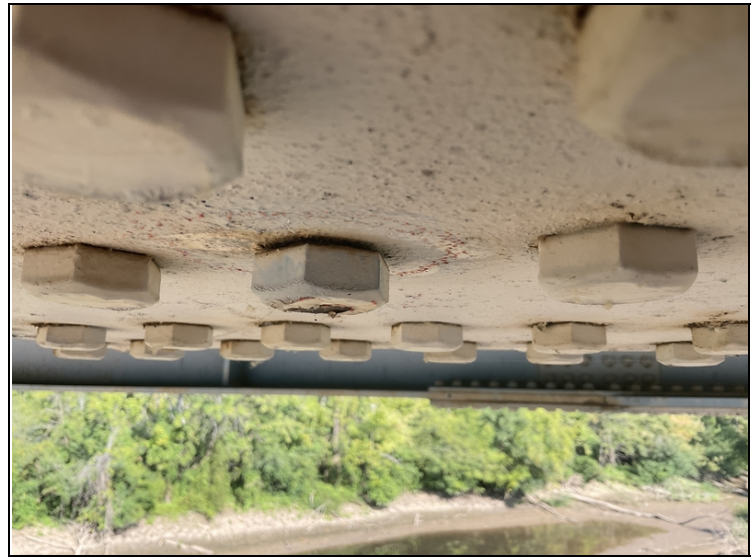
Loose bolt at field splice on Girder 2 at Span 6.

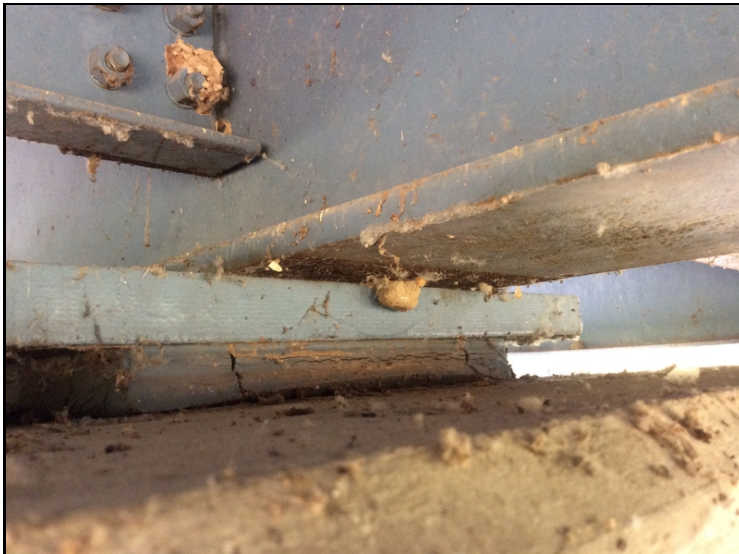
Surface rust to bottom of Girder 3 @ Bent 2.

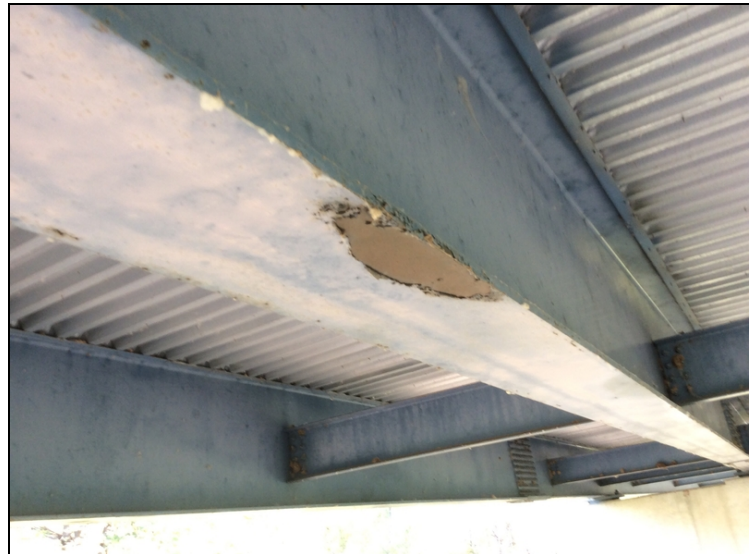
Peeling paint to bottom of Girder 2 @ Span 3.

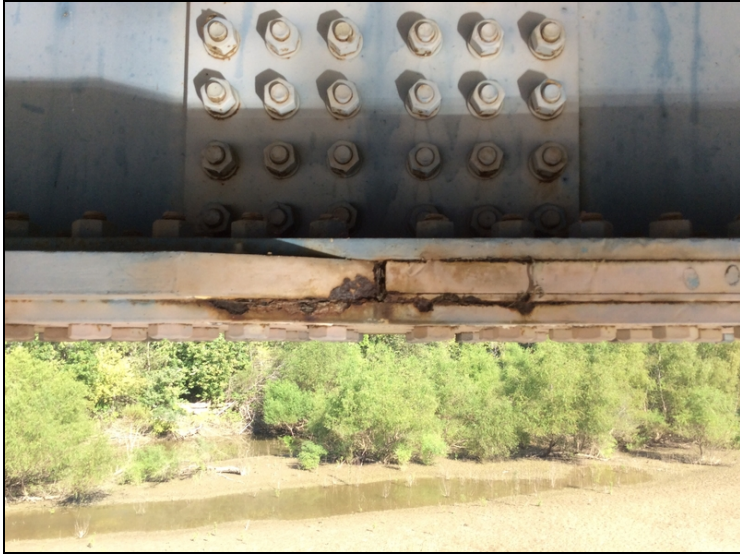
Pack rust to bottom of 1st splice plate @ Girder 1
Span 7.

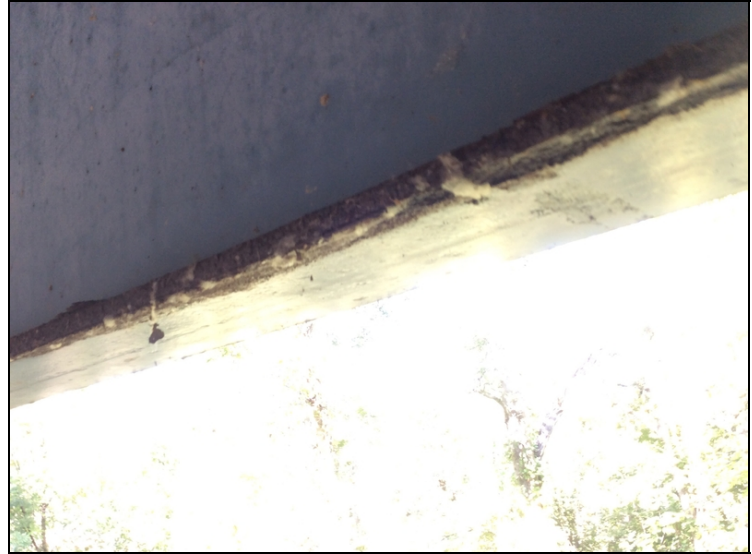
Rust with section loss to bottom flange of Girder 1
@ Span 13.

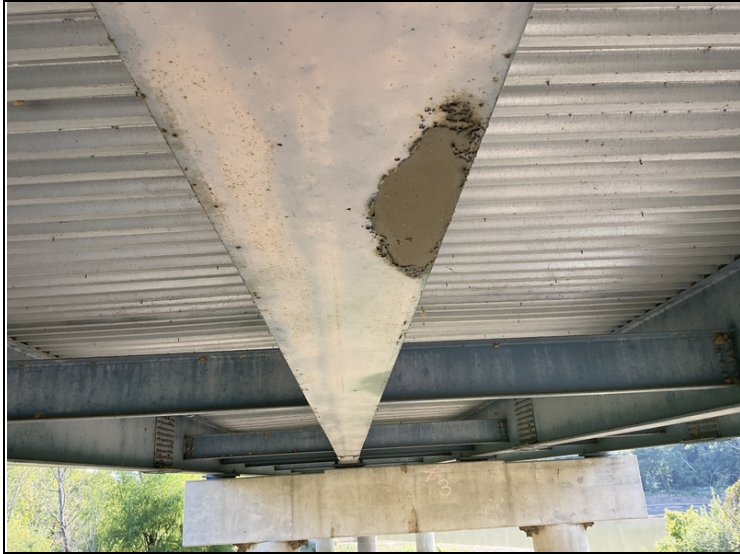
Paint is peeling with areas of surface rust on Girders at most spans.

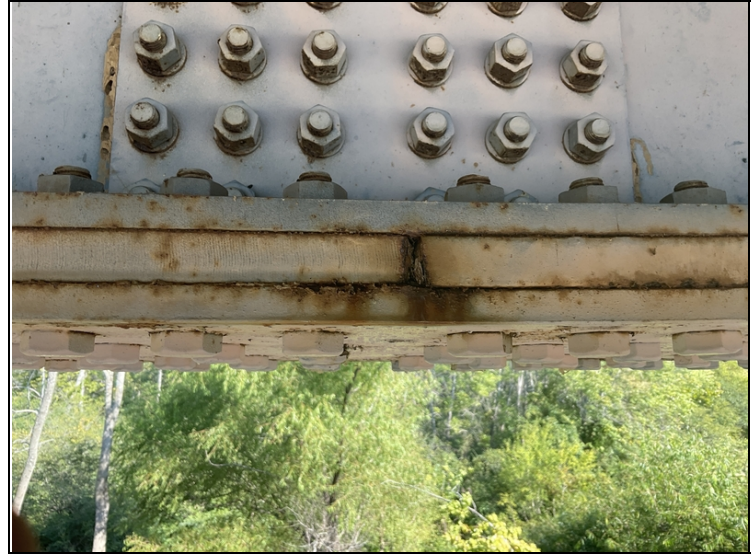
Pack Rust developing at bottom splice plates.

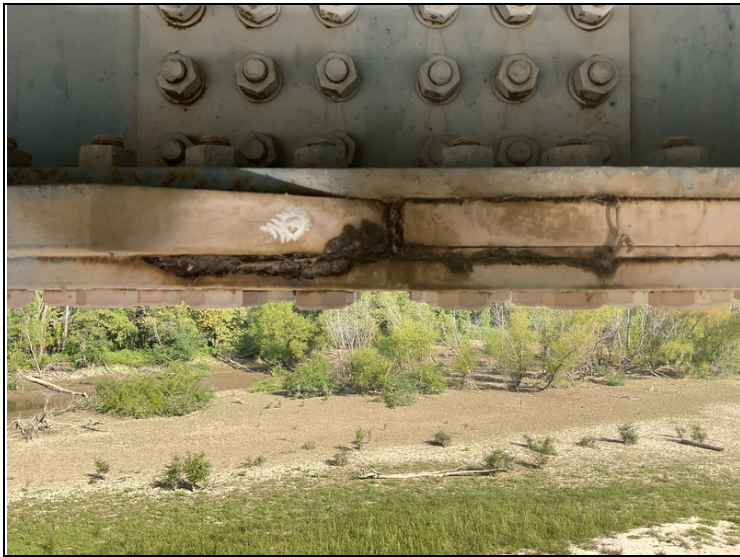
Pack Rust developing at bottom splice plates.
Girder 1 & 4, first splice plate @ span 7.

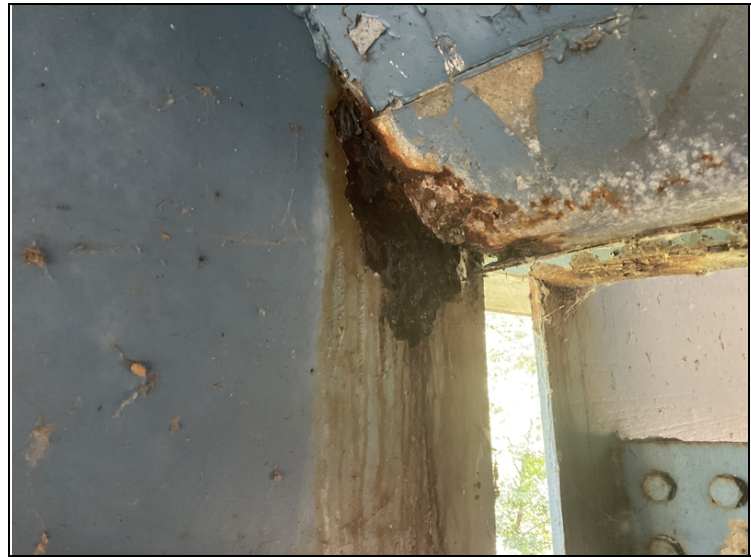
Rust with section loss to ends of girders at Spans
13, 17, 21 & 22.
Girder 1, bent 13.

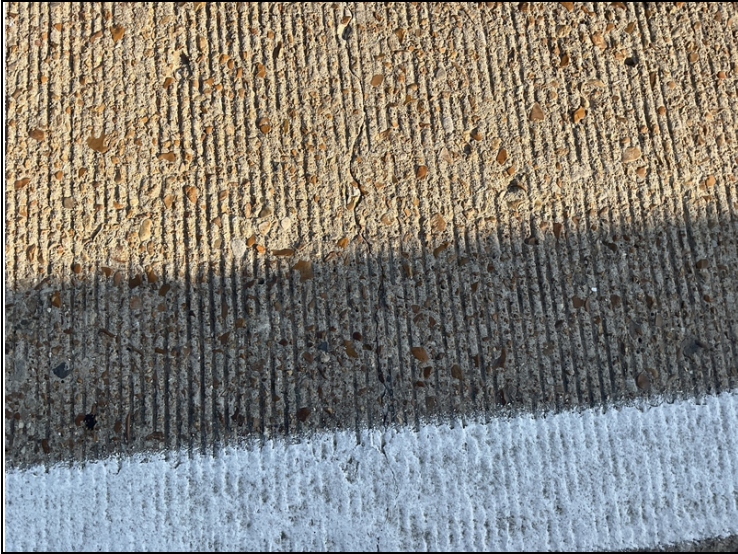
Deck
Unsealed cracks at all spans.

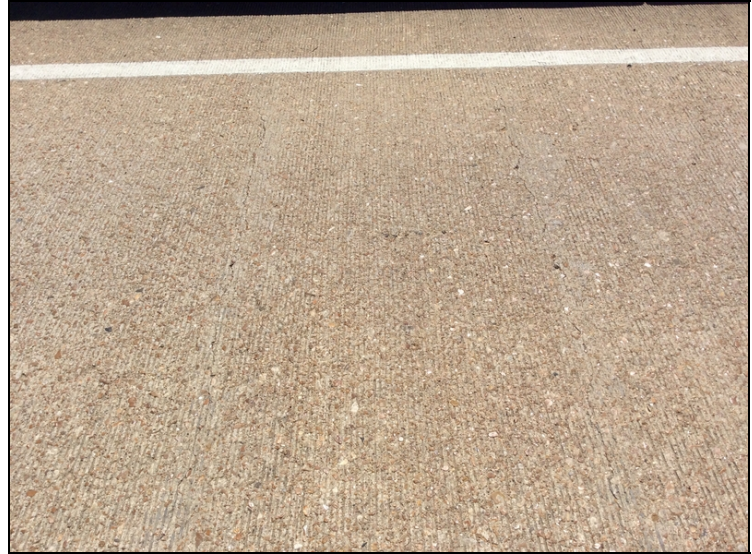
Unsealed transverse cracking to deck @ Span 8.

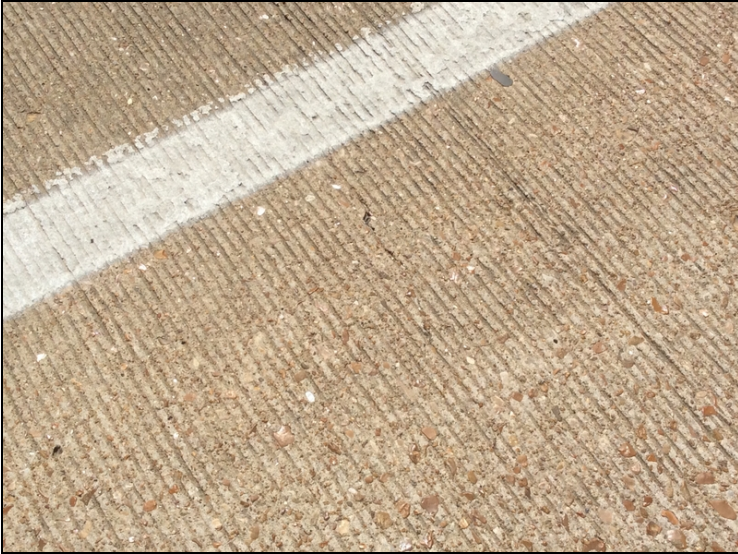
Unsealed transverse crack in deck @ Span 5.

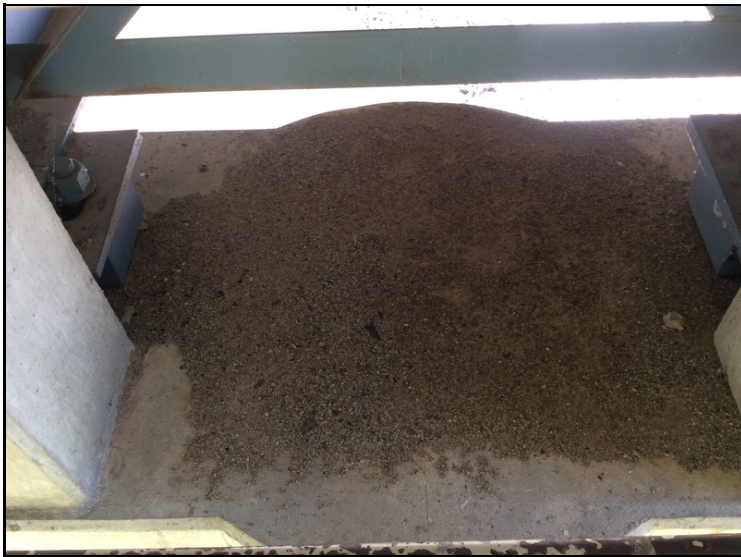
Debris on Cap @ Bent 5.

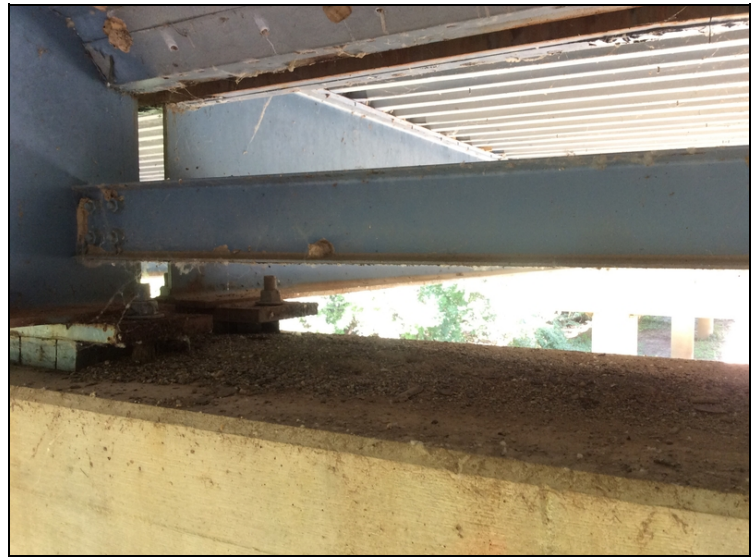
Debris on Cap @ Bent 17.

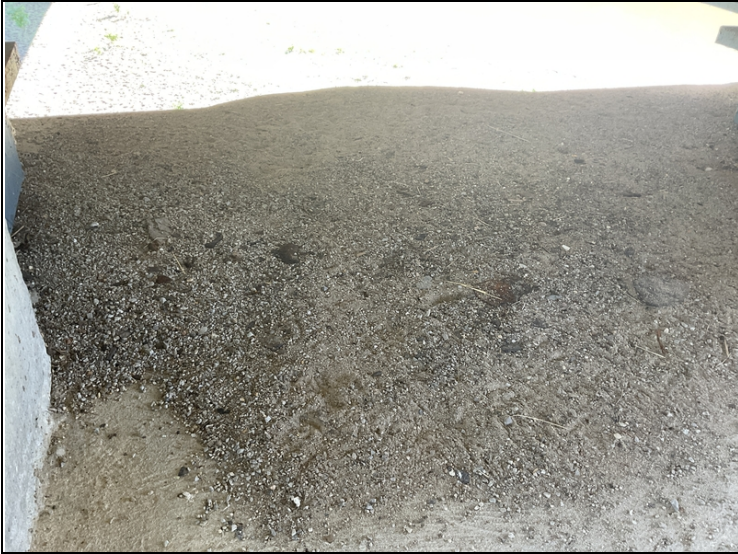
**Debri on Caps at Bents 5, 13, 17, 21 & Abutment 2.
Bent 5.**

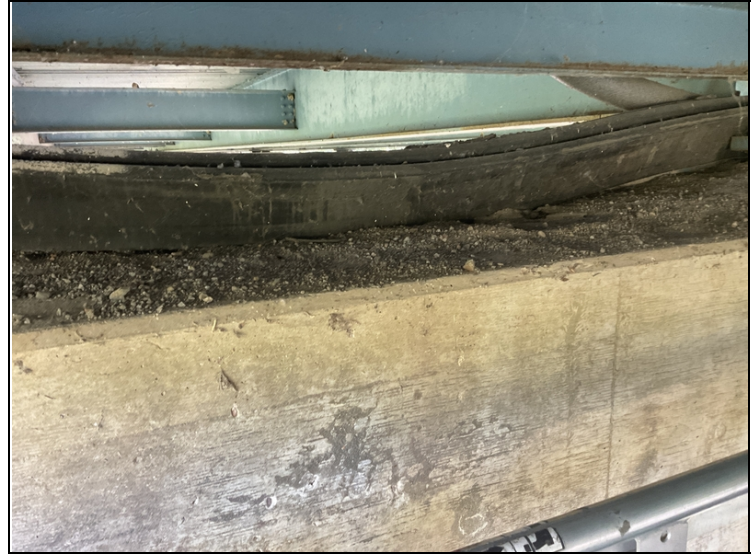
**Debri on Caps at Bents 5, 13, 17, 21 & Abutment 2.
Bent 13.**

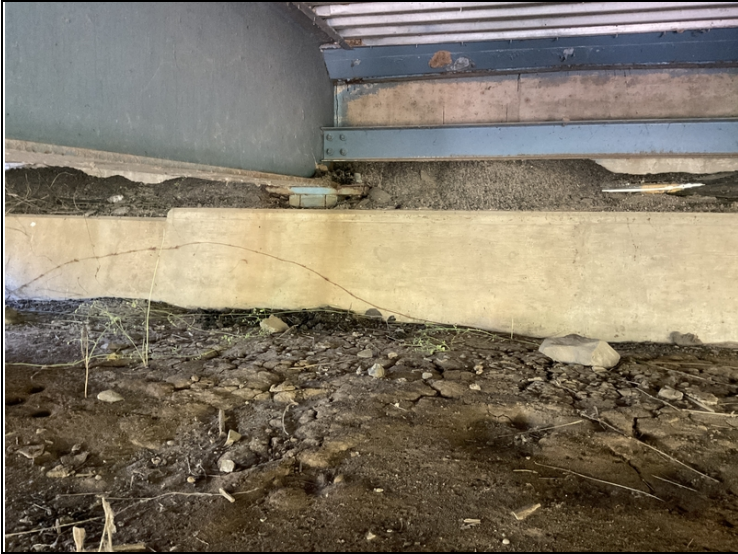
Debris on Caps at Bents 5, 13, 17, 21 & Abutment 2.
Abutment 2.

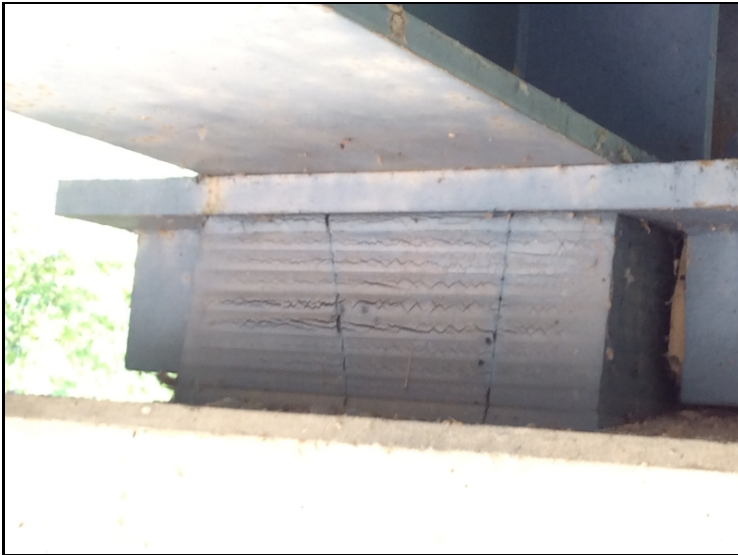
Cracking to Bearing 3 ahead @ Bent 5.

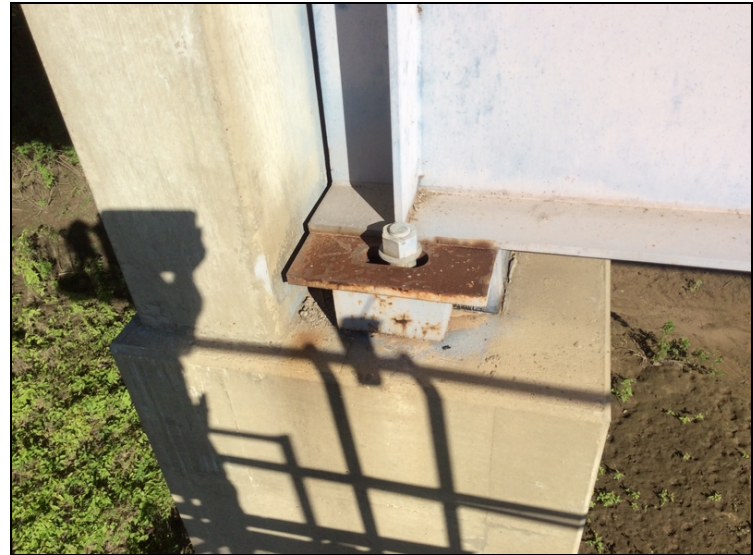
Rust to sole plate of Bearing 4 @ Bent 5 ahead.

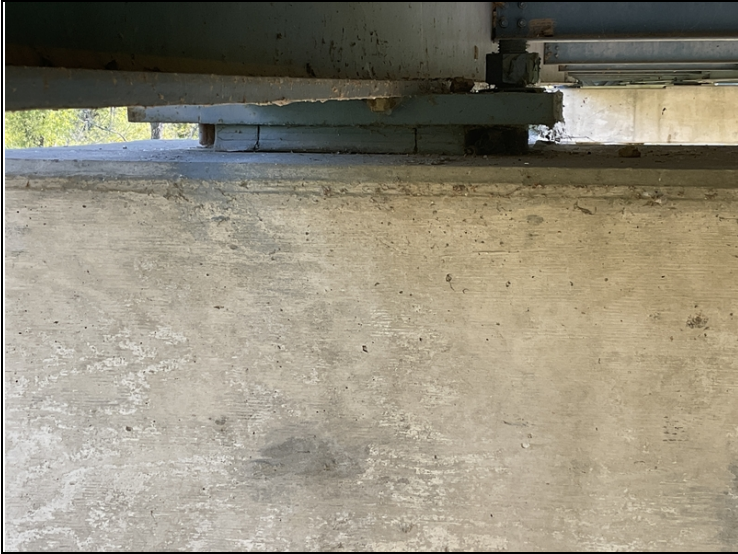
Cracks and deterioration to Elastomeric Bearings.

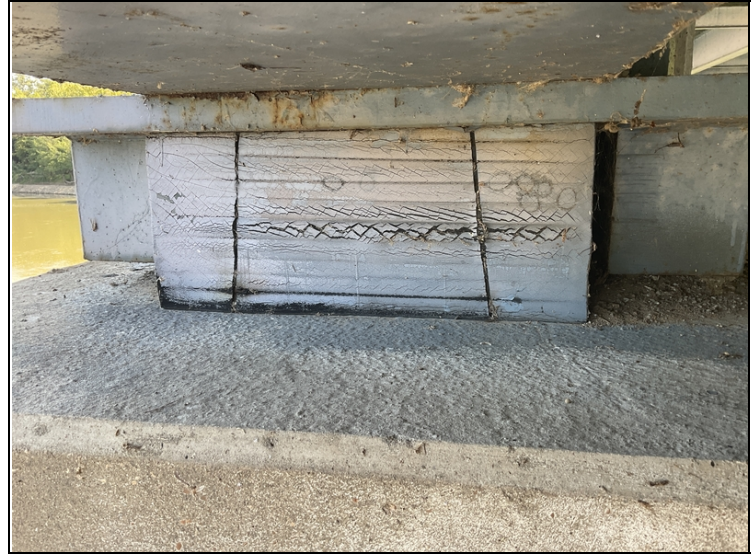
**Cracks and deterioration to Elastomeric Bearings.
Girder 1, bent 8.**

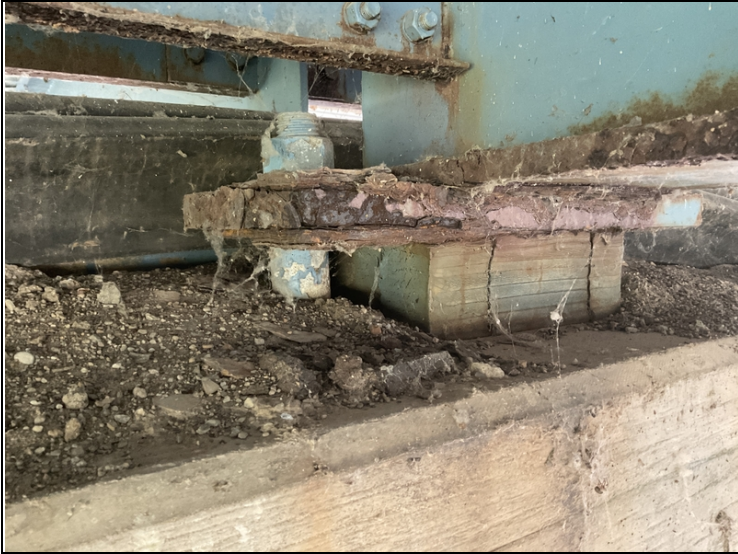
Rust to bearings and sole plates.
Girder 3, bent 13.

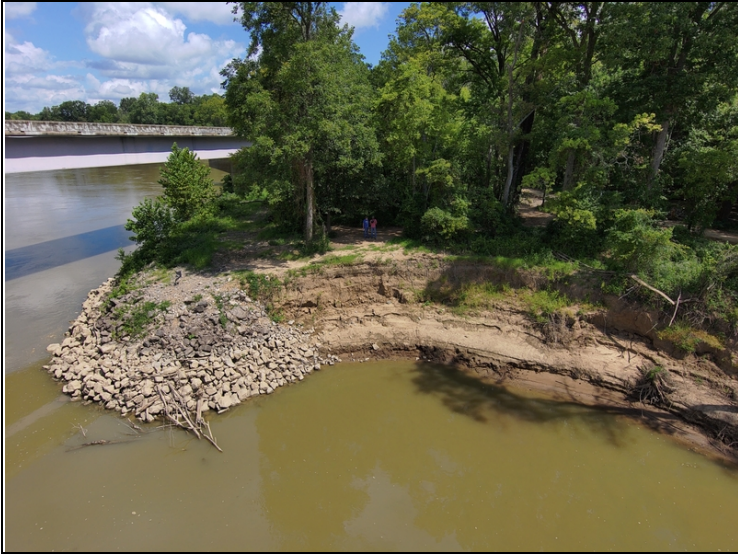
Erosion to rip rap repair.

Down stream Photo of erosion to embankment at the end of Rip Rap repair.

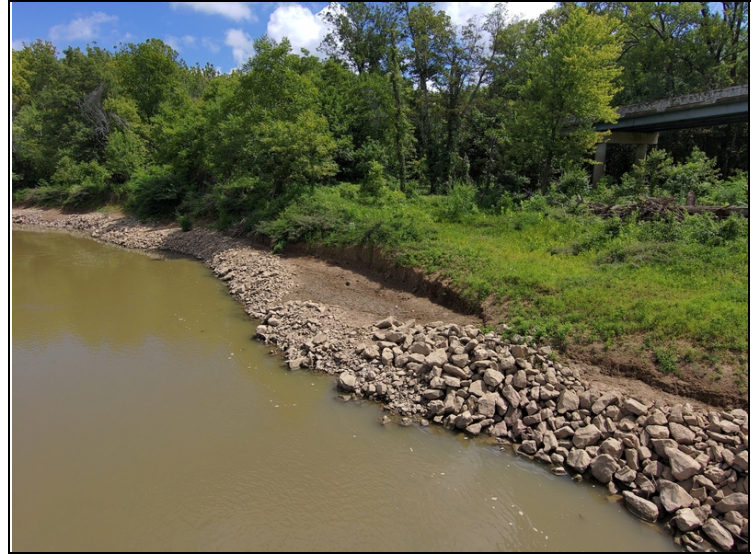
Erosion to rip rap repair.

Up stream photo of rip rap has slid down embankment causing erosion to slope.

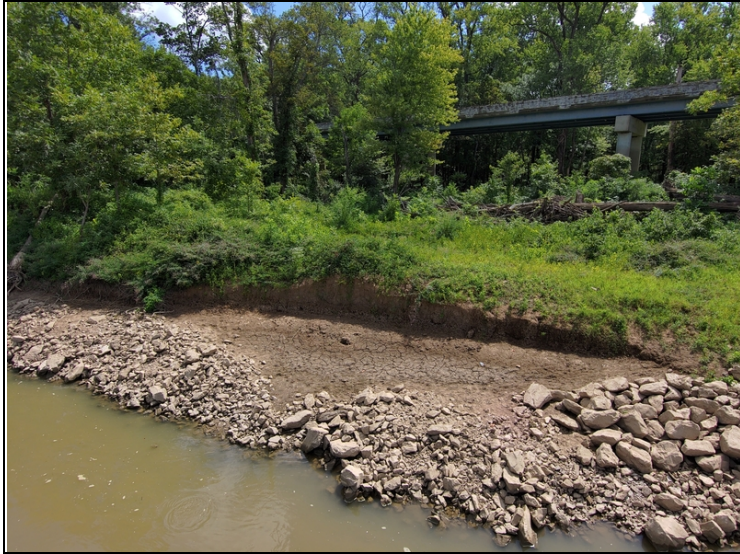
Erosion to rip rap repair.

Up stream photo of rip rap has slid down embankment causing erosion to slope.

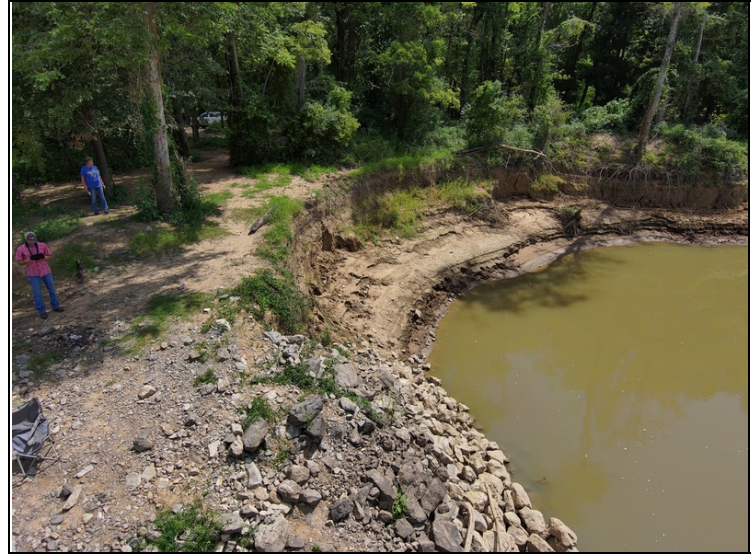
Erosion to rip rap repair.

Down stream Photo of erosion to embankment at the end of Rip Rap repair.
