**Asset #06838**(Routine, Underwater type 2)  
**SH 69/Indepen Co. over CREEK / LONG SLOUGH**

**Location: 6.6 MI E JCT SH 122 & 69**

**Team Lead: Kerry Little, Inspection Date: 09/06/2022**

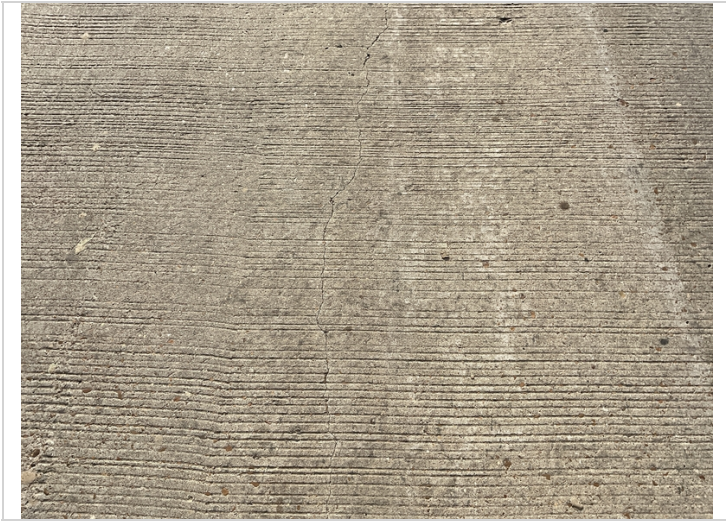
(12) Several sealed & unsealed cracks @ all spans. Minor efflorescent cracking to Left & Right overhangs.							
107	Steel Open Girder/Beam	LF	875	875	0	0	0
515	Steel Protective Coating	SF	7315	7315	0	0	0
215	Reinforced Concrete Abutment	LF	126	113	13	0	0
1120	Efflorescence/Rust Staining	LF	4	0	4	0	0
1130	Cracking (RC and Other)	LF	9	0	9	0	0

Typical cracks to deck @ all spans.

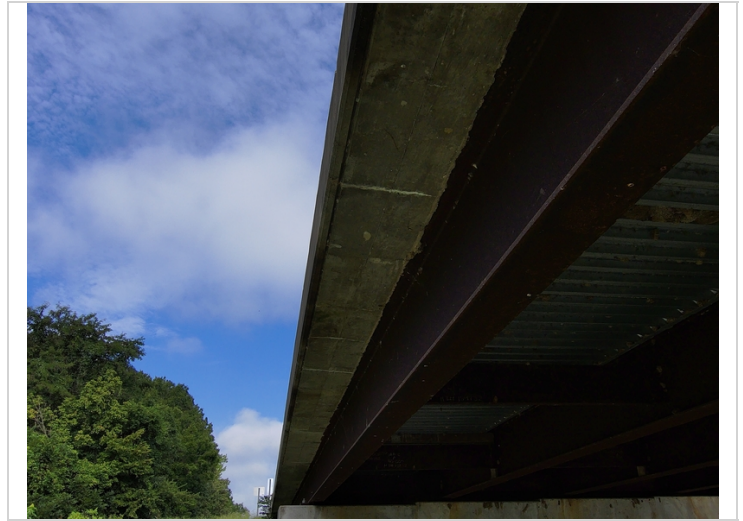
Typical efflor cracks to Lt & Rt overhangs.

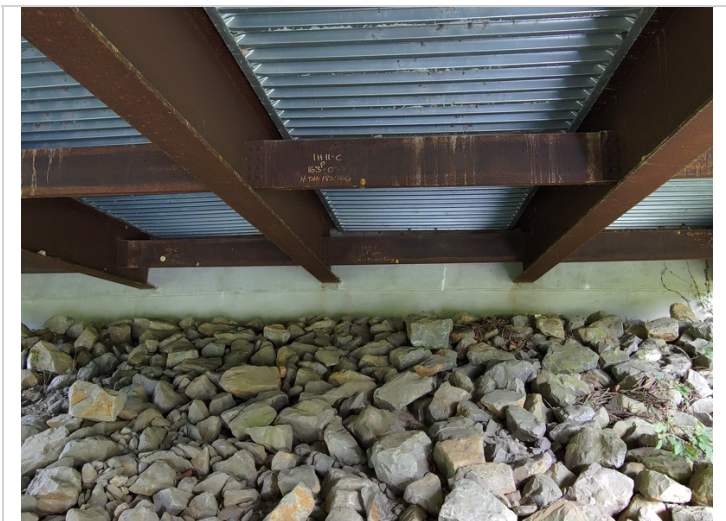
(215) 3 vertical efflorescent cracks to Abutment 1. 1 vertical efflorescent crack to Abutment 2. Vertical cracking to Abutments.							
229	Other Pile	EA	12	11	1	0	0
6000	Scour	EA	1	0	1	0	0

Efflor cracks to abutments 1 & 2.
