Asset #06839(Routine)

SH 69/Independ Co. over MUD CREEK

Location: 0.8 MI. E JCT. SH 122&69

Team Lead: Kerry Little, Inspection Date: 11/15/2021

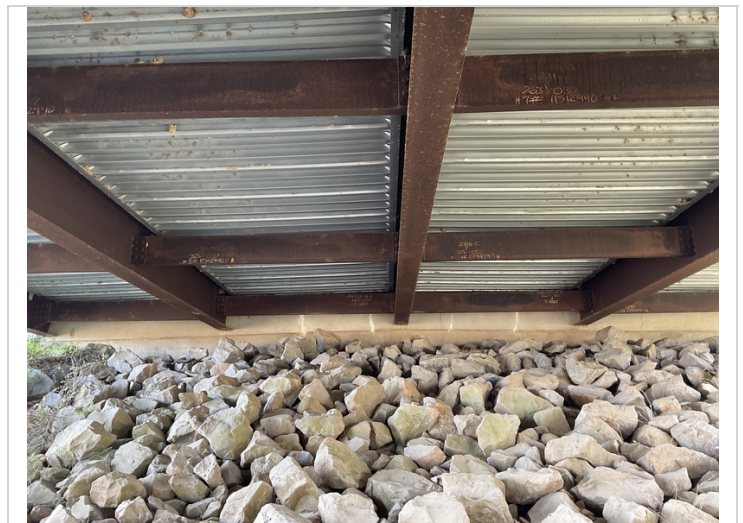
Overall deck below @ span 3.

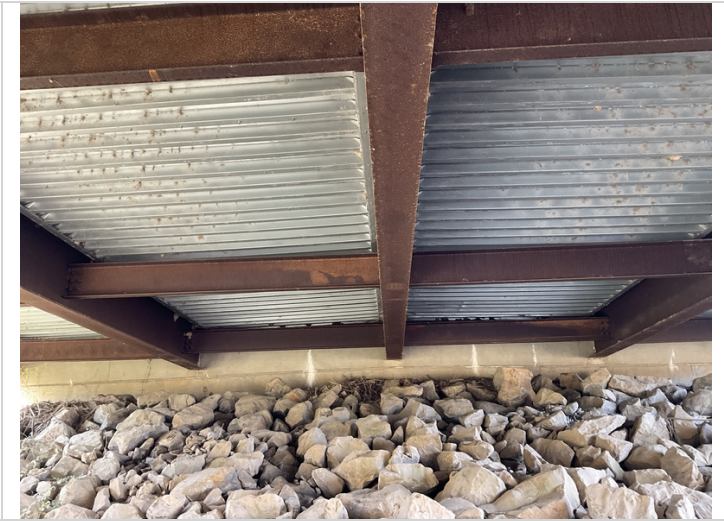
Overall soffit @ span 1.

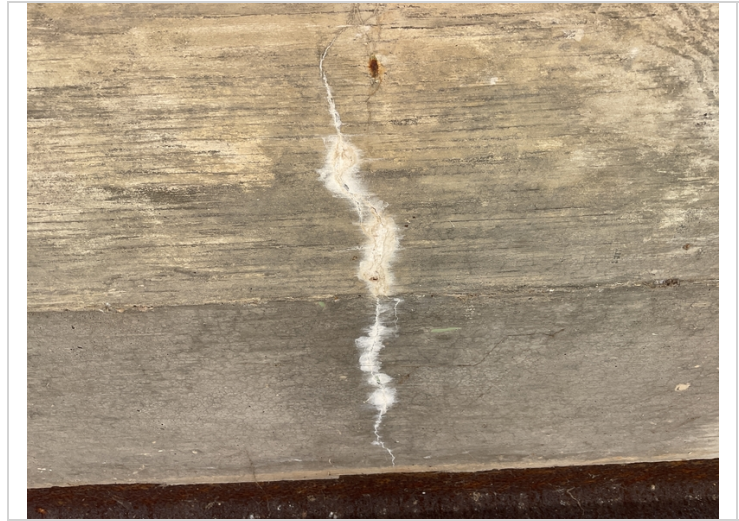
(12) Unsealed cracks to deck @ Spans 1 - 3. Efflorescent cracks to the overhangs.							
107	Steel Open Girder/Beam	LF	525	525	0	0	0
515	Steel Protective Coating	SF	3271	3271	0	0	0
215	Reinforced Concrete Abutment	LF	126	116	10	0	0
1120	Efflorescence/Rust Staining	LF	10	0	10	0	0

Typical efflor cracks to Lt & Rt overhangs.

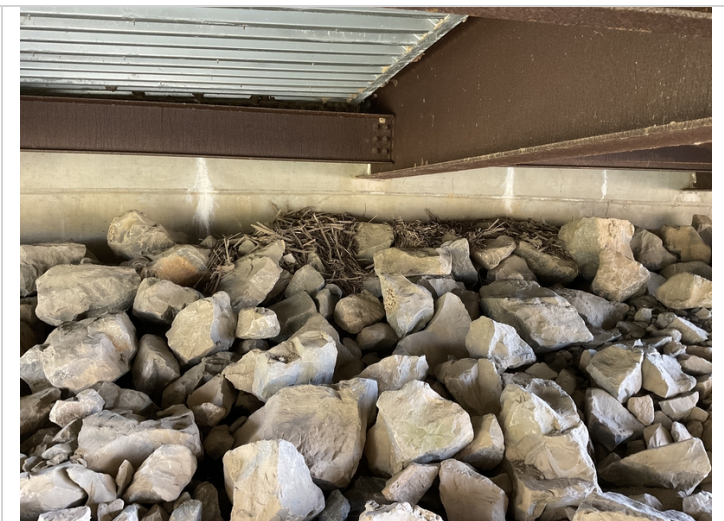
(215) 6 efflorescent cracks to Abutment 1. 4 efflorescent cracks to Abutment 2.							
225	Steel Pile	EA	12	12	0	0	0
515	Steel Protective Coating	SF	456	456	0	0	0
234	Reinforced Concrete Pier Cap	LF	86	80	3	3	0
1080	Delamination/Spall/Patched Area	LF	6	0	3	3	0
313	Fixed Bearing	EA	10	10	0	0	0
515	Steel Protective Coating	SF	20	20	0	0	0
321	Reinforced Concrete Approach Slab	SF	1752	1672	80	0	0
1130	Cracking (RC and Other)	SF	80	0	80	0	0

Typical efflor cracks to abutments 1 & 2.

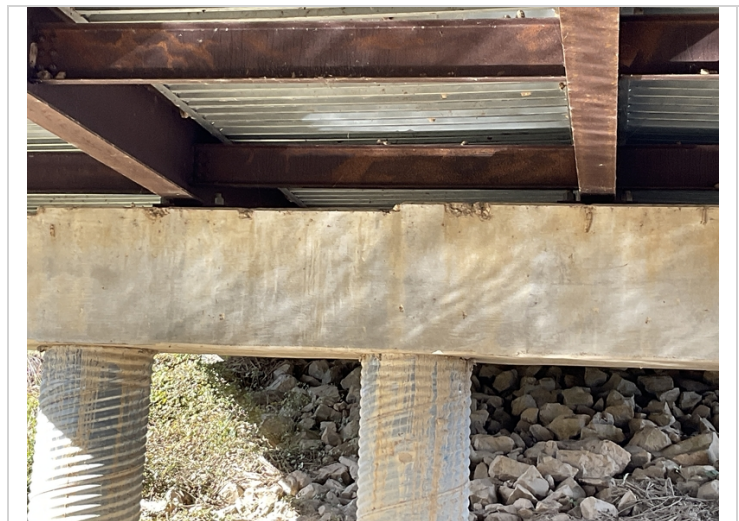
Minor spalls to ahead side of cap @ bent 1.

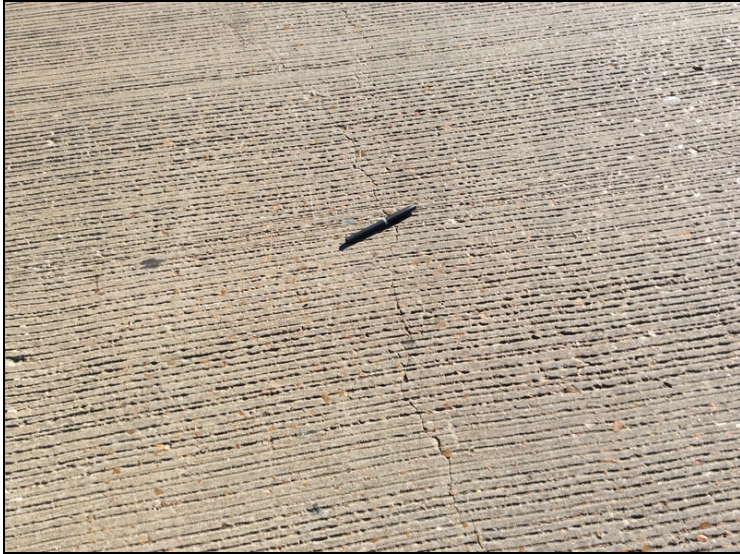
Unsealed cracks to deck @ Spans 1 - 3.

Typical deck cracking.

Date Reported: 11/12/2015
Priority: D- Routine
Type of Work: Repair (General)
Status: Monitor
Component:

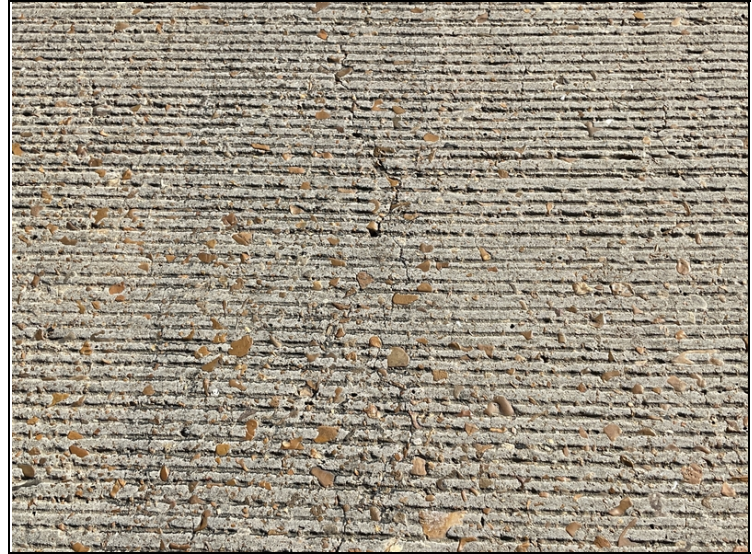
Unsealed cracks to deck @ Spans 1 - 3.

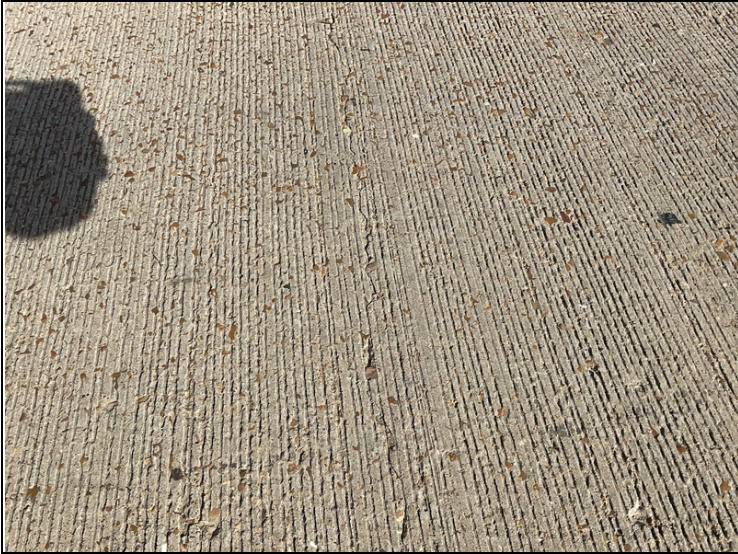
Unsealed cracks to deck @ Spans 1 - 3.
