Asset #06874(Routine)

SH 226/Jackson Co. over VILLAGE CREEK

Location: 3.48 MI. E. JCT. US. 67

Team Lead: Kerry Little, Inspection Date: 01/11/2022

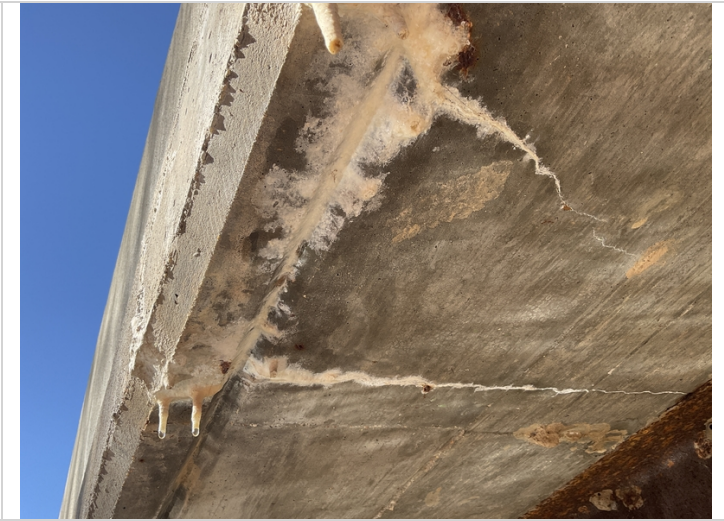
(12) Efflorescent cracks to outside edge of Deck over bents & to Left & Right overhangs. Several unsealed transverse & longitudinal cracks to deck @ all spans.							
107	Steel Open Girder/Beam	LF	1980	1980	0	0	0
515	Steel Protective Coating	SF	14989	14989	0	0	0
215	Reinforced Concrete Abutment	LF	130	123	7	0	0
1120	Efflorescence/Rust Staining	LF	7	0	7	0	0

Typical efflor cracks to Lt & Rt overhangs.

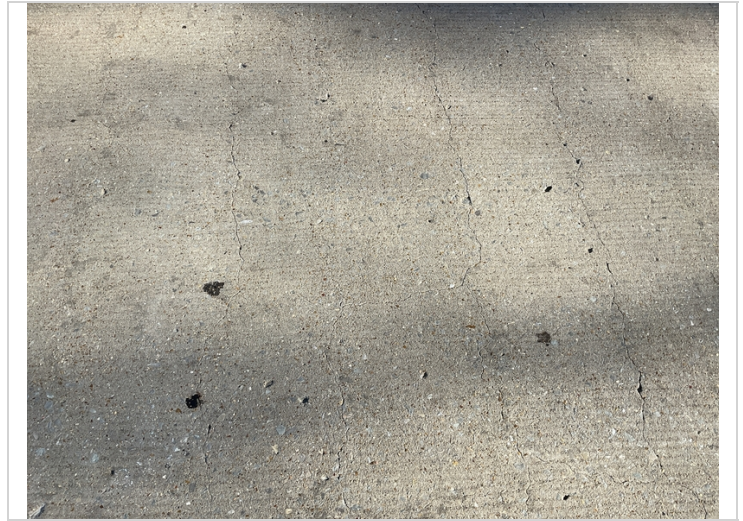
Typical cracks to deck @ all spans.

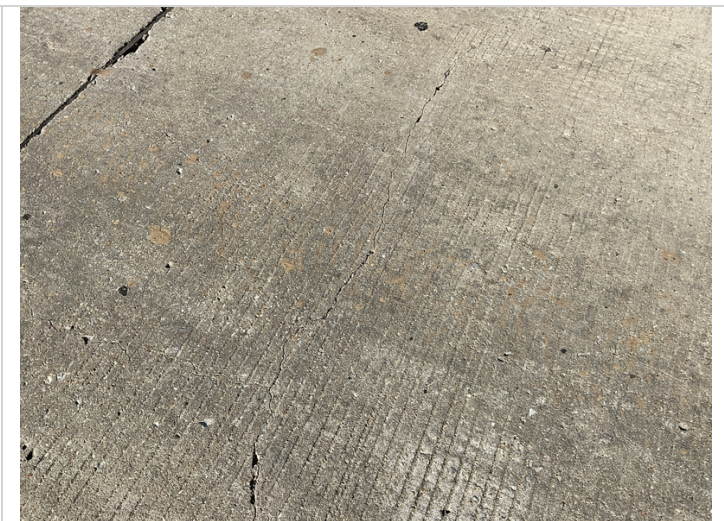
(310) Add protective coating.							
321	Reinforced Concrete Approach Slab	SF	1776	1536	170	70	0
1130	Cracking (RC and Other)	SF	240	0	170	70	0
(321) Unsealed longitudinal & transverse cracks to Approach Slabs @ Abutments 1 & 2.							
New Approach Slab quantity: 1776							
331	Reinforced Concrete Bridge Railing	LF	664	664	0	0	0

Typical cracks to approach slabs @ abutments 1 & 2.

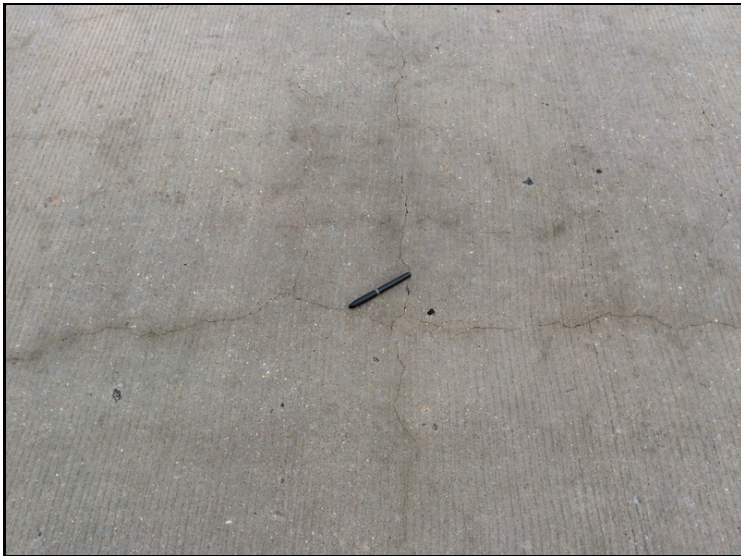
Several transverse and longitudinal unsealed cracks to all spans.

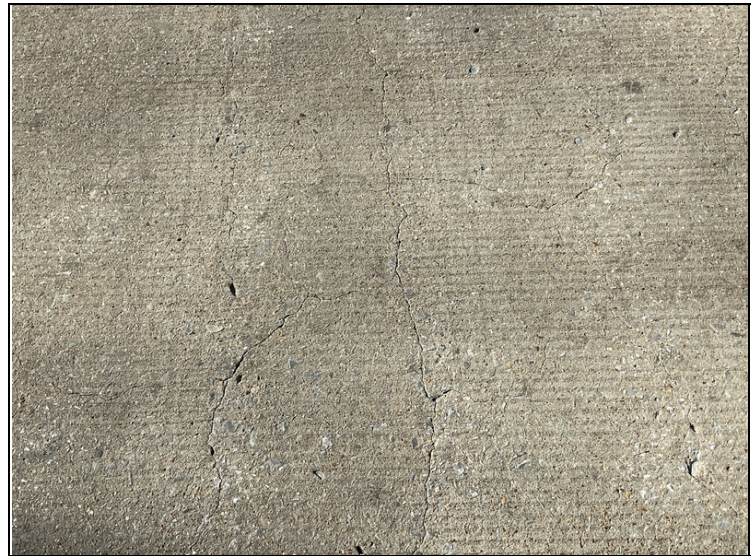
Deck all Spans.
Several Transverse and Longitudinal unsealed cracks to all spans

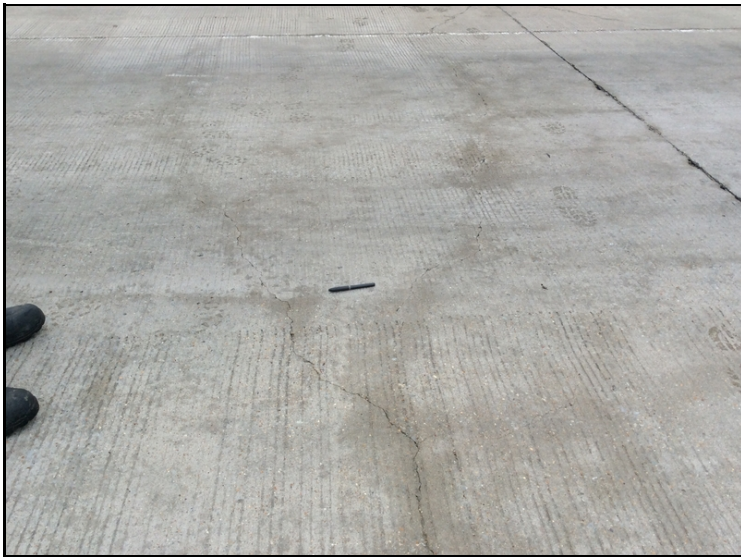
Approach Slabs @ Abutments 1 & 2
Several Transverse and Longitudinal unsealed cracks

Unsealed cracks to Approach Slab @ Abutment 1.

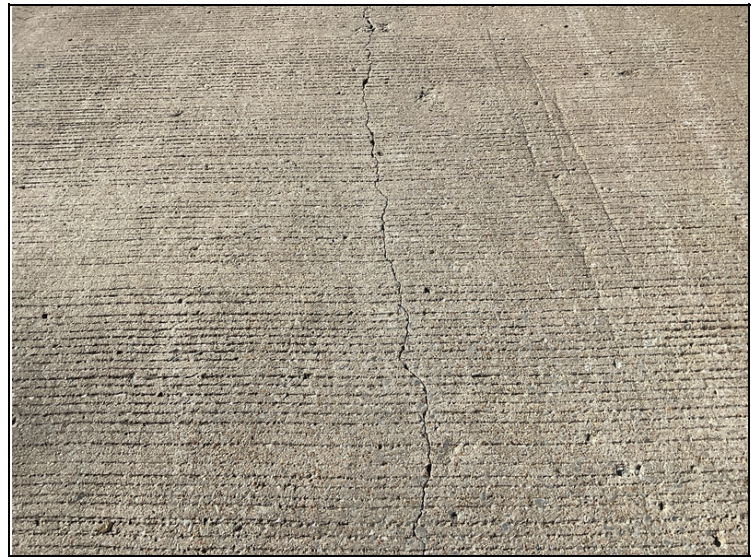
Approach Slabs @ Abutments 1 & 2
Several Transverse and Longitudinal unsealed
cracks

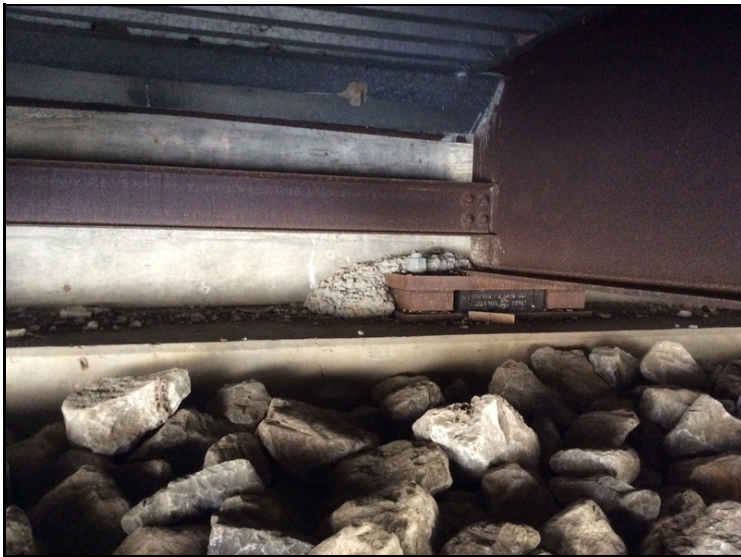
End of Girder 4 @ Abutment 2.

End of Girder 4 @ Abutment 2
Large concrete spill on cap, between bearing pad and backwall is restricting expansion.

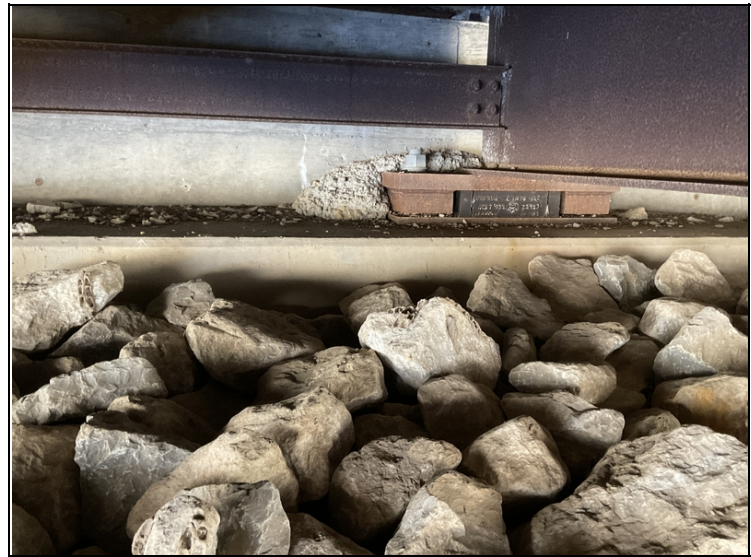
End of Girder 4 @ Abutment 2
Large concrete spill on cap, between bearing pad and backwall is restricting expansion.

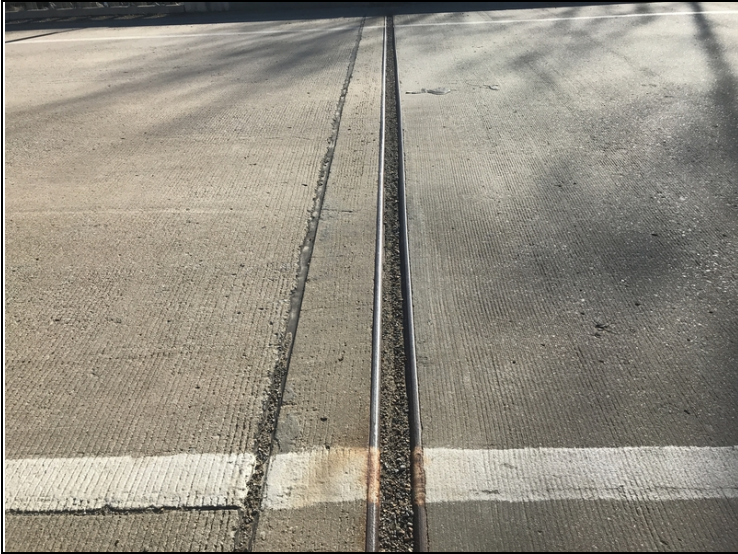
(302) Debris in joints @ Abutments 1 & 2.							
(2350-302) Debris impaction to Abutments 1 & 2.							
310	Elastomeric Bearing	EA	49	49	0	0	0
515	Steel Protective Coating	SF	98	98	0	0	0

Debris in compression joint seal @ Abutment 1.

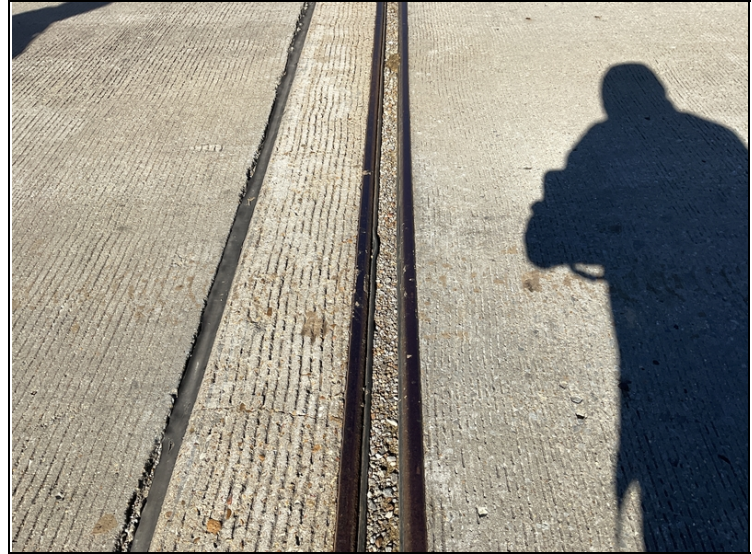
Debris impactation to compression joint seal @
Abutments 1 & 2.
Abutment 1.

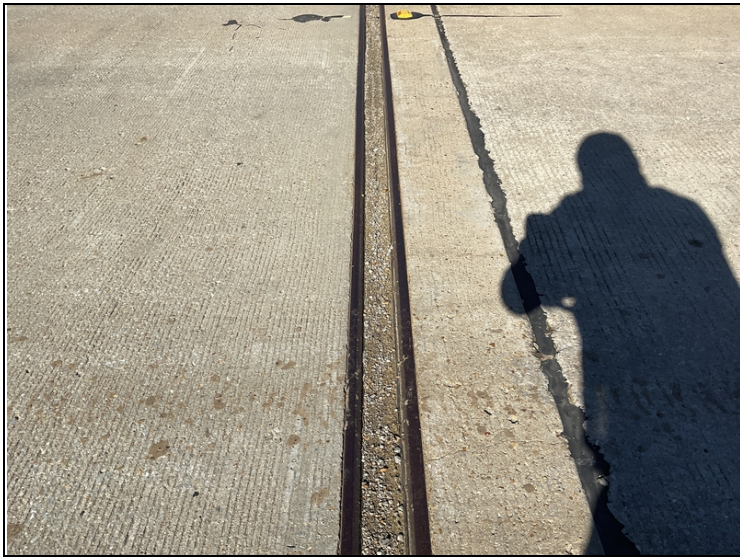
Debris impaction to compression joint seal @
Abutments 1 & 2.
Abutment 2.
