Asset #M0147(Routine)

SH 5/Cleburne Co. over WATERWAY

Location: 0.92 MI NO OF WHITE CO LI

Team Lead: Kerry Little, Inspection Date: 05/31/2022

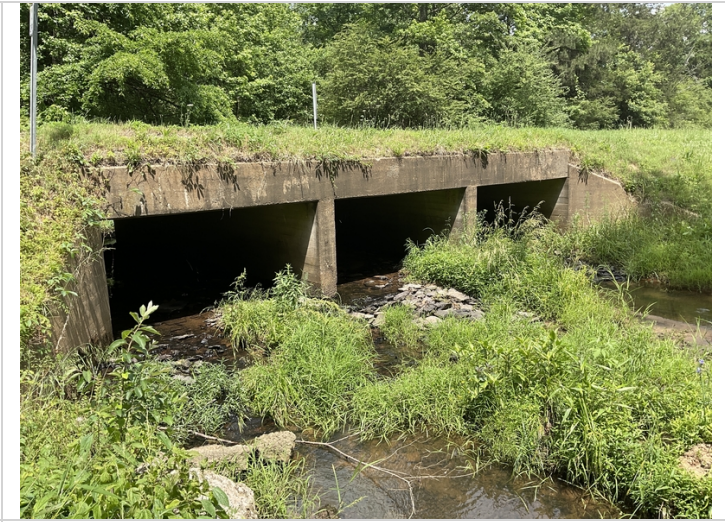
Elevation with log mile going right.

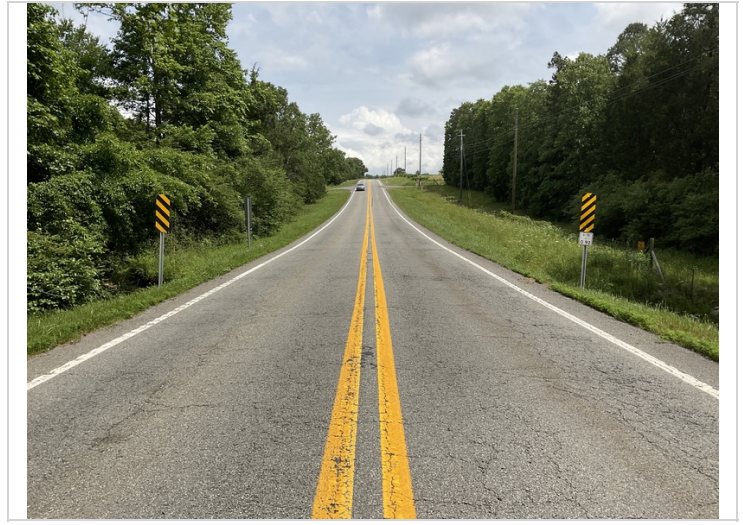
Roadway with log mile looking north.

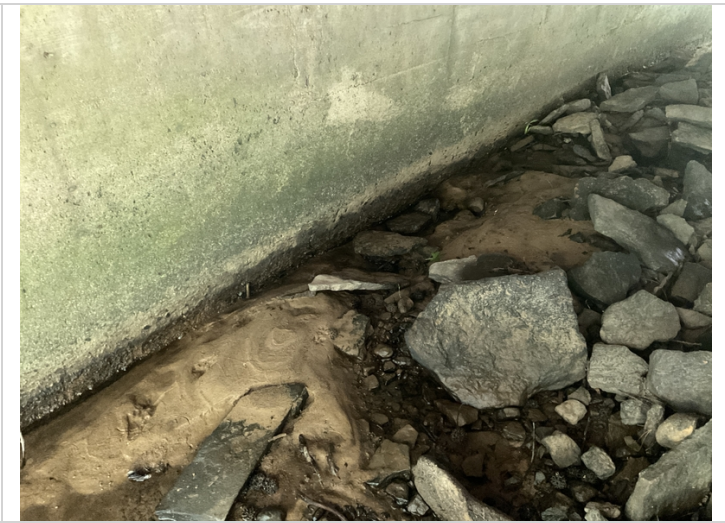
ELEMENTS	DESCRIPTION	UNITS	TOTAL	CS1	CS2	CS3	CS4
241	Reinforced Concrete Culvert	LF	99	3	15	81	0
1090	Exposed Rebar	LF	6	0	6	0	0
1130	Cracking (RC and Other)	LF	9	0	9	0	0
1190	Abrasion/Wear (PSC/RC)	LF	81	0	0	81	0
(241) Heavy scaling to bottom of wall at Abutment 1. Heavy scaling to floor at Barrel 2. Minor debris in all barrels. Minor scour to Right end of Barrels 2 & 3. (on solid rock) Light to moderate scaling to wall at Abutment 2. Large spall to Right wing @ Abutment 2. Spall with 8" of exposed rebar to left end of Barrel 1. Spall with 5' of exposed rebar to floor of Barrel 2(covered with sediment at time of this inspection). Minor vertical cracks to barrels 1 - 3.

Typical abrasion to bottom of walls @ all barrels.

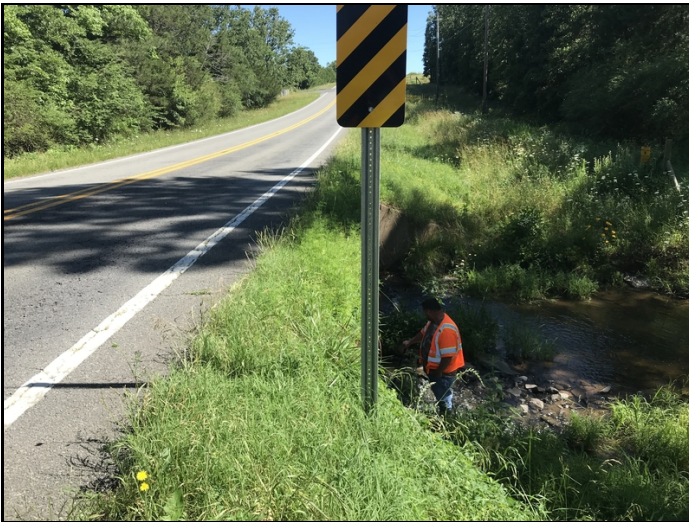
Log Mile sign is missing @ Abutment 1. Should read 0.92.

Log Mile sign is missing @ Abutment 1. Should read 0.92.
Repaired.

Has been repaired since last insp.

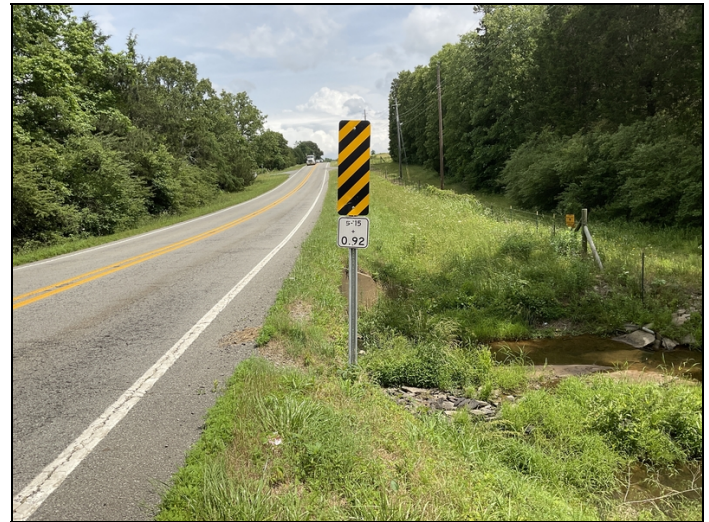
Log Mile sign is missing @ Abutment 1. Should read 0.92.
Repaired.
