Asset #06804(Routine, Underwater type 2)

US 63/Fulton Co. over Field Creek

Location: 3.30 Miles S. Mo. State

Team Lead: Kerry Little, Inspection Date: 09/27/2022

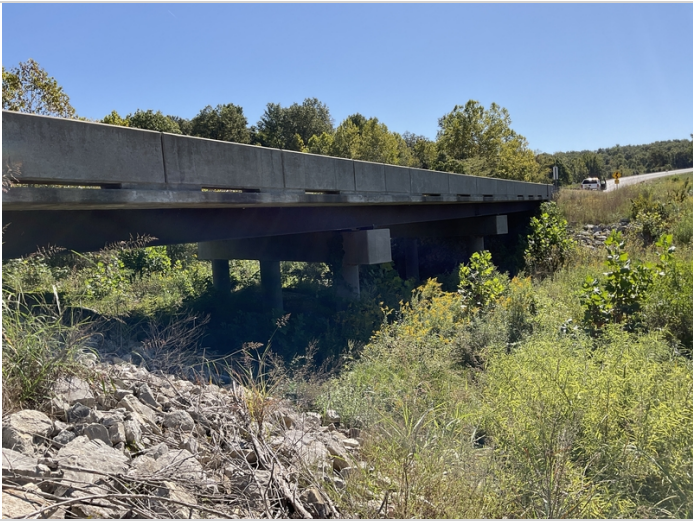
Elevation with log mile going right.

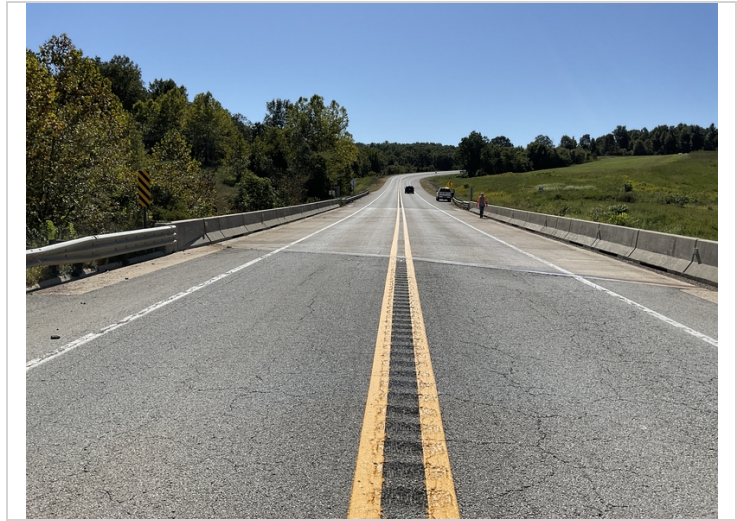
Roadway with log mile looking south.

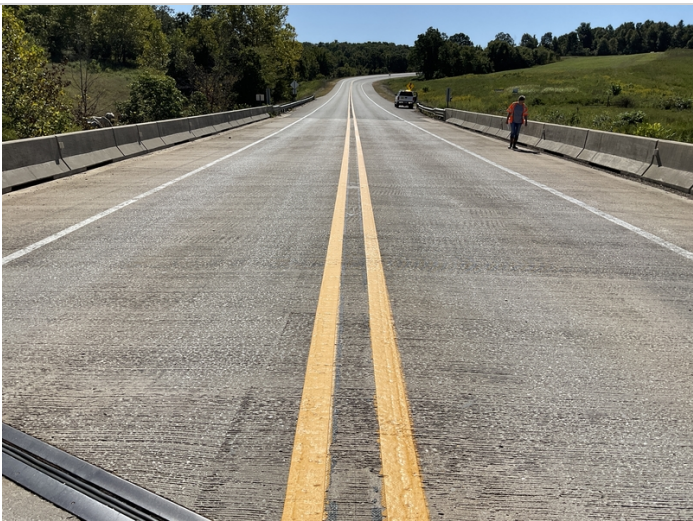
Overall deck.

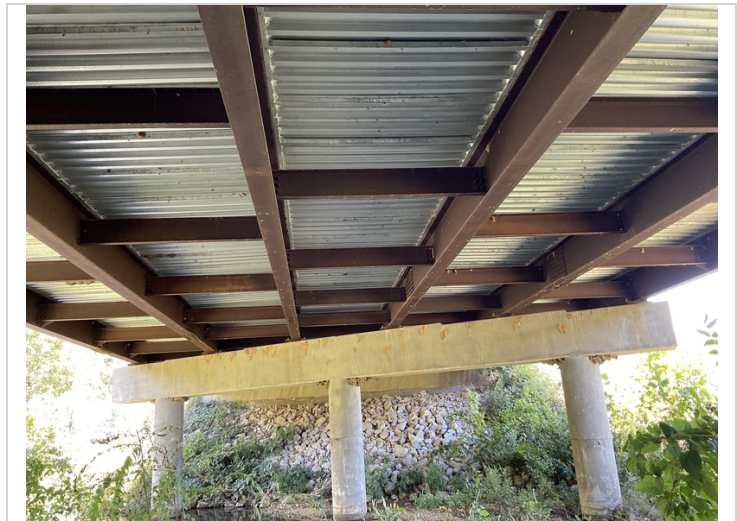
Overall soffit @ span 2.

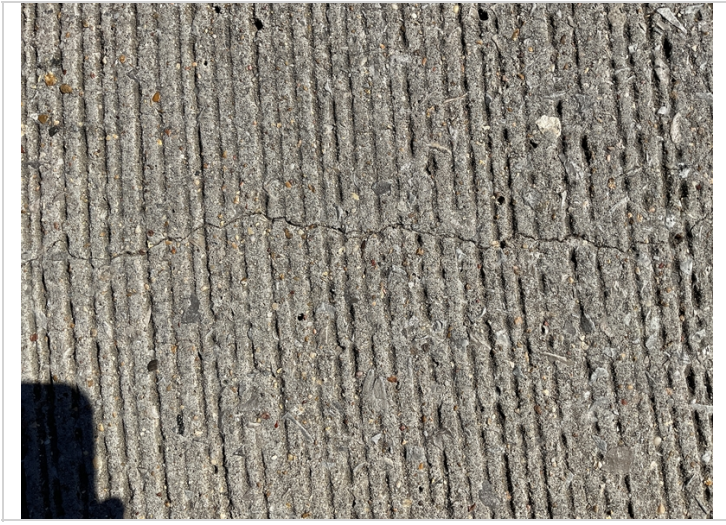
(12) Efflorescent cracking to Left & Right overhangs. Transverse & longitudinal cracking to deck @ all spans.							
107	Steel Open Girder/Beam	LF	780	780	0	0	0
515	Steel Protective Coating	SF	4750	4750	0	0	0
205	Reinforced Concrete Column	EA	6	6	0	0	0
215	Reinforced Concrete Abutment	LF	139	129	10	0	0
1120	Efflorescence/Rust Staining	LF	10	0	10	0	0

Typical cracks to deck @ all spans.

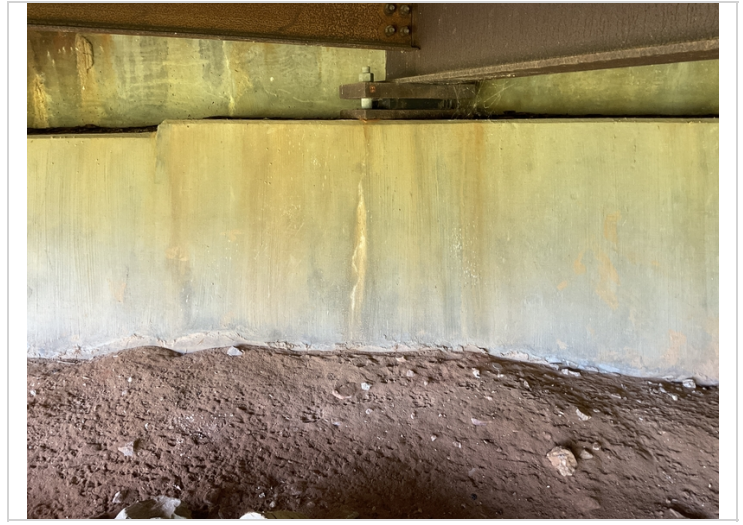
(215) Minor vertical efflorescent cracking to back walls @ Abutments 1 & 2.							
234	Reinforced Concrete Pier Cap	LF	95	95	0	0	0
302	Compression Joint Seal	LF	99	99	0	0	0
310	Elastomeric Bearing	EA	24	24	0	0	0
331	Reinforced Concrete Bridge Railing	LF	265	156	108	1	0
1080	Delamination/Spall/Patched Area	LF	1	0	0	1	0
1120	Efflorescence/Rust Staining	LF	32	0	32	0	0
1130	Cracking (RC and Other)	LF	76	0	76	0	0

Typical efflor cracks to @ abutment 1 & 2.

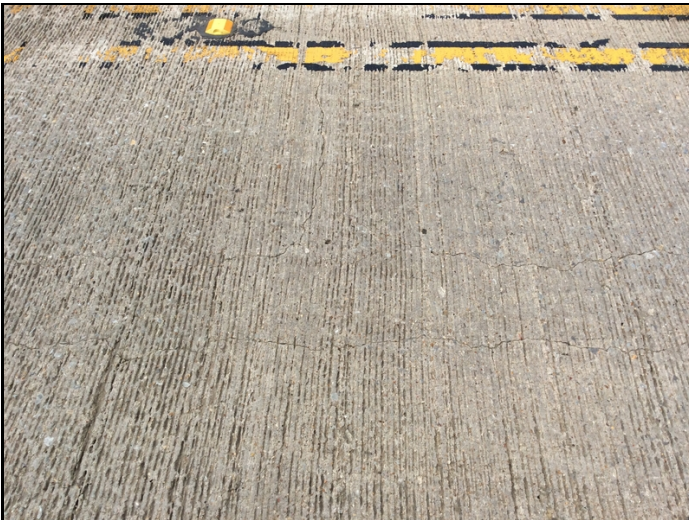
Deck at all Spans
Several longitudinal and a few transverse unsealed cracks.

Transverse @ longitudinal cracking to deck @ Span 2.

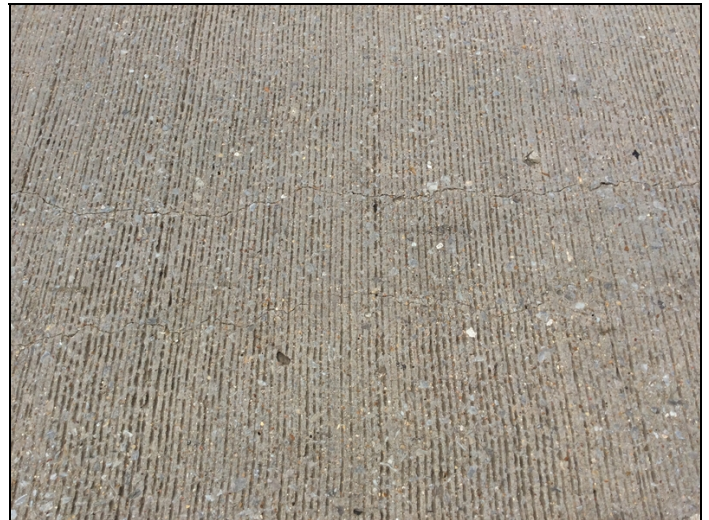
Longitudinal cracking to deck @ Span 1.

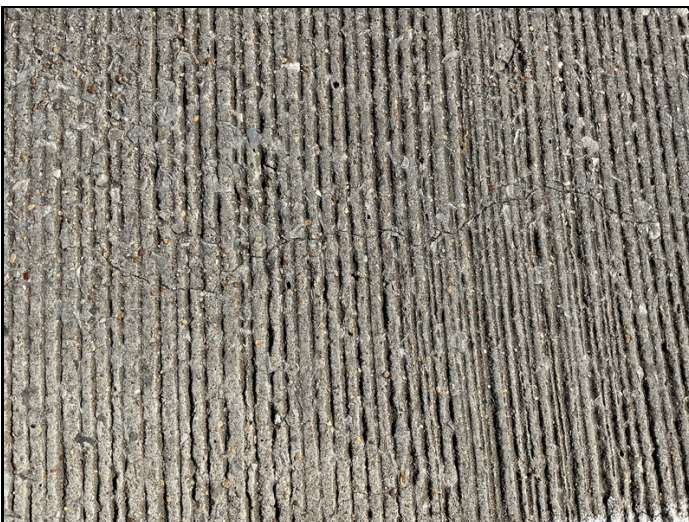
Deck at all Spans
Several longitudinal and a few transverse unsealed cracks.

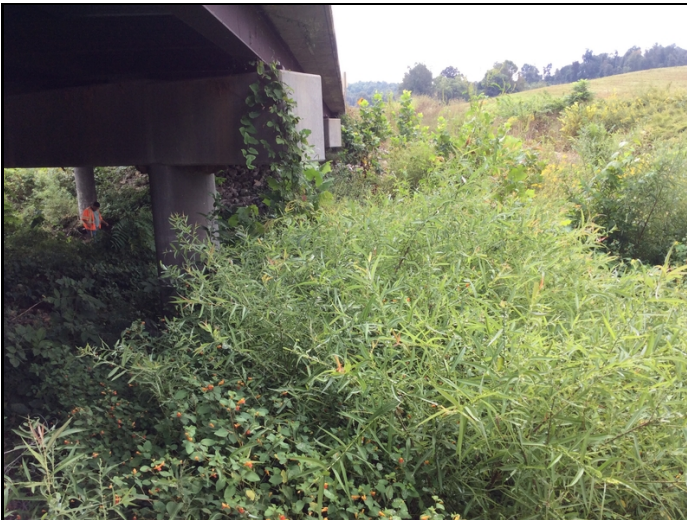
Vegetation growing around and under structure restricting flow and access.

Vegetation on Right side of bridge.

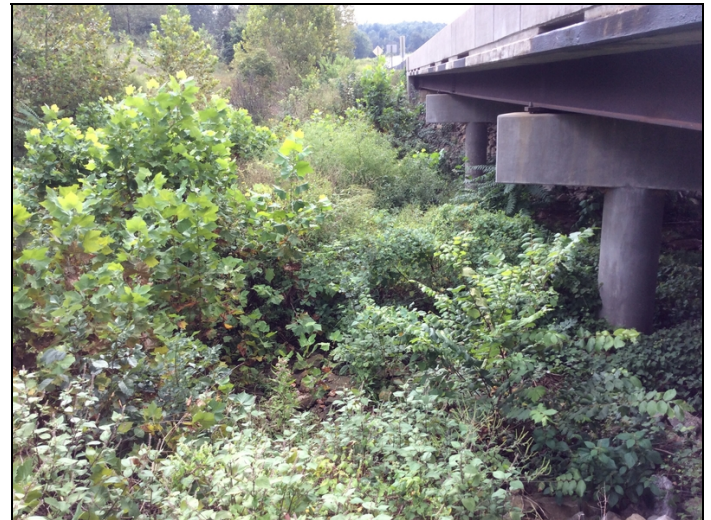
Vegetation on Left side of bridge.

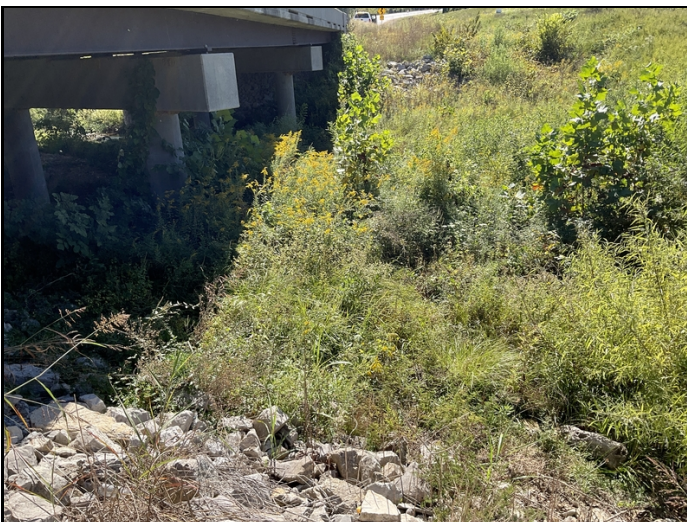
Channel

Vegetation growing around and under structure restricting flow and access.
