Asset #06805(Routine, Underwater type 2)

US 63/Fulton Co. over Big Creek

Location: 5.6 Miles S Mo.State Line

Team Lead: Kerry Little, Inspection Date: 09/27/2022

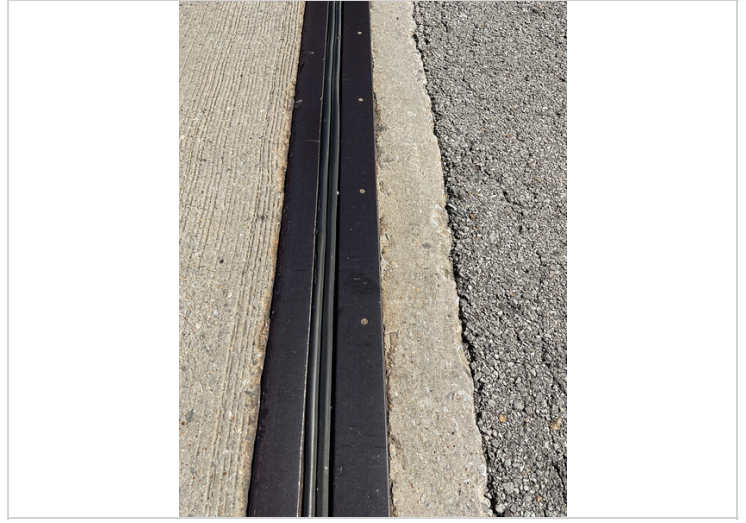
Cracking/tear to joint seal @ Abut. 2.

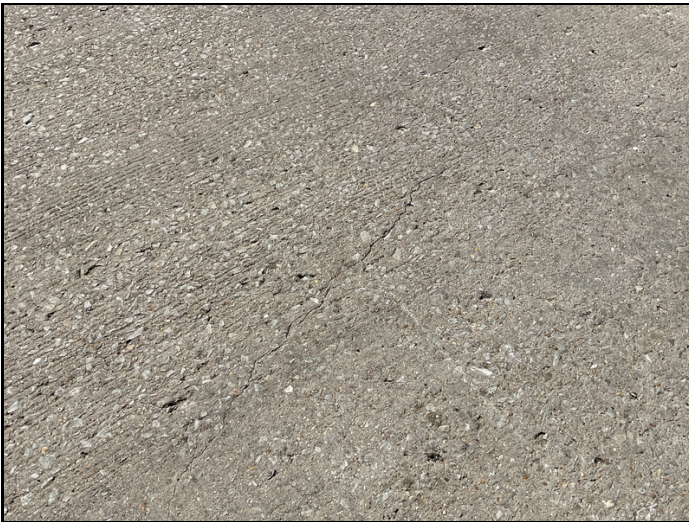
Deck at all spans  
Few longitudinal and transverse unsealed cracks.

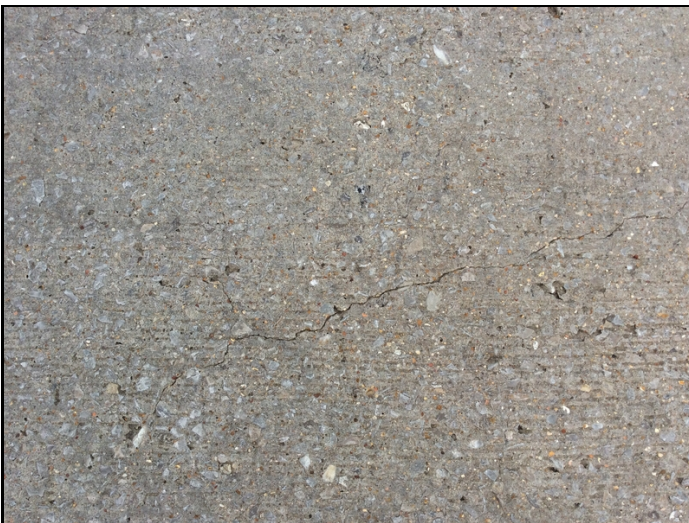
Transverse cracking to deck @ Span 1.

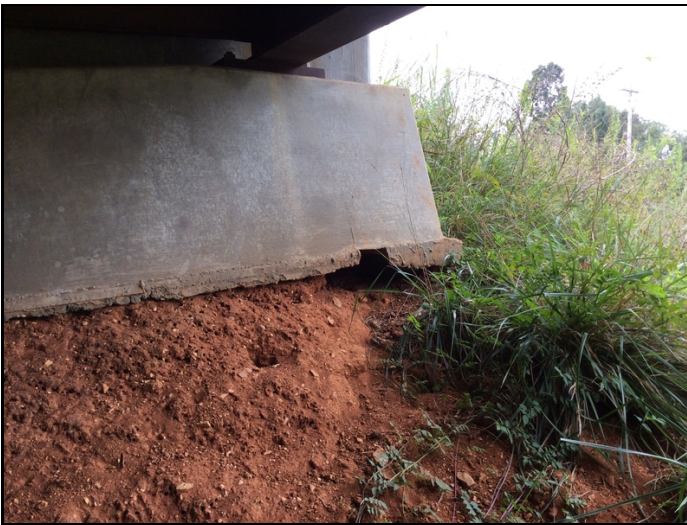
Abutment 2 has erosion to Left and Right ends.

Scour to Right end of Abutment 2.

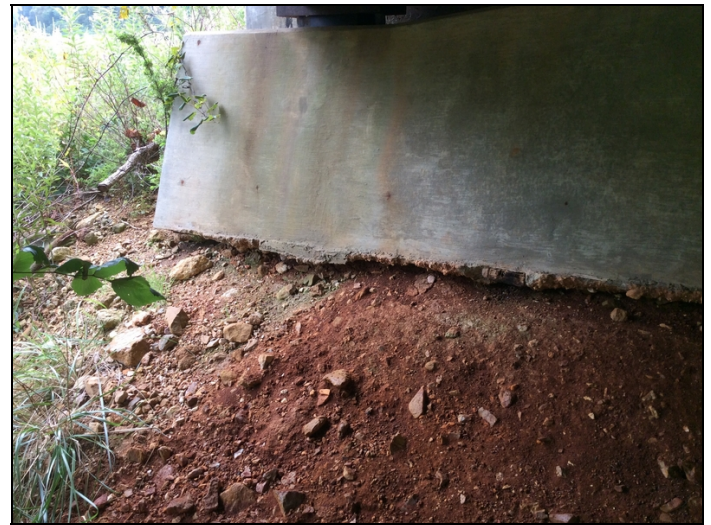
Scour to Left end of Abutment 2.

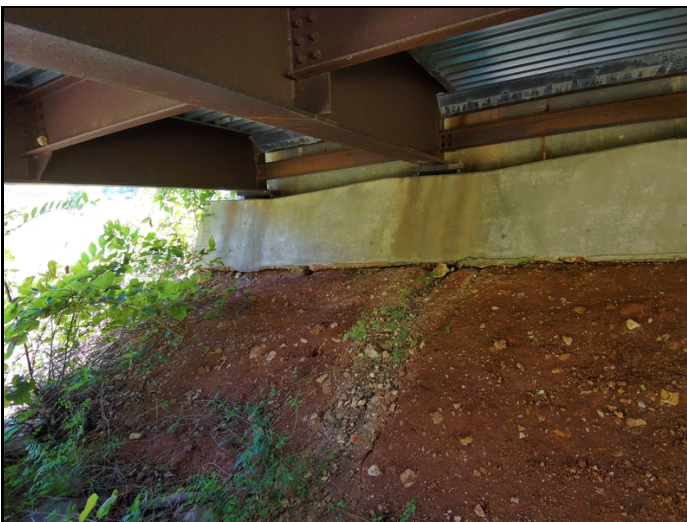
Abutment 2 has erosion to Left and Right ends.  
Left side.

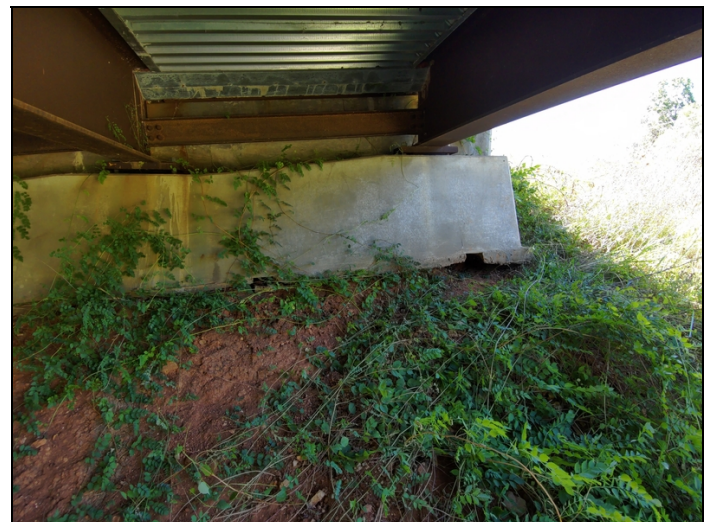
Abutment 2 has erosion to Left and Right ends.  
Right side.

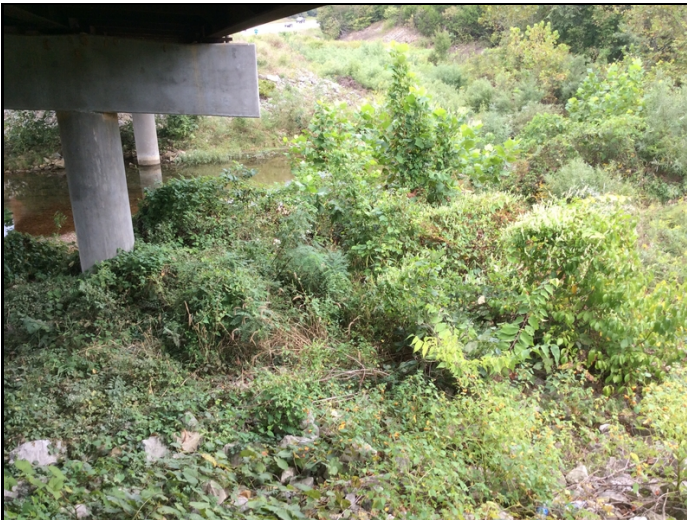
Vegetation growing under and around structure restricting flow and access.

Vegetation on Left side of bridge.

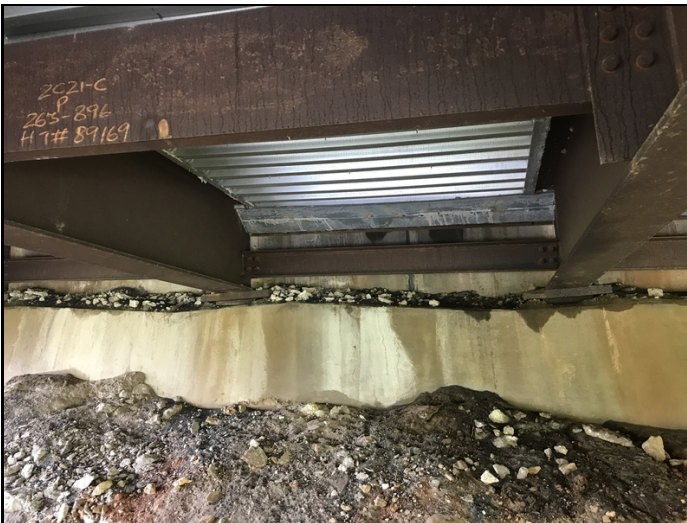
Heavy debris on cap @ Abutment 1.
