Asset #07337 (Routine, Underwater type 2)

US 63 FULTON over Gut Creek

Location: 4.45 Mi. N.SharpCo.Line

Team Lead: Nathan Edwards, Inspection Date: 04/25/2023

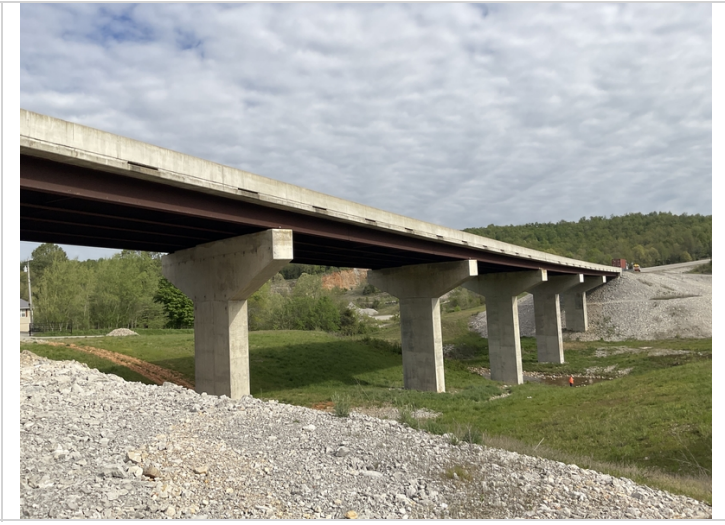
Elevation with Log Mile running to the Left.

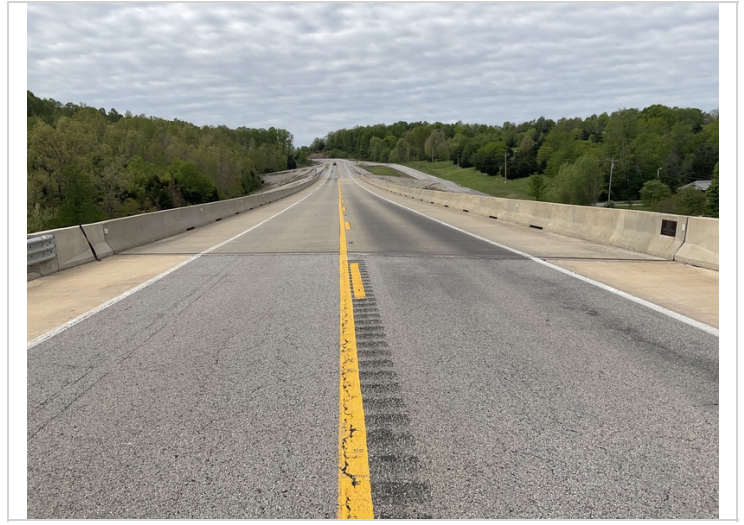
Roadway with Log Mile running North to South.
