**Asset #07126**(Routine)

**SH 9 Izard Co. over Big Hurricane Creek**

**Location: 2.48 M N SH 69**

**Team Lead:** Kerry Little **Inspection Date:** 07/24/2023

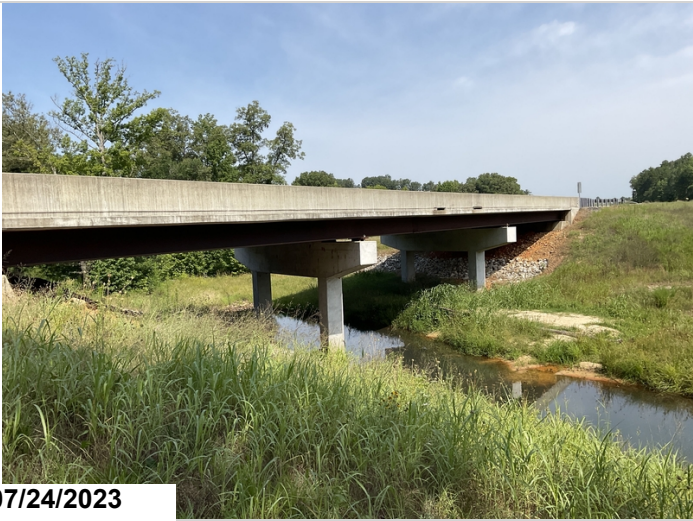
Elevation with log mile going right.

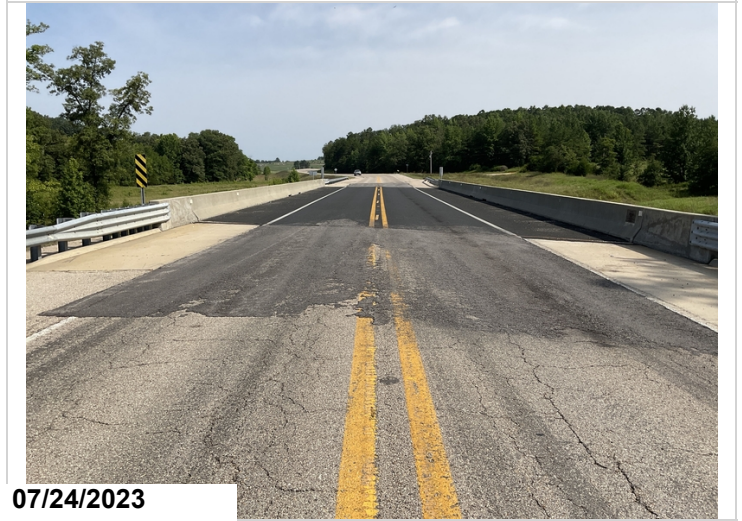
Roadway with log mile looking north.

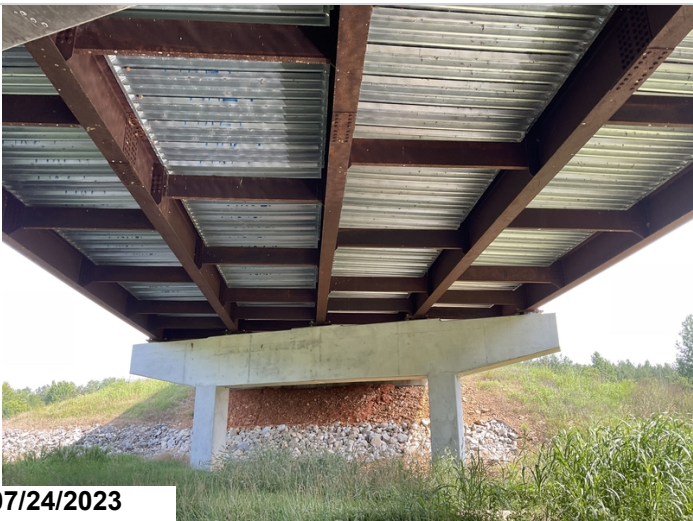
Overall deck below @ span 2.

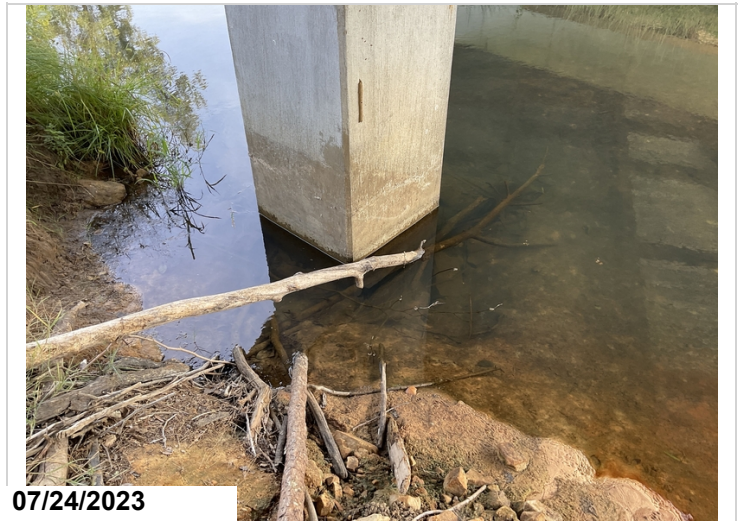
(205) Local scour @ Columns 1 & 2 @ Bent 1.							
215	Reinforced Concrete Abutment	LF	132	47	81	4	0
1120	Efflorescence/Rust Staining	LF	9	0	9	0	0
6000	Scour	LF	76	0	72	4	0

Local scour @ Columns 1 & 2 @ Bent 1.

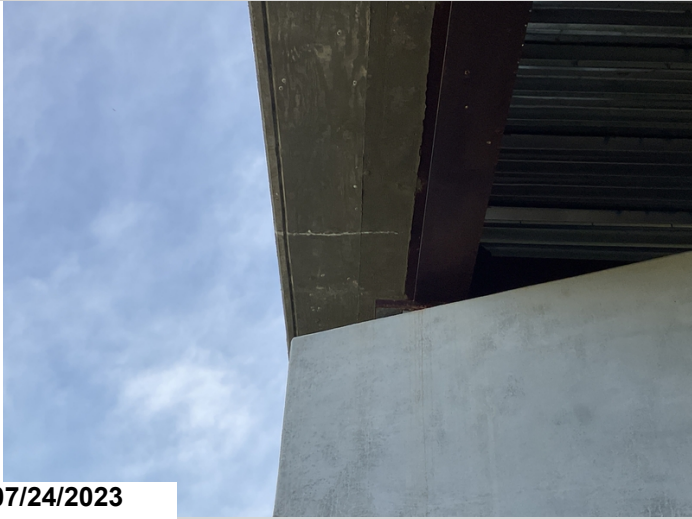
(12) Few minor cracks to deck. Minor efflorescent cracking to Left & Right overhangs.							
107	Steel Open Girder/Beam	LF	725	725	0	0	0
515	Steel Protective Coating	SF	5510	5510	0	0	0
205	Reinforced Concrete Column	EA	4	2	2	0	0
6000	Scour	EA	2	0	2	0	0

Efflor cracks to Lt & Rt overhangs.

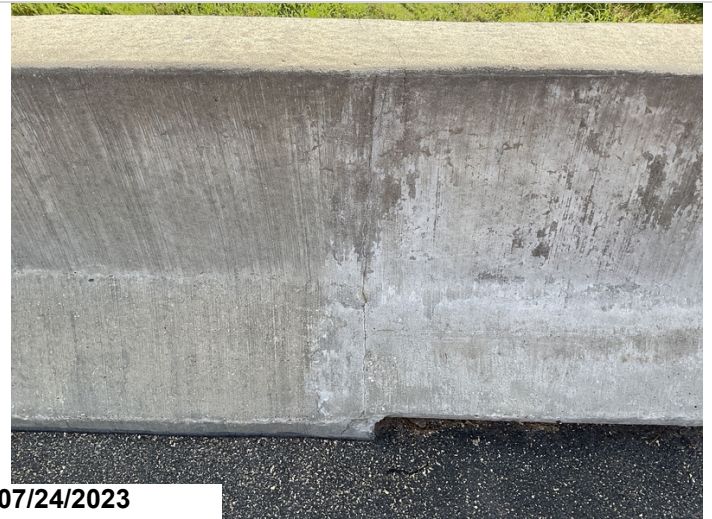
(331) Minor vertical cracking to Left & Right parapets.

Typical cracks to Lt & Rt parapet wall.

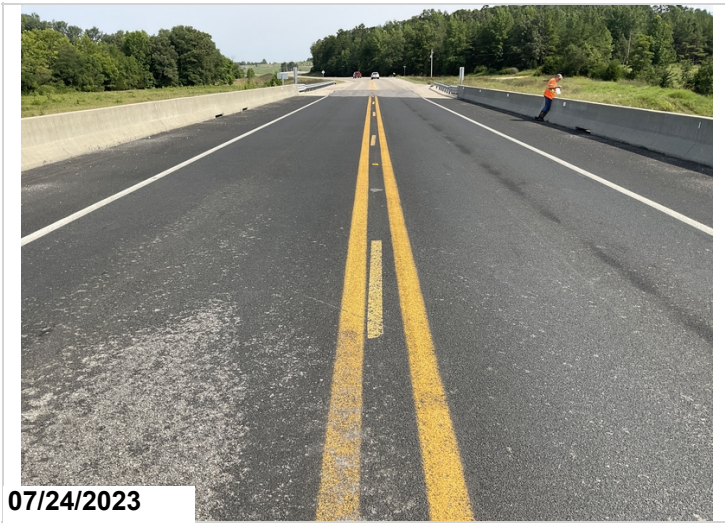
Overall deck.

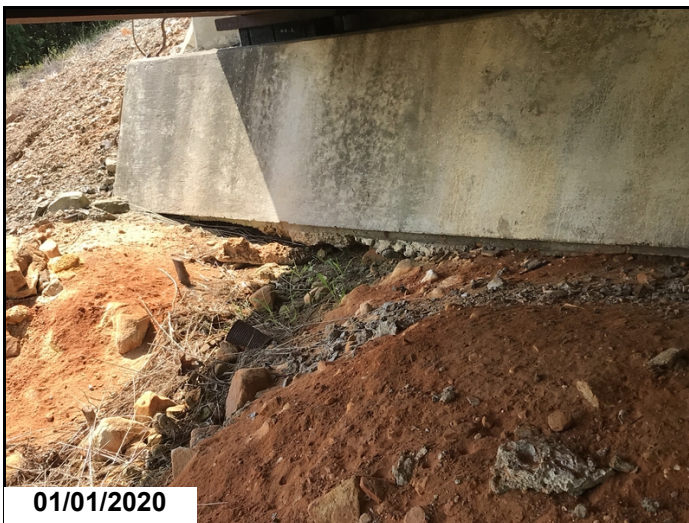
Minor scouring to Abutments 1 & Rt. end of Abutment 2.

Minor erosion to Rt ends @ abutments 1.

Status: Monitor

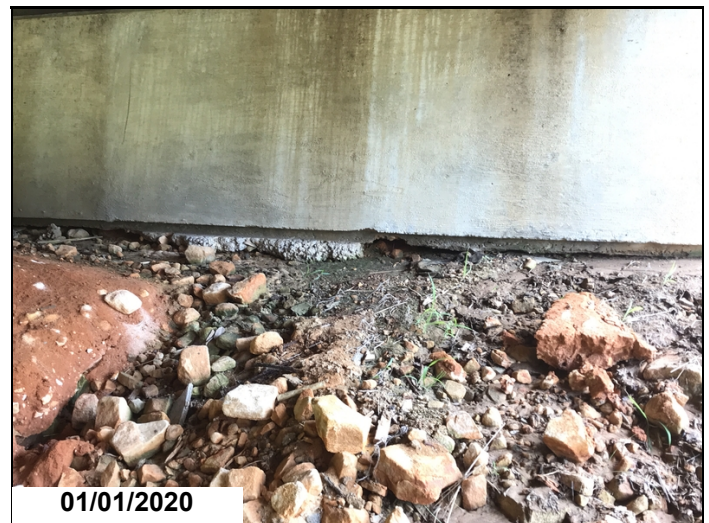
Minor erosion to Rt. end of Abutment 2

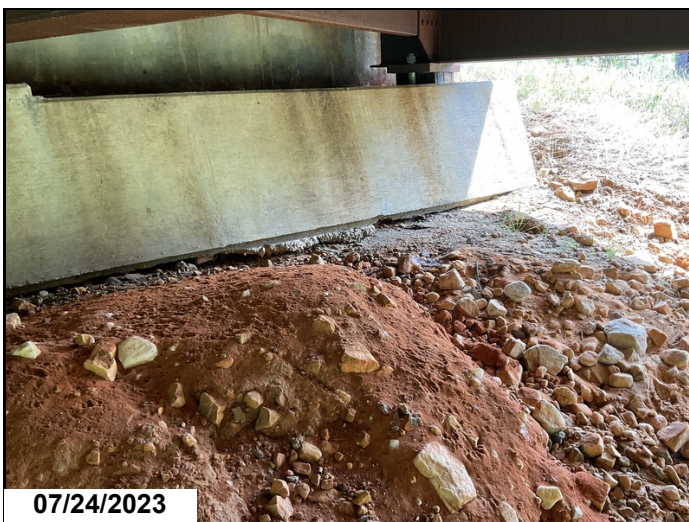
Minor scouring to Abutments 1 & 2 on Rt ends.  
Abutment 2.

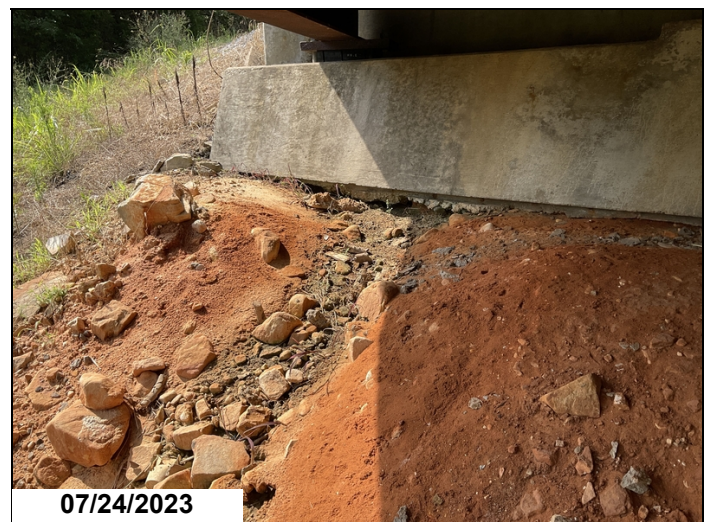
Minor scouring to Abutments 1 & 2 on Rt ends.  
Abutment 1.
