Asset #03406(Routine)

US 63/Sharp Co. over MARTIN CREEK

Location: .5 MI E JCT OF SH 58 63

Team Lead: Kerry Little, Inspection Date: 06/20/2023

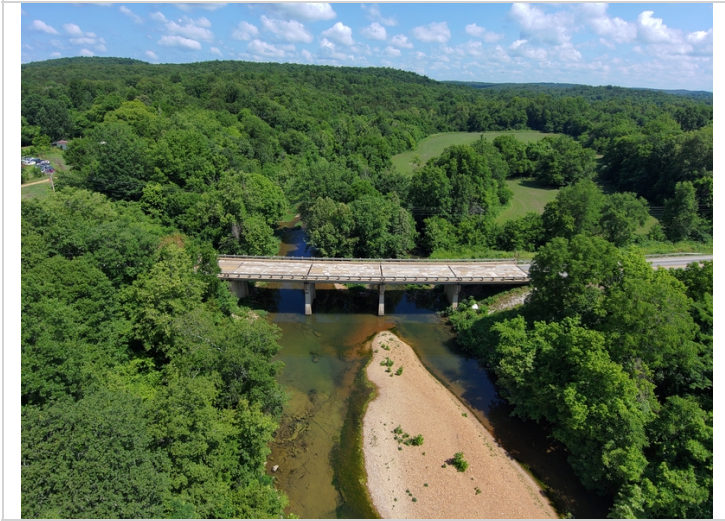
Elevation with Log Mile going right.

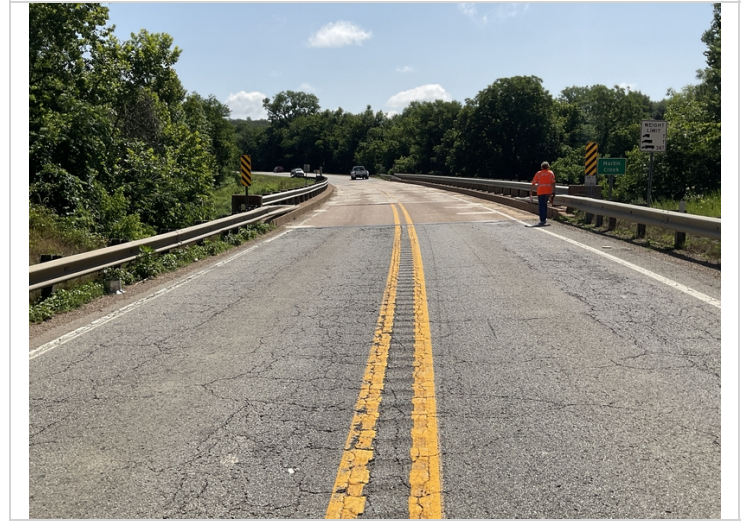
Roadway with log mile looking east.

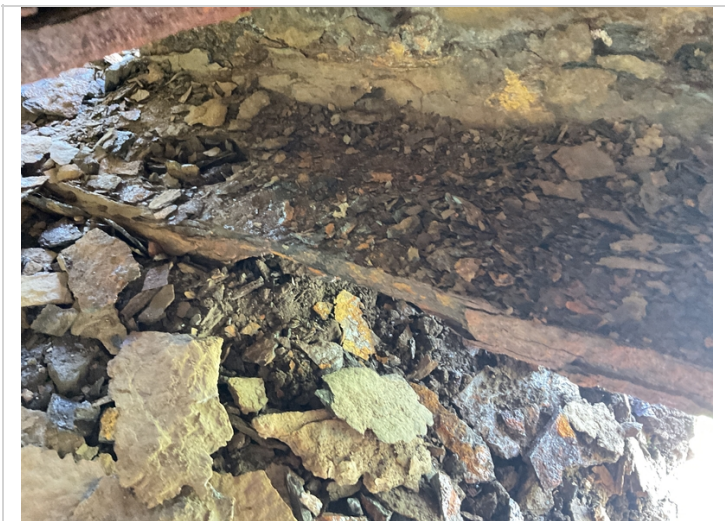
Heavy rust with section loss to girder 1 @ beginning of span 5. Holes to bottom flange on each side of web.

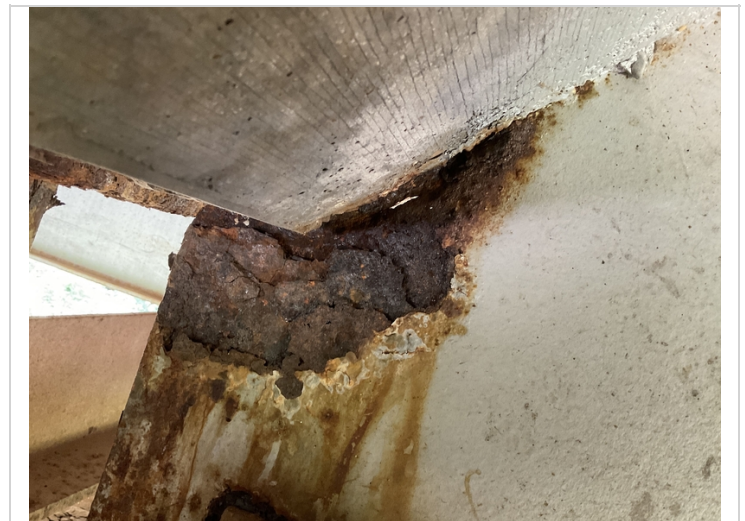
Hole in web below paving haunch @ girder 3, end of span 4.

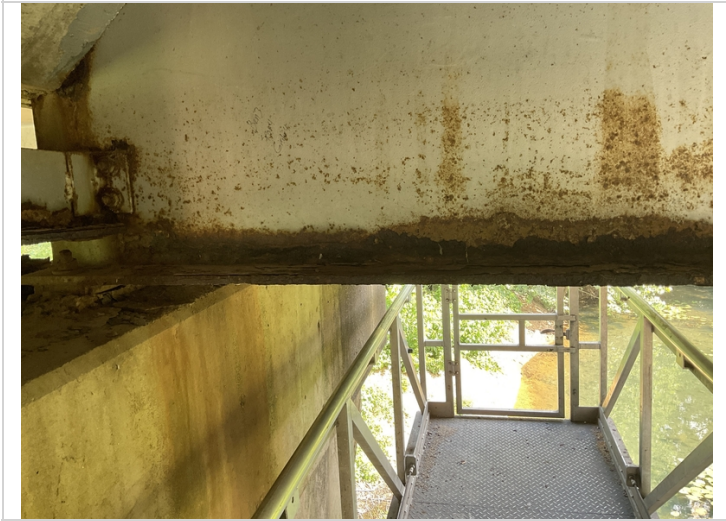
Heavy rust with section loss to girders 2 & 3 @ beginning of span 4.

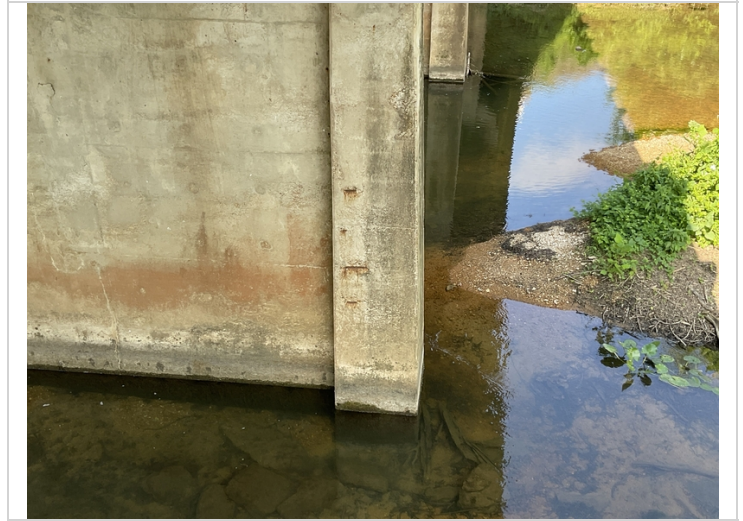
Spalls with rebar exposed to column 1 @ ahead side of bent 3.

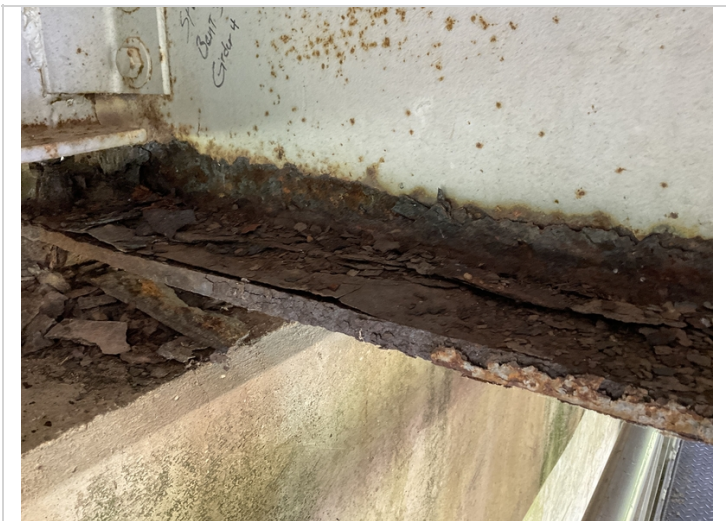
Heavy rust with section loss to bottom of web & flange to girder 2, end of span 3.

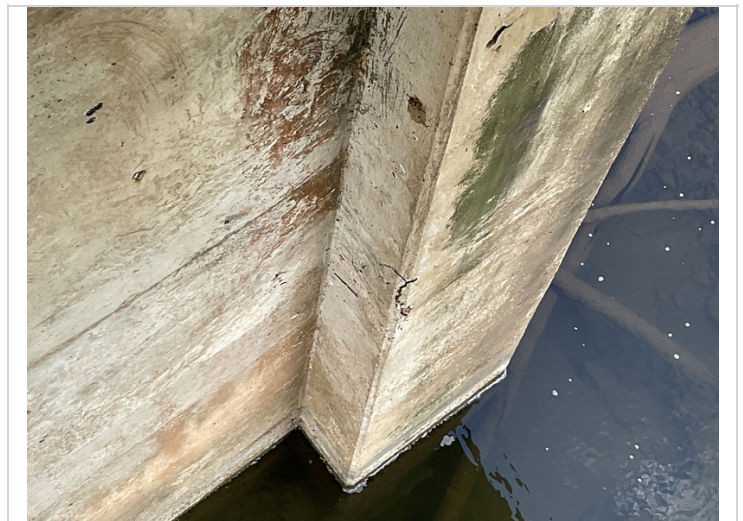
Cracking to column 1 @ ahead side of bent 2.

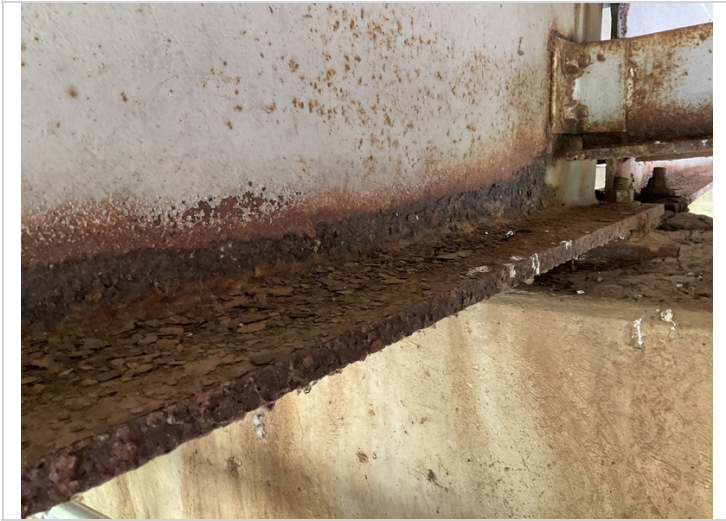
Typical rust to ends of girders @ all spans.  
Girder 3, end of span 2.

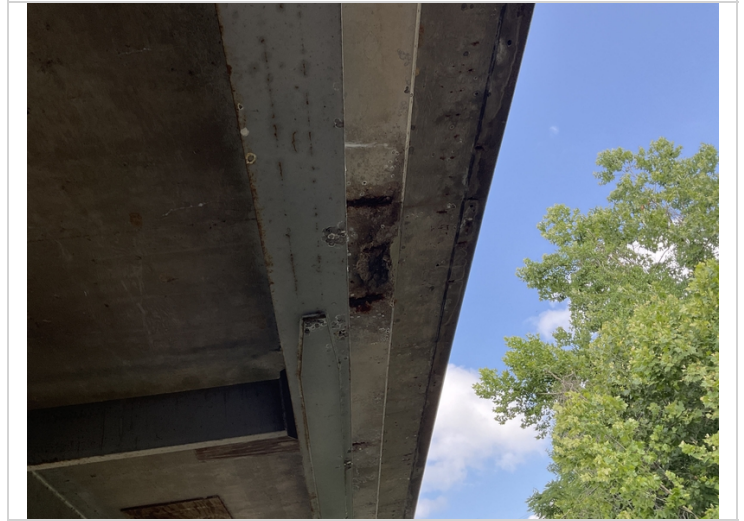
Spall with rebar exposed with section loss to Lt overhang @  
span 2.

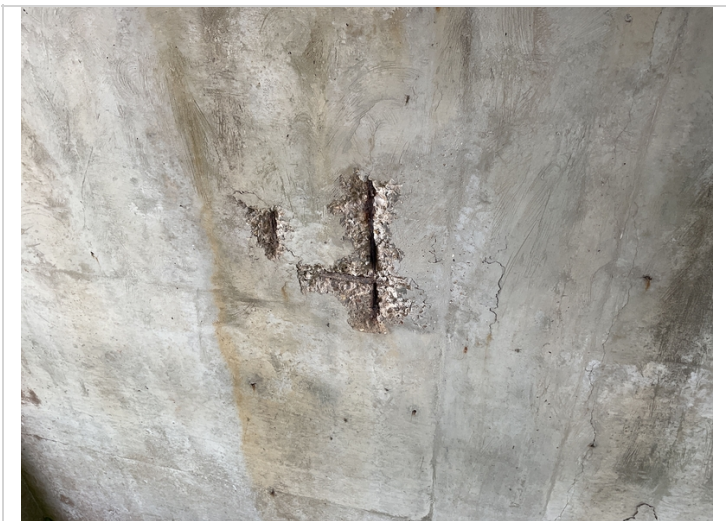
Spall with rebar exposed with section loss to pier wall @  
ahead side of bent 1.

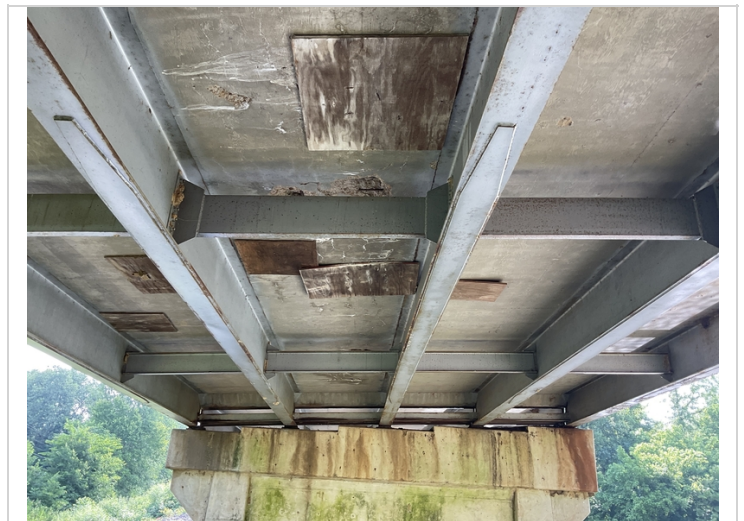
Overall soffit @ span 2.

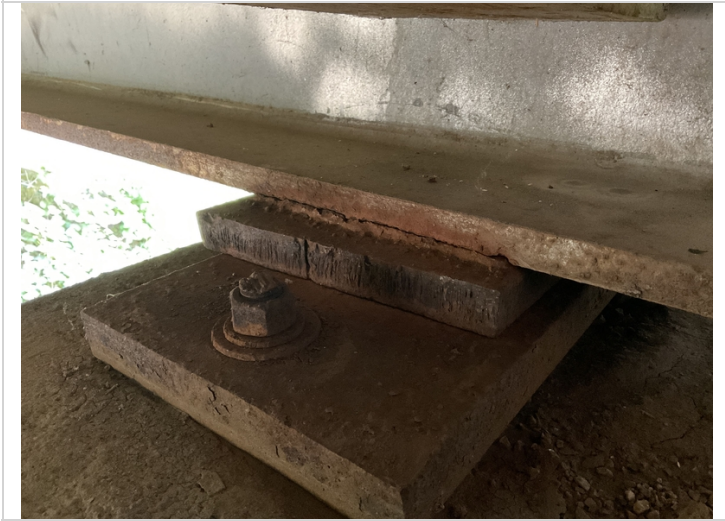
Broken weld to sole plate of bearing 2 @ end of span 1.

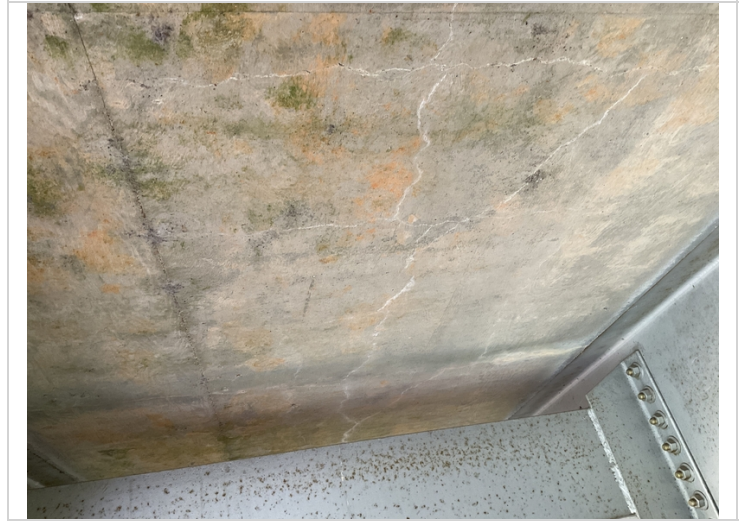
Typical efflor cracks to soffit @ all spans.  
Span 1

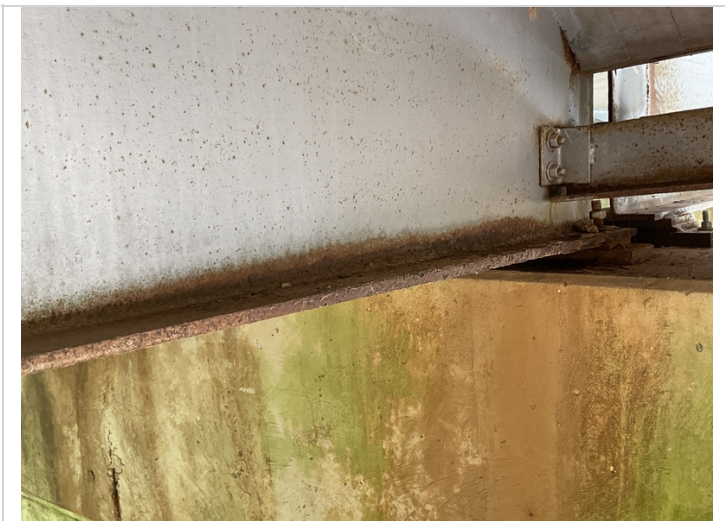
Typical rust to ends of girders @ all spans.

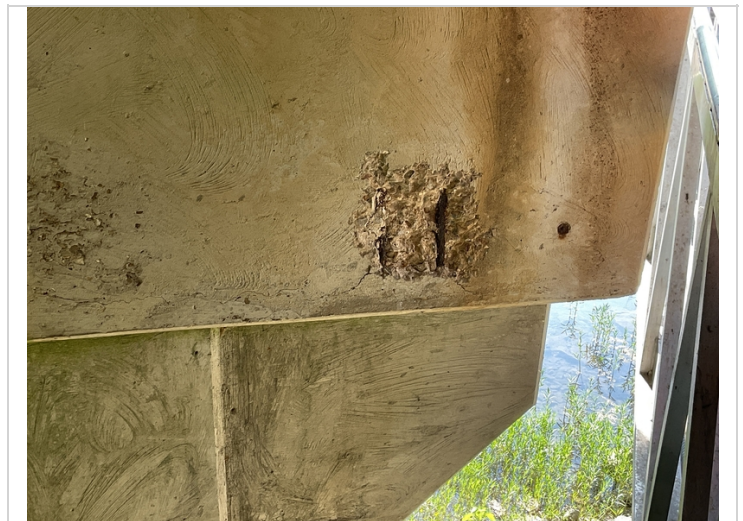
Spall with rebar exposed to rt end of cap with section loss @  
backside of bent 1.

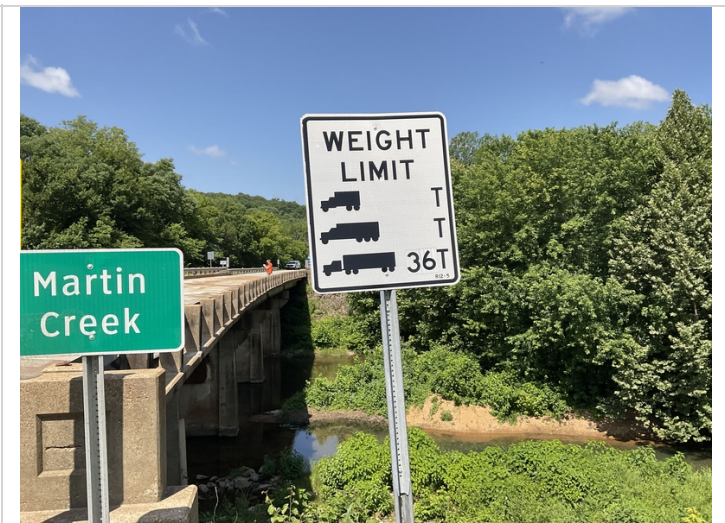
Load posting sign @ abutment 2.

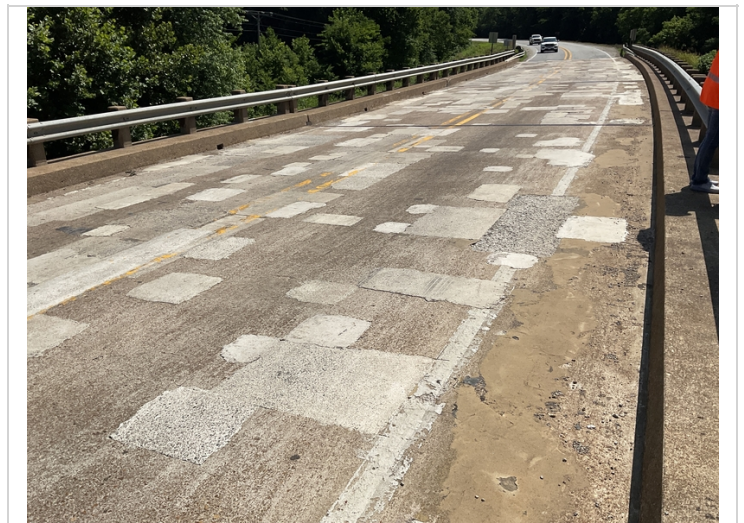
Typical patched areas to 90% of deck.

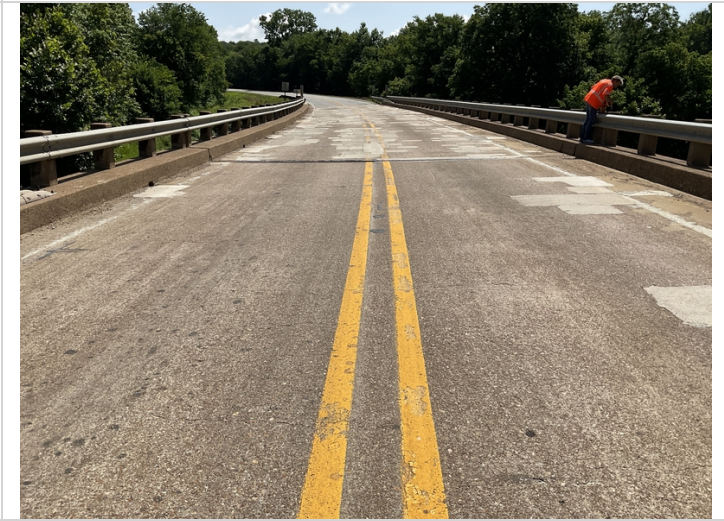
Overall deck

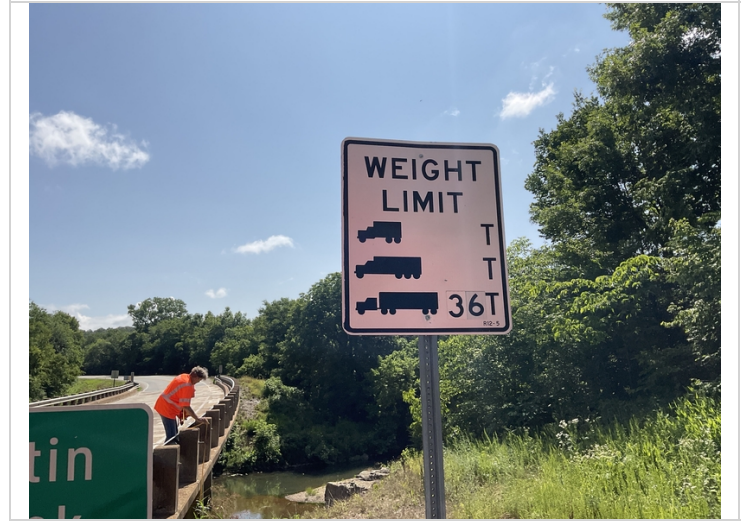
Load posting sign @ abutment 1.

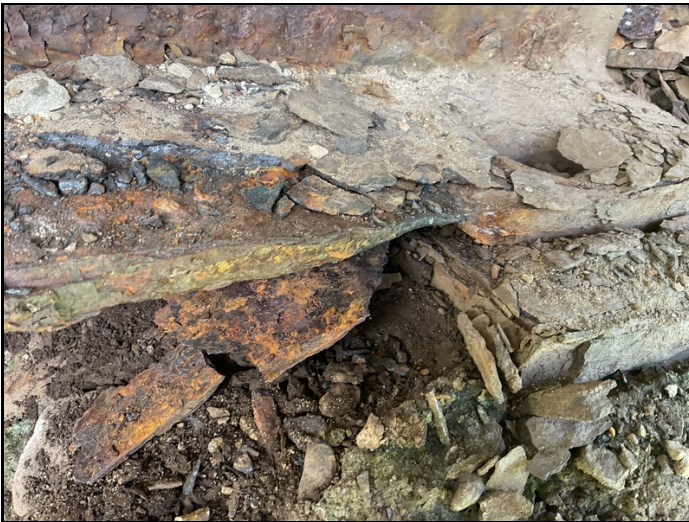
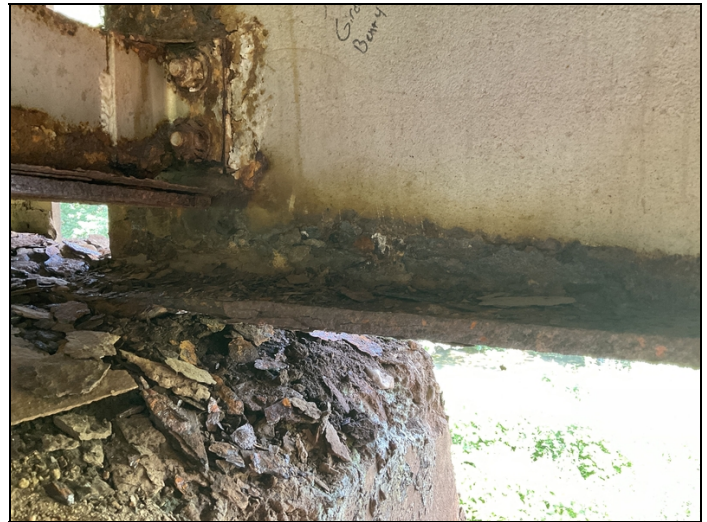
**Priority:** A - Safety deficiency; requires prompt action

Heavy rust with section loss to girder 1 @ beginning of span 5. Holes to bottom flange on each side of web.

**Type of Work:** Superstructure Repair

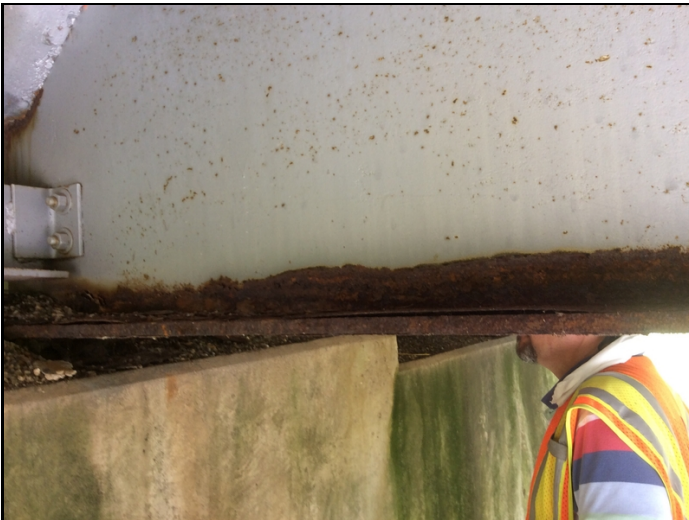
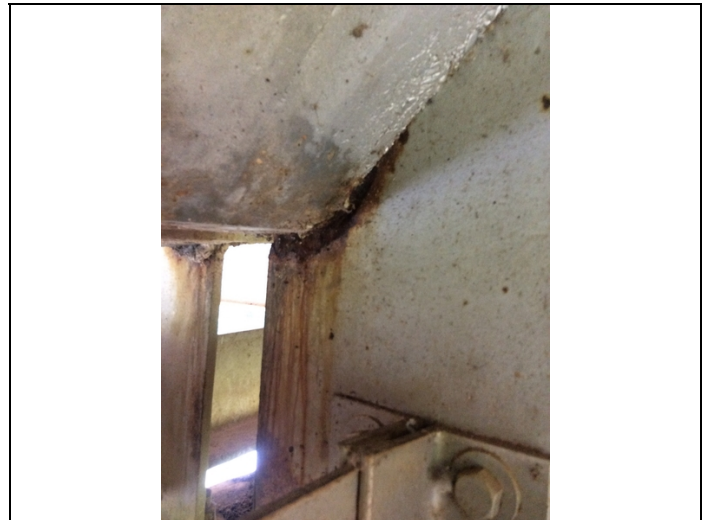
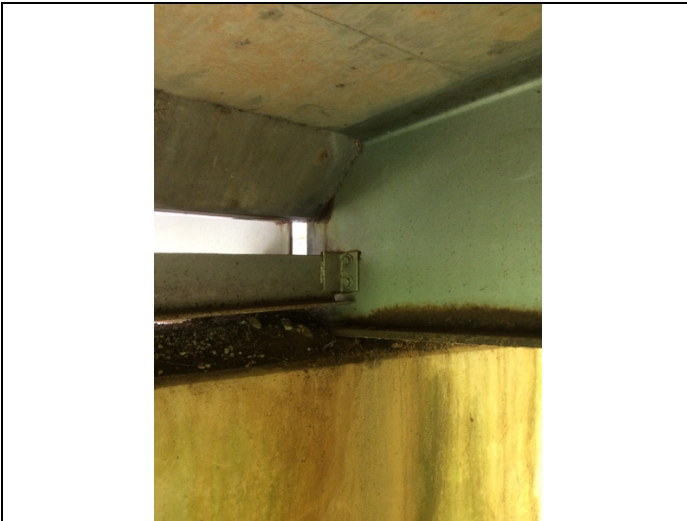
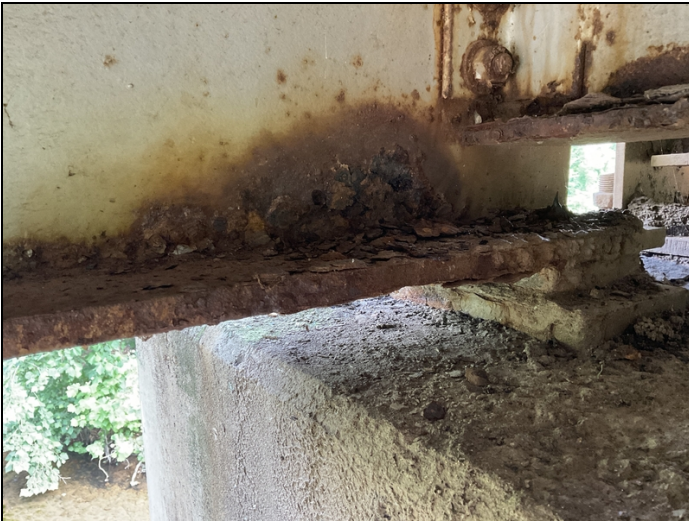
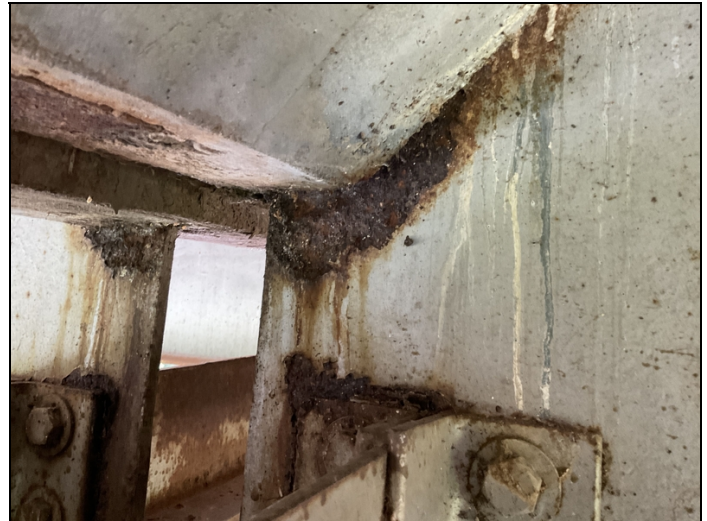
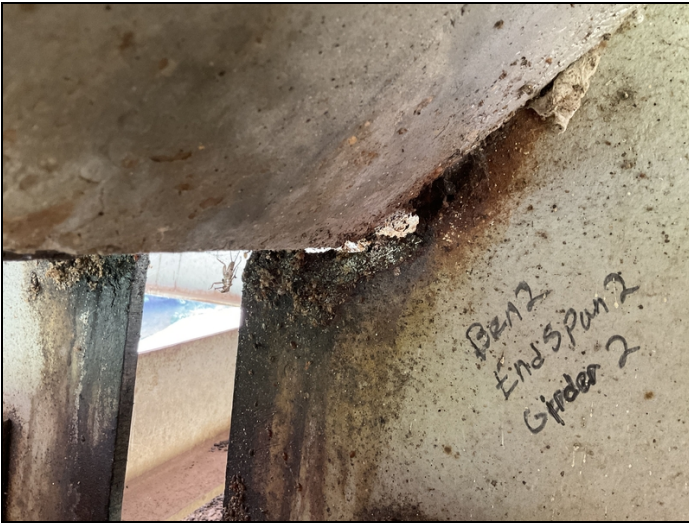
Rust and section loss, some with holes to ends of girders and bottom flange at all spans.  
Holes in Girders @: Span2 Girder 4 at end of span. Span 4 Girders 3, 4 at end of span.

Rust and section loss to ends of girders and bottom flange at all spans.

Rust and section loss, some with holes to ends of girders and bottom flange at all spans.  
Hole in web of Girder #4 at end of Span #2.

Rust and section loss, some with holes to ends of girders and bottom flange at all spans.  
Girder 1, end of span 2.

Rust and section loss, some with holes to ends of girders and bottom flange at all spans.  
Girder 2, end of span 2.

Rust and section loss, some with holes to ends of girders and bottom flange at all spans.

Hole to web below paving haunch @ girder 4, end of span 2.

**Type of Work:** Repair (General)

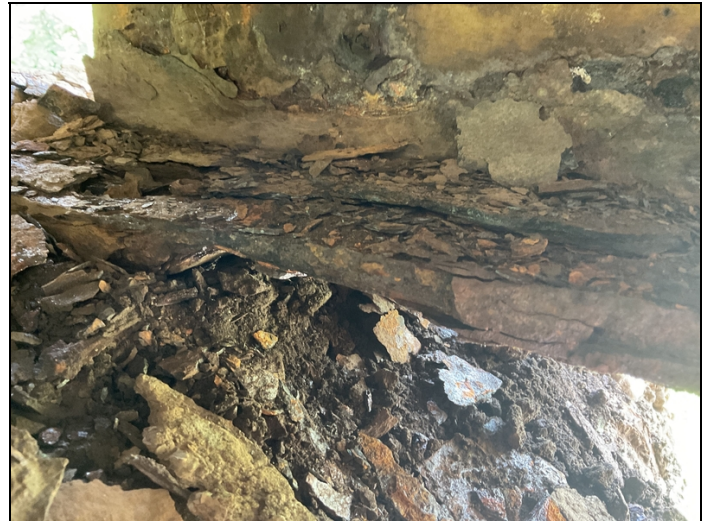
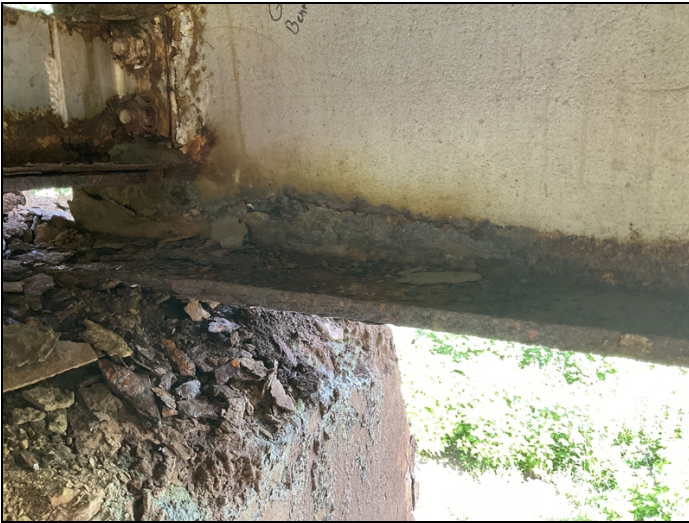
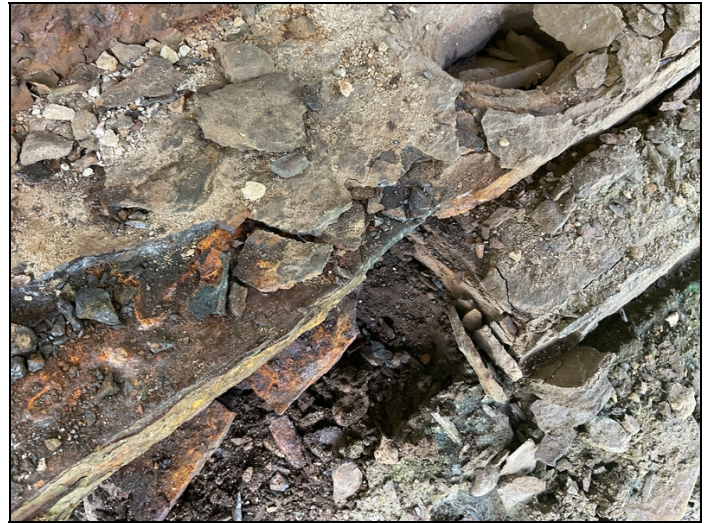
Heavy rust with section loss to girder 1 @ beginning of span 5. Holes to bottom flange on each side of web.

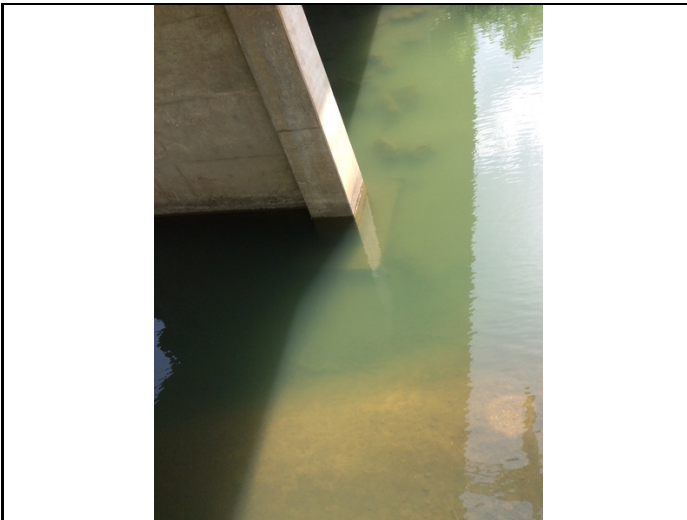
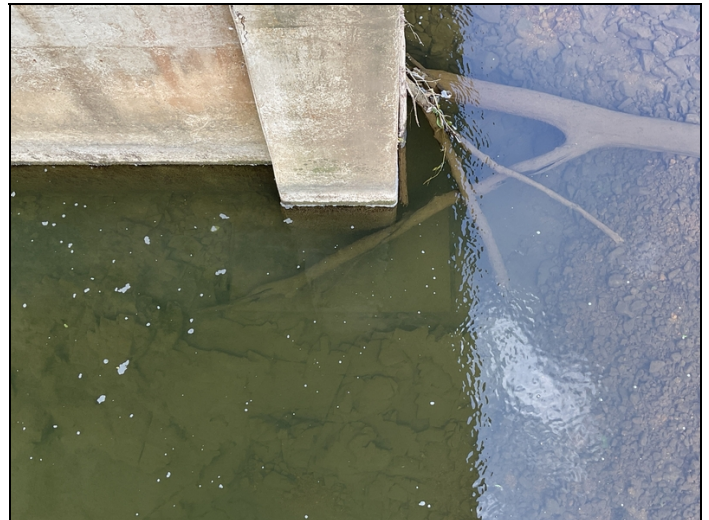
Bents #2 & #3

Scour to right side - top of footings exposed.

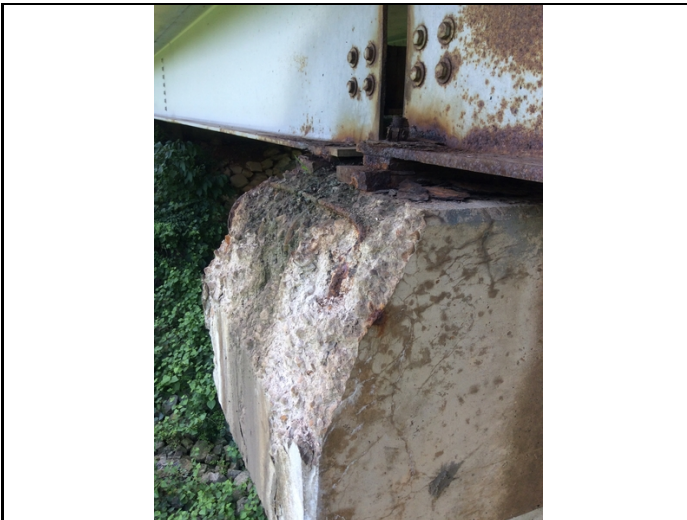
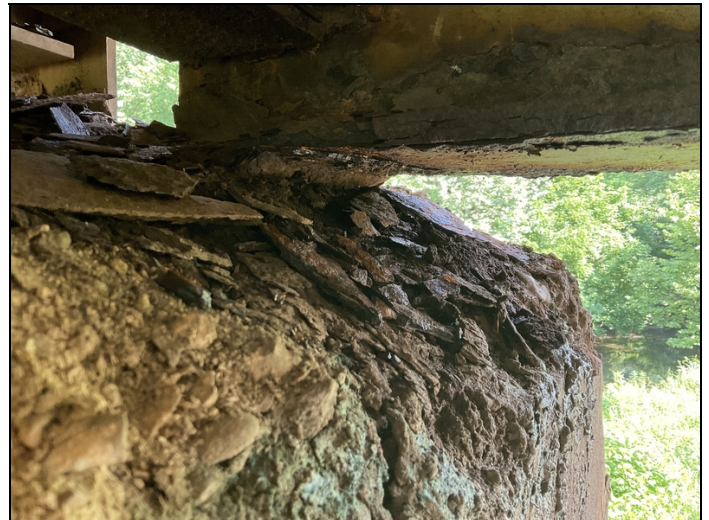
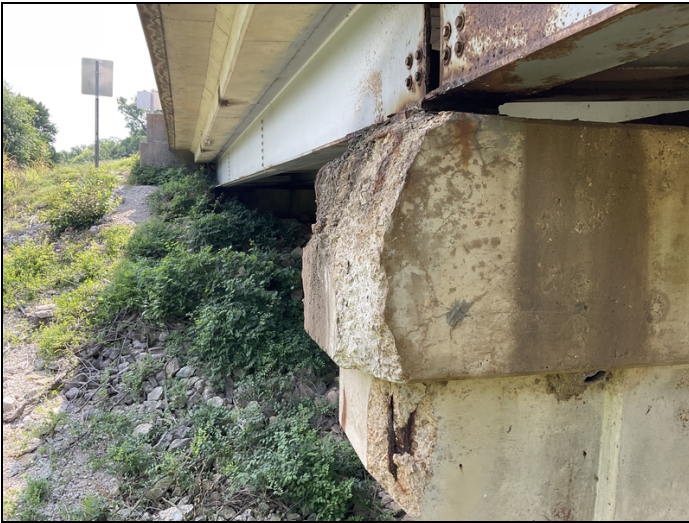
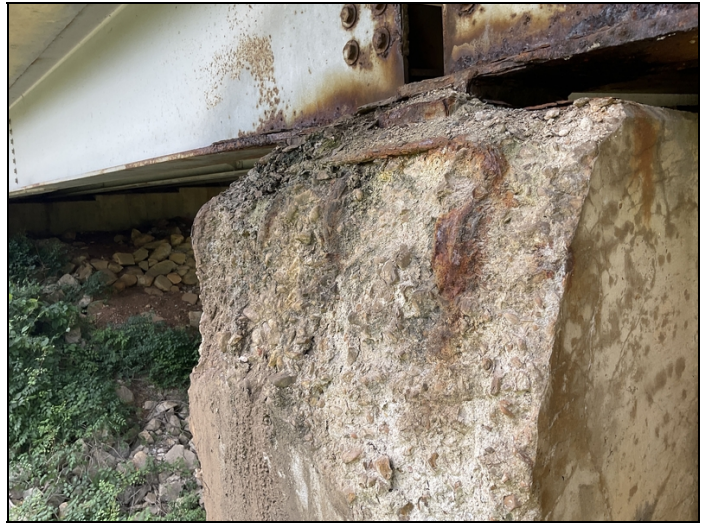
Efflor. map cracking, chemical deterioration, and spalls w/ rebar exposed & loss of bearing area to left end of cap at Bent #4

Efflor. map cracking, chemical deterioration, and spalls w/ rebar exposed to left end of cap at bent #4

Efflor. map cracking, chemical deterioration, and spalls w/ rebar exposed & loss of bearing area to left end of cap at bent #4

DEfflor. map cracking, chemical deterioration, and spalls w/ rebar exposed to left end of cap at bent #4

**Type of Work:** Substructure Repair

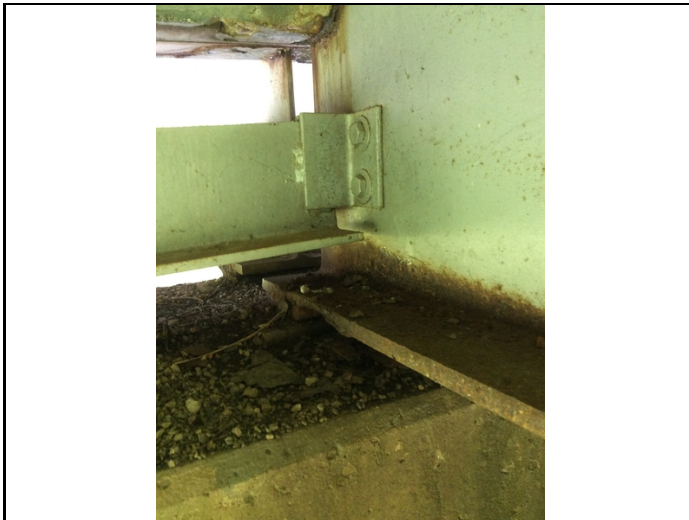
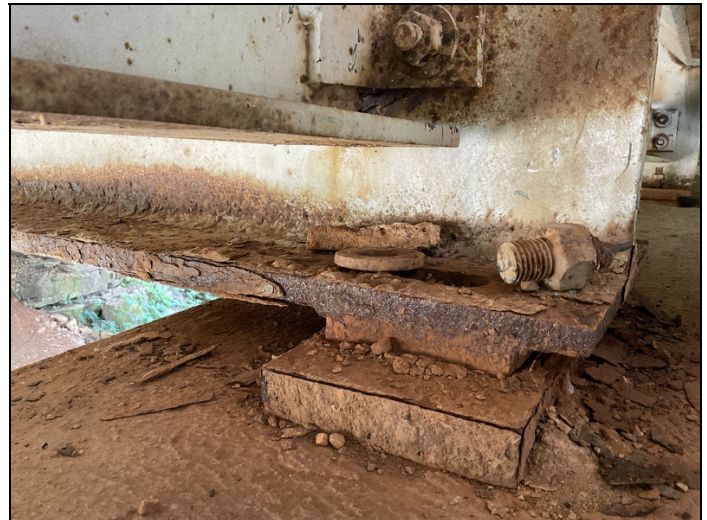
Bents #1, #2, #3 & #4

Section loss to anchor bolts with some missing.

Section loss to anchor bolts with some loose or missing.

Section loss to anchor bolts with some missing.  
Broken bolt @ bearing 4, end of span 1.

**Type of Work:** Replace (General)

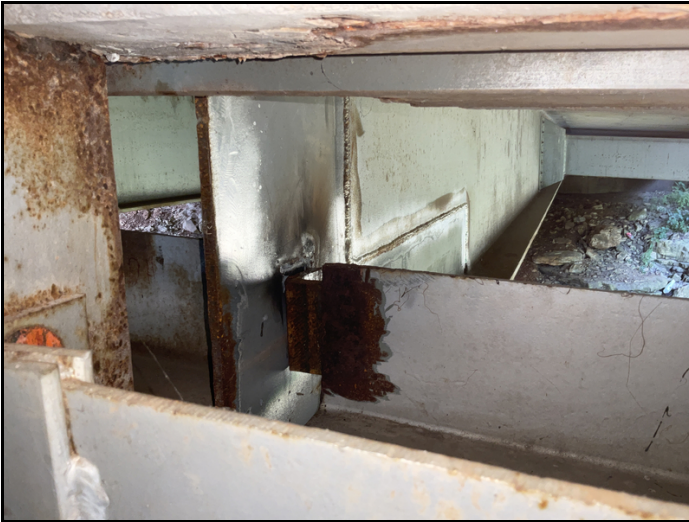
Diaphragm between Girders 1 & 2 @ end of Span 1 is not connected @ Girder 2. REPAIRED

Diaphragm between Girders 1 & 2 @ end of Span 1 is not connected @ Girder 2.

Assigned to Bridge Crew - 8/12/2022

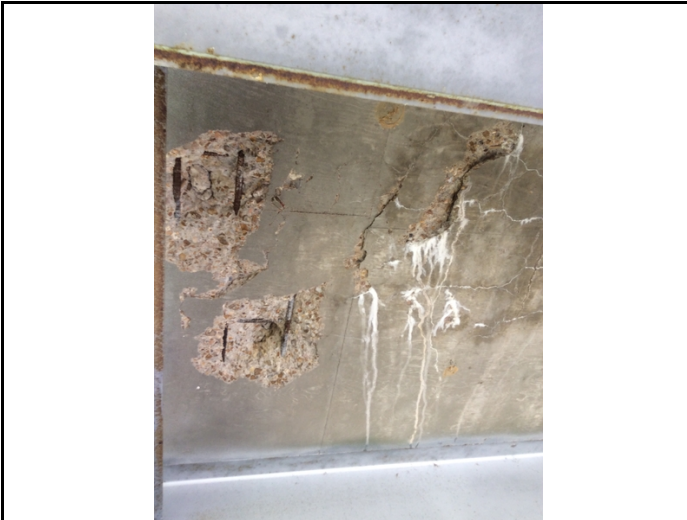
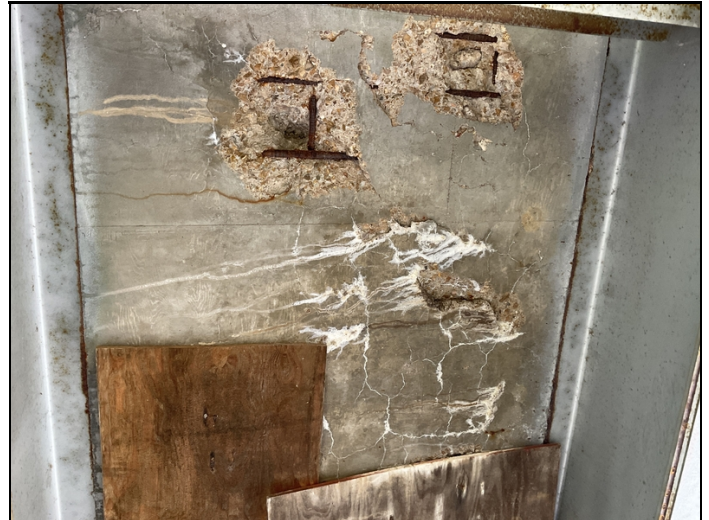
Spans #2 - #5 have spalls w/ rebar exposed, some with efflor. to soffit.

Spans #2 - #5 have spalls w/ rebar exposed, some with efflor. to soffit.  
Span 2, between girders 2 & 3.

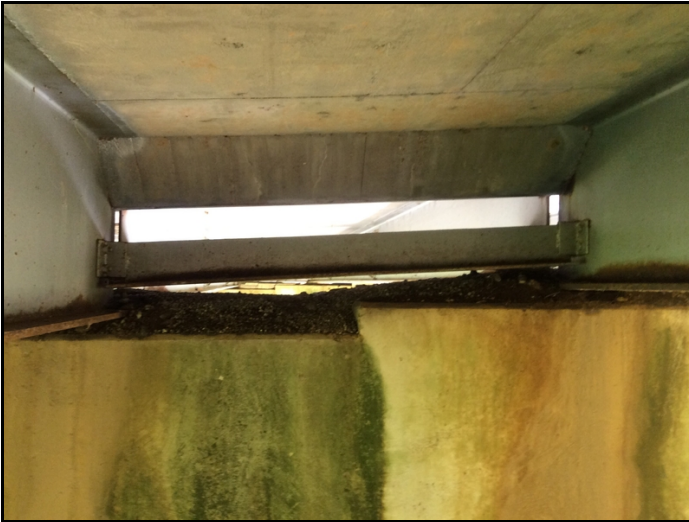
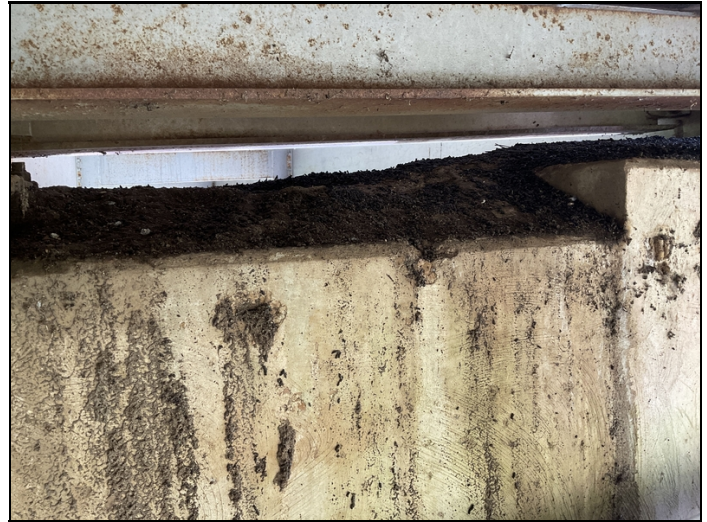
Debris on caps at all spans.

Typical debris on cap @ all spans.

**Type of Work:** (Inactive) (Inactive) 1 - Clean
